FINAL
Drainage Feasibility Study
Volume II (Geotechnical Component Vol. 1)

Community of Rimforest
County of San Bernardino, CA

**GEOLOGICAL INVESTIGATION AND FEASIBILITY
EVALUATION OF PROPOSED MITIGATION
PROCEDURES TO REDUCE THE POTENTIAL
FOR ACTIVE LANDSLIDING IMMEDIATELY SOUTH
OF THE COMMUNITY OF RIMFOREST
SAN BERNARDINO COUNTY, CALIFORNIA**

PROJECT NO.: 168-H09
REPORT NO.: 1

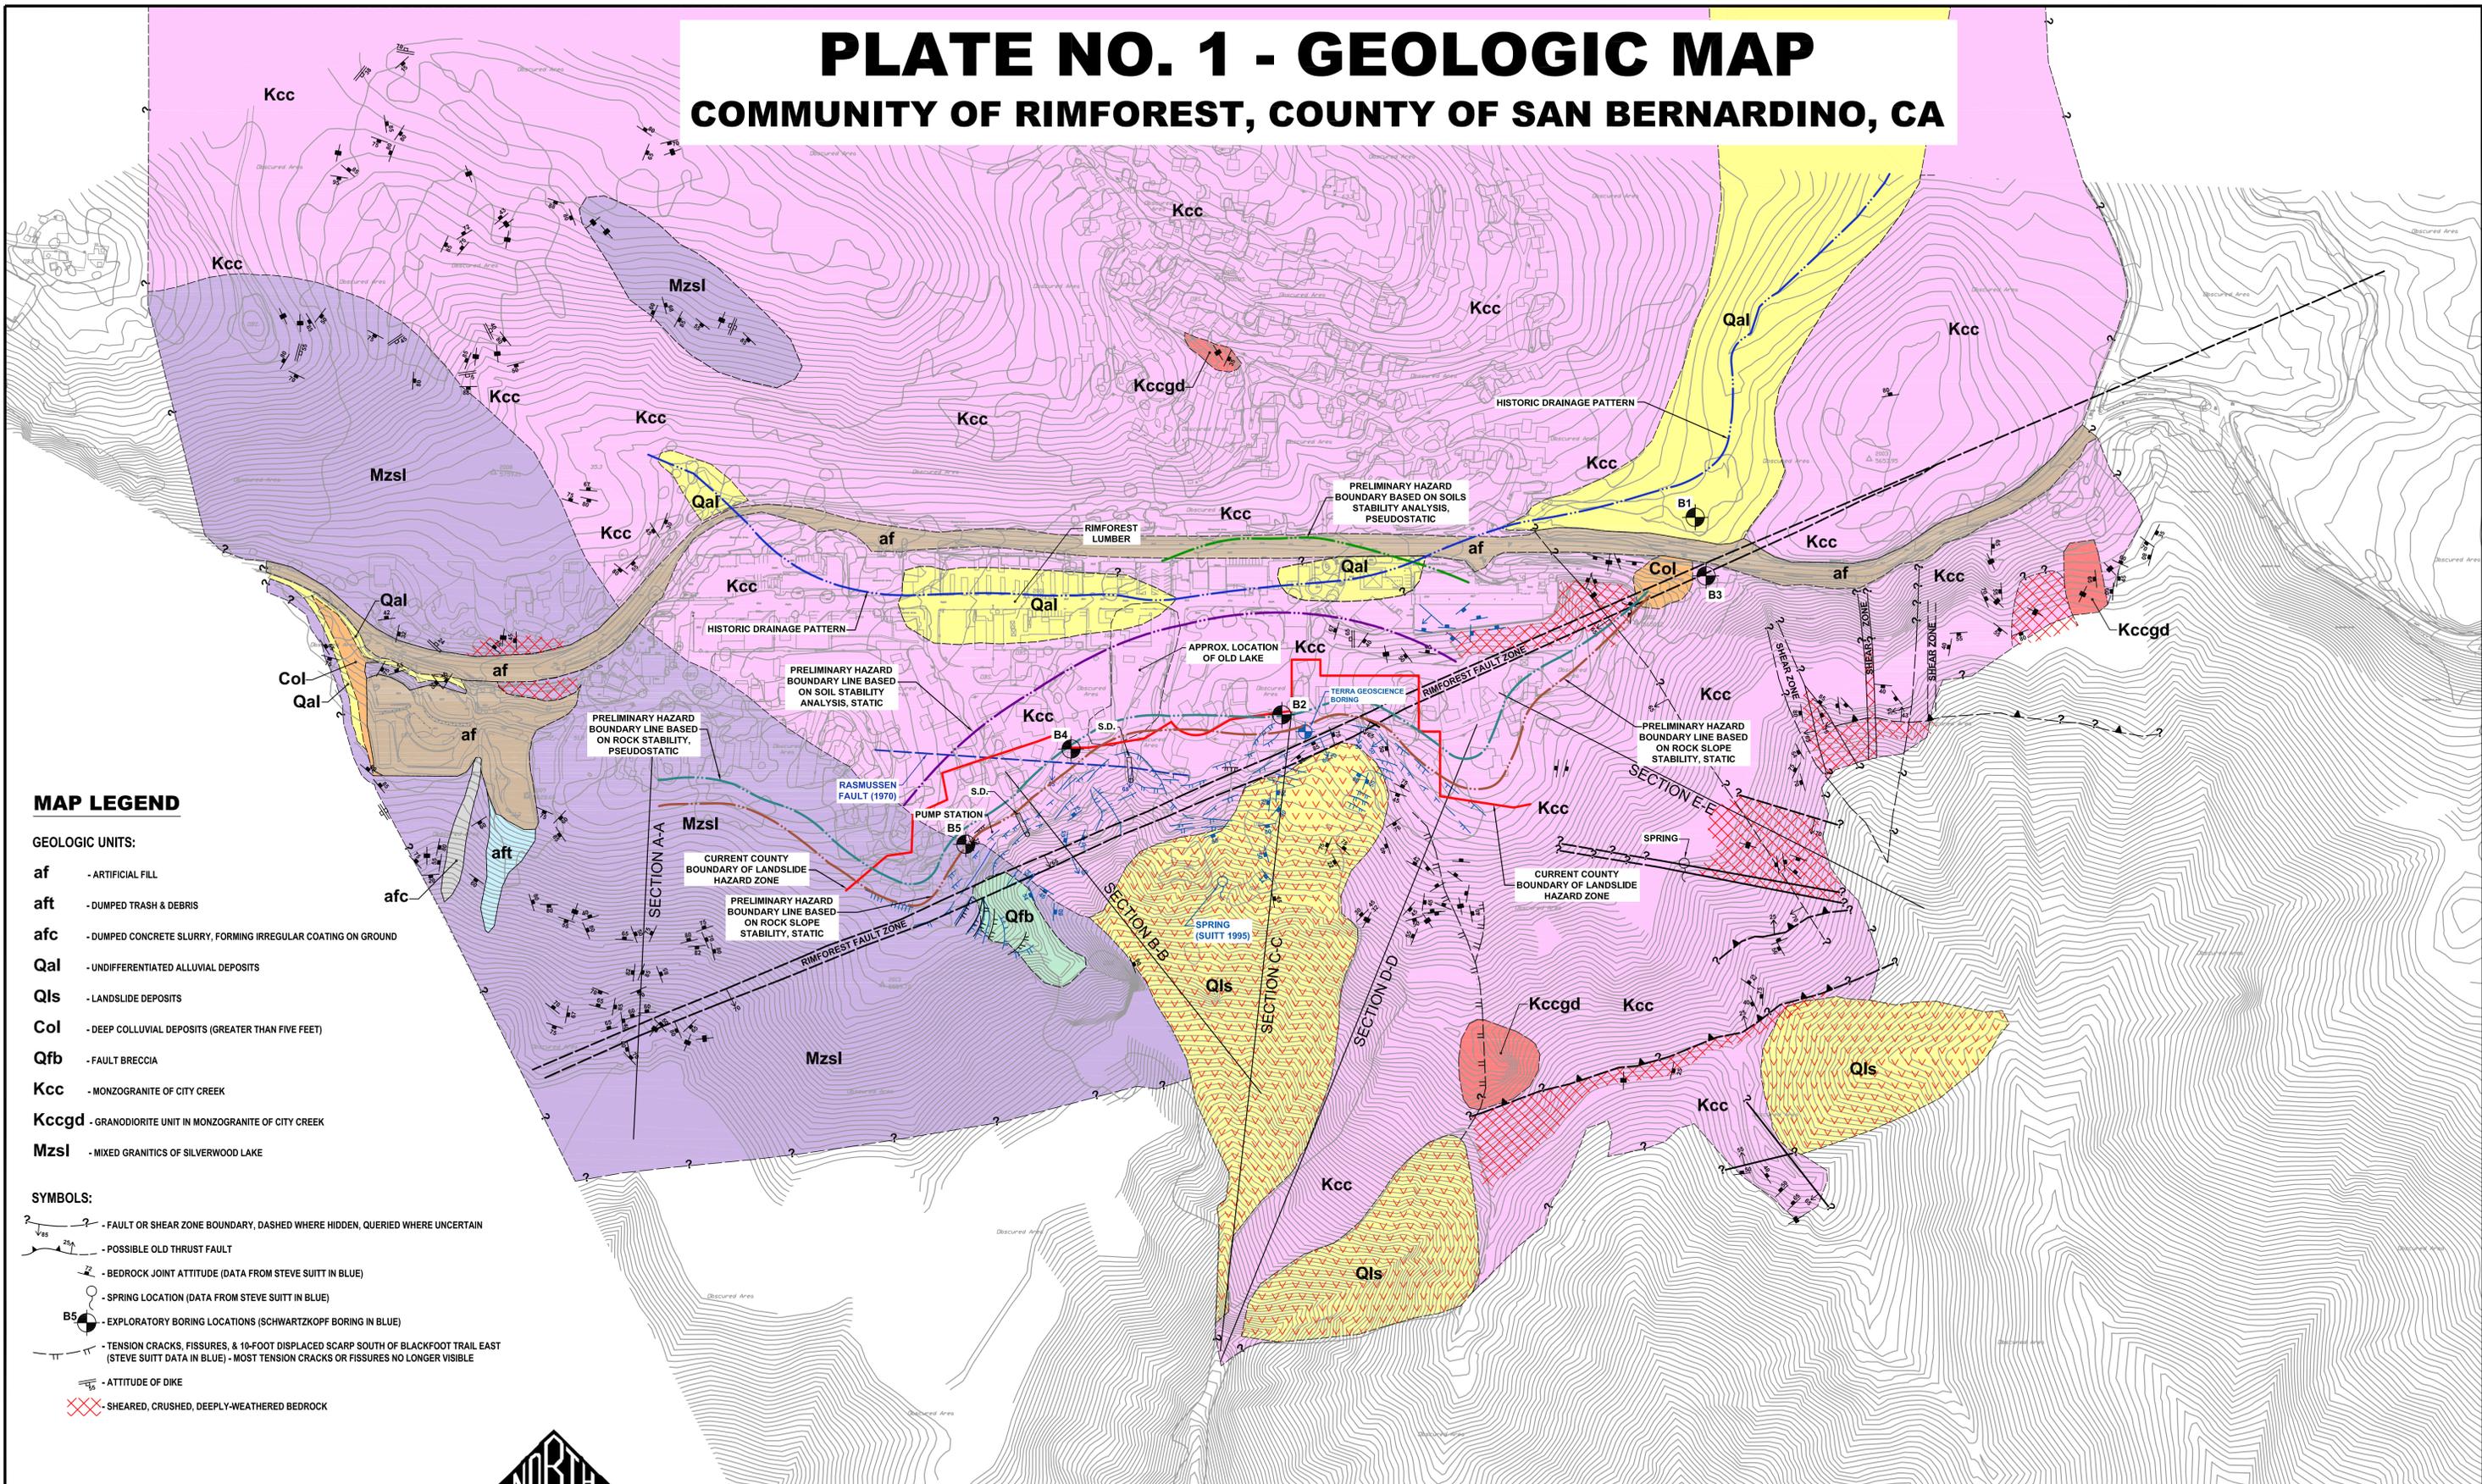
PLATE NO. 1 - GEOLOGIC MAP

Slope stability analyses, carried out using rock slope stability and soil slope stability parameters and methods, determined that significant areas of potential slope failure extend beyond the present top of slope and incorporate some currently occupied residences. Preliminary hazard boundary lines have been created as a result of this investigation. The preliminary hazard boundary lines represent estimated limits of increased landslide risk and are depicted on Plate No. 1.

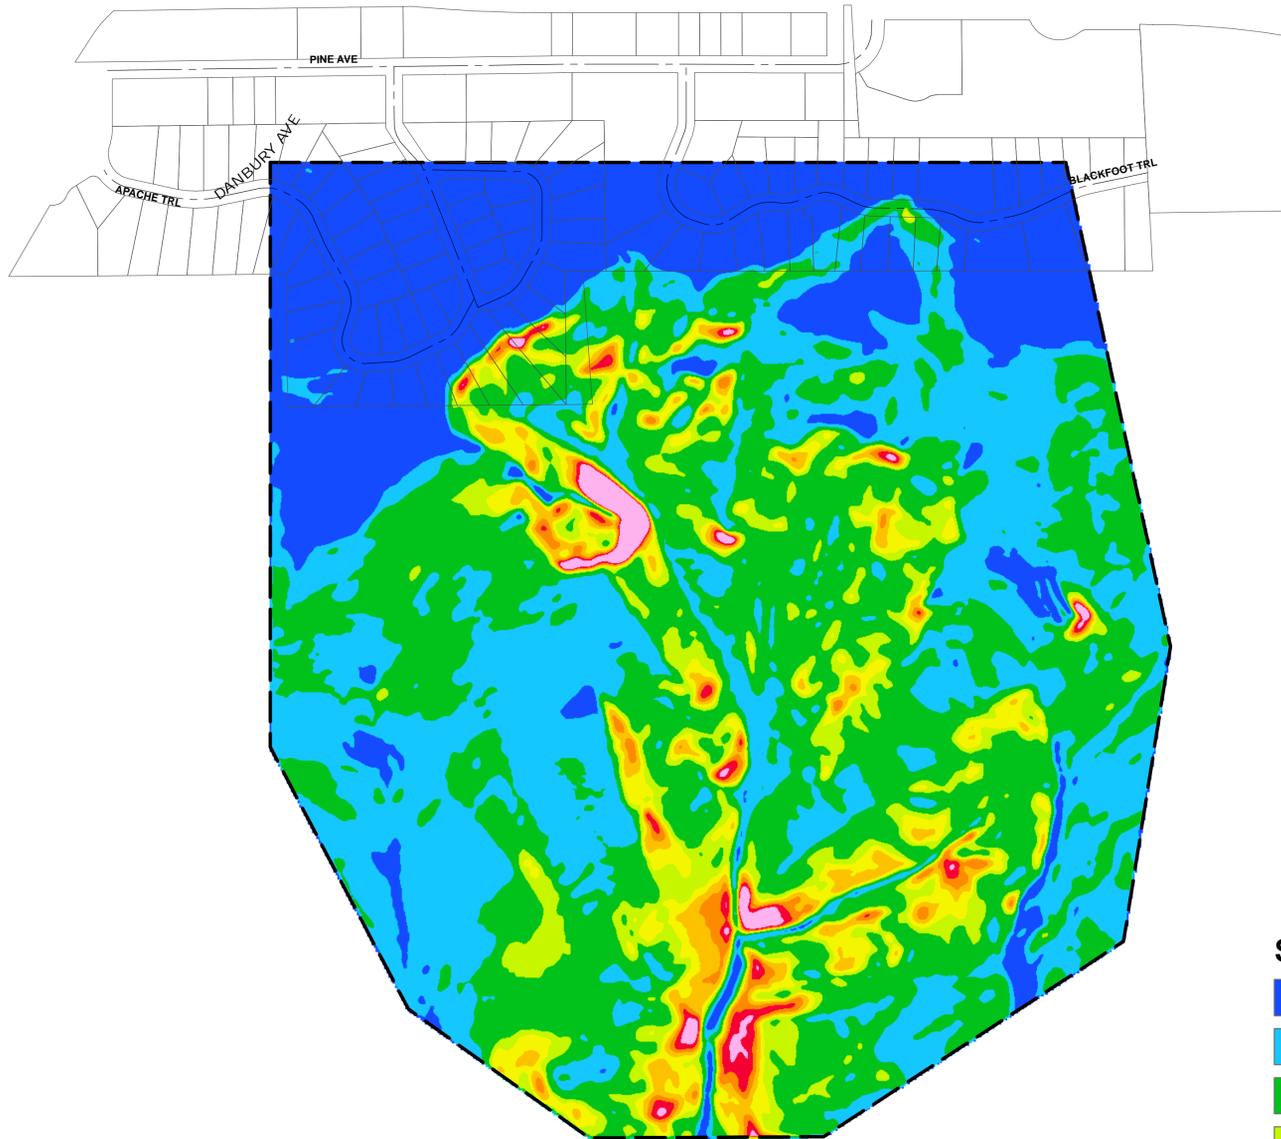
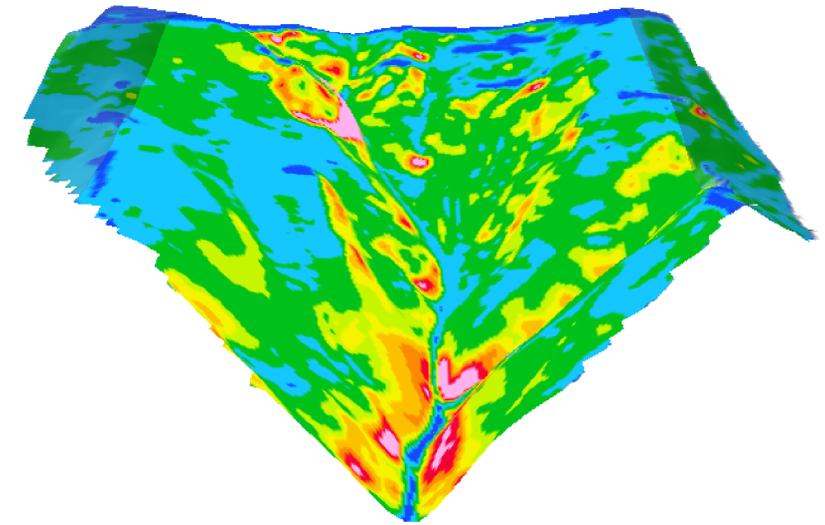
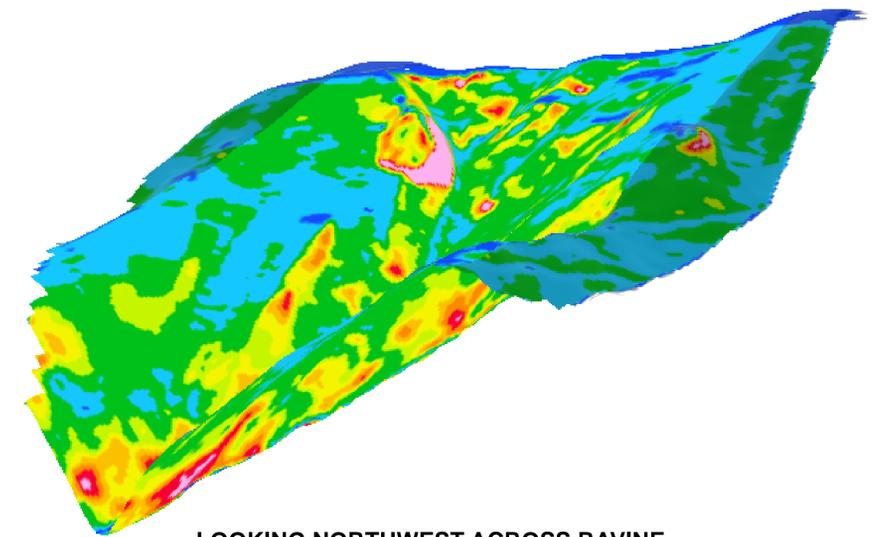
Landslide activity within the Rimforest area over the last 30+ years has left many slopes below the town over-steepened and unstable to marginally stable, at best. Slope gradients in the Rimforest landslide area are shown on Plate No. 2. Localized over-steepened conditions have made much of the area more susceptible to additional failure. The over-steepened slopes act to undermine otherwise more stable areas above the slopes and, as such, produce larger areas beyond the slopes that are potentially unstable. Rock integrity, slope geometry and geomorphology, tectonics, seismicity, bedrock orientation, fractures, faulting, shear zones, groundwater and surface water runoff are all components that contribute to the future stability of slopes below Rimforest.

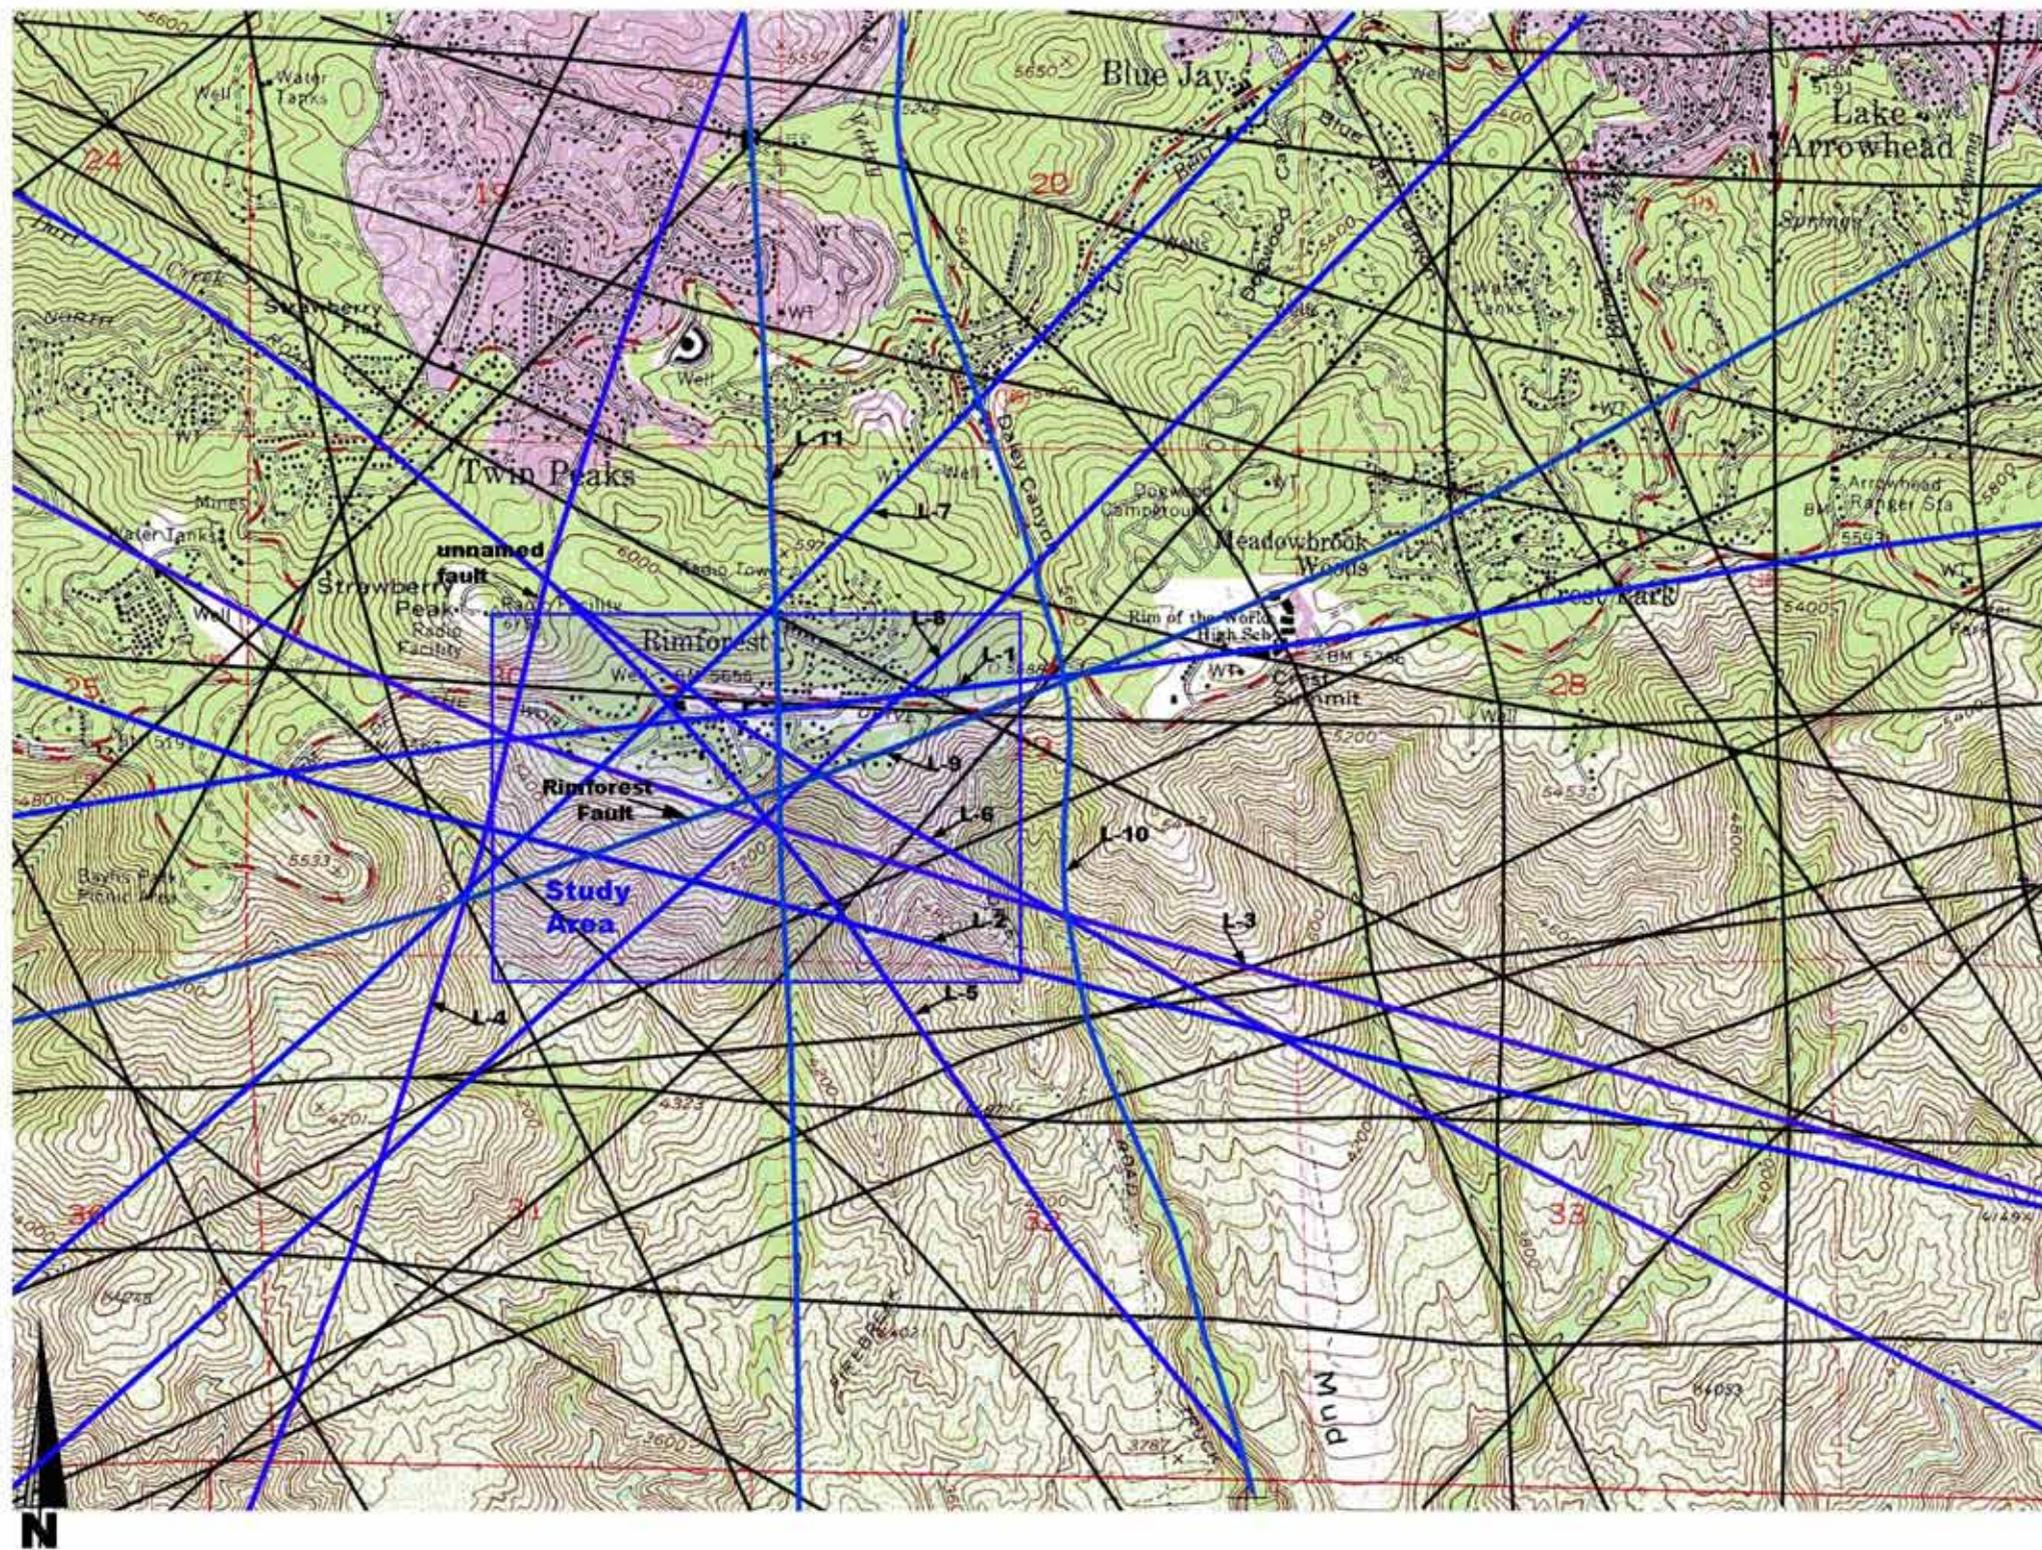
Aerial Photograph Lineaments	
By: RG	Date: 10/09
Project No.: 168-H09.1	Plate No.: 8

Looking at Plate No. 8, it is clear that not all visible lineaments are likely to be associated with faults or shear zones. Many likely result from joint trends, near linear contacts between rock types, large dikes, or other features. However, as noted on Plate No. 8, six lineaments that either crossed Rimforest or were located nearby and were deemed important for this investigation were field checked. All six locations, correlating with aerial photo lineaments, were found to contain shear zones (in which displacement could not be readily identified) or faults. As such, it seems likely that a relatively high percentage of photo lineaments identified during this investigation correlate to structurally important features and most likely represent zones of weakness that may relate to future stability of affected areas.

At least eleven photo lineaments cross into or adjacent to the community of Rimforest. The locations and identifying numbers can be found on Plate No. 8. Lineament No. L1 passes through the topographic saddle and a hairpin turn on Highway 18, both of which are north of Red Rock Wall Point, then continues east-northeast through a topographic bench, which is located southeast of Strawberry Peak and is occupied by Rimforest. Lineament L1 continues east-northeastward through the campus of Rim-of-the-World High School, approximately one-half mile east-northeast of Rimforest. The western location of this lineament was verified

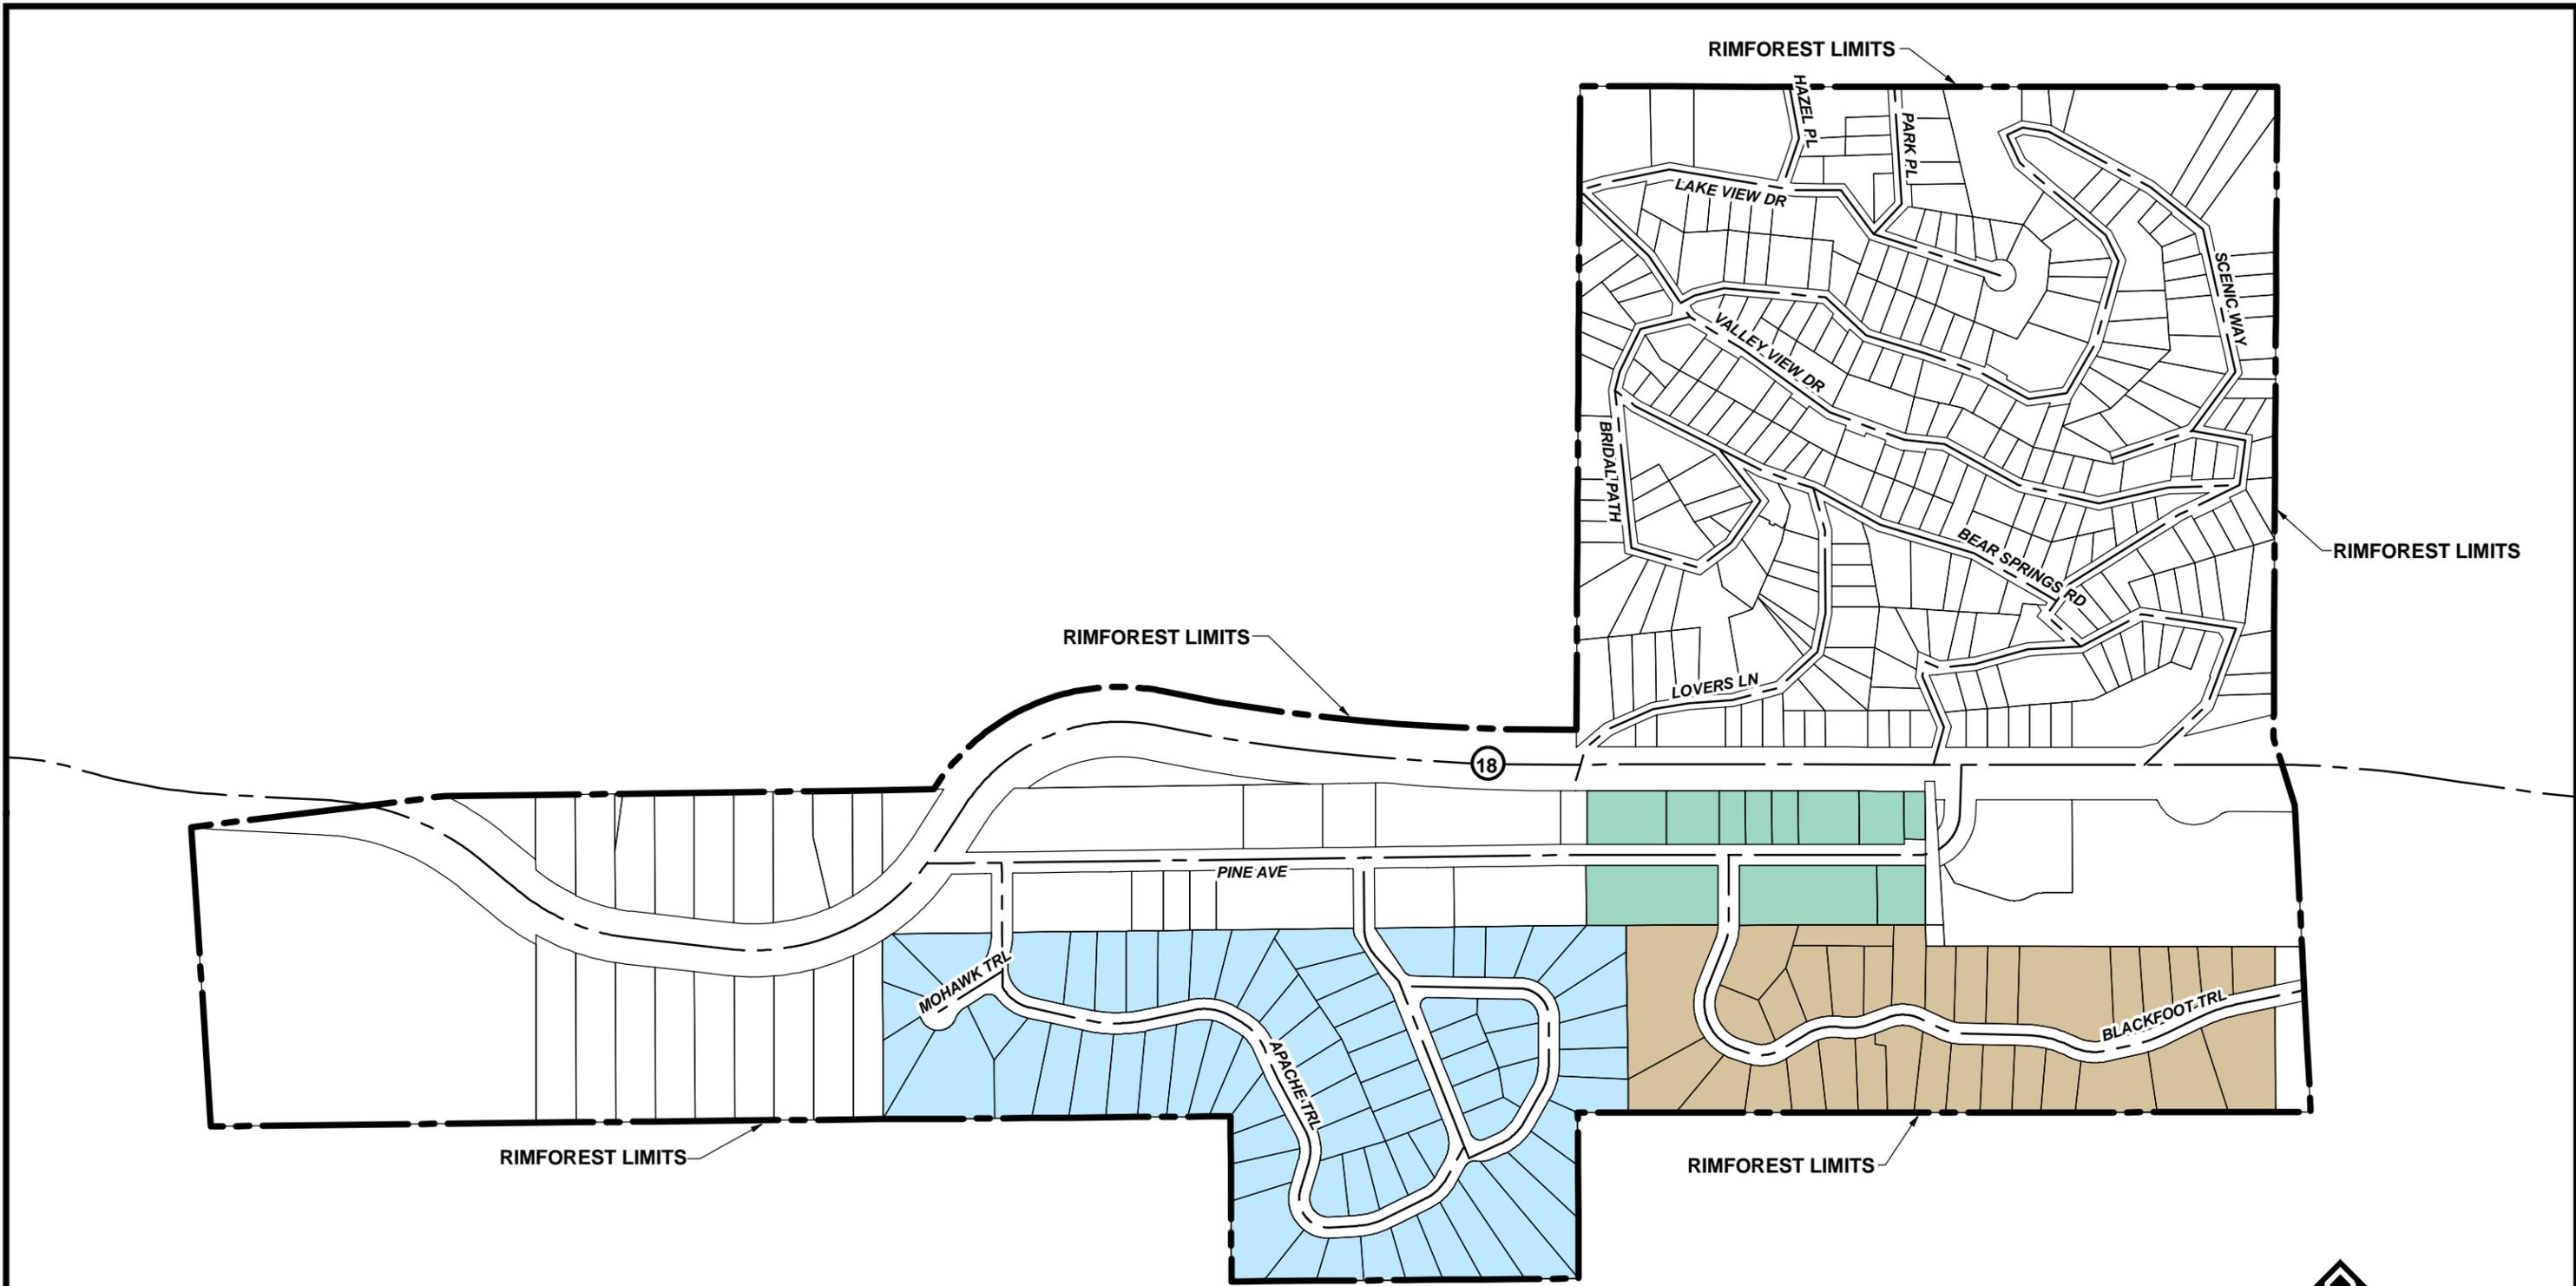
PLATE NO. 9 - TRACT MAP
 IN THE COMMUNITY OF RIMFOREST
 COUNTY OF SAN BERNARDINO, CA

It should be noted that between the 1938 and 1953 photographs, development on the town of Rimforest had begun. The town of Rimforest primarily consisted of two tracts near the southern slopes at the south edge of town (See Plate No. 9). Both tracts were accepted by the County of San Bernardino in 1946. Tract No. 2986 makes up the eastern portion of Rimforest. Tract No. 2797 essentially contains the western side of Rimforest. As part of the tract development, a storm drain system was installed, which is still used today. The storm drain system collects runoff water through pipes and culverts and empties directly on the south facing slope near the present day sewer lift station (See Plate No. 1). Another drain lies immediately below the lumber yard (where the old pond used to drain) and also exits directly over the natural slope. This drain appears to carry surface water from both tracts.
