FINAL
Drainage Feasibility Study
Volume III (Geotechnical Component Vol. 2)

Community of Rimforest
County of San Bernardino, CA

November 8, 2010

APPENDIX B
PHOTOGRAPHS

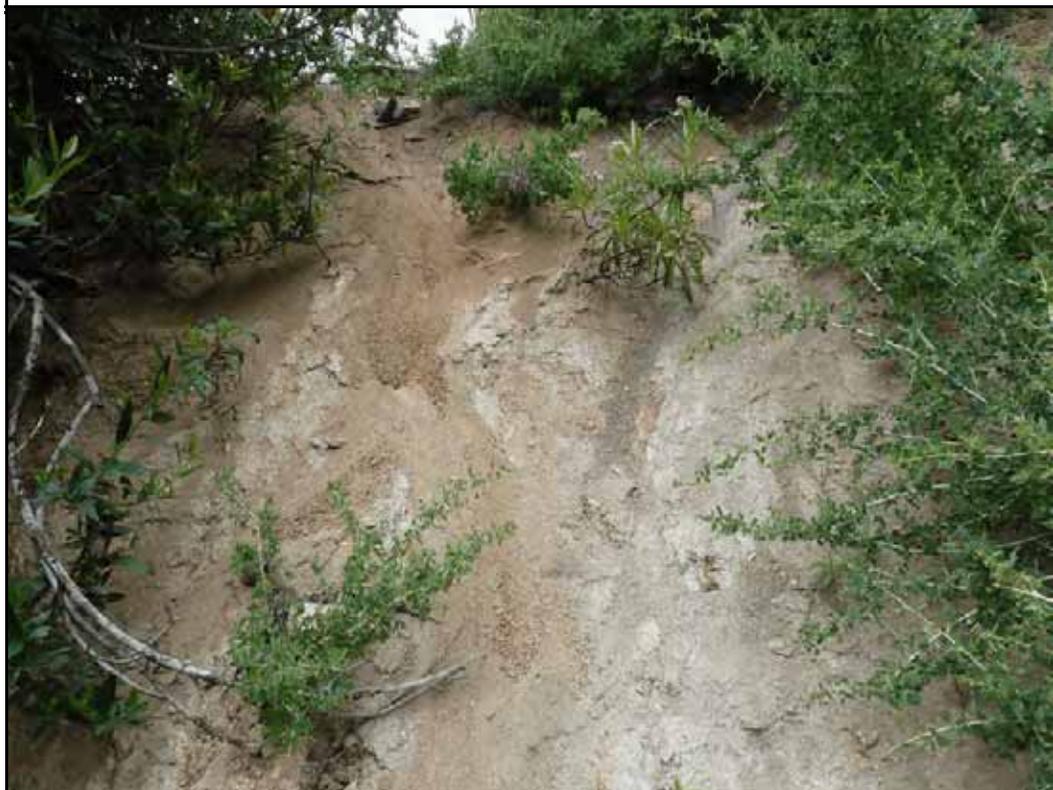
The Rimforest fault was exposed in the grading cut southwest of the original Arrowhead well. Fractured, but hard, granitic rock was observed within 100 feet on either side of the fault and fault gouge found within the fault zone.

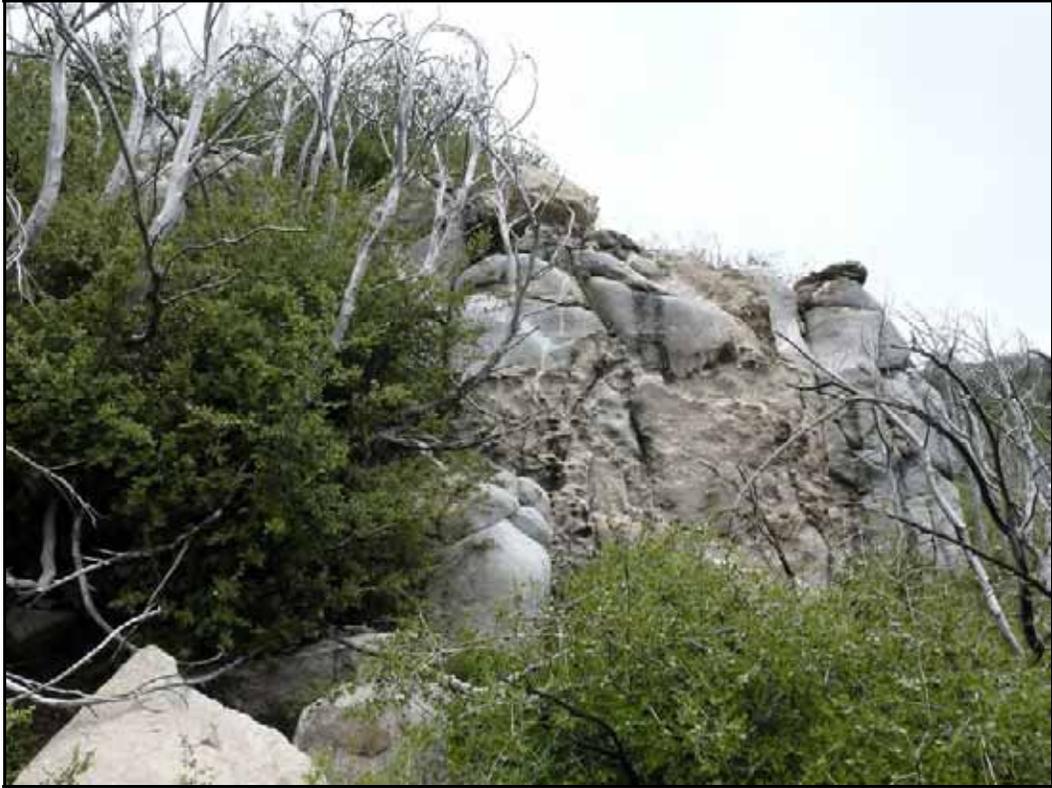
Hard, resistant outcrop of Mzsl, mixed granitics, located 100 to 200 feet north of the Rimforest fault zone and the Arrowhead Water well.

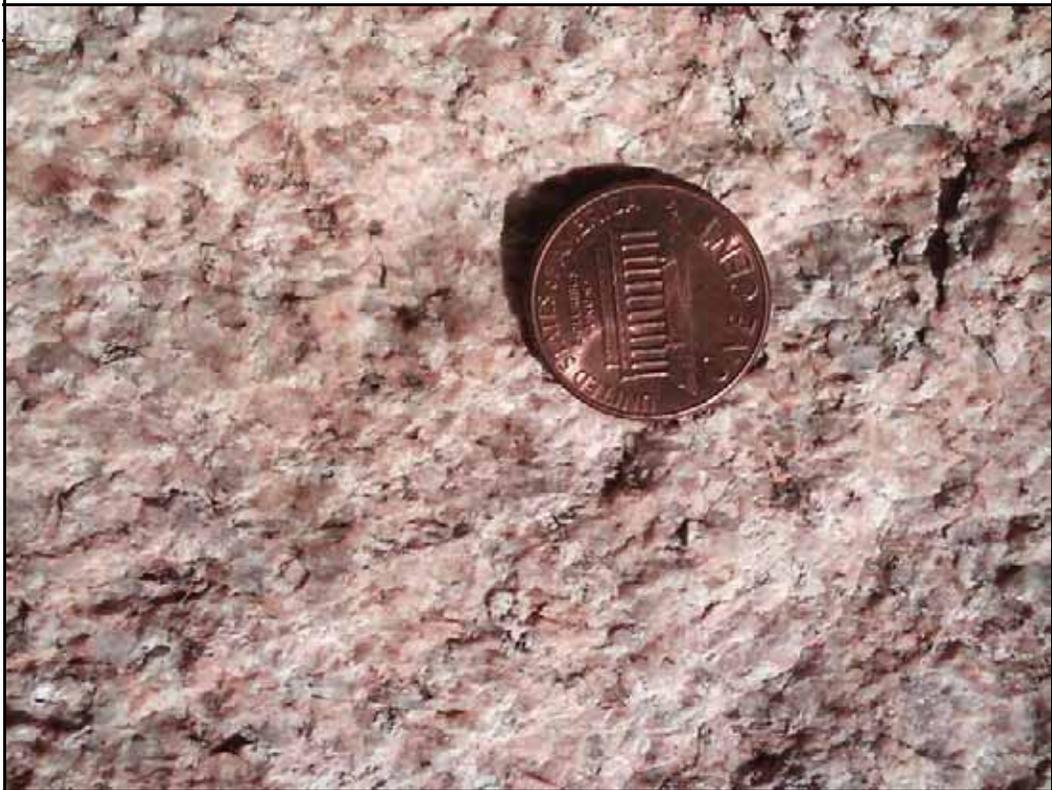
As with the Mzsl, the Monzogranite of City Creek (Kcc) unit had great variability of composition and texture. However, near Rimforest, relatively large crystals of pink orthoclase were only found in the Kcc.

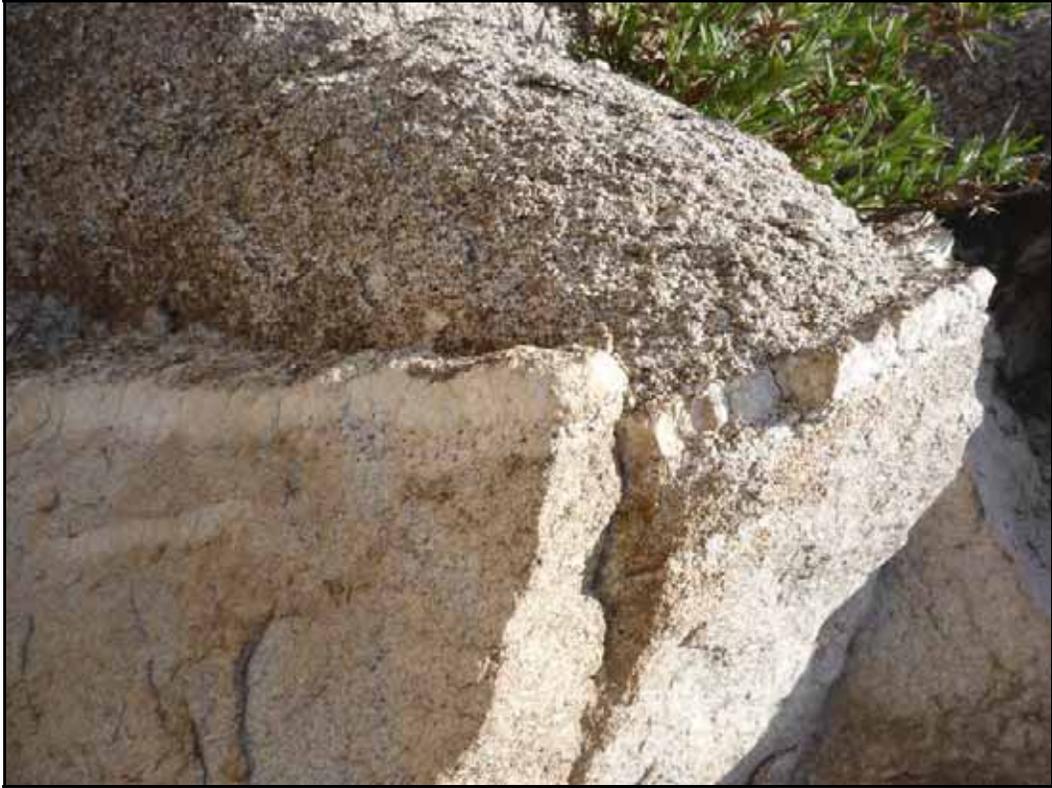
Competent, hard rock often was observed next to highly weathered material. Here, age, composition, and textural differences all may have contributed to the highly weathered and friable granodiorite separated from monzogranite by a dike.

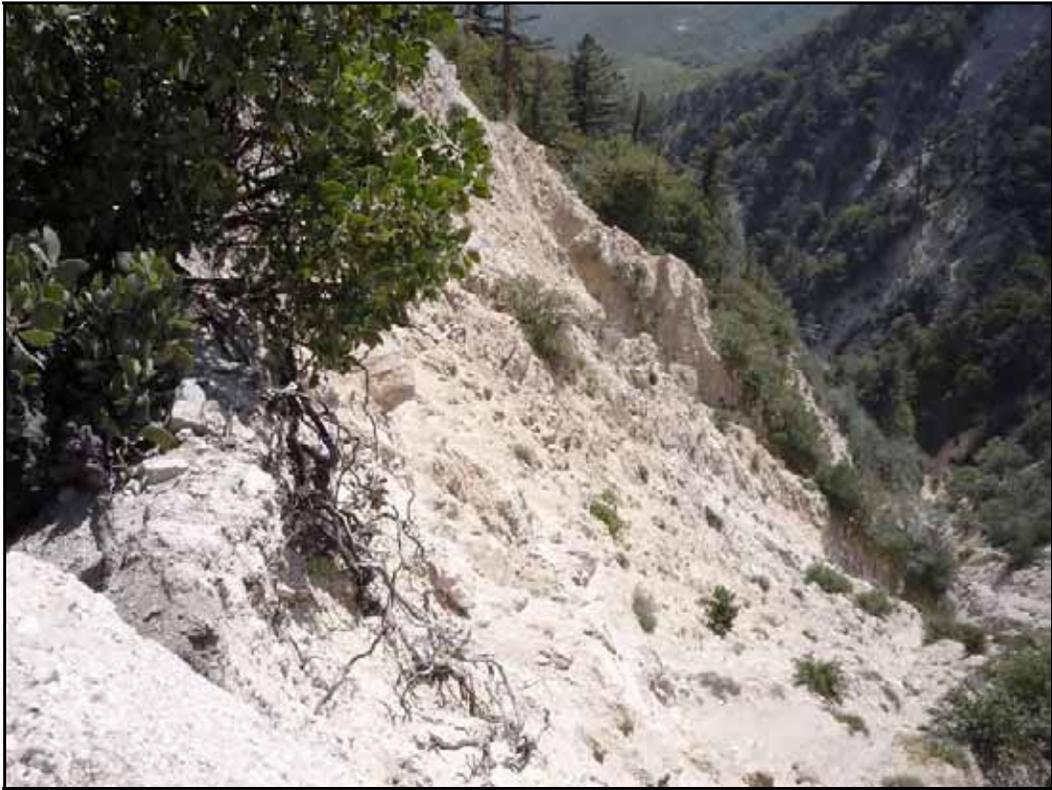
Southern edge of southeastern landslide, revealing the highly fractured and weathered nature of the bedrock.

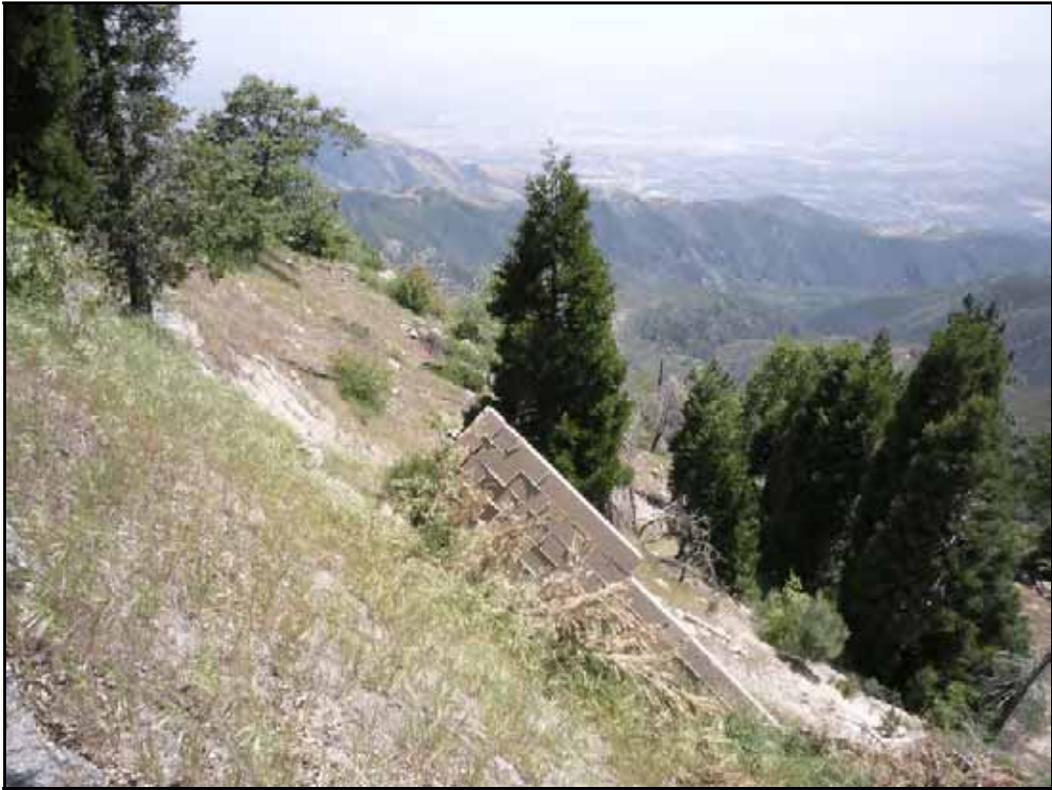
Northeastern landslide. Foundation remnant of building that was located at the northeastern edge of the landslide.

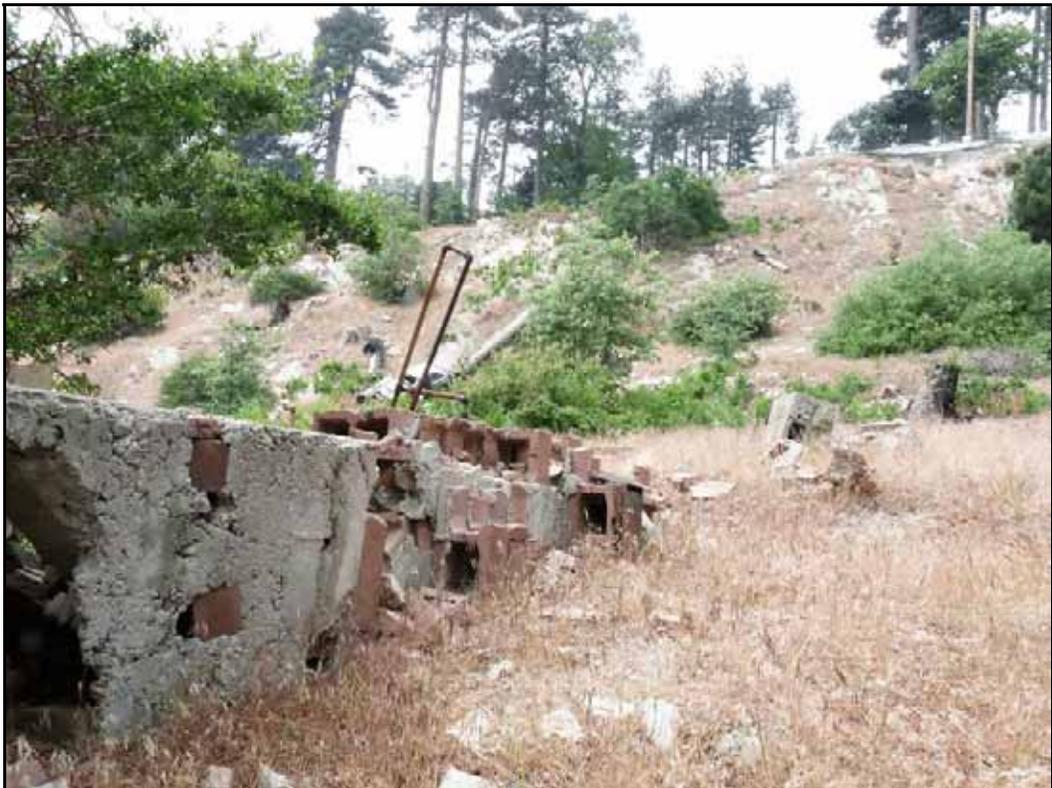
Northeastern landslide. View toward the current headscarp from the top of the main slide block. A chimney and plumbing from a house that moved more than 60 feet downslope during the slide.

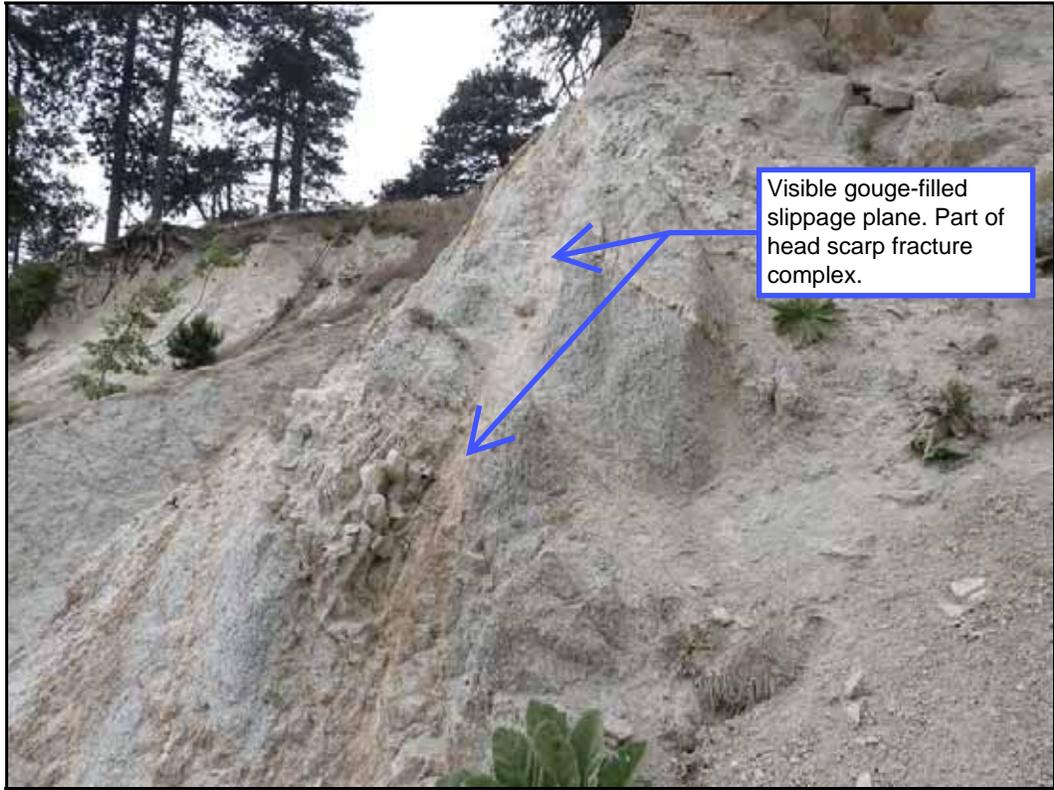
Visible gouge-filled
slippage plane. Part of
head scarp fracture
complex.

Northeastern landslide, current headscarp. The scarp passes through the weathered bedrock in the foreground. A small slide plane is visible as a pink line extending toward the lower left from the top center of the photo.

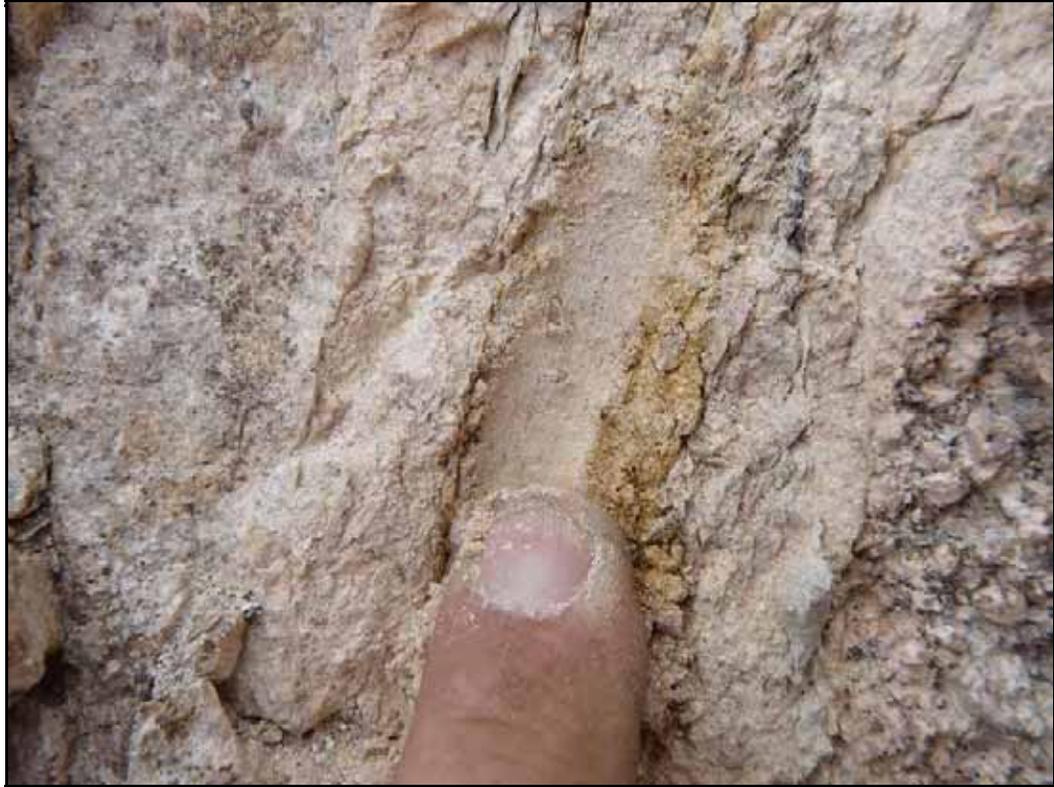
Northeastern landslide, current headscarp. The slide plane visible in the previous photo was composed of gouge. Soft gouge smeared by finger pressure.

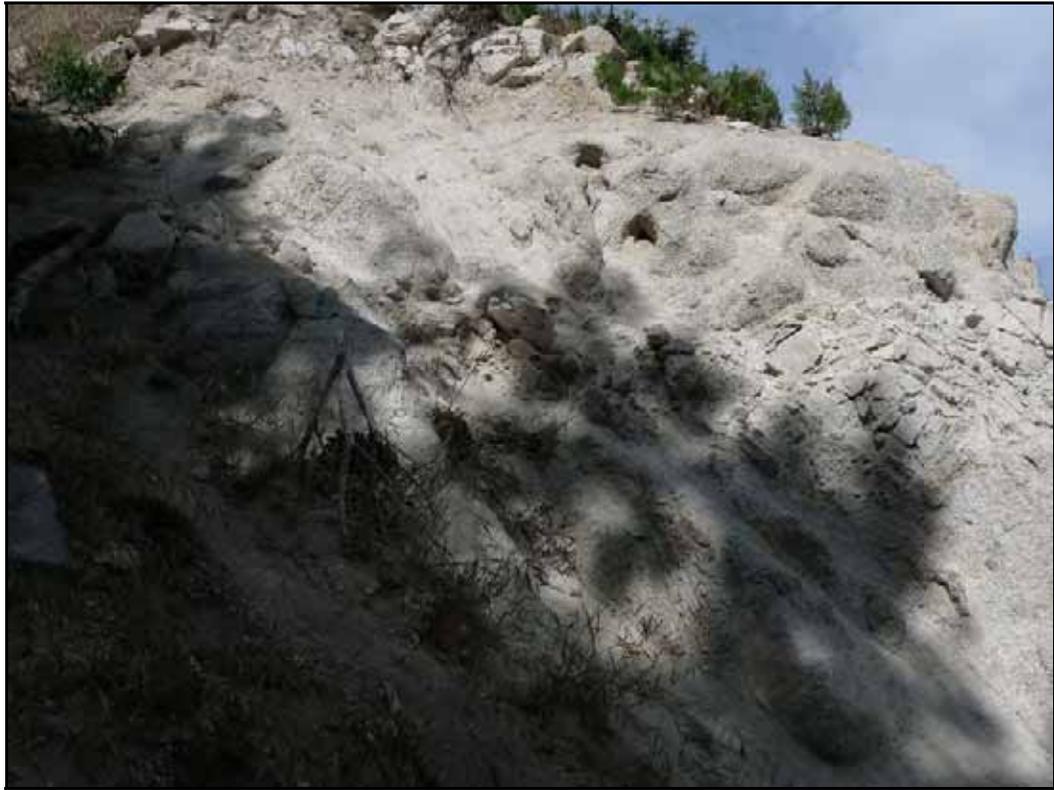
Highly fractured and deeply weathered monzogranite, located immediately north of the Rimforest fault zone.

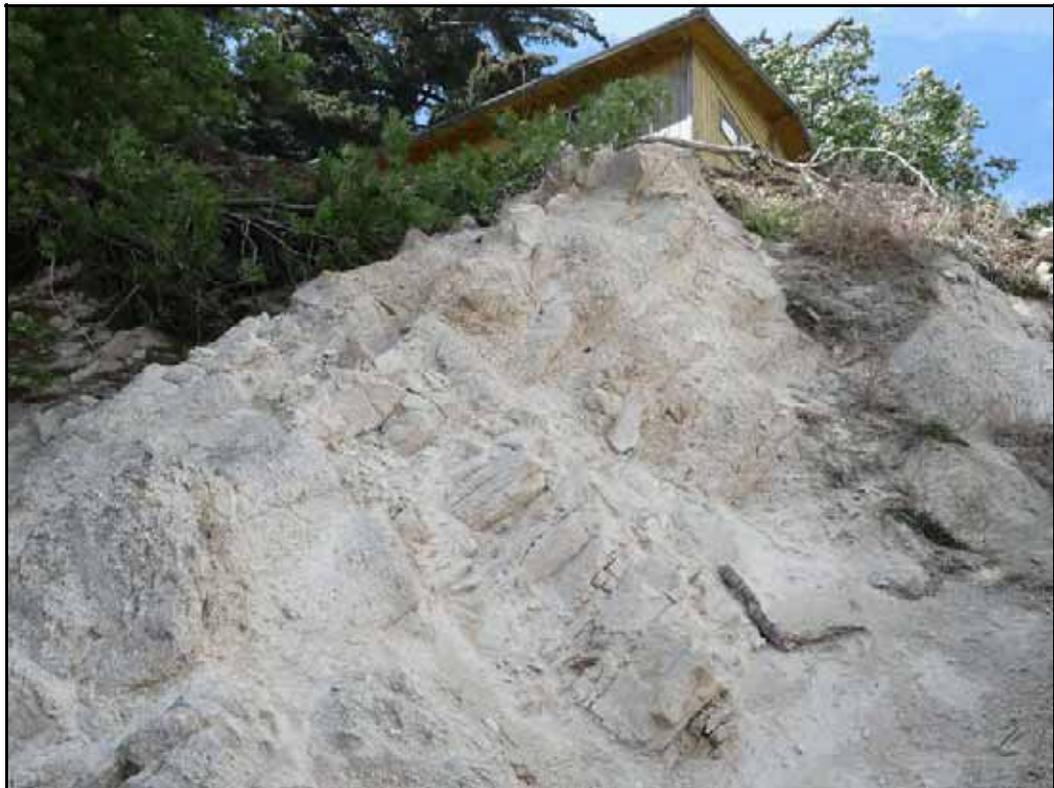
West of the northeastern landslide and north of the Rimforest fault. This highly eroded slope exposes numerous planar discontinuities that are parallel to each other and parallel to the slope above.

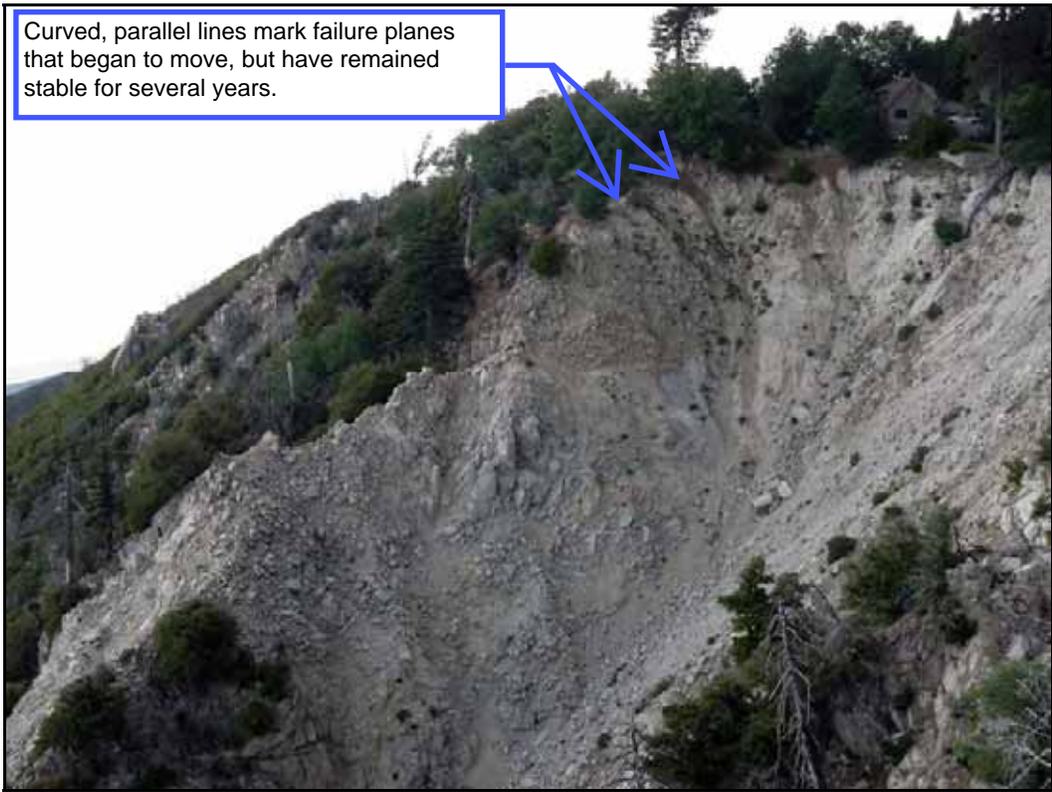
Western landslide. Several parallel failure planes are visible at the upper end of the slope, near the middle of the photo. Surface rupturing fissures, some over one foot wide, can be found on the ground surface in this location.

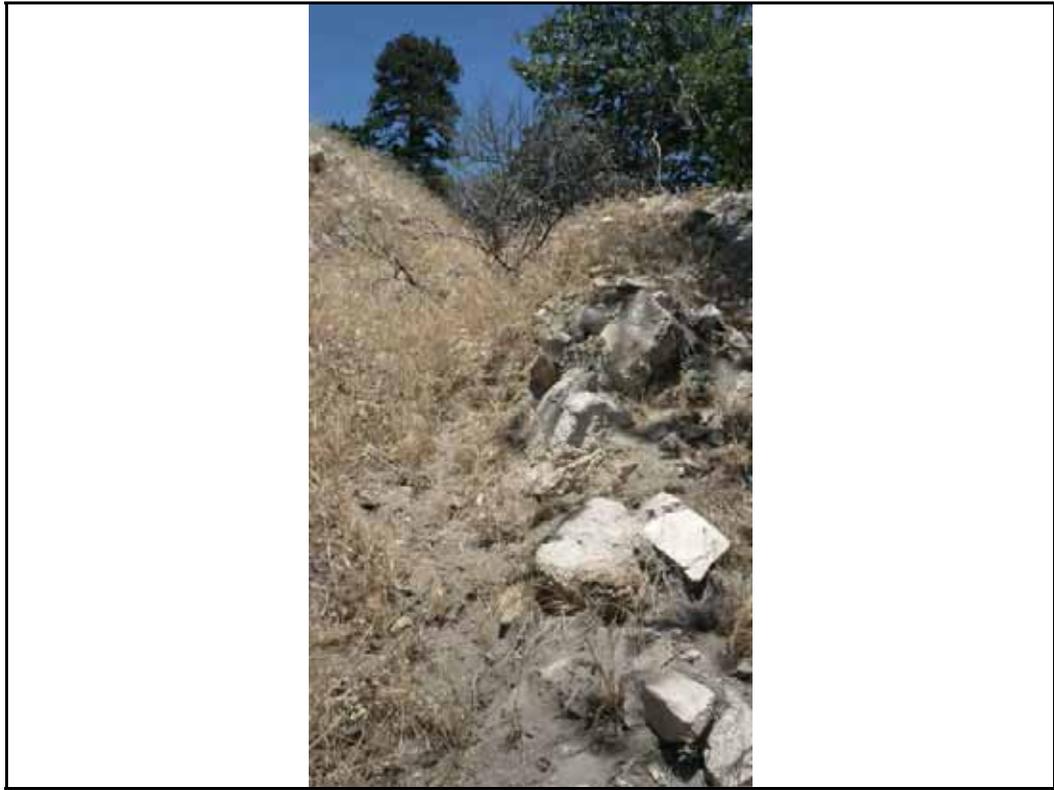
South of western landslide. Notch in topography is the location of one of the failure planes. An open fissure was visible at the northeast end of this feature. This slide block has moved downslope more than six feet. (vertical photo)

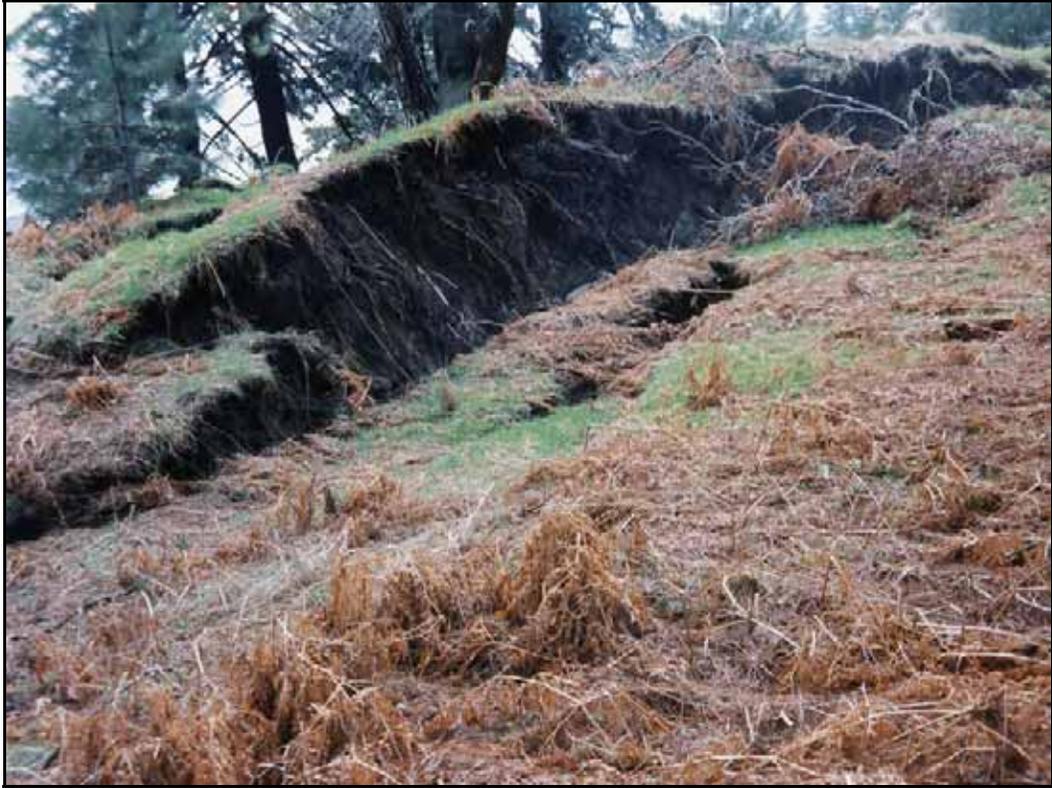
Large fissures, like this one, by 2009 have eroded to form 'steps' in the topography above the western landslide. A few fissures remain open. Photo supplied by Wes Reeder.

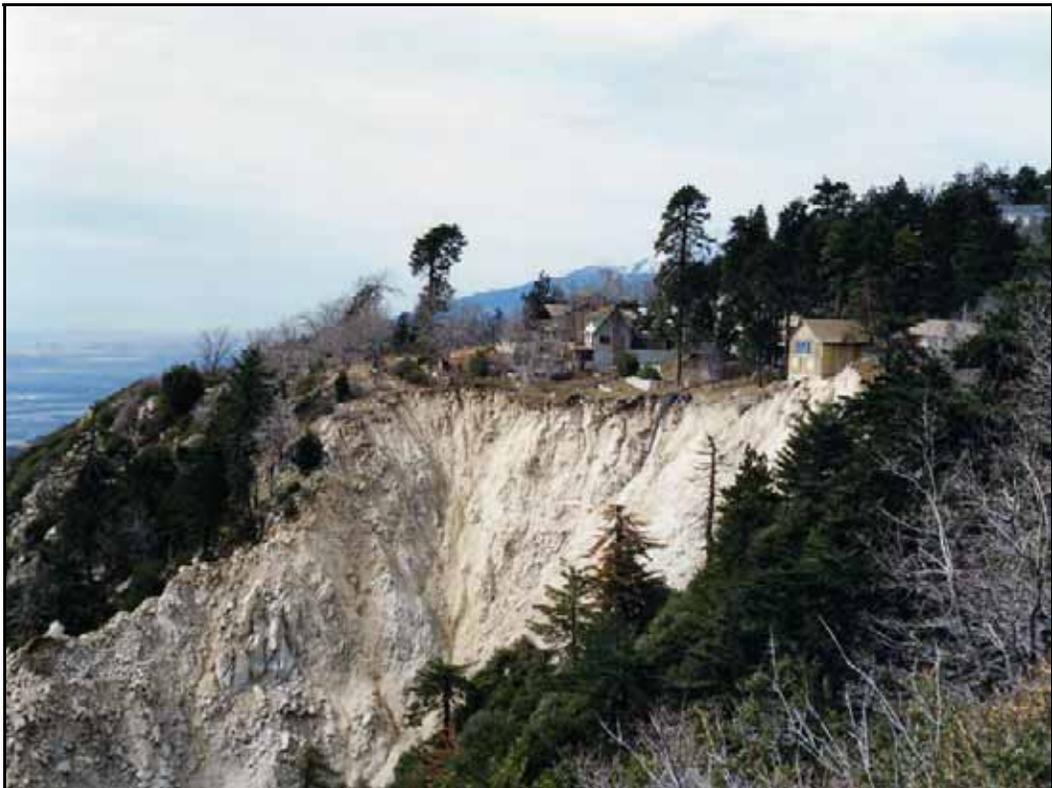
The western landslide soon after the 1993 movement. The appearance of the slide scar has undergone relatively minor changes since 1993. Photo supplied by Wes Reeder.

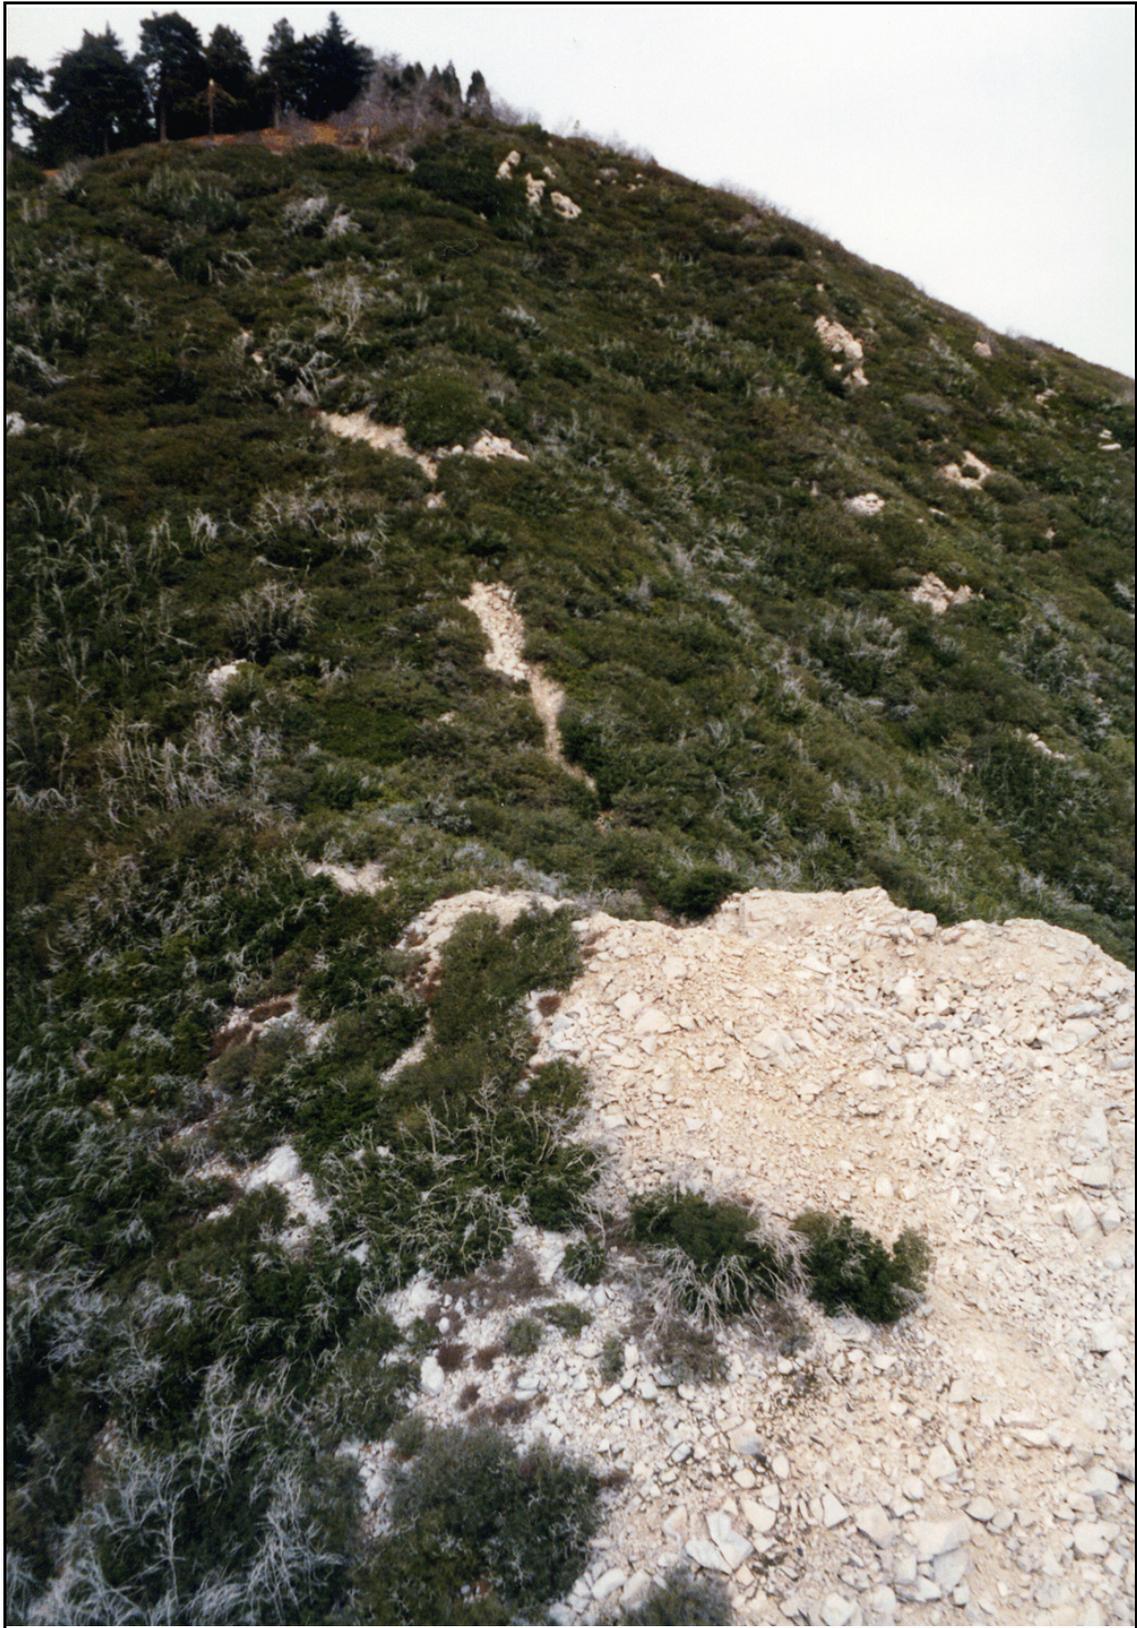
The 1986 scarp, located south of Black Foot Trail East. The length of this feature does not seem to have changed significantly since it was first observed in 1986. However, the height previously was reported to be 2 meters; during the 2009 investigation, the maximum observed height was slightly more than 3 meters.

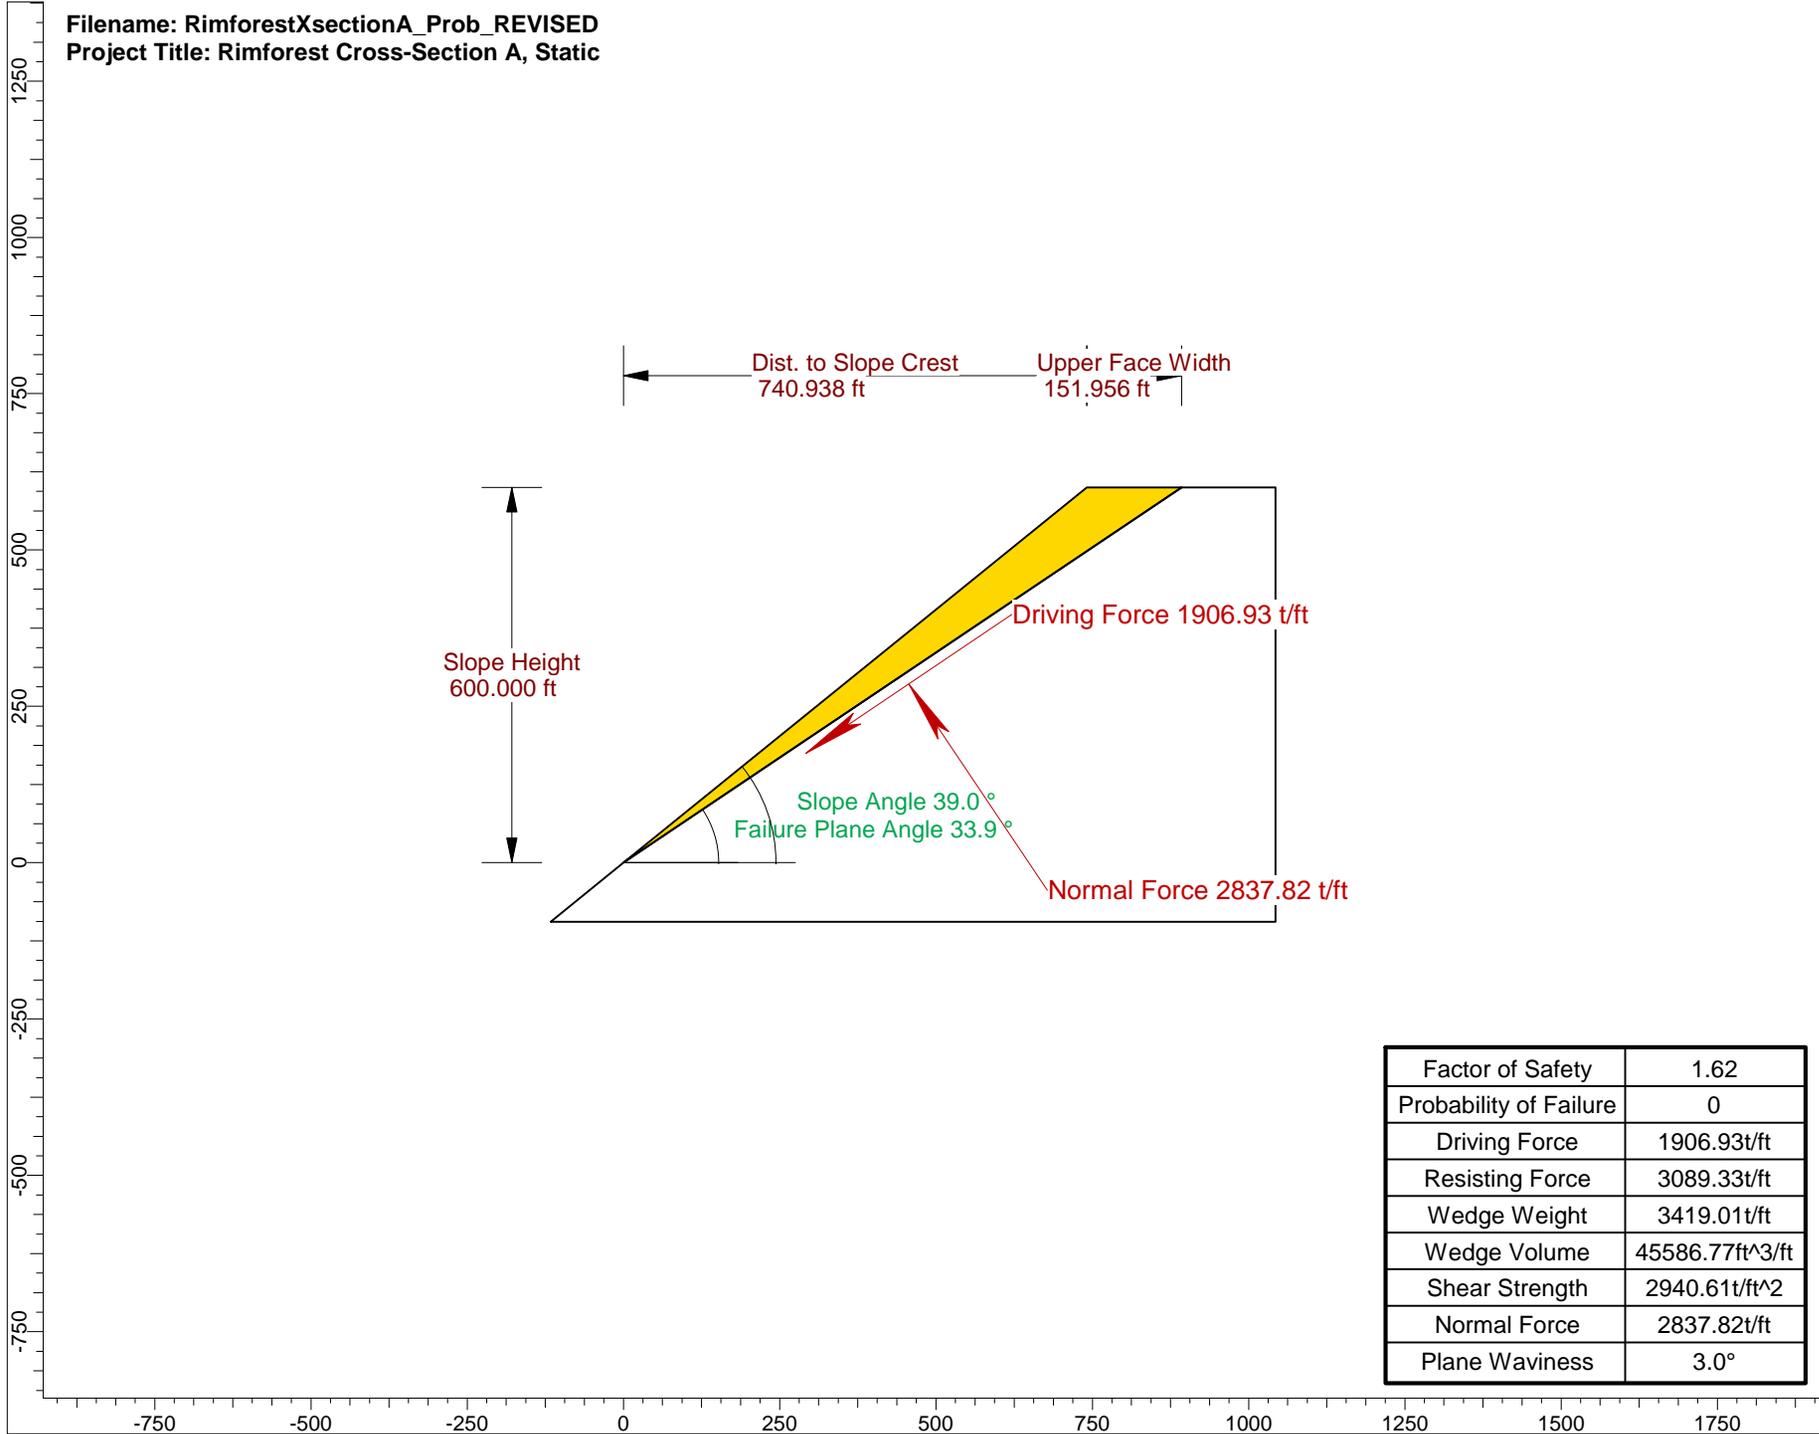
Filename: RimforestXsectionA_Prob_REVISED
 Project Title: Rimforest Cross-Section A, Static

Factor of Safety	1.62
Probability of Failure	0
Driving Force	1906.93t/ft
Resisting Force	3089.33t/ft
Wedge Weight	3419.01t/ft
Wedge Volume	45586.77ft ³ /ft
Shear Strength	2940.61t/ft ²
Normal Force	2837.82t/ft
Plane Waviness	3.0°

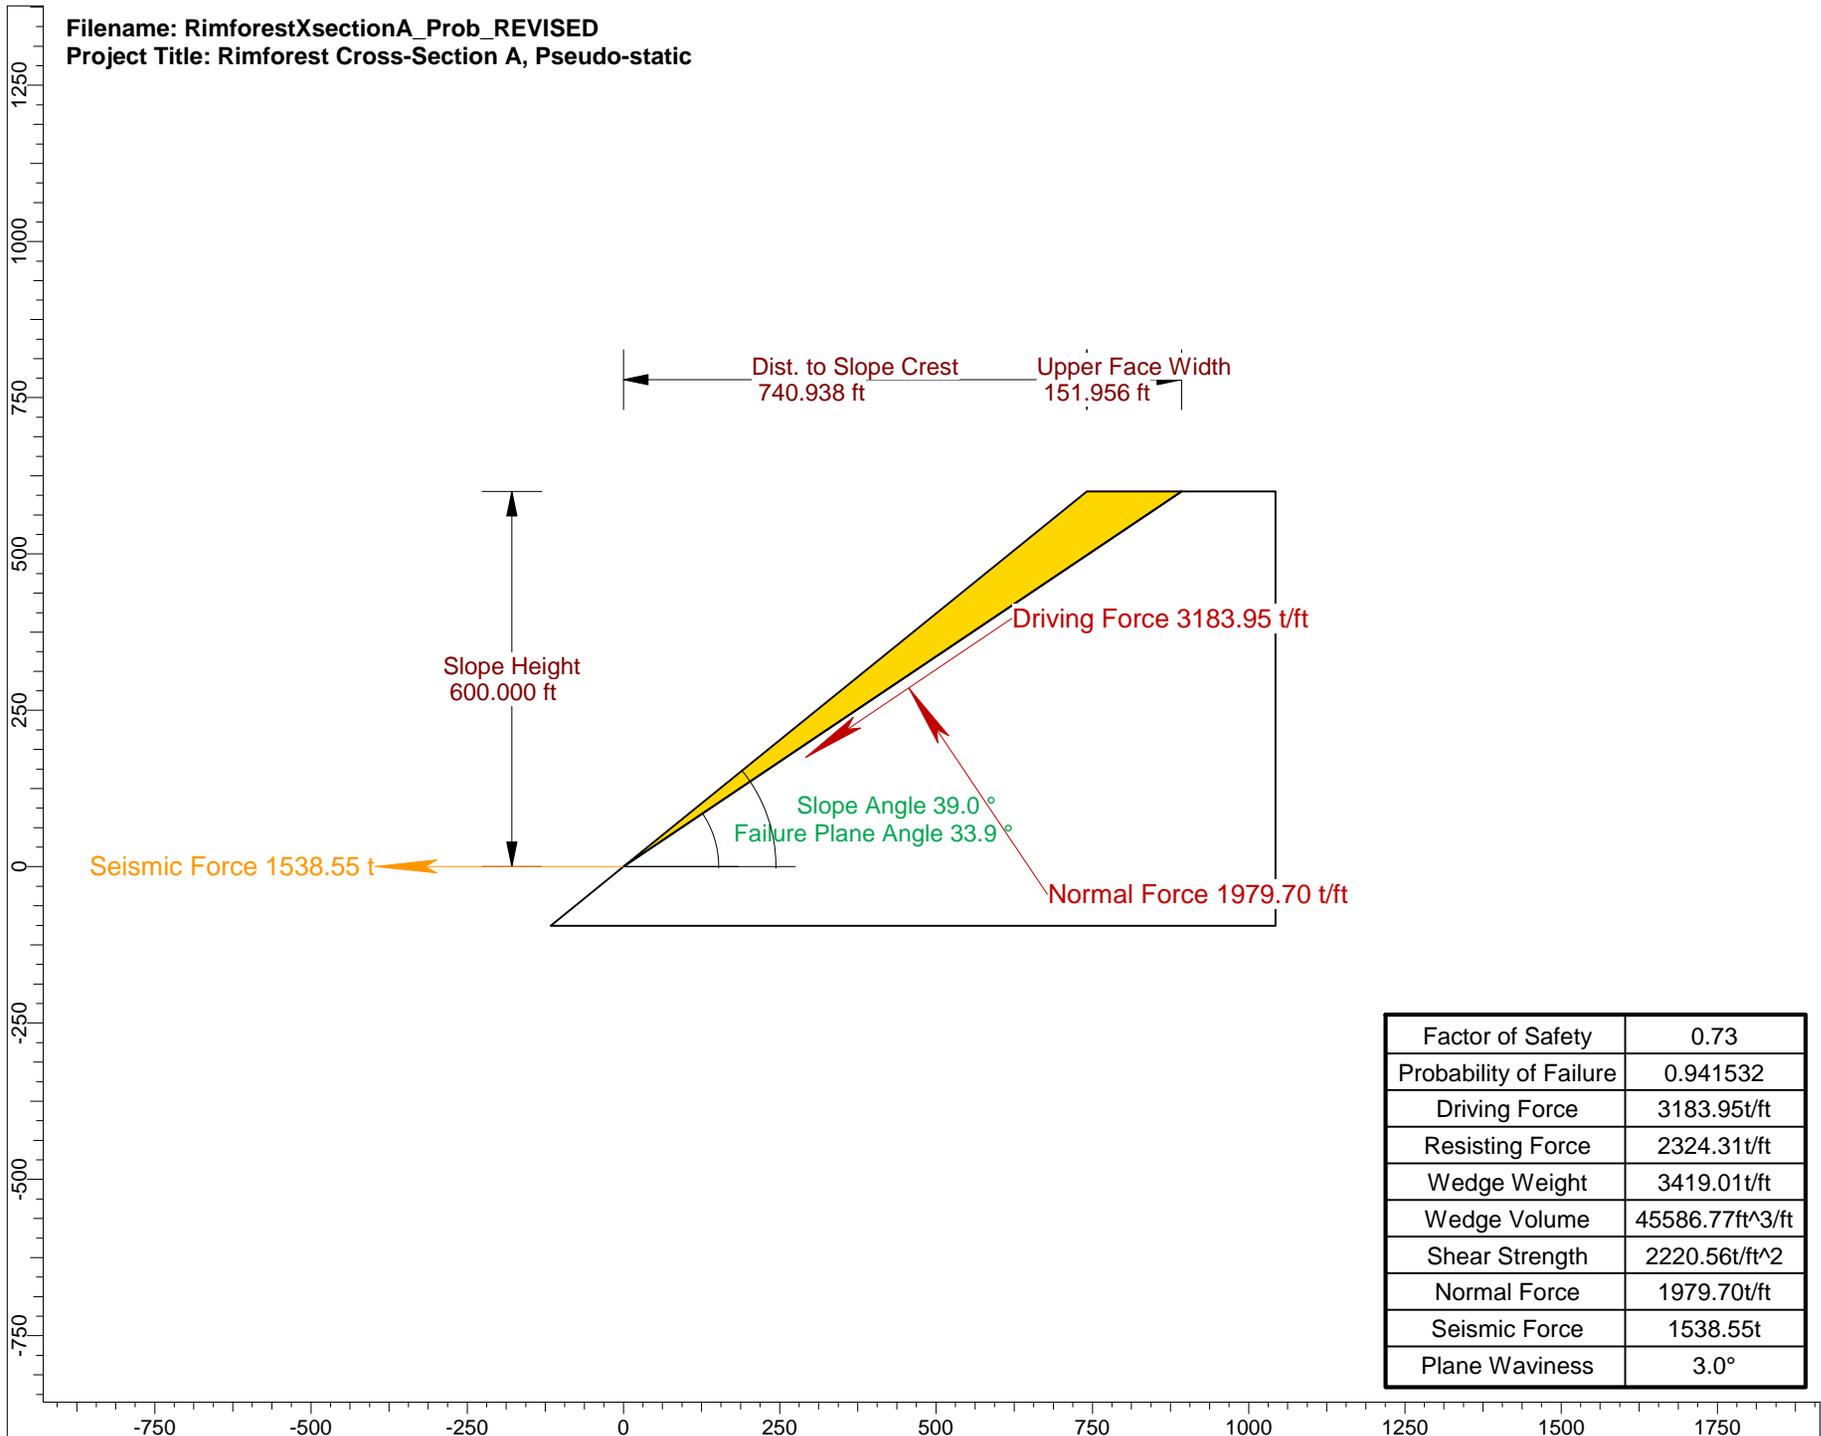
Filename: RimforestXsectionA_Prob_REVISED
 Project Title: Rimforest Cross-Section A, Pseudo-static

Factor of Safety	0.73
Probability of Failure	0.941532
Driving Force	3183.95t/ft
Resisting Force	2324.31t/ft
Wedge Weight	3419.01t/ft
Wedge Volume	45586.77ft ³ /ft
Shear Strength	2220.56t/ft ²
Normal Force	1979.70t/ft
Seismic Force	1538.55t
Plane Waviness	3.0°

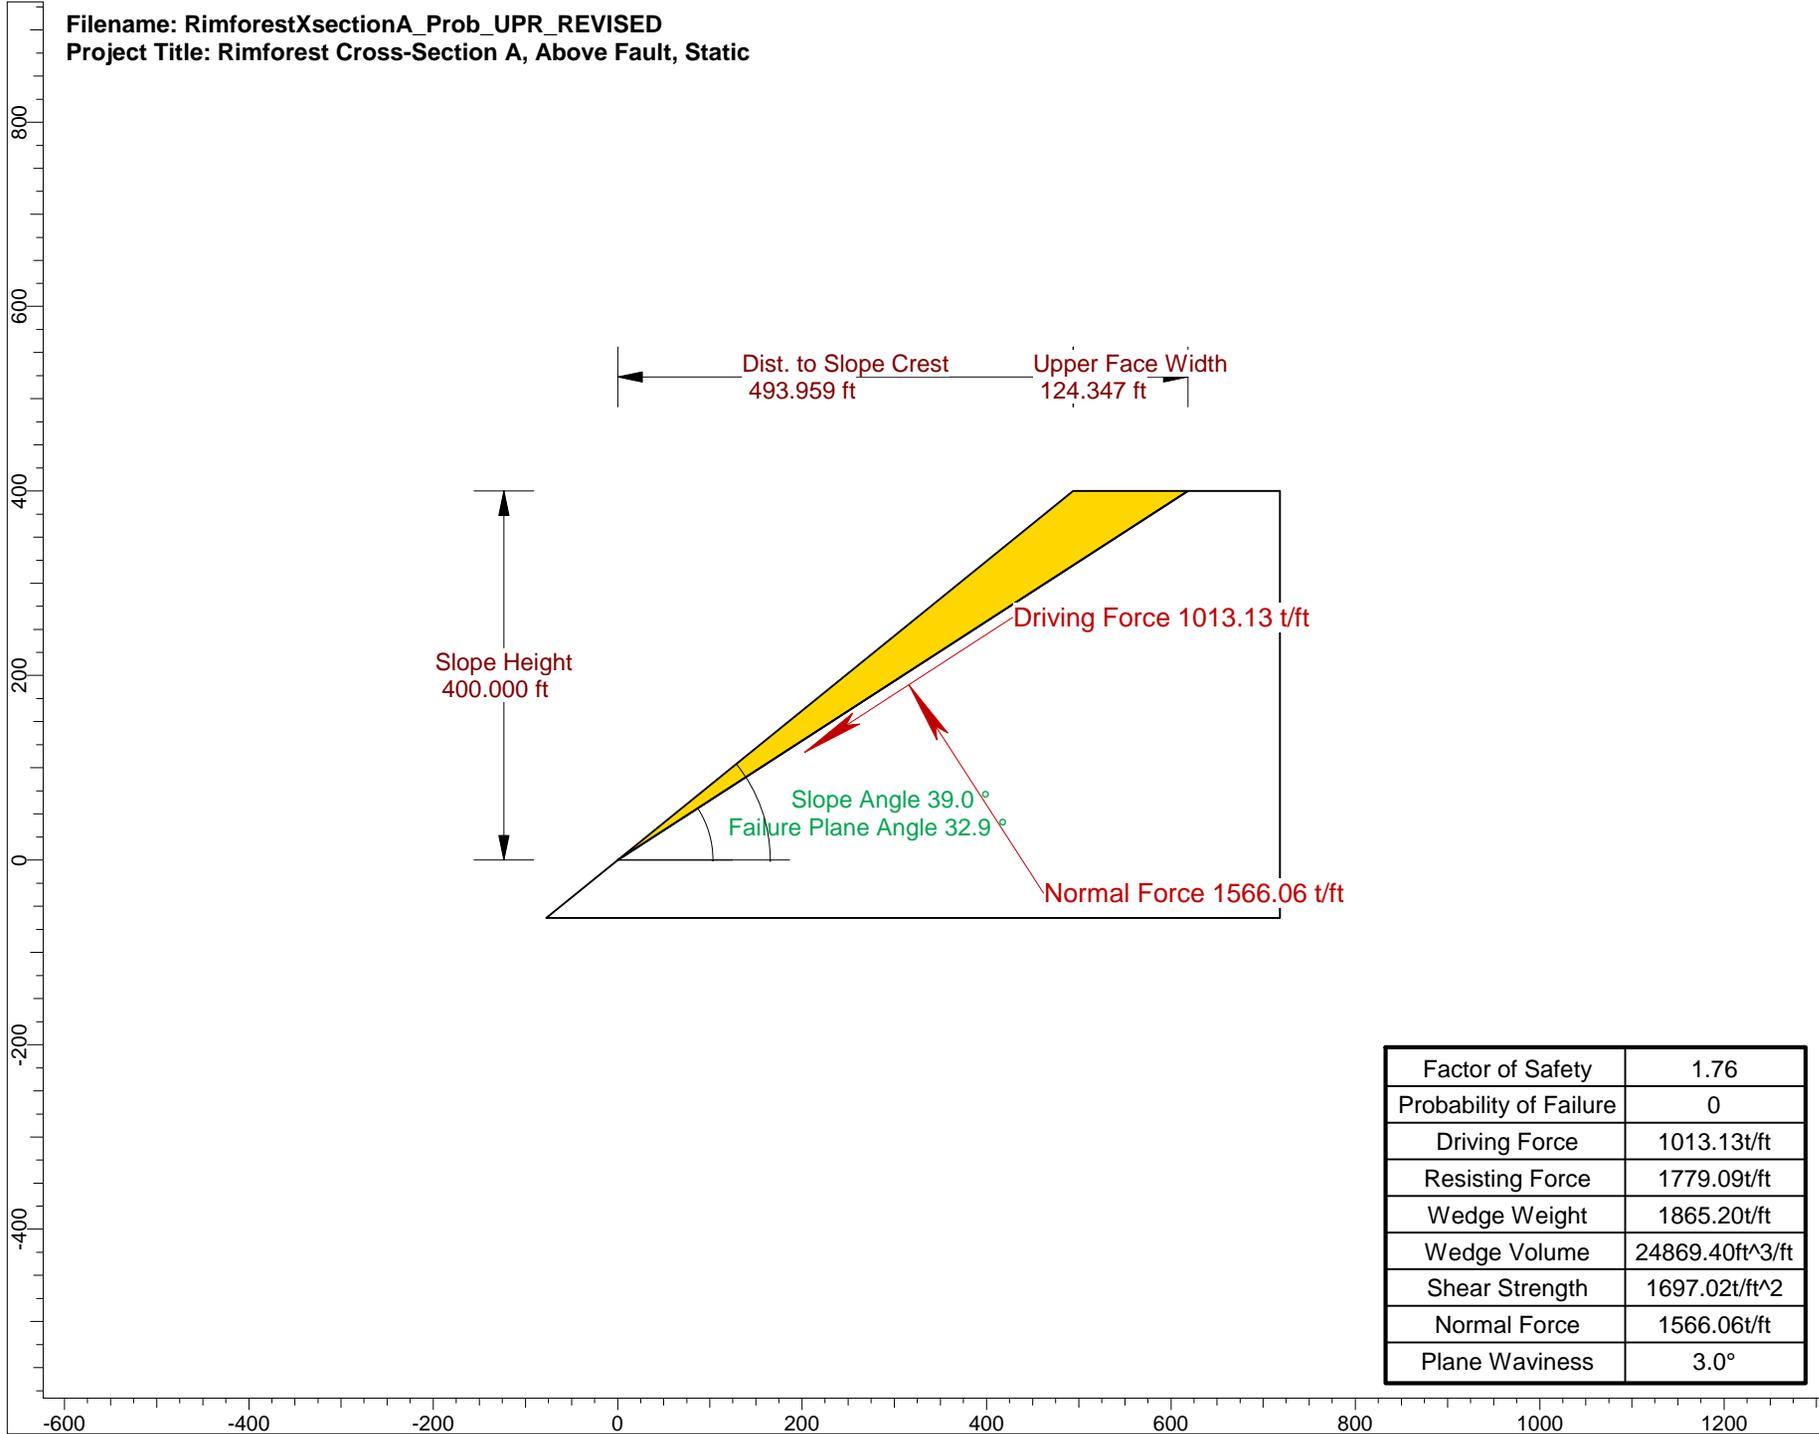
Filename: RimforestXsectionA_Prob_UPR_REVISIED
 Project Title: Rimforest Cross-Section A, Above Fault, Static

Factor of Safety	1.76
Probability of Failure	0
Driving Force	1013.13t/ft
Resisting Force	1779.09t/ft
Wedge Weight	1865.20t/ft
Wedge Volume	24869.40ft ³ /ft
Shear Strength	1697.02t/ft ²
Normal Force	1566.06t/ft
Plane Waviness	3.0°
