FINAL
Drainage Feasibility Study
Volume III (Geotechnical Component Vol. 2)

Community of Rimforest
County of San Bernardino, CA

November 8, 2010

APPENDIX B
PHOTOGRAPHS

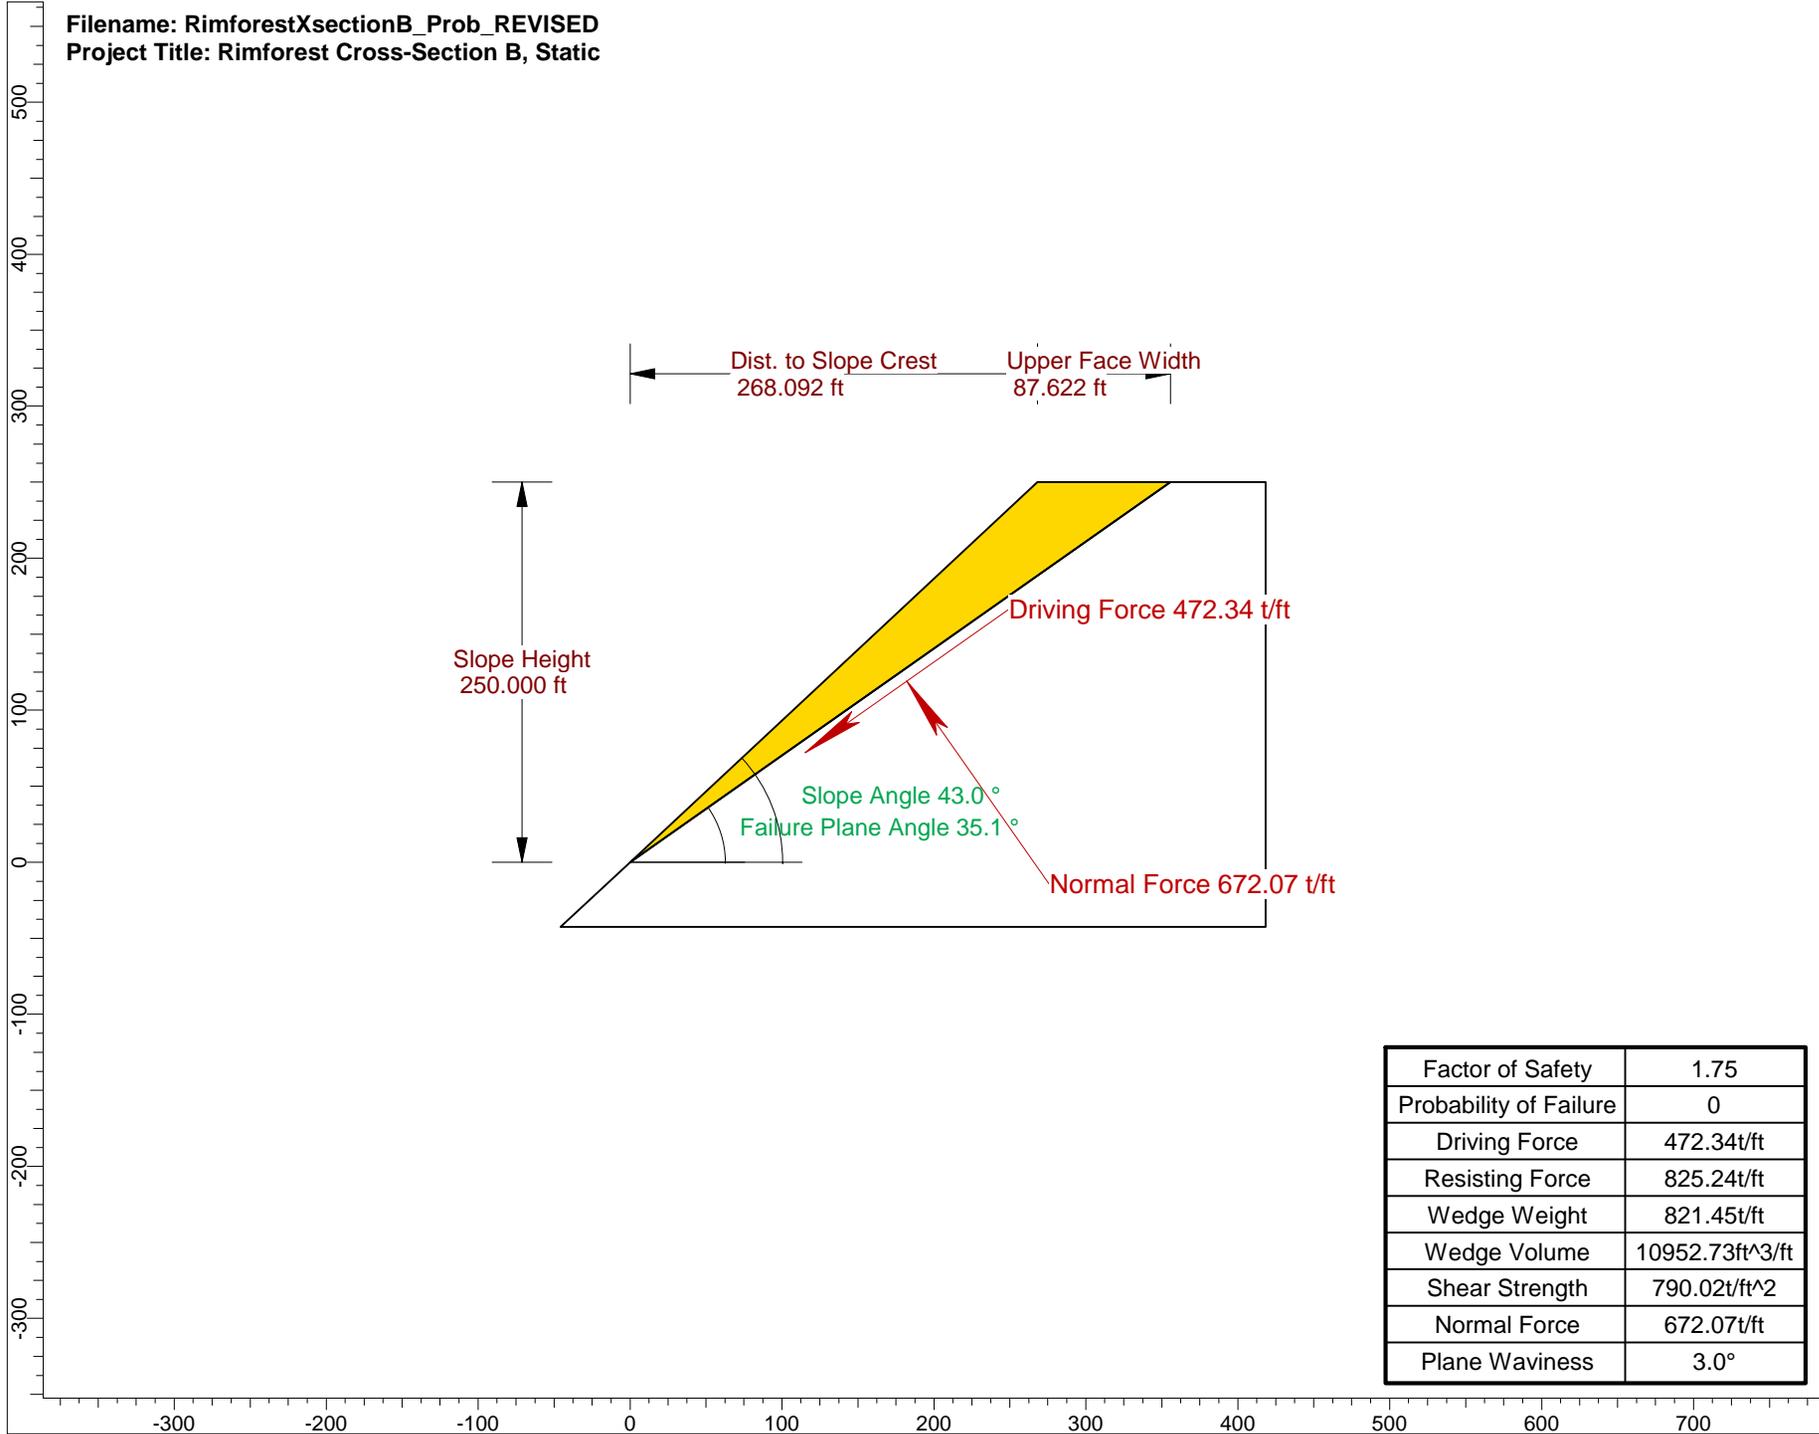
Filename: RimforestXsectionB_Prob_REVISED
 Project Title: Rimforest Cross-Section B, Static

Factor of Safety	1.75
Probability of Failure	0
Driving Force	472.34t/ft
Resisting Force	825.24t/ft
Wedge Weight	821.45t/ft
Wedge Volume	10952.73ft ³ /ft
Shear Strength	790.02t/ft ²
Normal Force	672.07t/ft
Plane Waviness	3.0°

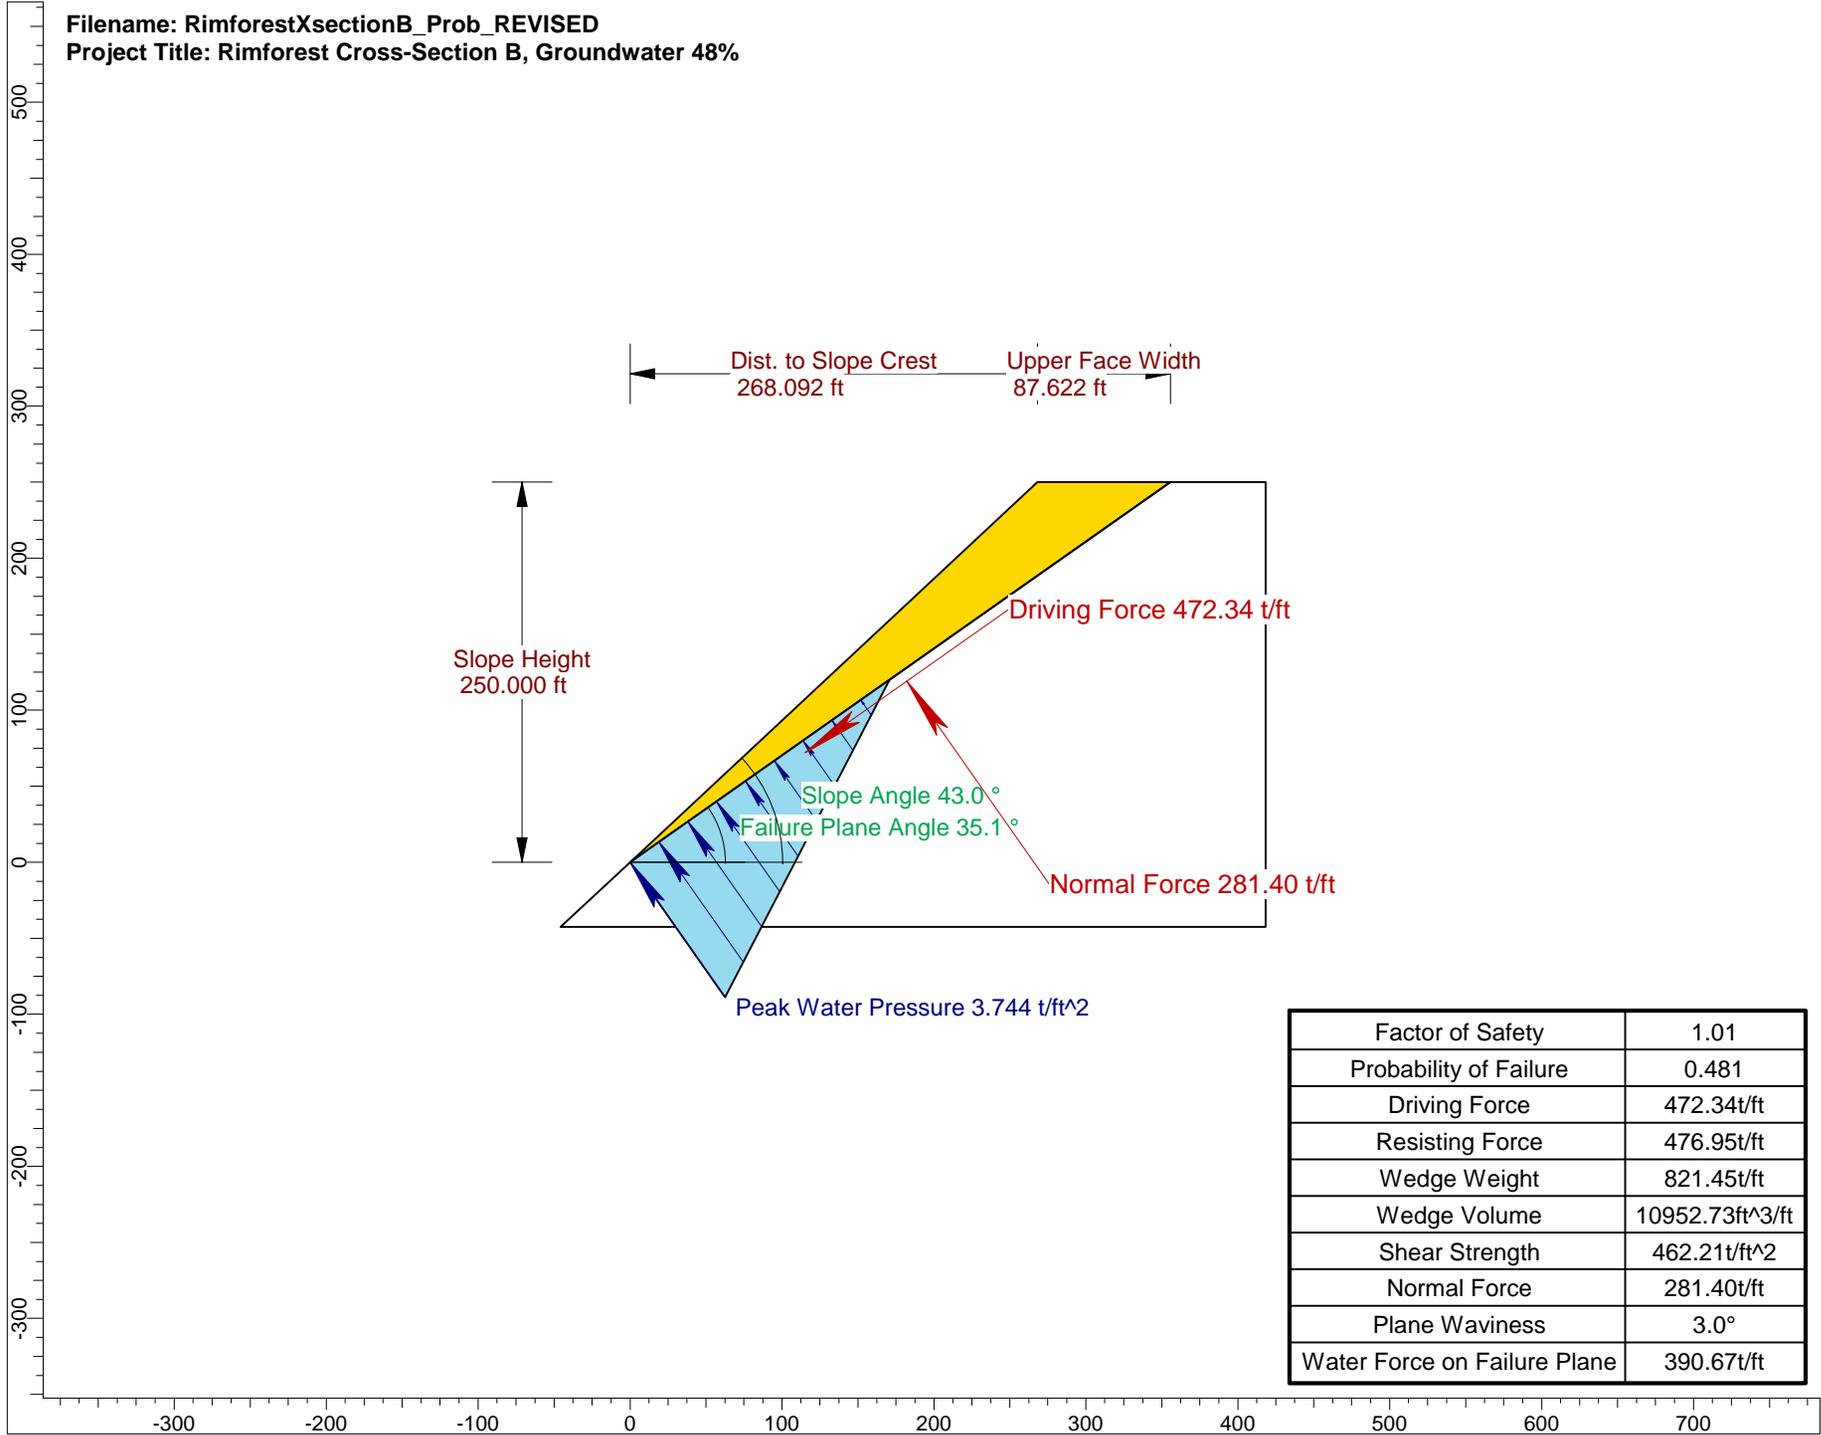
Filename: RimforestXsectionB_Prob_REVISED
 Project Title: Rimforest Cross-Section B, Groundwater 48%

Factor of Safety	1.01
Probability of Failure	0.481
Driving Force	472.34t/ft
Resisting Force	476.95t/ft
Wedge Weight	821.45t/ft
Wedge Volume	10952.73ft ³ /ft
Shear Strength	462.21t/ft ²
Normal Force	281.40t/ft
Plane Waviness	3.0°
Water Force on Failure Plane	390.67t/ft

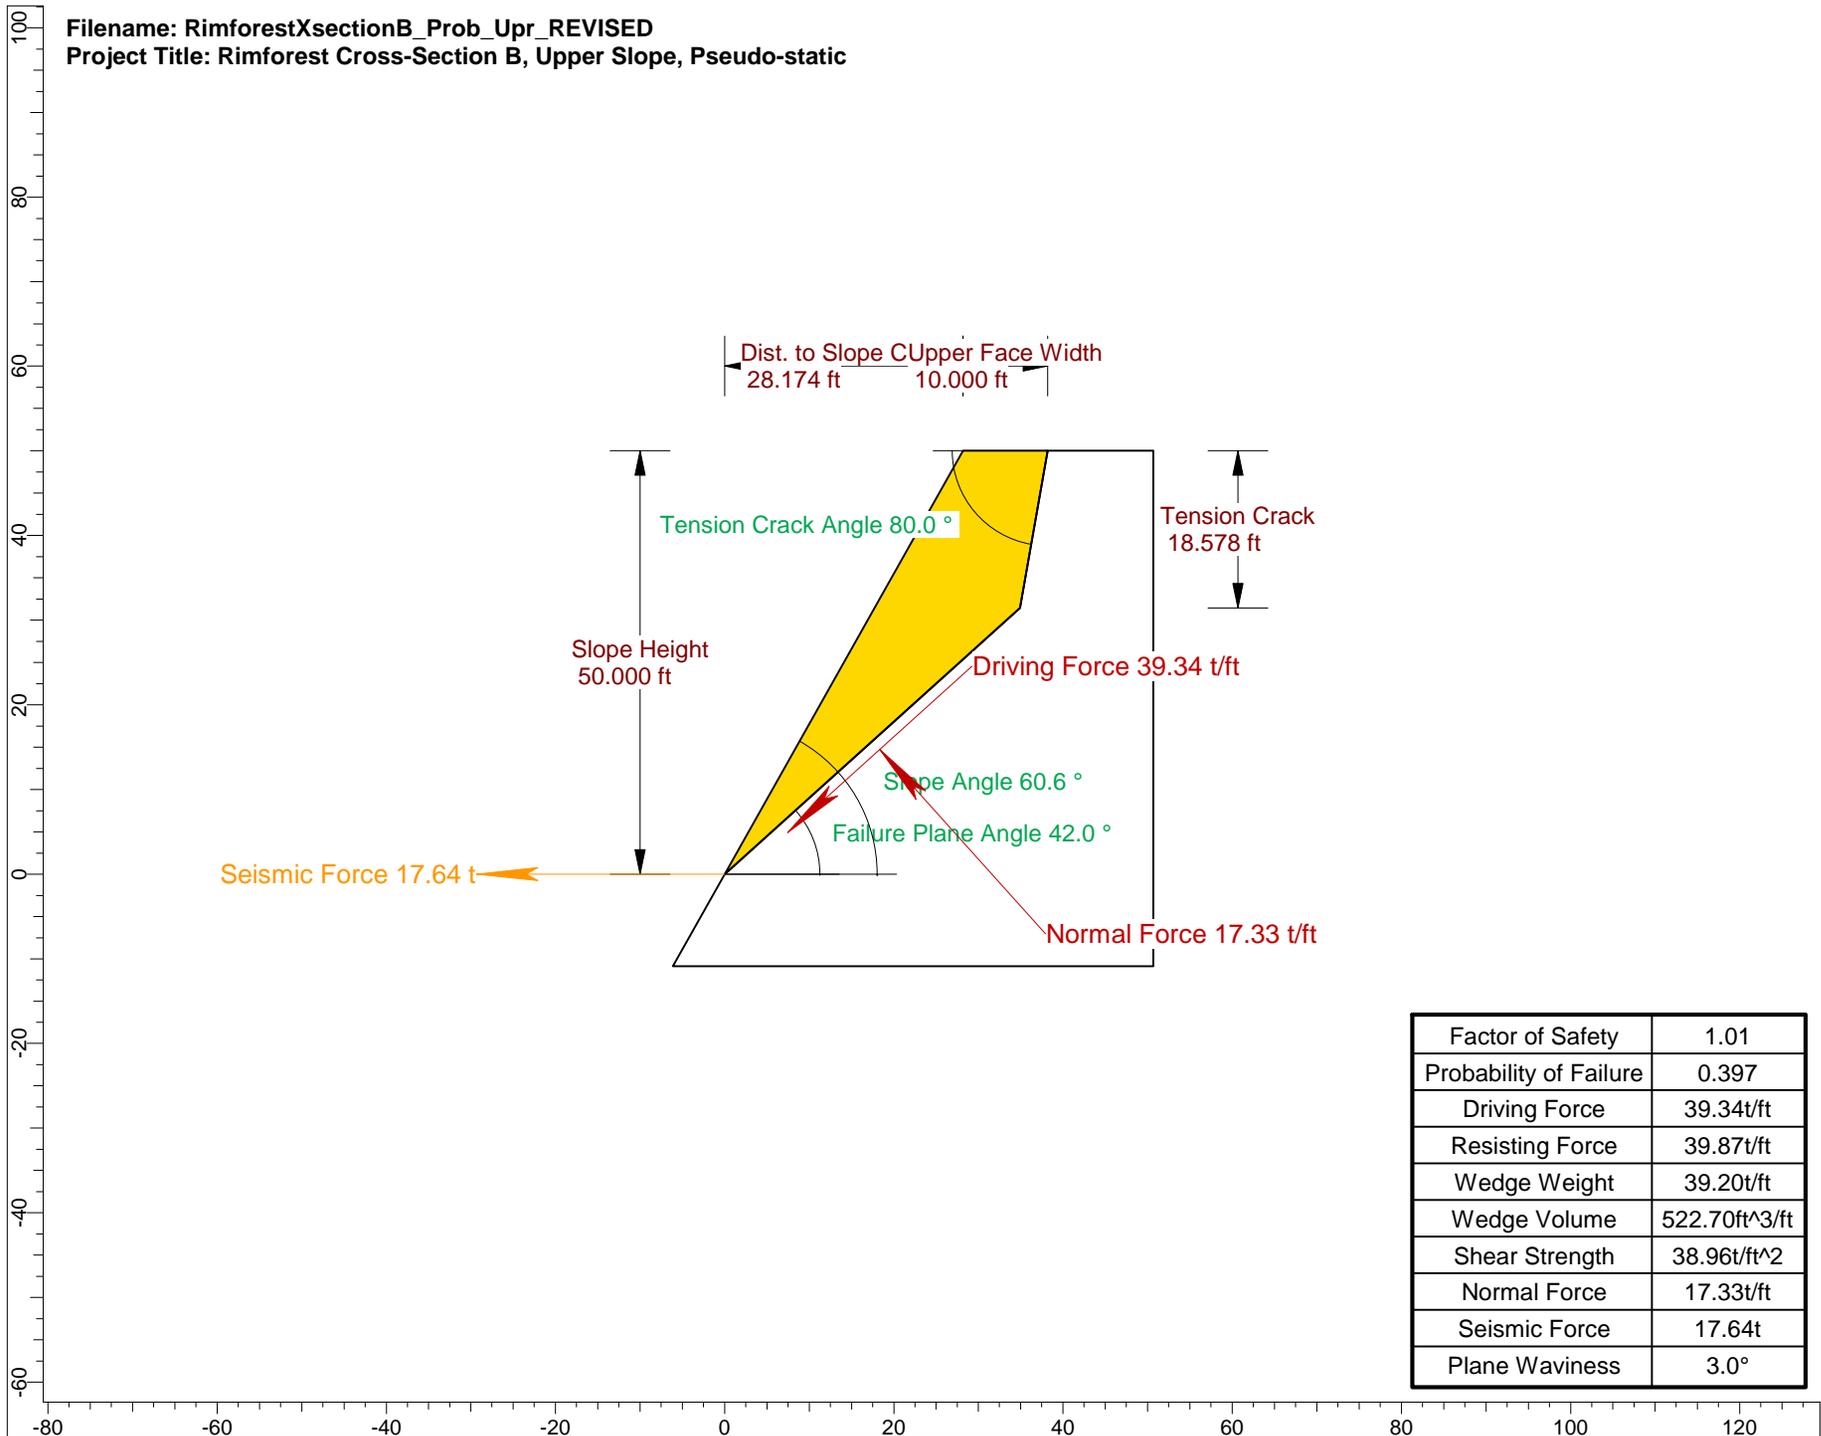
Filename: RimforestXsectionB_Prob_Upr_REVISED
 Project Title: Rimforest Cross-Section B, Upper Slope, Pseudo-static

Factor of Safety	1.01
Probability of Failure	0.397
Driving Force	39.34t/ft
Resisting Force	39.87t/ft
Wedge Weight	39.20t/ft
Wedge Volume	522.70ft ³ /ft
Shear Strength	38.96t/ft ²
Normal Force	17.33t/ft
Seismic Force	17.64t
Plane Waviness	3.0°

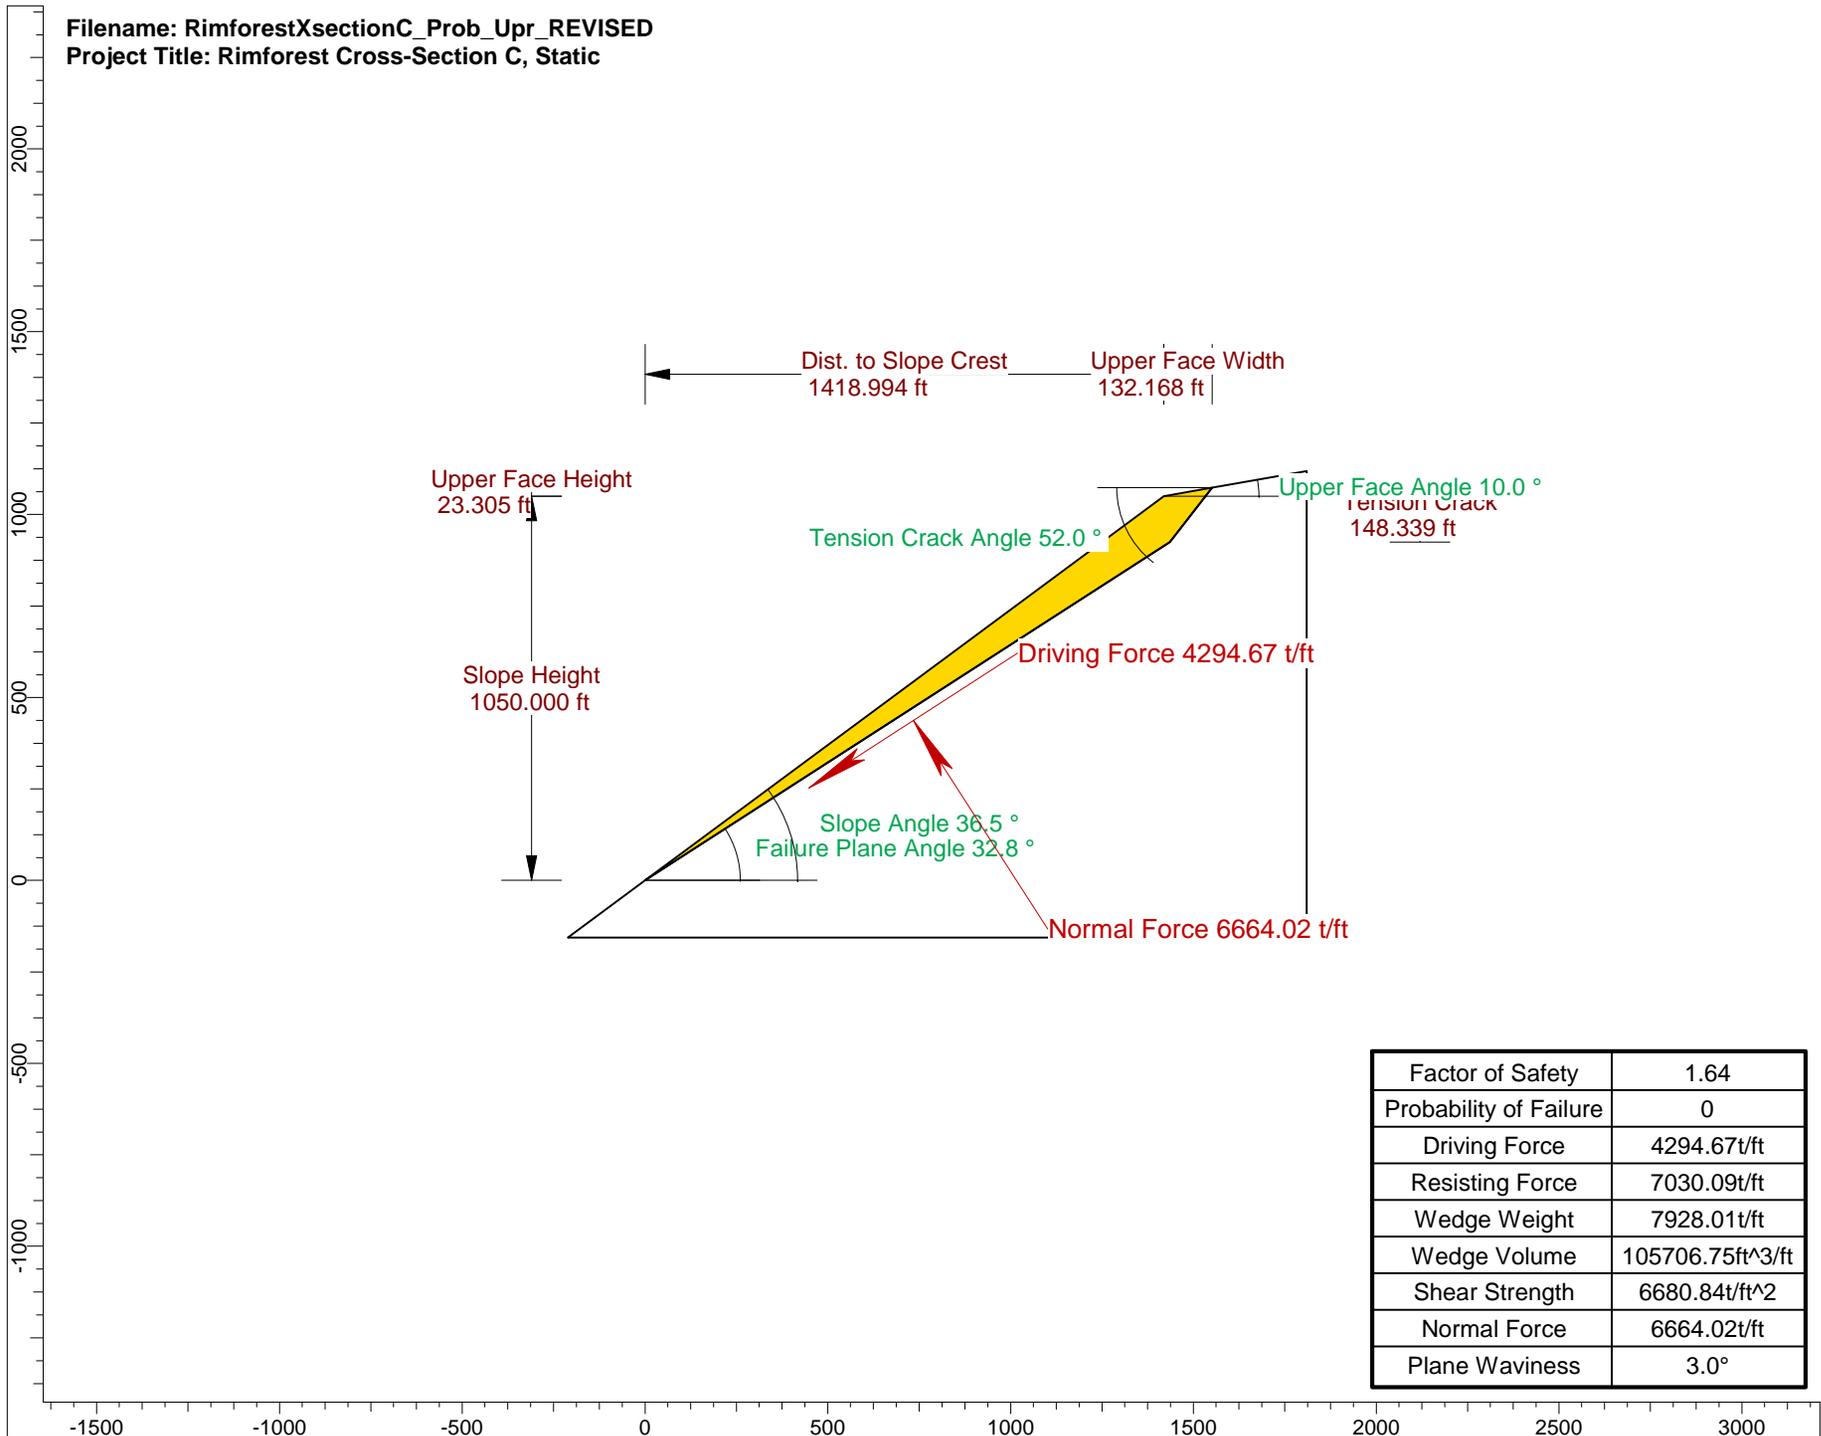
Filename: RimforestXsectionC_Prob_Upr_REVISED
 Project Title: Rimforest Cross-Section C, Static

Factor of Safety	1.64
Probability of Failure	0
Driving Force	4294.67t/ft
Resisting Force	7030.09t/ft
Wedge Weight	7928.01t/ft
Wedge Volume	105706.75ft ³ /ft
Shear Strength	6680.84t/ft ²
Normal Force	6664.02t/ft
Plane Waviness	3.0°

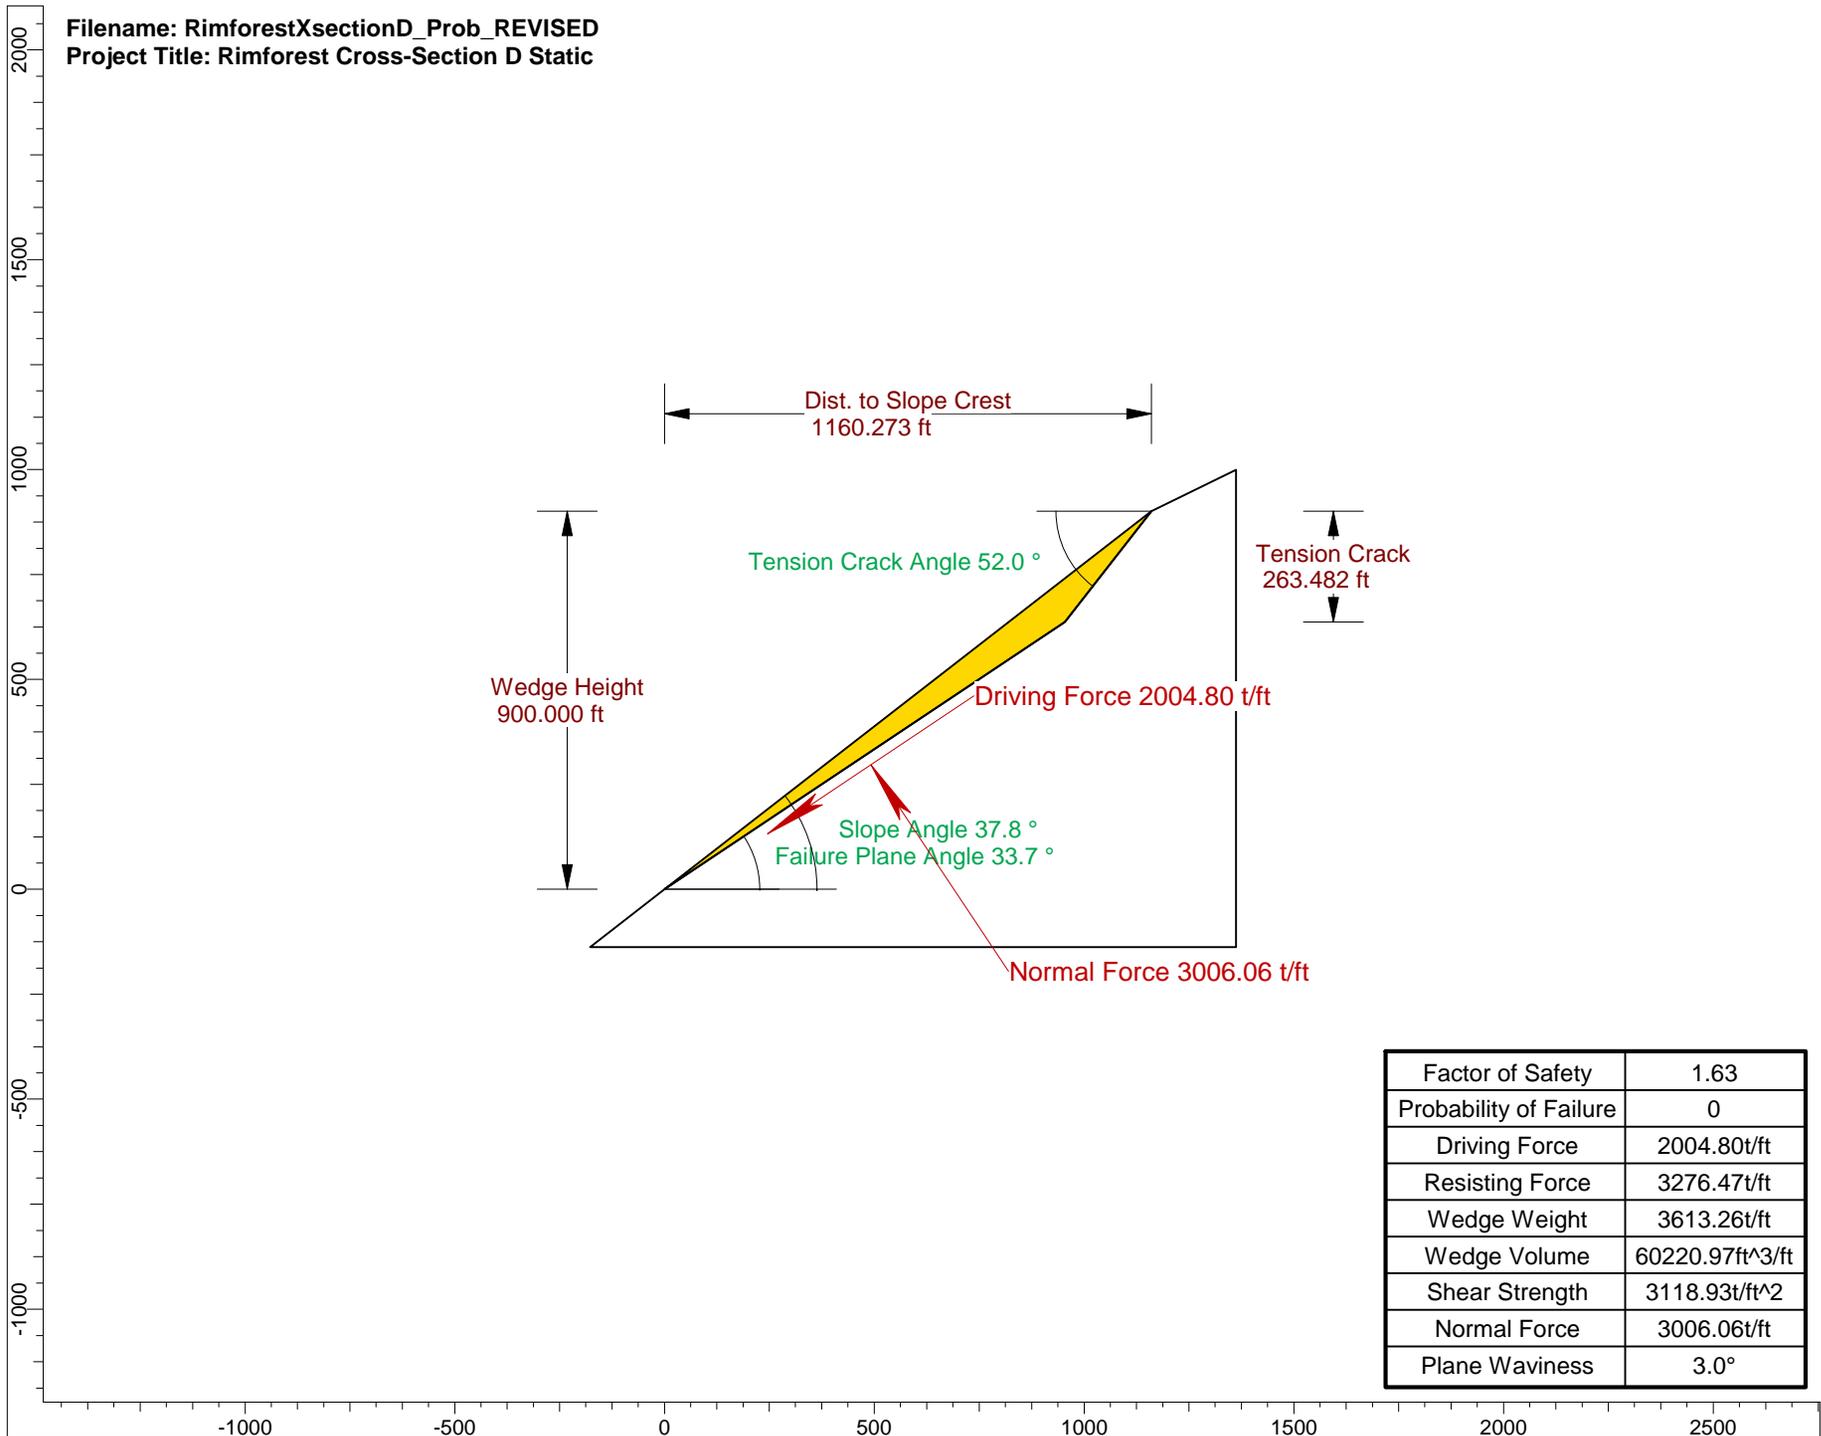
Filename: RimforestXsectionD_Prob_REVISIED
 Project Title: Rimforest Cross-Section D Static

Factor of Safety	1.63
Probability of Failure	0
Driving Force	2004.80t/ft
Resisting Force	3276.47t/ft
Wedge Weight	3613.26t/ft
Wedge Volume	60220.97ft ³ /ft
Shear Strength	3118.93t/ft ²
Normal Force	3006.06t/ft
Plane Waviness	3.0°

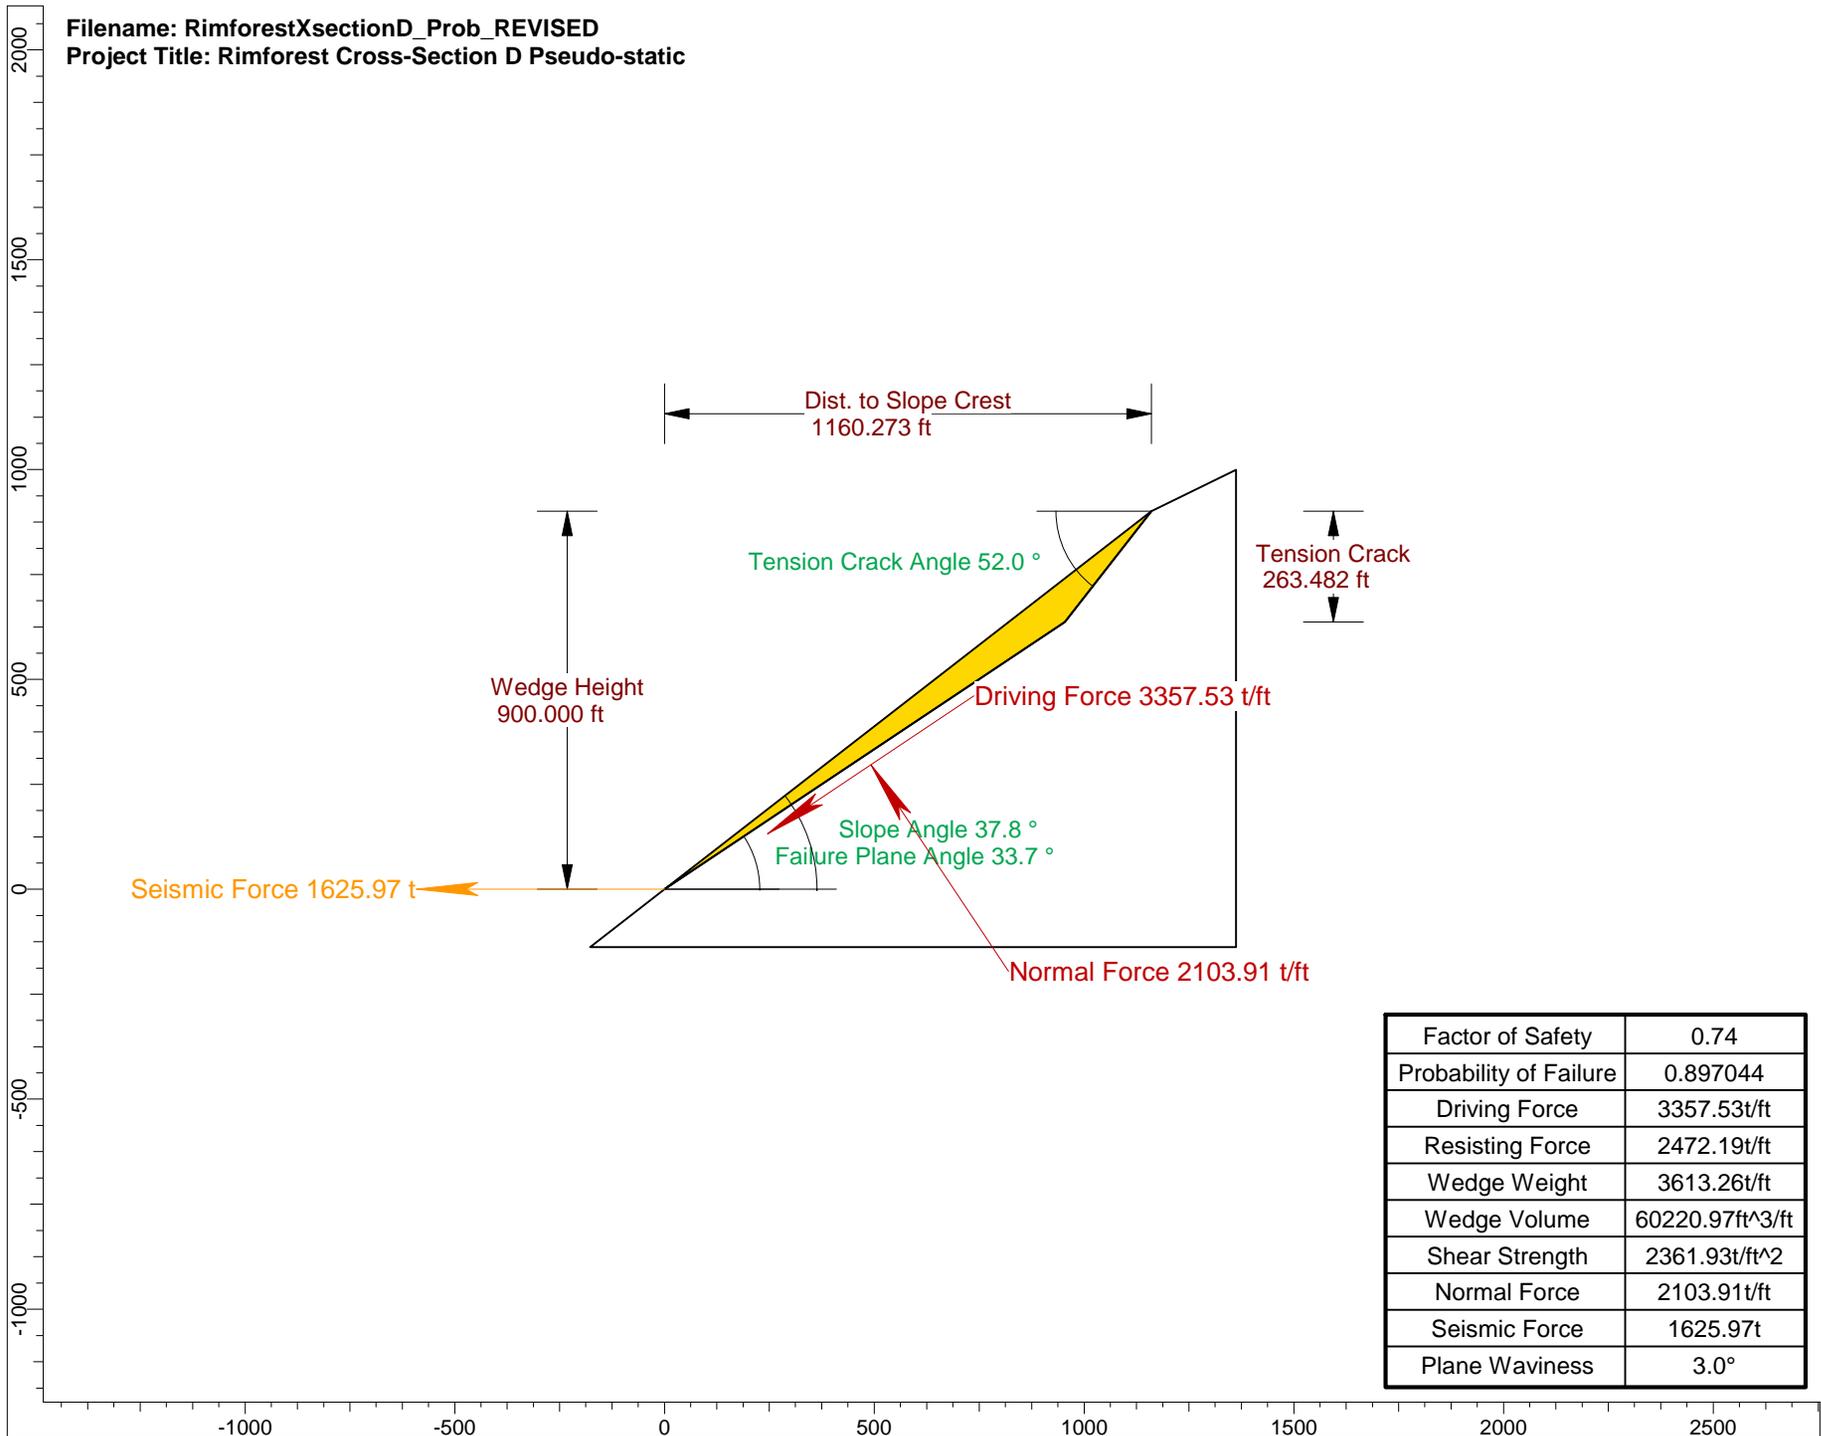
Factor of Safety	0.74
Probability of Failure	0.897044
Driving Force	3357.53t/ft
Resisting Force	2472.19t/ft
Wedge Weight	3613.26t/ft
Wedge Volume	60220.97ft ³ /ft
Shear Strength	2361.93t/ft ²
Normal Force	2103.91t/ft
Seismic Force	1625.97t
Plane Waviness	3.0°

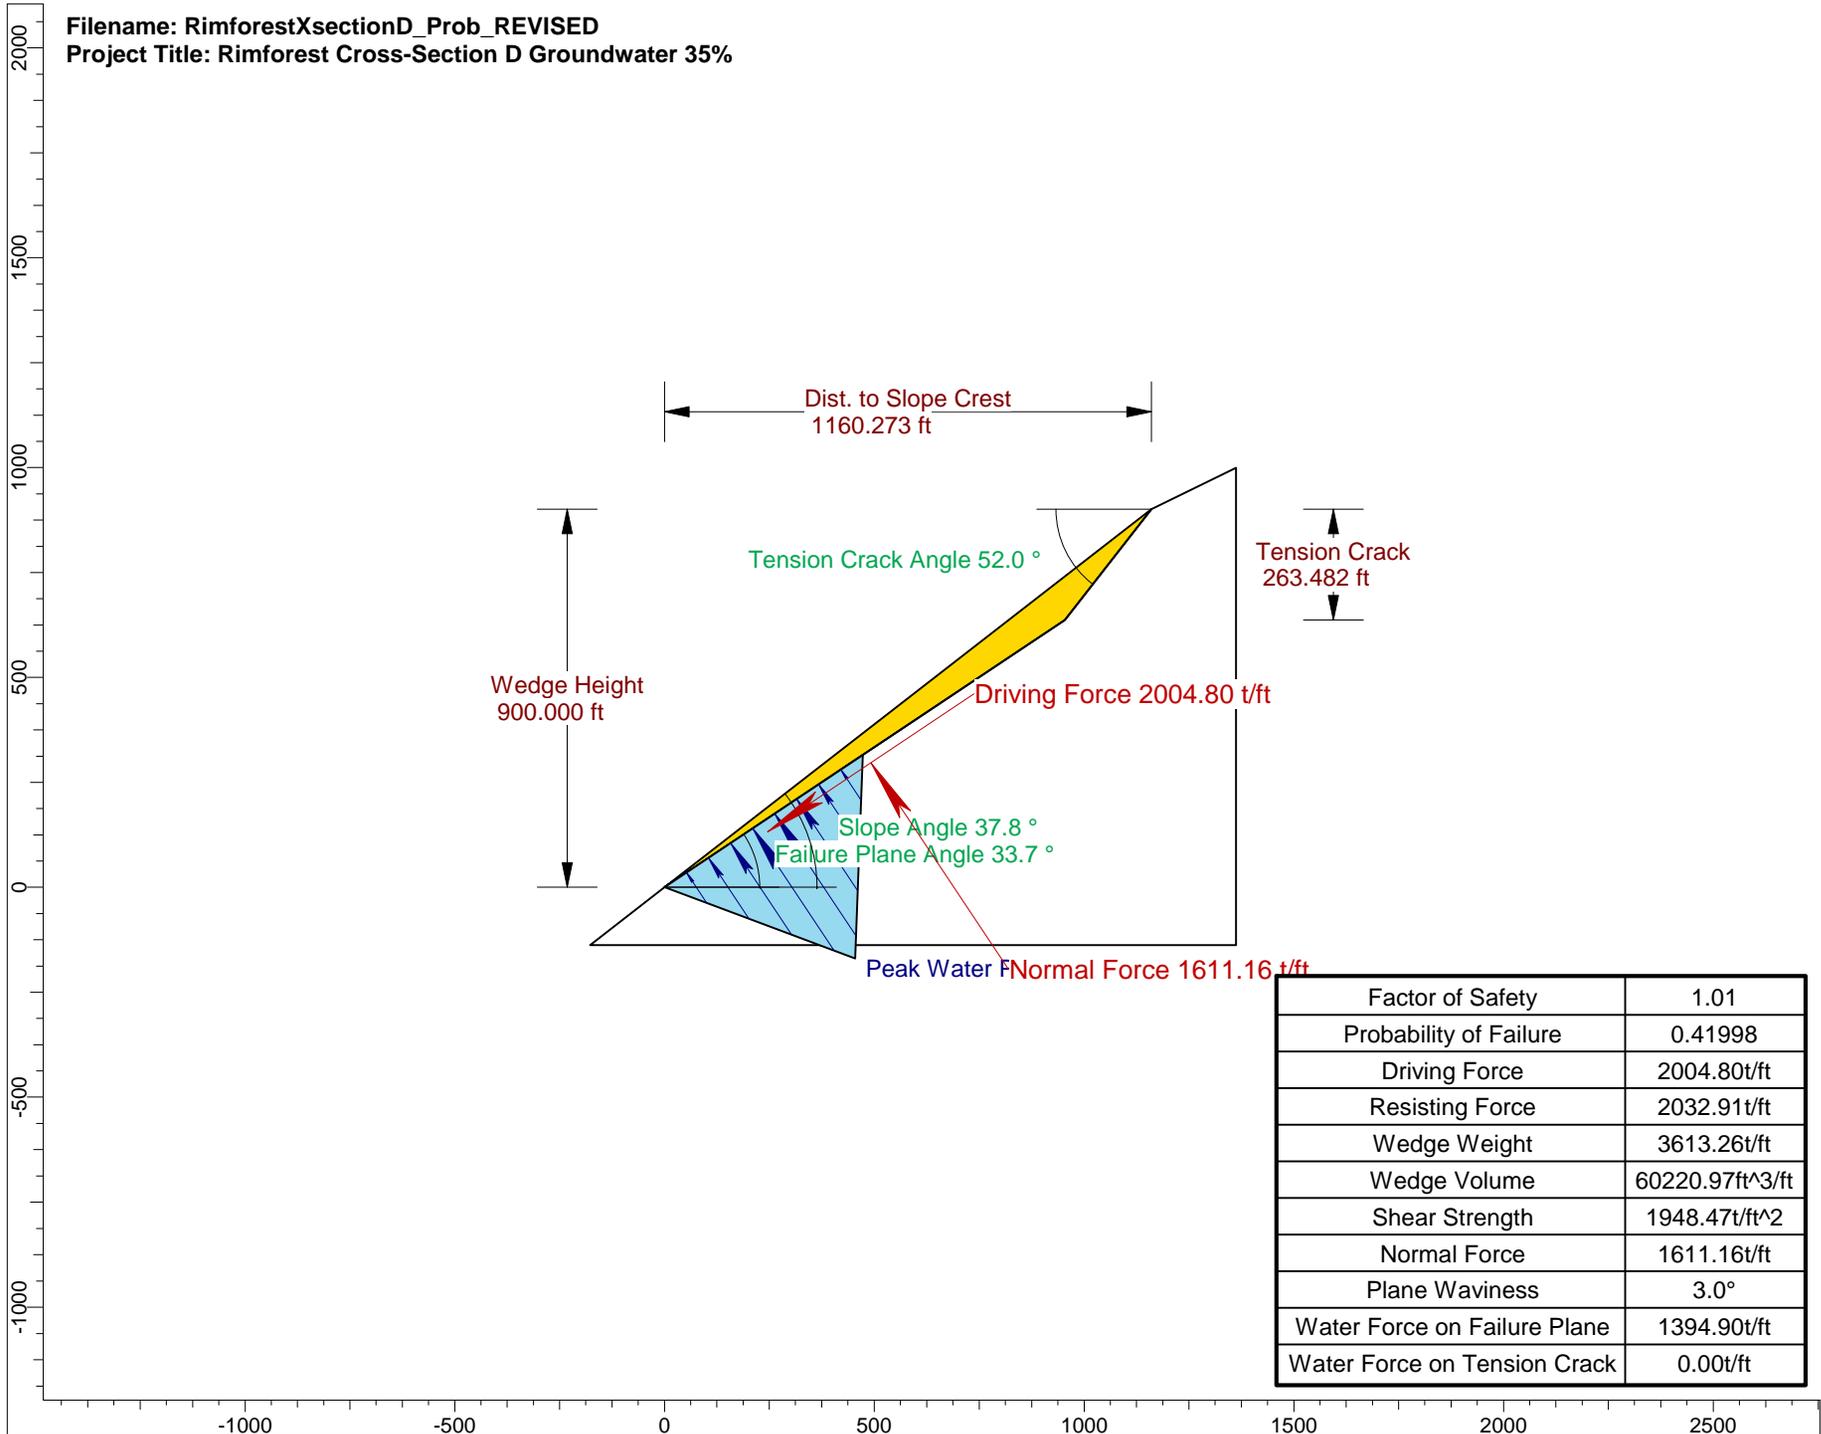
Filename: RimforestXsectionD_Prob_REVISED
 Project Title: Rimforest Cross-Section D Groundwater 35%

Factor of Safety	1.01
Probability of Failure	0.41998
Driving Force	2004.80t/ft
Resisting Force	2032.91t/ft
Wedge Weight	3613.26t/ft
Wedge Volume	60220.97ft ³ /ft
Shear Strength	1948.47t/ft ²
Normal Force	1611.16t/ft
Plane Waviness	3.0°
Water Force on Failure Plane	1394.90t/ft
Water Force on Tension Crack	0.00t/ft
