APPENDIX D
Subject Property Photographs

Sunray Solar Site

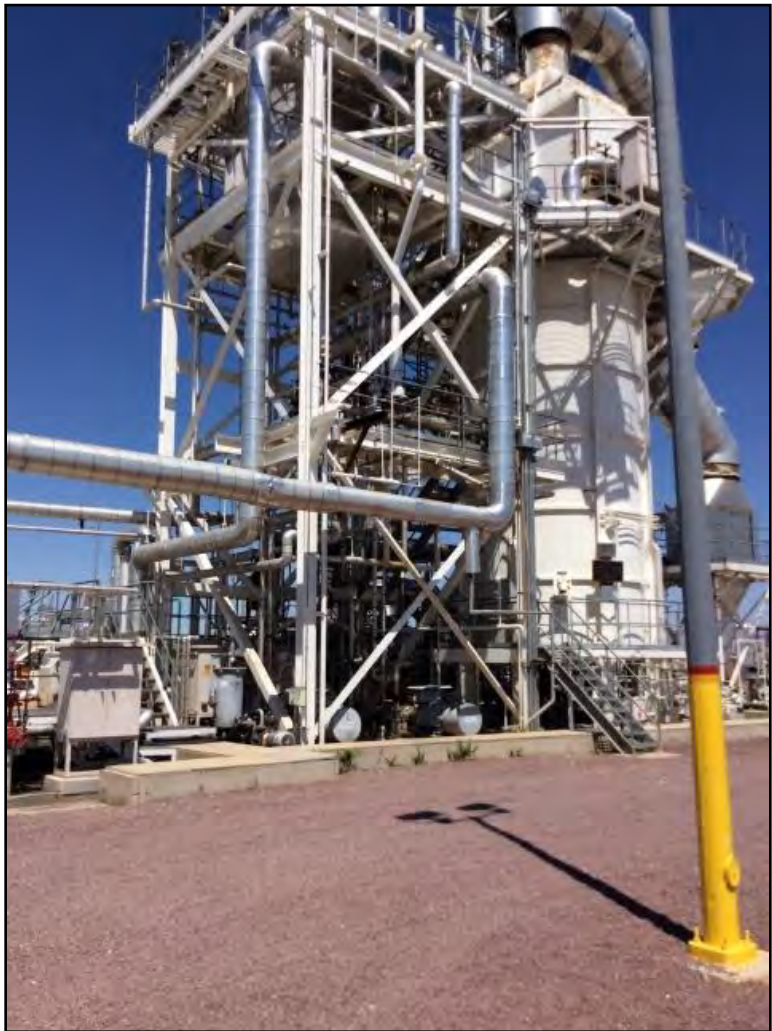
Attributes	
Comments	SEGS 1powerblock
Photo ID	3

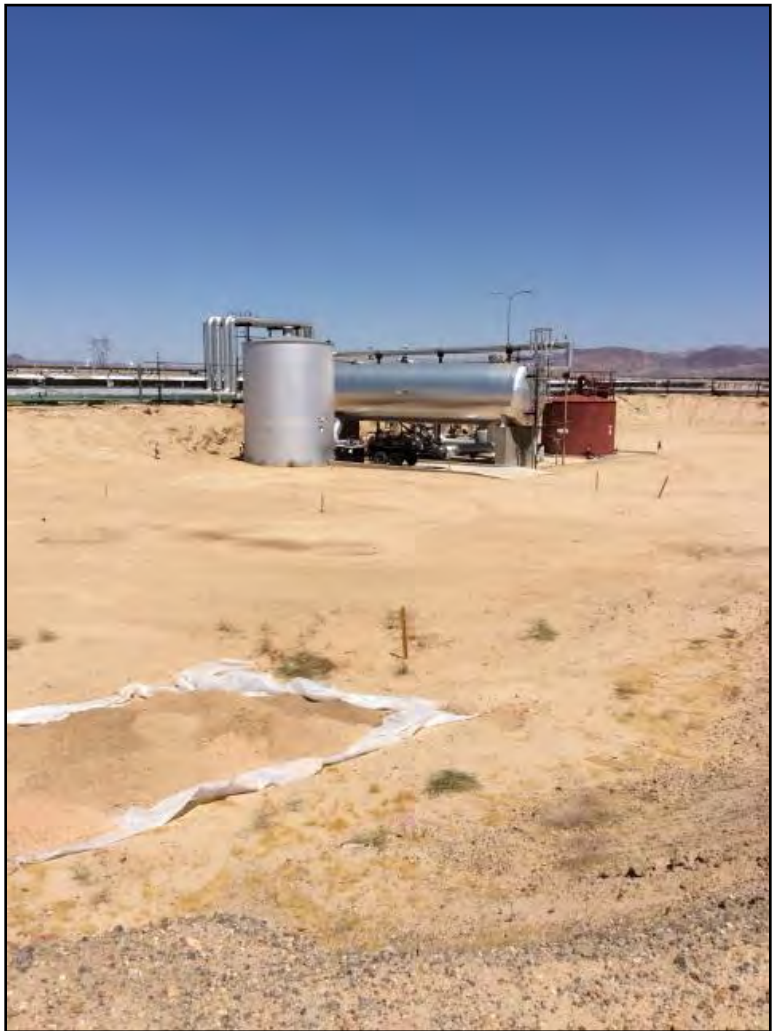
Attributes	
Comments	Caloria tanks in SEGs 1. Also, location of fire pit.
Photo ID	4

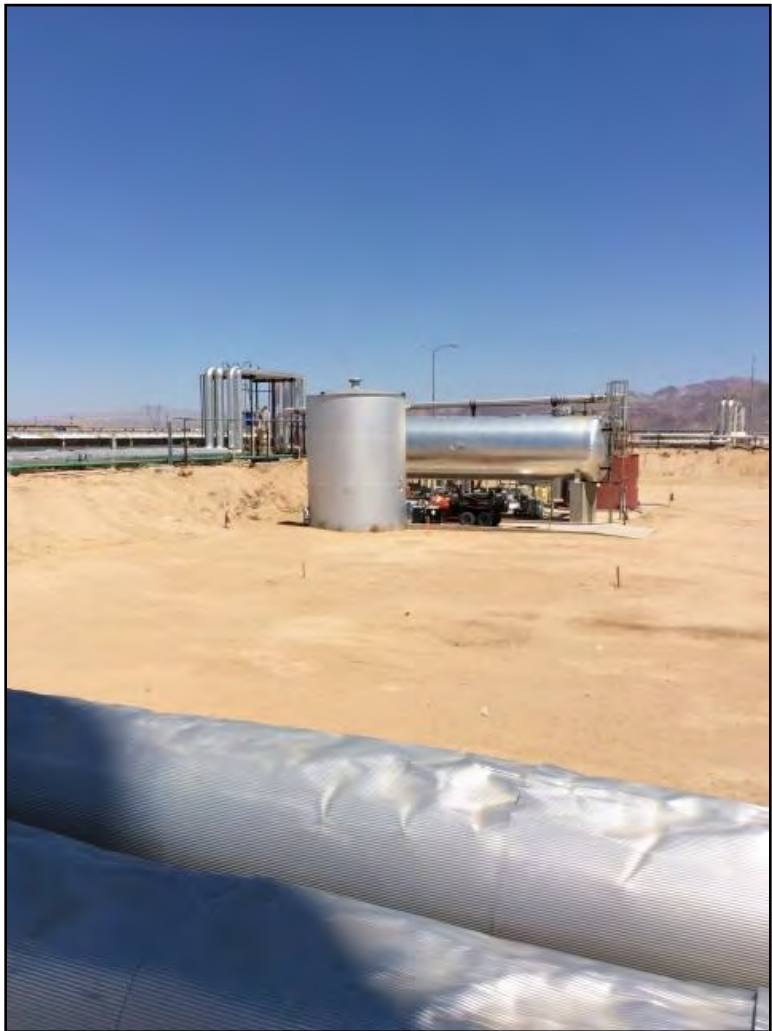
Attributes	
Comments	Caloria ASTs in fire pit area at SEGs
Photo ID	6

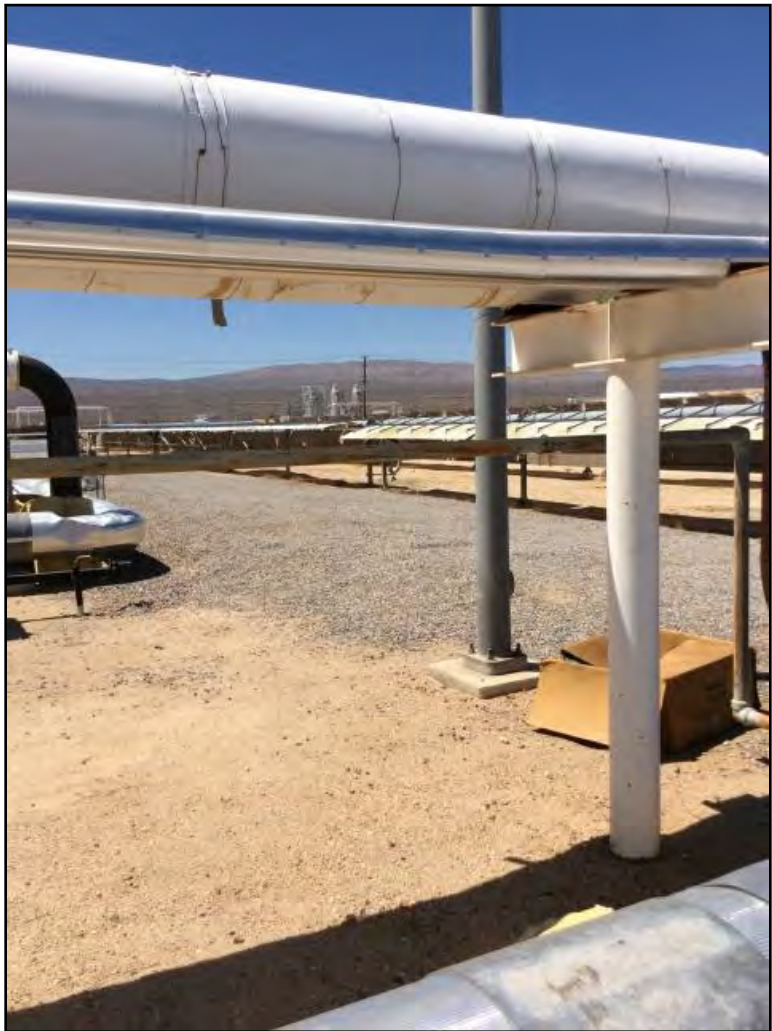
Photo ID: 7

Attributes	
Comments	Boring location S-1 HTF line at SEGs 1 powerblock
Photo ID	7

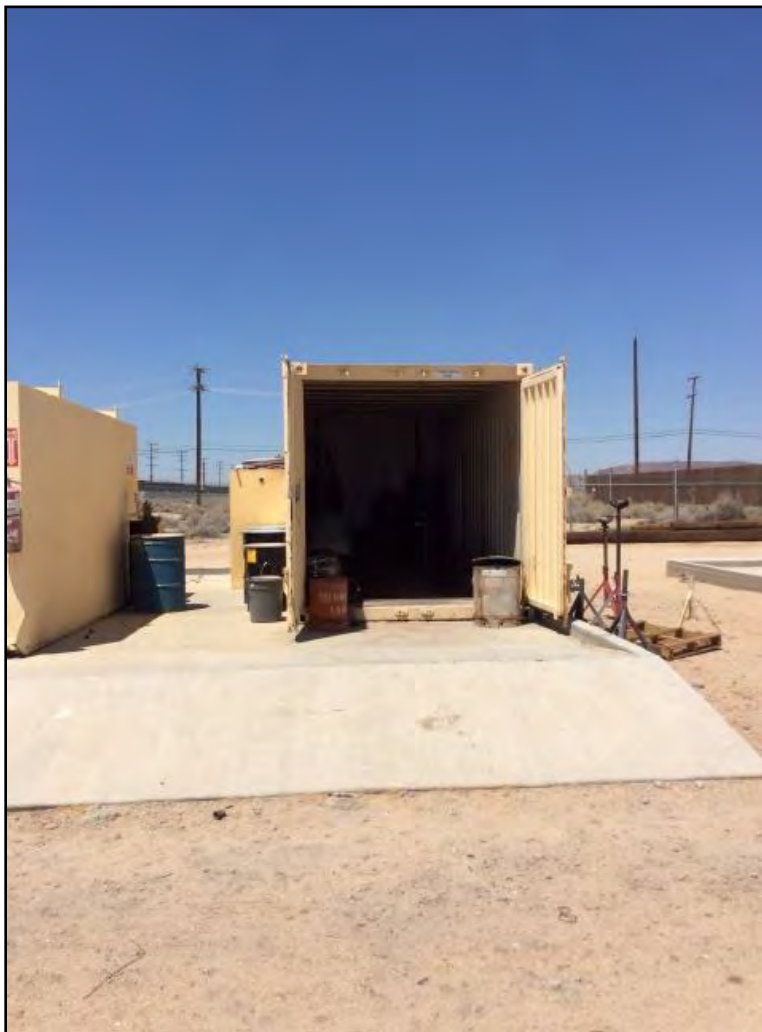
Attributes	
Comments	Hazardous waste storage containers.
Photo ID	9

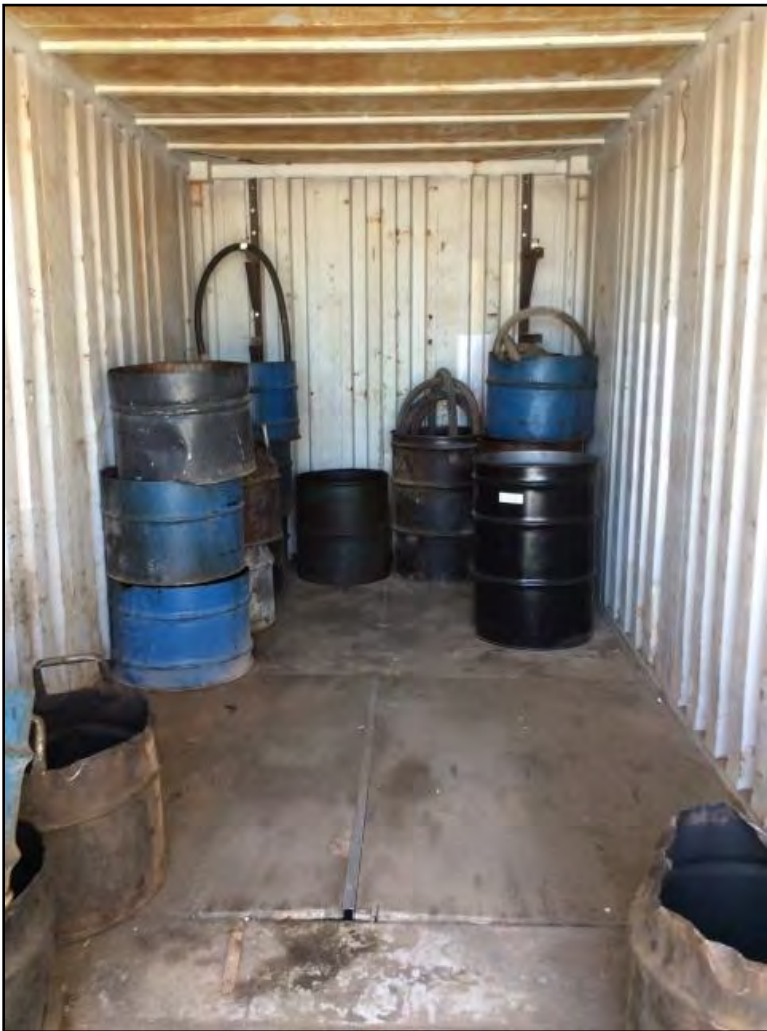
Attributes	
Comments	Drip pans, oil residues drums, in hazardous waste storage container
Photo ID	10

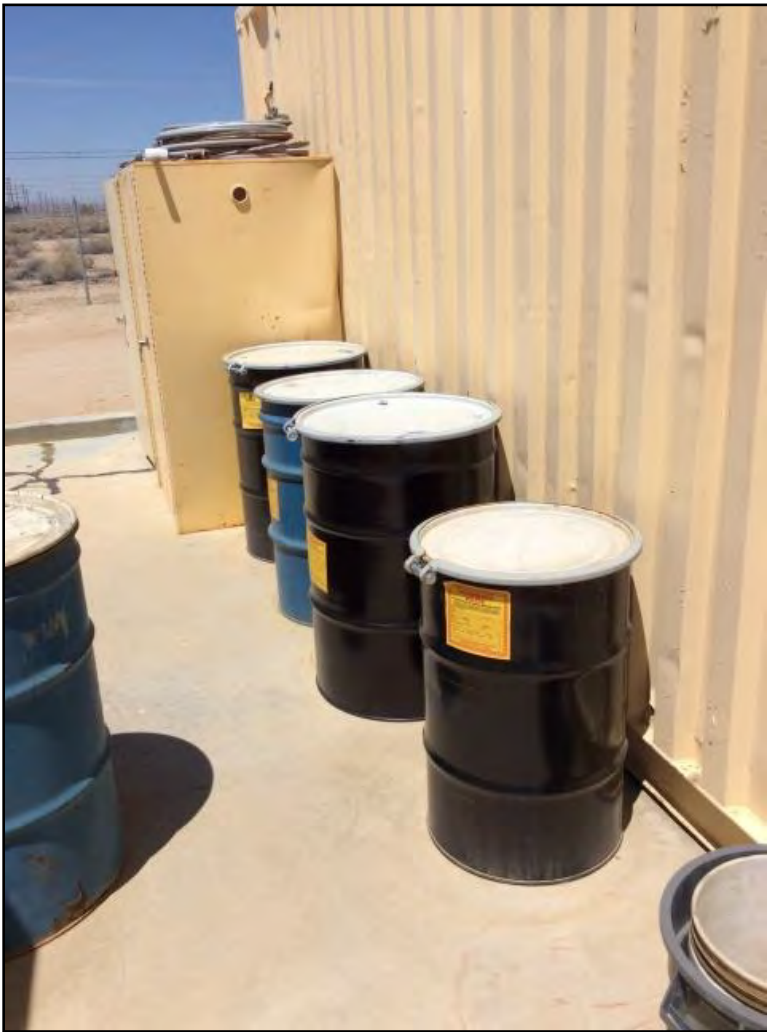
Attributes	
Comments	Drums in hazarous waste storage area
Photo ID	11

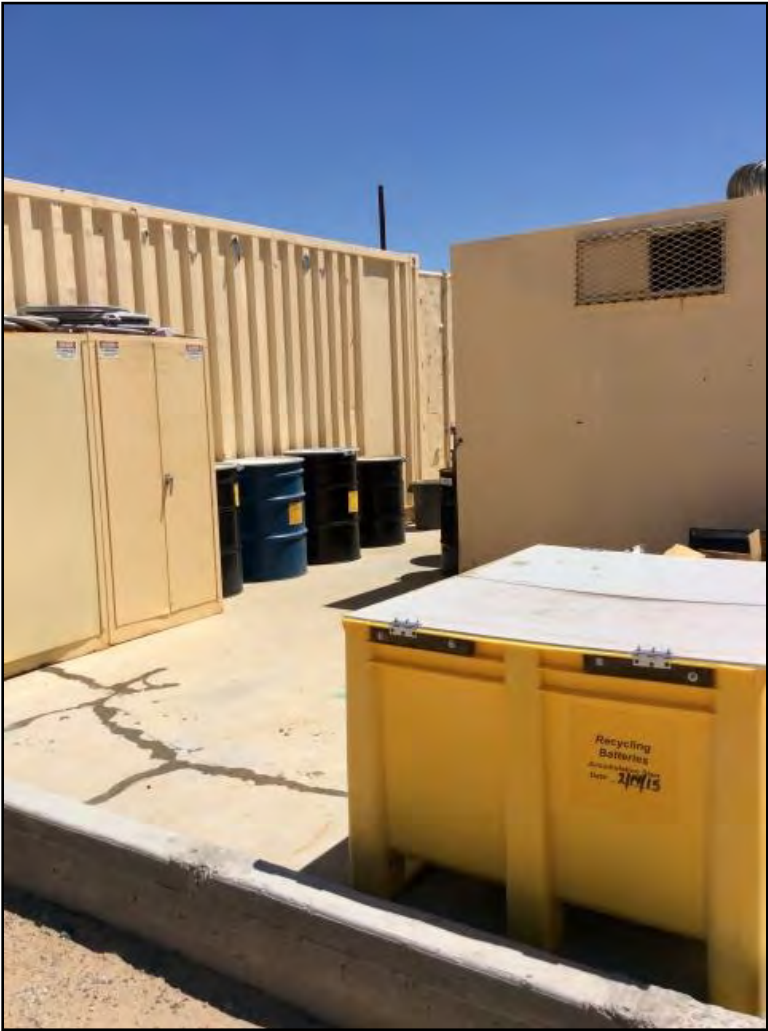
Attributes	
Comments	Hazardous waste area. Note battery storage in yellow container. No leaks or spills observed on drip/spill pads. Cracks have been recently sealed.
Photo ID	12

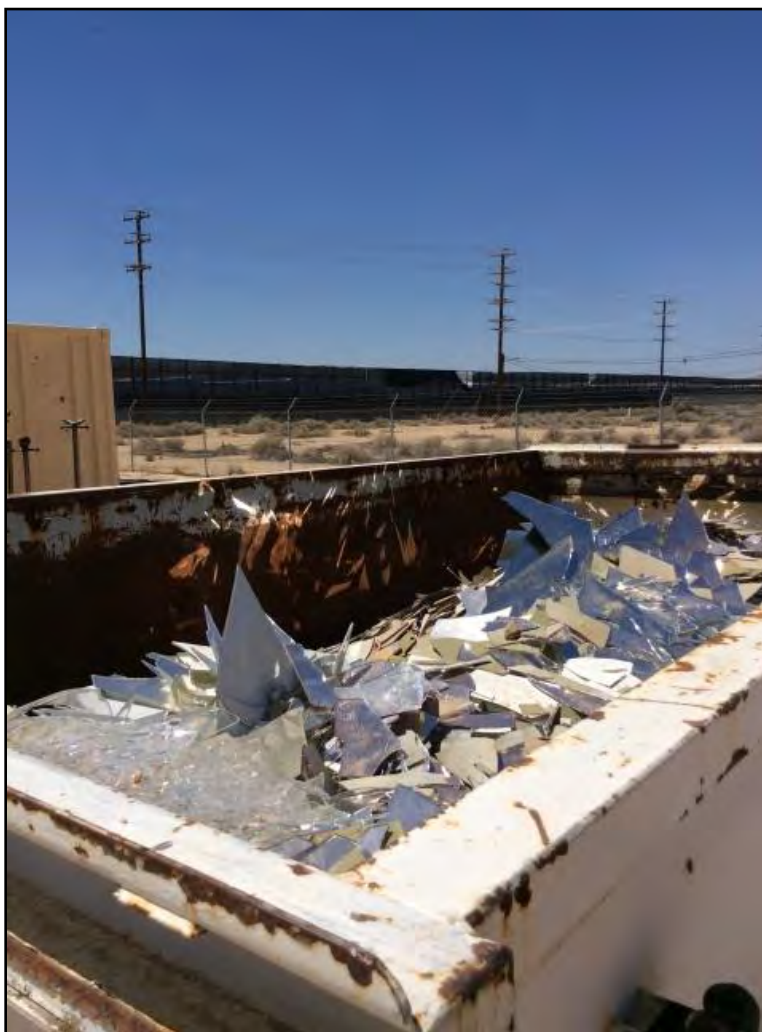
Photo ID: 13

Attributes	
Comments	Storage of mirror glass. The mirror glass has a coating that contains lead. The glass is considered hazadous waste because of TCLP testing above the 5 mg/L limit.
Photo ID	13

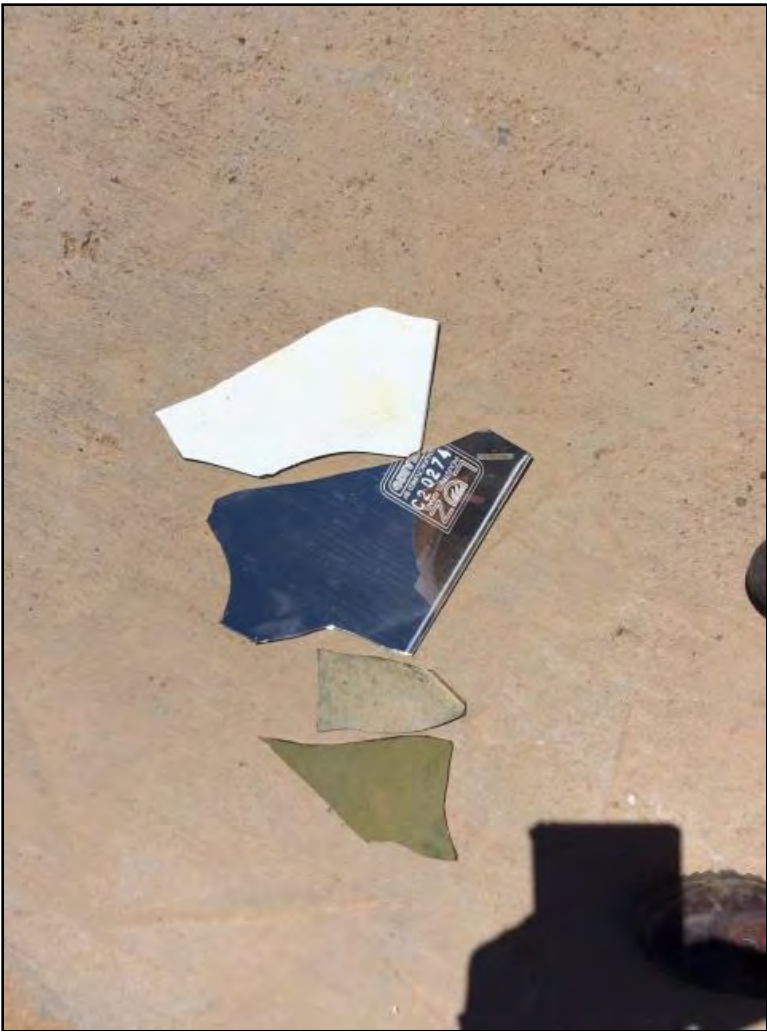
Attributes	
Comments	The olive green and faded olive green mirror glass contains the lead that tests above the limits. The white coating does not contain lead.
Photo ID	14

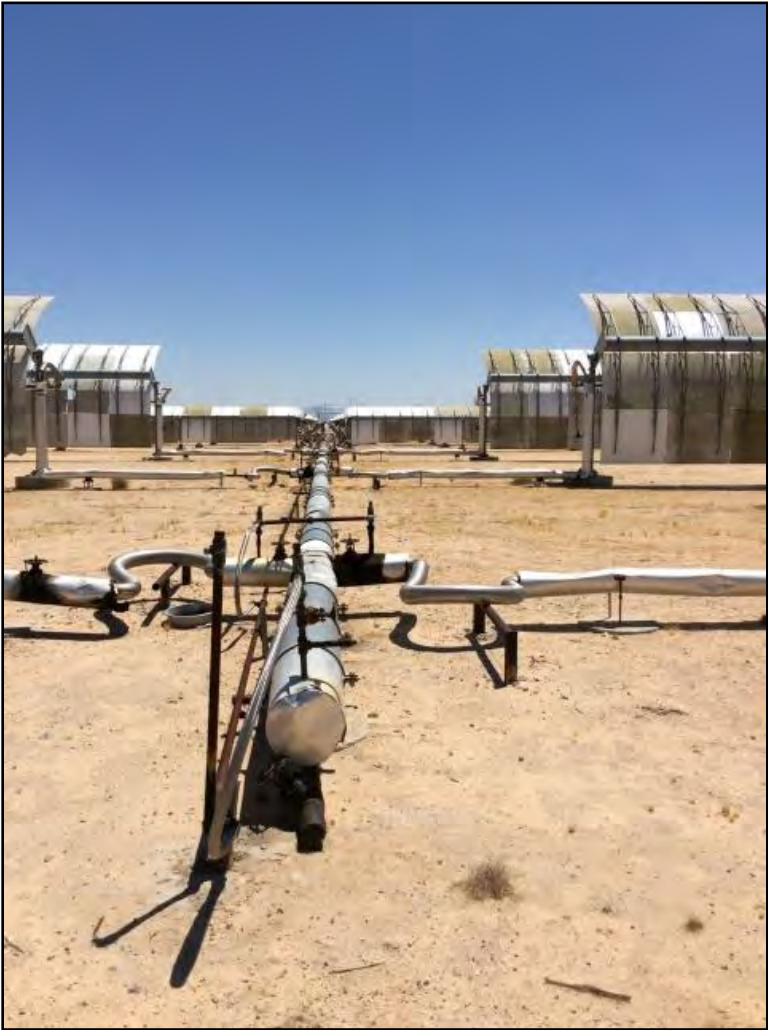
Attributes	
Comments	Header lines at SEGs 1 array field that contains or contained caloria. The SEGs 1 field is no longer in operation. They are currently purging the oil out of the lines with a evacuation pump and storing the oil for recycling in the ASTs located in the fire pit area.
Photo ID	15

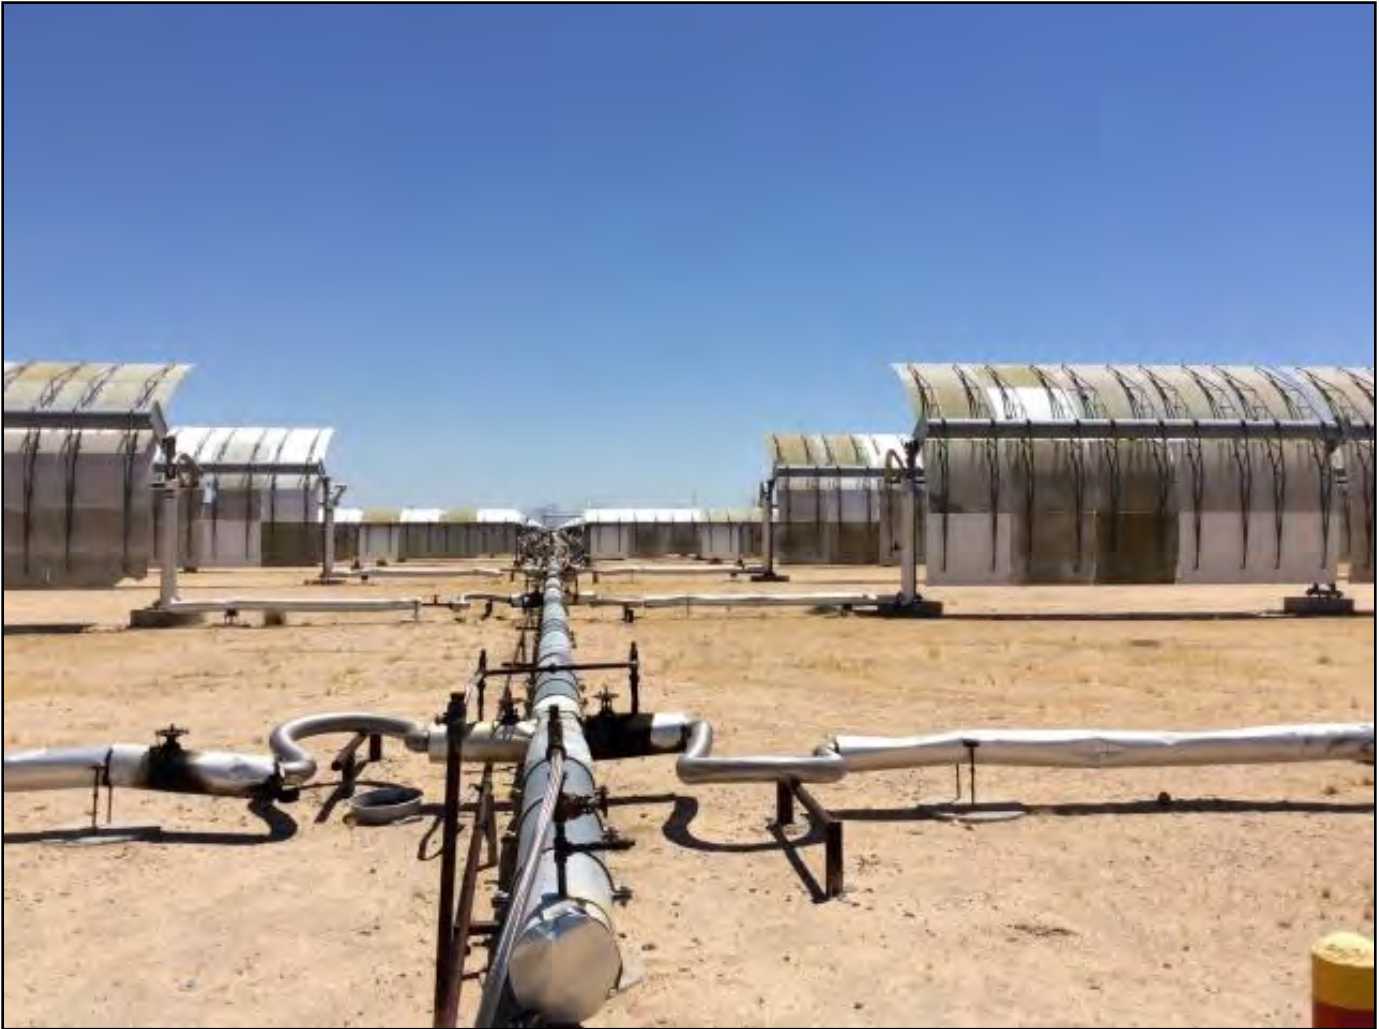
Attributes	
Comments	Note different mirror panels in SEGs 1 array field. White panels do not have lead-based coatings.
Photo ID	16

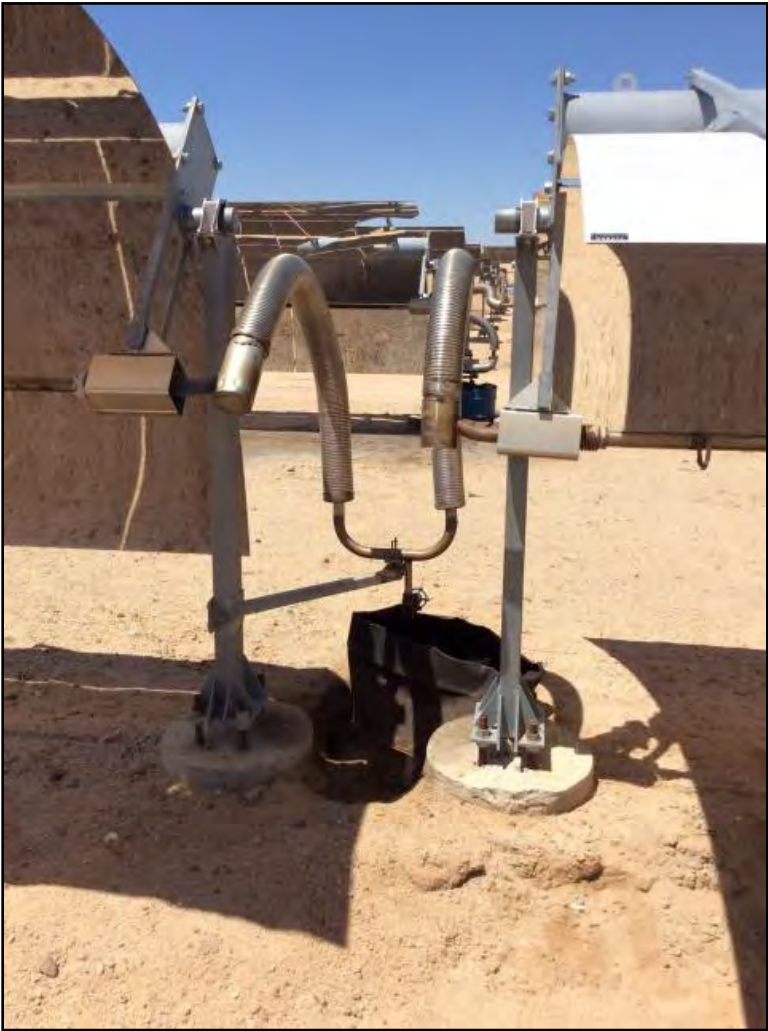
Attributes	
Comments	Double flex hose is were leaks commonly occur
Photo ID	19

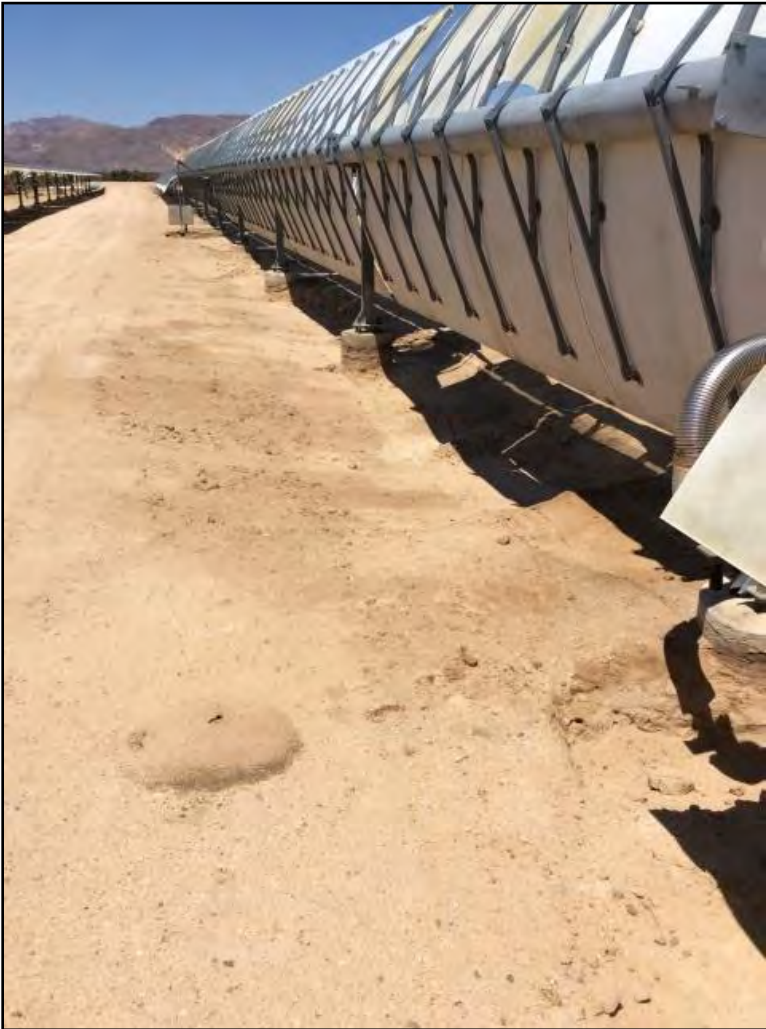
Attributes	
Comments	Spill cleanup at 22C in progress
Photo ID	20

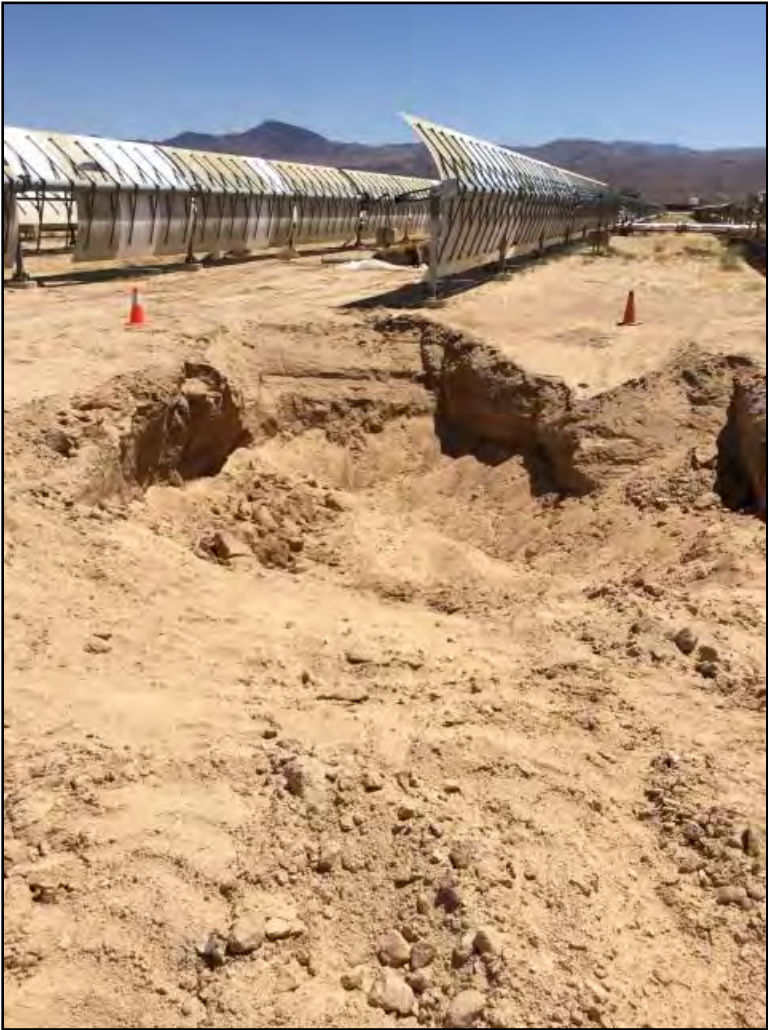
Attributes	
Comments	Excavation remediation at leak from double flex hose - rows 55 and 56C/D
Photo ID	23

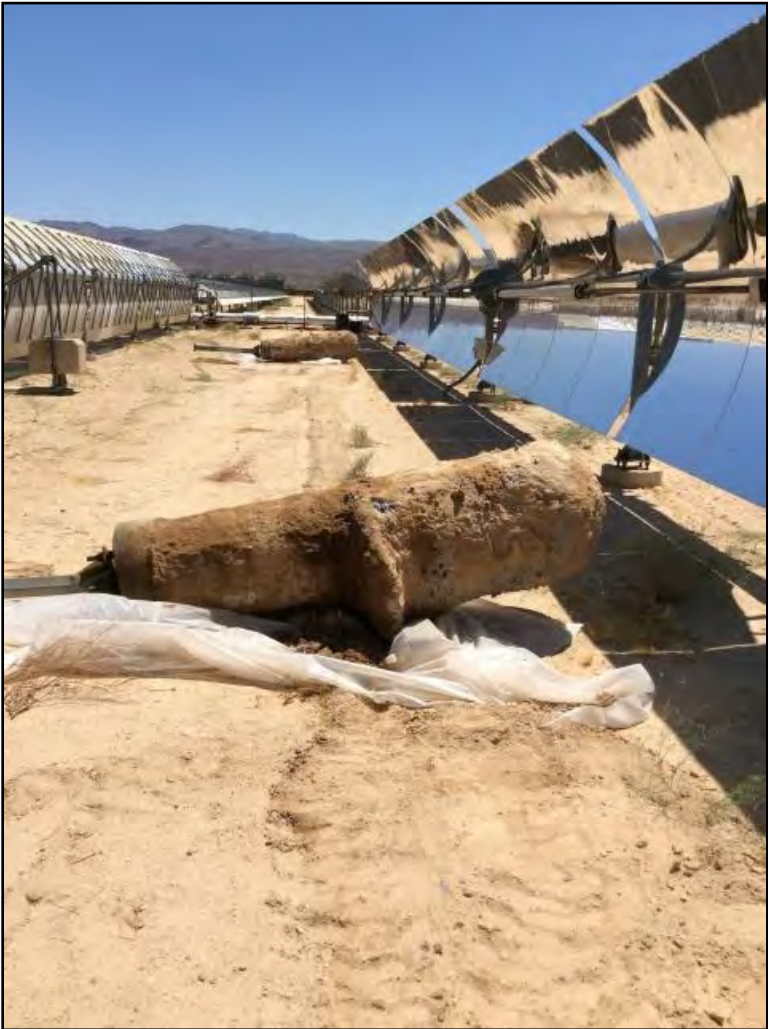
Attributes	
Comments	Concrete piling for array structure. Note contaminated soil around concrete.
Photo ID	24

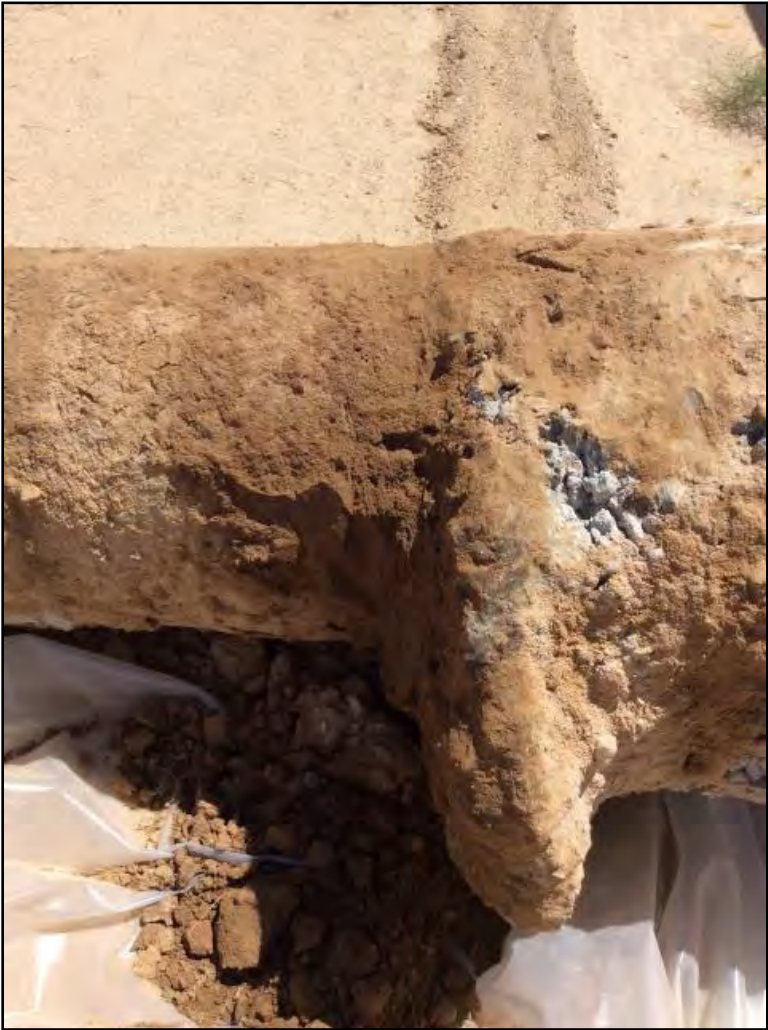
Attributes	
Comments	Caloria contaminated soils on concrete piling.
Photo ID	25

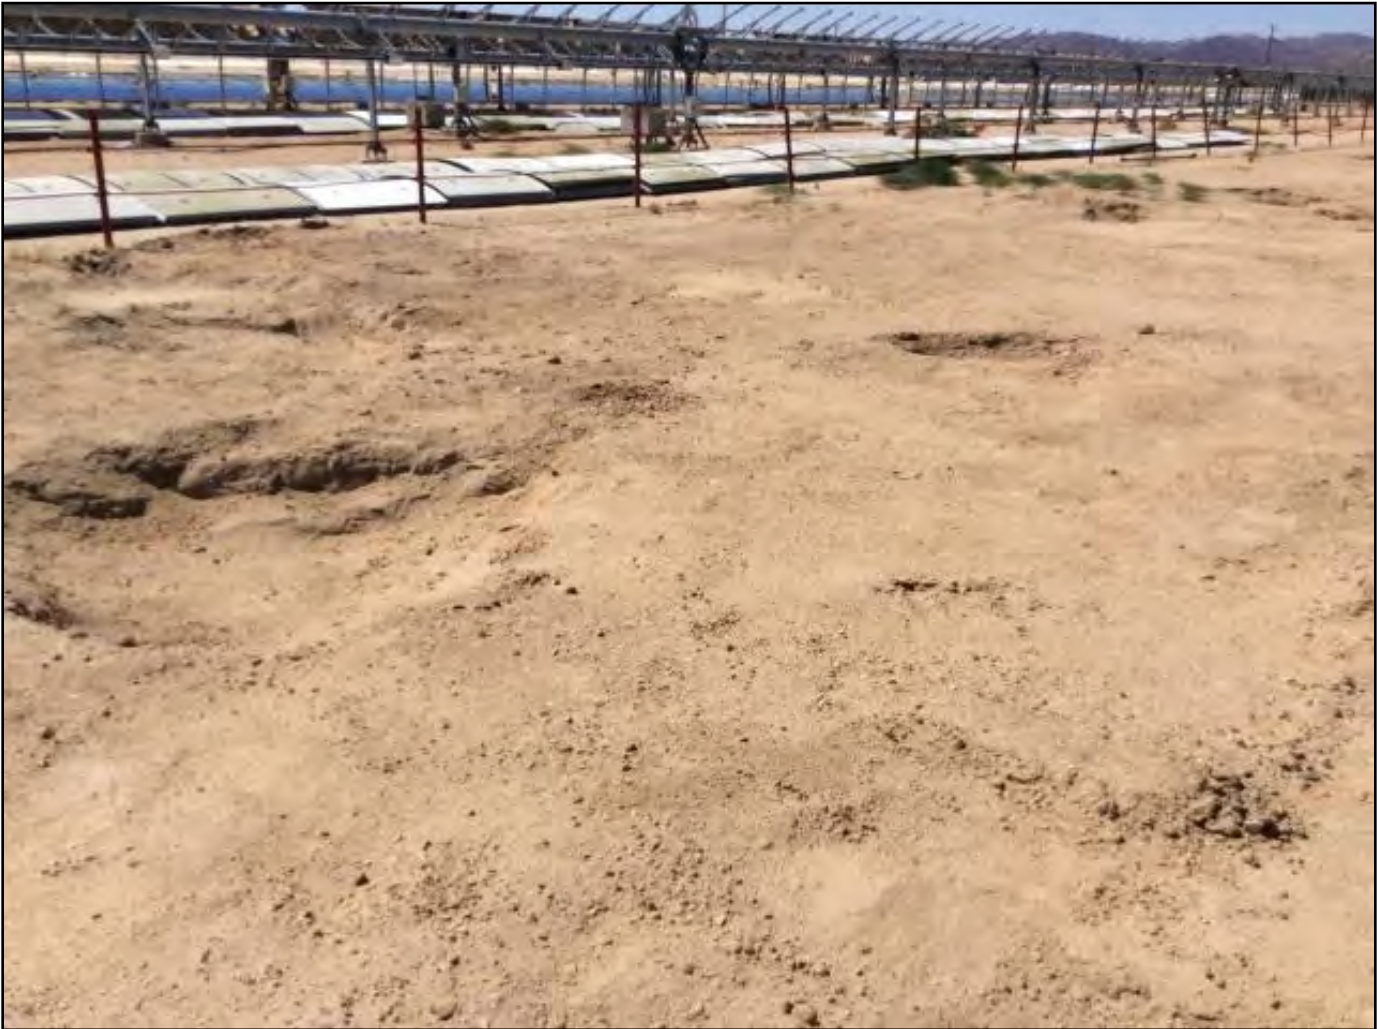
Attributes	
Comments	Remediated area where numerous deminimus leaks from vehicles in the maintenance and storage yard.
Photo ID	46

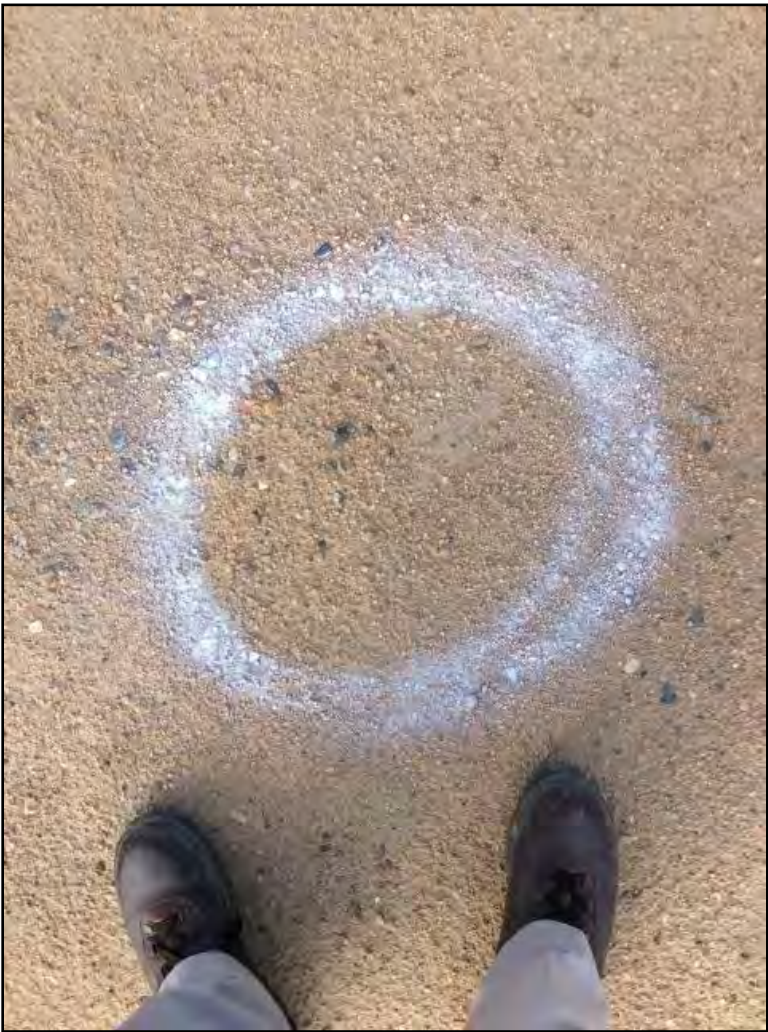
Attributes	
Comments	Soil boring M-6 located in the remediated oil area.
Photo ID	47
