**ENGINEERING GEOLOGY STUDY
PROPOSED INFILTRATION BASIN AND NEW STRUCTURE
APN 0266-012-10
20075 KENDALL DRIVE
SAN BERNARDINO, SAN BERNARDINO COUNTY
CALIFORNIA**

File No.: 12491-01
Doc. No.: 17-09-709

Project: **Proposed Infiltration Basin and New Structure**
APN 0266-012-10
20075 Kendall Drive
San Bernardino, San Bernardino County, California

Subject: **Engineering Geology Study**

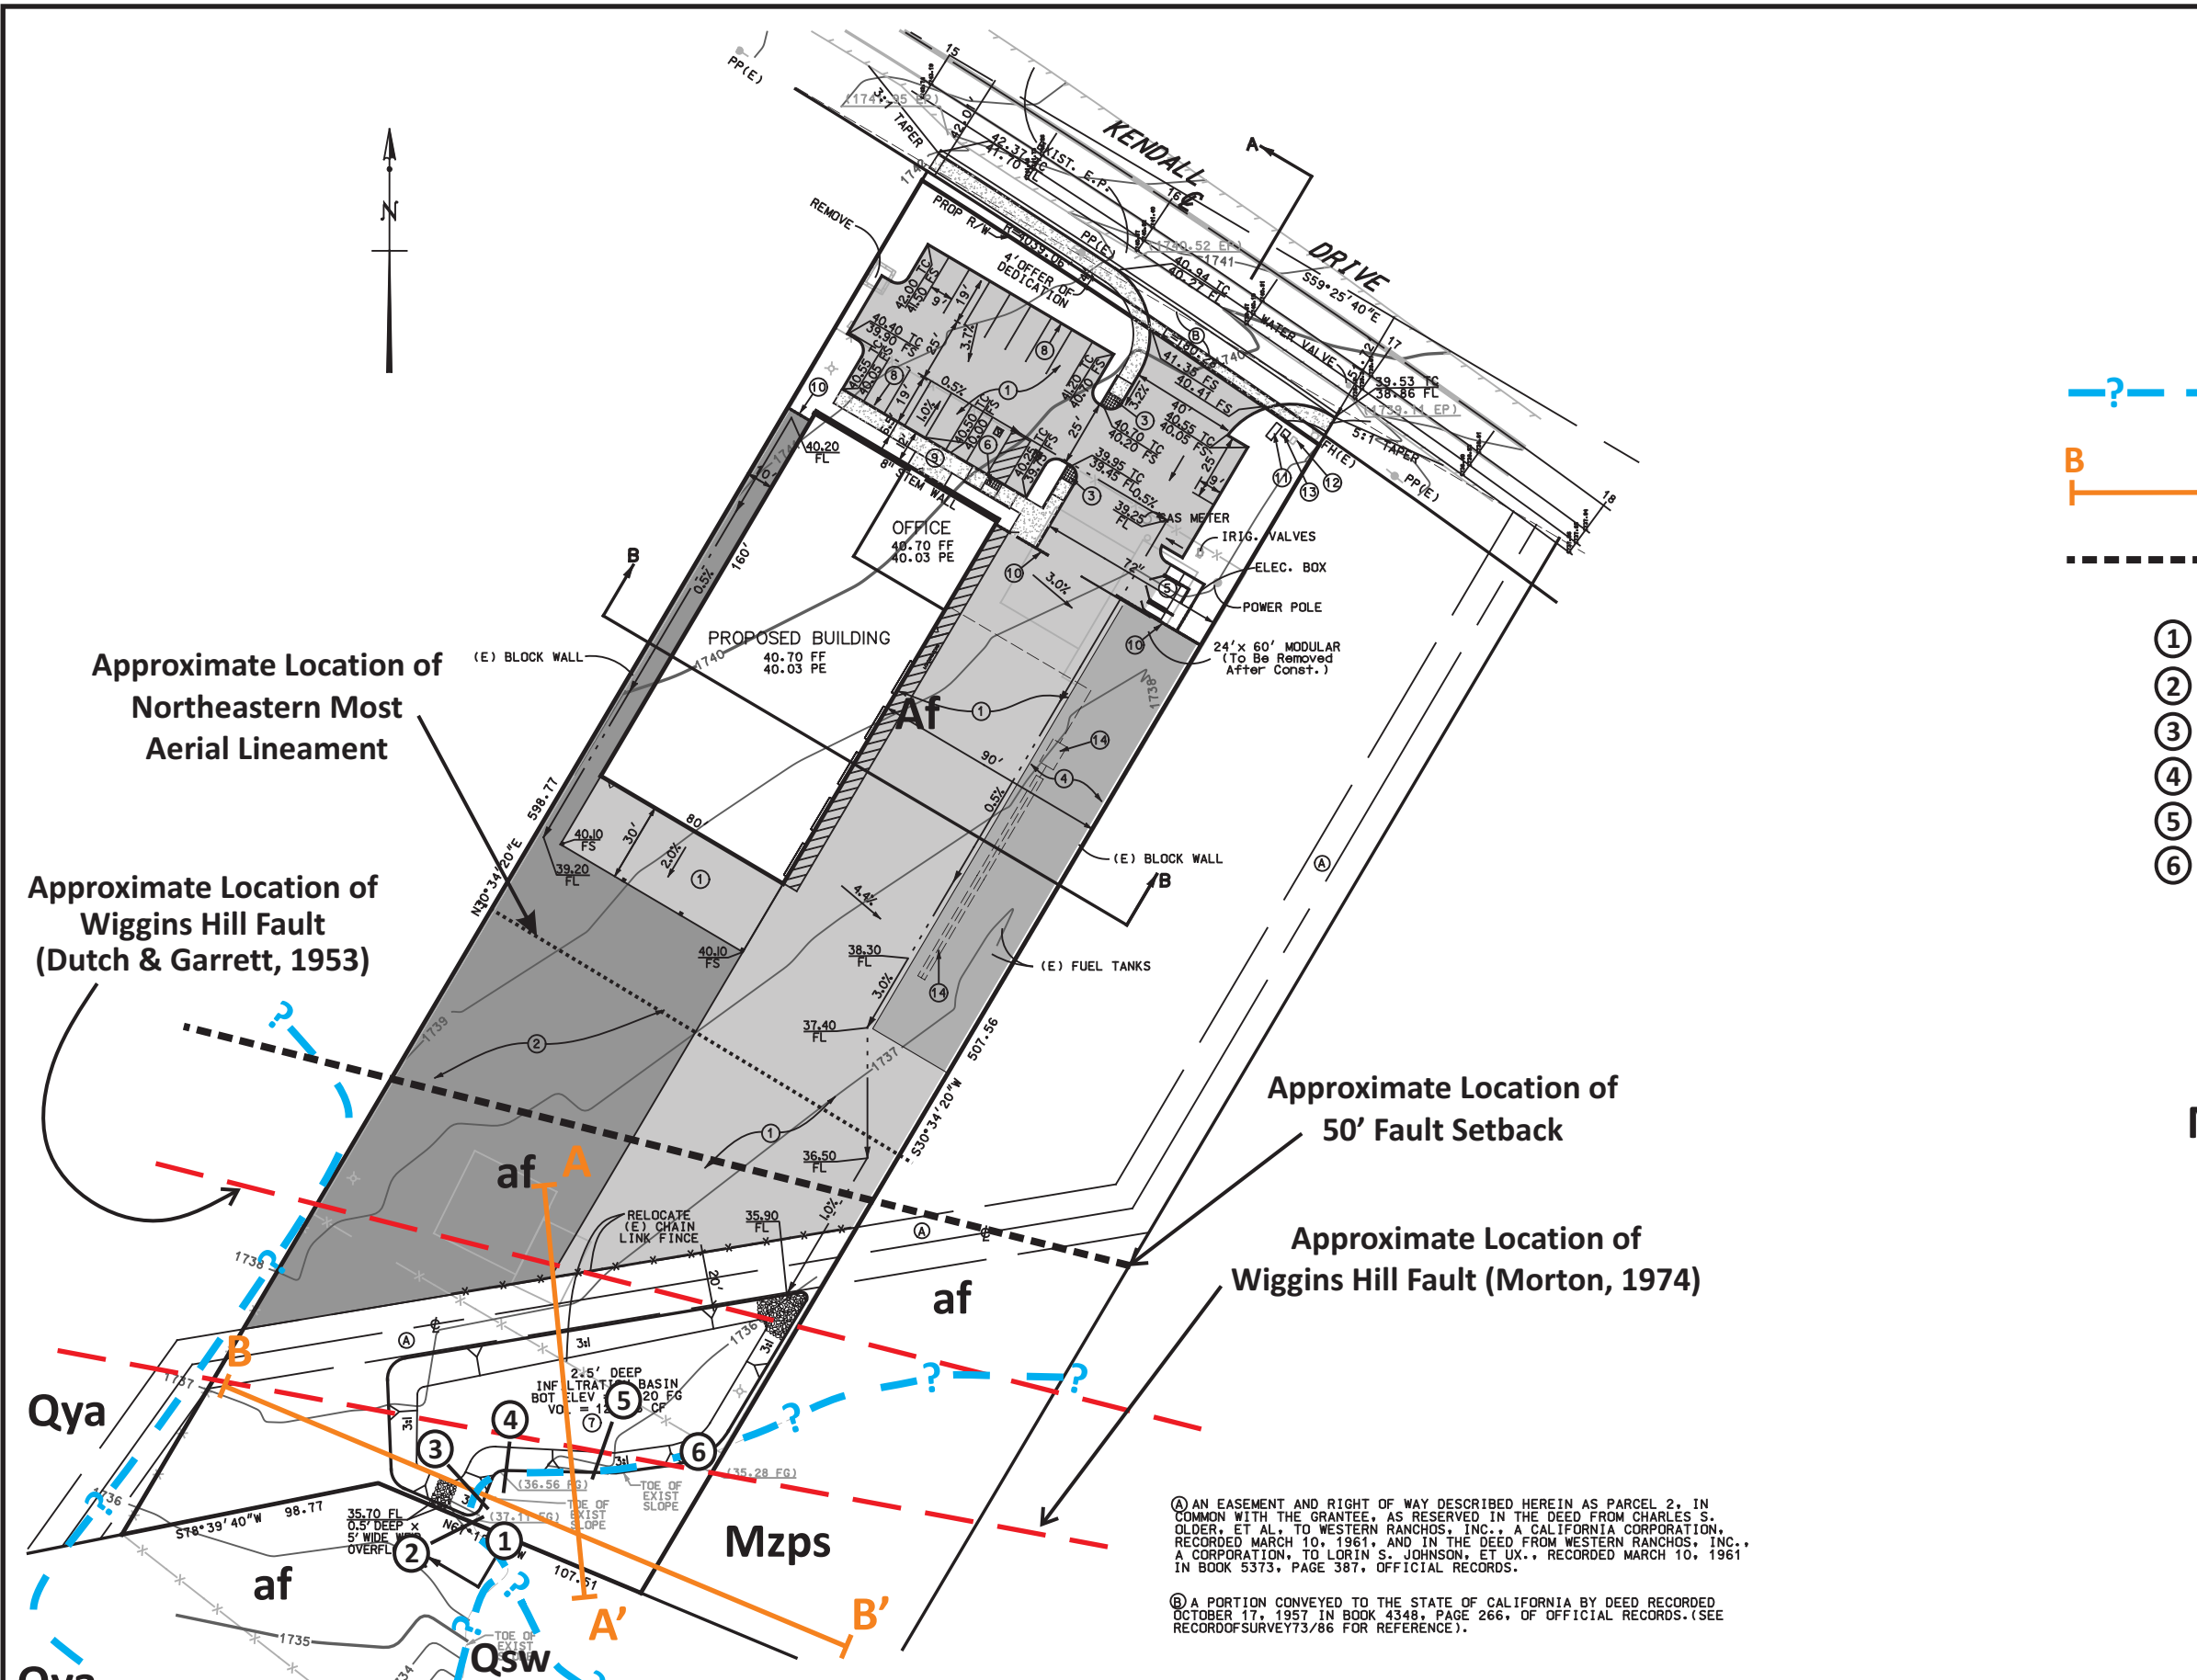
These observed lineaments have been plotted on a copy of the 1995 Google Earth satellite image, see Plate A-5. The approximate location of the northeastern-most lineament is also plotted on Plate A-2. This lineament alignment is about 65 feet southwest of the planned building location.

A senior engineering geologist from Earth Systems performed a site reconnaissance of the site on September 7, 2017. The surface geology was mapped and plotted on a copy of the precise grading plan, see Plate A-2. The strike and dip of observed foliation, joints, and shears exposed within the bedrock are documented. Portions of the site, as well as, the vacant property directly adjacent to the western property line were observed with respect to potential signs of shearing or tensional stresses possibly related to local faulting. No evidence of surficial signs of shearing or tensional stresses were observed.

The Wiggins Hill fault, if actually present, is mapped by others in the southern portion of the property (see Plate A-2). The fault projects near the northeast corner and southern limits of the planned retention basin and is well-south of the proposed building by approximately 80 feet. Effects of surface fault rupture near the basin would include disturbance to the below-grade 3:1 slopes. Catastrophic flooding due to slope failure is unlikely. The potential for surface fault rupture in the immediate proximity of the planned building is considered low.

- Structures intended for human occupancy should be located northeast of the designated Fault Setback line (see Plate A-2).
- The northwest terminus of Wiggins Hill (Verdemont) has been modified with over-steepened graded slopes that are, in our professional opinion, subject to slope instability by raveling and wedge failures. If left as is, rubble will need to be cleaned out of the infiltration basin. If slope instability is unacceptable, then the over-steepened slopes need to be regraded at 2:1 (horizontal to vertical) finished slopes.

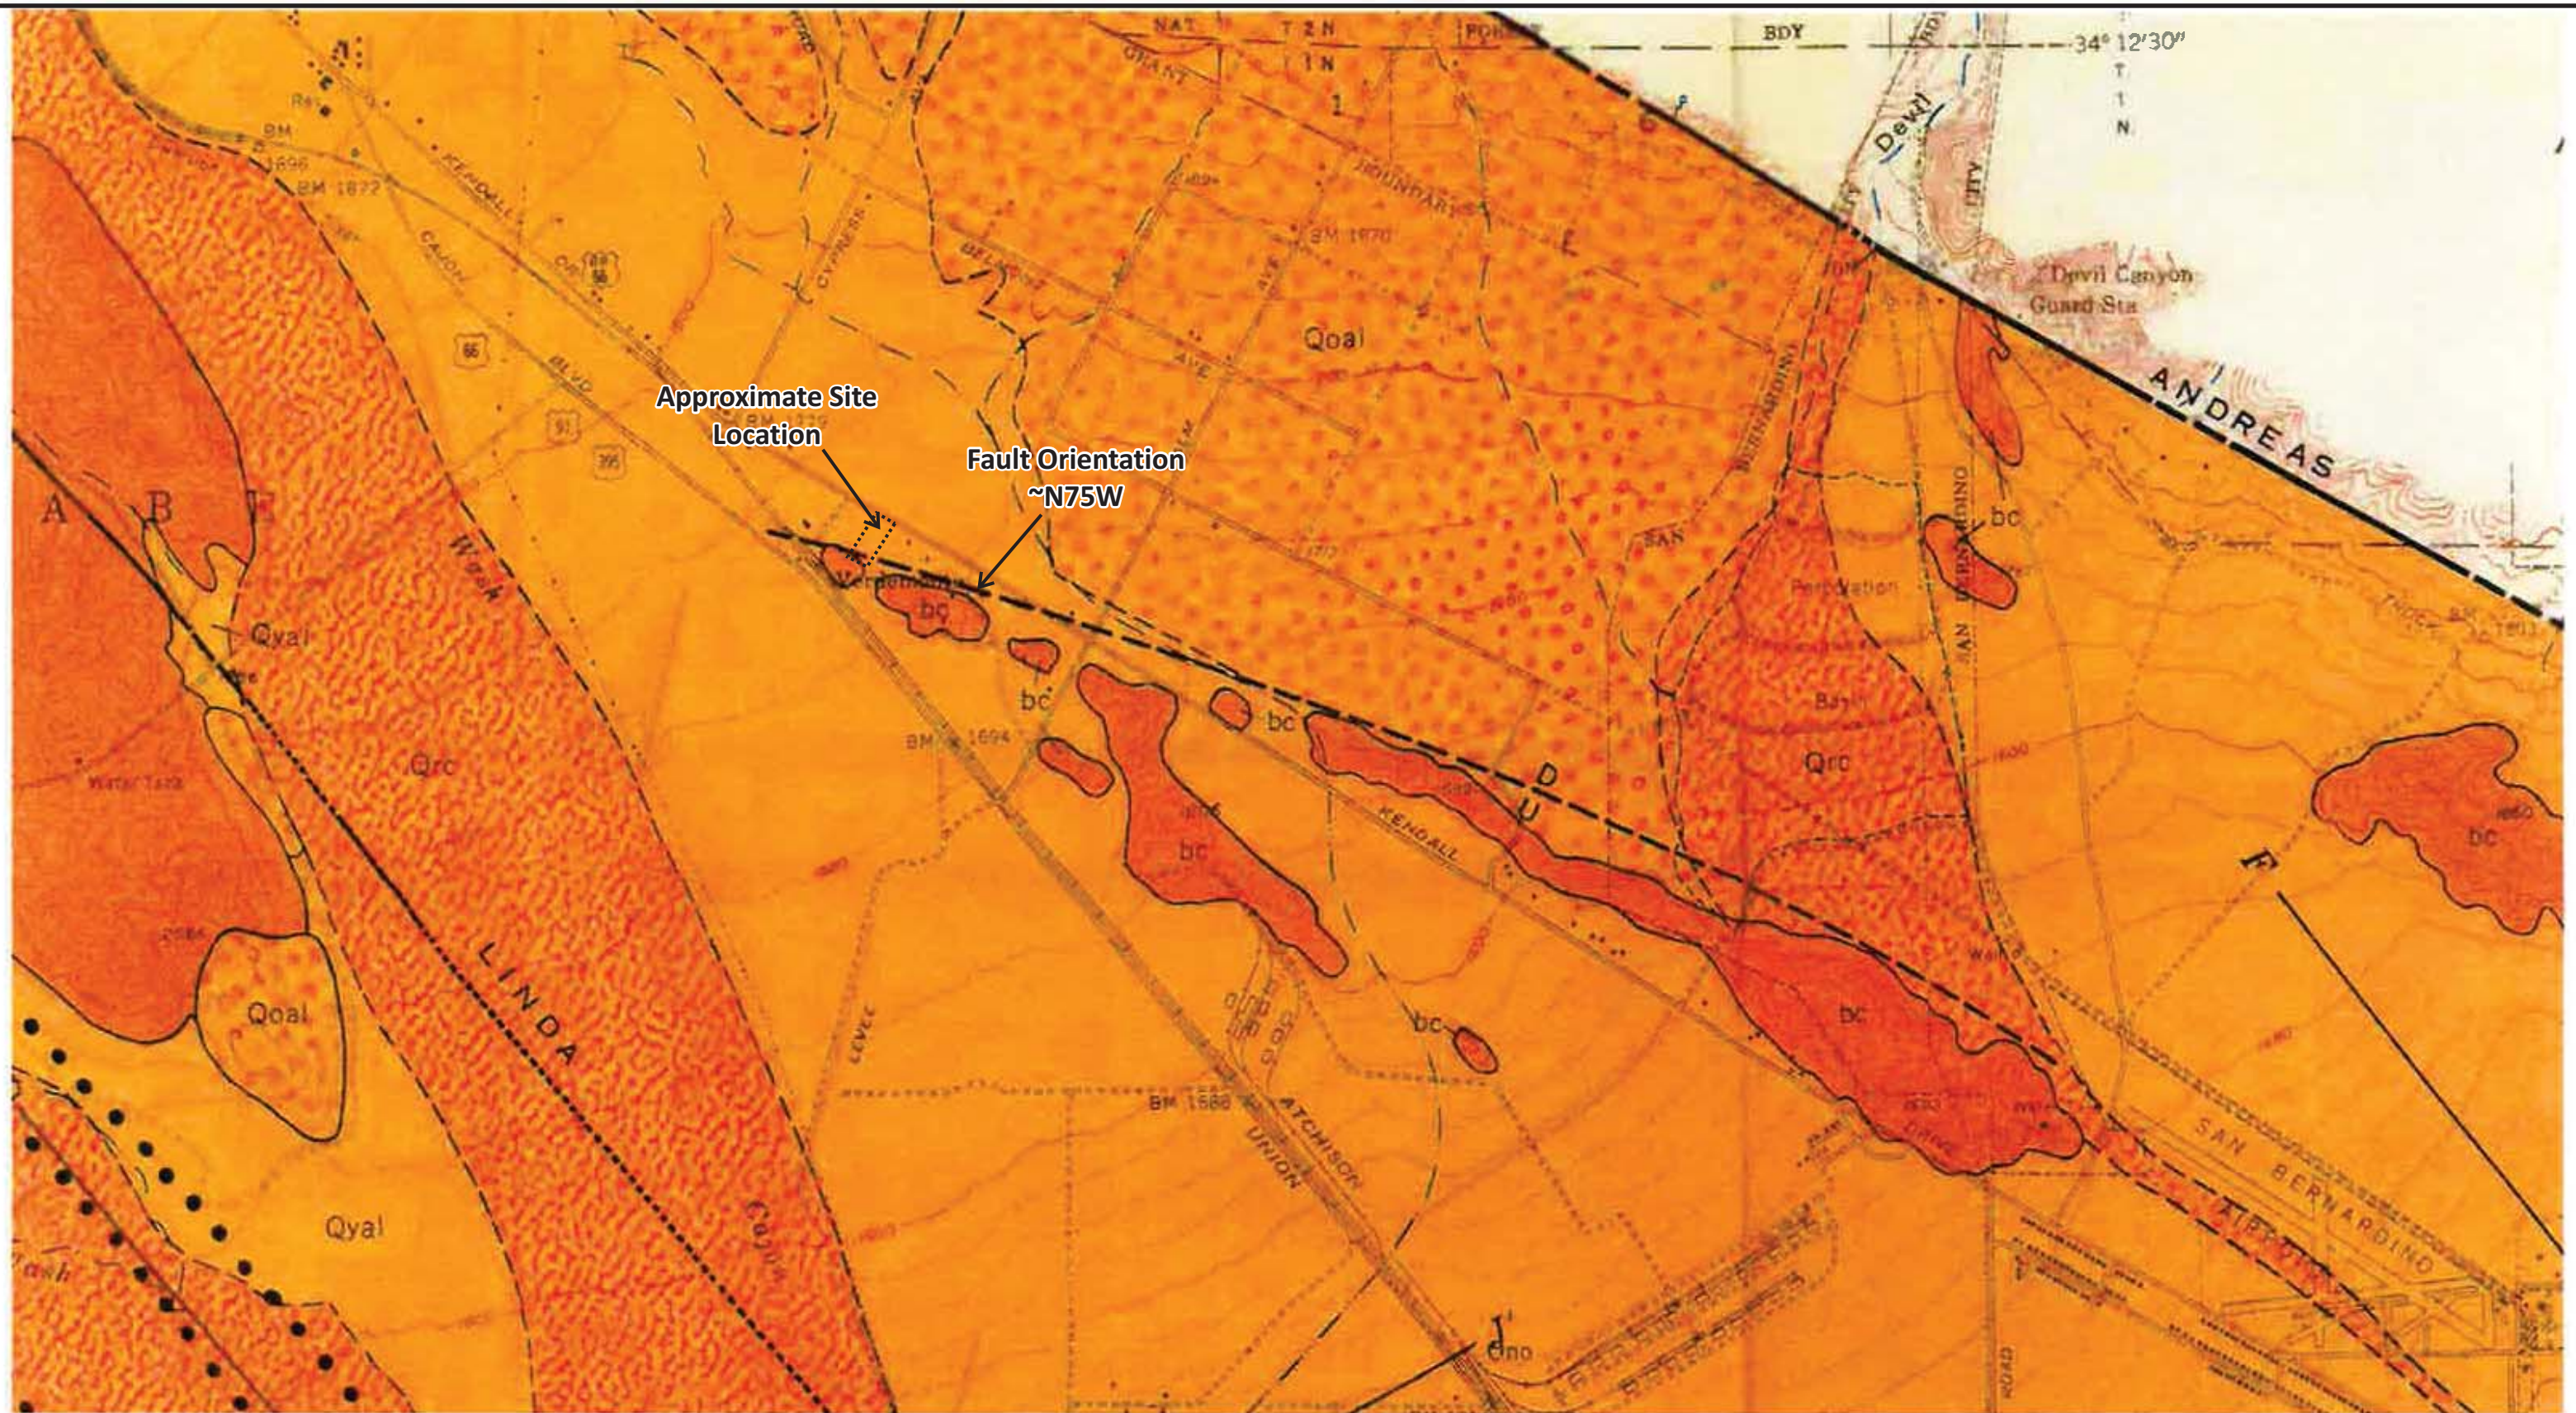
Plate A-3	
Wiggins Hill Fault Location per Dutcher & Garrett, 1963	
Proposed Infiltration Basin and New Structure 20075 Kendall Drive North San Bernardino, San Bernardino County, California

Two mapped traces of the Wiggins Hill fault cross the southern portion of the site, generally along the northern front of Wiggins Hills (Verdemont). The northernmost trace (Dutch & Garrett, 1953) is shown north of the hill, buried by alluvium. However, the southern trace (Morton, 1974) is inferred, based on scaling off the maps and transposing onto the site plan, within the hillside, and if actually present should be exposed in the existing cut face. While a minor shear was noted in the exposed rock face near the projected trend of the fault, the strike of the shear was oblique to the mapped fault trend. Based upon field mapping, the mapped trace of the Wiggins Hill fault, per Morton, 1974, is not corroborated by field mapping. If actually present, the Dutch & Garrett (1953) mapped trace is considered more likely.

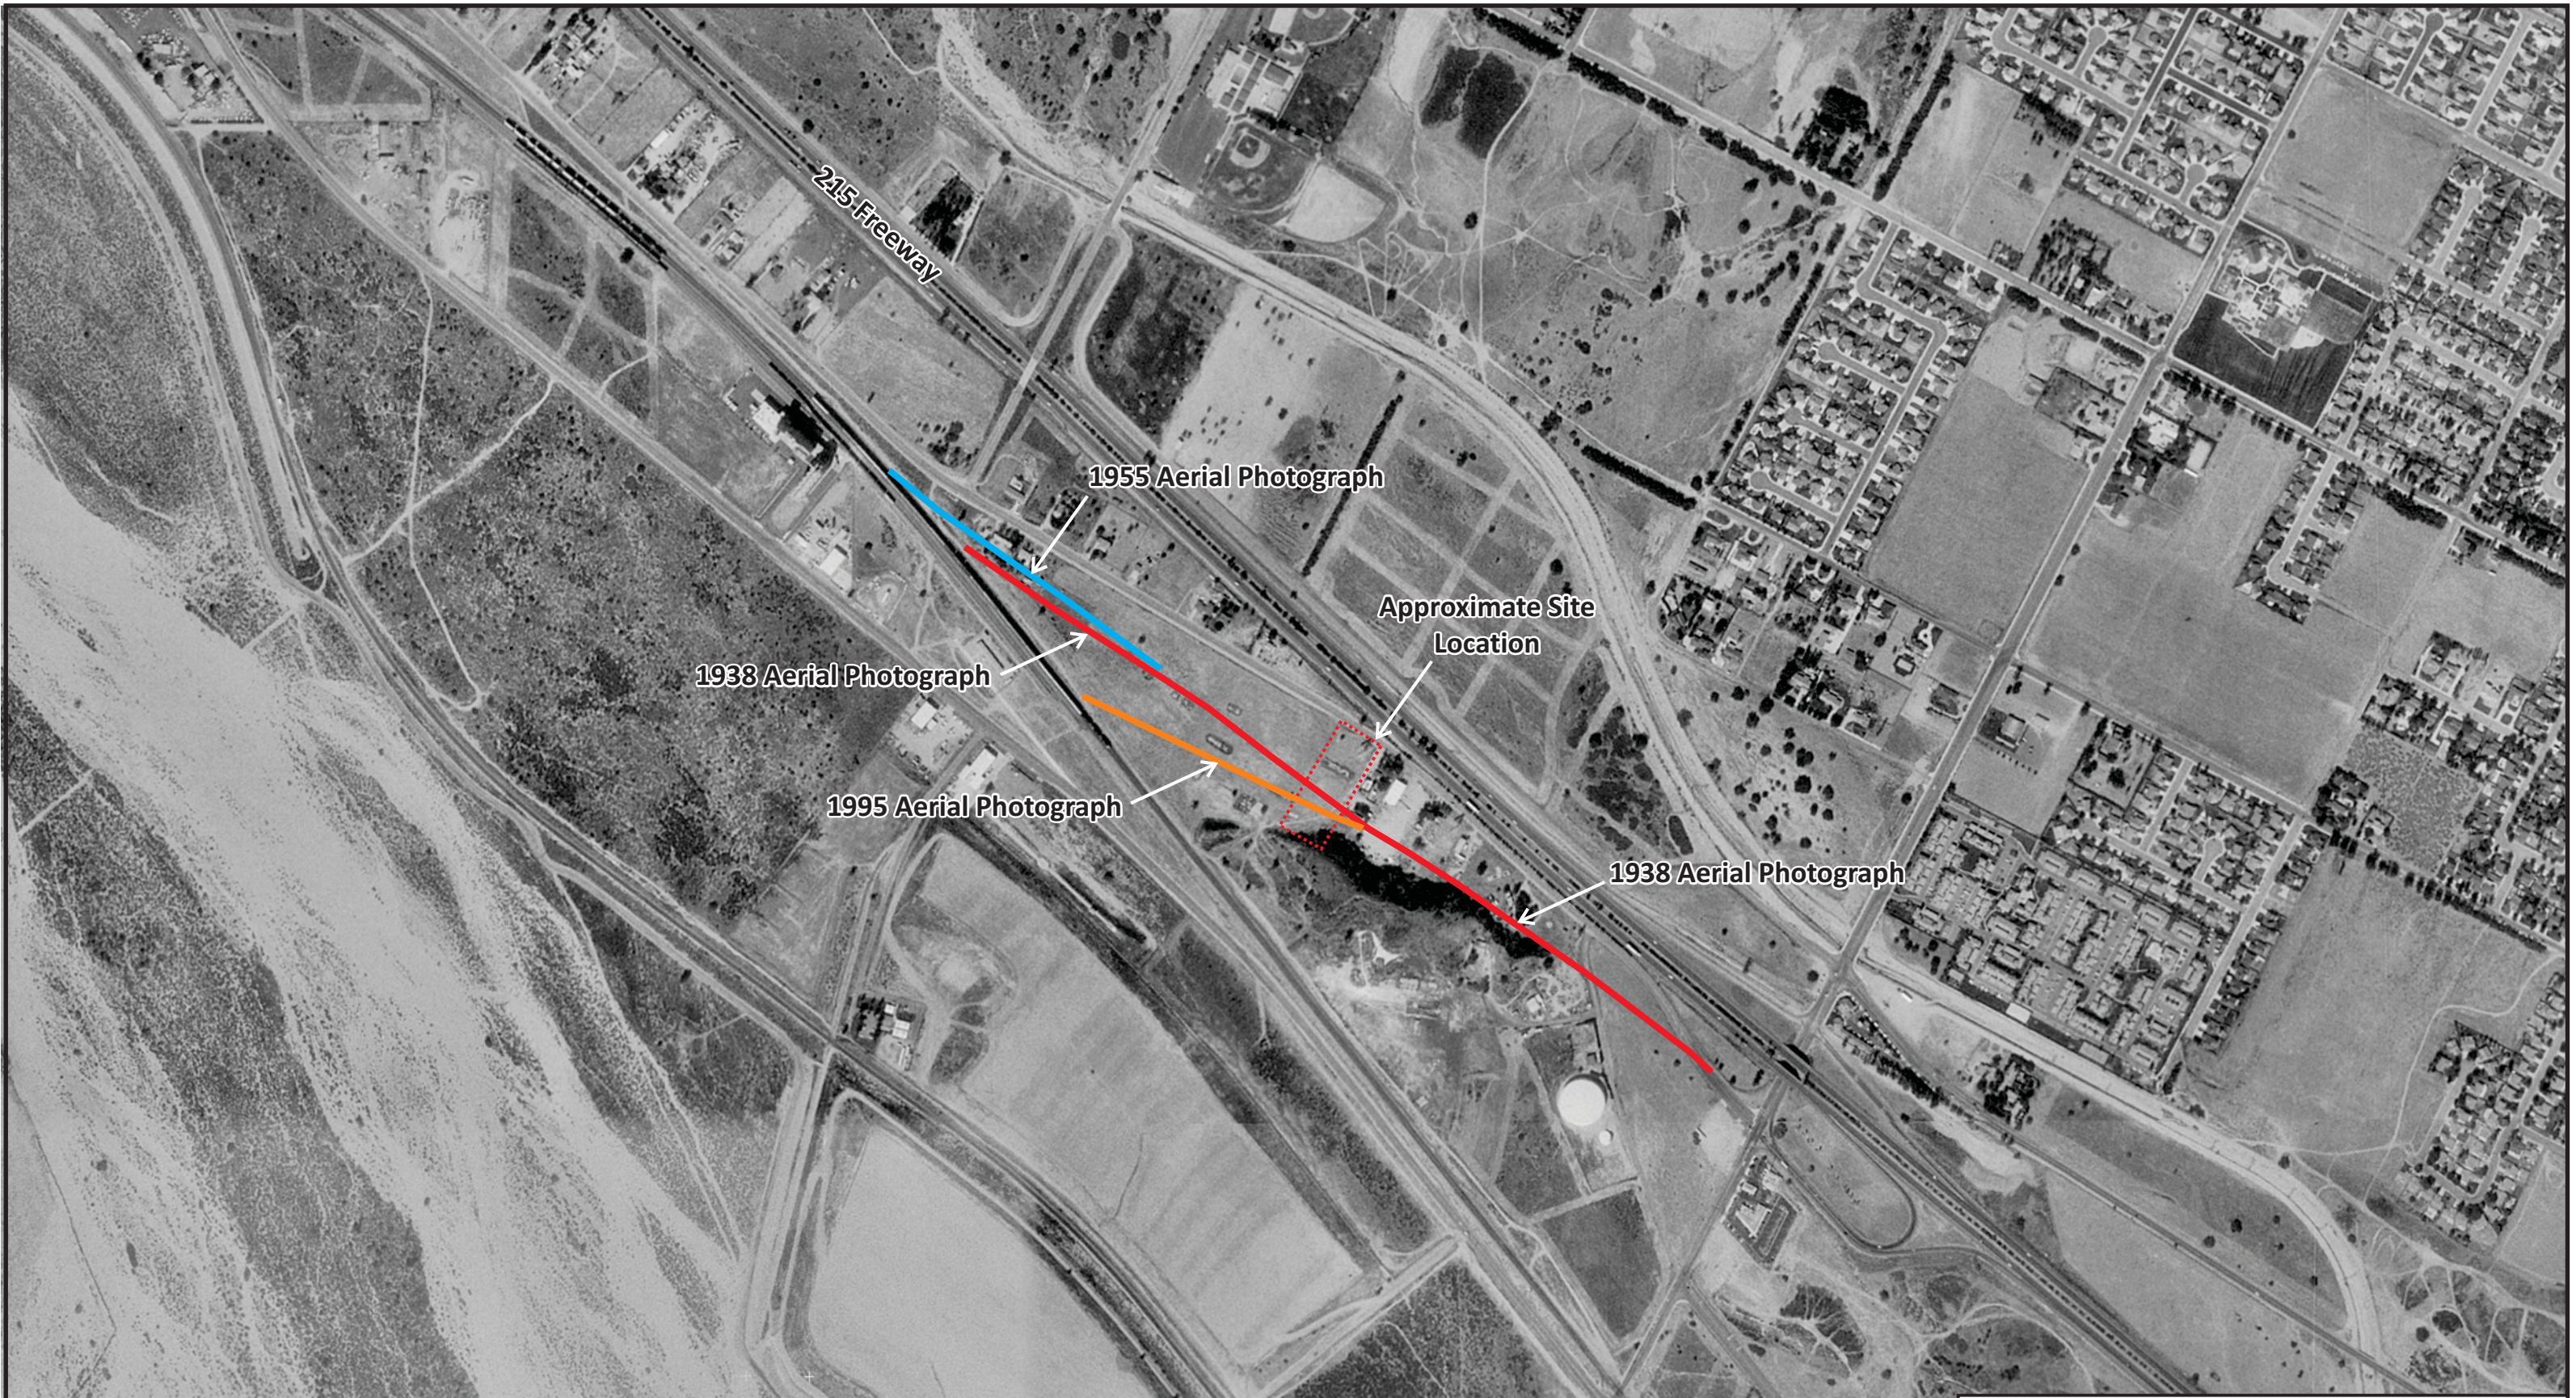
Plate A-5	
Observed Lineaments on Reviewed Historical Aerial Photographs	
Proposed Infiltration Basin and New Structure 20075 Kendall Drive North San Bernardino, San Bernardino County, California	
Earth Systems Southwest	
9/29/2017	File No.: 12491-01

Date	Photo Nos.	Lineament Observations
2/7/1970	87/88	No lineaments observed
1/30/1969	45/85	No lineaments observed
11/10/1955	7-30/7-31	Faint lineament NW of the site, (see Plate A-5)
7/9/1938	AXL-63-80/63-81	Faint lineament crosses the site, (see Plate A-5)

We also reviewed historical satellite photographs on Google Earth dating from 1993 to 2017. The black and white Google Earth photo from 1995 had a faint tonal change which has been plotted on Plate A-5. However, review of older photos suggest that this particular tonal change might be associated with differential vegetation growth associated with manmade disturbances. Historical aerial photographs on the HistoricAerials website dating from 1938 to 2012 were also reviewed. The lineament observed in the previously mentioned 1938 photo was also observed on the 1938 photo at the HistoricAerials website and it appears that these were the same photograph.

The alignment and location of the 1955 and 1938 observed lineaments appear to be very similar in orientation with the mapped Wiggins Hill fault southwest of the project, but trend more northerly, northwest of the site. We suspect that the northwesterly lineaments have probable anthropic origins. It should be noted that the observed lineaments cross through a nearby relatively large commercial building that was constructed sometime between 2007 and 2009.

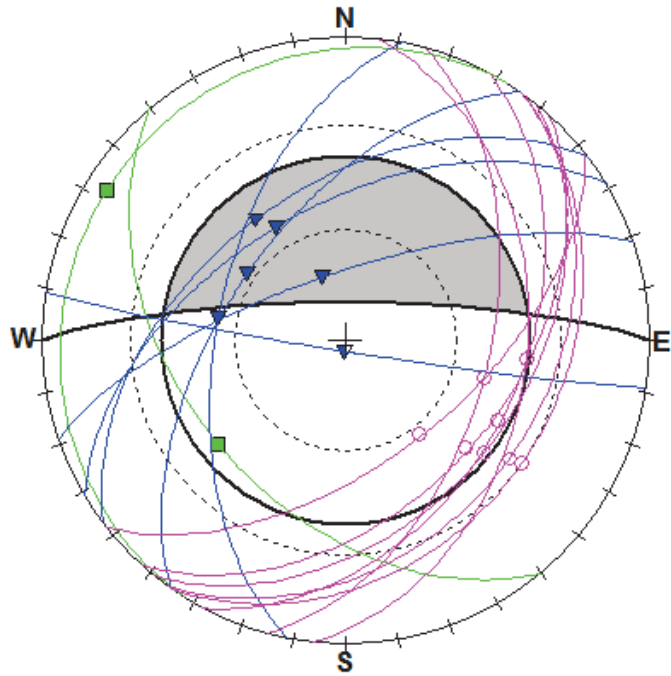
North Facing Cut Slope

Kinematic analysis of the Pelona Schist bedrock discontinuities (foliation and jointing) was performed to evaluate the potential for adverse conditions with respect to the near vertical graded cut slopes adjacent to the proposed infiltration basin. Foliation is consistent with northeast strikes and moderate dips to the southeast, and is not considered adverse with respect to the existing over-steepened slopes adjacent to the proposed infiltration basin. Multiple joints were observed to be adverse considering the near vertical conditions of the graded cut slopes. Wedge failures and block failures are considered likely. Simplified block analysis indicates static factors of safety of just above 1.0 for current conditions for the near-vertical cut faces. Seismic analysis factors of safety are less than 1.0 for current conditions. Raveling is also currently occurring. Strong seismic shaking could easily result in small wedge or block-type failures of the

- Previous graded over-steepened cut slopes at the south portion of the site at the northwest terminus of the Wiggins Hill (Verdemont), are subject to instability. Raveling and small block and wedge failures should be anticipated. Rubble will fall into the proposed shallow detention basin.

Adverse Joint Planes
Foliation Not Adverse

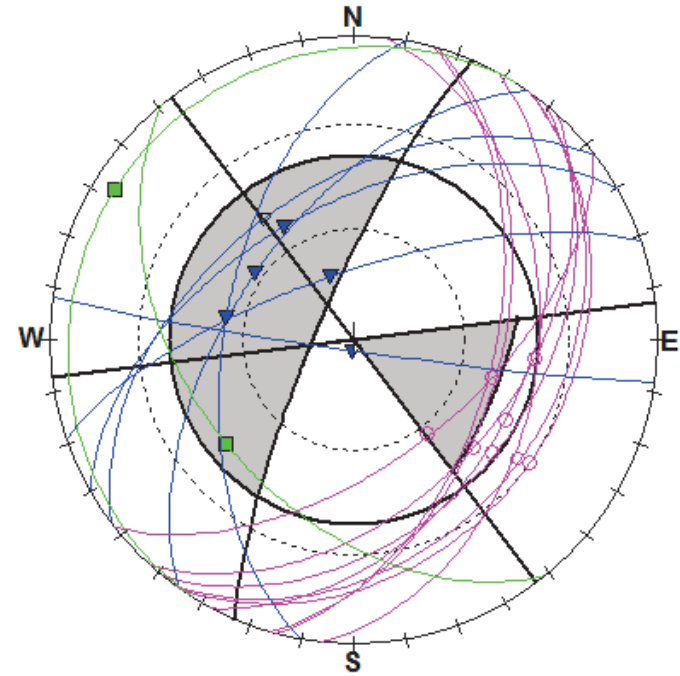
Northwest Facing Cut Slope

Adverse Joint Planes
No Topple Hazard
Foliation Not Adverse
