April 8, 2014  
J.N. 13-305

**Subject: Revised Fault Rupture Hazard Investigation, Proposed Ling Yen Mountain Temple Site, Located at 13938 DeCliff Drive Generally Northeast of the Intersection of DeCliff Drive and Wardman Bullock Road, Etiwanda Area, San Bernardino County, California.**

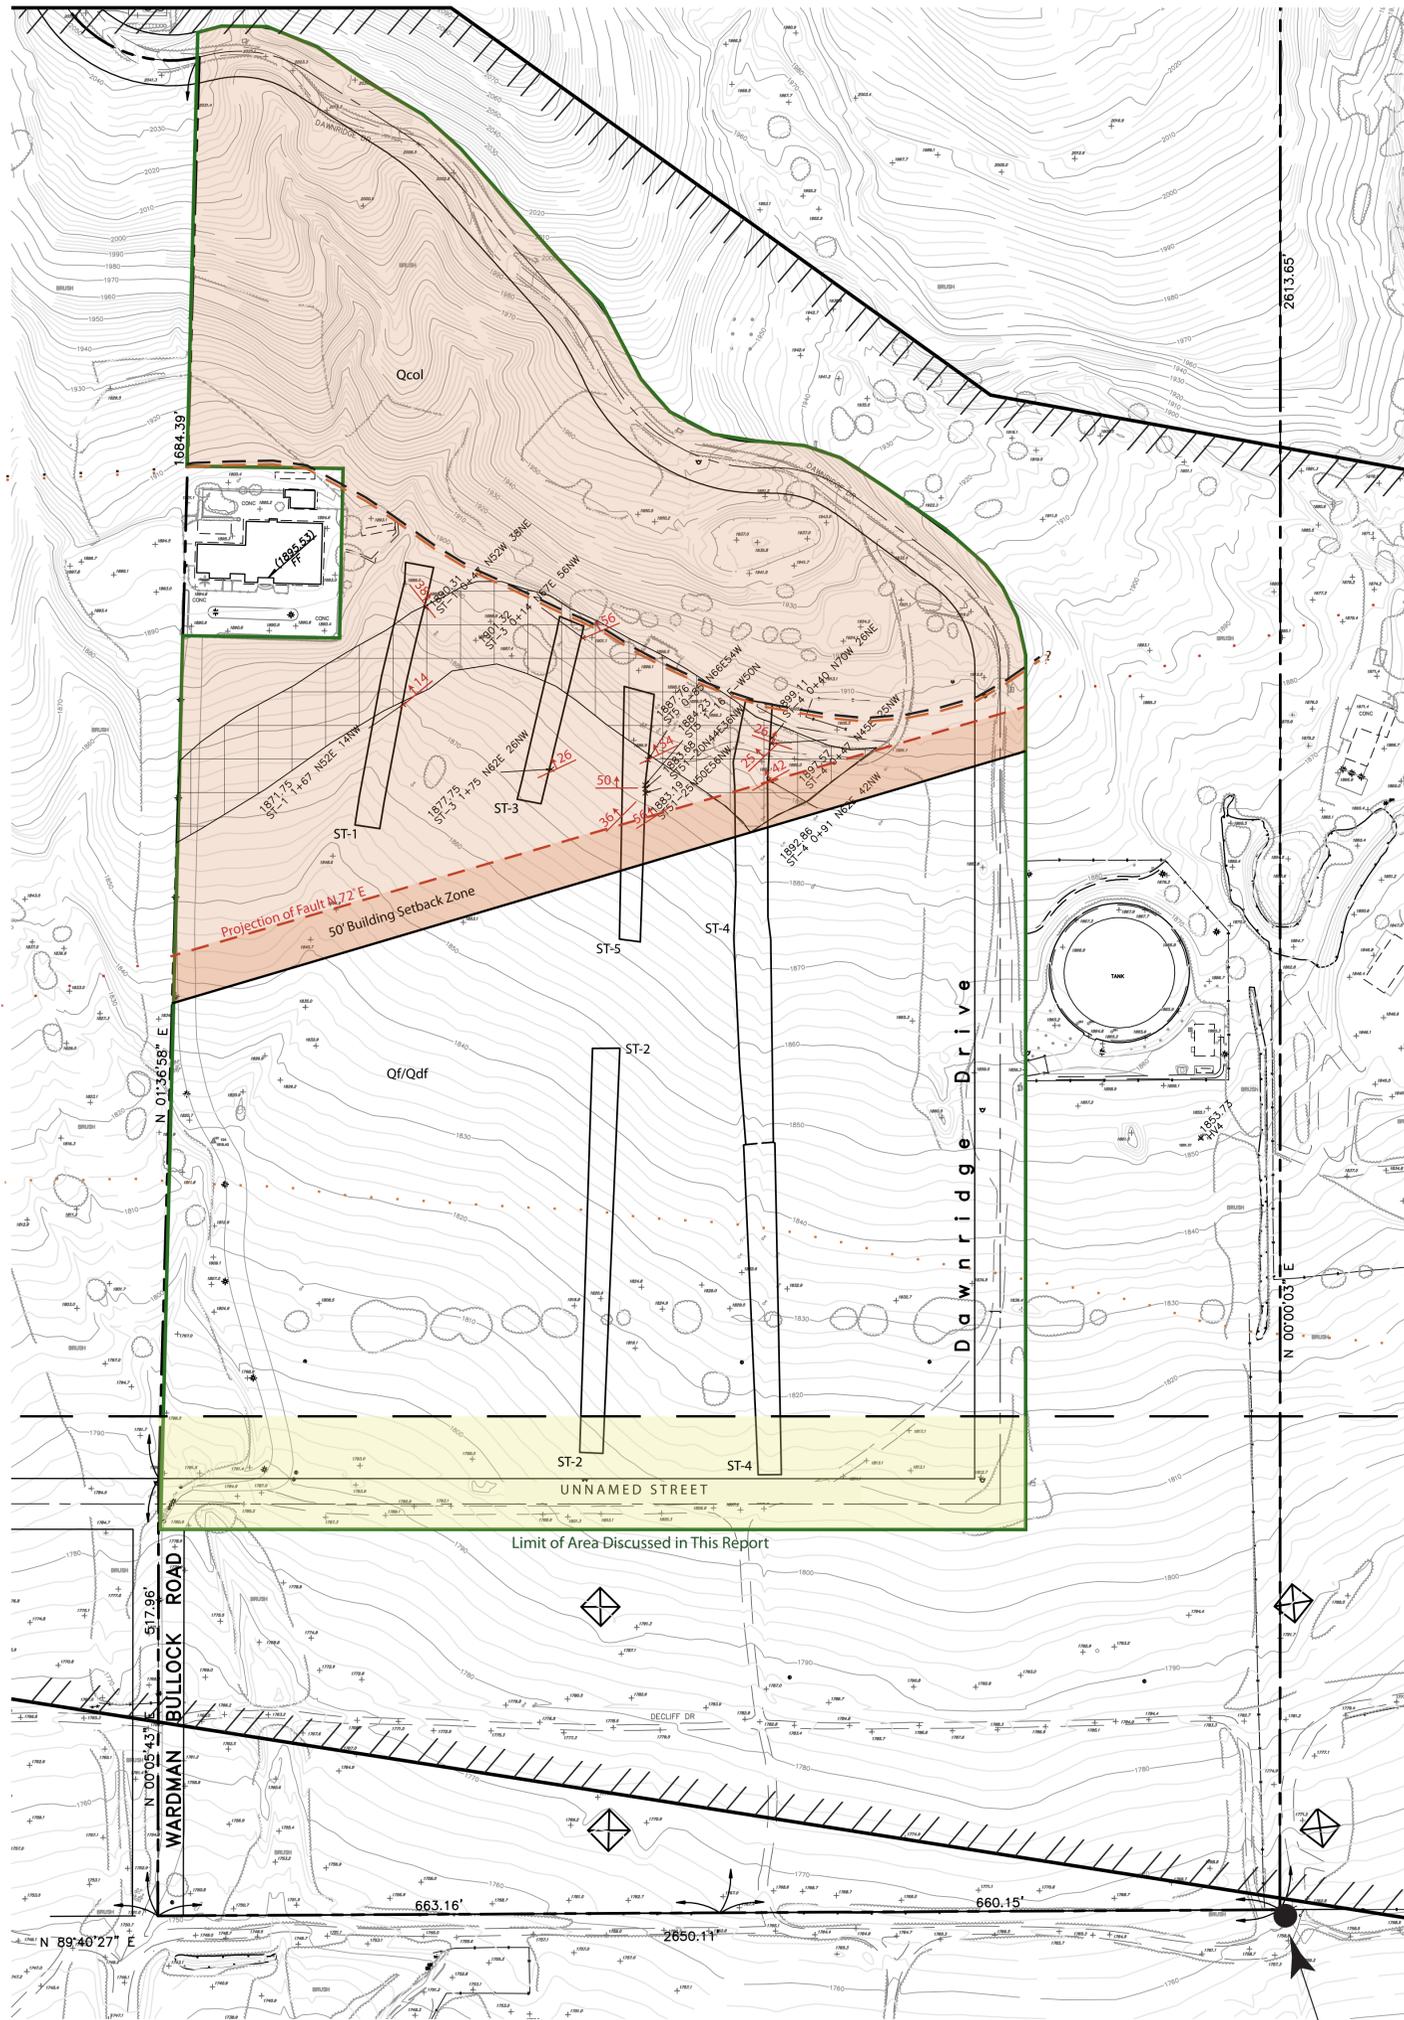
DATE: April 2014	J.N.: 13-305	<b>Plate 1</b>
DWG BY: AP	SCALE: See Bar Scale

Faulting was observed in trenched ST-1, ST-3, ST-4, and ST-5 (Plate 1). The faults observed were restricted to the northern portion of the site and had both northwest and northeast orientations. The faults were staked at the top of trench (eastern trench wall) and were surveyed in by a State of California Licensed Professional Surveyor. Survey Coordinates are based on North American Datum 83, Zone 5, California State Plane. The surveyed locations are presented below.

It is our opinion, based on the results of our trenching investigation, that active/potentially active faulting occurs at the site at the locations presented on Plate 1. Accordingly, building restriction/setback zones should be established. The building restriction/setback zones are shown on Plate 1 and described below.

Southern Building Setback - There is a water line owned and operated by the Cucamonga Valley Water District (CVWD) immediately north of the right of way for the Unnamed Street. Our investigation was restricted by the presence of this waterline and we were not able to trench across all the area considered for development that is within the Alquist-Priolo Fault zone. Accordingly, we trenched as close as practicable to the waterline and established a setback from the furthest southerly point in the trench that we could establish unfaulted sediments. This point is identified as Station 9+00 in Trench ST-4. This corresponds to a distance of 70 feet north of the northern boundary of the Unnamed Street as shown on Plate 1 along the length of the Unnamed Street. There is a Survey Monument at the southeast corner of the Ling Yen Temple Property (see Plate 1). The Survey Monument is located at Northing 1893004.4923 and Easting 6724560.0304 Elevation 1763.11. The southern setback is 650 feet west of the point then 570 feet north. That point defines the northern limit of the southern set back which trends east-west.

Northern Building Restriction and Setback Zone – The faults identified in ST-4 at station 0+91 and ST-5 at Station 1+25 in our opinion line up as a continuous feature and represent the orientation of the southernmost fault. The orientation is N72E. Accordingly, the building setback is defined as 50 feet in a direction perpendicular to the trend (N72E) from the point the where the fault was surveyed at Station 0+91 in Trench ST-5

Note: Southern Building Setback - There is a water line owned and operated by the Cucamonga Valley Water District (CVWD) immediately north of the right of way for Decliff Drive. Our investigation was restricted by the presence of this waterline and we were not able to trench across all the area considered for development that is within the Alquist-Priolo Fault zone. Accordingly, we trenched as close as practicable to the waterline and established a setback from the furthest southerly point in the trench that we could establish unfaulted sediments. This point is identified as Station 9+00 in Trench ST-4. This corresponds to a distance of 70 feet north of the northern boundary of Decliff Drive as shown on Plate 1 along the length of Decliff Drive.

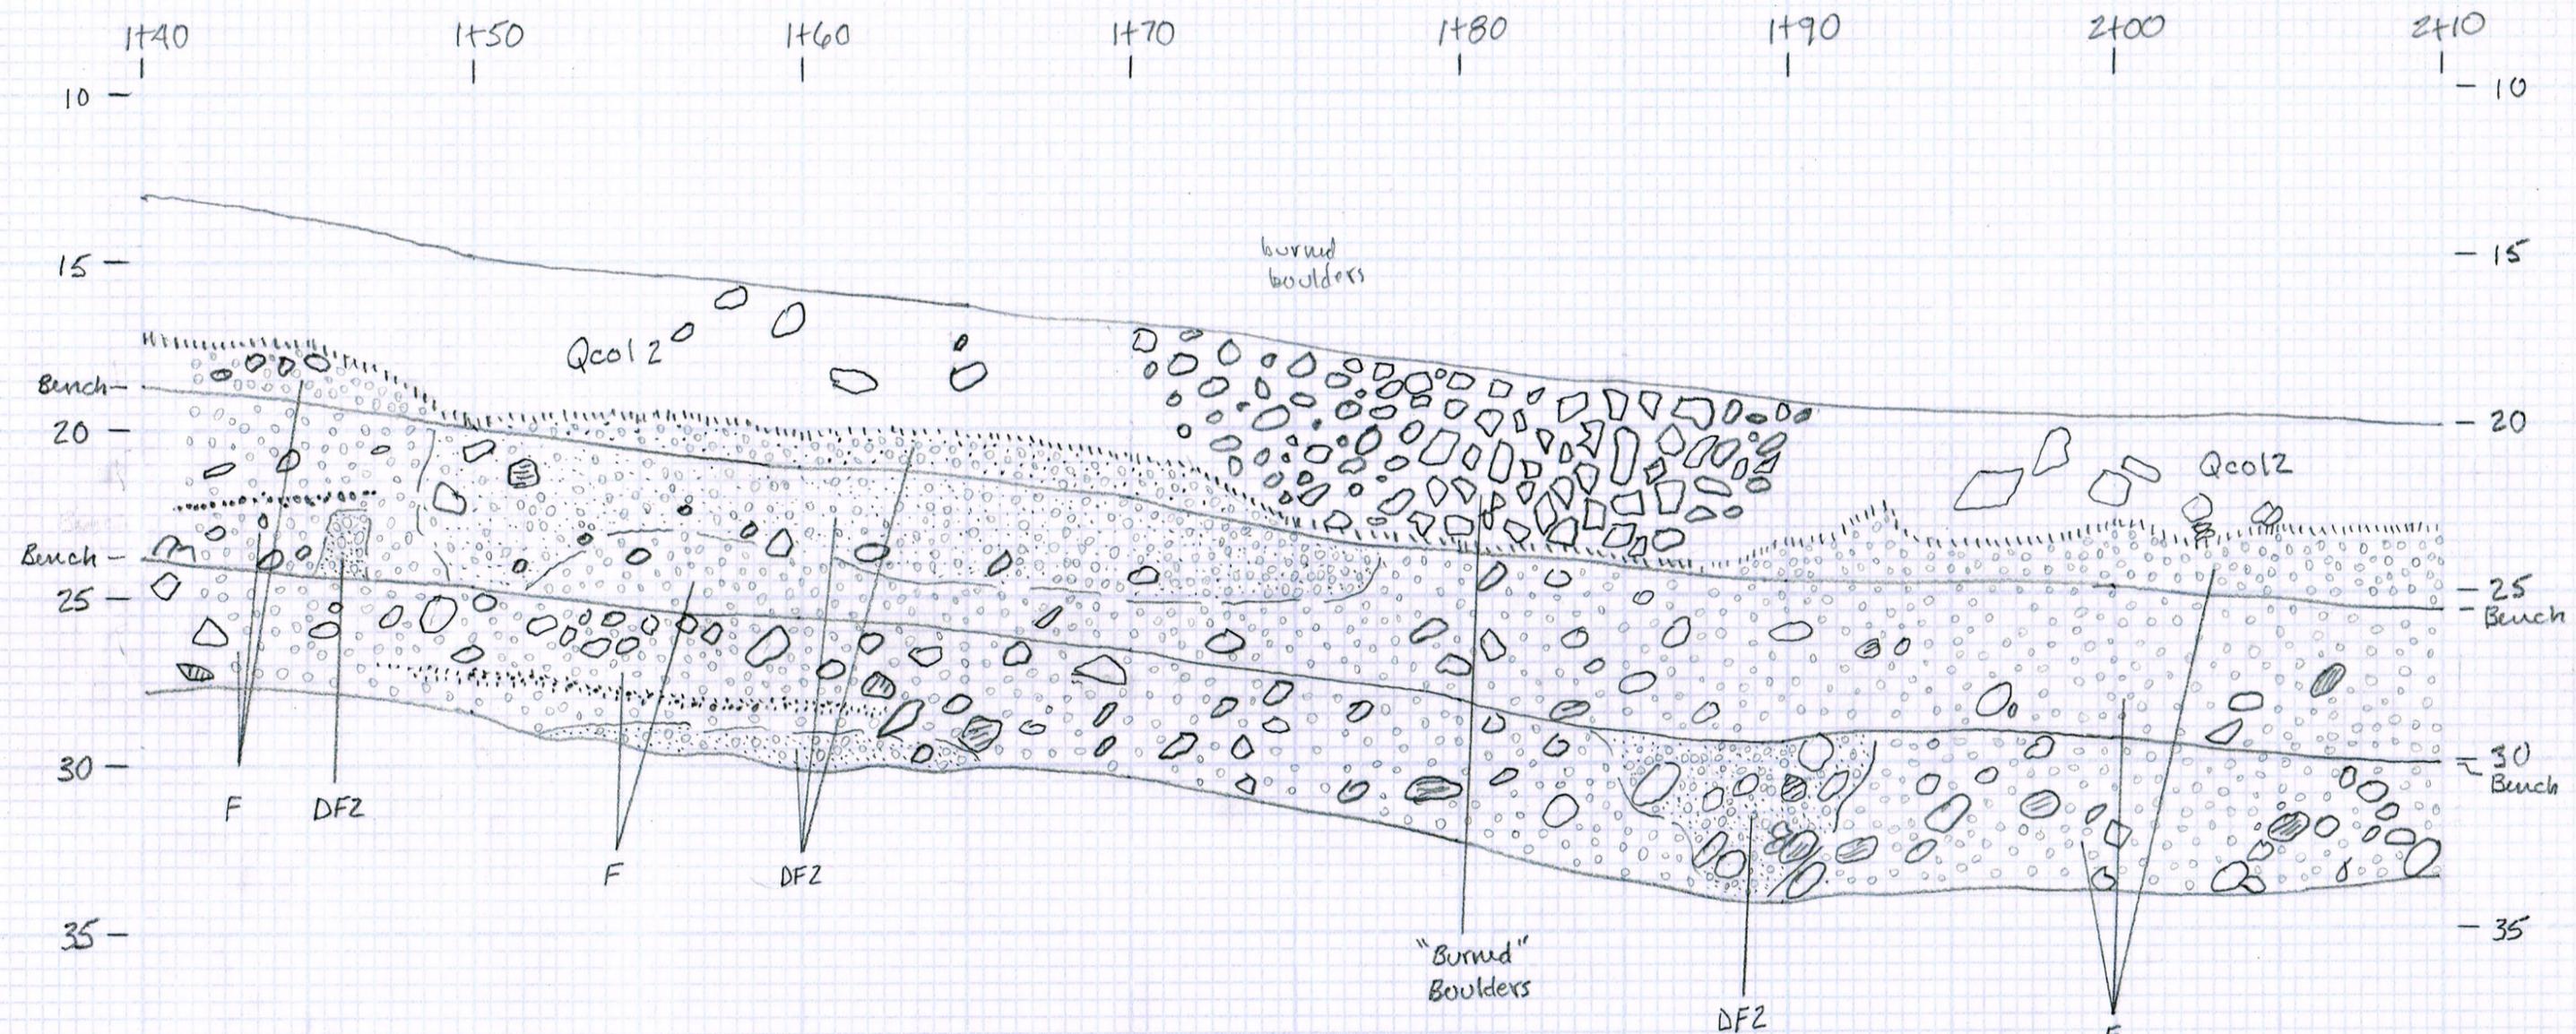
ST-2  
 13-305  
 Ling Yen Mtu Temple  
 July 2013  
 SK3 OF 7

2+37  
N42E  
24NW

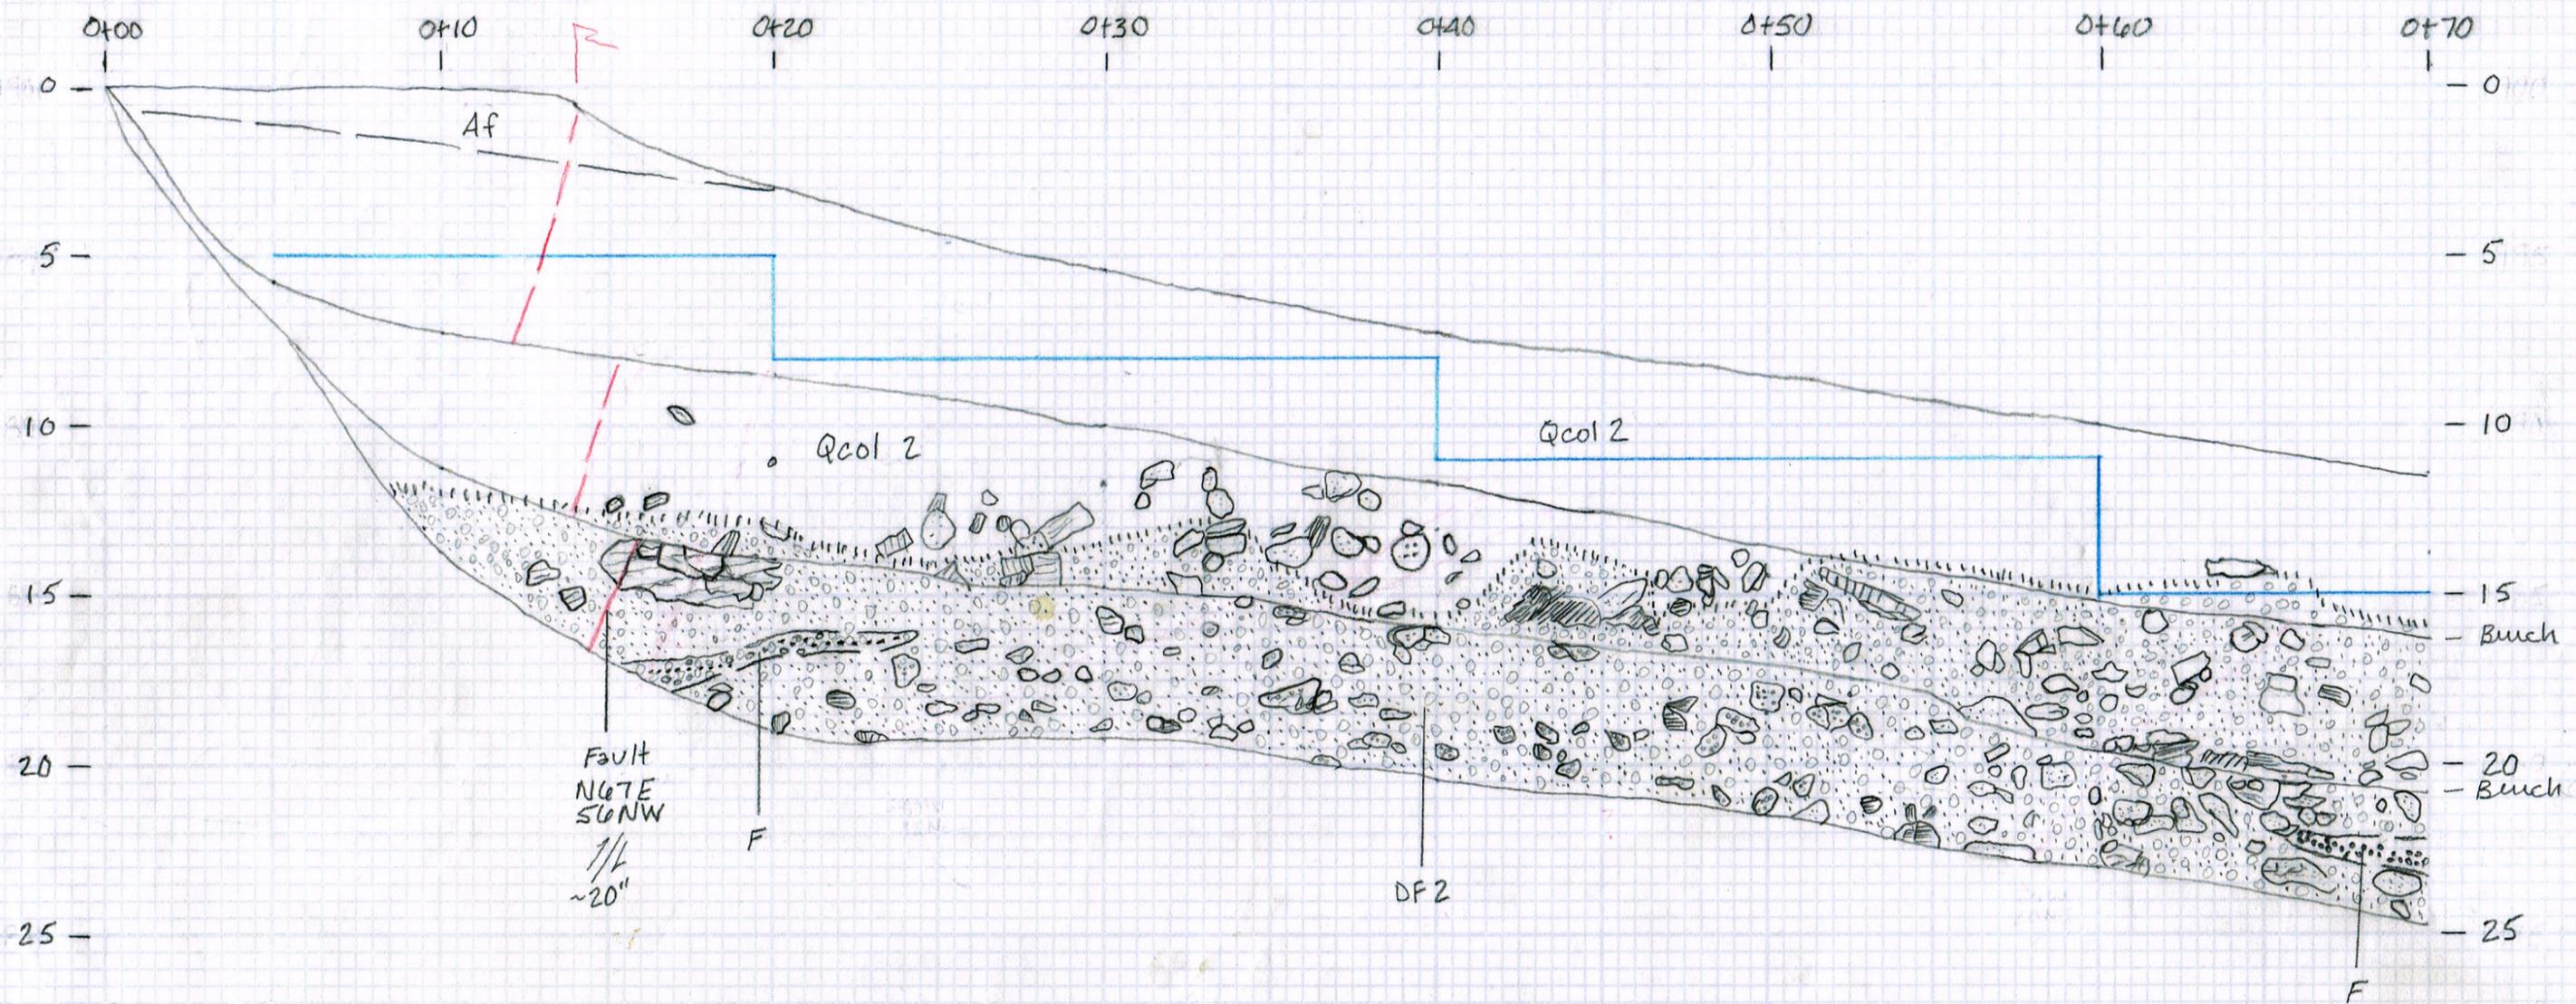
ST-3  
13-305  
Ling Yen Mtn Temple  
July 2013  
sh 1 of 3

Fault  
N67E  
S6NW  
1/4  
~20"
