*Southern Rubber Boa Habitat Assessment for the
Master Storm Water System Maintenance Program*

Southern Rubber Boa Habitat Assessment for the Master Storm Water System
Maintenance Program
December 2015

Steve Loe, Certified Wildlife Biologist
33823 Nebraska St.
Yucaipa, CA 92399
909-809-4726

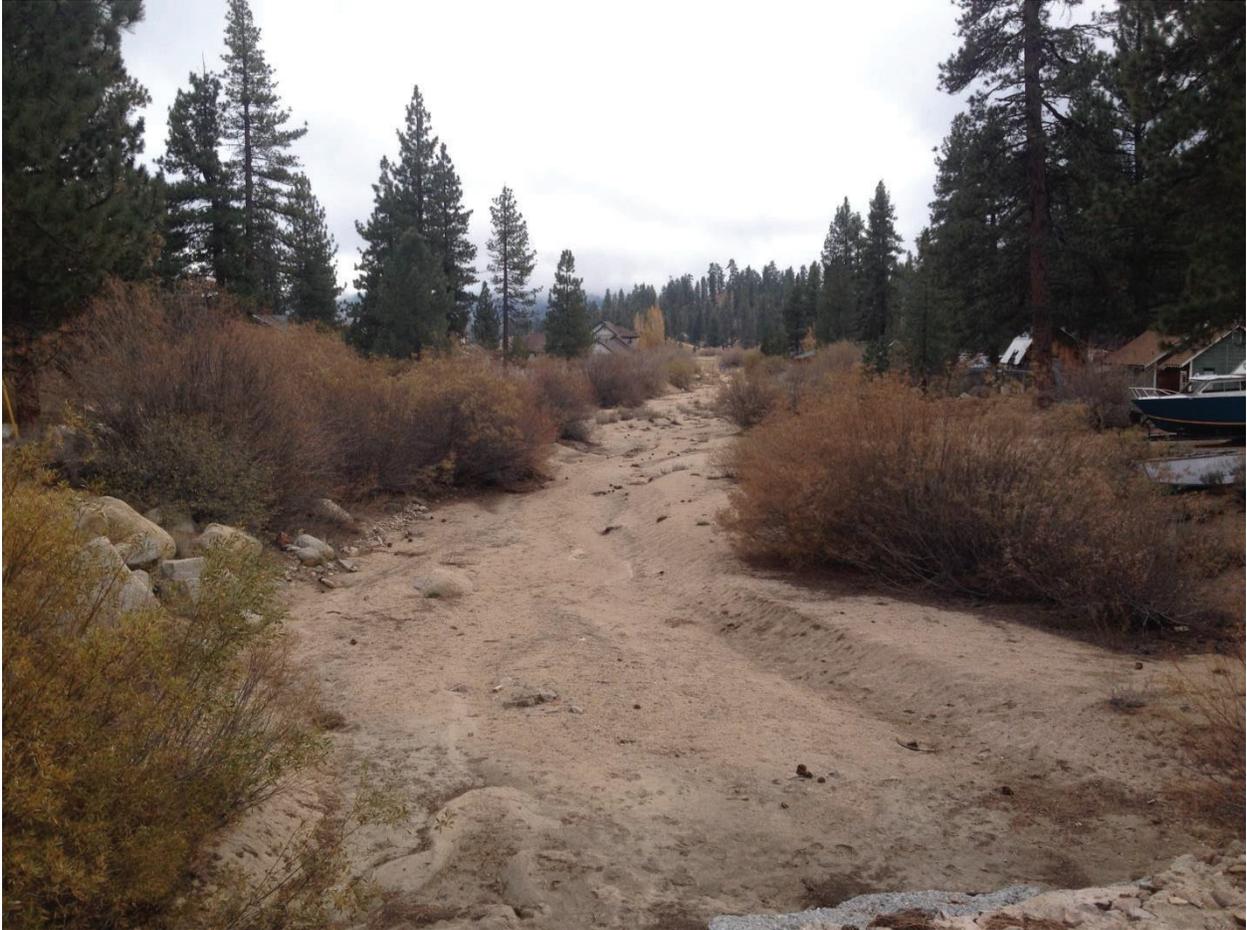
View downstream from the Highway 38 bridge. Fair habitat, narrow, but potentially occupied due to excellent habitat upstream and along highway 38 as it circles Grout Bay to the South. Housing density fairly high, but only one layer along the highway with lots of rock and rock outcrops with excellent stands of willow along the lake and some willow below the Hwy.38 bridge.

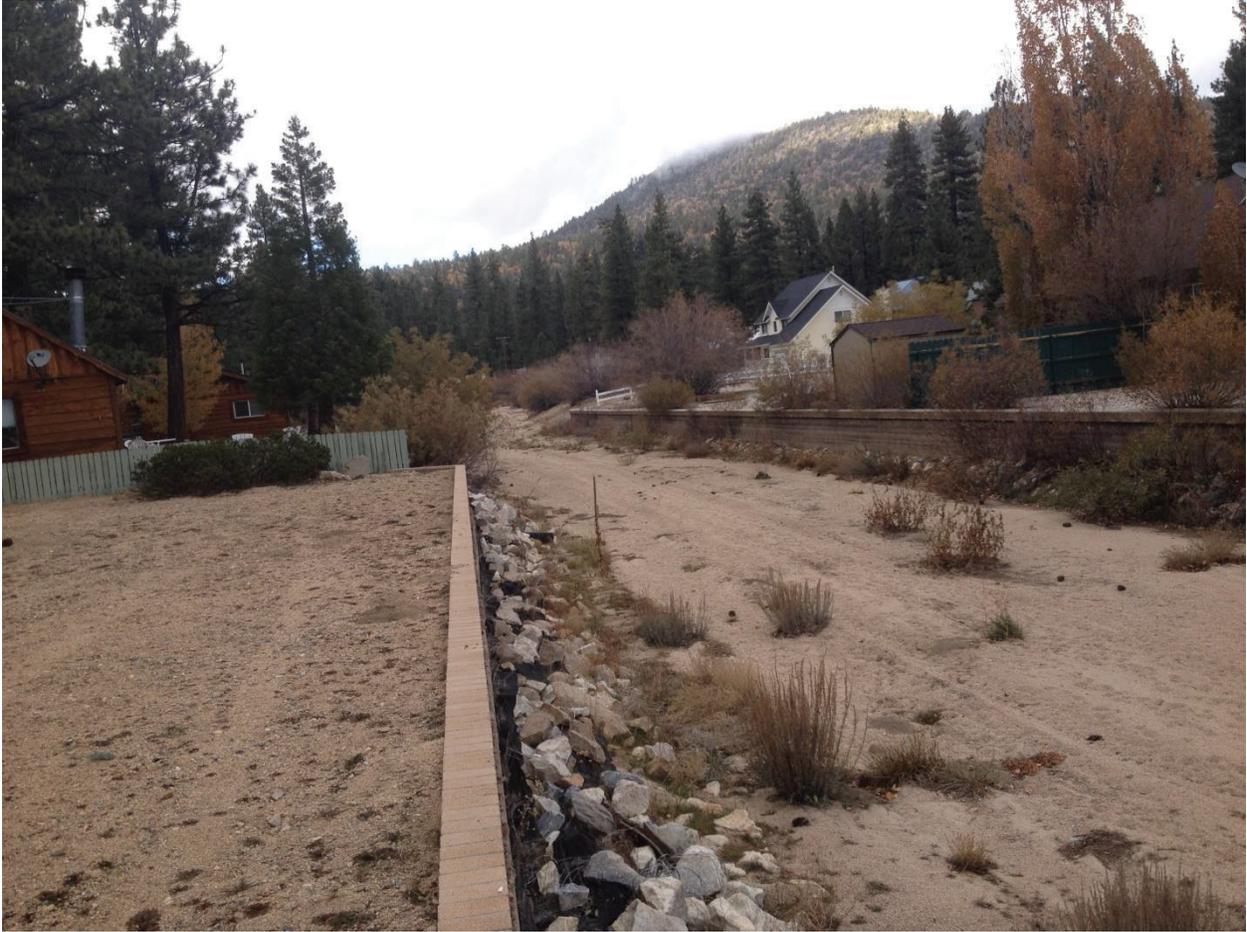
View from the lower end of the flood control channel just before the mouth of the drainage in Big Bear Lake looking upstream. Small section channelized with retaining walls. Adjacent to excellent willow stands at the lake edge and riprap at the base of the retaining walls could hold boas seasonally and provide for movement through the channelized area.

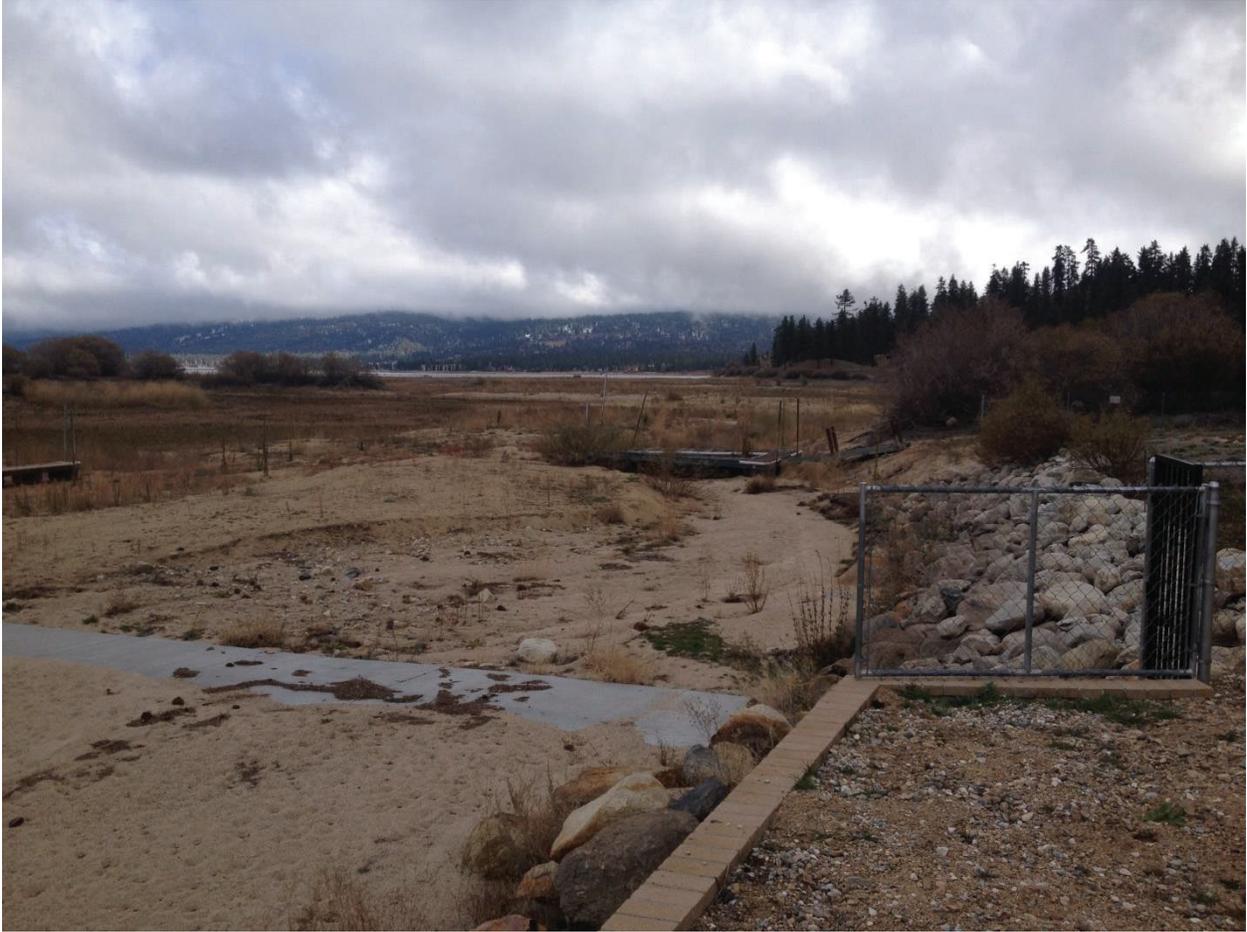
Mouth of Grout Creek with concrete grade control bottom and start of retaining wall. Note the good riprap habitat downstream as the channel merges with stands of willows on the west side of Grout Bay.

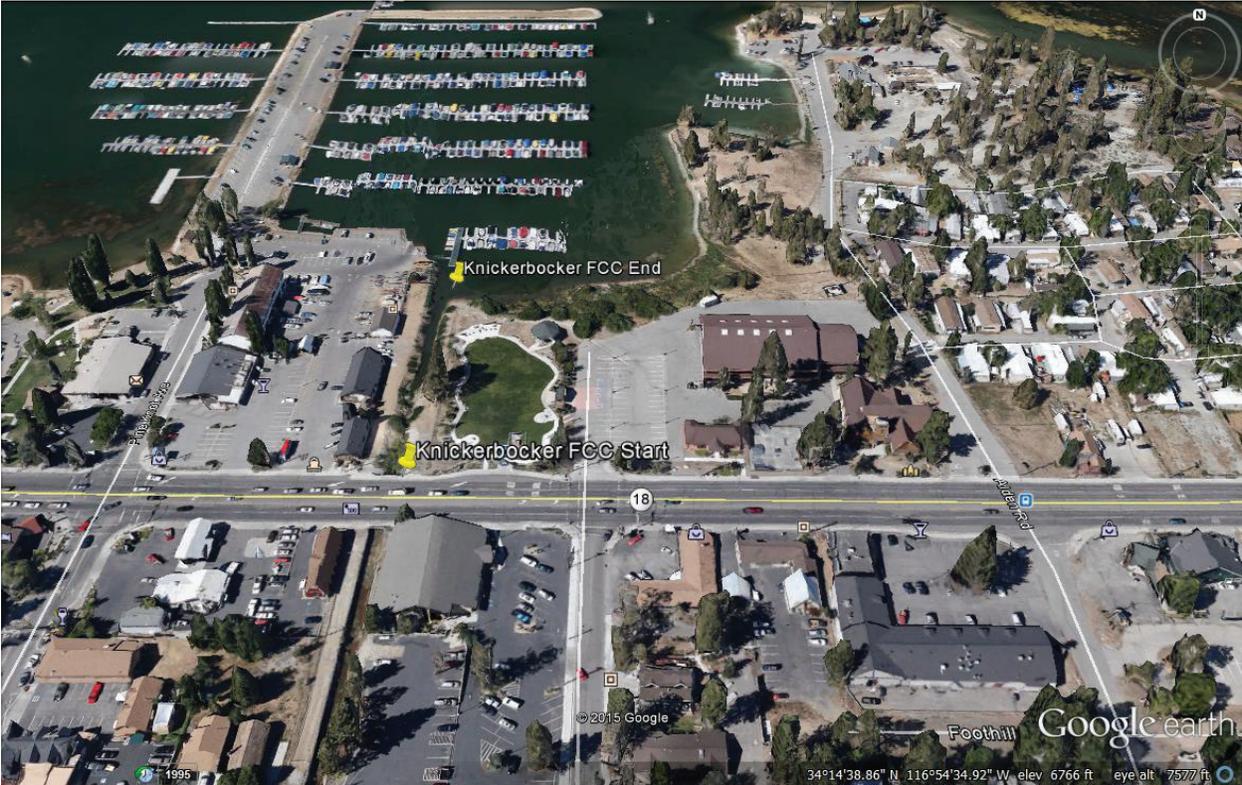
Knickerbocker 10-28-15

Knickerbocker Creek is the most isolated by development of all the flood control channels.

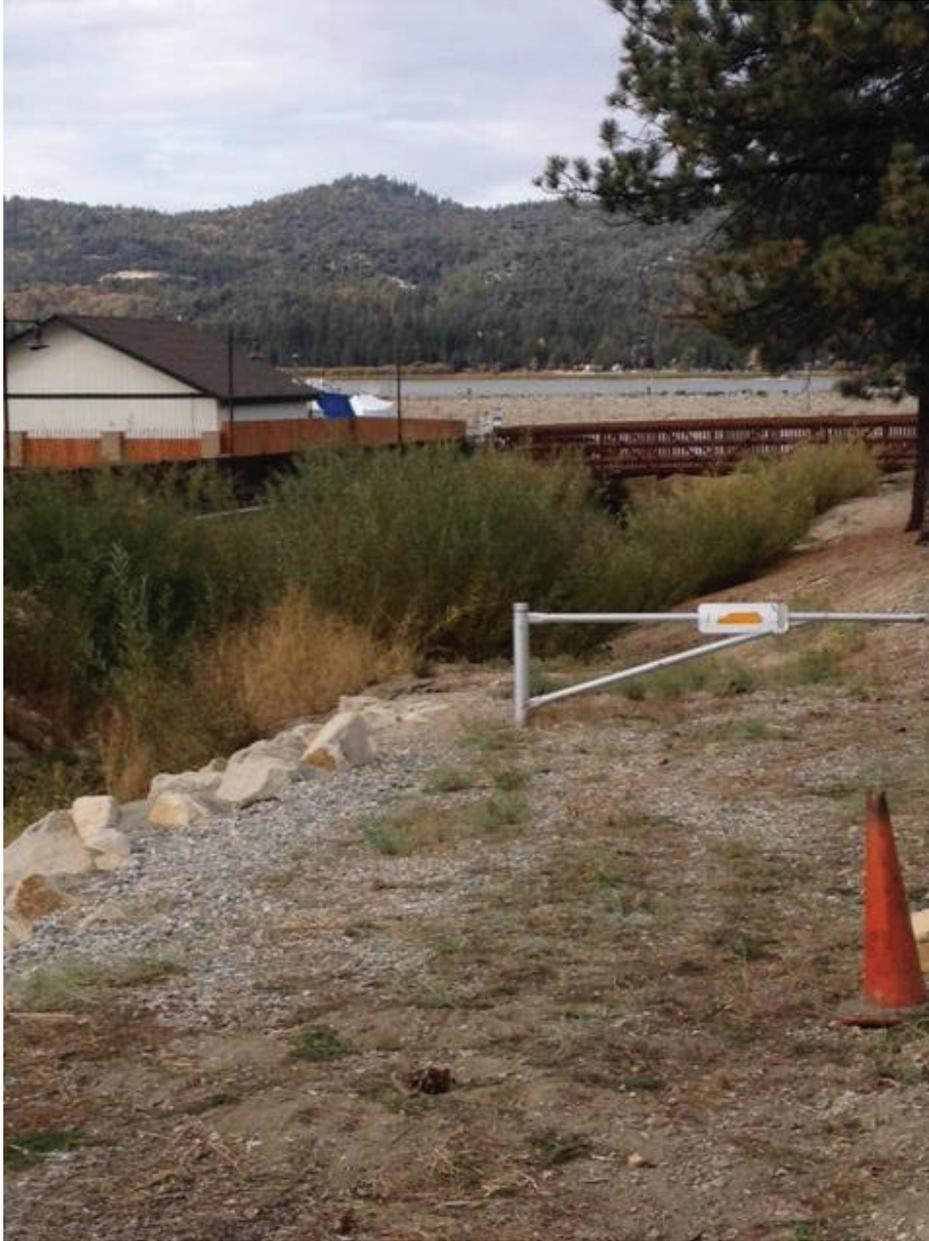
Big Bear Blvd looking to lake. Short, very narrow stretch of degraded willow riparian habitat from BB Blvd. to high water mark of Big Bear Lake. Riparian habitat would be suitable for seasonal use if there were adjacent suitable uplands. This habitat is extremely isolated because it is surrounded by high density development with no connection to suitable habitat for some distance. Creek is in concrete channel upstream of BB Blvd for quite a distance. This habitat would not support boas without a connection to undeveloped habitat.

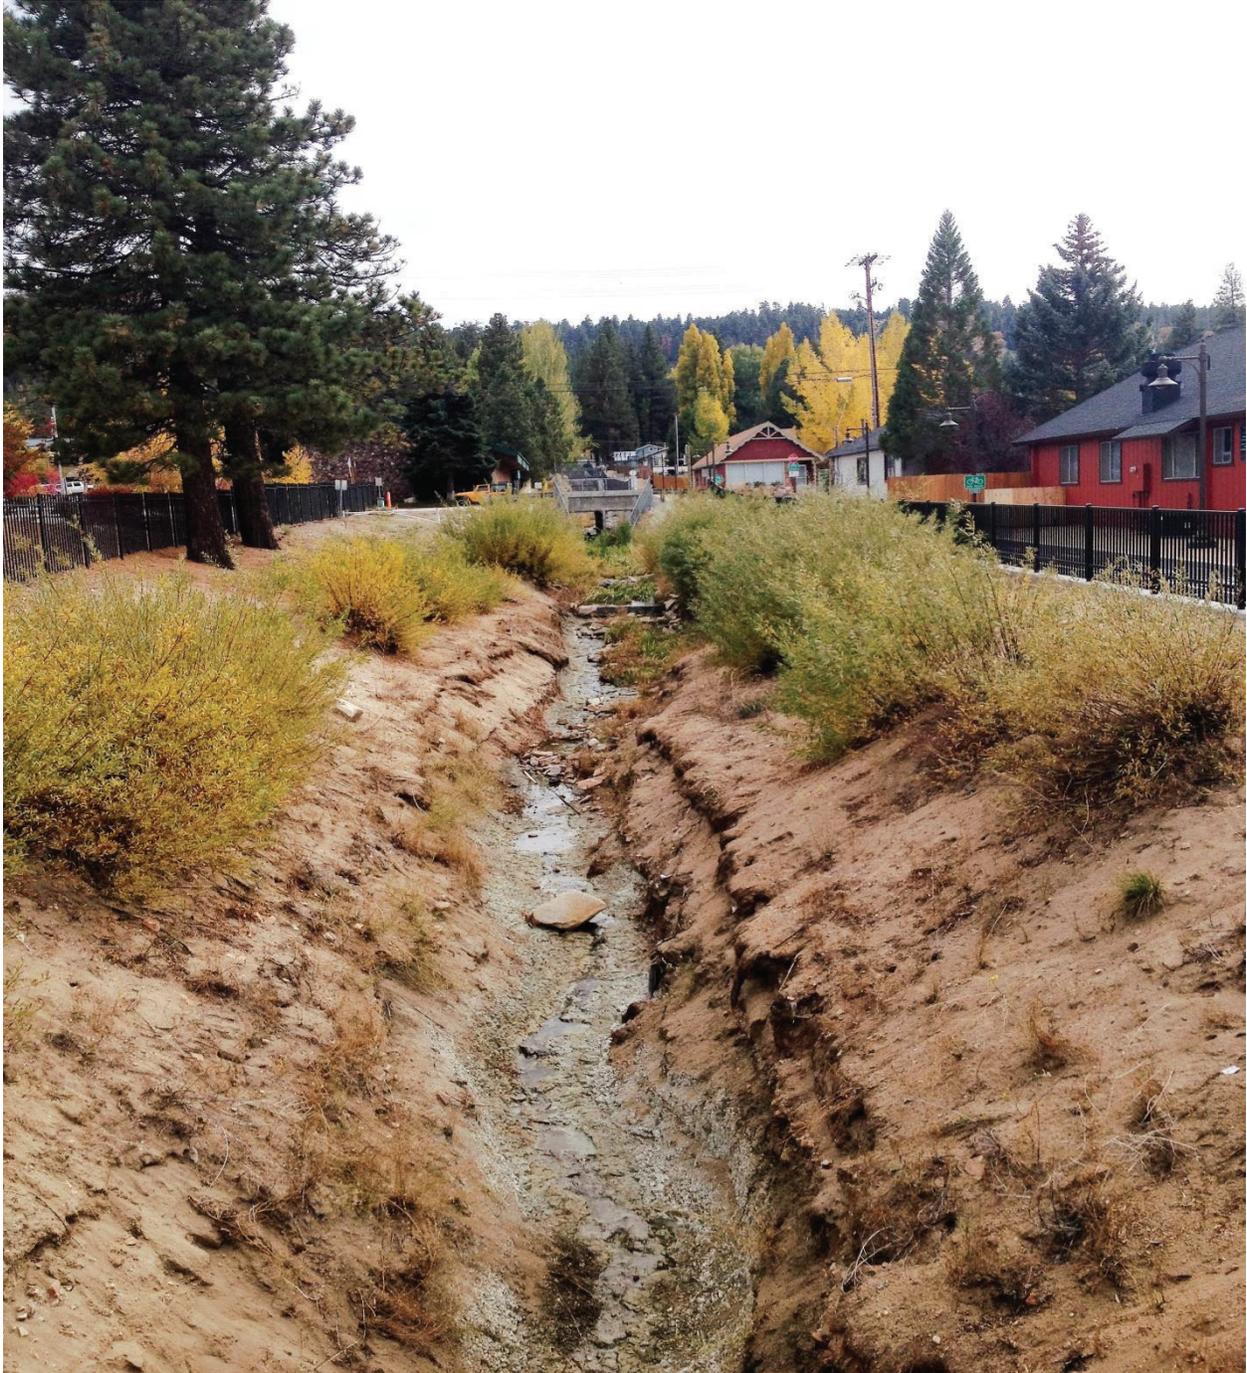
From bridge at mouth of creek to Big Bear Blvd. Even though there is some willow riparian habitat, it is too isolated and small to be used by southern rubber boas.

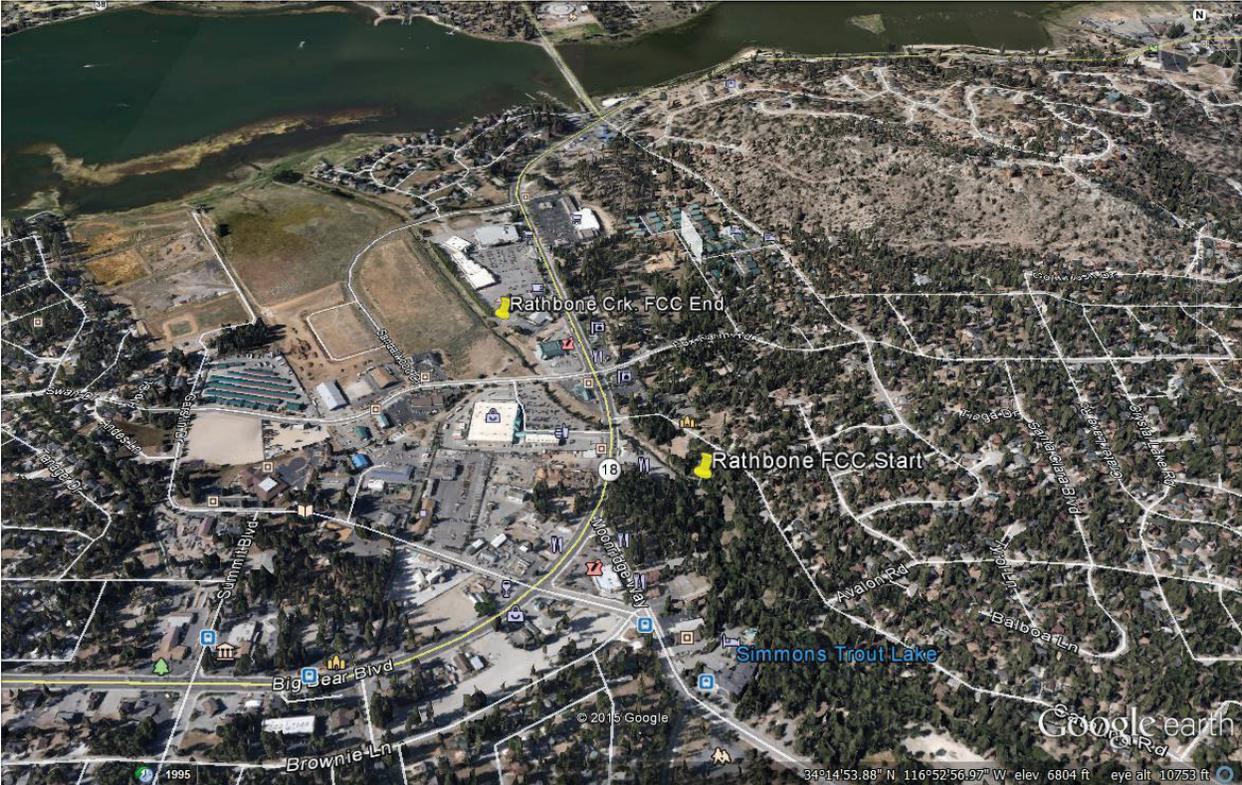
Rathbone Creek 10-23-15

Rathbone Creek is isolated from suitable southern rubber boa habitat by dense housing and commercial development.

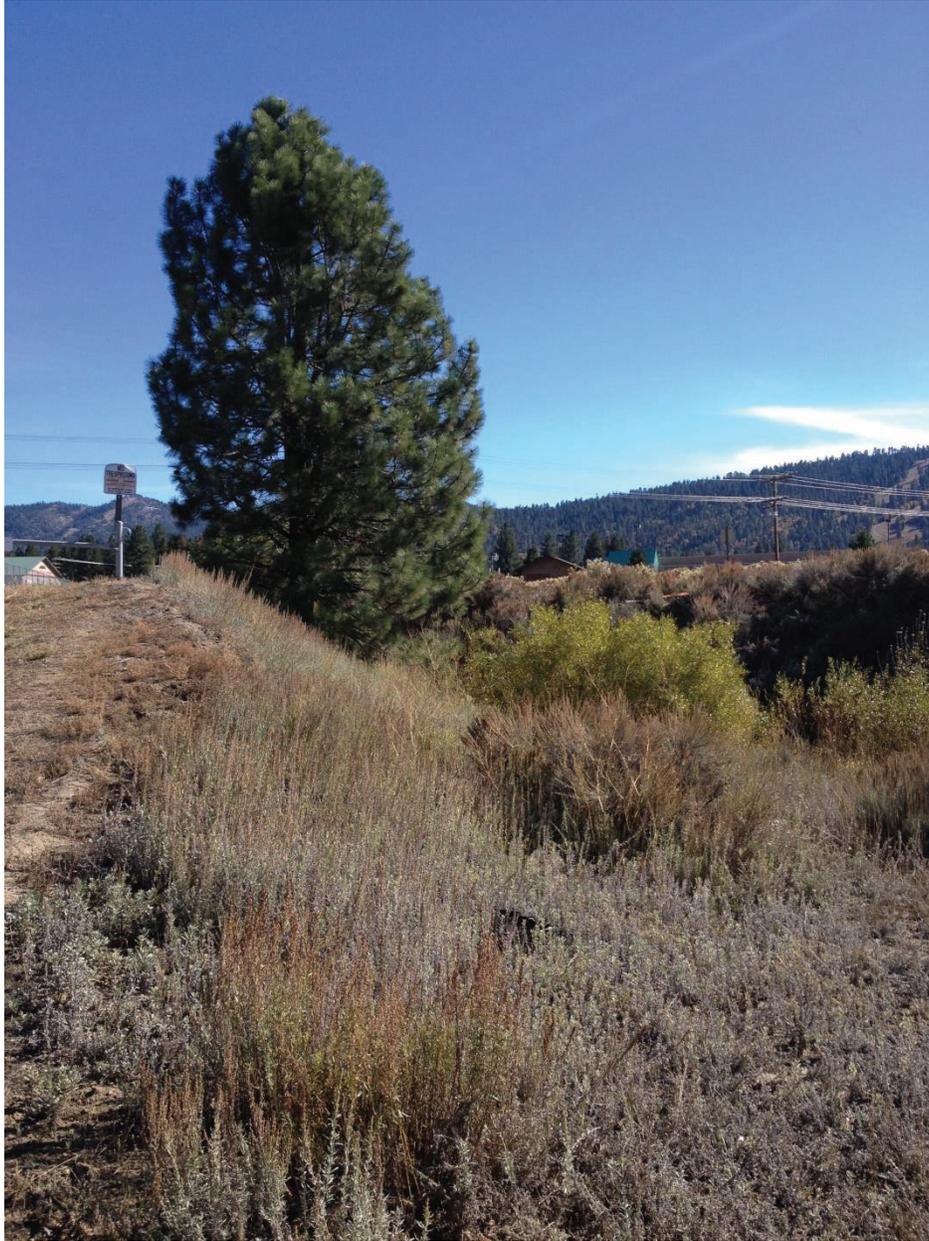
Meadow looking south, or upstream at East Levy. Habitat typical of sagebrush/rabbitbrush habitat in the basin. If it connected to other, larger blocks of suitable habitat, it would be suitable for boas.

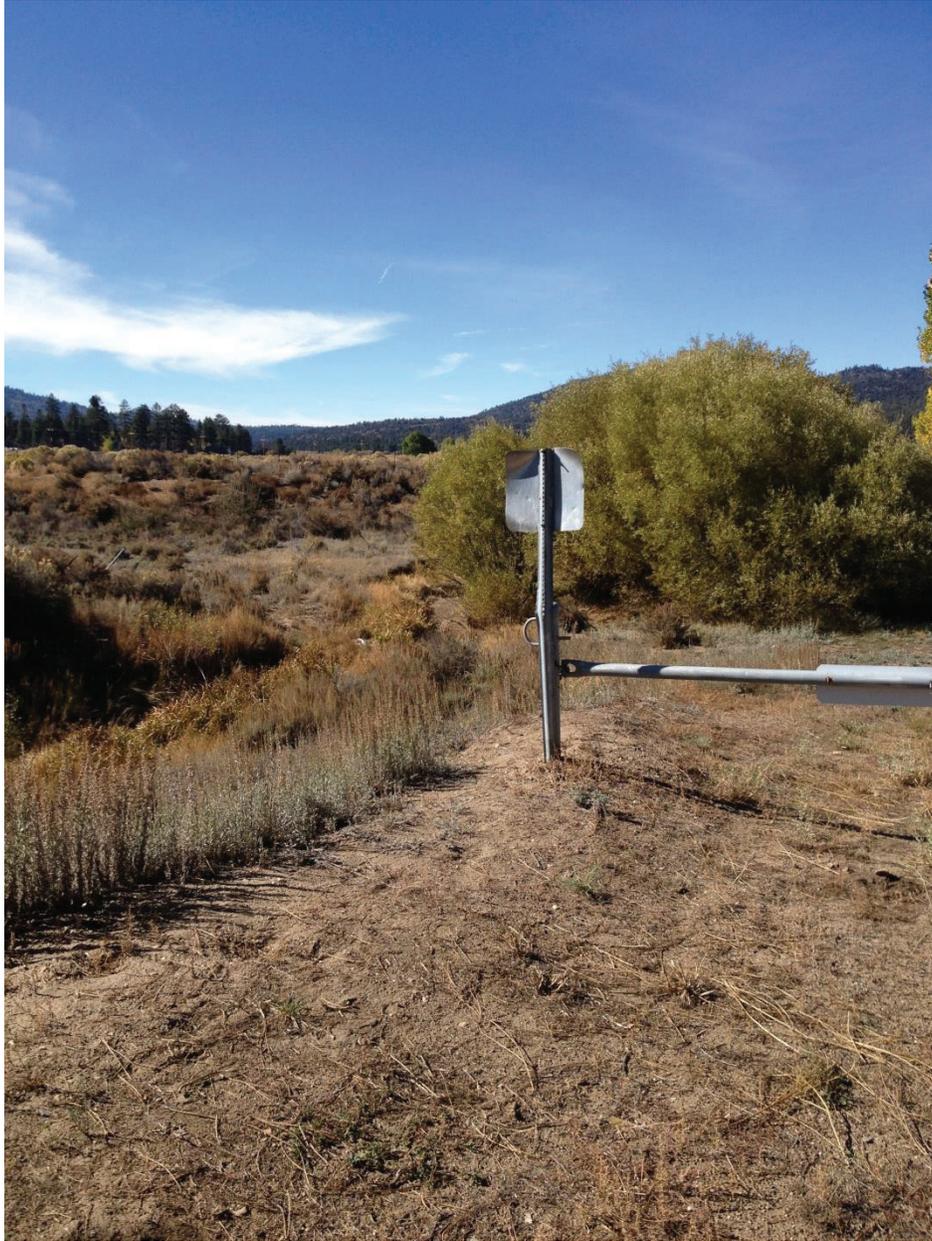
From end of levy looking North as drainage enters the meadow. Again, potential habitat if it wasn't so isolated by development.

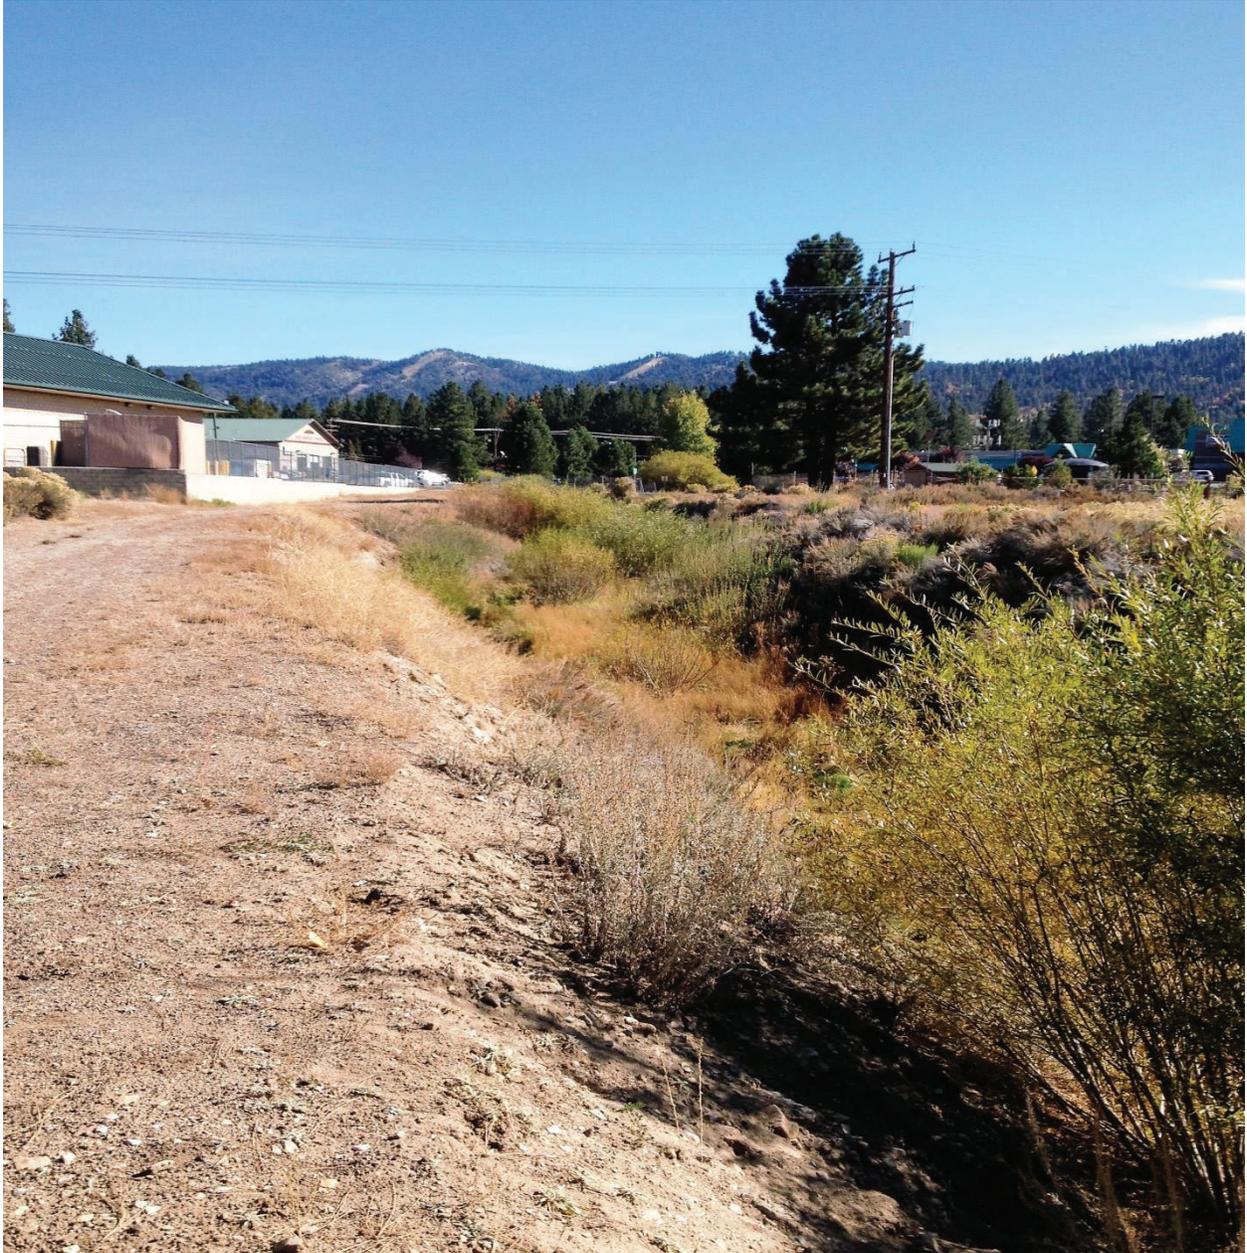
Levy along Rathbun below Fox Farm Rd. showing businesses, parking lots etc. immediately to east.

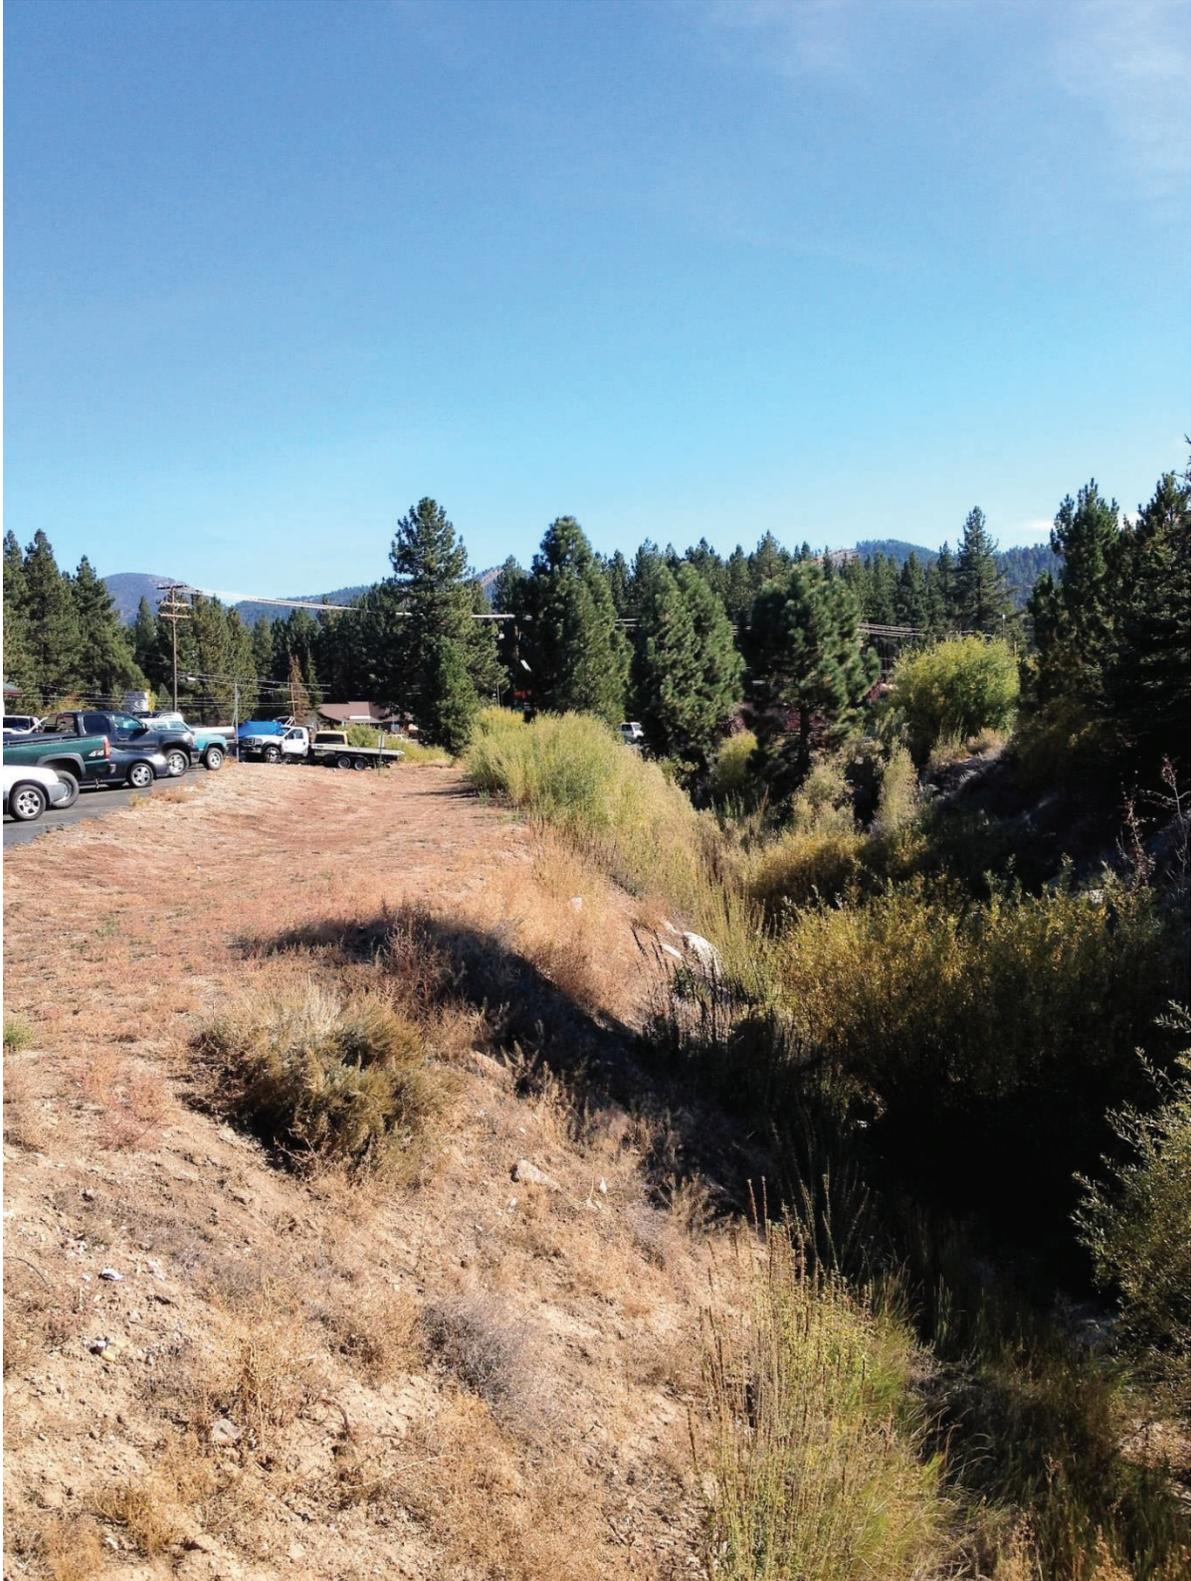
Rathbun between Fox Farm and BB Blvd. Note parking lot and cars and businesses surrounding this. Other side of stream is large parking lot.

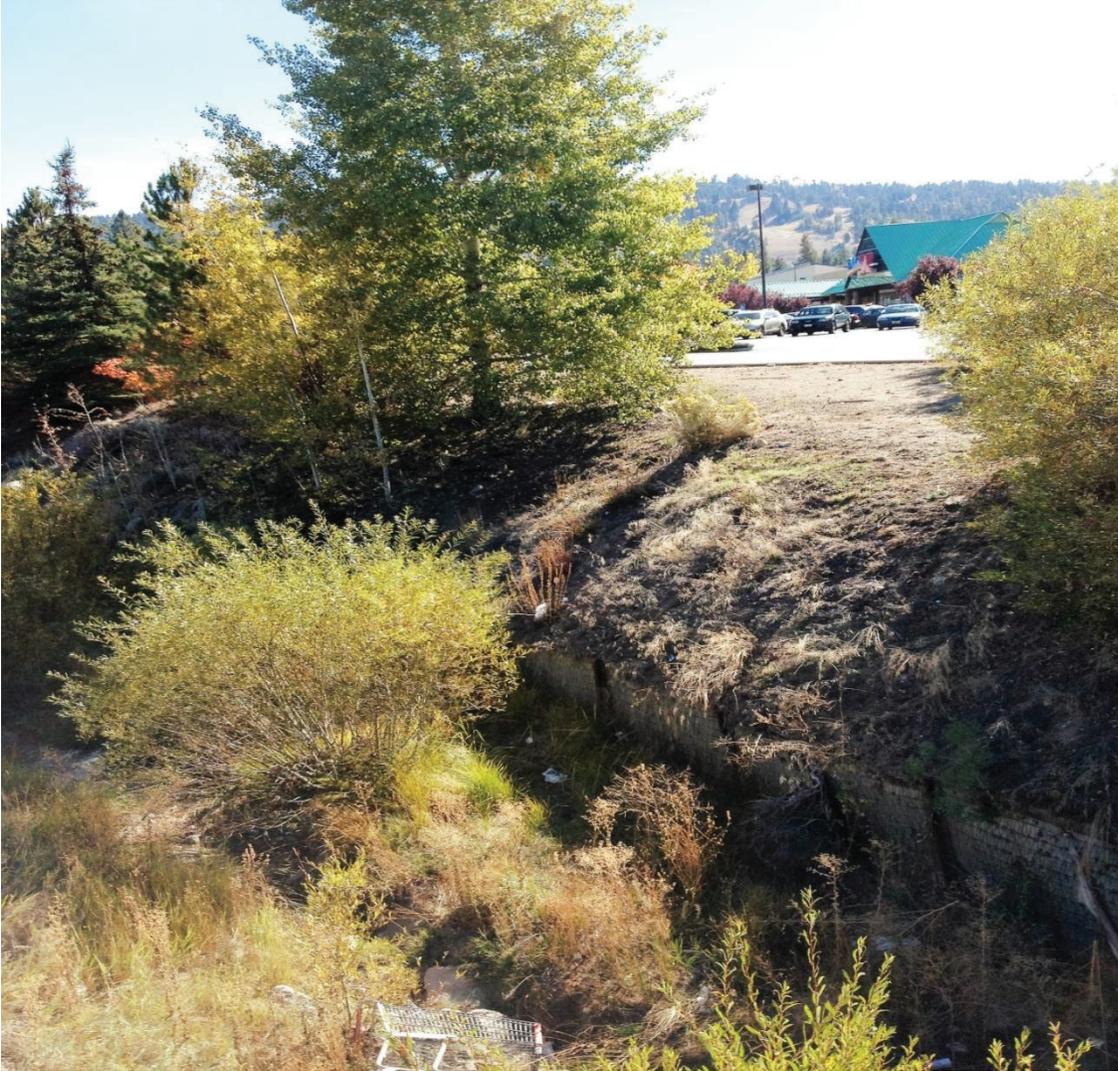
K Mart Parking lot on southwest side of Rathbone Creek. Note the grocery cart. Again, habitat would be suitable if not so isolated by development, Big Bear Blvd. etc.

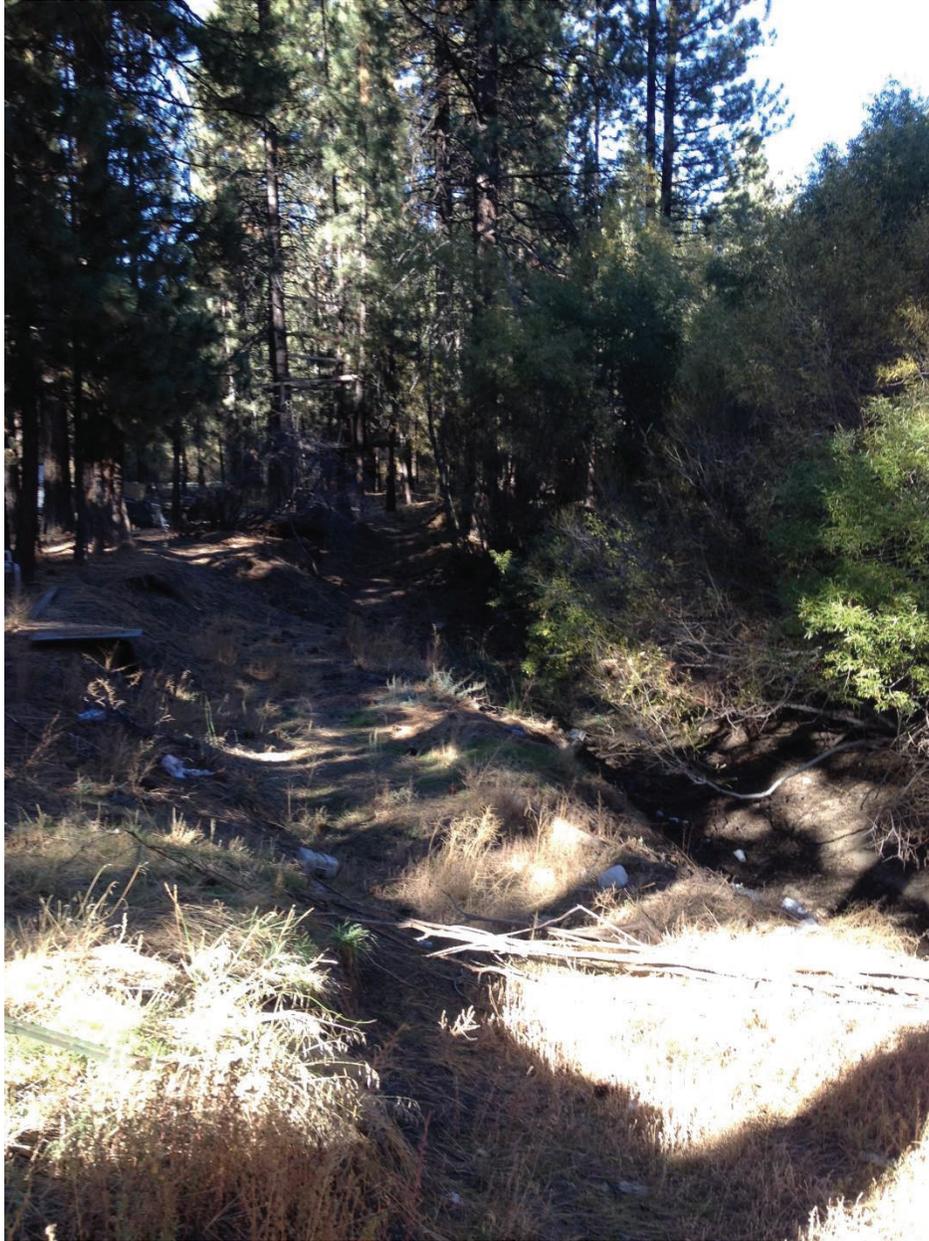
Some of the best habitat on the stream upstream from BB Blvd. above the start of the SB Co. Flood Control channel. This habitat could be occupied if it was connected to a larger block of natural habitat with down logs, rocks and rock outcrops. All of this habitat above BB Blvd. is surrounded by multiple layers of fairly dense housing with very little rock and down woody debris. There are no rock outcrops or area with large logs and woody debris for boas to winter in.

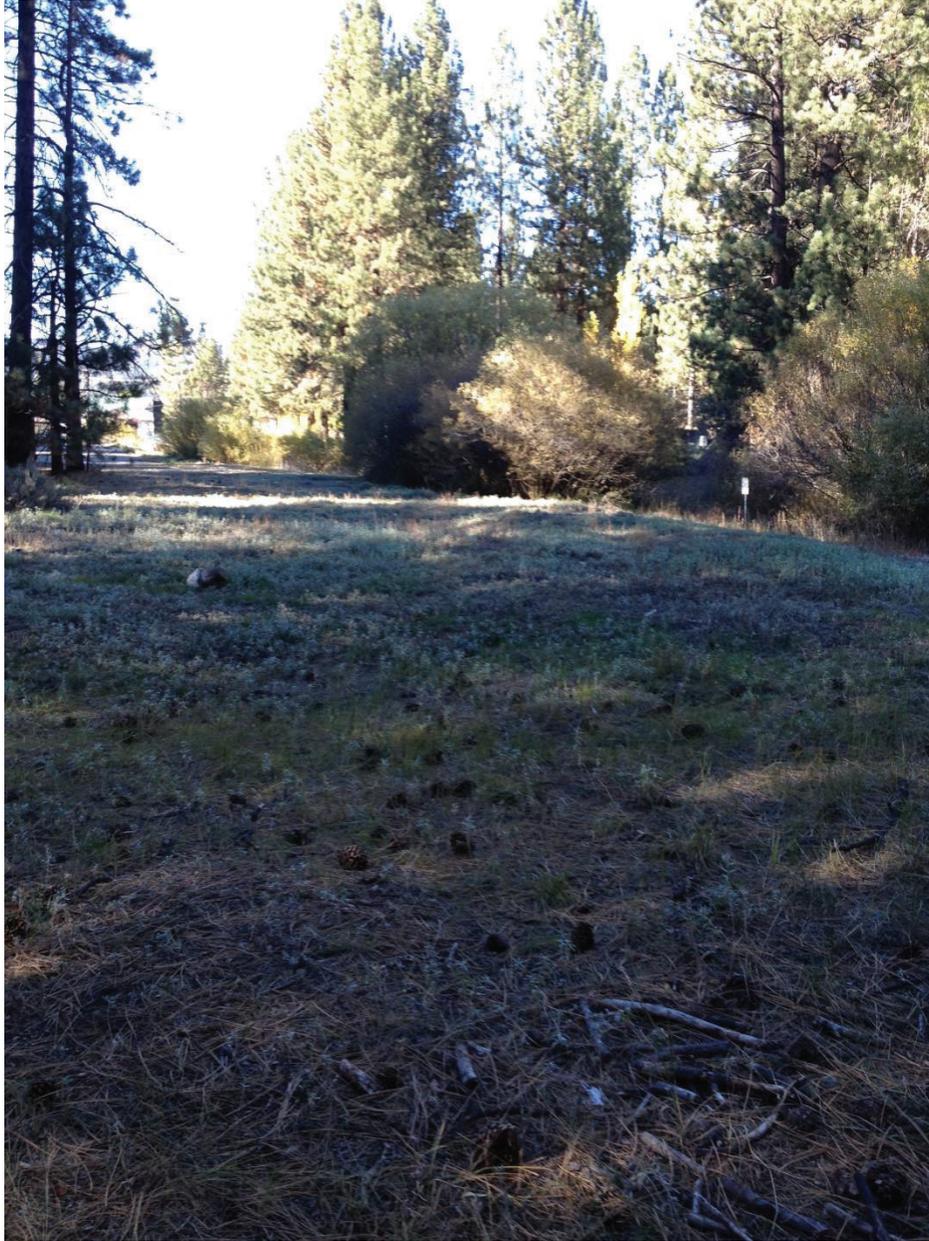
Upland adjacent to Rathbone Creek above BB Blvd. and the start of the flood control channel showing how clear most areas are being kept for fire protection. This habitat could also be used by boas if it was connected to better habitat with rock, down logs etc..

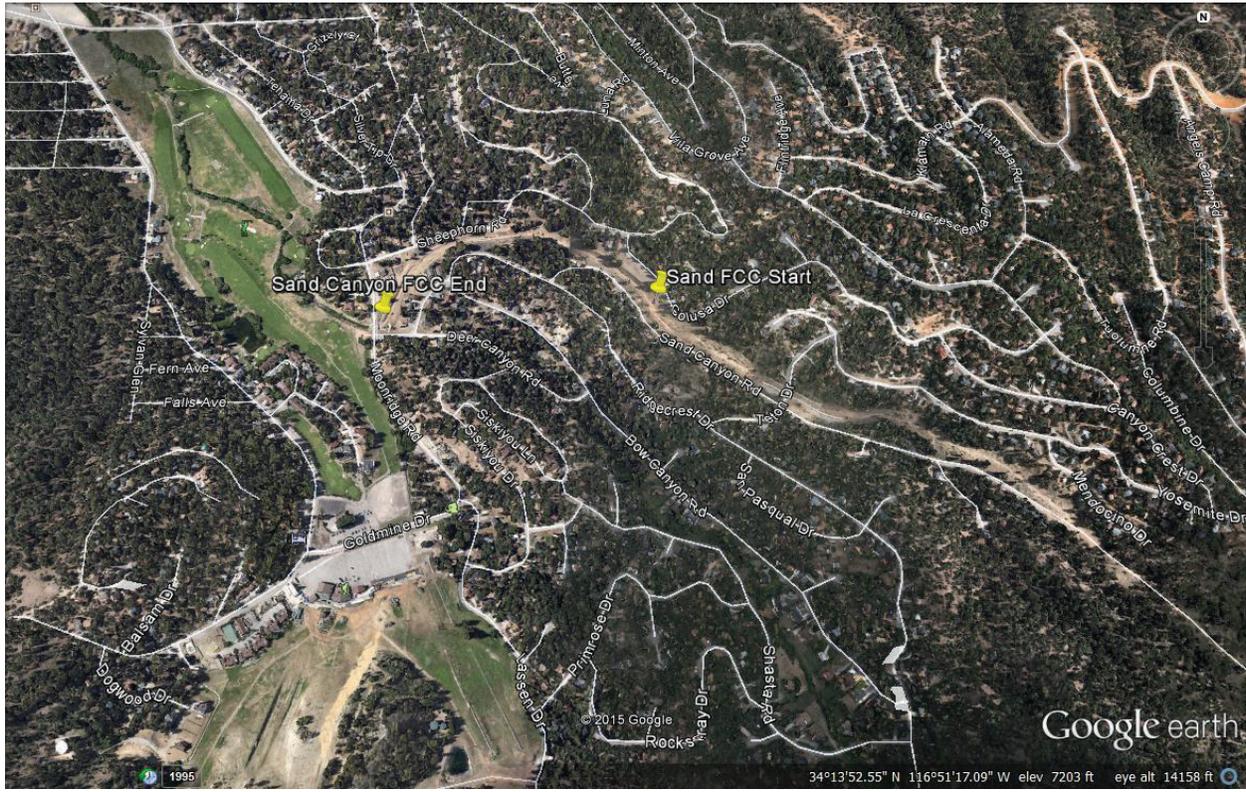
Sand Canyon

Multiple layers of development surrounding the flood control channel.

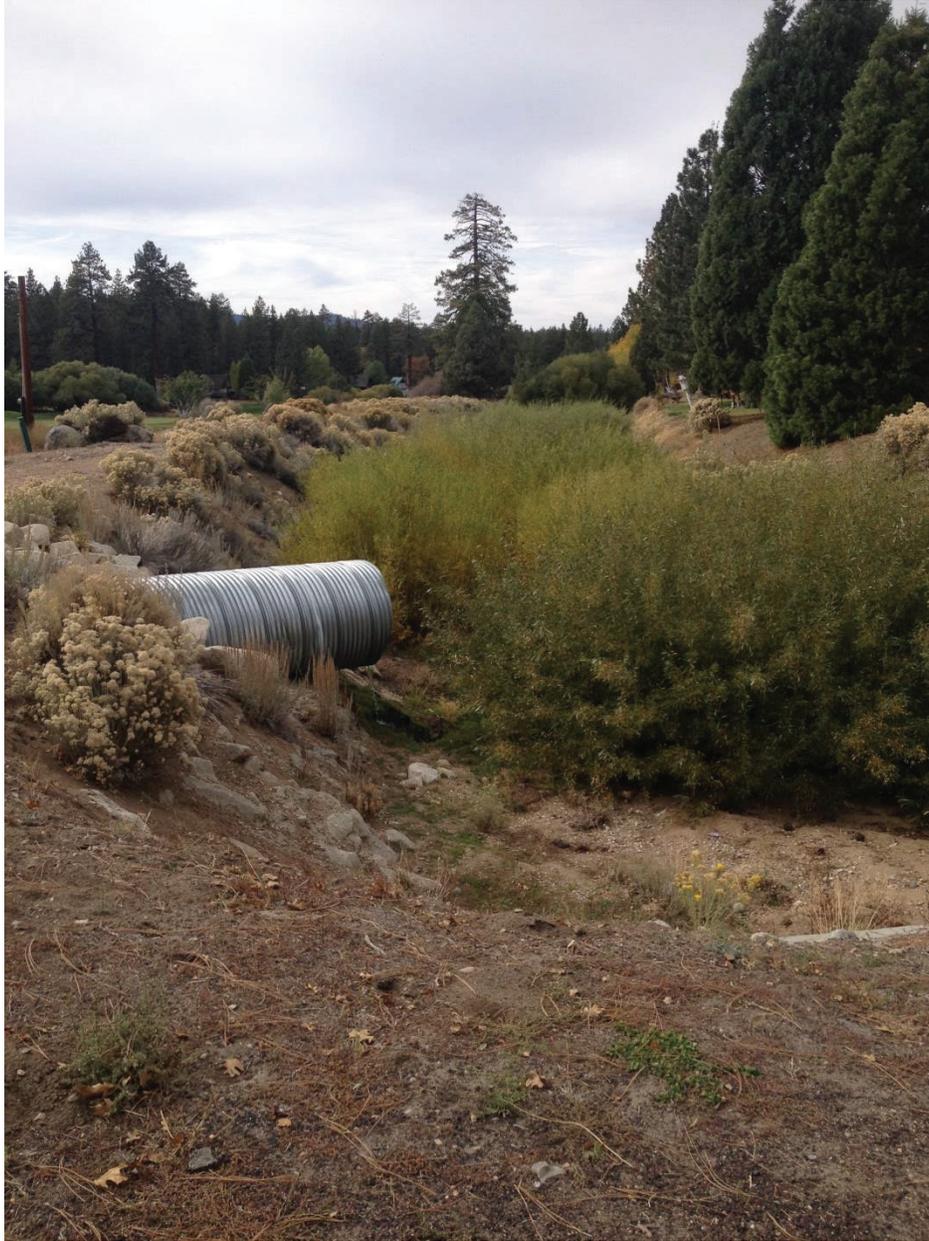
Sand Canyon Crossing of Moonridge immediately above the Golf Course. Note the good stand of willow. Willows do not extend above Moonridge into the maintained flood control channel. Above Moonridge, the channel becomes more dry wash type rather than willow riparian.

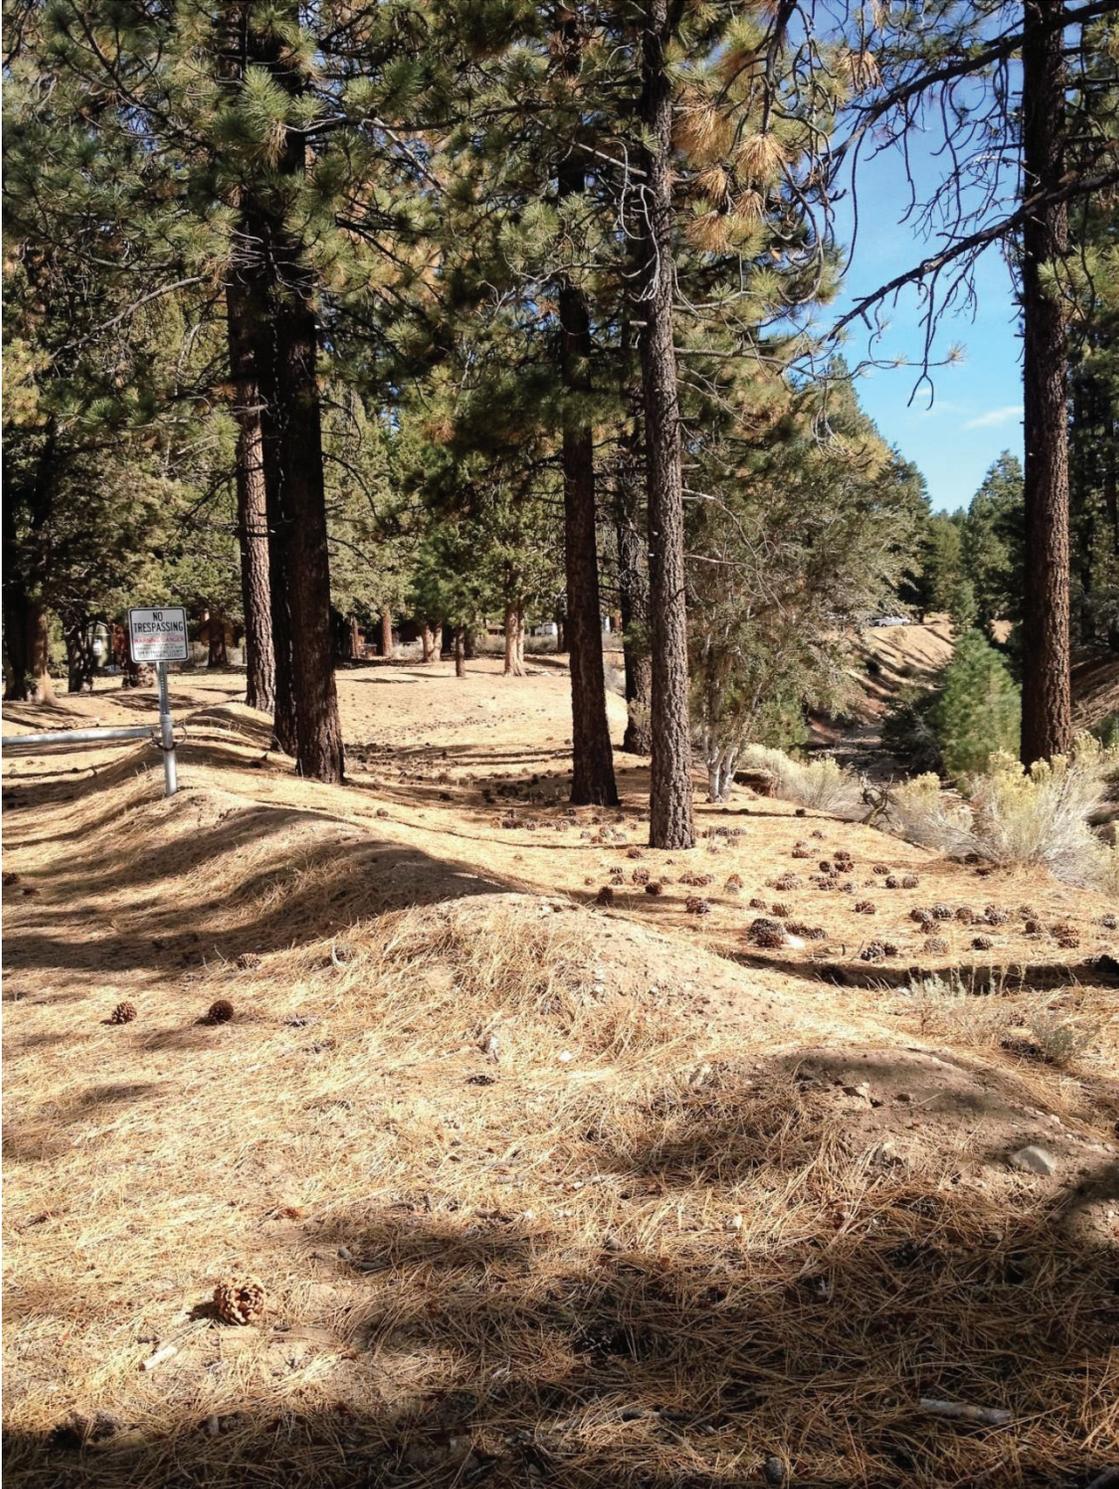
Lower end of Sand Canyon Flood Control Channel. Very little down woody debris such as logs etc.. Very little surface rock and no rock outcrops.
