*Southern Rubber Boa Habitat Assessment for the
Master Storm Water System Maintenance Program*

Southern Rubber Boa Habitat Assessment for the Master Storm Water System
Maintenance Program
December 2015

Steve Loe, Certified Wildlife Biologist
33823 Nebraska St.
Yucaipa, CA 92399
909-809-4726

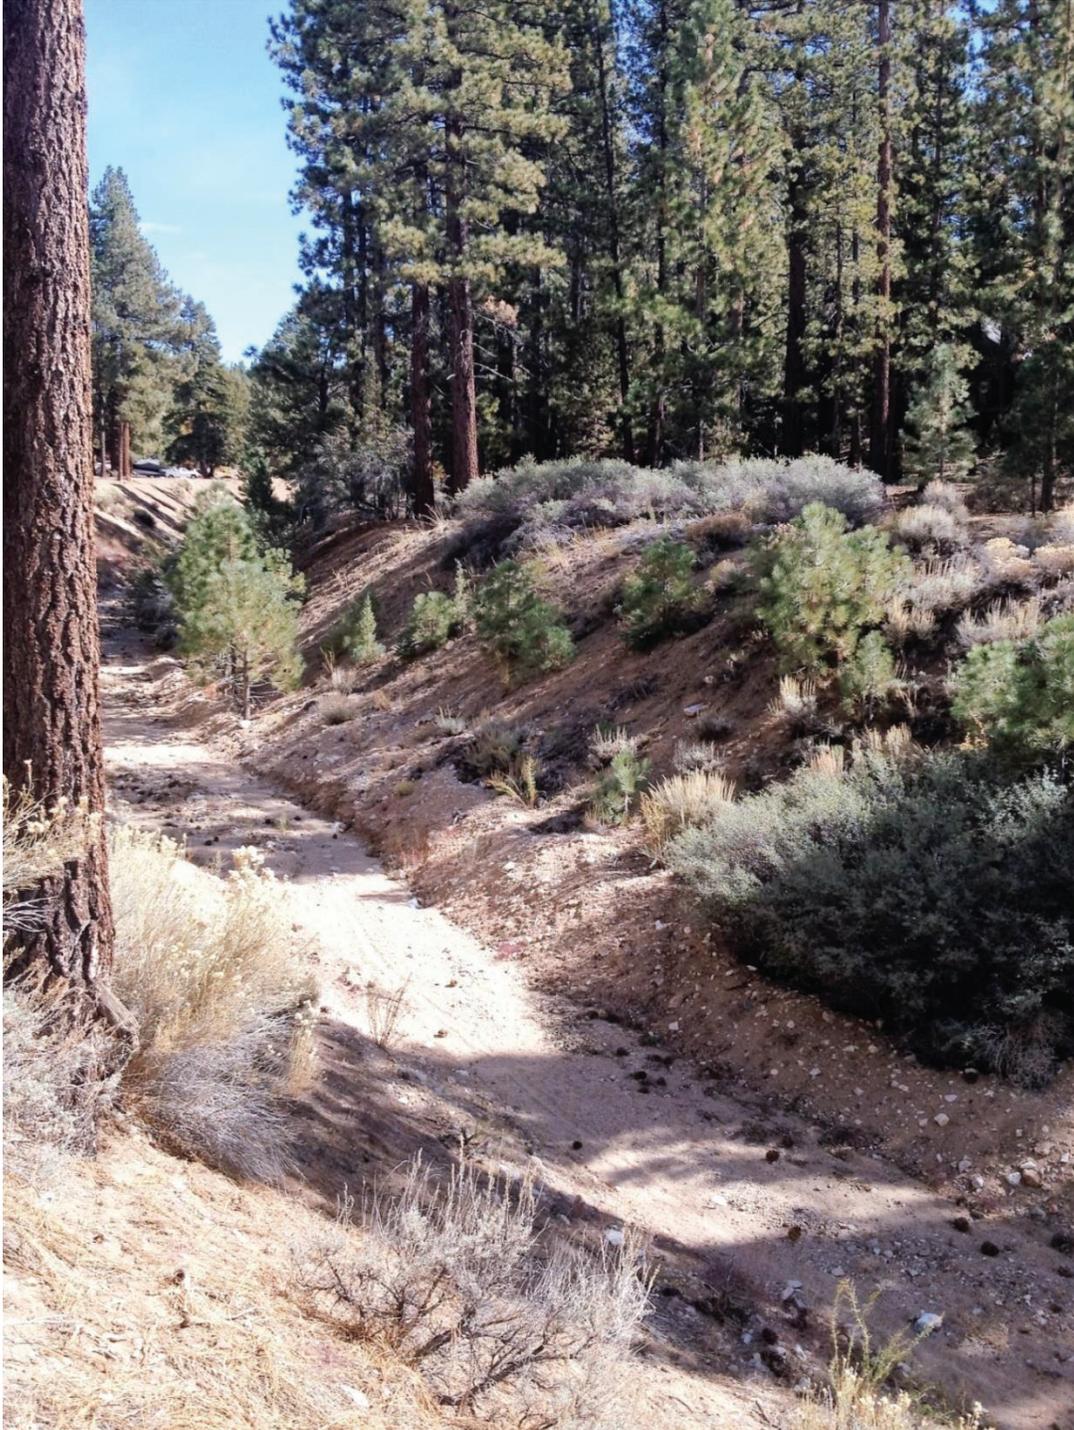
Shot of drainage upstream from the lower end of the flood control channel. Typical of this lower section near Sheephorn. Creek is more like a dry wash than it is downstream of the golf course where it becomes willow riparian. Drainage has been periodically maintained with heavy equipment. There is very little willow indicating a pretty dry streambed. Habitat is marginal, but could support boas if connected to larger blocks of suitable habitat.

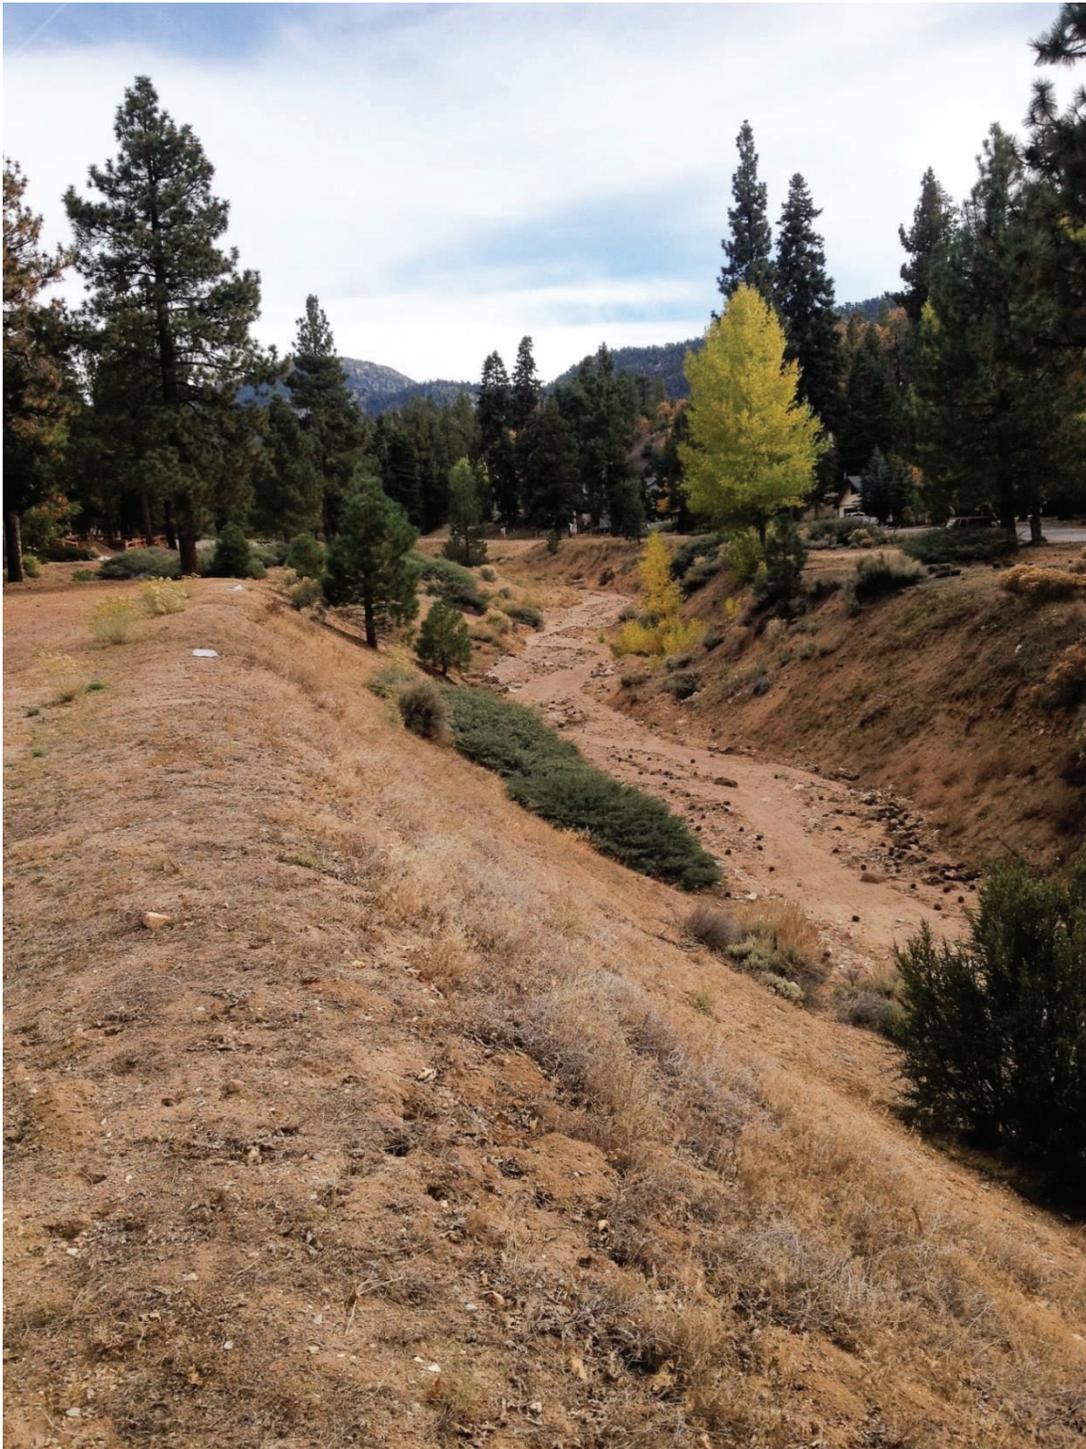
Upper Section of Sand Canyon flood control channel maintained by SB Co. off of Calusa. Marginal habitat with dry wash characteristic, little vegetation and rock and no down woody debris (logs etc.). Relatively flat ground with dense development surrounding that precludes rubber boa use.

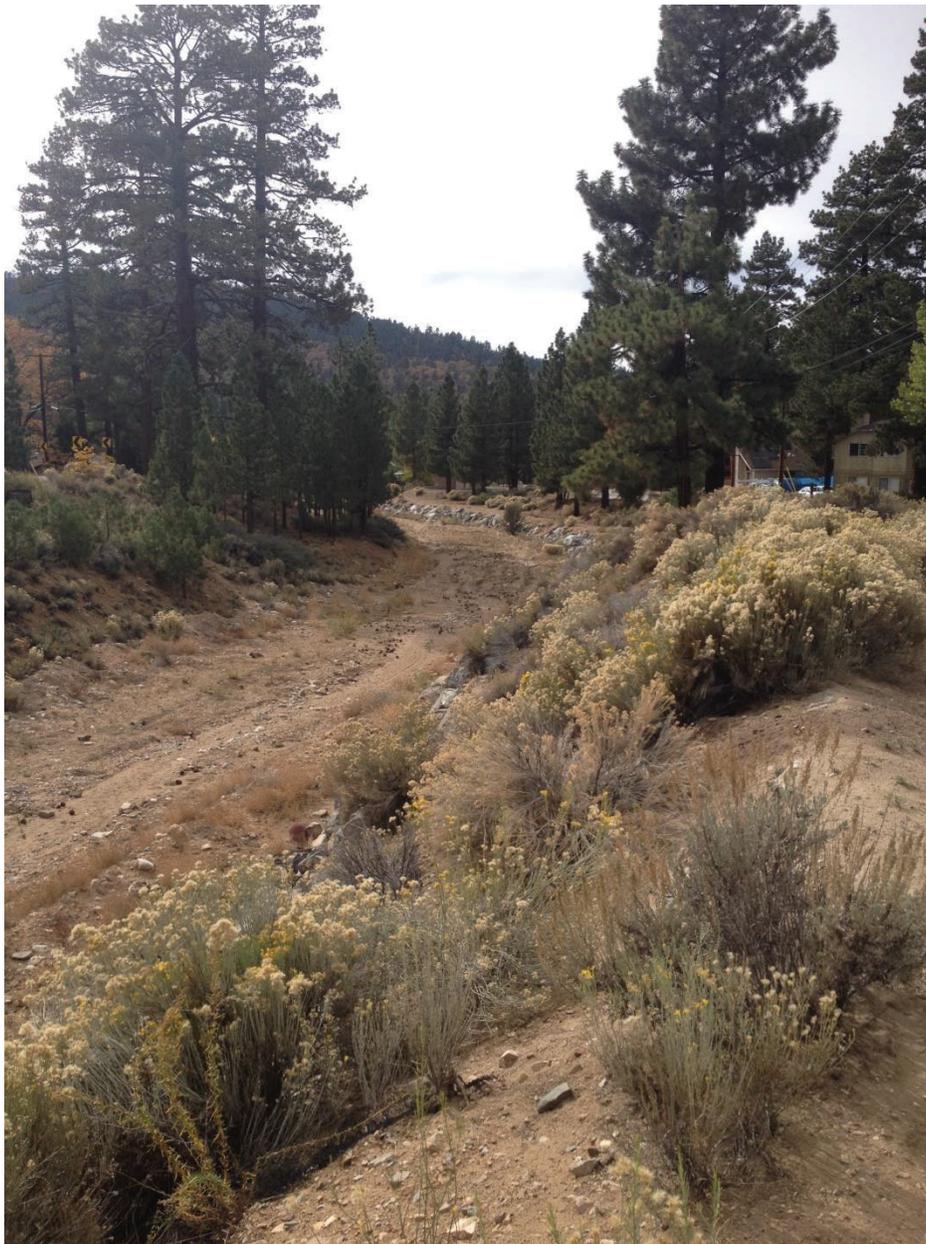
Upper Section of Sand off of Colusa looking downstream. Areas with vegetative cover like this could be used by boa if it was connected to other larger blocks of suitable habitat. This habitat is so isolated by housing that it is not capable of supporting boas.

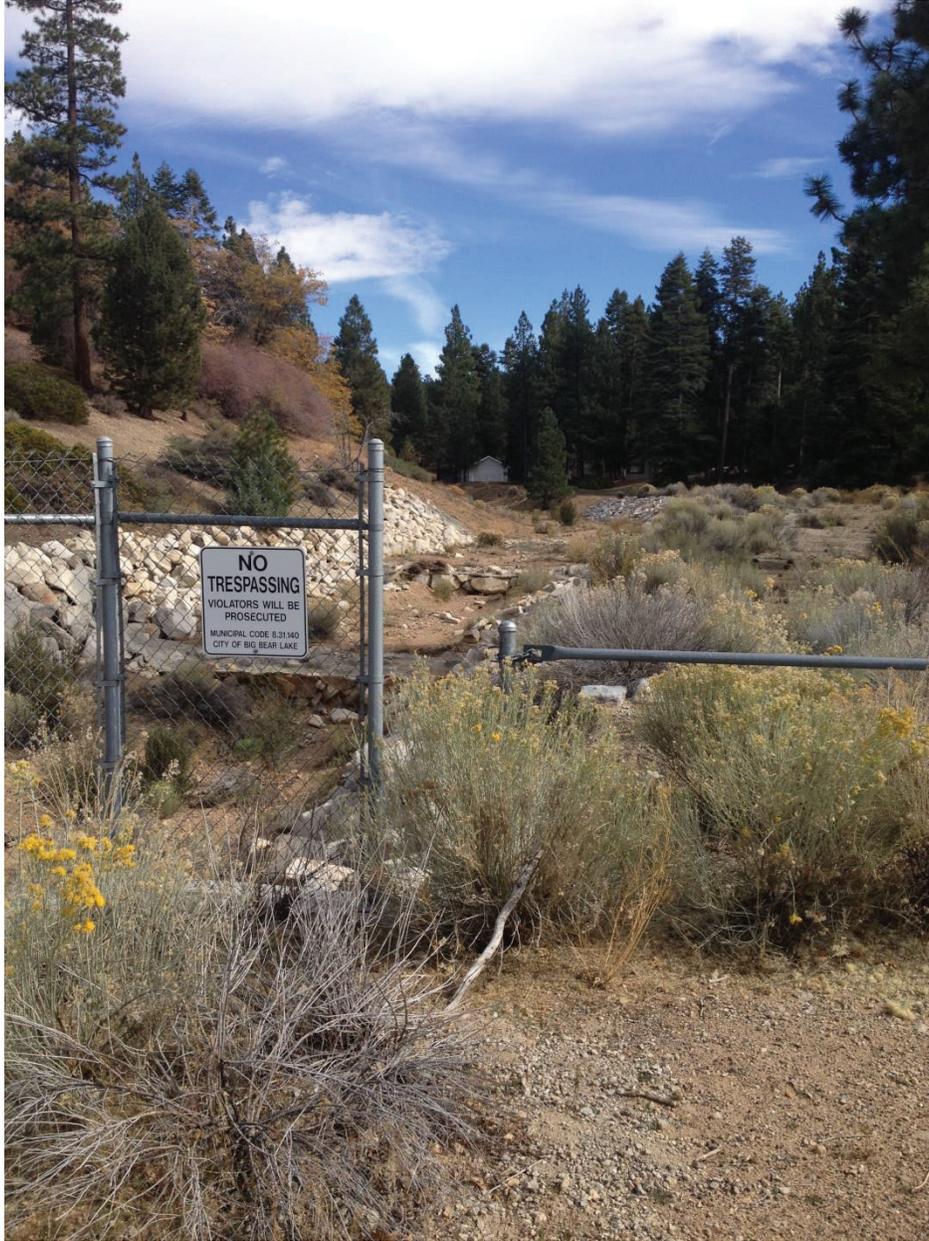
Teton Street (1/4 mile above SB County maintenance responsibility) looking up into City of Big Bear Lake flood control channel. Fair habitat, but still very surrounded by dense, multiple layer dense housing making it unsuitable..

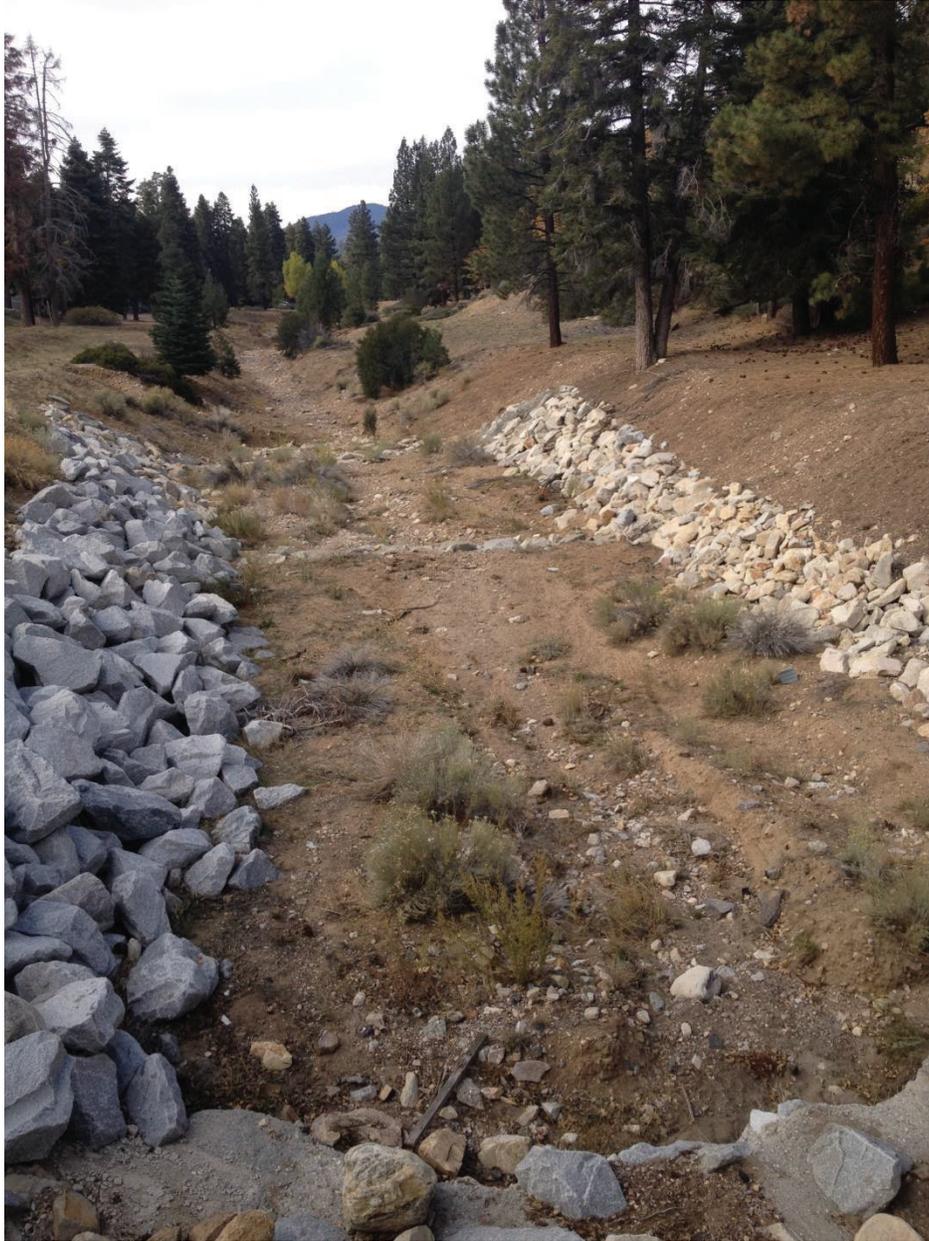
View downstream from Teton St.. Riprap would be suitable, but beyond that gets very barren again. This habitat downstream of this point is all surrounded by multiple layer dense housing with very sparse groundcover. SB Co. Flood Control maintenance starts approximately ¼ mile downstream of this point.

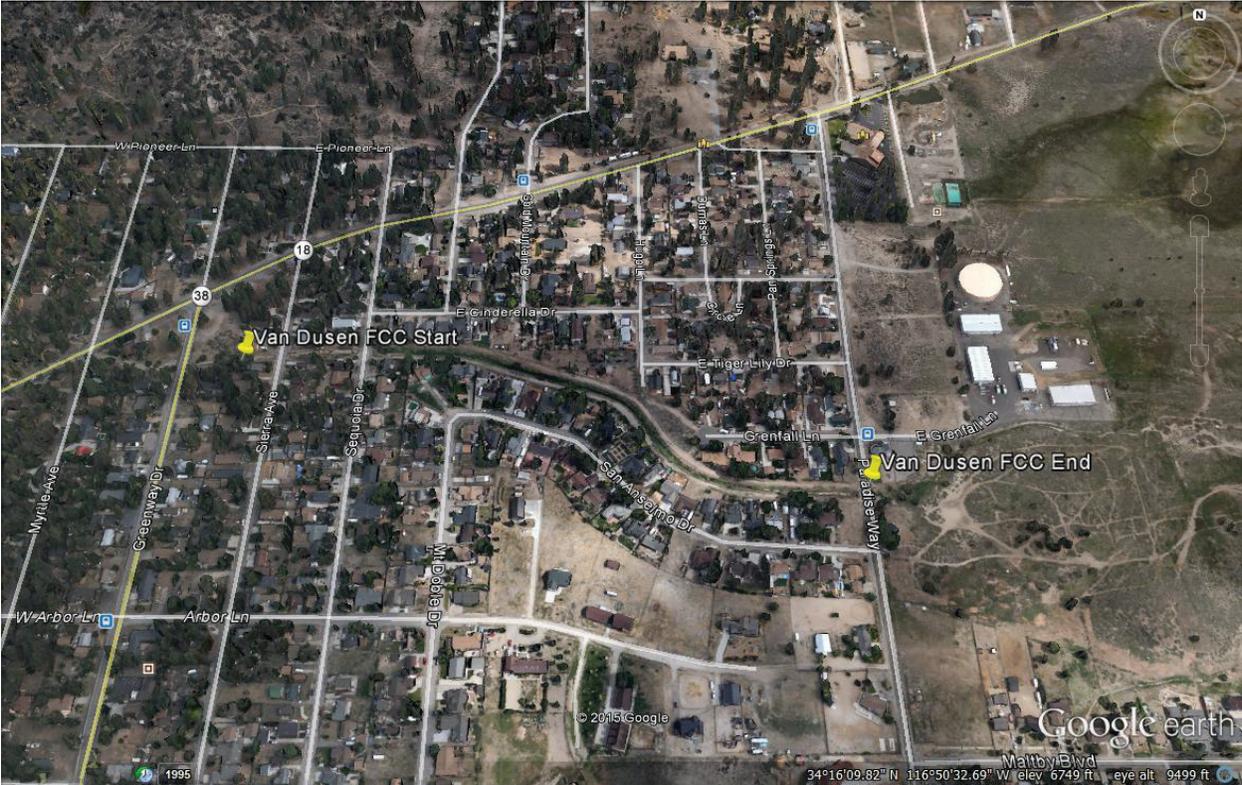
Van Dusen Creek

Van Dusen flood control channel is surrounded by dense development.

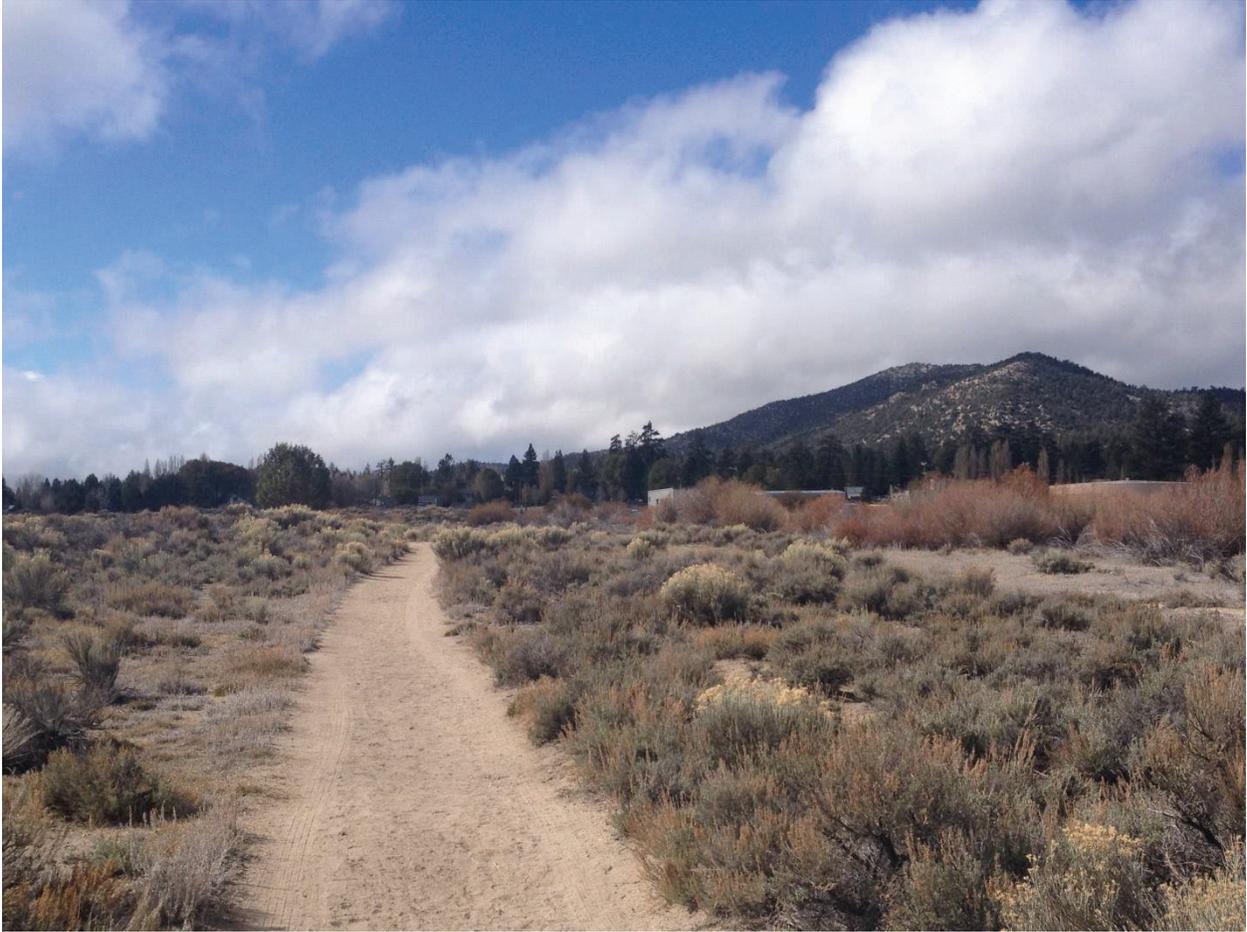
Mouth of Van Dusen Creek below Paradise on undeveloped land. Not SB Co. Flood Control responsibility. Excellent rocky habitat north of Highway 18 (1/2 mile to the North) and potentially occupied sagebrush, rabbitbrush, and juniper habitat with willows along the drainage.

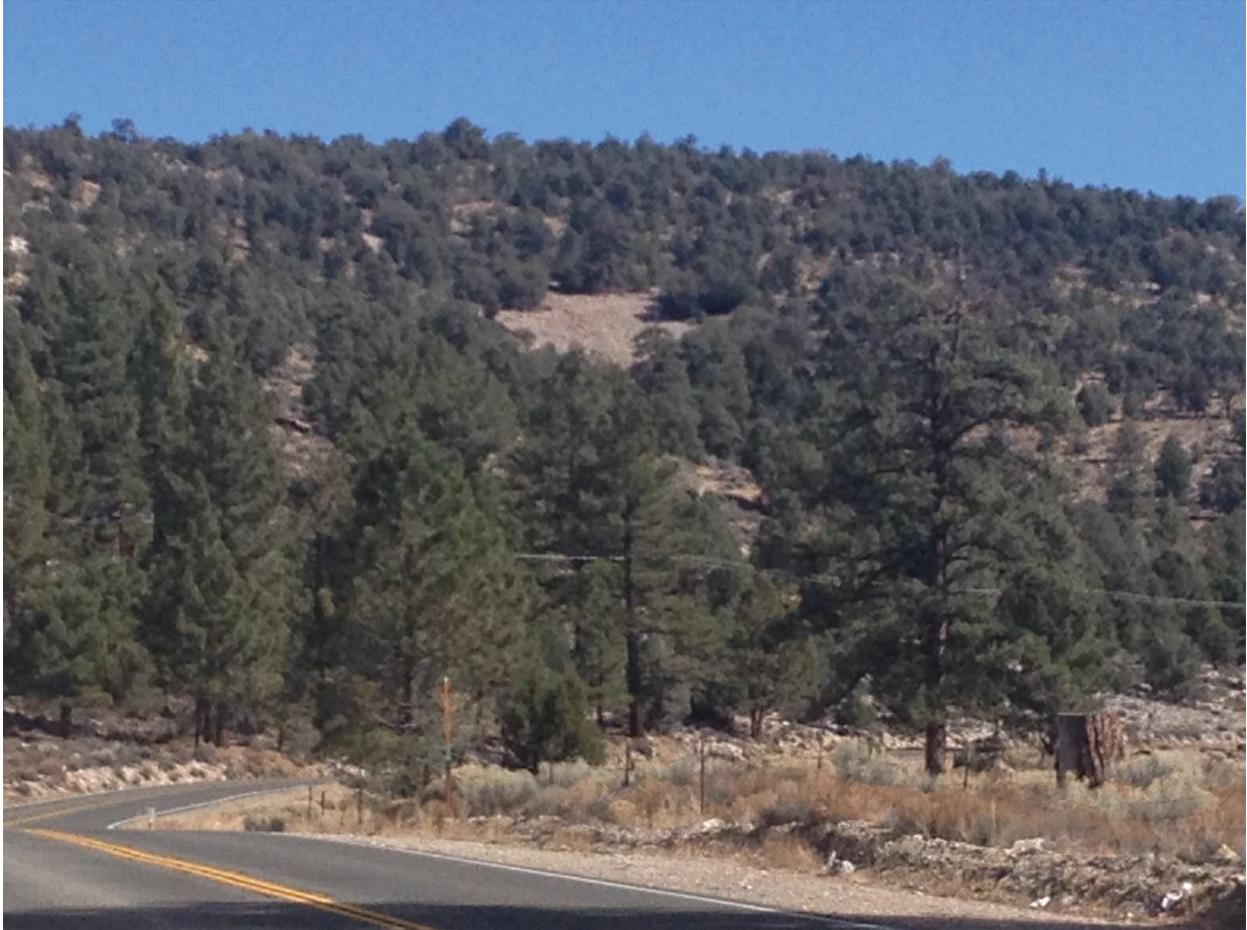
View of habitat along highway 18, below Gold Mountain. Excellent habitat with lots of rock outcrops, talus slopes and good cover. Suitable habitat extends to the sagebrush/juniper flats below Van Dusen Creek at Paradise.

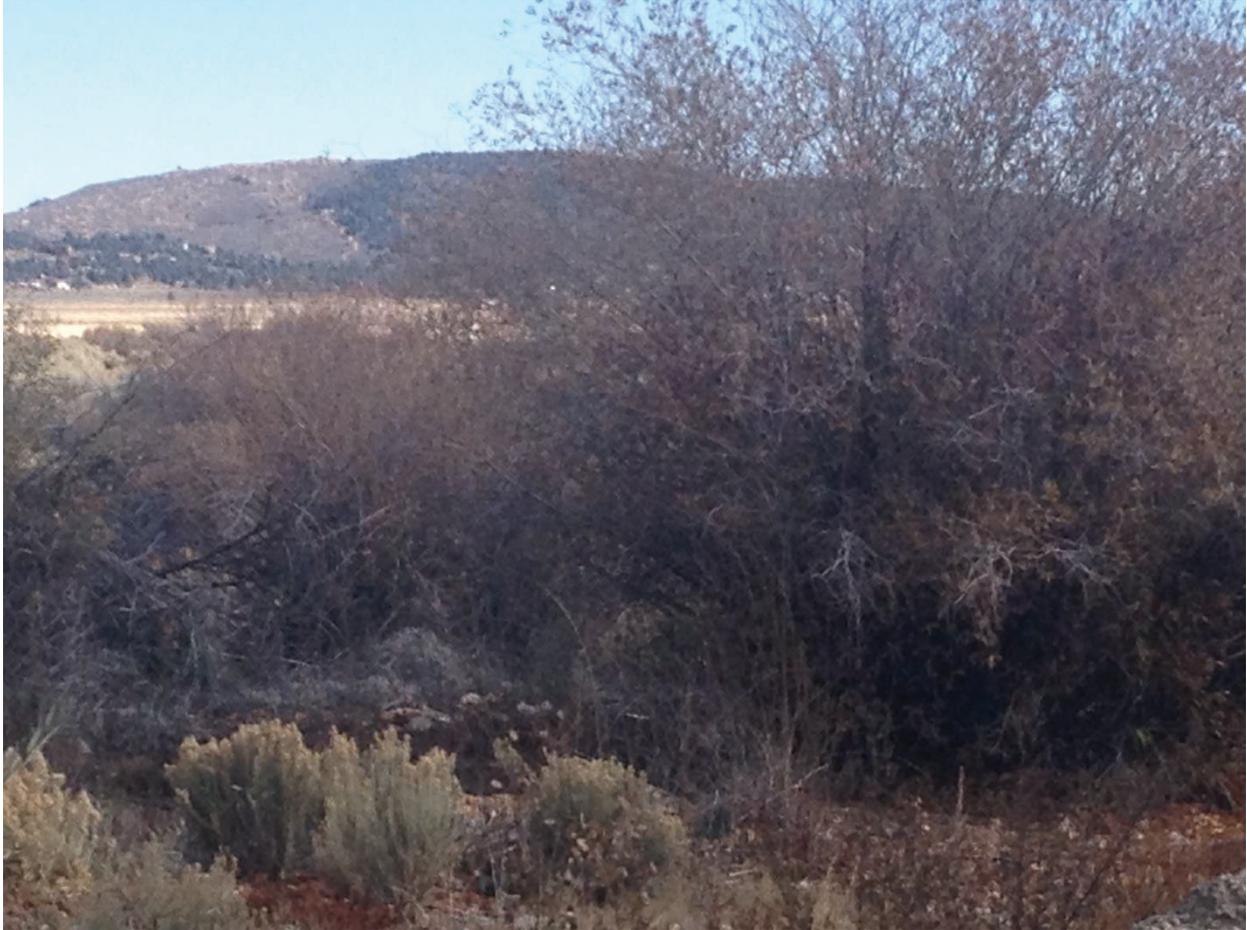
View downstream of Paradise at the mouth of Van Dusen. Willow, sagebrush, and rabbitbrush. Suitable habitat that is connected to the great habitat on the slopes and bottom of Gold Mountain $\frac{1}{4}$ mile to the North.

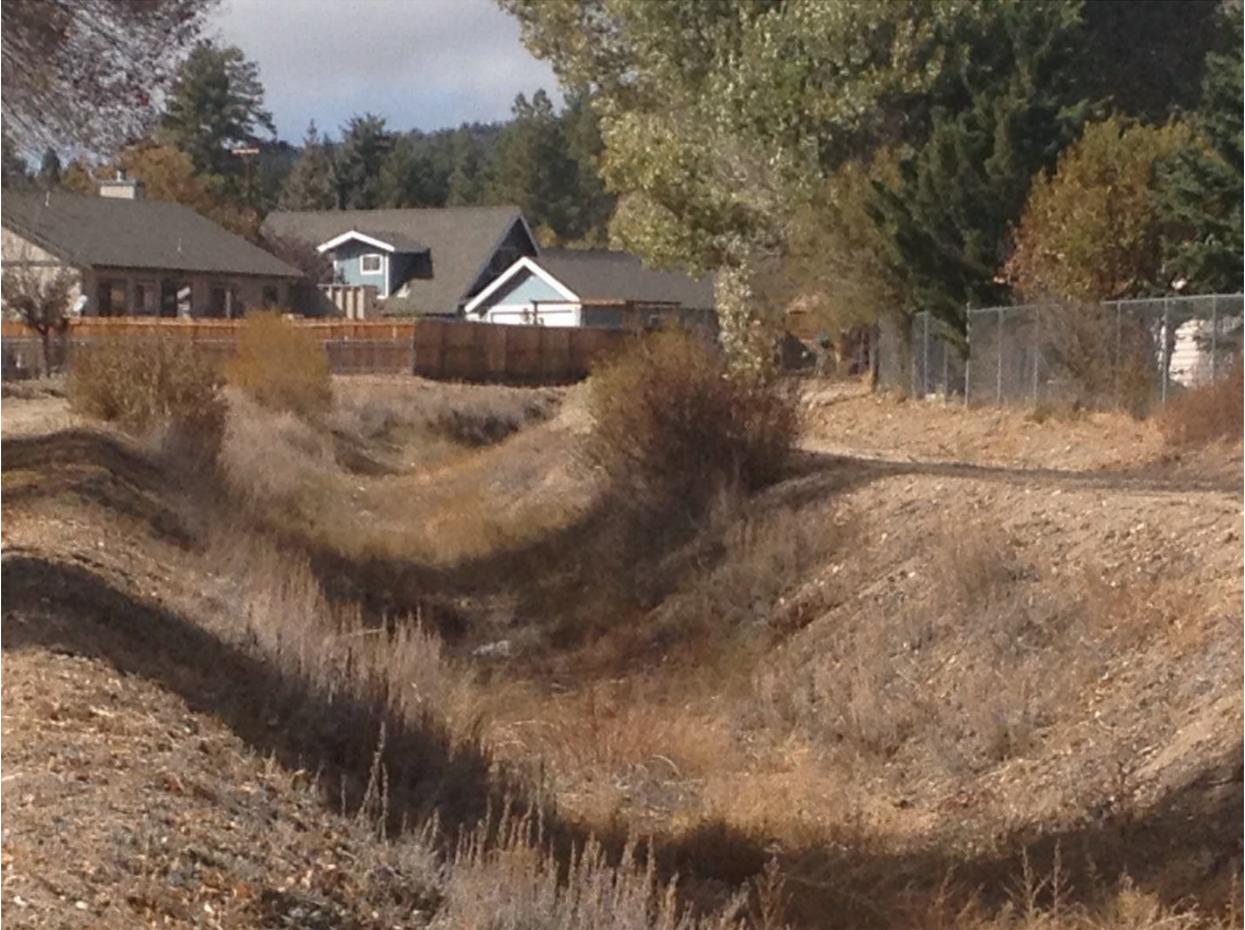
Paradise looking upstream. Note the lack of any real rock of any size, no down logs or other woody debris to use for cover. Very dry and wash like. Multiple layers of dense houses line both sides of Van Dusen Creek throughout the SB Co. flood control area.

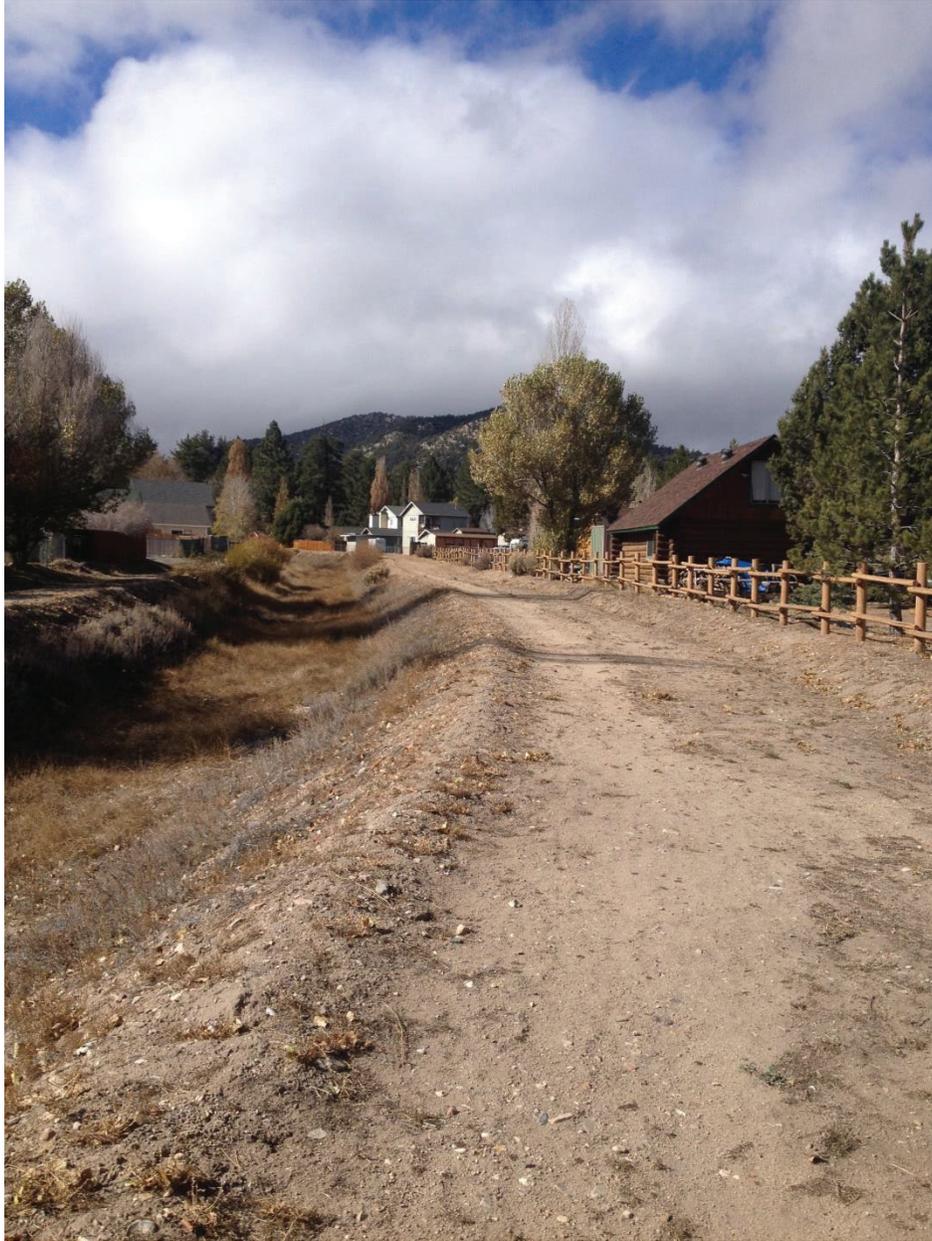
View upstream from end of Hugo St. Notice how barren it is. There is virtually no cover for boas in this area.

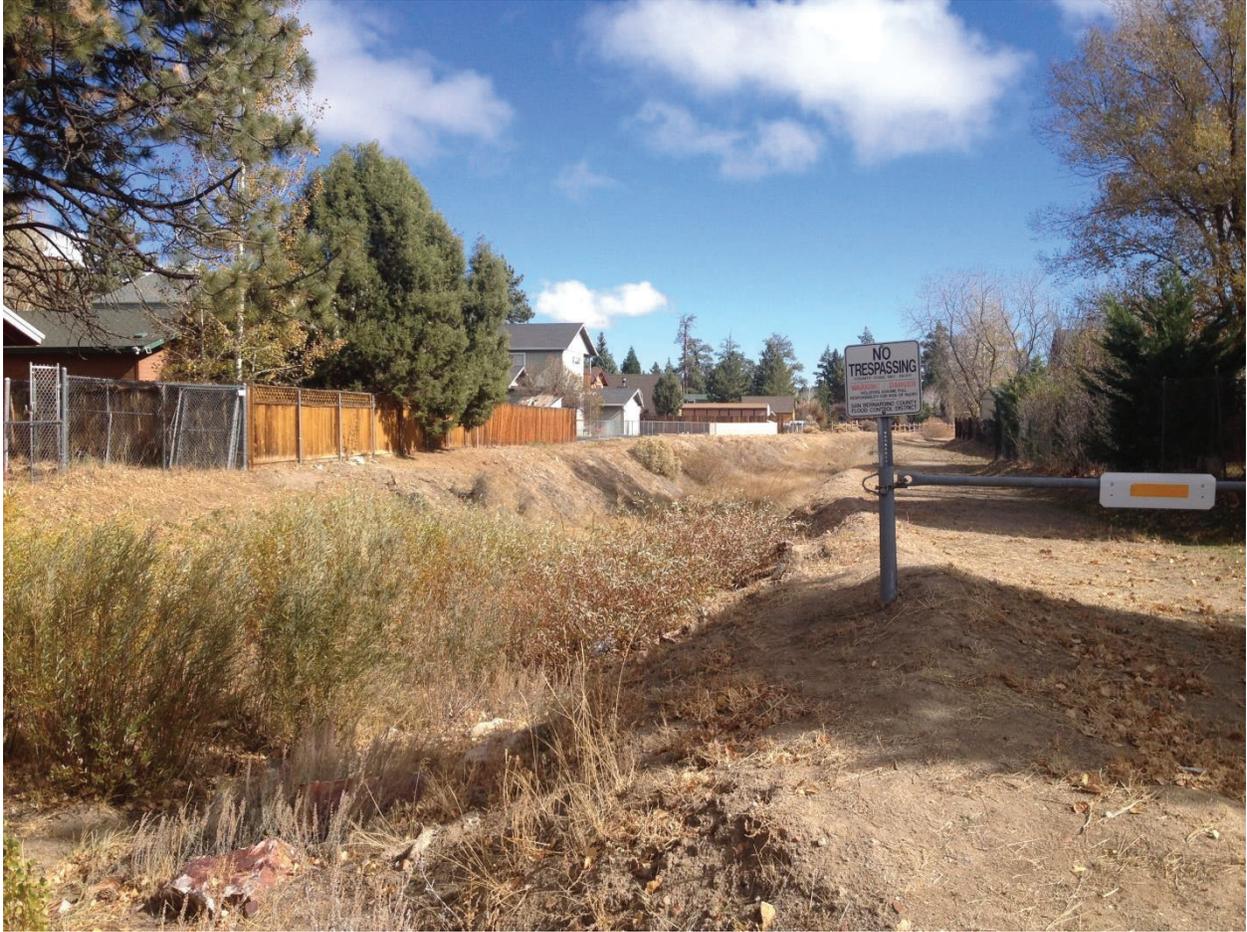
View downstream at Sequoia. Few willows at the crossing, but generally very barren and surrounded by multiple layers of dense housing.

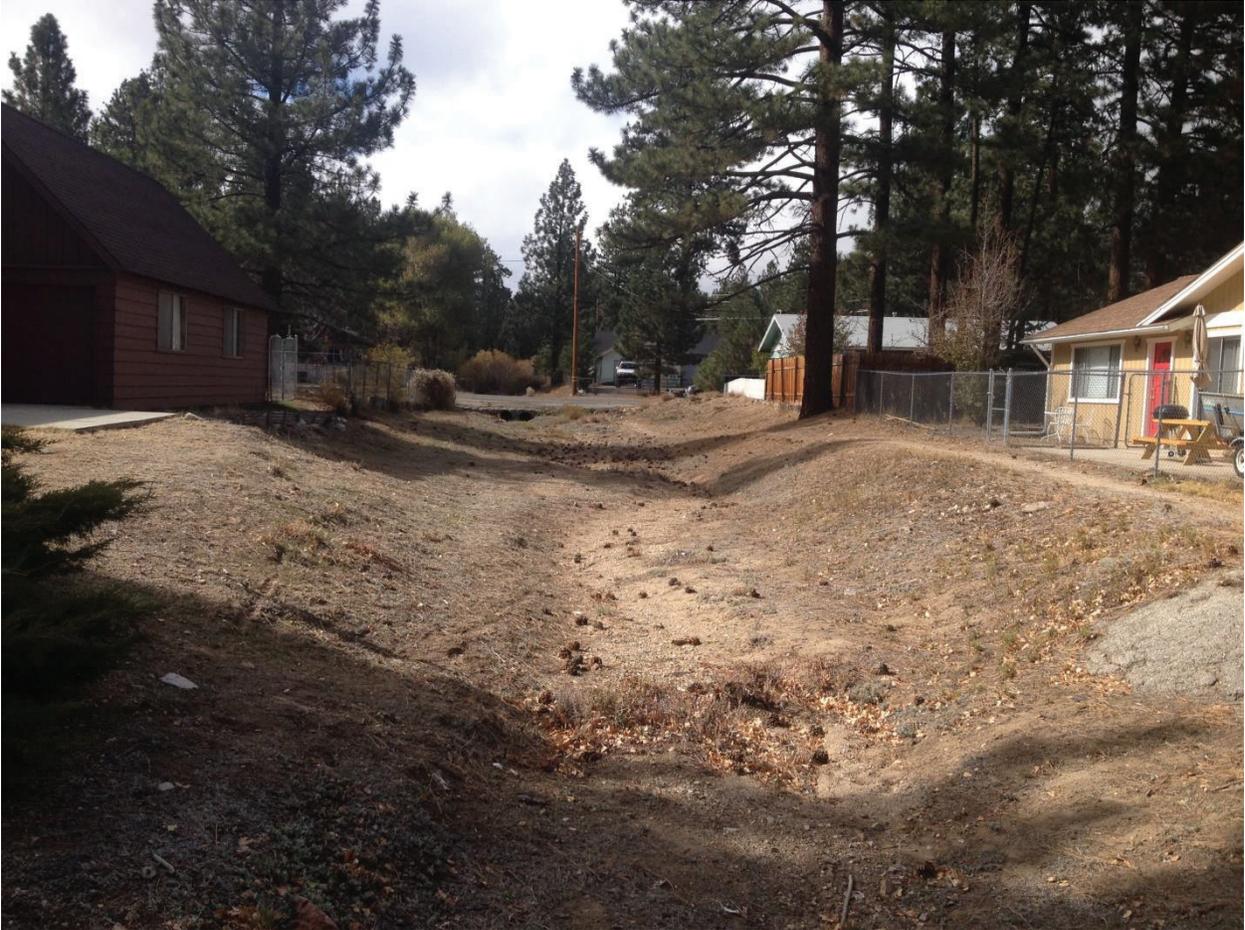
View upstream of Sequoia. Note how barren and still surrounded by dense housing. There is nothing to attract boas to this location. They need good cover.

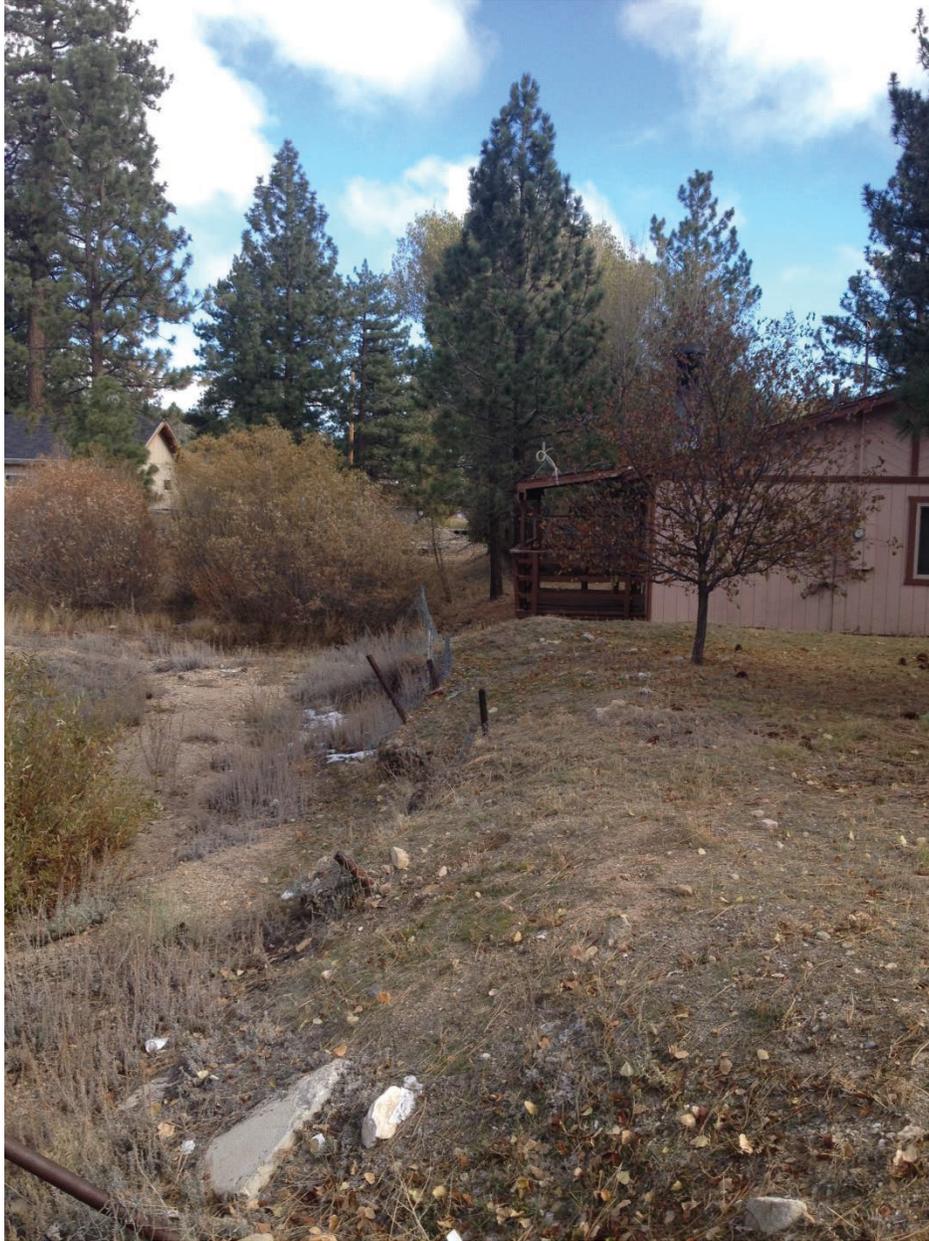
View looking downstream at Greenway. A few willows, but generally very bare and surrounded by dense housing.

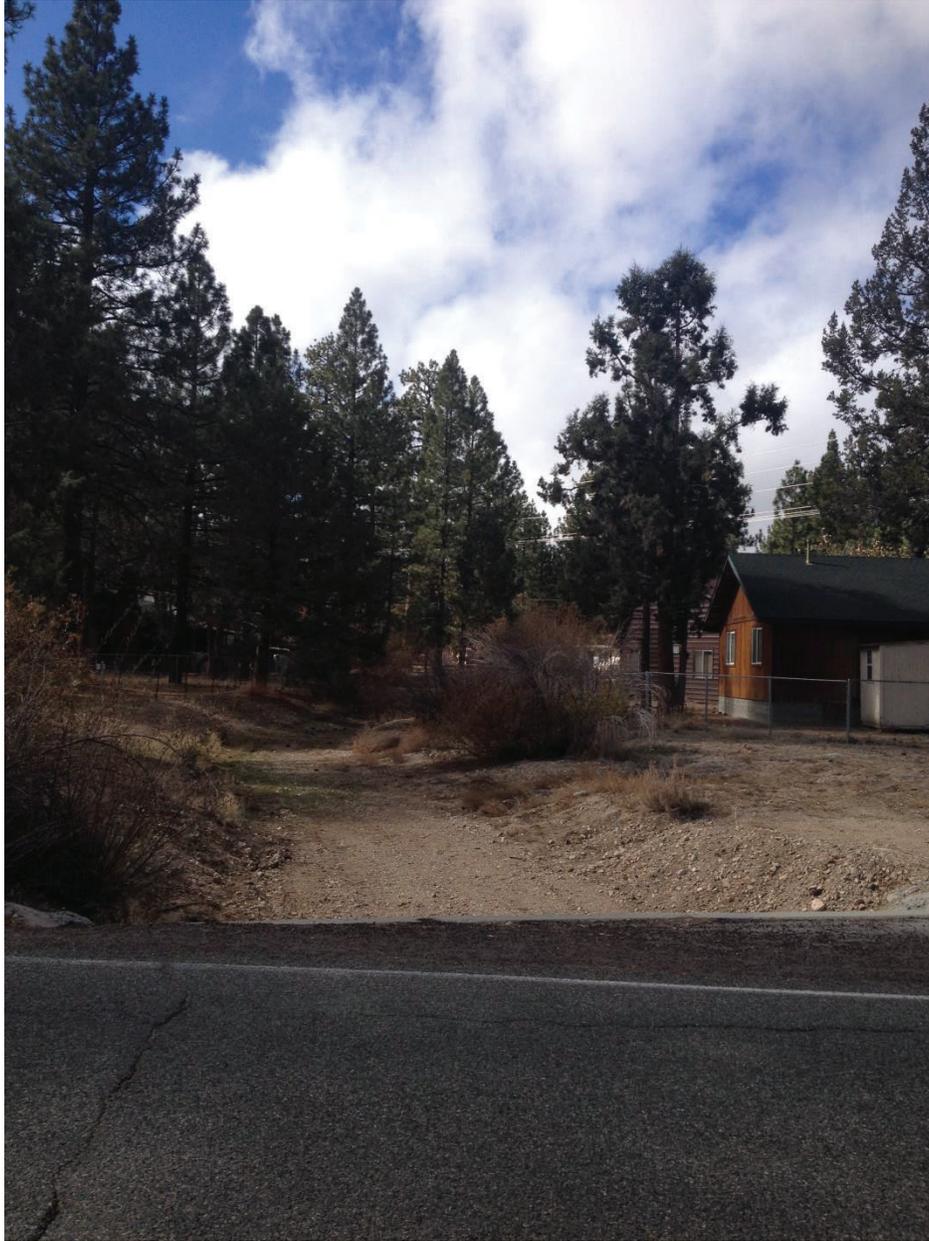
Upstream at Greenway above the SB Co. maintenance responsibility. Habitat is still pretty barren and isolated from suitable habitat of a size that could support boas.
