JOSHUA TREE SOLAR SITE PRELIMINARY HYDROLOGY STUDY

Joshua Tree Solar Farm, LLC 700 Louisiana St, 33rd Floor Houston, TX 77002

WG Project Number: 1100.0002 July 6, 2012

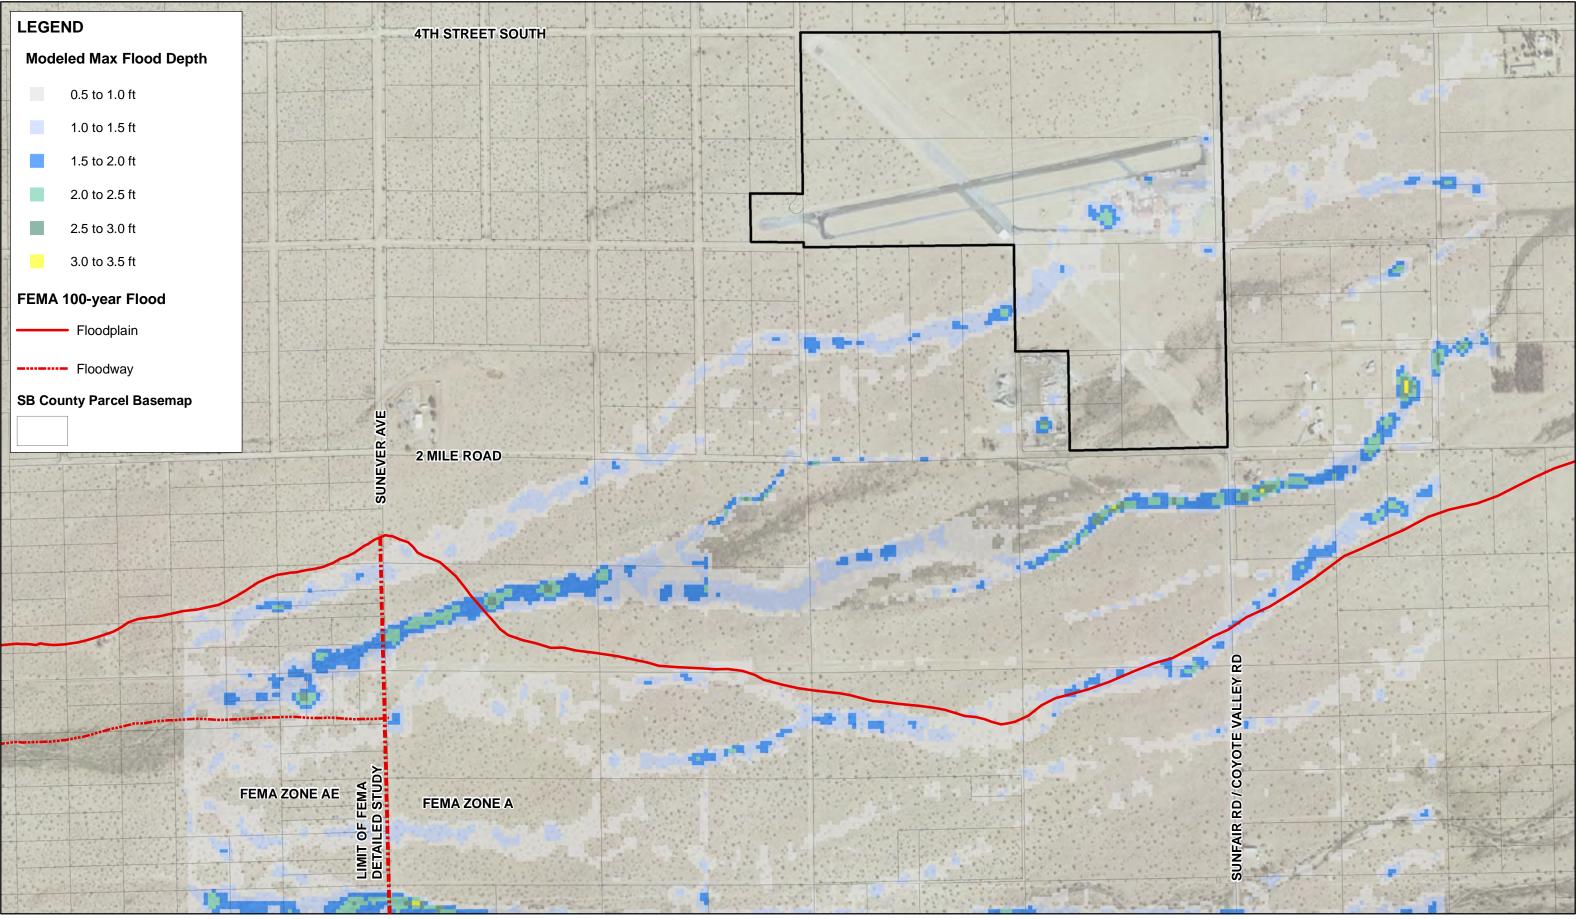
EXISTING CONDITIONS 10-YEAR FLOOD DEPTH JOSHUA TREE SOLAR SITE

The FLO-2D model results were evaluated for maximum flood depth throughout the study area. See Appendix A for exhibits of the flood model results.

Overall, the modeled floodplain limits matched closely to the FEMA Zone AE floodplain limits, which were derived using a similar detailed modeling methodology. Downstream of Sunever Avenue (FEMA detailed study limits) the modeled floodplain diverges from the FEMA Zone A floodplain and shows floodwater flowing north and northeast across the project site. The southern modeled floodplain boundary and FEMA floodplain boundary correlate closely throughout the study area. The modeled floodplain flow also correlates well to drainage pathways visible on aerial imagery of the study area. A field review of drainage conditions confirmed that in general the flood model adequately represents sheet flow conditions across the site; however due to the accuracy of the topographic data used the flood model may not capture enough detail to be representative of smaller storm events.

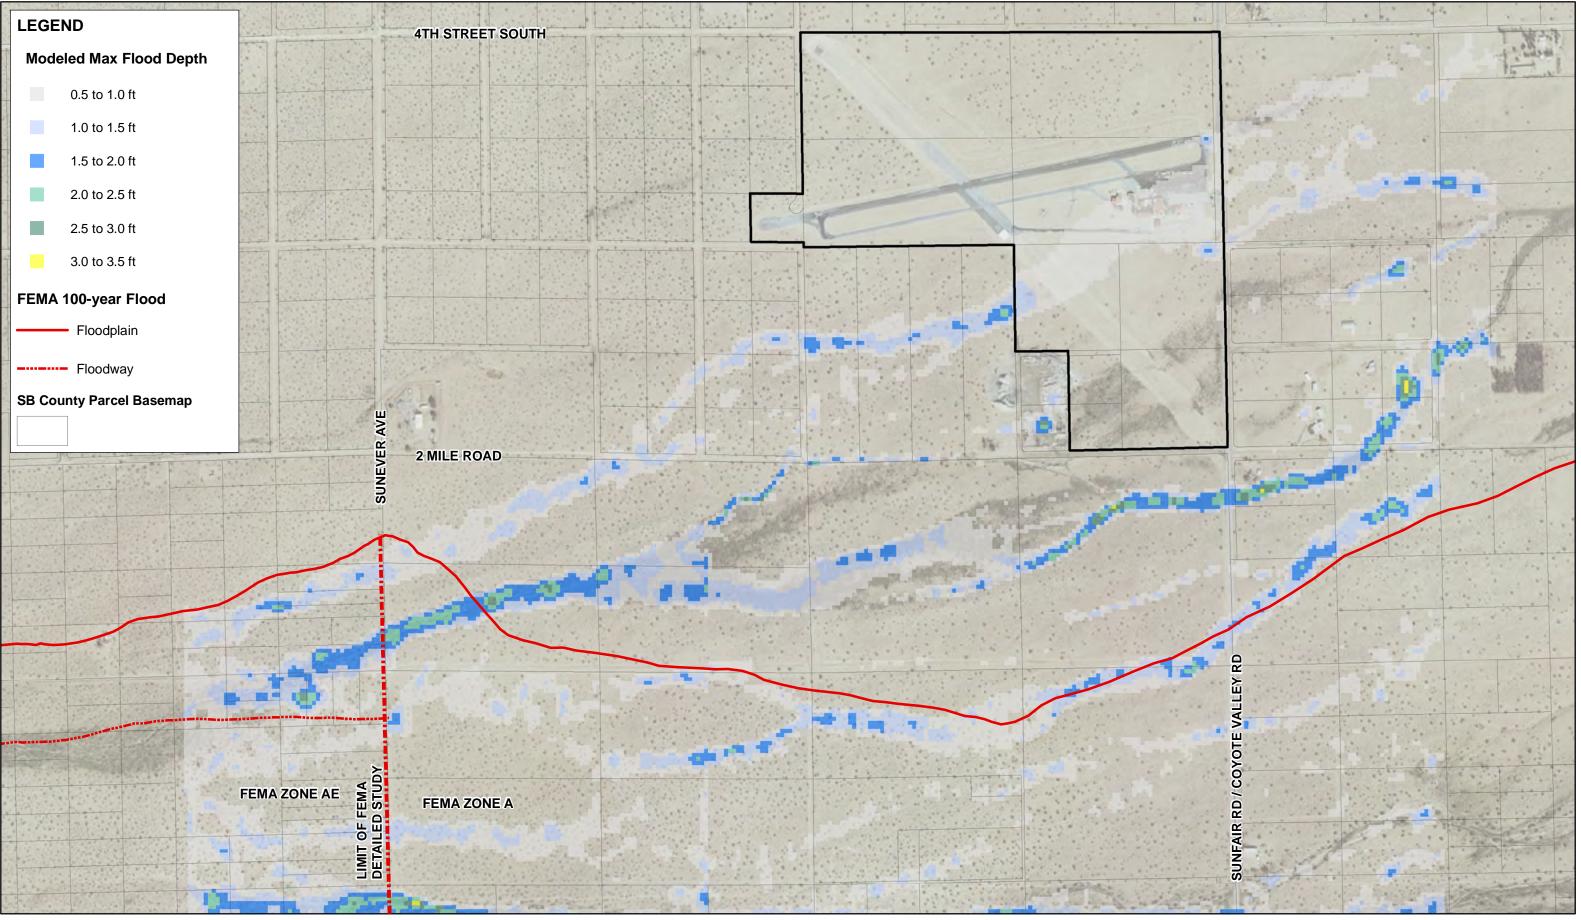
PROPOSED CONDITIONS 10-YEAR FLOOD DEPTH JOSHUA TREE SOLAR SITE

A proposed conditions model was developed to review flood depths based on proposed site grading. See Appendix A for exhibits of the flood model results. Site grading was designed to spread storm water flow across the site, to minimize depth of flow and maximize sheet flow conditions. The model results demonstrate that with the proposed grading the desired sheet flow conditions are achieved with minimal to no change in the drainage patterns downstream from the project.

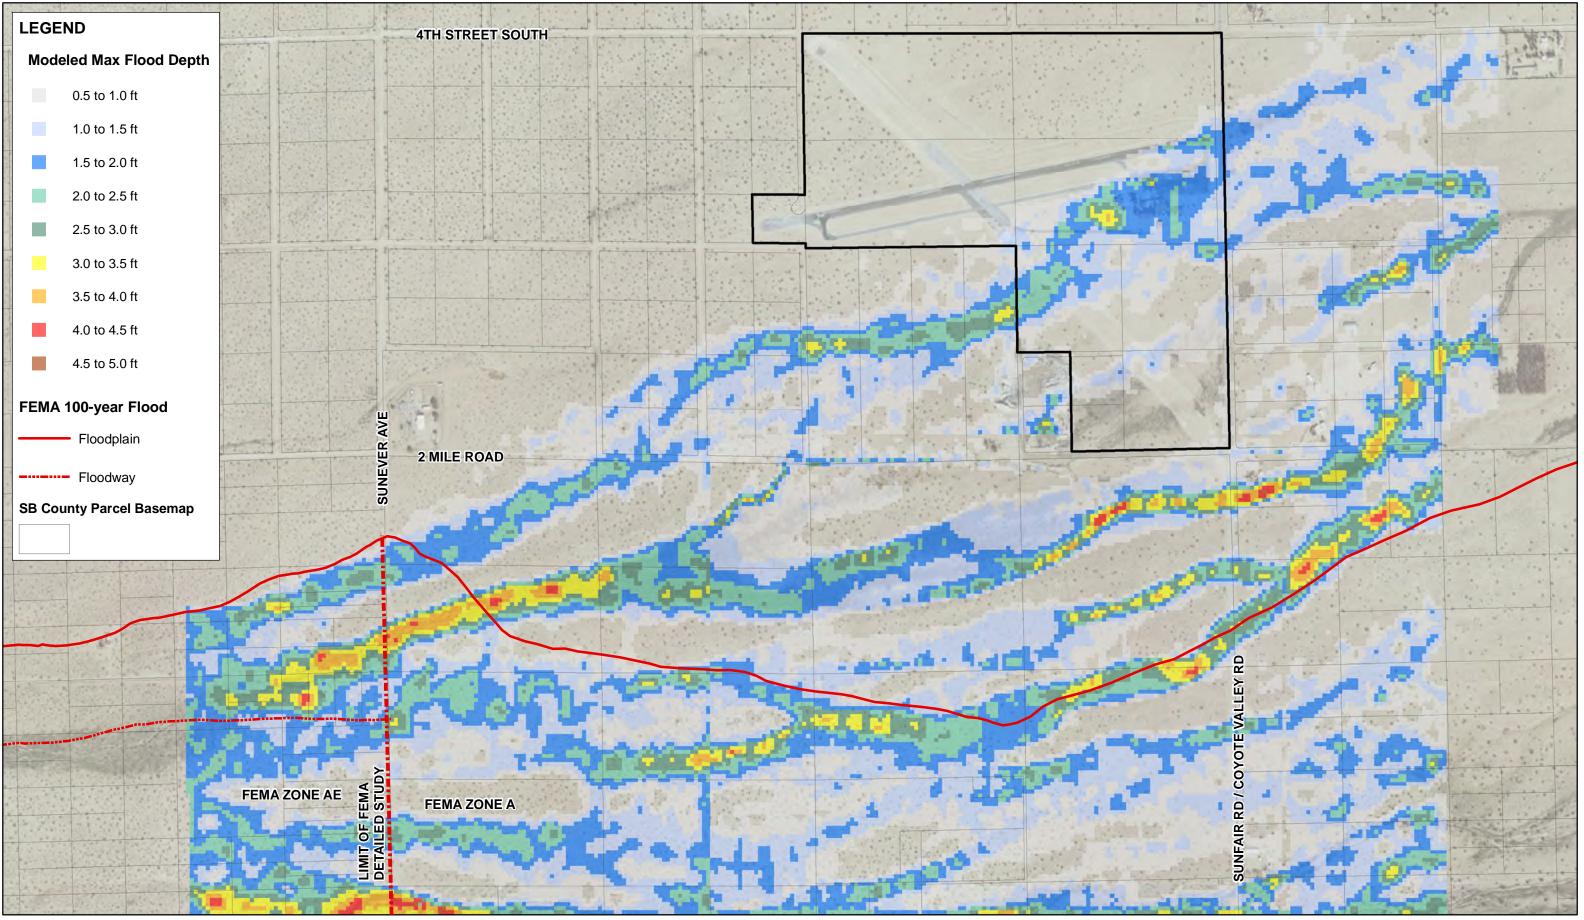
EXISTING CONDITIONS 100-YEAR FLOOD DEPTH JOSHUA TREE SOLAR SITE

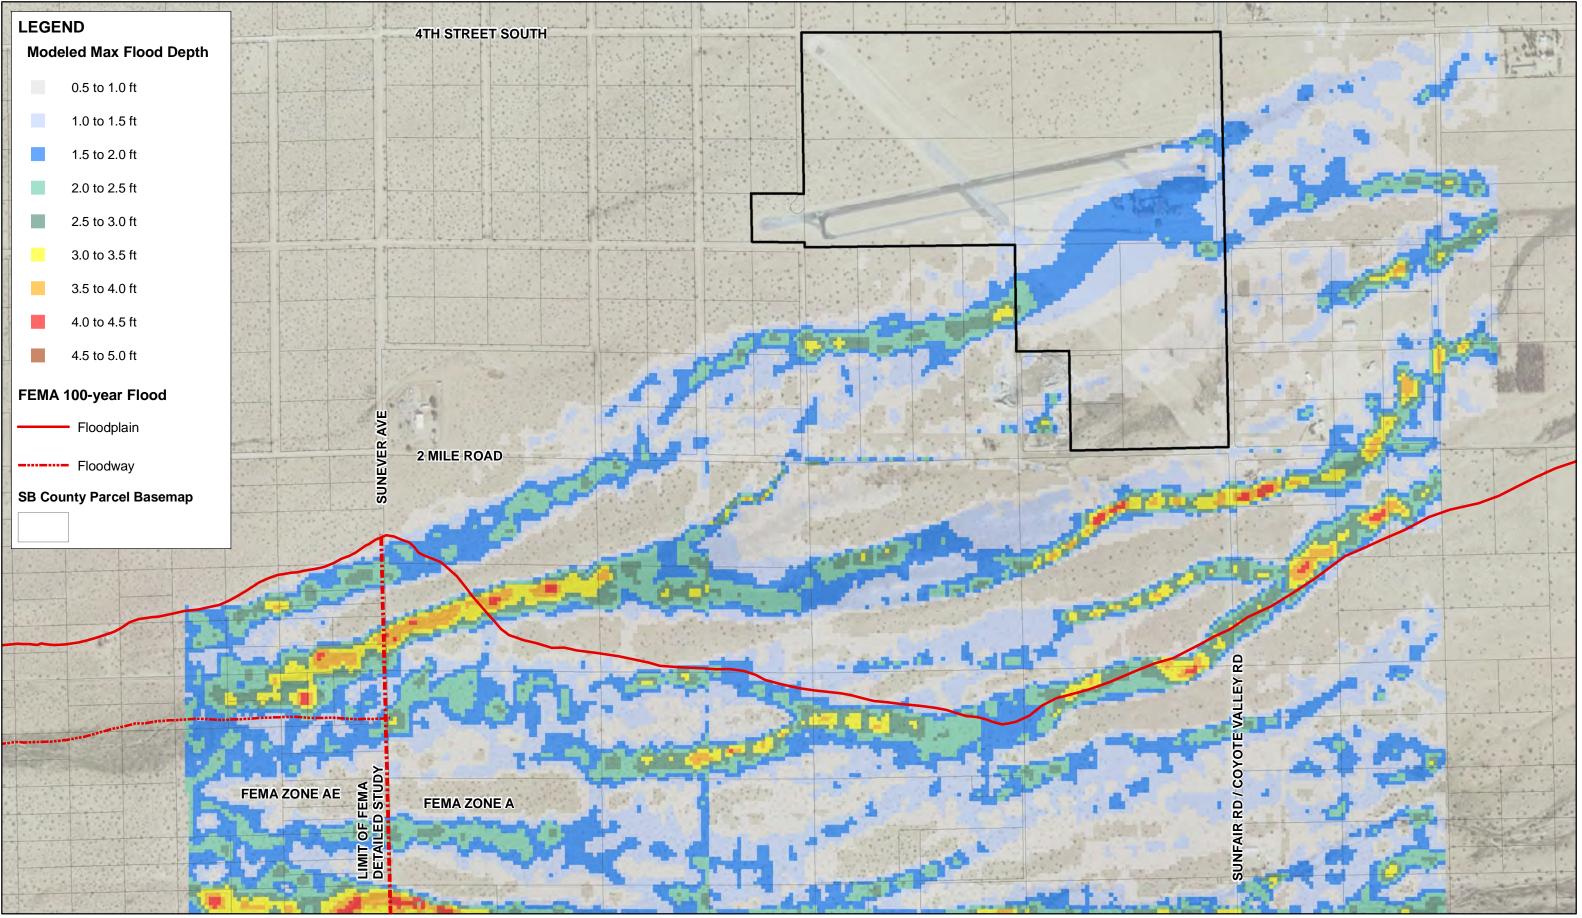
PROPOSED CONDITIONS 100-YEAR FLOOD DEPTH JOSHUA TREE SOLAR SITE

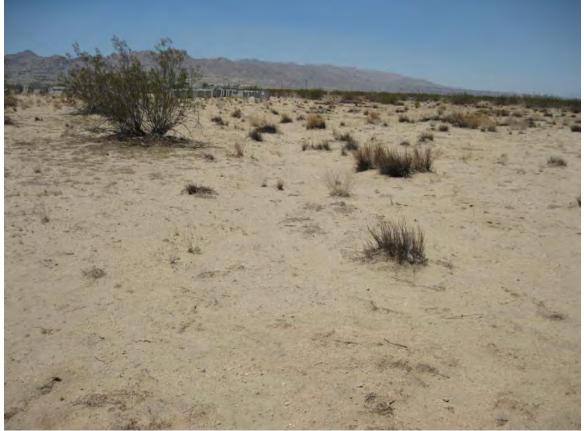
Photo 1: Indication of sheet flow towards project site, north of concrete plant and west of graded dirt runway, looking southwest.

The project site and surrounding land is relatively flat, with average ground slopes between 1 and 2 percent from west to east. Site drainage is characterized by shallow sheet flow conditions, with no significant drainage channels on the site. The current composition of the existing land is best described as mostly vacant land of dirt and sand with a sparse vegetative community consisting of native grasses and shrubs. See photos 1 through 6 Appendix B for typical sheet flow conditions across the site.

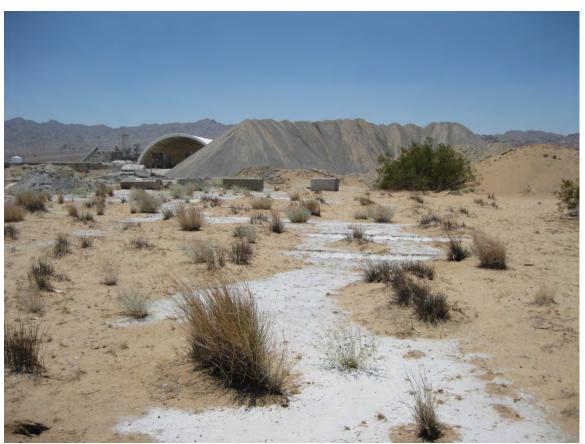
Photo 2: Runoff from concrete plant onto site, looking south.

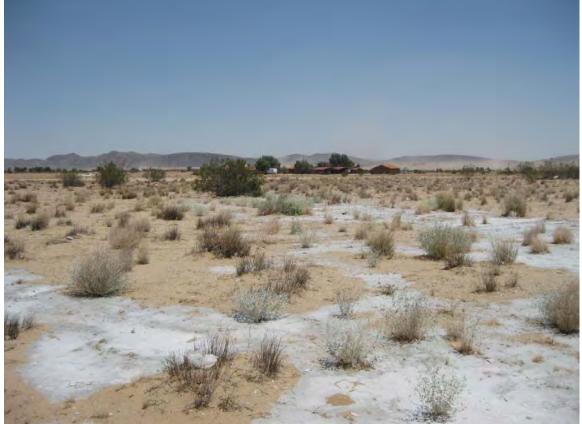
Photo 3: Runoff from concrete plant onto site, looking north.

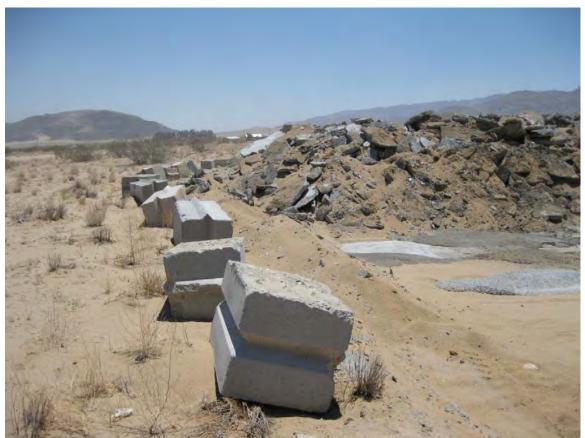
Photo 4: Concrete washout area upstream of runoff pictured above, northeast corner of the concrete plant site.

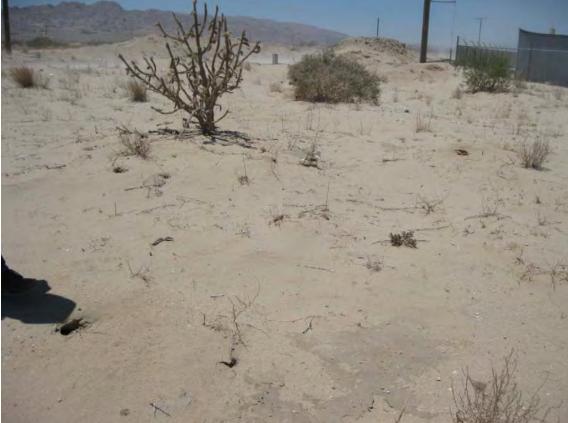
Photo 5: Indication of sheet flow onto the site, southwest corner of the site looking southwest.

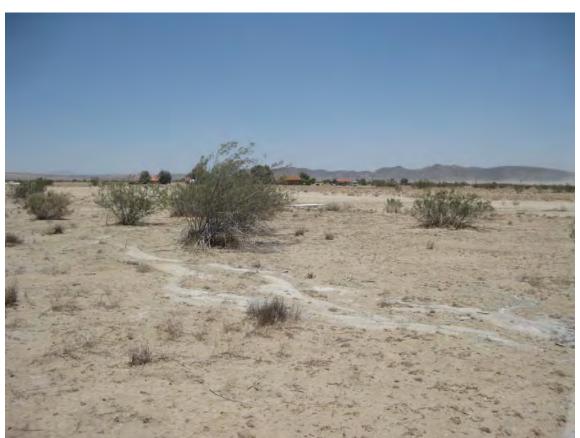
Photo 6: Indication of sheet flow across the site, mixed with concrete, southwest corner of the site looking northeast.

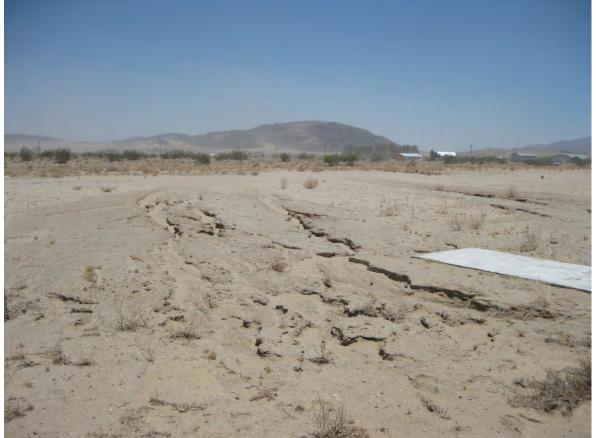
Photo 7: Erosion across graded dirt runway, looking northeast.

We observed a single area of the site with definite signs of erosion. This existing erosion is on the graded dirt runway east of the concrete plant. We believe the cause of this erosion to be change in grade, as the cross slope across the runway at this particular location is steeper than the surrounding areas. Where the runway cross slope flattens out again the erosion ended and evidence of ponding and sheet flow was observed. This further confirms our view that slope is the main factor for erosion at this location. Lack of vegetation may also contribute to the erosion, however the majority of sheet flow areas onsite also have sparse vegetation and therefore the presence or absence of vegetation likely plays a lesser role in erosion compared to land slope. See photos 7 through 10 Appendix B for existing site erosion.

Based on our observations of existing site conditions, the recommended method to reduce ongoing stormwater erosion is to perform grading to flatten the areas with slopes susceptible to erosion. We have observed other solar plants in desert regions experience erosion in sheet flow areas based on subtle changes in slope. For final design we recommend detailed survey to confirm slopes that are associated with the existing site erosion, and verification that final grading design will reduce cross slope across the eroded area of the site.

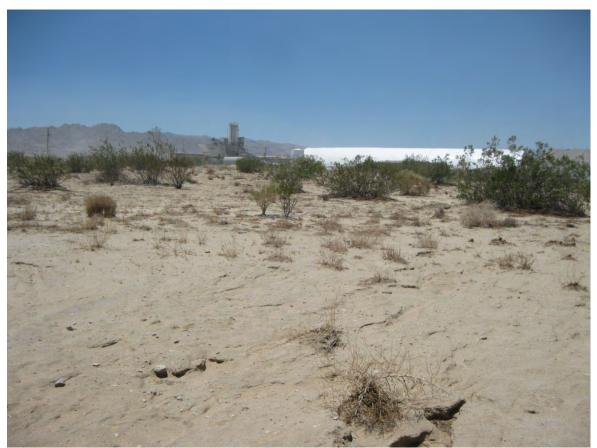
Photo 8: Sheet flow just upstream from runway erosion, looking southwest.

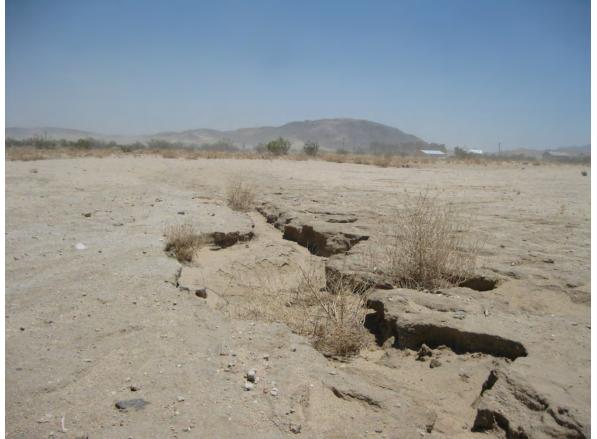
Photo 9: Erosion across graded dirt runway, looking northeast.

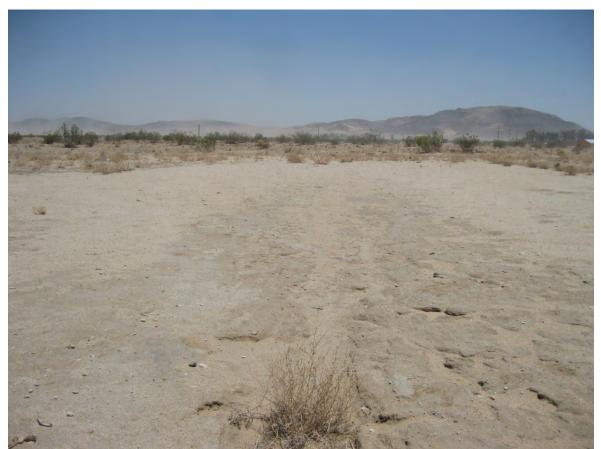
Photo 10: Sheet flow downstream from runway erosion, looking northeast.

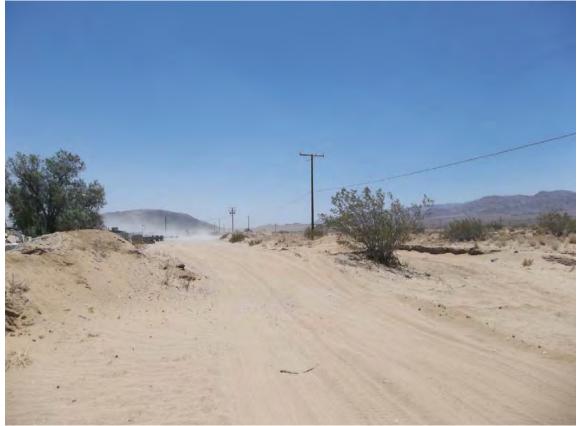
Photo 11: Offsite berm along south side of concrete plant (left side of photo) redirects flow away from the project site (channel to the right of the roadway).

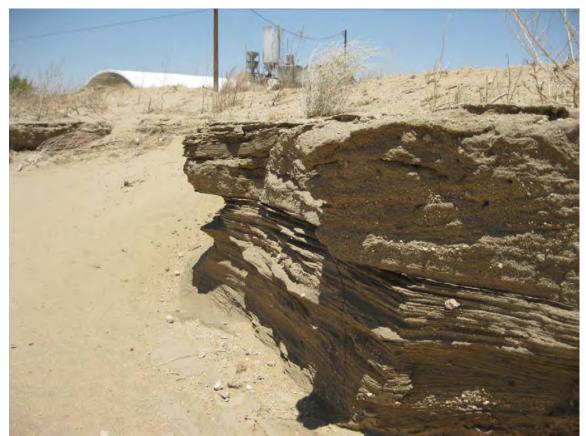
Photo 12: Offsite channel erosion downstream from berm pictured above. Vertical face approximately 18 to 24 inches high.

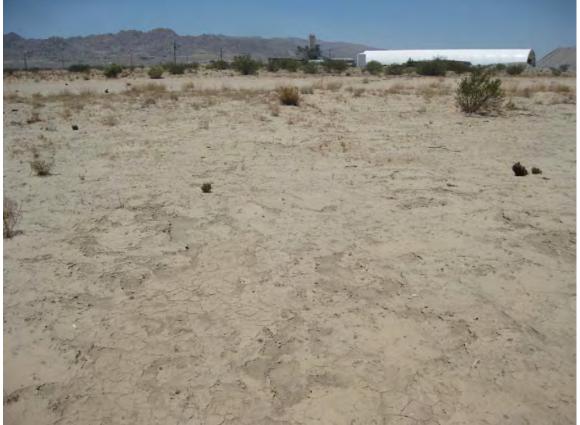
Photo 13: Indication of sheet flow leaving project site, southeast project corner at Sunfair Road looking west (flow direction is towards viewer).

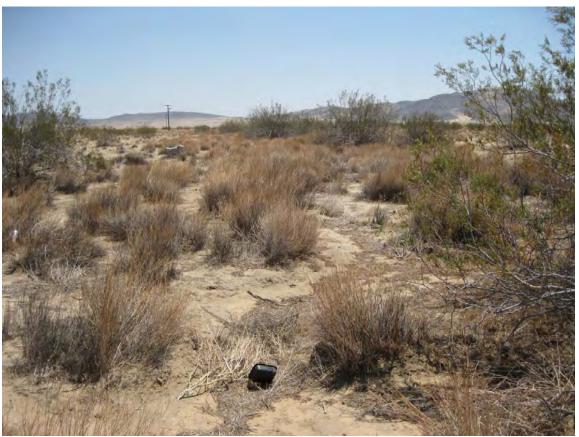
Photo 14: Offsite flow path, downstream from project site and across runway from Coyote Valley Road, looking east.

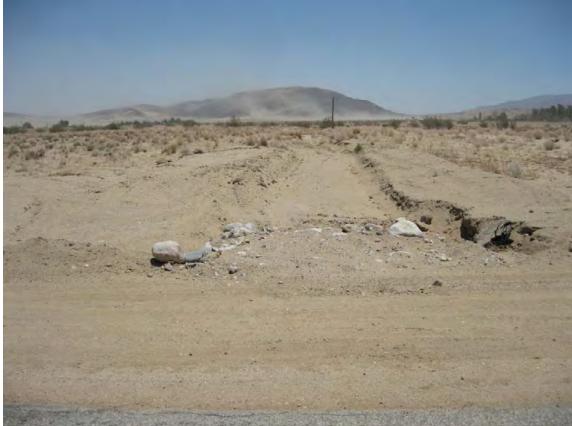
Photo 15: Offsite flow path, downstream from project site and across Coyote Valley Road, looking east.

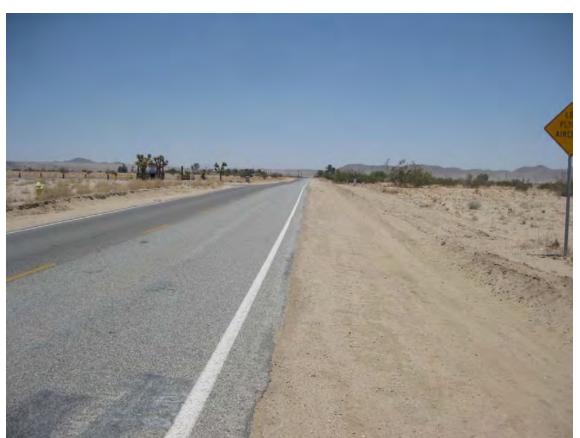
Photo 16: Graded shoulder along east side of Coyote Valley Road, directs stormwater flow to path pictured above, looking north.

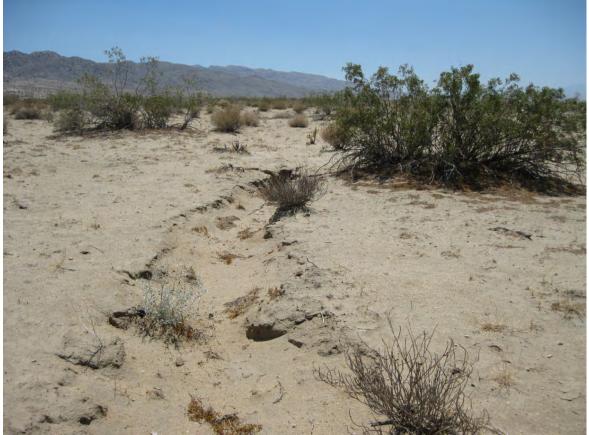
Photo 17: Offsite channel exhibits typical crust on soil surface and loose conditions where soil has been disturbed.

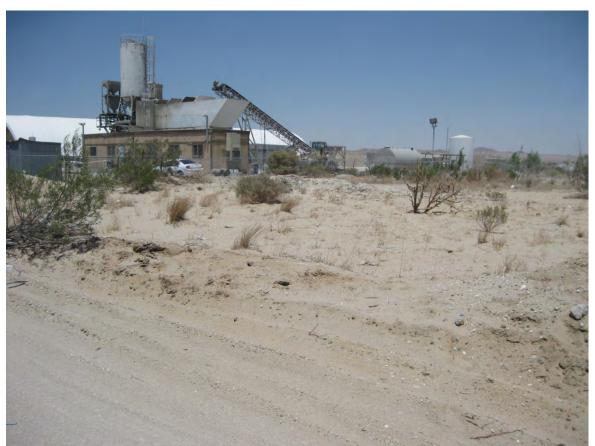
Photo 18: Low berm along south of project site, notice loose soil in area of disturbance.

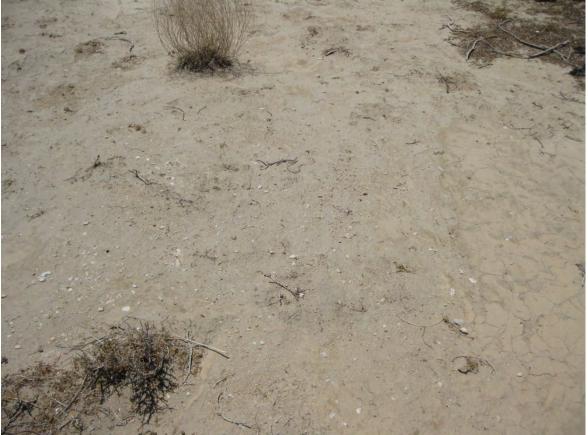
Photo 19: Typical crust on soil surface.

We observed that site soils are characterized by a thin crust that forms over the surface, likely due to silt content. However, the site soil was very loose where disturbed. The crust appears to protect against wind and water erosion, but when the crust is broken, or its protective capacity exceeded, the soil is essentially loose sand and is highly erosive. Even the crusted soil would likely flow (erode and deposit) under faster moving sheet flow conditions. See photos 19 and 20 Appendix B for typical soil conditions.

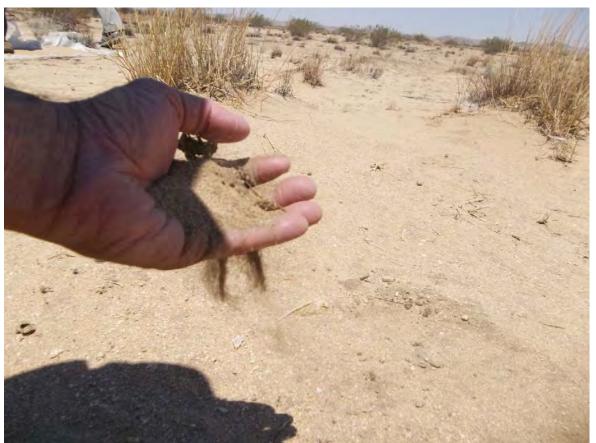
Photo 20: Loose, previously disturbed soil.

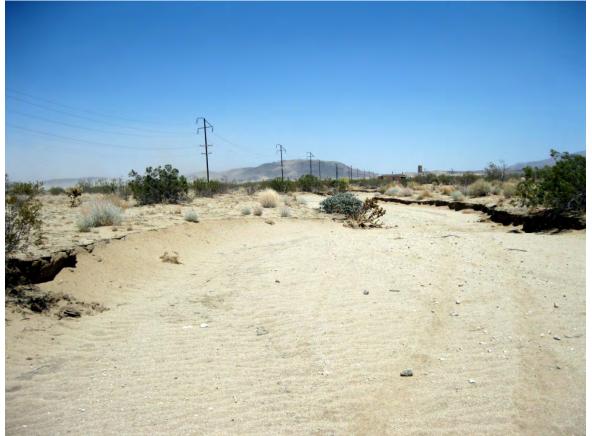
Photo 21: Coyote Wash at Hollinger Road, looking east. (offsite)

The drainage channels upstream from the site are characterized by shallow depths with meandering and braided alignments. Based on this channel type, it is anticipated that existing upstream channels will have a tendency to shift location over time. Sediment deposition from prior storm events can decrease channel capacity, and cause floodwaters to form new channels, or overflow to other nearby channels. Of particular concern is the current "flow split" near the intersection of Pipeline Road and Rice Avenue. At this location a smaller secondary drainage channel breaks away from the Coyote Wash and flows toward the site. The unimproved Coyote Wash has the potential to shift course at this flow split and direct additional flood flow toward the project site. If a full diversion of flow occurred upstream of the site, the increased flood flow could result in significant site impacts, particularly to the southern half of the site. This is a risk to be considered in the course of project design, and alleviation would require considerable improvements and/or maintenance to the Coyote Wash upstream of the site. Offsite improvements of the Wash are not anticipated as a part of this project. See photos 21 and 22 Appendix B, of the Coyote Wash south and west of the site.

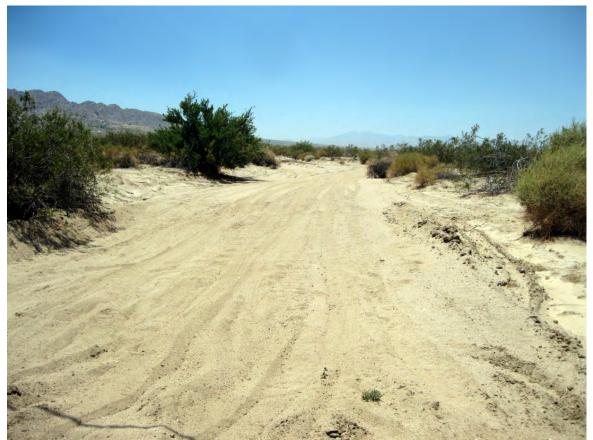
Photo 22: Southern channel of Coyote Wash at Coyote Valley Road, looking west. (offsite)

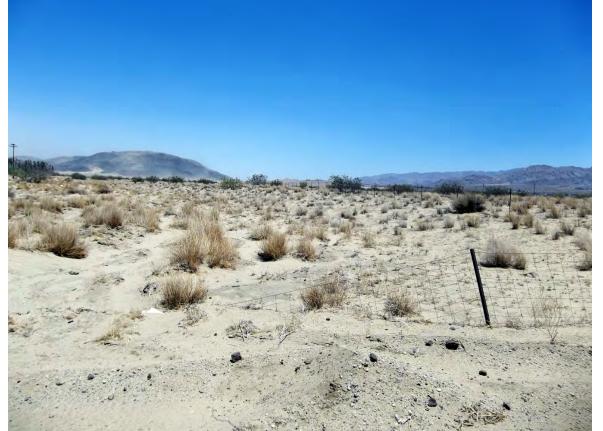
Photo 23: Fence crossing desert wash that has been covered with debris and silt over time. (offsite)

Fencing will be installed around the perimeter of the site. The fencing will be eight feet tall consisting of a 7 foot tall chain link fence topped with approximately a one foot height of barbed wire. Desert tortoise exclusion fencing may be attached to the lower two feet of the chain link fence, and buried at least one foot, according to specifications from the United States Fish and Wildlife Service. Fencing installed in the path of stormwater flow will likely accumulate sediment and debris over time. However, since upstream drainage patterns may change over time it is not possible to determine location of flow over the life-span of the project, and some sediment accumulation is unavoidable. If sediment accumulation becomes an issue then breakaway fence panels could be installed in locations of stormwater flow, or the lower portion of the chain link fence could be replaced with a rail and post type fence that allows for passage of sediment and debris. See photo 23 Appendix B for an example photo of fencing that has been damaged due to siltation and stormwater flow.
