JOSHUA TREE SOLAR SITE PRELIMINARY HYDROLOGY STUDY

WG Project Number: 1100.0002
December 2014

**JOSHUA TREE SOLAR SITE
PRELIMINARY HYDROLOGY STUDY**

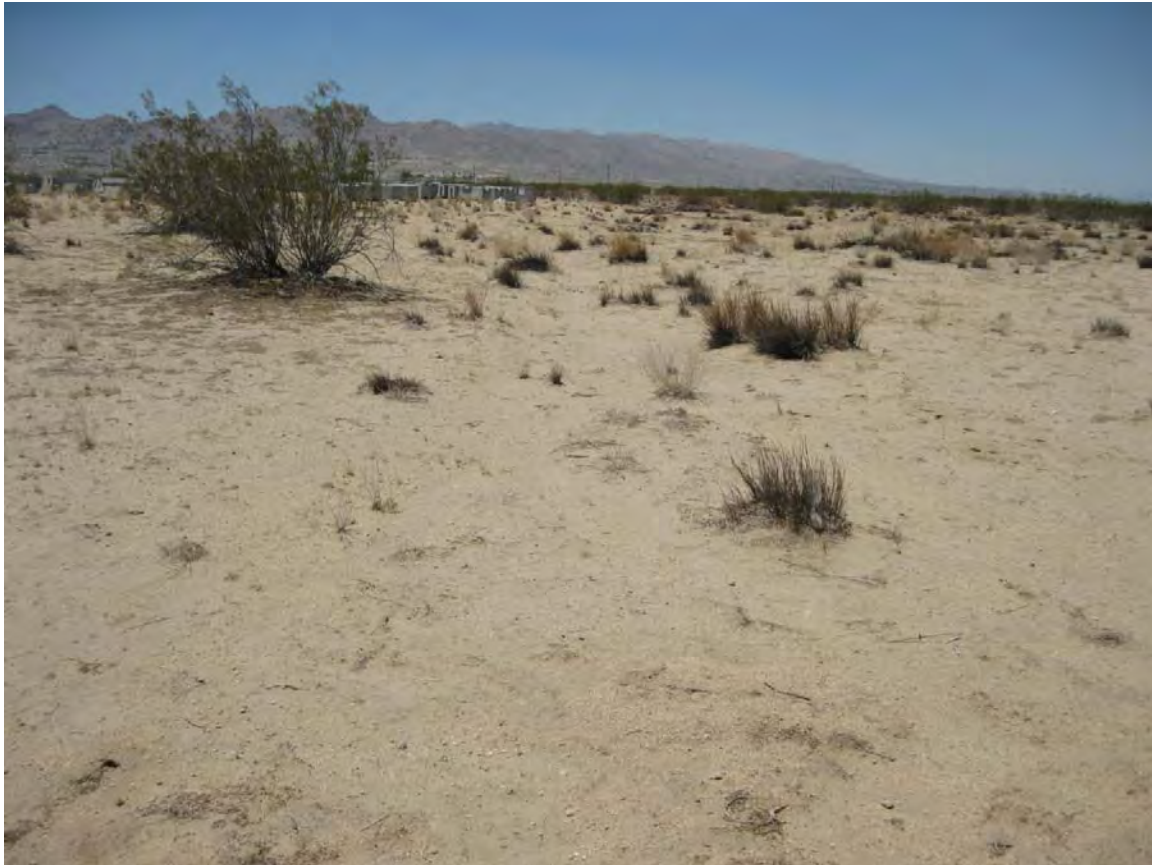
Photo 1: Indication of sheet flow towards project site, north of concrete plant and west of graded dirt runway, looking southwest.

The project site and surrounding land is relatively flat, with average ground slopes between 1 and 2 percent from west to east. Site drainage is characterized by shallow sheet flow conditions, with no significant drainage channels on the site. The current composition of the existing land is best described as mostly vacant land of dirt and sand with a sparse vegetative community consisting of native grasses and shrubs. See photos 1 through 6 Appendix B for typical sheet flow conditions across the site.

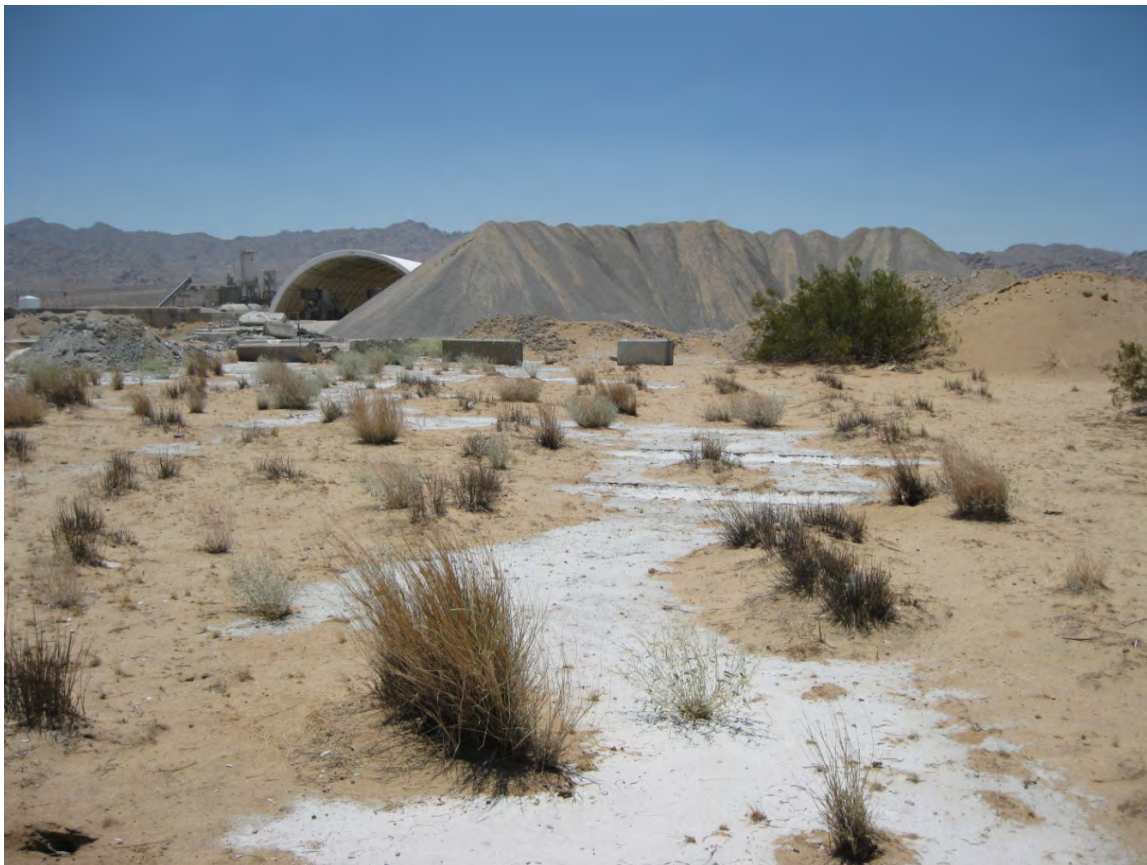
Photo 2: Runoff from concrete plant onto site, looking south.

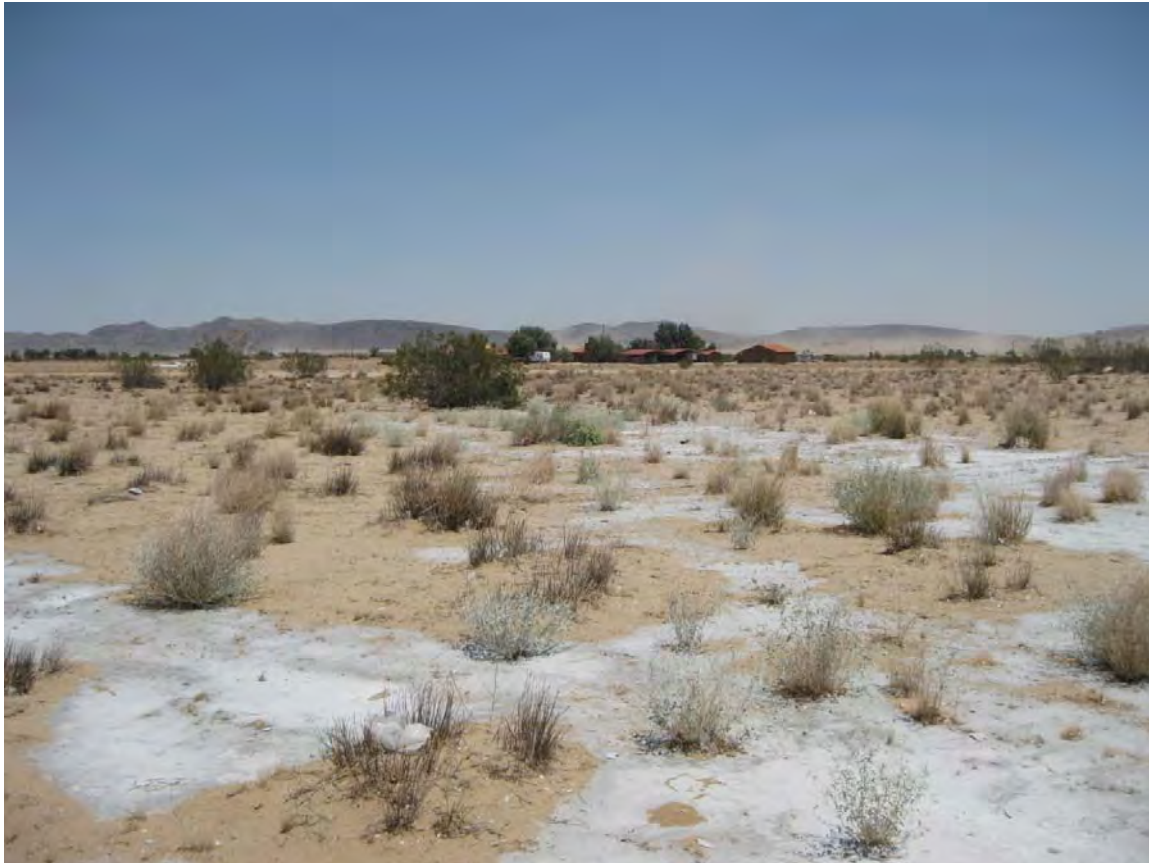
Photo 3: Runoff from concrete plant onto site, looking north.

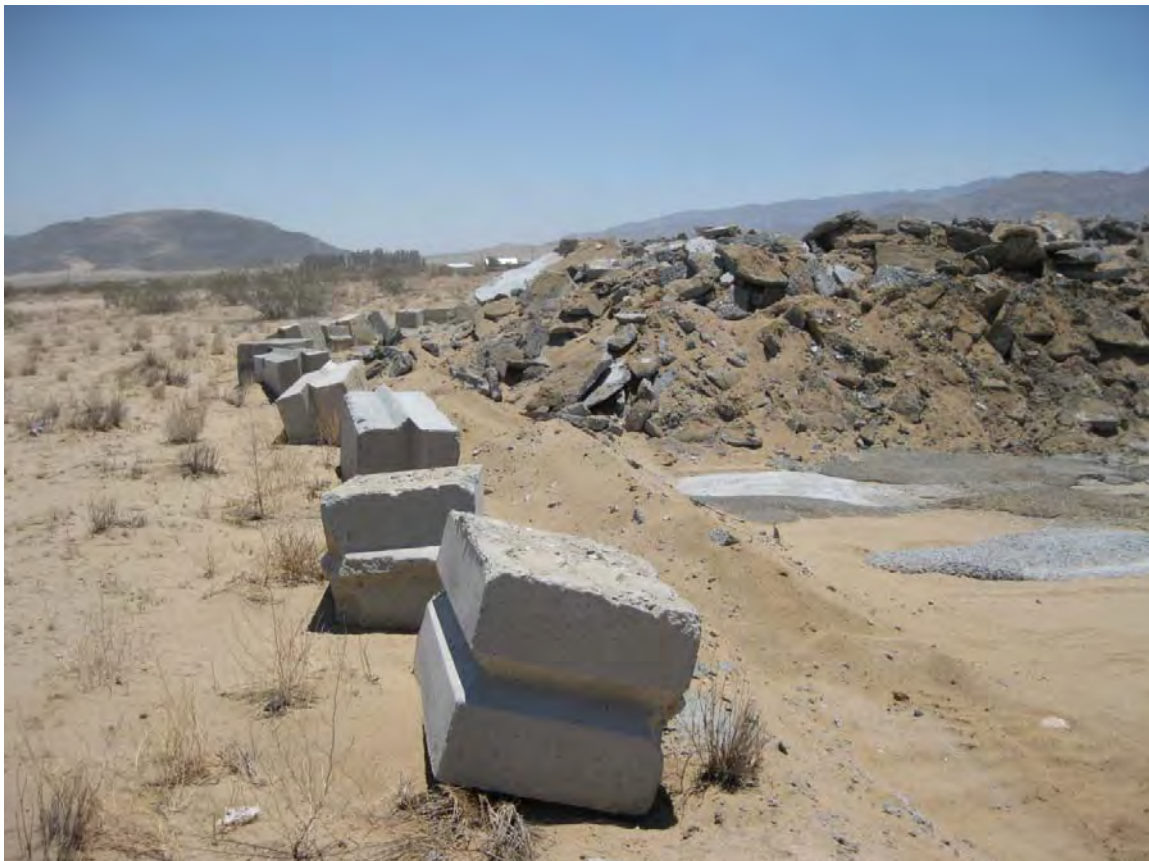
Photo 4: Concrete washout area upstream of runoff pictured above, northeast corner of the concrete plant site.

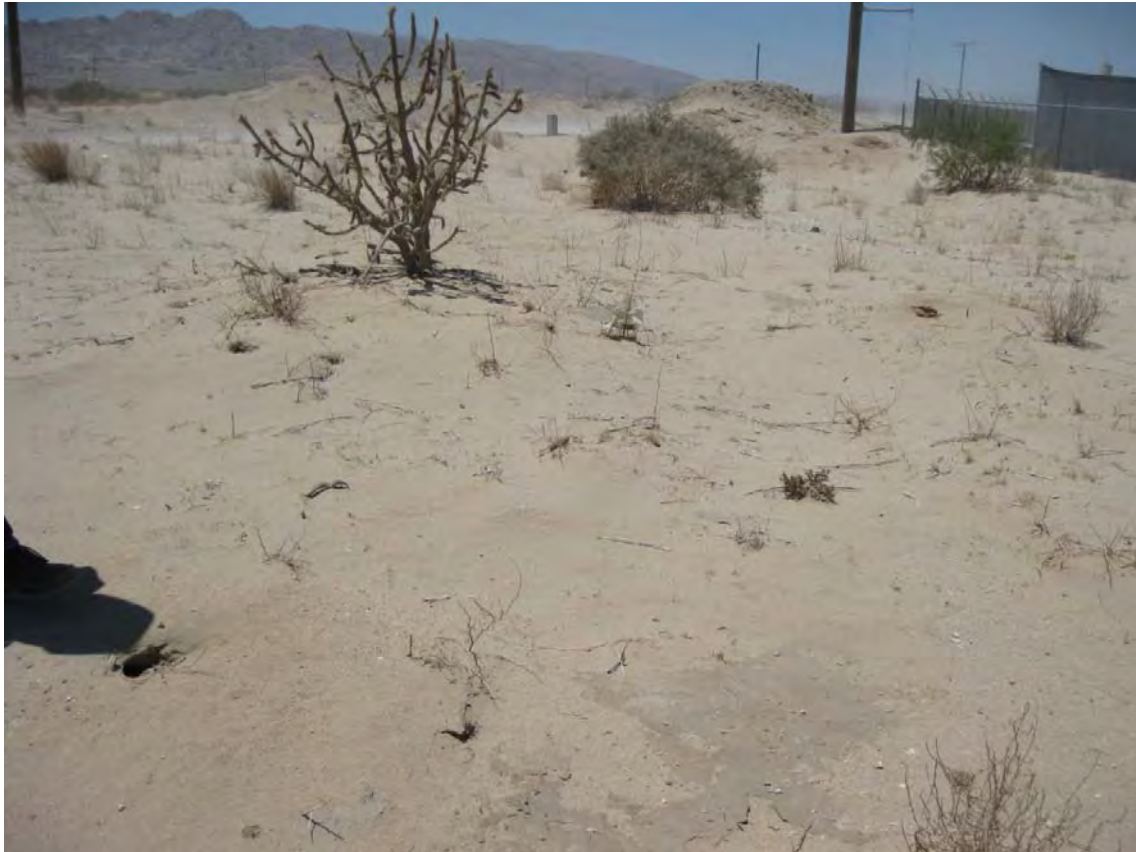
Photo 5: Indication of sheet flow onto the site, southwest corner of the site looking southwest.

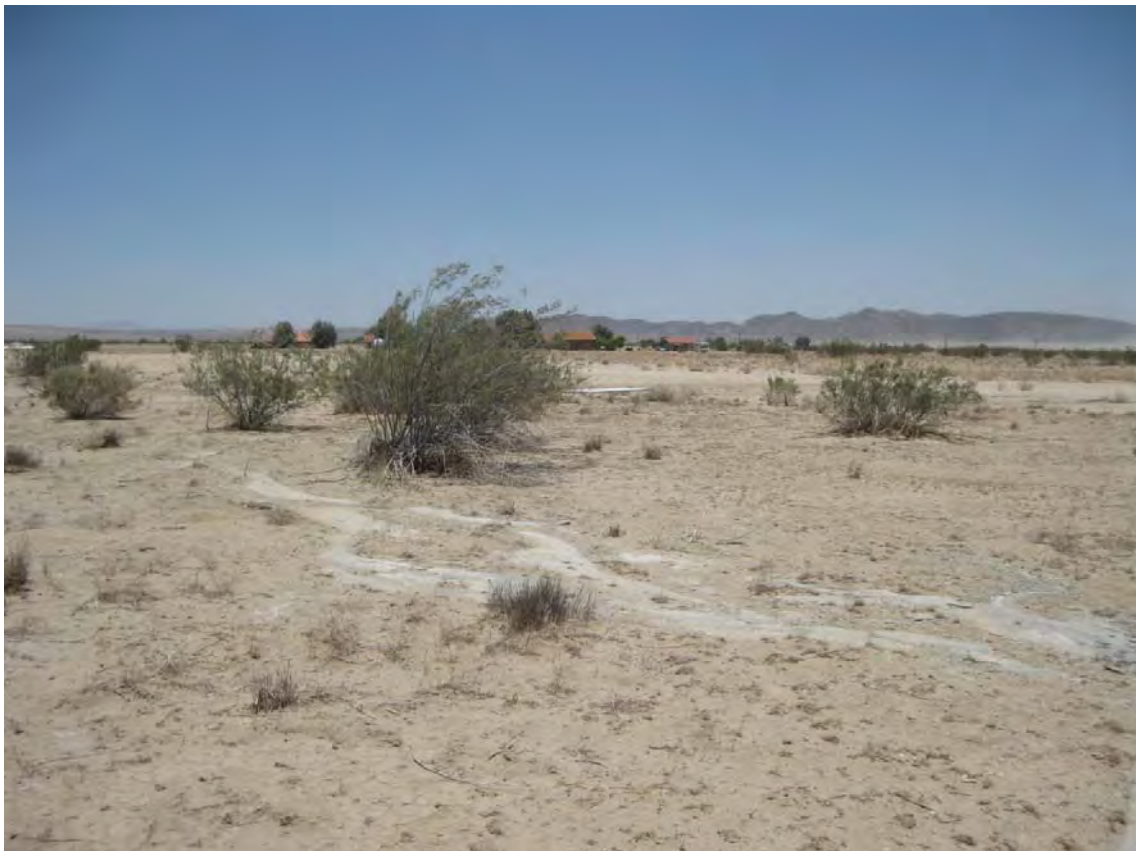
Photo 6: Indication of sheet flow across the site, mixed with concrete, southwest corner of the site looking northeast.

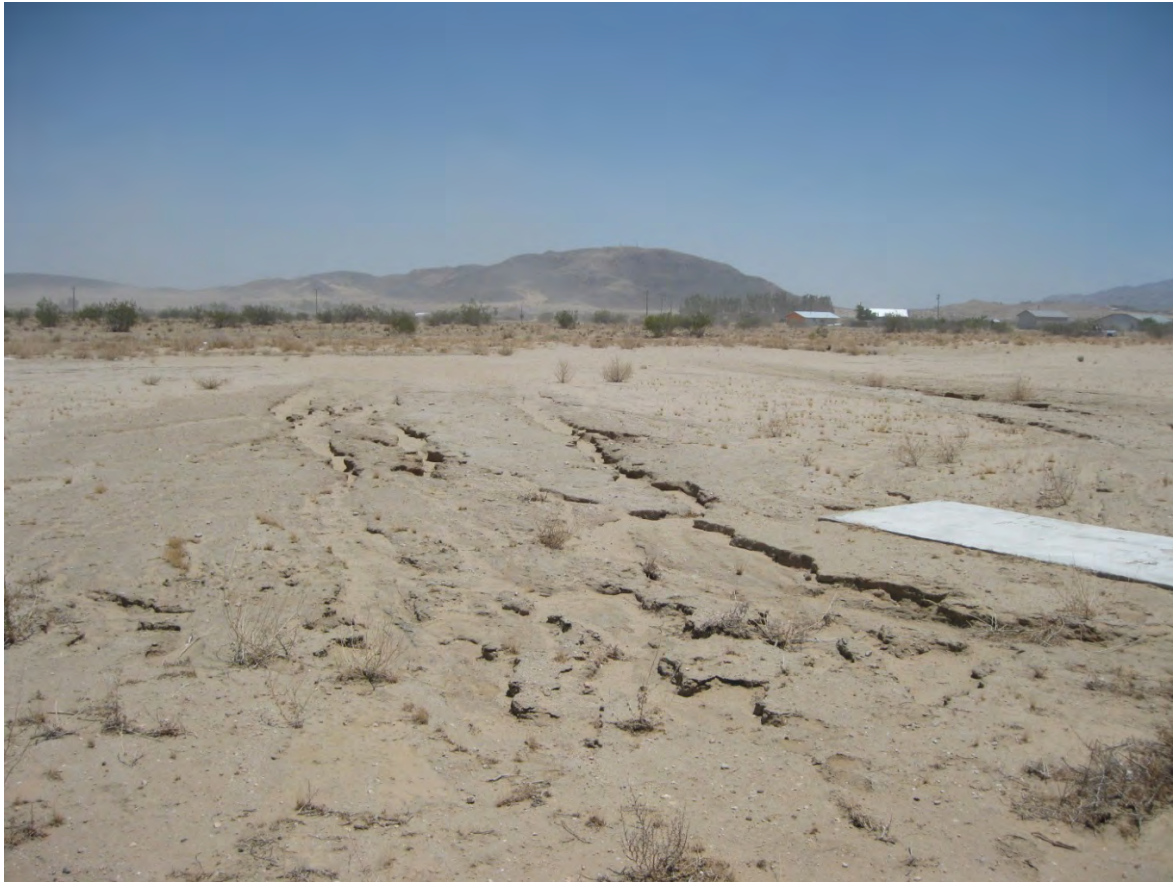
Photo 7: Erosion across graded dirt runway, looking northeast.

We observed a single area of the site with definite signs of erosion. This existing erosion is on the graded dirt runway east of the concrete plant. We believe the cause of this erosion to be change in grade, as the cross slope across the runway at this particular location is steeper than the surrounding areas. Where the runway cross slope flattens out again the erosion ended and evidence of ponding and sheet flow was observed. This further confirms our view that slope is the main factor for erosion at this location. Lack of vegetation may also contribute to the erosion, however the majority of sheet flow areas onsite also have sparse vegetation and therefore the presence or absence of vegetation likely plays a lesser role in erosion compared to land slope. See photos 7 through 10 Appendix B for existing site erosion.

Based on our observations of existing site conditions, the recommended method to reduce ongoing stormwater erosion is to perform grading to flatten the areas with slopes susceptible to erosion. We have observed other solar plants in desert regions experience erosion in sheet flow areas based on subtle changes in slope. For final design we recommend detailed survey to confirm slopes that are associated with the existing site erosion, and verification that final grading design will reduce cross slope across the eroded area of the site.

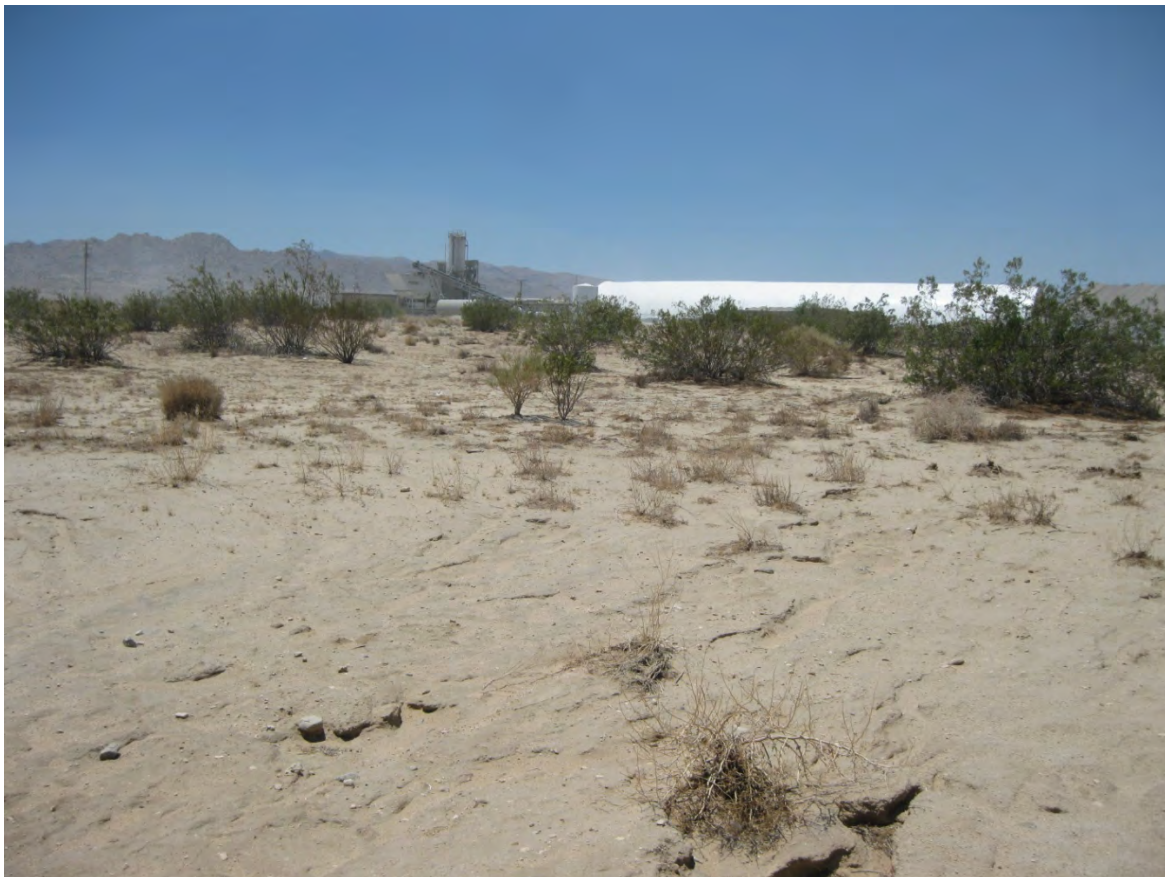
Photo 8: Sheet flow just upstream from runway erosion, looking southwest.

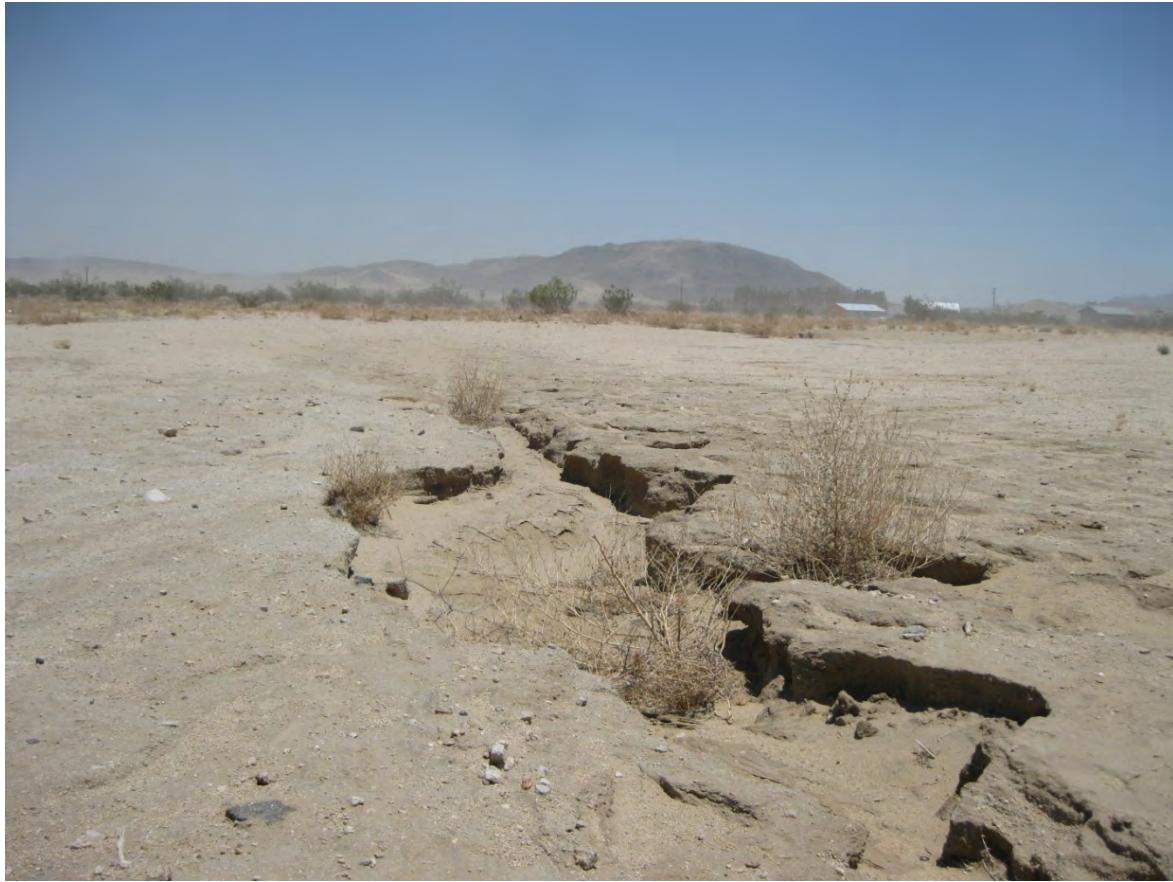
Photo 9: Erosion across graded dirt runway, looking northeast.

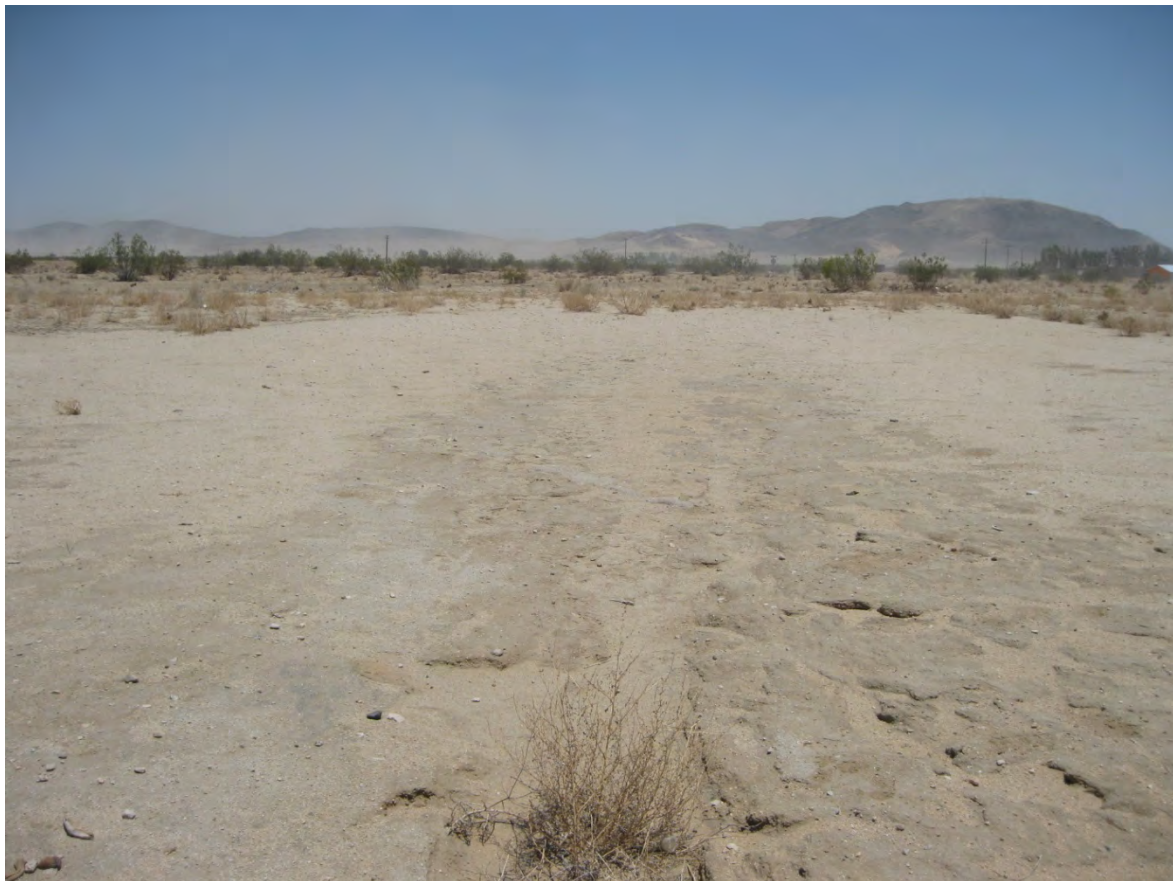
Photo 10: Sheet flow downstream from runway erosion, looking northeast.

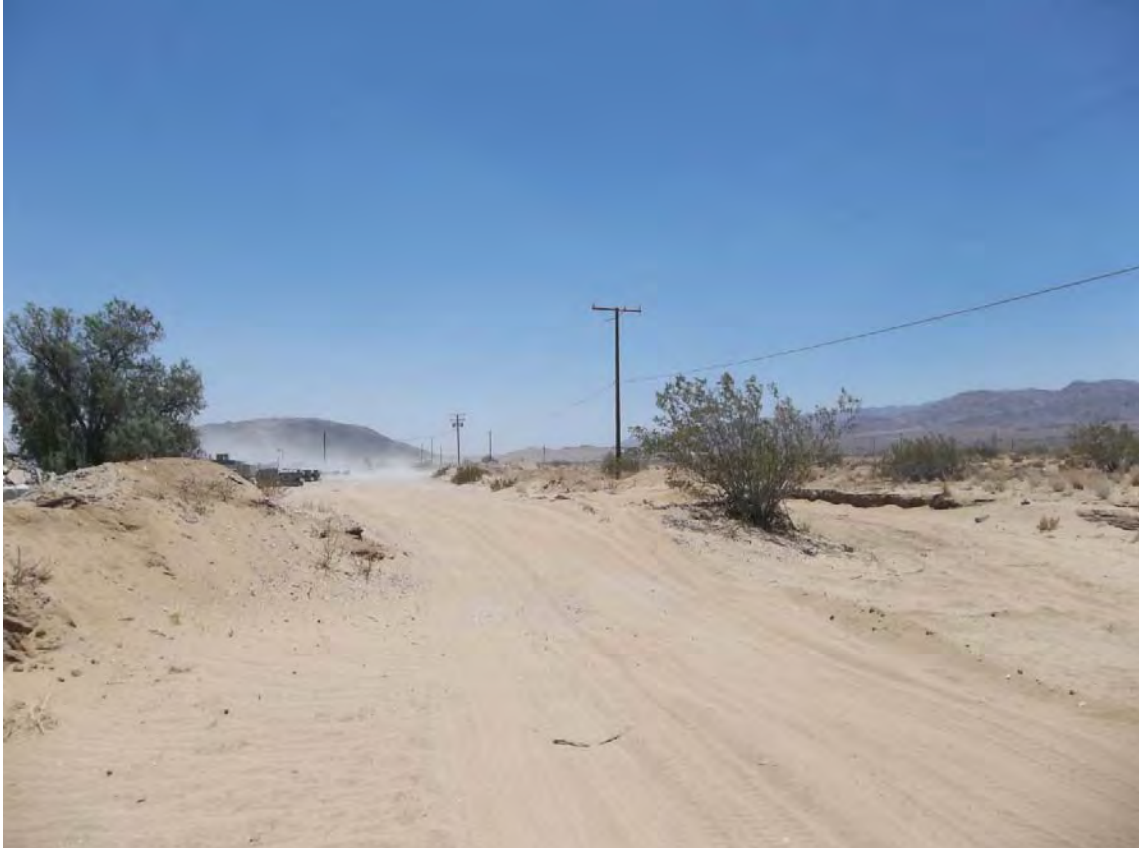
Photo 11: Offsite berm along south side of concrete plant (left side of photo) redirects flow away from the project site (channel to the right of the roadway).

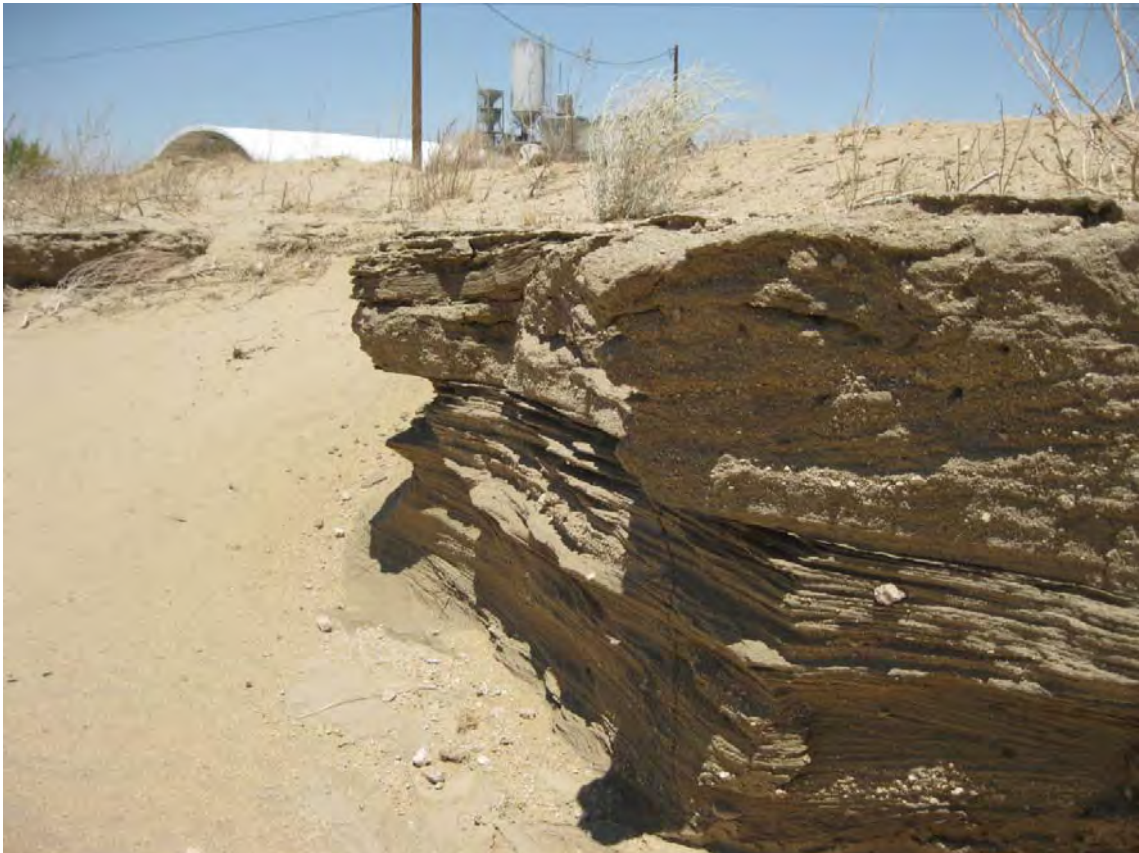
Photo 12: Offsite channel erosion downstream from berm pictured above. Vertical face approximately 18 to 24 inches high.

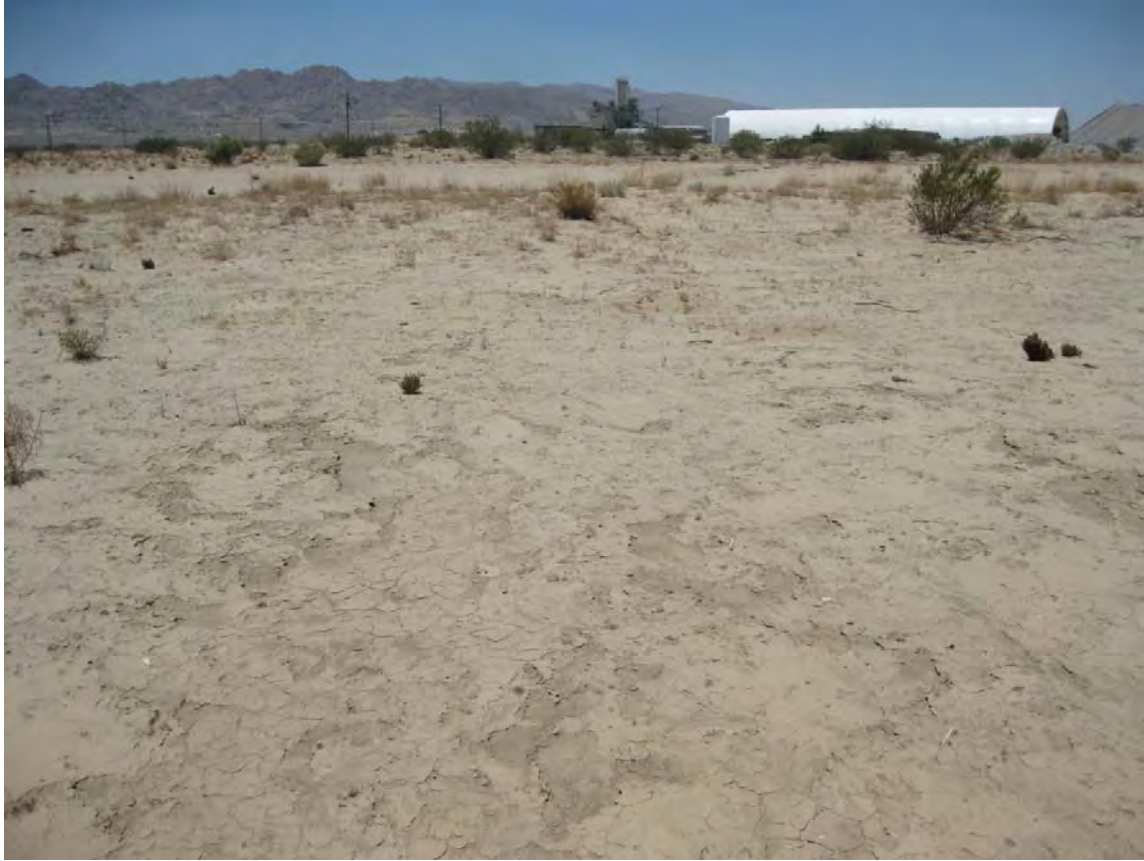
Photo 13: Indication of sheet flow leaving project site, southeast project corner at Sunfair Road looking west (flow direction is towards viewer).

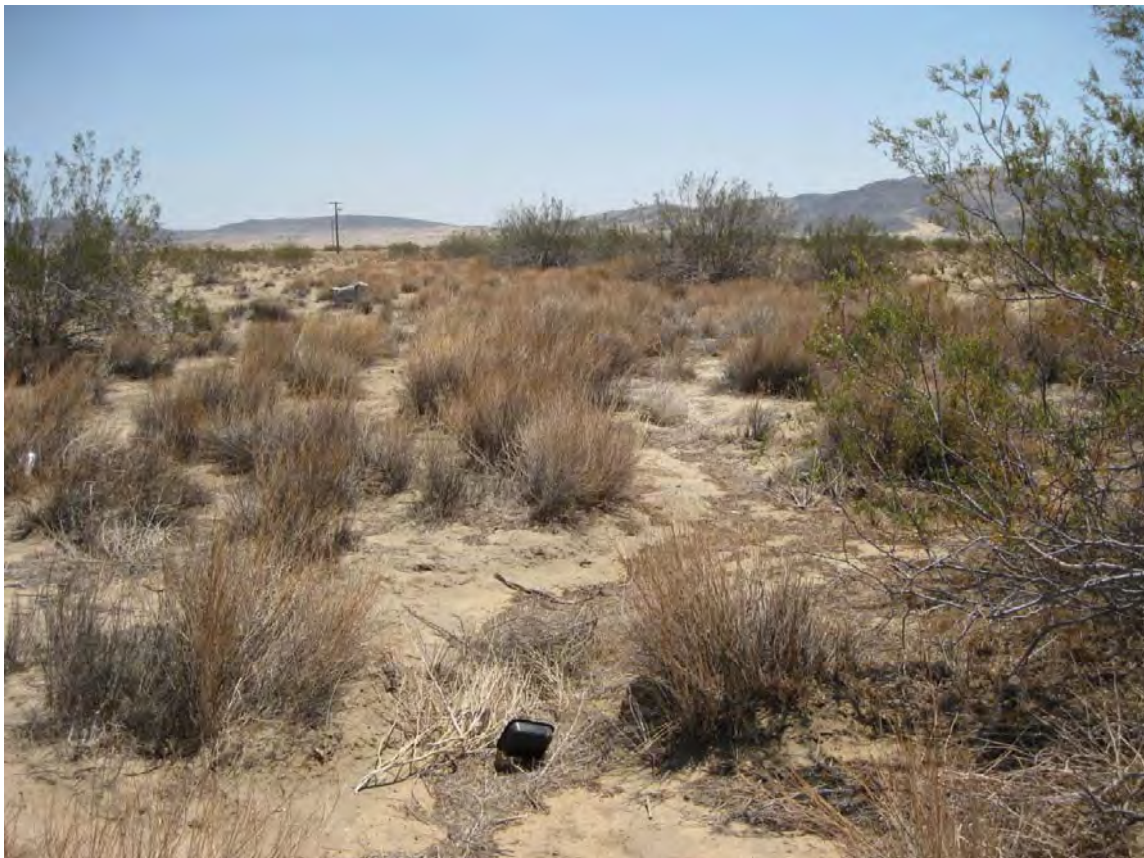
Photo 14: Offsite flow path, downstream from project site and across runway from Coyote Valley Road, looking east.

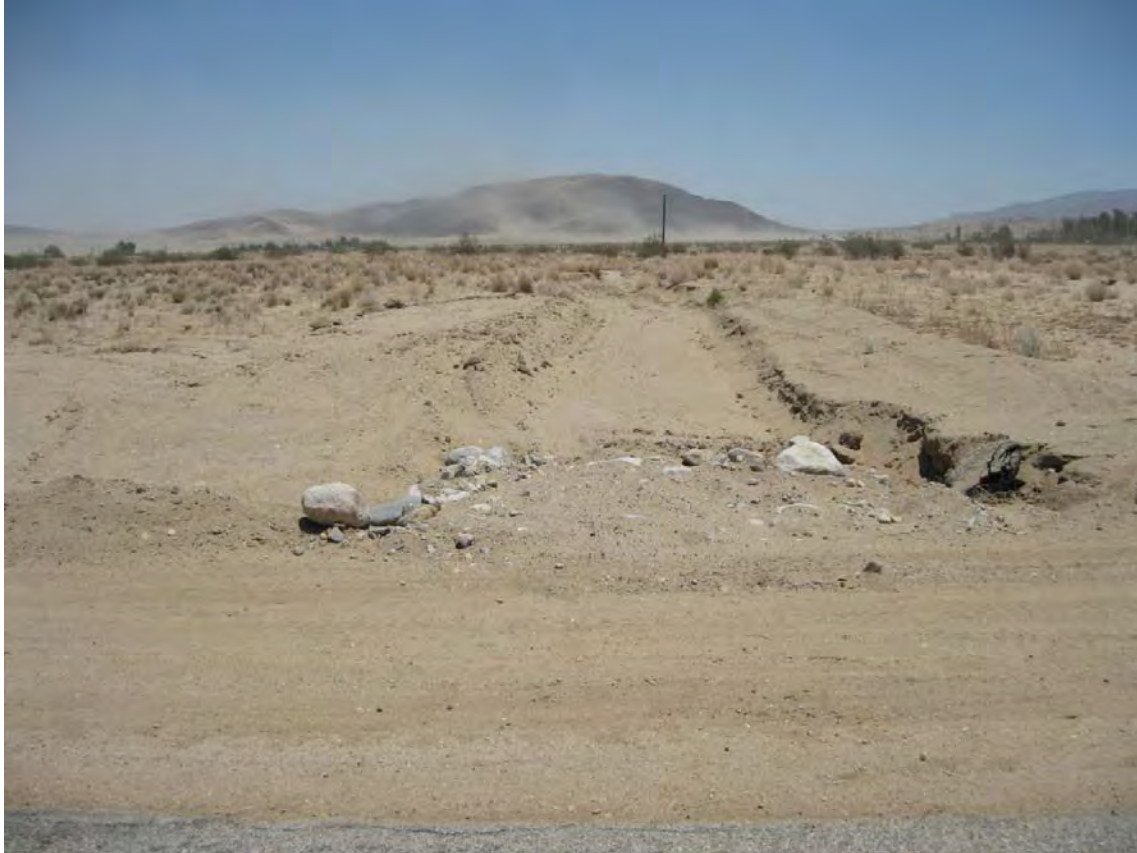
Photo 15: Offsite flow path, downstream from project site and across Coyote Valley Road, looking east.

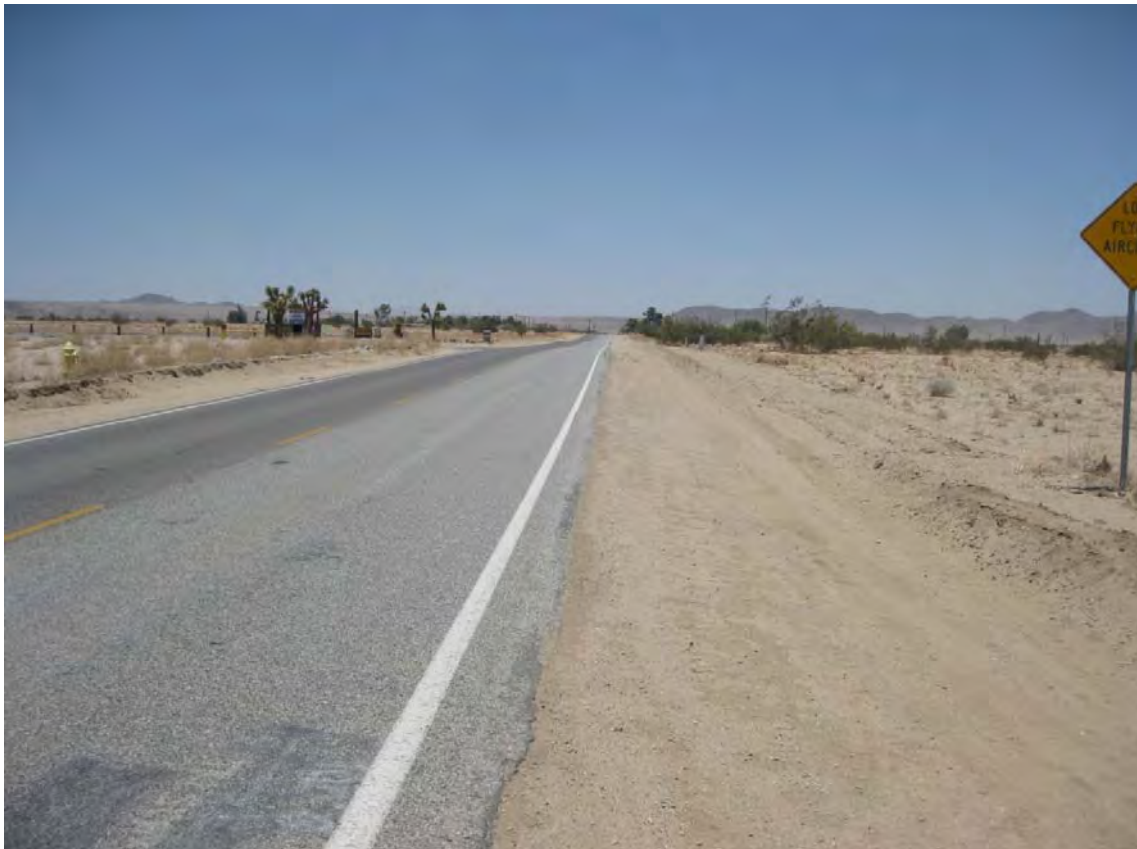
Photo 16: Graded shoulder along east side of Coyote Valley Road, directs stormwater flow to path pictured above, looking north.

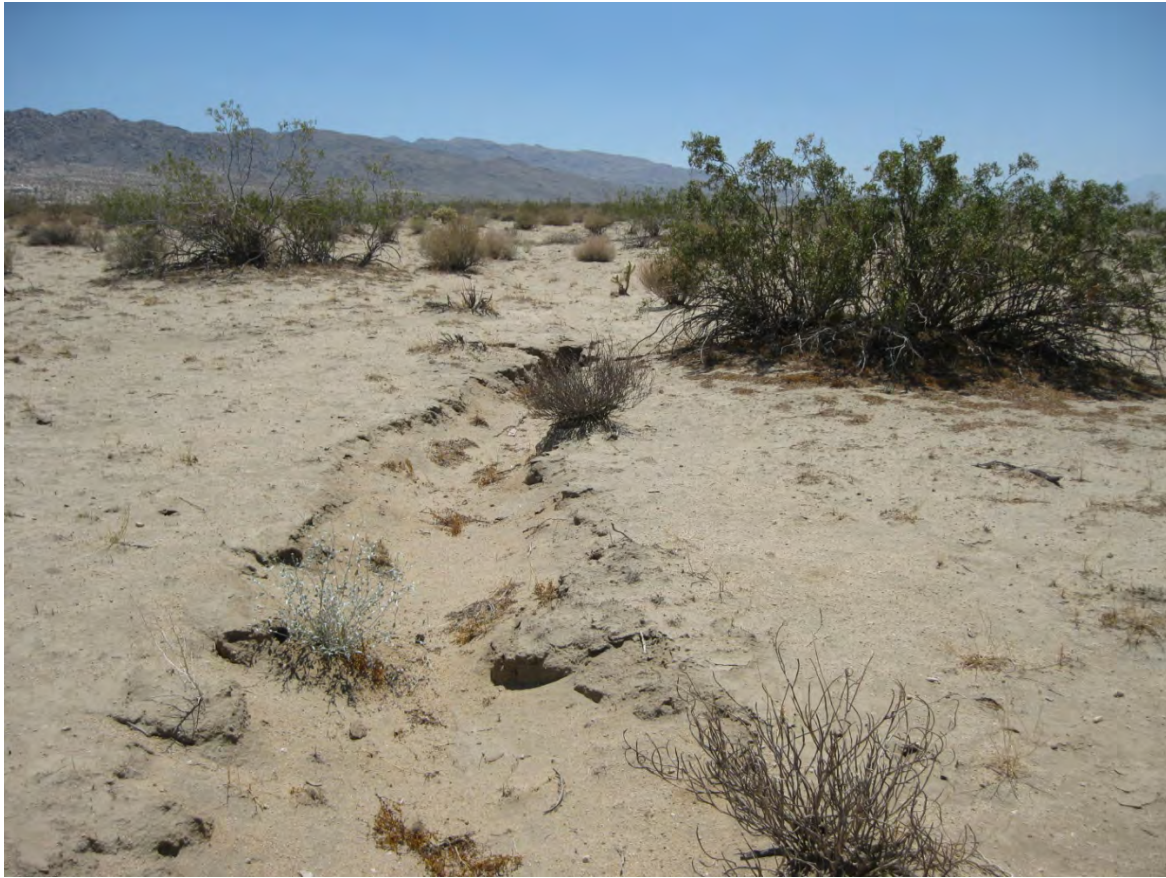
Photo 17: Offsite channel exhibits typical crust on soil surface and loose conditions where soil has been disturbed.

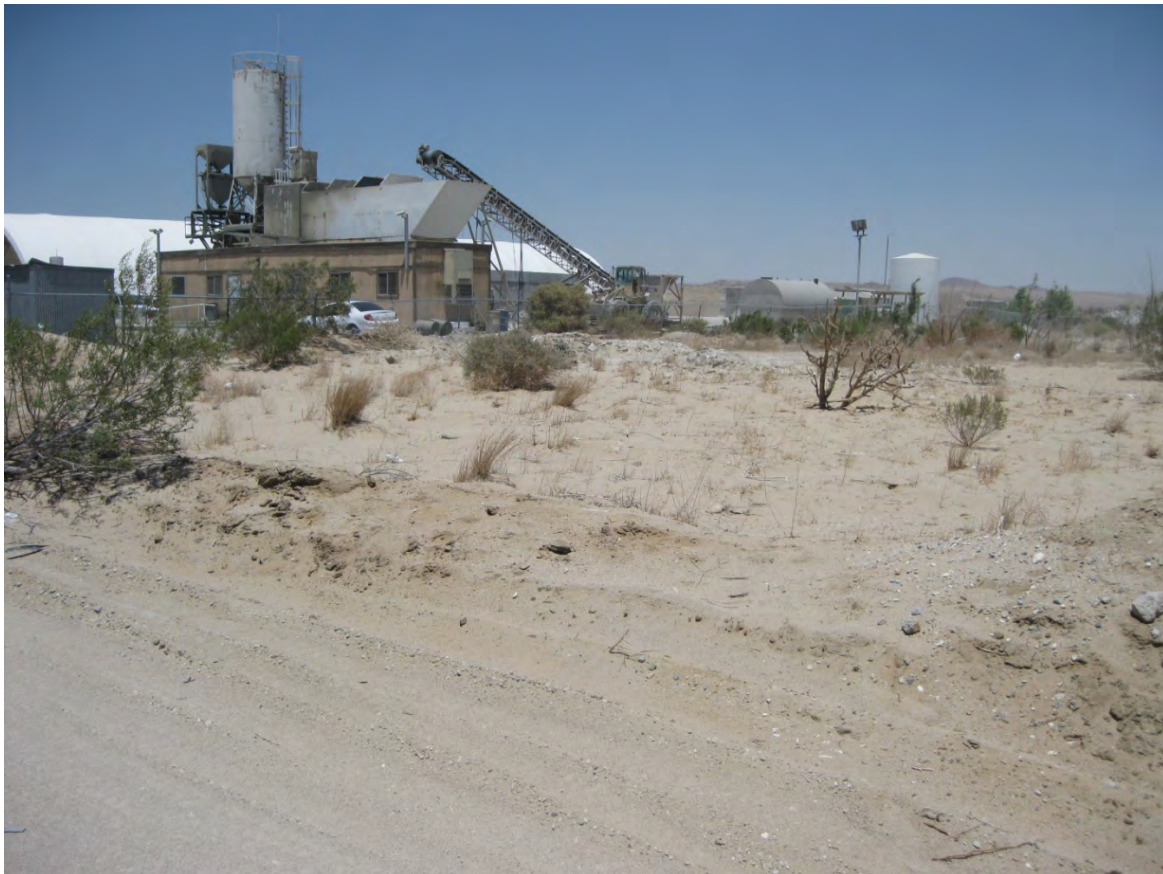
Photo 18: Low berm along south of project site, notice loose soil in area of disturbance.

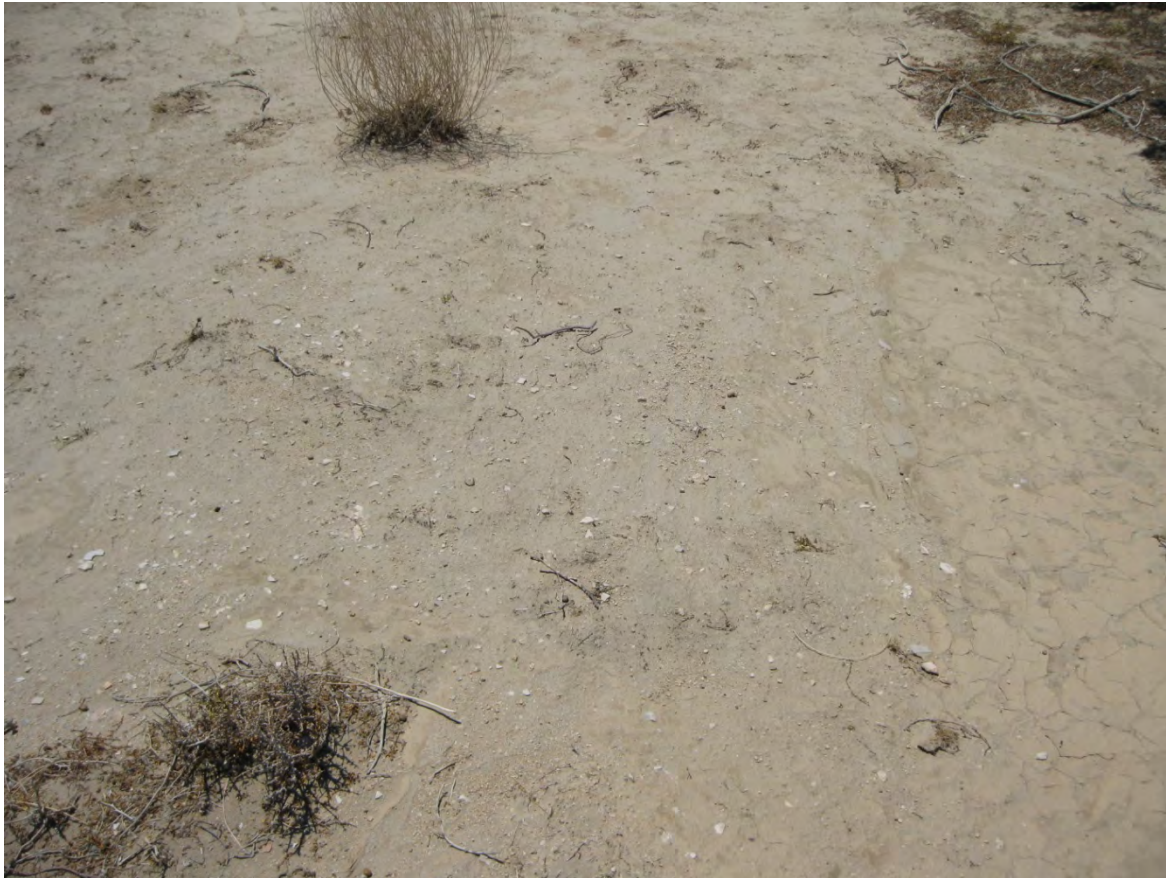
Photo 19: Typical crust on soil surface.

We observed that site soils are characterized by a thin crust that forms over the surface, likely due to silt content. However, the site soil was very loose where disturbed. The crust appears to protect against wind and water erosion, but when the crust is broken, or its protective capacity exceeded, the soil is essentially loose sand and is highly erosive. Even the crusted soil would likely flow (erode and deposit) under faster moving sheet flow conditions. See photos 19 and 20 Appendix B for typical soil conditions.

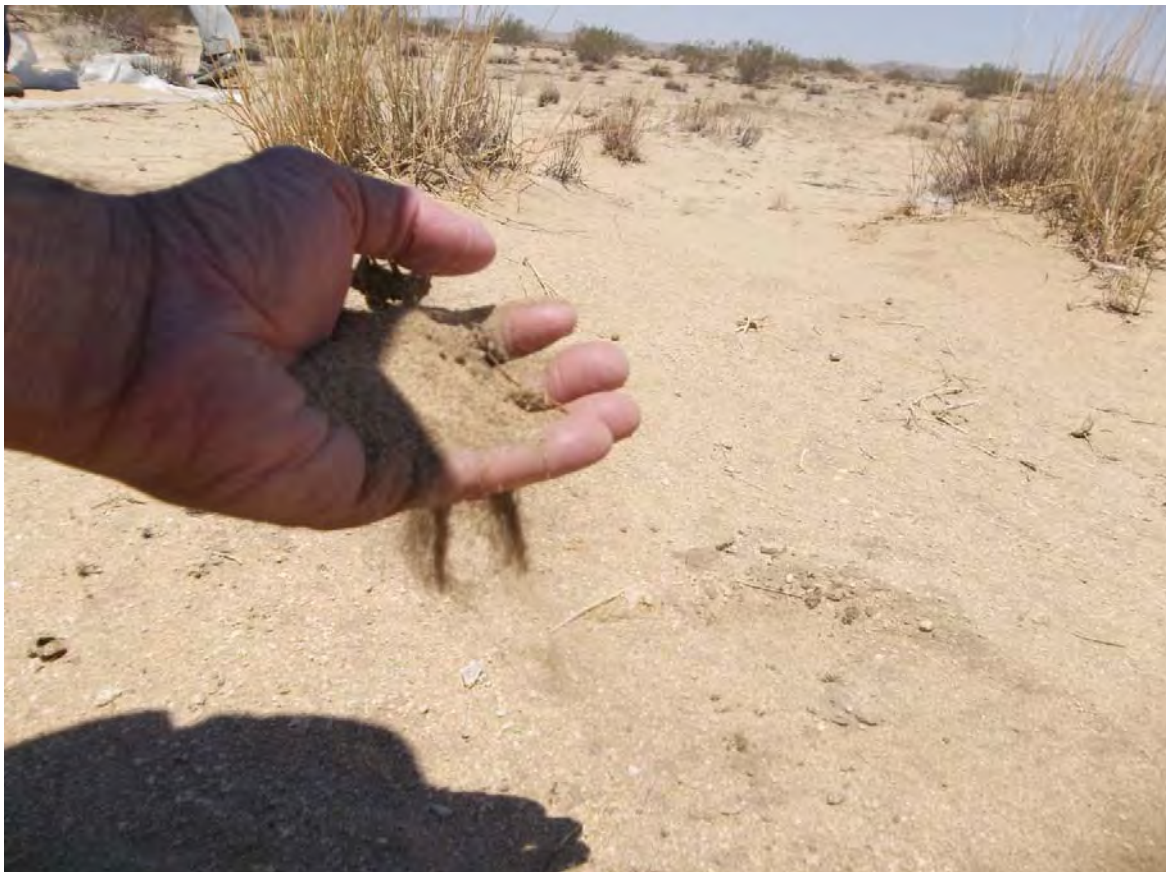
Photo 20: Loose, previously disturbed soil.

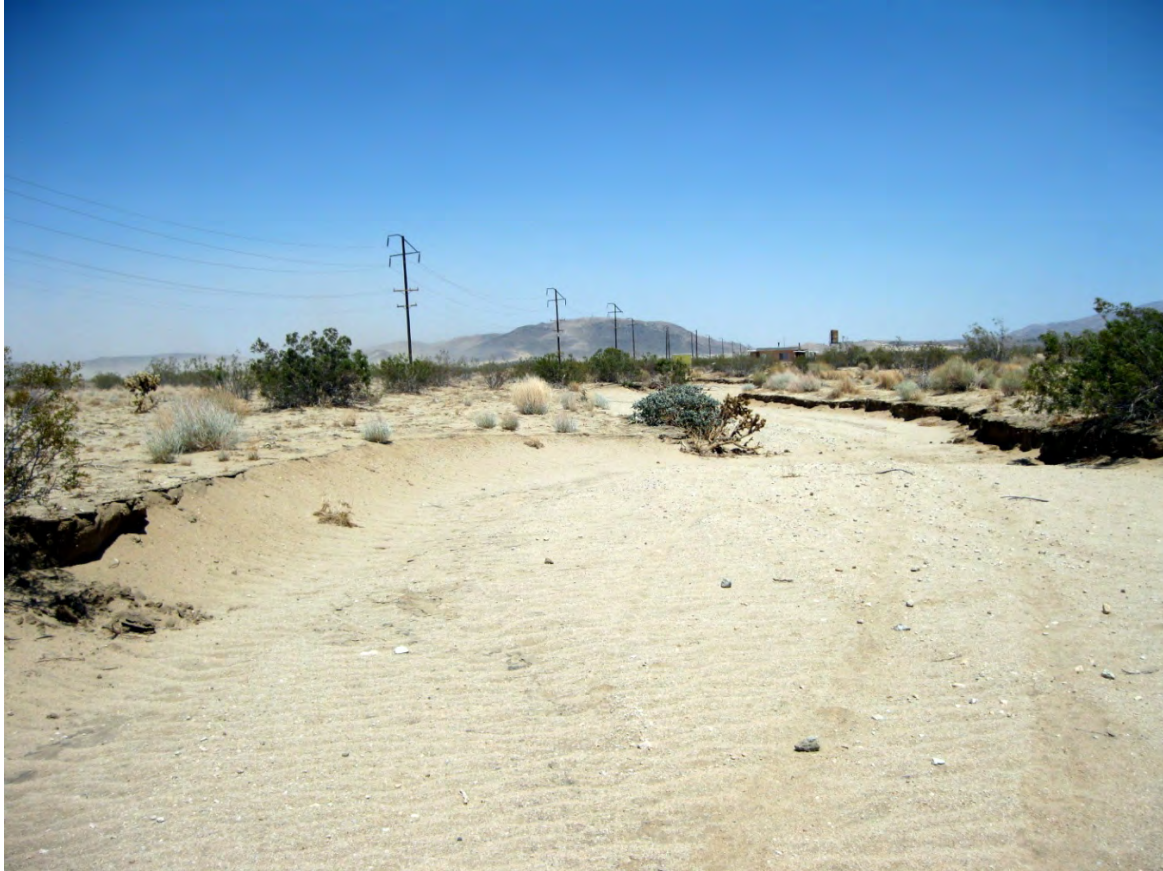
Photo 21: Coyote Wash at Hollinger Road, looking east. (offsite)

The drainage channels upstream from the site are characterized by shallow depths with meandering and braided alignments. Based on this channel type, it is anticipated that existing upstream channels will have a tendency to shift location over time. Sediment deposition from prior storm events can decrease channel capacity, and cause floodwaters to form new channels, or overflow to other nearby channels. Of particular concern is the current “flow split” near the intersection of Pipeline Road and Rice Avenue. At this location a smaller secondary drainage channel breaks away from the Coyote Wash and flows toward the site. The unimproved Coyote Wash has the potential to shift course at this flow split and direct additional flood flow toward the project site. If a full diversion of flow occurred upstream of the site, the increased flood flow could result in significant site impacts, particularly to the southern half of the site. This is a risk to be considered in the course of project design, and alleviation would require considerable improvements and/or maintenance to the Coyote Wash upstream of the site. Offsite improvements of the Wash are not anticipated as a part of this project. See photos 21 and 22 Appendix B, of the Coyote Wash south and west of the site.
