JOSHUA TREE SOLAR SITE PRELIMINARY HYDROLOGY STUDY

WG Project Number: 1100.0002
December 2014

**JOSHUA TREE SOLAR SITE
PRELIMINARY HYDROLOGY STUDY**

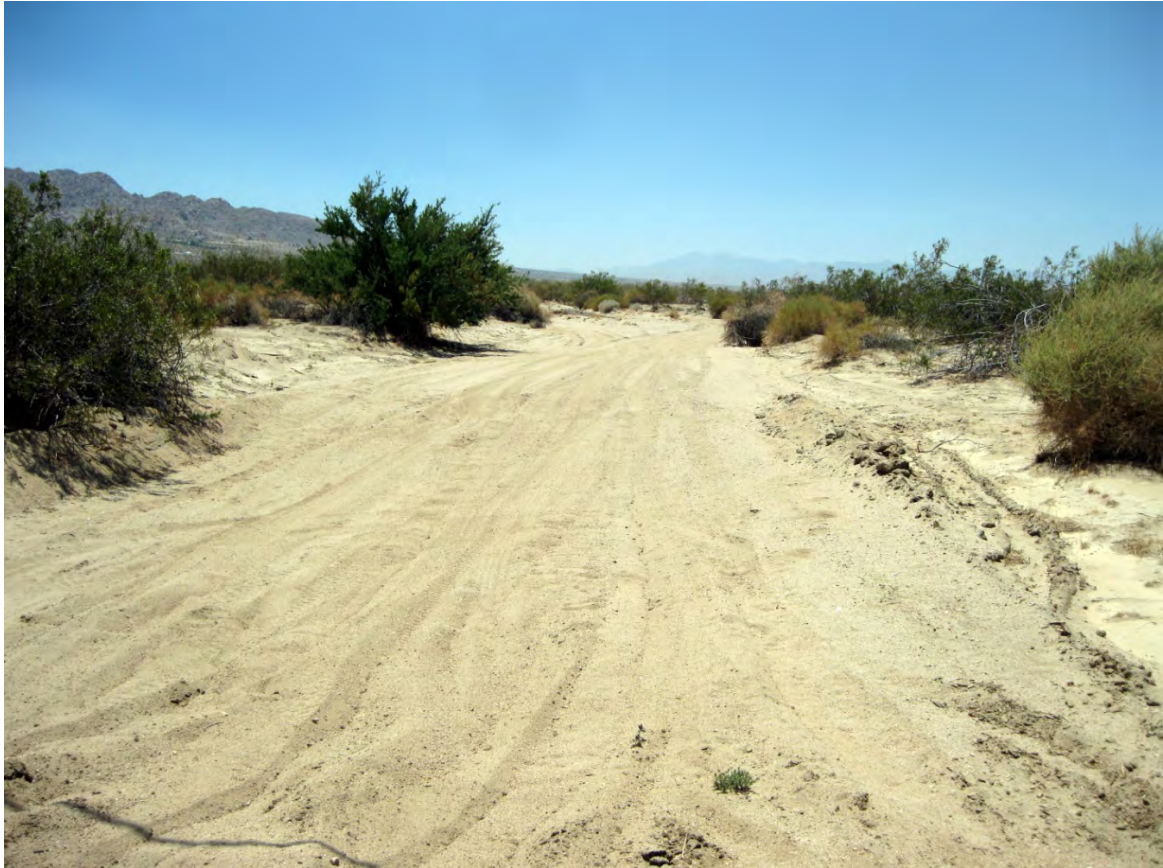
Photo 22: Southern channel of Coyote Wash at Coyote Valley Road, looking west. (offsite)

The drainage channels upstream from the site are characterized by shallow depths with meandering and braided alignments. Based on this channel type, it is anticipated that existing upstream channels will have a tendency to shift location over time. Sediment deposition from prior storm events can decrease channel capacity, and cause floodwaters to form new channels, or overflow to other nearby channels. Of particular concern is the current “flow split” near the intersection of Pipeline Road and Rice Avenue. At this location a smaller secondary drainage channel breaks away from the Coyote Wash and flows toward the site. The unimproved Coyote Wash has the potential to shift course at this flow split and direct additional flood flow toward the project site. If a full diversion of flow occurred upstream of the site, the increased flood flow could result in significant site impacts, particularly to the southern half of the site. This is a risk to be considered in the course of project design, and alleviation would require considerable improvements and/or maintenance to the Coyote Wash upstream of the site. Offsite improvements of the Wash are not anticipated as a part of this project. See photos 21 and 22 Appendix B, of the Coyote Wash south and west of the site.

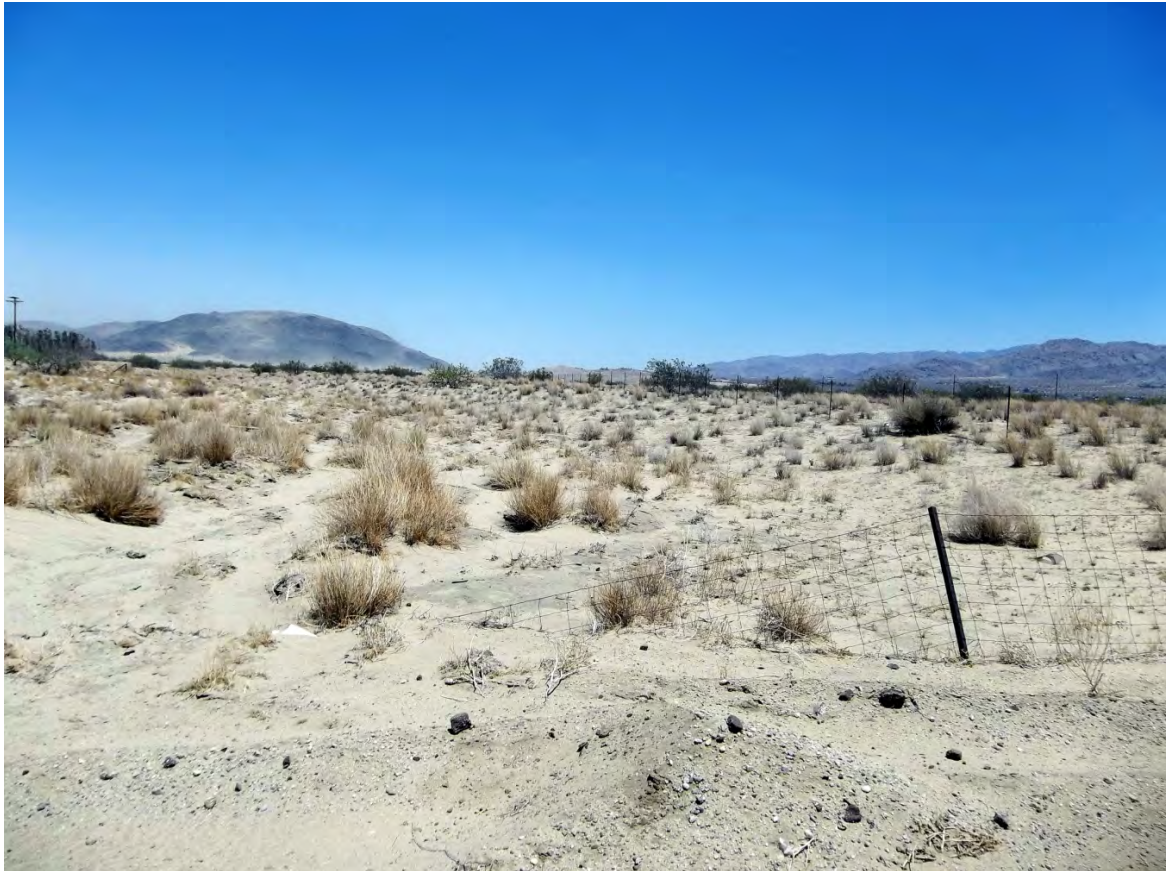
Photo 23: Fence crossing desert wash that has been covered with debris and silt over time. (offsite)
