CALPORTLAND - ORO GRANDE QUARRIES REVISED RECLAMATION PLAN

CA MINE ID #91-36-0023

ORO GRANDE, SAN BERNARDINO COUNTY, CALIFORNIA

Revegetation Plan

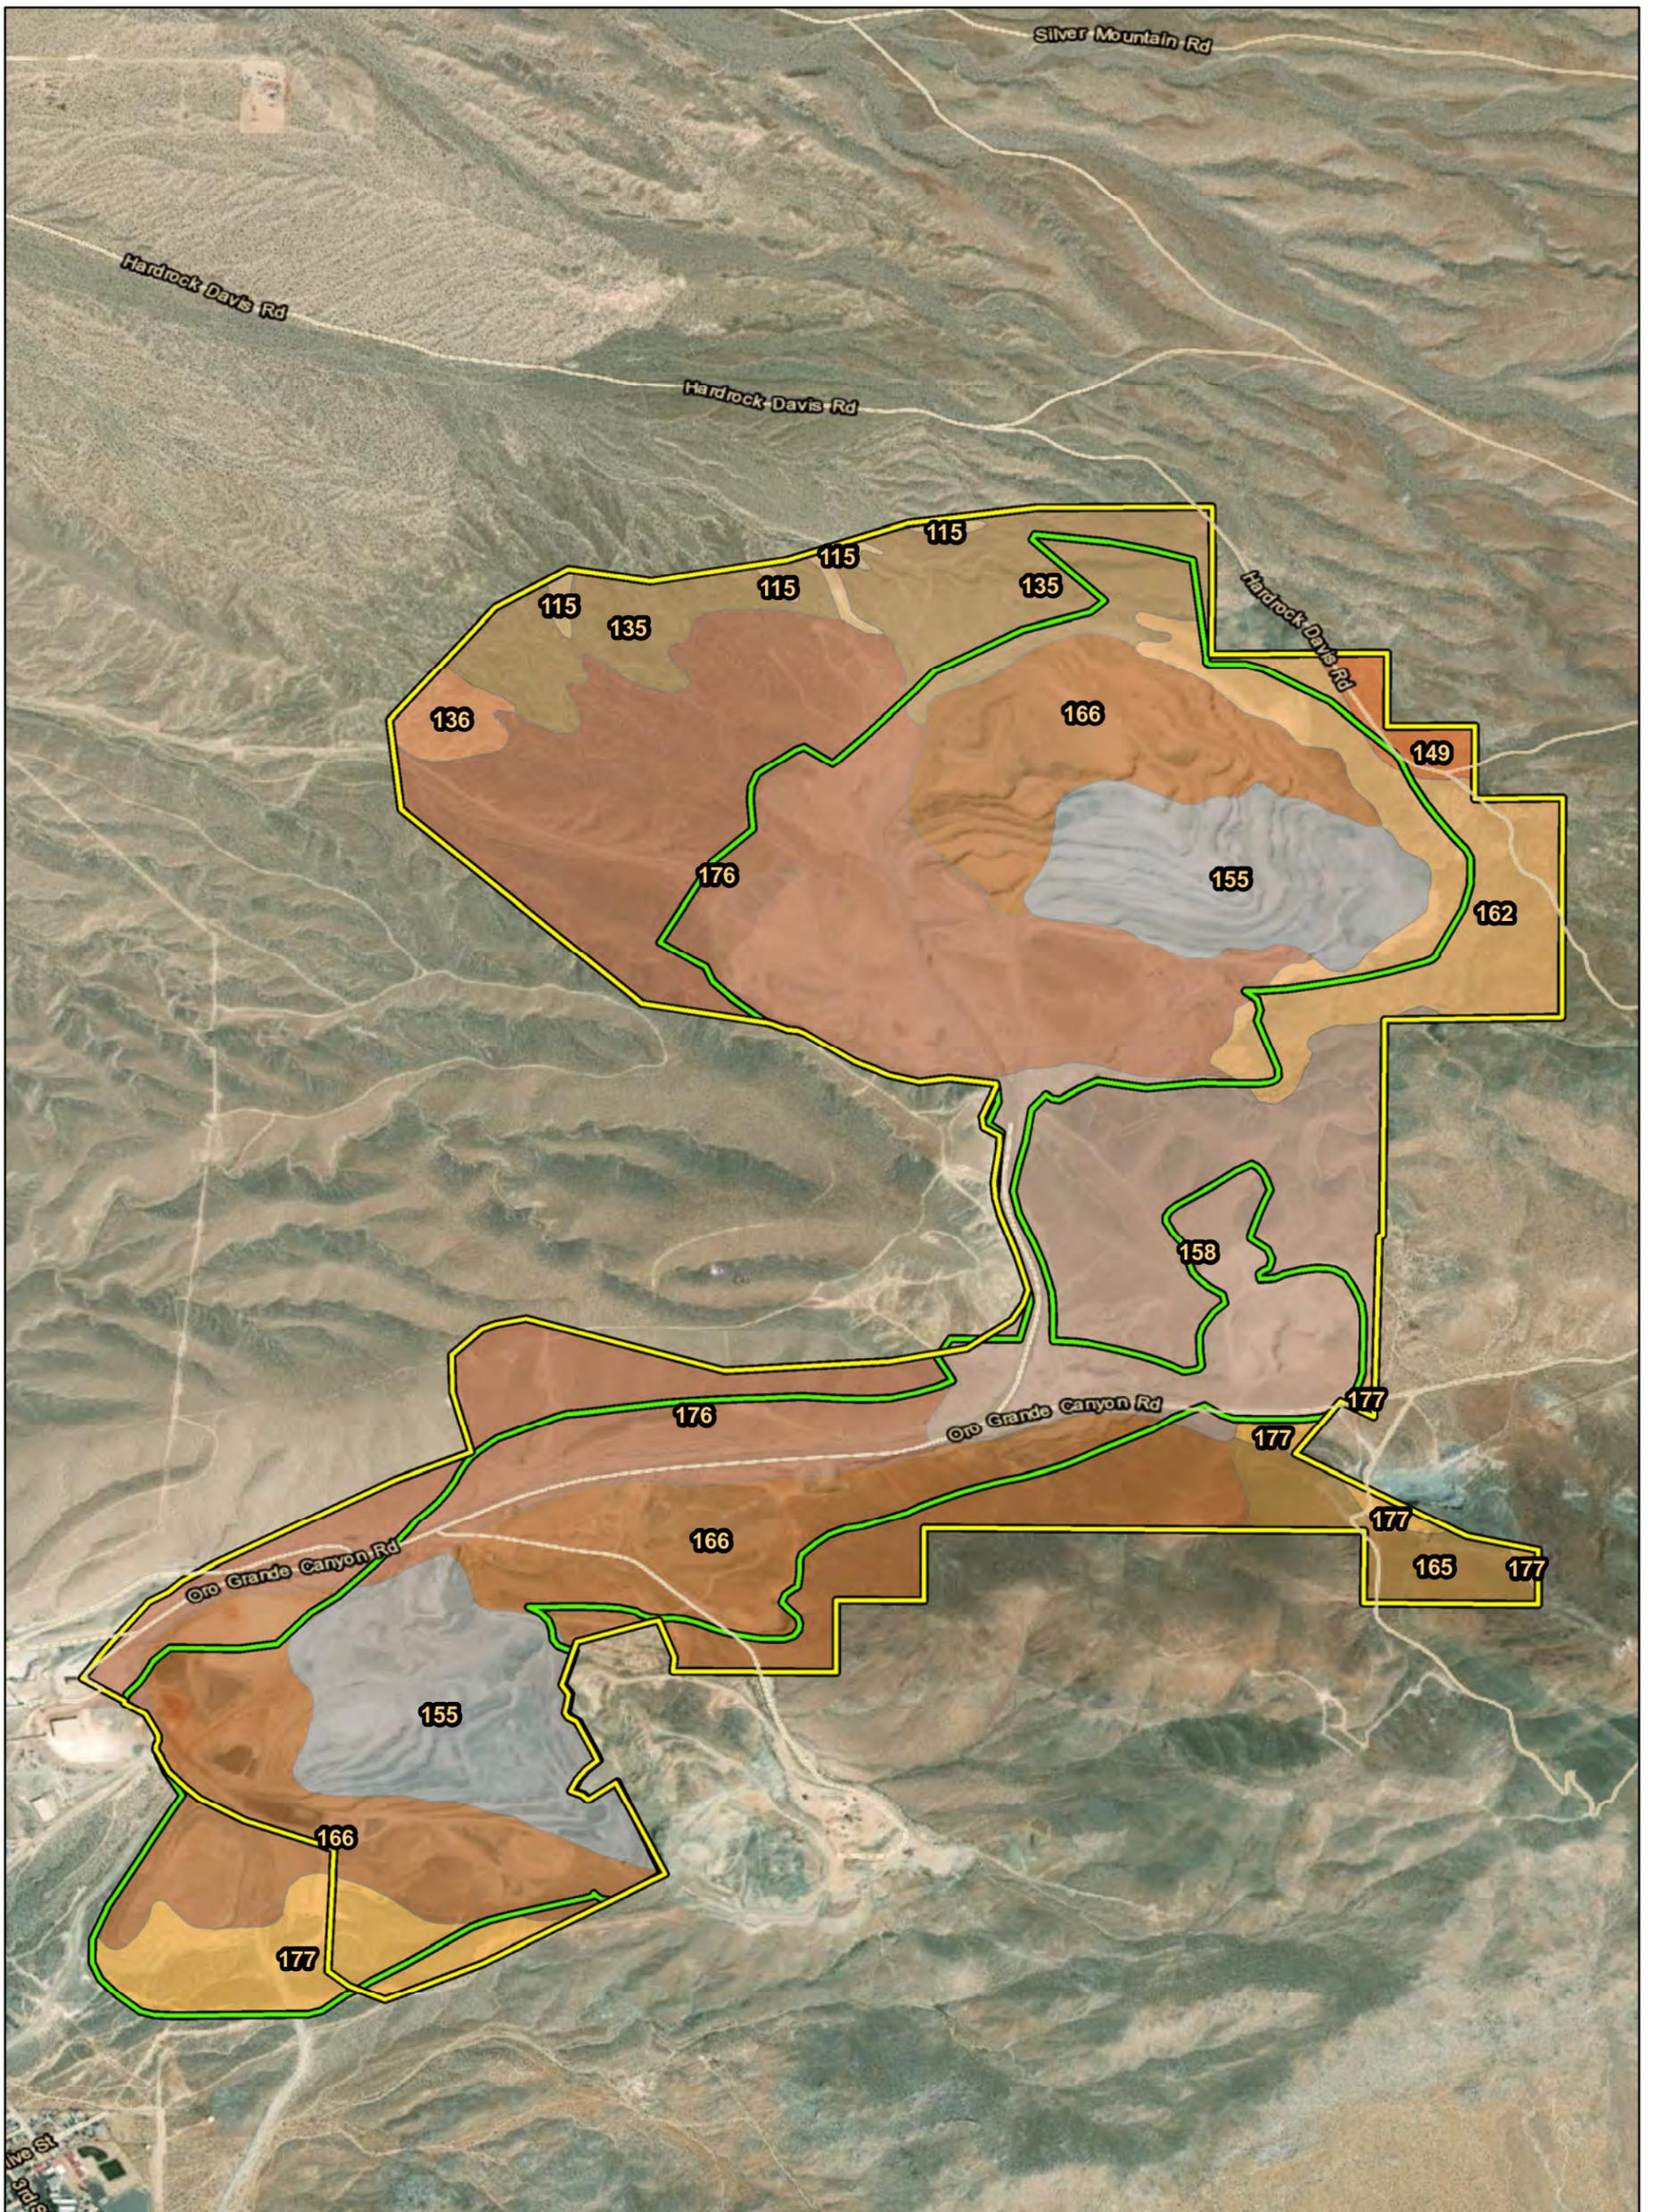
Legend

| Amended Reclamation Plan Area 1,652 Acres | Cajon Gravelly Sand, 2 to 15 percent slopes (115) | Sparkhule-Rock Outcrop Complex, 15 to 50 percent slopes (162) |
| Approved Reclamation Plan 971.5 Acres | Joshua Loam, 2 to 5 percent slopes (135) | Trigger-Sparkhule-Rock Outcrop Association, Steep (165) |
| | Joshua Loam, 9 to 15 percent slopes (136) | Trigger-Rock Outcrop Complex, 30 to 50 percent slopes (166) |
| | Mirage-Joshua Complex, 2 to 5 percent slopes (149) | Yermo Gravelly Sandy Loam, 30 to 50 percent slopes (176) |
| | Pits (155) | Yermo-Kimberlina, cool, association, sloping (177) |
| | Rock Outcrop-Lithic Torriothents Complex, 15 to 50 percent slopes (158) | |

According to the NRCS Custom Soil Resource Report, the project site is underlain by the following soil units: Sparkhule-rock outcrop complex (15 to 50 percent slopes), Mirage-Joshua complex (2 to 5 percent slopes), Rock outcrop-lithic torriorthents complex (15 to 50 percent slopes), Joshua loam (2 to 5 percent slopes), Joshua loam (9 to 15 percent slopes), Cajon gravelly sand (2 to 15 percent slopes), Cajon loamy sand (5 to 9 percent slopes), Yermo gravelly sandy loam (30 to 50 percent slopes), Yermo-Kimberlina cool association (sloping), Trigger-Sparkhule-rock outcrop association (steep), Trigger-rock outcrop complex (30 to 50 percent slopes), and Pits (Exhibit 4, *Soils*).

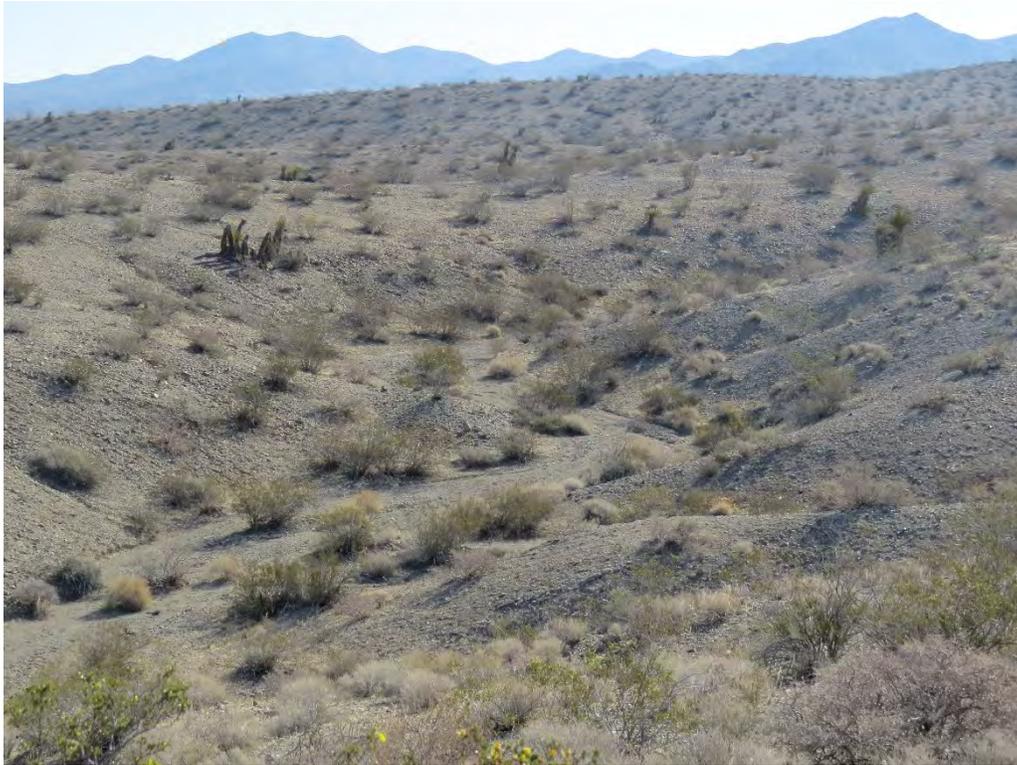
Photograph 9: Dry wash at the bottom of the rolling hills on the northwestern portion of the site.

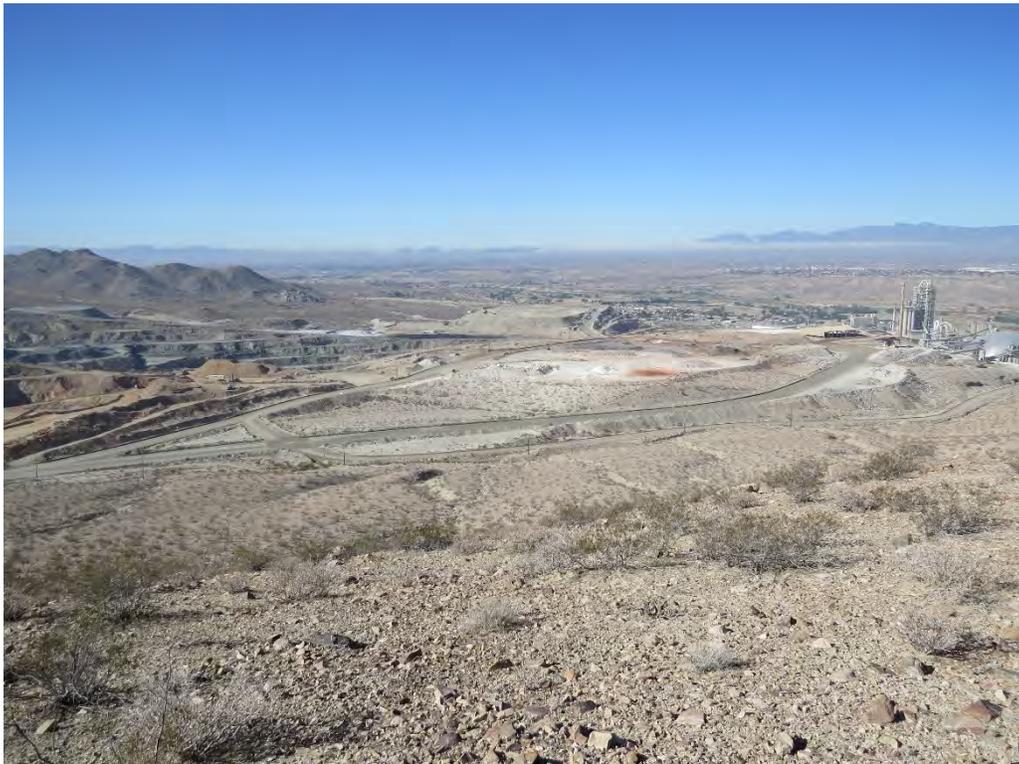
Photograph 16: Looking southwest at the areas that have been mined.

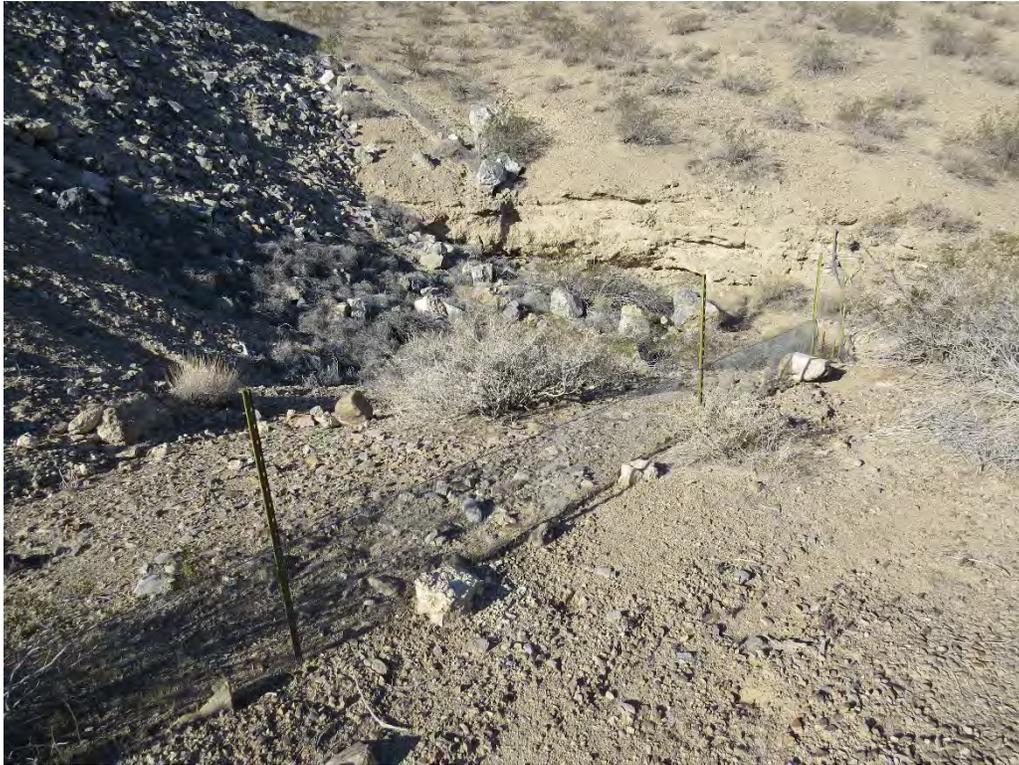
Photograph 19: Desert tortoise exclusionary fence found on the western portion of the site.

The project site is relatively undeveloped except those areas that have been subject to existing mining activities. The areas on the perimeter of the project site are relatively undeveloped/undisturbed, while the middle portion of the project site supports mining pits, and dirt access roads. It should be noted that a desert tortoise exclusionary fence was observed on the northwestern portion of the project site along a portion of the western boundary of the Sparkhule Mine Plan area. This exclusionary fence was installed as a previous mitigation measure.
