# **CEMEX – BLACK AND WHITE MOUNTAIN QUARRIES AMENDED RECLAMATION PLAN**

SAN BERNARDINO COUNTY, CALIFORNIA

## **Revegetation Plan**

May 2021

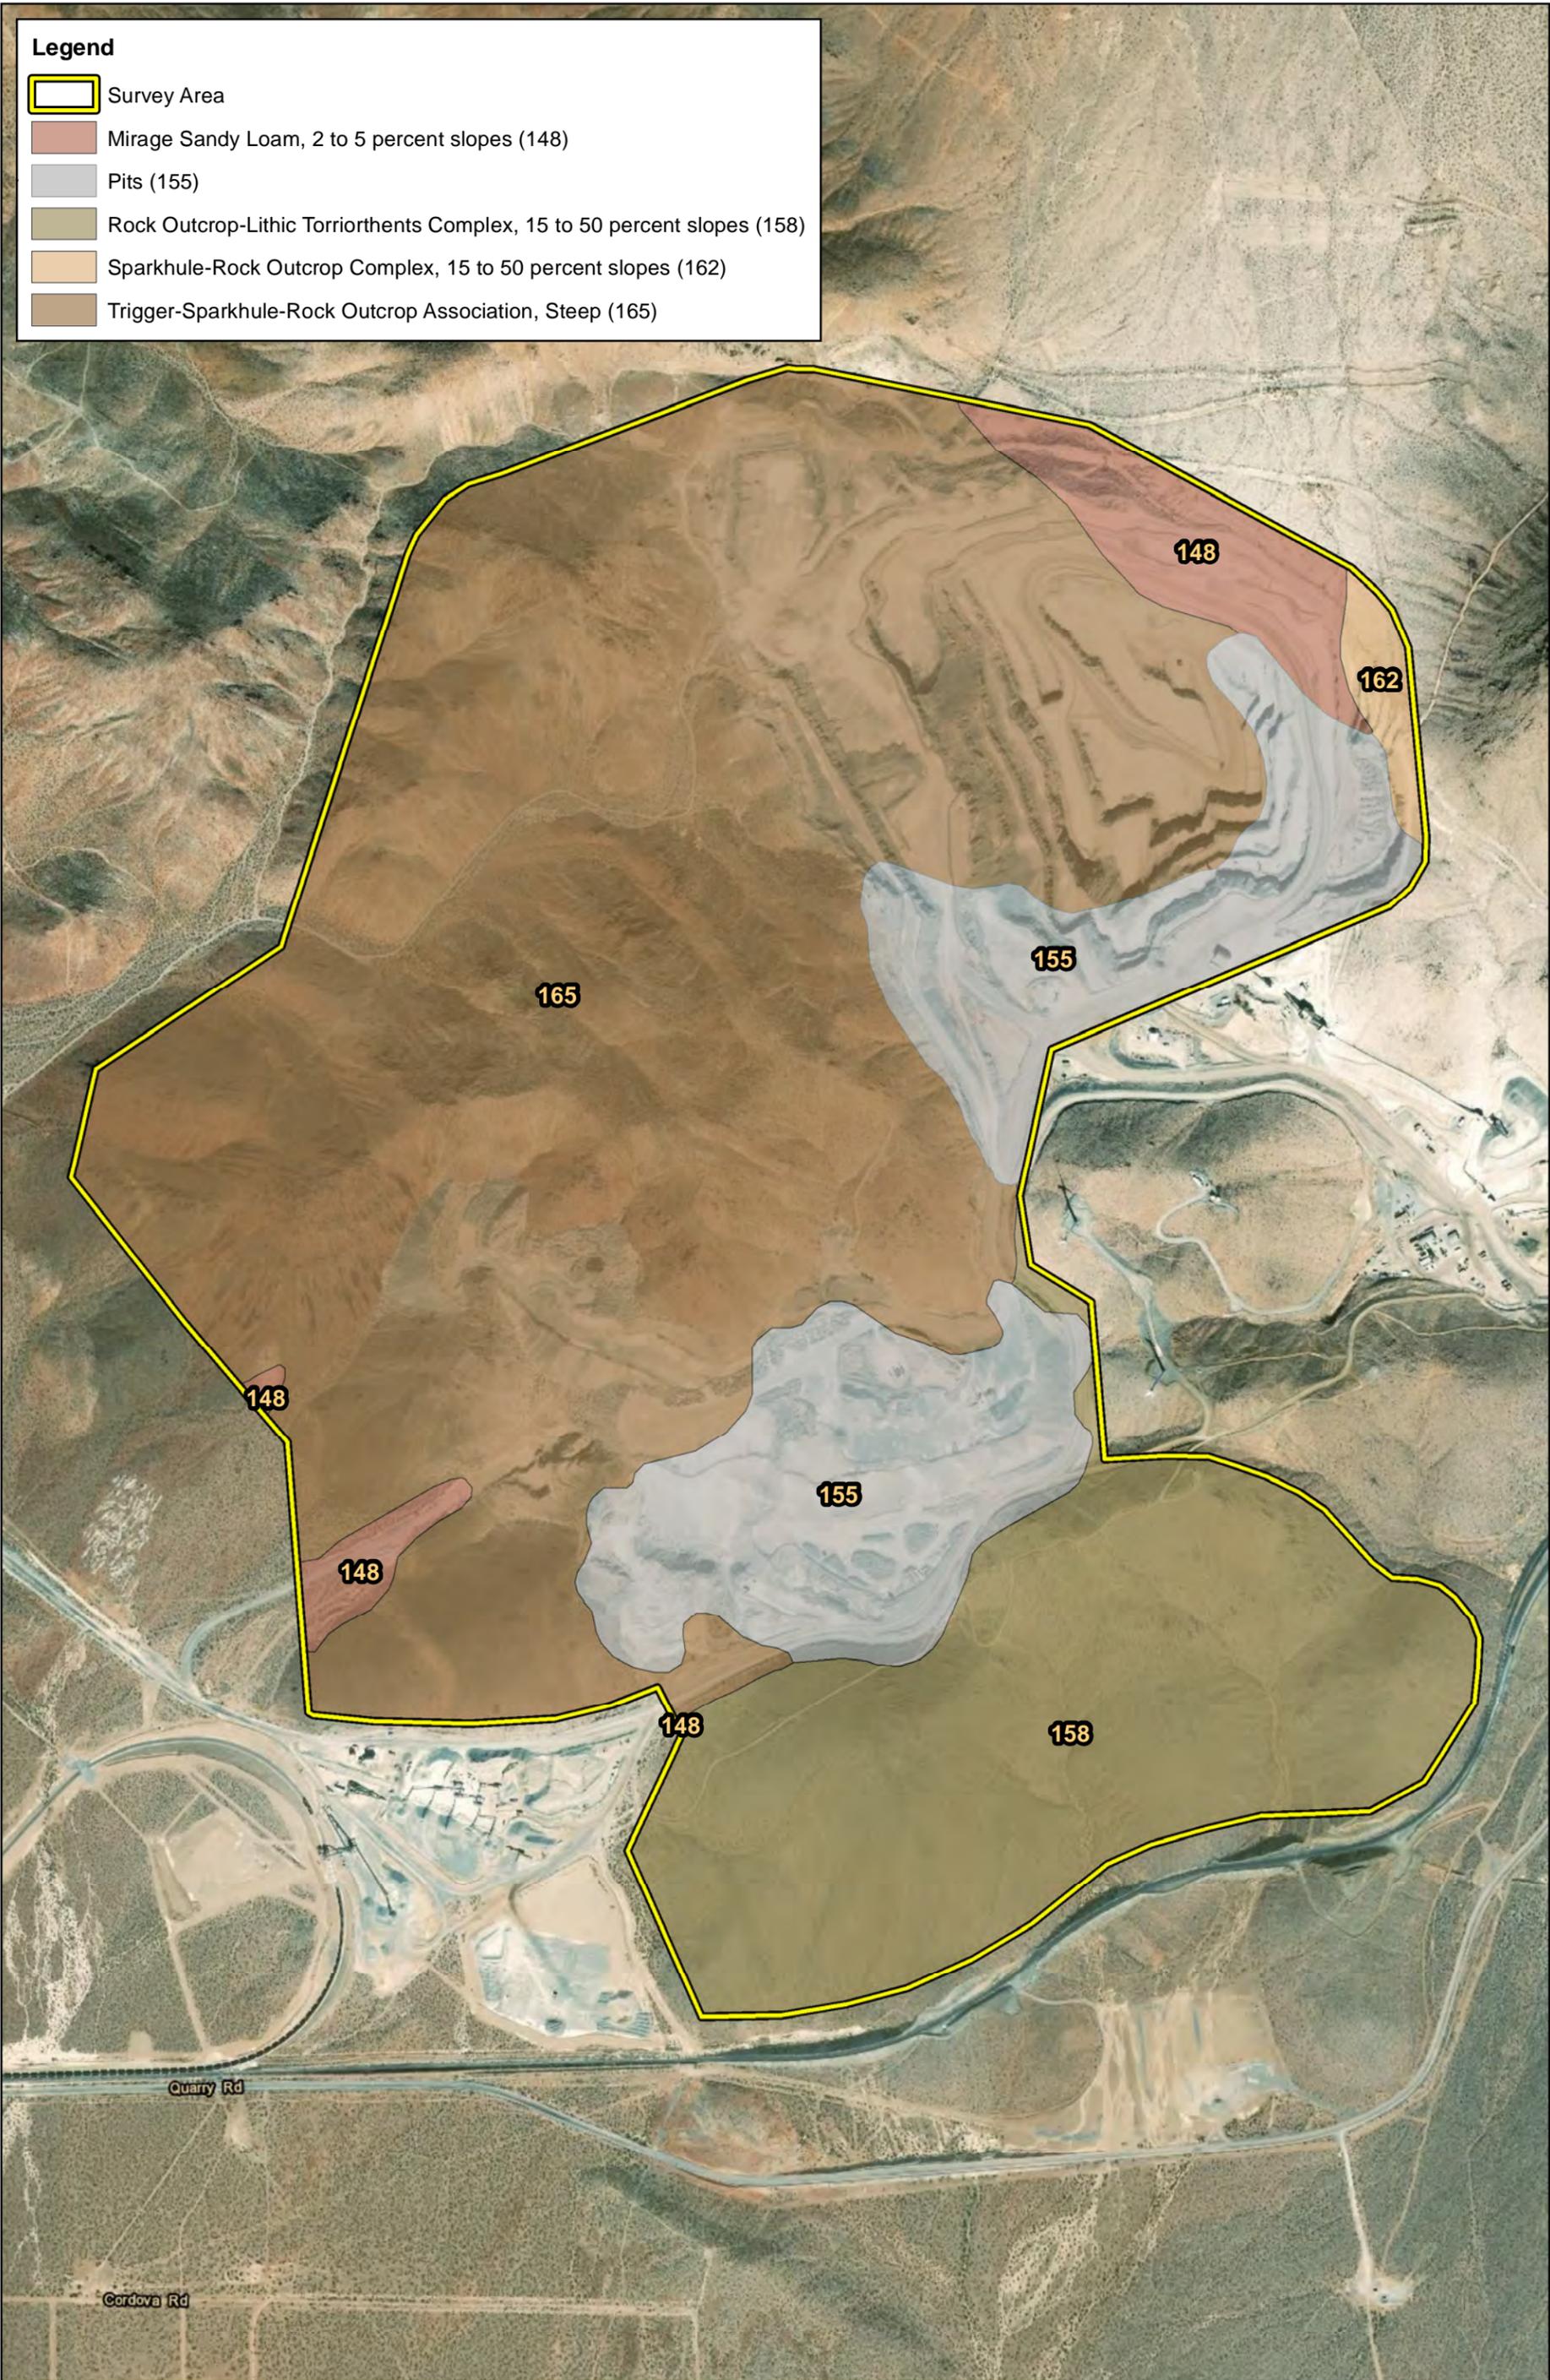
**Soils**

- Survey Area
- Mirage Sandy Loam, 2 to 5 percent slopes (148)
- Pits (155)
- Rock Outcrop-Lithic Torriorthents Complex, 15 to 50 percent slopes (158)
- Sparkhule-Rock Outcrop Complex, 15 to 50 percent slopes (162)
- Trigger-Sparkhule-Rock Outcrop Association, Steep (165)

According to the Custom Soil Resource Report, the project site is underlain by the following soil units: Mirage sandy loam (2 to 5 percent slopes), Rock Outcrop-Lithic Torriorthents Complex (15 to 50 percent slopes), Sparkhule-Rock Outcrop Complex (15 to 50 percent slopes), Trigger-Sparkhule-Rock Outcrop Association (steep), and Pits (Exhibit 4, *Soils*). Soils within the existing mining area have been mechanically disturbed and compacted from mining activities, while soils adjacent to the existing mine area, within the undeveloped portions of the survey area are undisturbed.

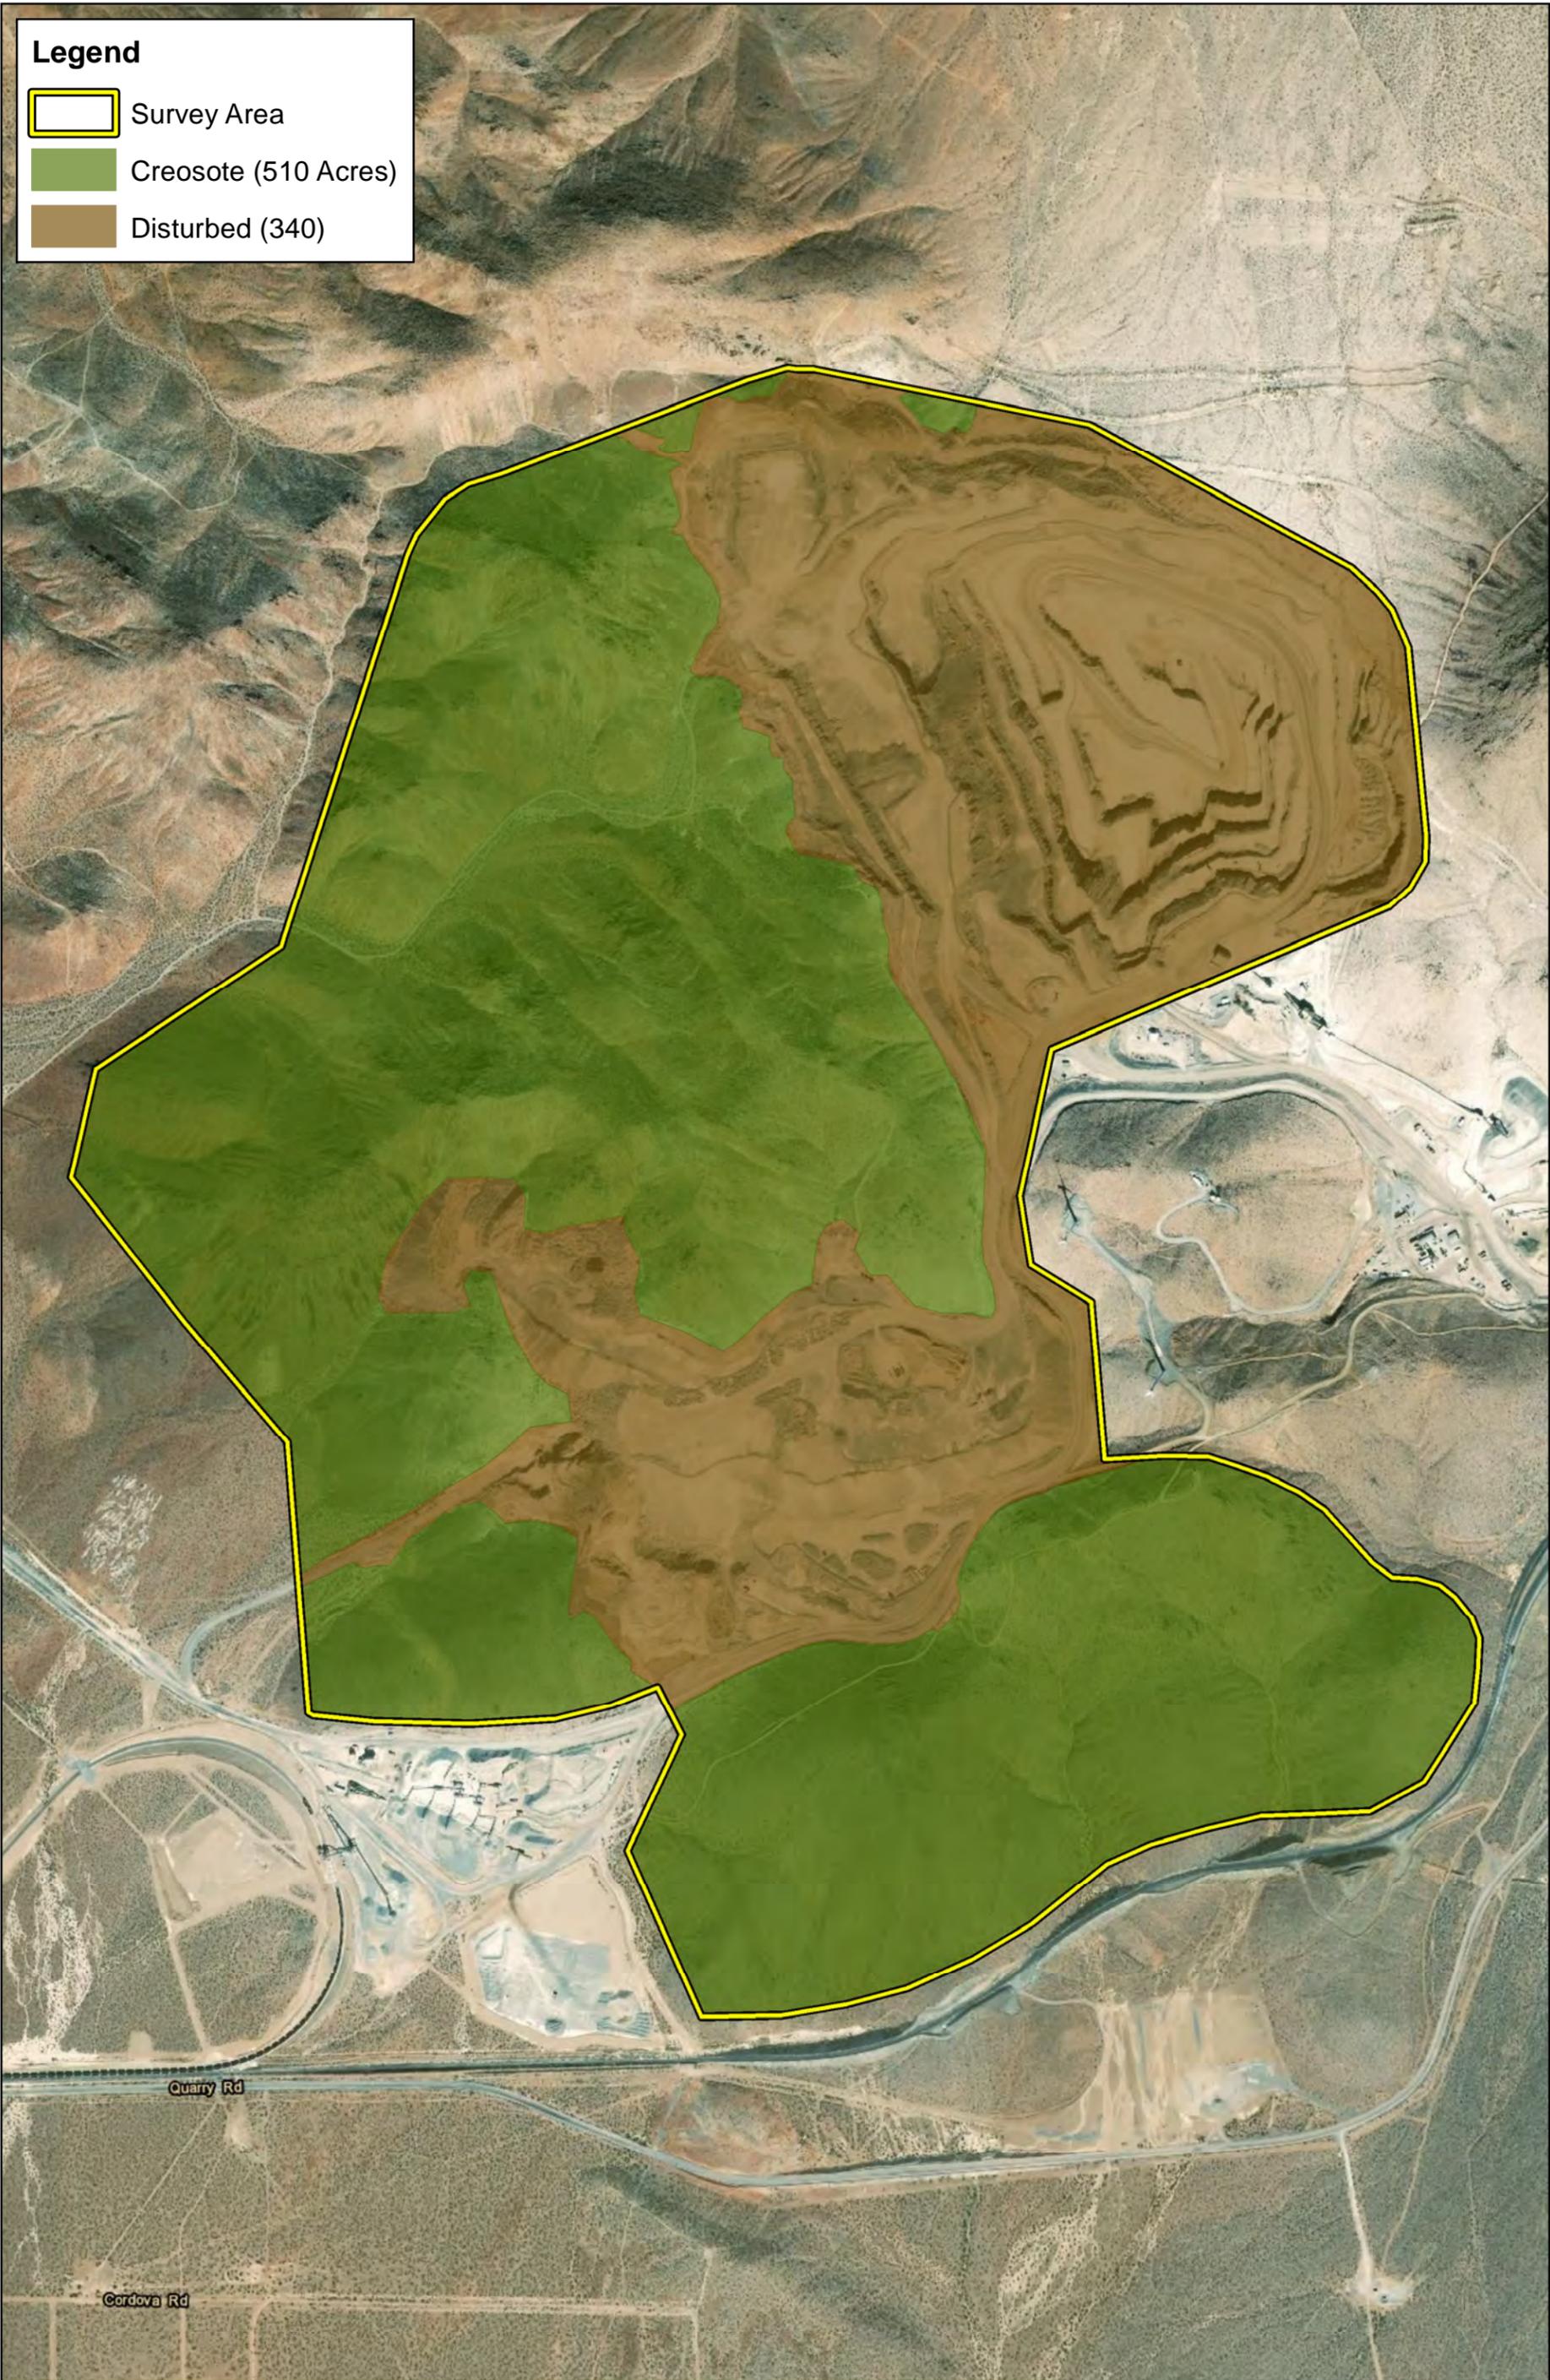
**Vegetation**

- Survey Area
- Creosote (510 Acres)
- Disturbed (340)

During the field investigation one (1) plant community was observed within the boundary of the project site: creosote bush scrub (Exhibit 5, *Vegetation*). In addition, one (1) land cover type that would be classified as disturbed was observed onsite. This area is not a vegetation classification, but rather a land cover type. The vegetation community and land cover type are described in further detail below.

The creosote bush scrub plant community occurs throughout the undeveloped/undisturbed portions on, generally on the perimeter of the survey area and is the dominant plant community within the surrounding landscape. This plant community is found in the middle, northwestern, and southern portions of the project site boundaries, outside of the areas that have been subject to existing mining activities, and is dominated by creosote (*Larrea tridentata*). Common plant species found within this plant community include fiddleneck (*Amsinckia tessellata*), desert dudleya (*Dudleya saxosa*), Mormon tea (*Ephedra nevadensis*), red-stemmed filaree (*Erodium cicutarium*), red brome (*Bromus madritensis* ssp. *rubens*), Mojave yucca (*Yucca schidigera*), California buckwheat (*Eriogonum fasciculatum*), Veatch's blazing star (*Mentzelia veatchiana*), winged combseed (*Pectocarya penicillata*), desert trumpet (*Eriogonum inflatum*), peach thorn (*Lycium cooperi*), pencil cholla (*Cylindropuntia ramosissima*), burrobrush (*Ambrosia dumosa*), needle goldfields (*Lasthenia gracilis*), hedgehog cactus (*Echinocereus* sp.), beavertail cactus (*Opuntia basilaris*), barrel cactus (*Echinocactus* sp.), common phacelia (*Phacelia distans*), desert wishbone (*Mirabilis laevis*), winterfat (*Krascheninnikovia lanata*), and Mediterranean grass (*Schismus barbatus*).

Disturbed areas are generally areas that have been subject to a high level of human disturbances from existing mining activities and no longer comprise a native plant community. These areas are unpaved and are primarily or entirely devoid of vegetation, or support ruderal/weedy plant species and are found primarily in the northeast corner and the south portion of the middle of the project site. Disturbed areas include existing mining pits, dirt access roads, and spoil piles. Plant species occurring within these disturbed areas include red brome, short-podded mustard (*Hirschfeldia incana*), and Mediterranean grass.

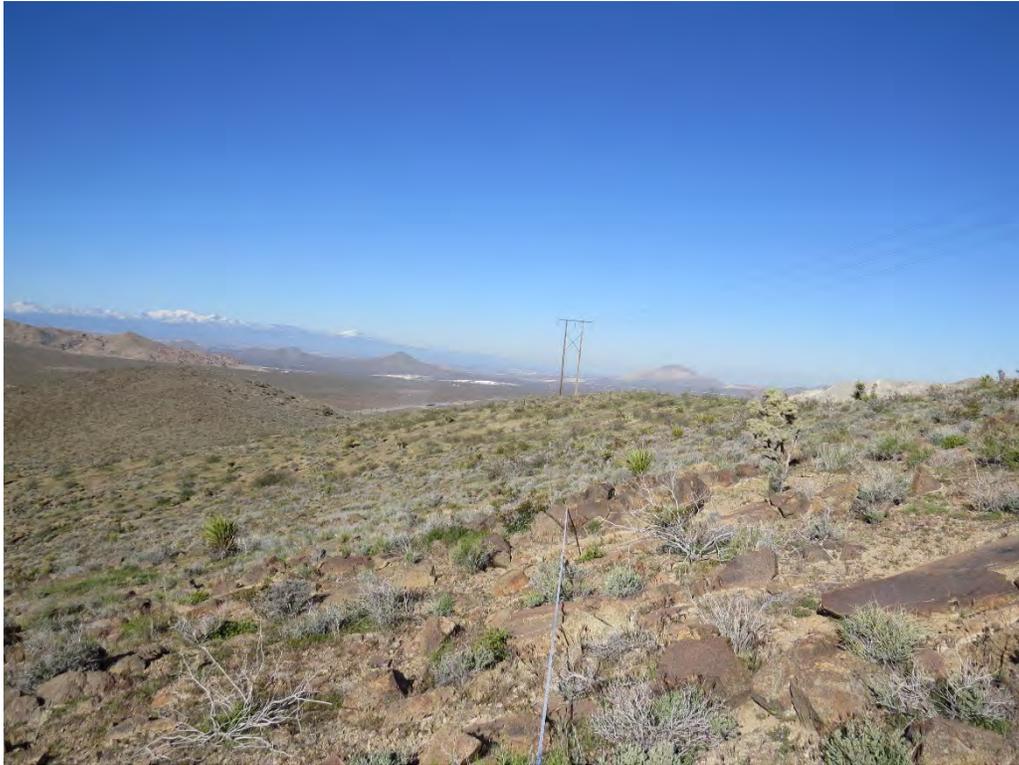
**Photograph 1:** From the northeast end of Transect 1 looking southwest along the transect.

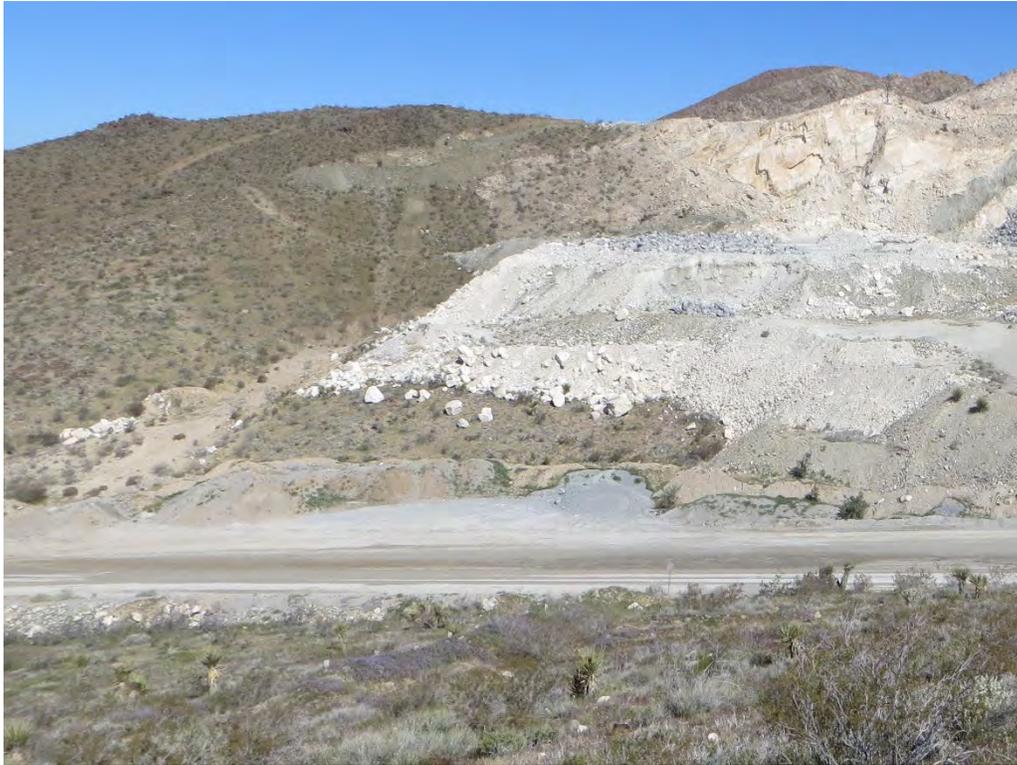
**Photograph 23:** From within the southwest corner of the project site looking northwest. The central disturbed area supporting existing mining activities is visible on the right; creosote bush scrub is visible on the left.
