APPENDIX B-2
ADDENDUM TO VISUAL IMPACT ANALYSIS

Project: Daggett Solar Power Facility

Subject: Administrative Draft Addendum to Visual Impact Analysis – Key Observation Point 6

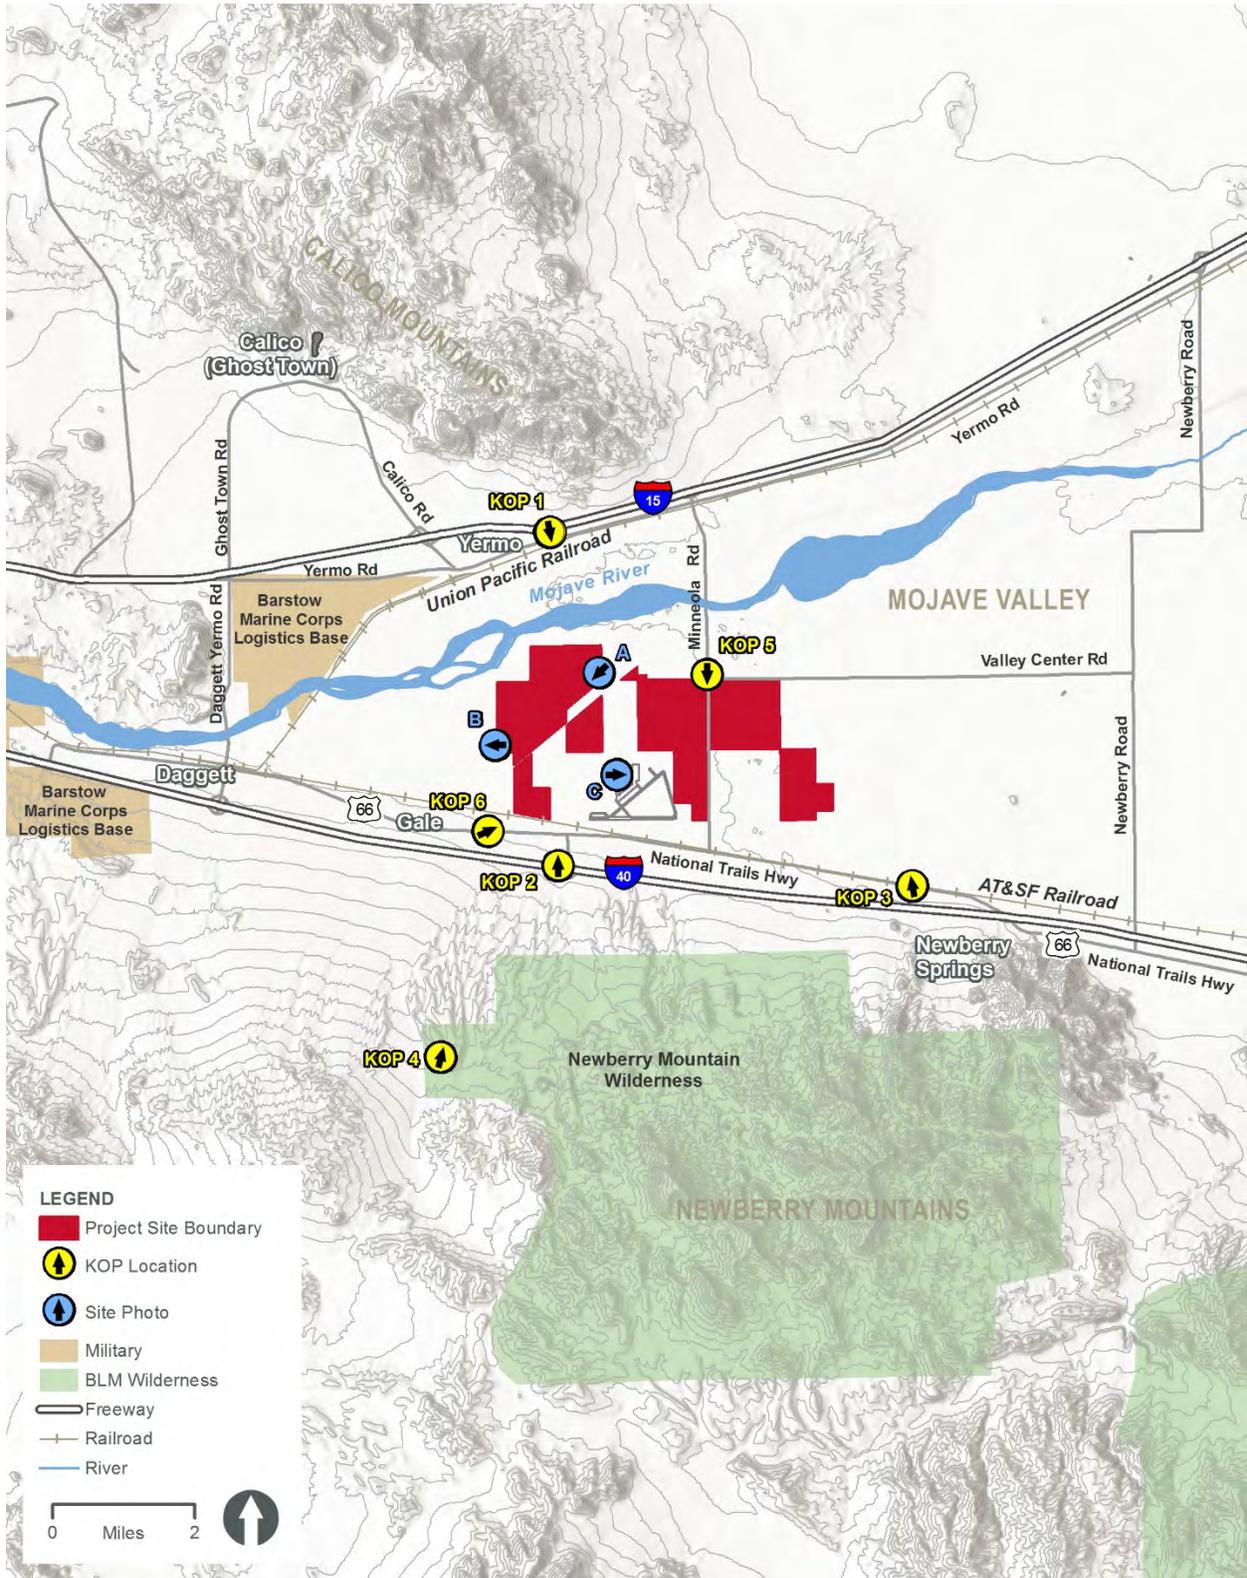
Figure 1. Key Observation Point 6

KOP 6 is located directly on US 66, approximately one mile west of Hidden Springs Road (approximately 34.84916667 latitude, 116.82333333 longitude) (Figure 1). This KOP depicts views of the western Mojave Valley floor along US 66 (Figure 2). A paved road (Sante Fe Street) and electrical distribution lines (and poles) are visible in the foreground, along with a double-tracked railroad, irrigated pasture, and rural residential structures. Bartow-Daggett Airport and scattered rural residential structures and windrows of trees are visible in the middleground. KOP 6 contains a portion of the Project site in the fore- and middleground. Existing physical encroachments include the roadways, overhead power lines (and poles),

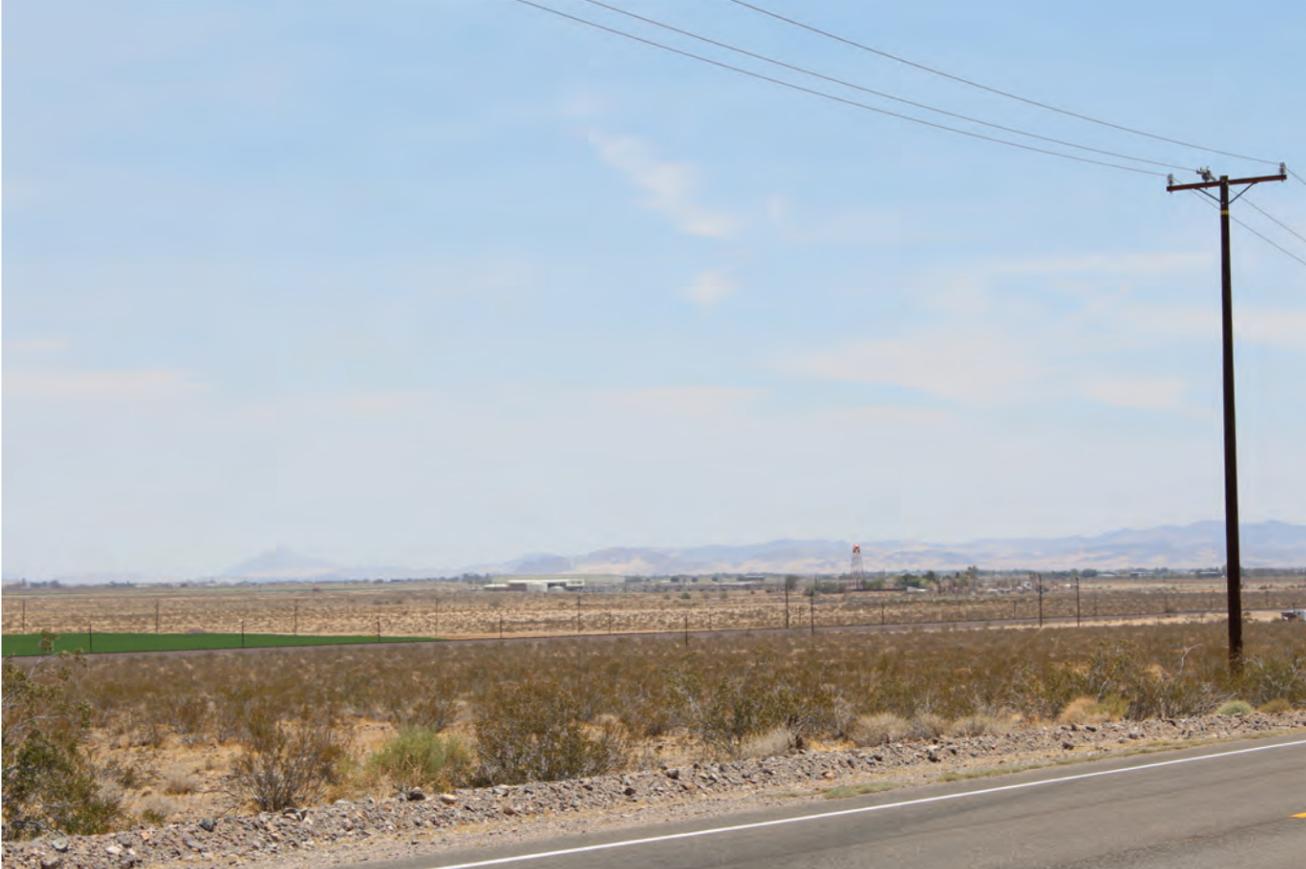
BEFORE - Original Photo

Figure 2. Pre- and Post-Project Conditions at KOP6

Image Data
Camera Model: Canon EOS Rebel T6
Camera Height: 68 inches
Direction of View: East
Distance to Project: 520 meters

KOP 6 is located at the western extent of US 66 in the Mojave Valley, close to where the highway enters the valley near Daggett. This KOP faces east-northeast and is situated just south of the southwestern most solar field in the project site. Both existing and post-project simulation views from KOP 6 are depicted in Figure 2. In addition to eastbound travelers along US 66, there are a few residents just east of KOP 6 that would have a similar view of the project site. As shown in Figure 2, the solar arrays (and fencing) would be visible in the immediate foreground and middleground and would replace the view of an irrigated pasture. The new gen-tie structures and substation would be visible behind the solar array, in the middleground and just west of the Barstow-Daggett Airport. Solder Mountain would continue to be visible in the background. As a result, although the Project would add to the existing visual encroachments within the viewshed, the project solar arrays would be vertically shallow and the transmission towers and substation at distance such that the project would not substantially degrade the viewshed or limit the feeling of openness. Given the existing typical attractiveness, low to moderate scenic quality (Class III), and preexisting visual encroachments, no significant, adverse landscape change is identified for KOP 6.

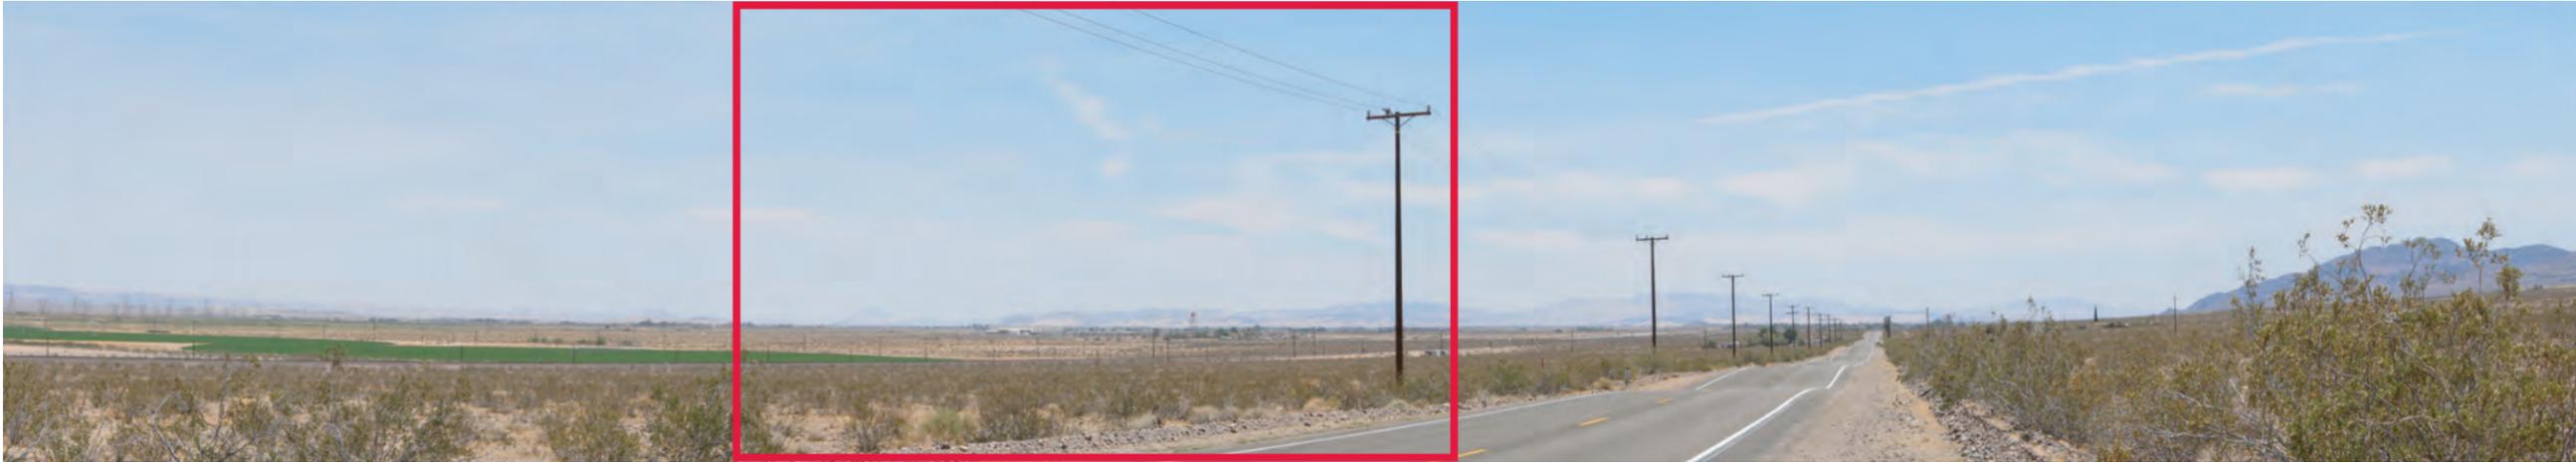
CONTEXT - Original Photo (above left) within Original Panoramic Context
