# **Biological Analysis of a Proposed Lime Plant in Trona, California**

## **Prepared for and Submitted to:**

Panamint Valley Limestone, Inc.  
82532 2<sup>nd</sup> Street  
Trona, CA 93562  
(760) 384-8172

**June 2, 2018**

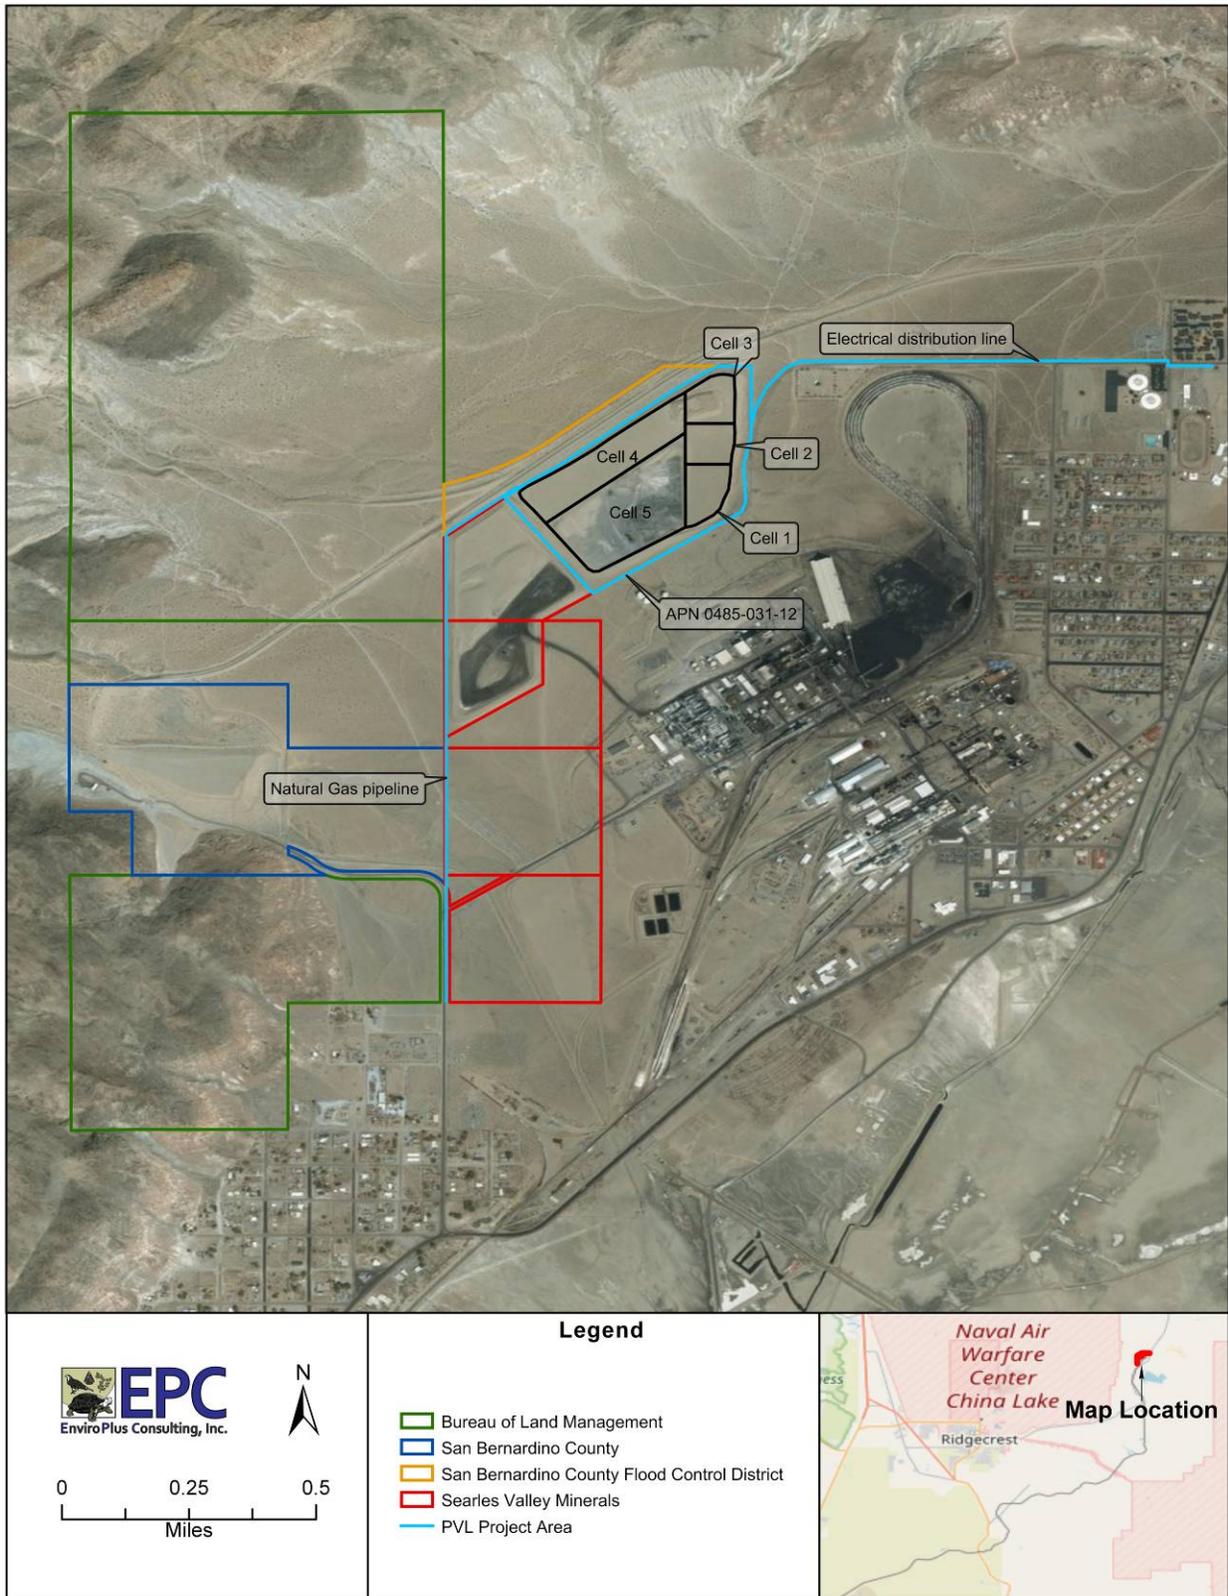
**Figure 2. PVL Lime Plant Project and Land Ownership**

The proposed lime production plant will be located on San Bernardino County Accessor's Parcel Number (APN) 0485-031-12 and will occupy about thirty acres of the 61.65 acre site. Additional utilities for the site will include a 1.1 mile long natural gas pipeline and a 0.8 mile electrical distribution line. Plastic pipe eight inches or less in diameter will be used for construction of the gas pipeline. These features are shown on Figure 2.

The lime plant will require a natural gas supply for the kiln. A 1.1 mile natural gas pipeline will be constructed to the facility. Electricity will be provided to the site via a newly constructed electrical distribution line approximately 0.8 mile in length. Both of these utilities are shown on Figure 2.

The ash landfill is segregated into five individual cells (Figure 2). When ACE ceased operations, all ash remaining at the boiler was disposed in the landfill and ash disposal operations terminated. Cells #1 to #4 had previously been closed, capped, and allowed to naturally revegetate. Cell #5 was approximately 80% full with solidified ash sloping gently from the two ash disposal locations on the north and south of the cell toward the west. A portion of cell #5 was left open to allow for disposal of boiler refractory lining during demolition of the plant facilities. This activity is no longer planned.

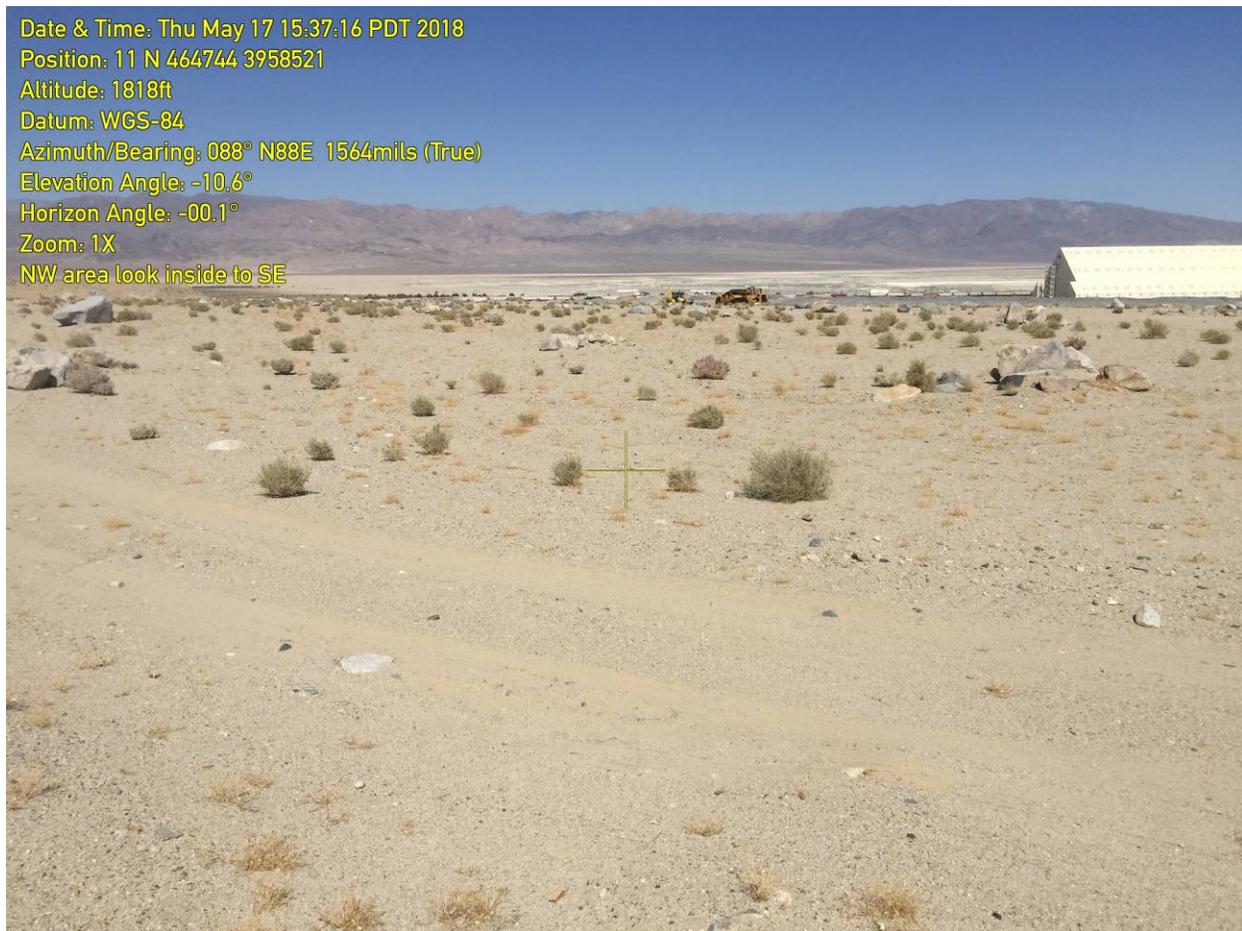
**Photograph 1. PVL Lime Plant Project site showing very low succesional vegetation density.**

Twenty-three years of deposition at the Site has resulted in a landfill that is about 15 feet higher than the surrounding terrain and lies at an elevation of about 1,800 feet. Limited revegetation (Photo 1) has occurred on the landfill in the four years since operations ceased with the exception of Cell #5 which is currently open and denuded (Photo 2). The successional vegetation on the site is characteristic of the vegetation surrounding the site only at a much lower vegetation density (Photo 3). The vegetation is an Allscale Shrubland Alliance (Sawyer, Keeler-Wolf and Evens 2009) dominated by allscale (*Atriplex polycarpa*), desert holly (*Atriplex hymenelytra*), and shadscale (*Atriplex confertifolia*).

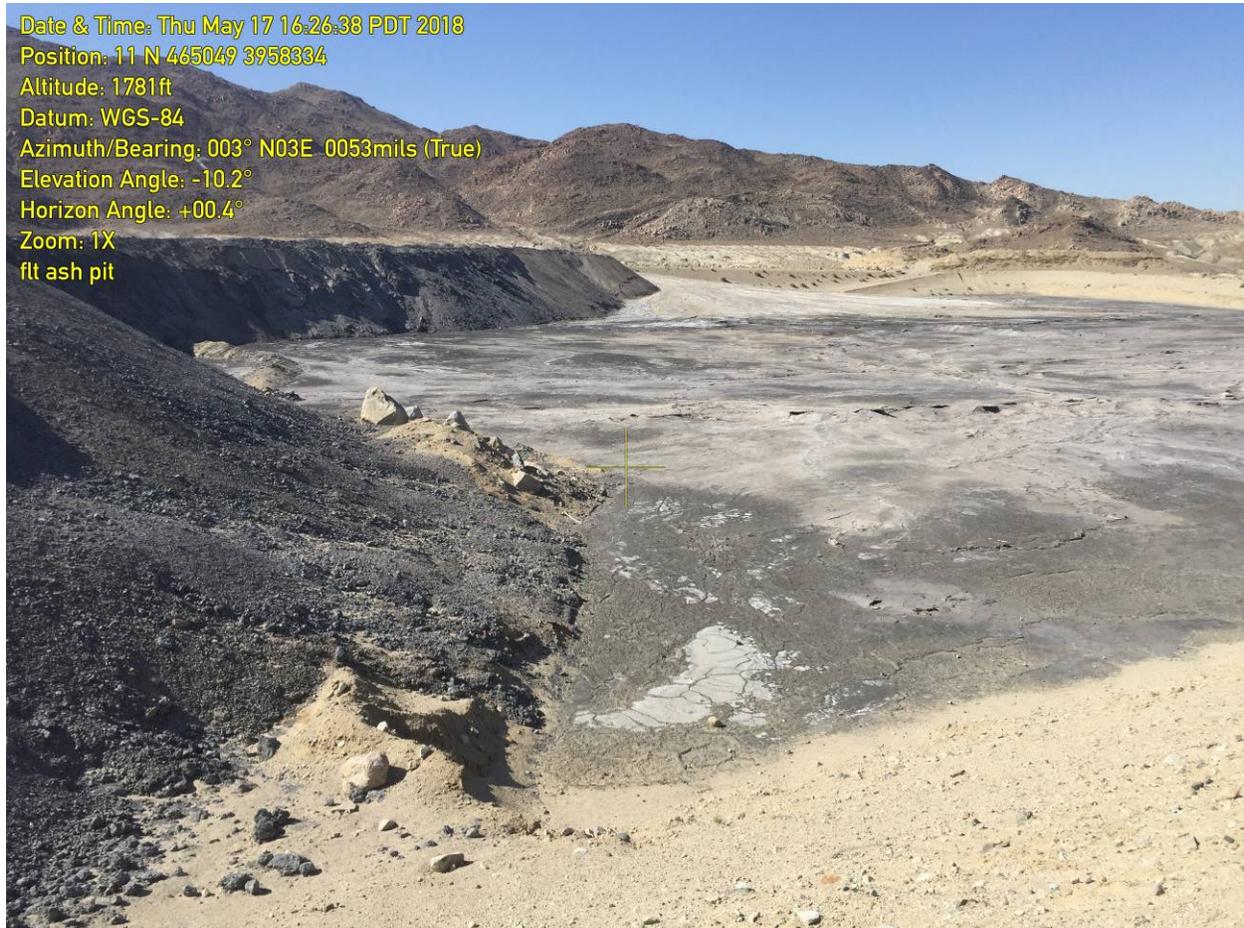
**Photograph 2. PVL Lime Plant Project – view of open Cell #5 showing disposed ash**

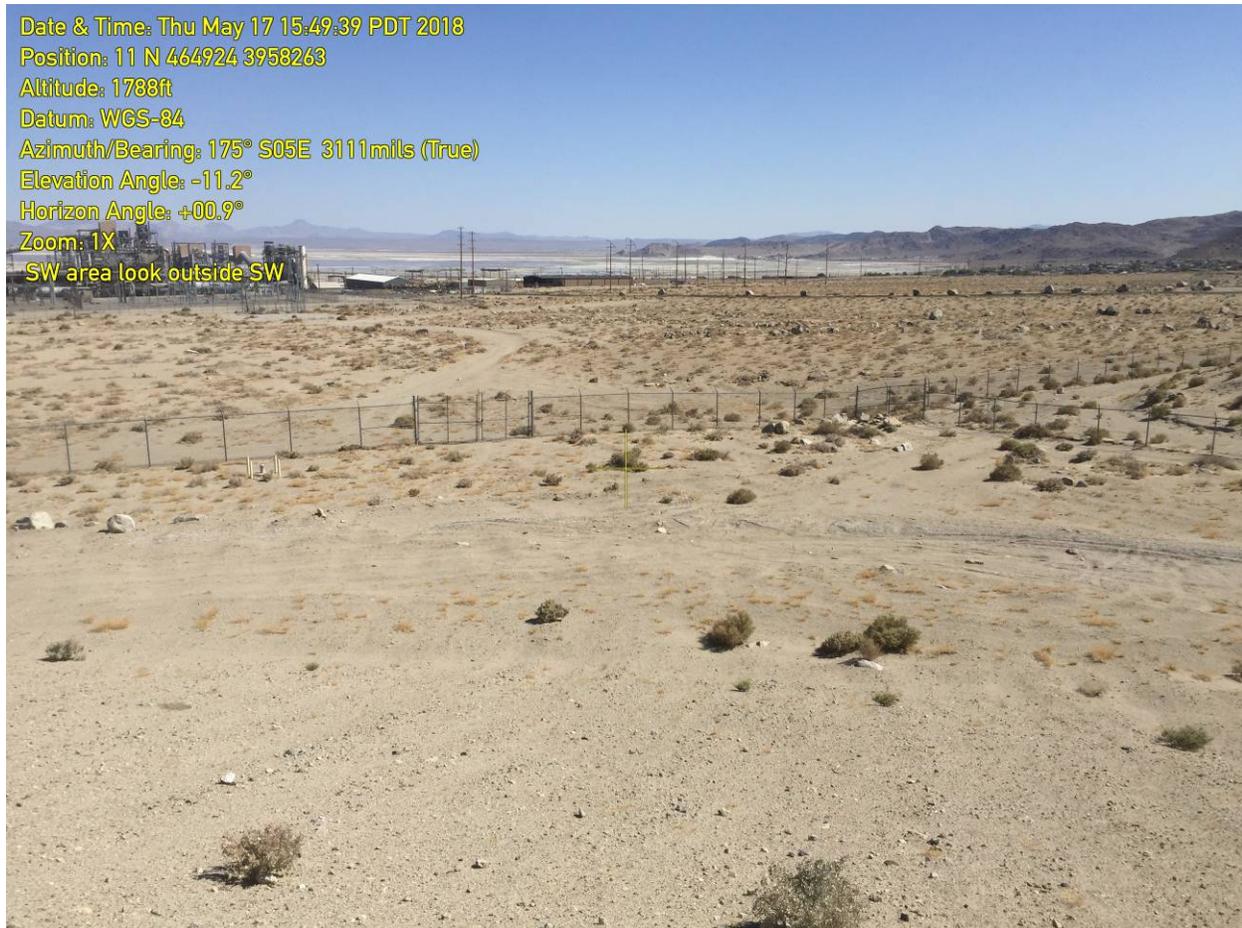
**Photograph 3. PVL Lime Plant Project – comparison of vegetation density inside (foreground) and outside (background across fence) of proposed site**

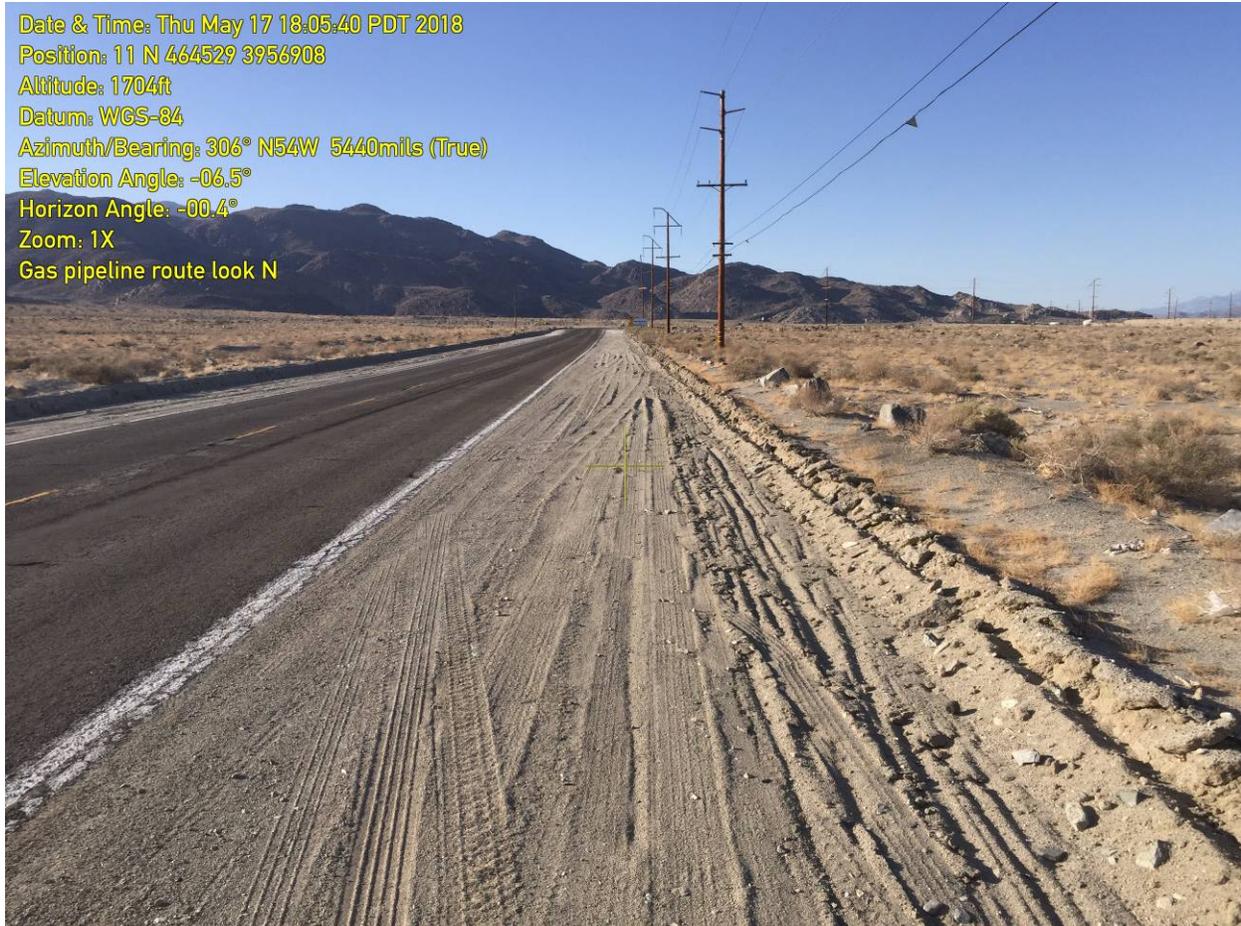
**Photograph 4. PVL Lime Plant Project – view north from the origin of the natural gas pipeline along First Street**

The natural gas pipeline originates near the northern terminus of residential housing along paved First Street in Trona where it will tie-in to an existing pipeline (Figure 2) and traverse along the road right-of-way (Photo 4). The paved road turns abruptly about 1,200 feet north of the pipeline origin while the pipeline continues northward. The pipeline route then traverses generally along a dirt road for about 1,500 feet. There are numerous dirt roads and off-road vehicle trails and tracks in this area indicating a moderate level of human impacts. This area and the more northerly segment of the pipeline route is relatively sparsely vegetated Allscale Shrubland Alliance (Sawyer, Keeler-Wolf and Evens 2009) dominated by allscale and desert holly. A few creosote bushes (*Larrea tridentata*) are found in the area (Photo 5). The pipeline route continues northward for about 3,500 feet immediately adjacent to another ash landfill surrounded by a chain link fence, this one operated by Searles Valley Minerals. In this stretch, the pipeline would be on located under an existing dirt road (Photo 6). Finally, the gas pipeline turns to the northeast and will be sited between the Searles Valley Minerals ash landfill chain link fence and a moderate use dirt road that parallels a San Bernardino County Flood Control District channel (Photo 7). The gas pipeline would enter the site along its northern boundary.

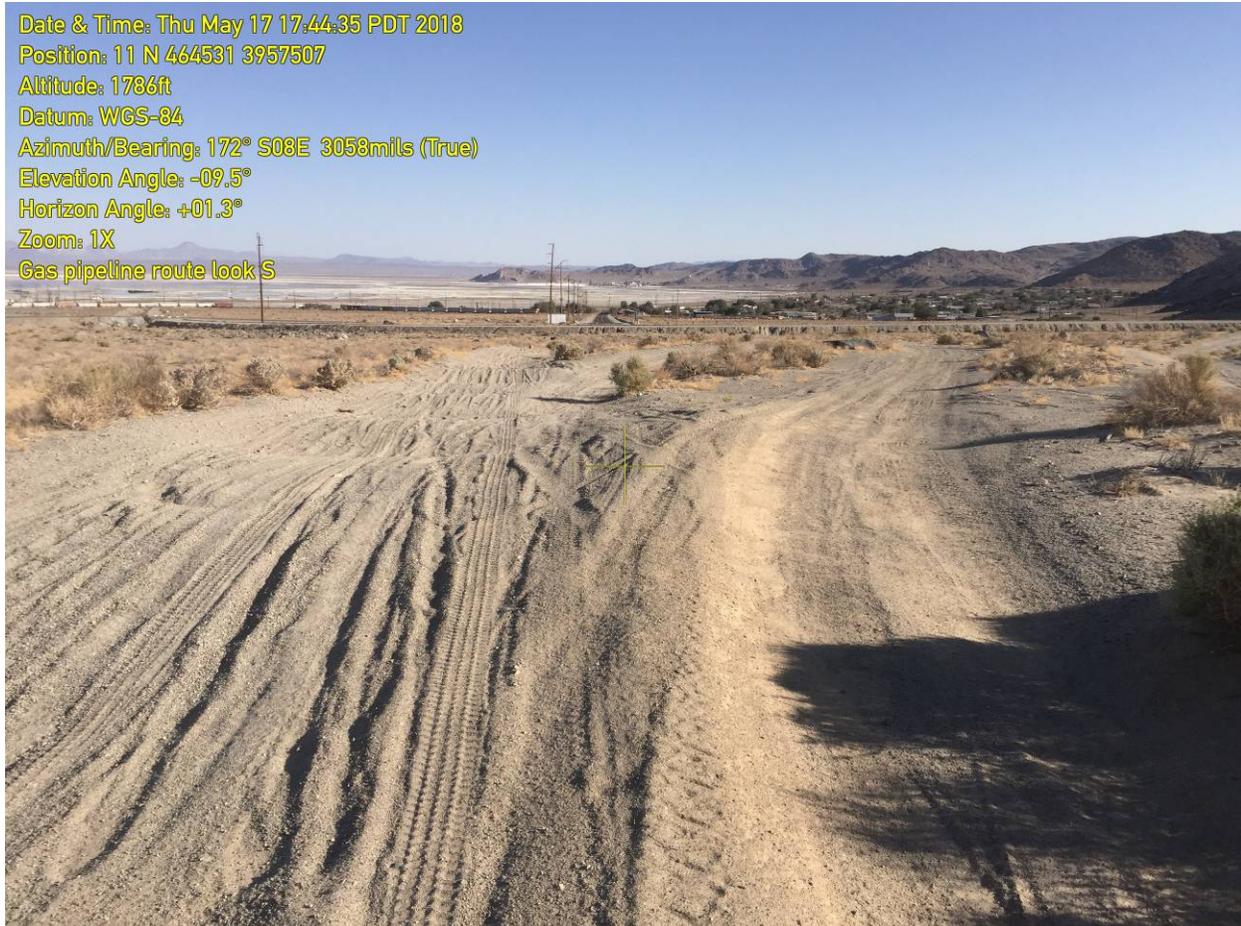
**Photograph 5. PVL Lime Plant Project – view south along 1,500 foot, moderately impacted native habitat section of natural gas pipeline**

Portions of the natural gas pipeline lie along paved and dirt roads. However, approximately 2,200 feet of the line (a 1,500 foot section and an 800 foot section) lies in native habitat that has been moderately disturbed by the presence of dirt roads and trails. In this area the potential exists for Borrego milk-vetch to be found. This plant is of limited distribution in California and is not very endangered (CNPS 2018). It is not a state or federally listed species.

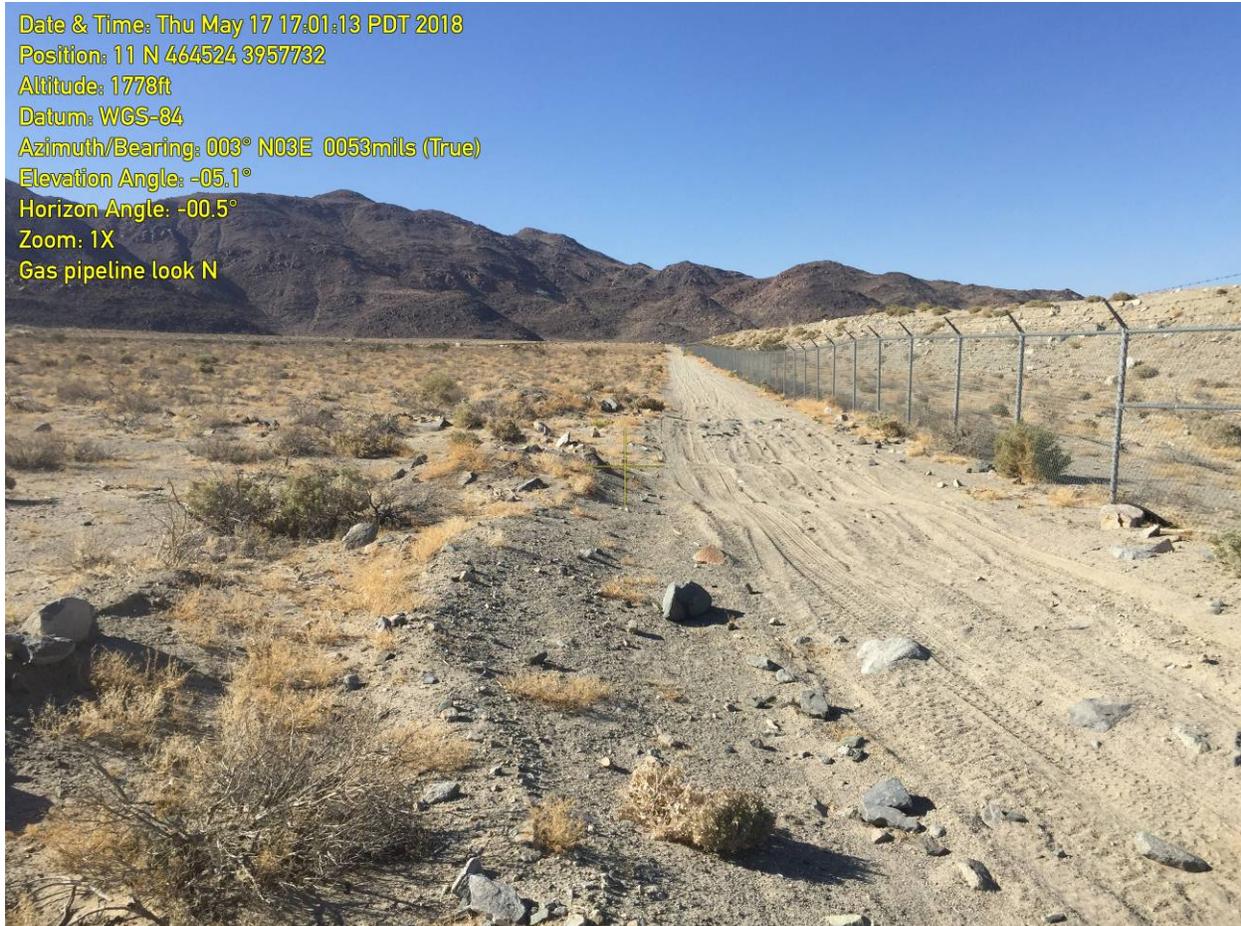
**Photograph 6. PVL Lime Plant Project – view north along 3,500 foot section of natural gas pipeline that will lie on an existing dirt road immediately adjacent to Searles Valley Minerals ash disposal landfill (seen on the right side of the frame)**

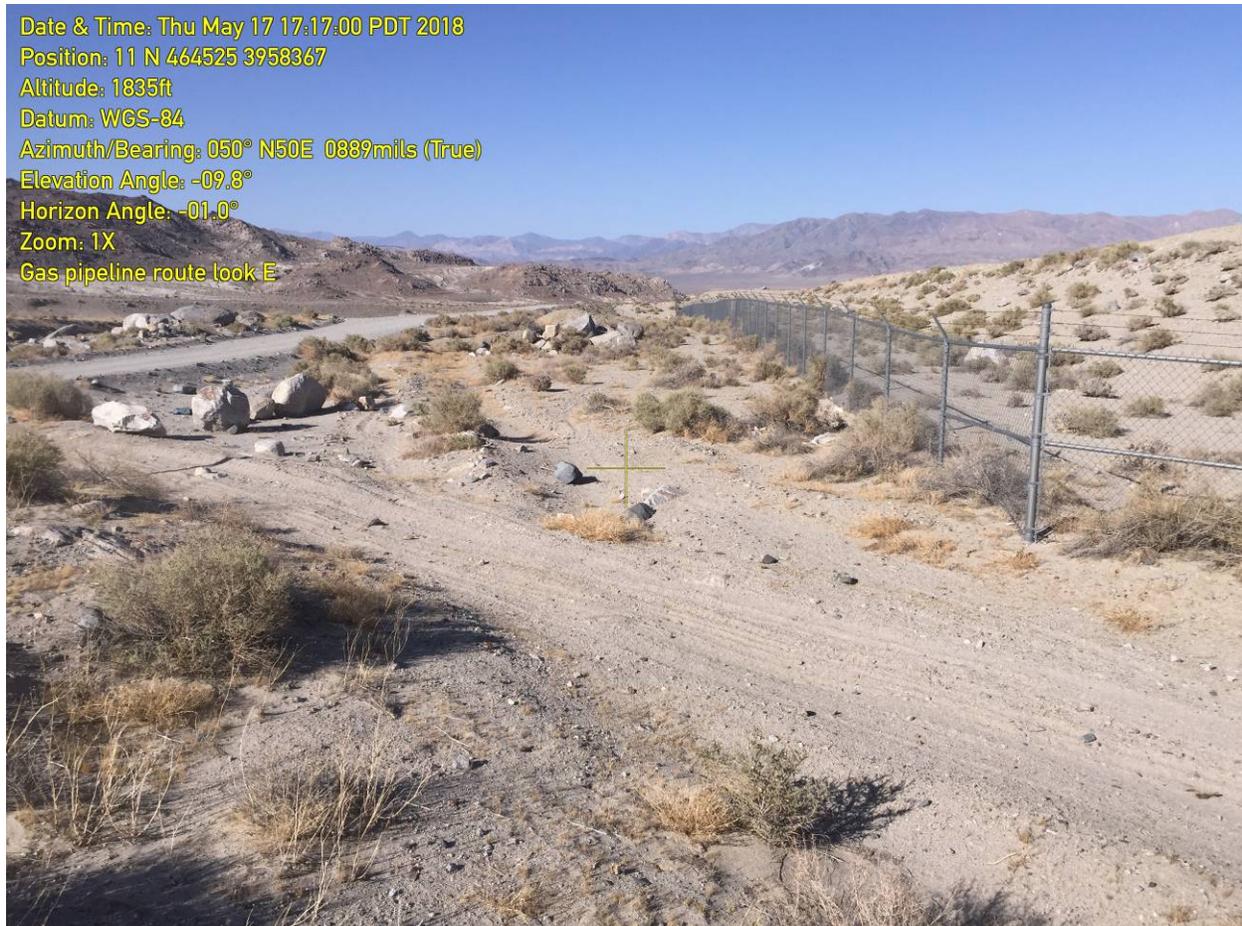
**Photograph 7. PVL Lime Plant Project – view northeast along 800 foot section of pipeline route between an existing Searles Valley Minerals ash landfill on the right and a moderated used dirt road at the top of a flood control channel on the left**

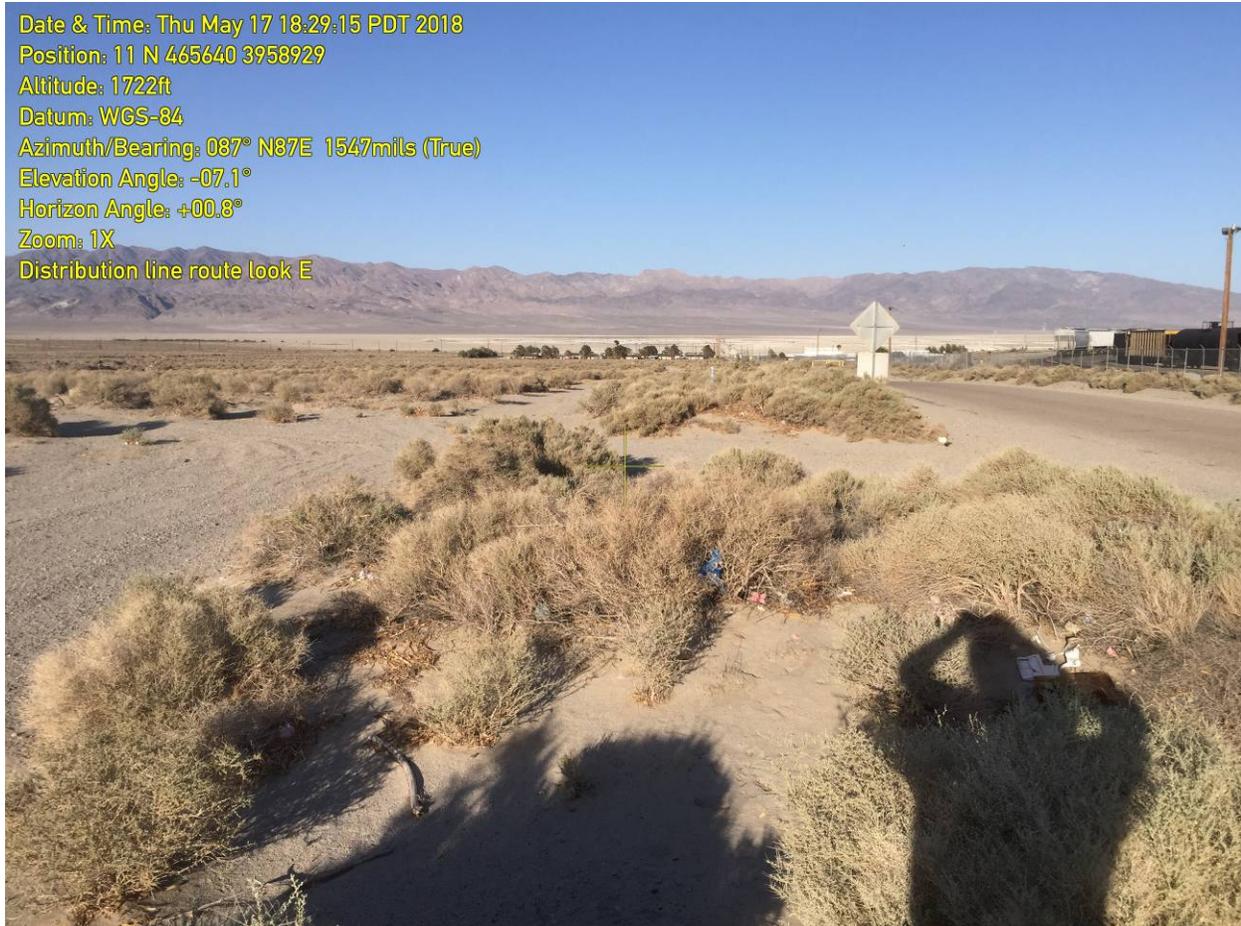
**Photograph 8. PVL Lime Plant Project – view east along proposed electrical distribution line adjacent to paved Athol Street**

The electrical distribution line originates at the Trona substation near the Trona High School. From there it traverses westward following paved Athol Street which curves to the south as it enters the Site (Figure 2). The entirety of the electrical distribution line is along the paved road which is heavily impacted by utilization of the roadway (Photo 8). Vegetation along the electrical distribution line differs from other project areas in that it is a near monoculture of allscale.

No evidence of sensitive species was observed along the route of the electrical distribution line. It will be located immediately adjacent to an existing paved road and the potential for sensitive species occurrence is considered very low.
