Project No. 16027-01

SUBJECT: Response to County of San Bernardino Geotechnical/Geological Report Review Sheet dated July 13, 2017, Proposed Islamic Community Center, Northwest Corner of Beaumont Avenue and Nevada Street, APN 0293-111-15-0000, Redlands, California

REVIEW RESPONSES

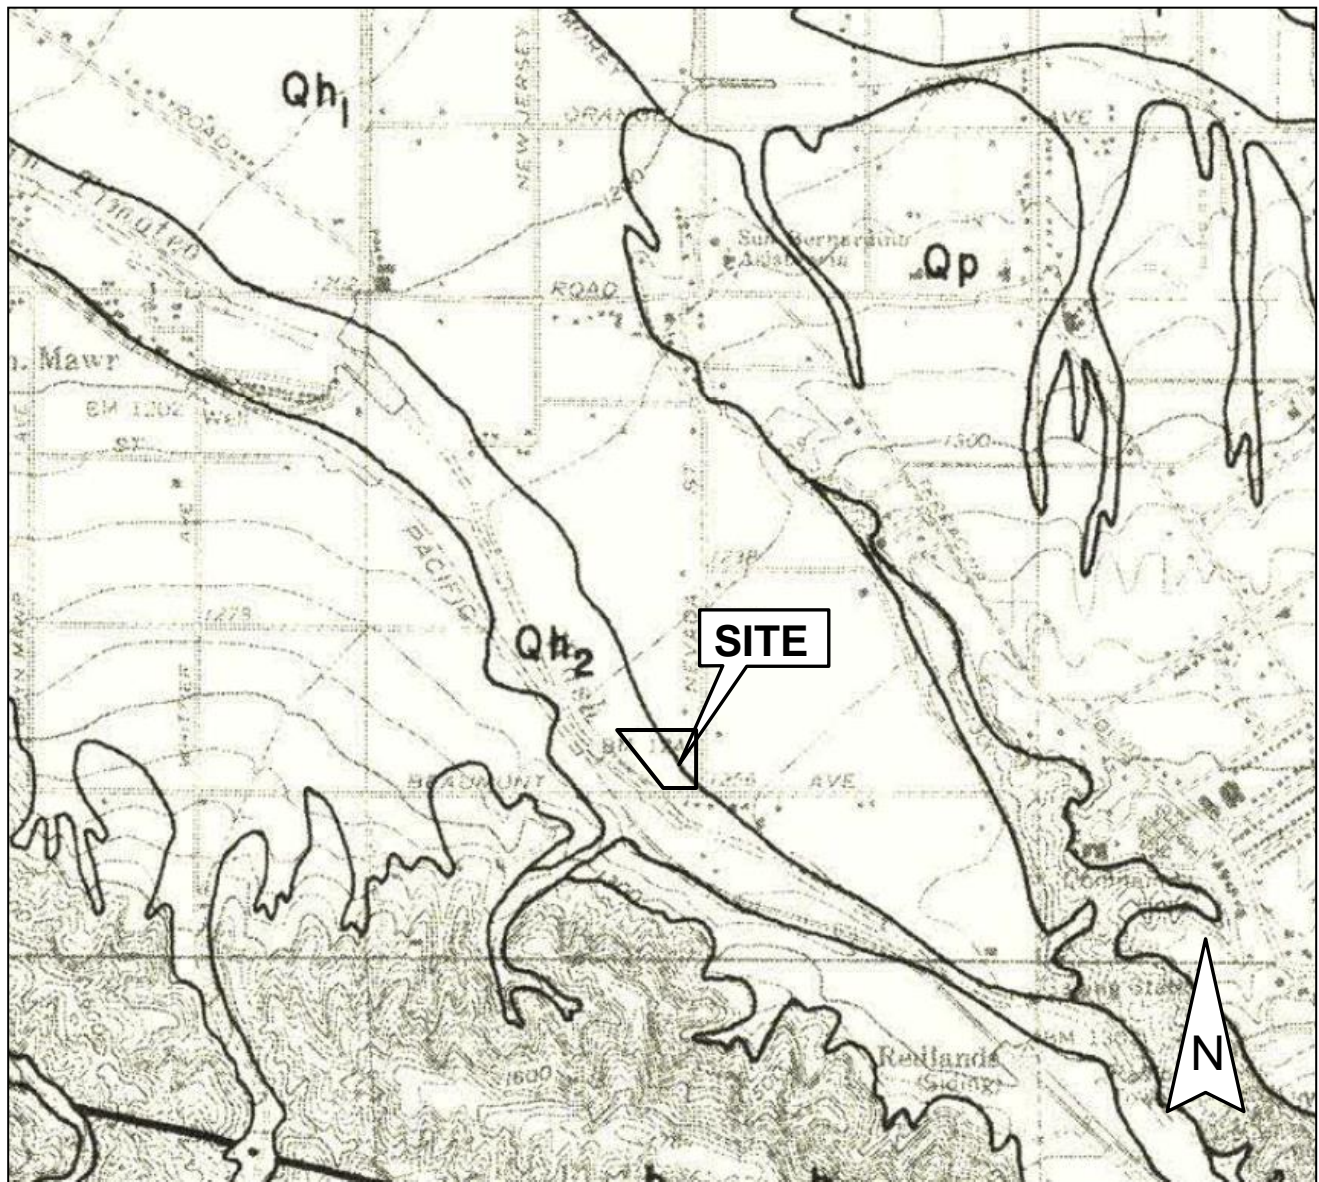
FIGURE 1

REGIONAL GEOLOGIC MAP – USGS BULL 1898

- Qh₂** YOUNGER HOLOCENE ALLUVIAL DEPOSITS—Undissected to slightly dissected surfaces. Pedogenic soil development ranges from none to weak; the most well-developed soils have A horizons and thin C_{ox} horizons. Geomorphologic and soil evidence suggests that these materials were deposited within approximately the last 500 to 1,000 years
- Qh₁** OLDER HOLOCENE ALLUVIAL DEPOSITS—Moderately dissected surfaces. Pedogenic soil development ranges from soils with A horizons and thin C_{ox} horizons to soils with A, weak argillic, and C_{ox} horizons. Geomorphologic and soil evidence suggests that these materials were deposited between approximately 500 to 1,000 years ago and 10,000 years ago, although deposits as old as 15,000 years may be included

According to USGS Bull 1898 (Figure 1), the site is underlain by Holocene-age alluvial deposits derived from sedimentation of San Timoteo Creek. The alluvium has been divided into Younger Holocene (Qh2) and Older Holocene deposits (Qh1) based on pedogenic soil development. The northeastern portion of the site is mapped as Older Holocene Alluvium (age ranging from 500 to 10,000 years, and possibly as old as 15,000 years). The southwestern portion of the site is mapped as Younger Holocene Alluvium (age ranging from approximately 500 to 1,000 years), closer to the San Timoteo Wash. The subject site in relation to the younger and older alluvial units is indicated on Figure 1.

Review of the above aerial photographs reveal that the subject lot was occupied by an orchard from 1938 through 1969. Curvilinear tonal variations across the ground surface appear to represent meanders associated with fluvial sediment deposition, and are consistent with the contact between younger and older Holocene alluvial units transecting the site from northwest to southeast as shown on Figure 1 (from USGS BULL 1898) and Figure 3 (from OFR 2003-0302).

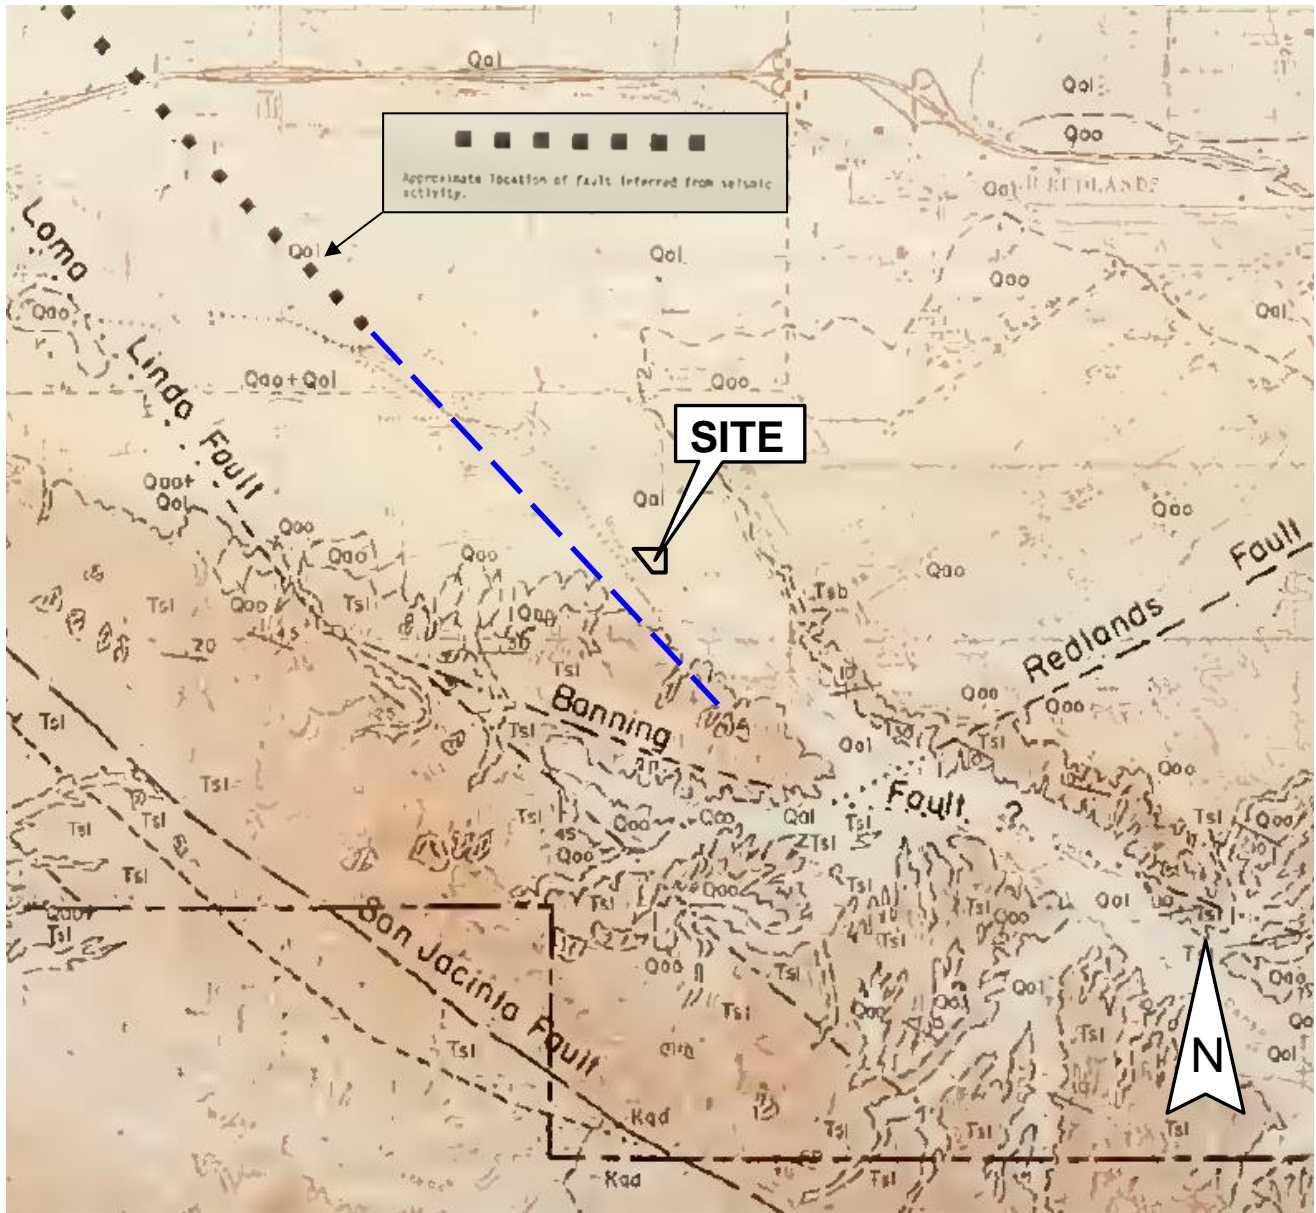
FIGURE 2

REGIONAL FAULTS – SR 113

GENERALIZED GEOLOGIC MAP OF
SOUTHWESTERN SAN BERNARDINO COUNTY, CALIFORNIA
Compilation By D. M. Morton, 1974
U. S. Geological Survey

According to SR 113 (Morton, 1974) a northwest-trending fault is located approximately 3,600 feet southwest of the site; this fault is labeled “Banning Fault” according to this reference. The active San Jacinto fault is mapped approximately 1.8 miles southwest of the site according to this reference. The subject site in relation to faulting presented in SR 113 is indicated on Figure 2.

According to CDMG SR 113 (Morton, 1974) an "inferred northwest-trending fault that projects southeastward toward the site based on seismic activity" is located approximately 1 ½ miles northwest of the site (see Figure 2). Extrapolation of this fault toward the subject site shows that it passes southwest of the site, across the San Timoteo Creek channel, along the base of the southwesterly-ascending hills. CDMG SR 113 also contains an alluvial isopach map (see Figure 7) showing contours of alluvial thickness. The contours appear concentrated at a location south-southeast of the site, which may be evidence for a deeply buried escarpment feature along the base of the ascending hills southwest of the San Timoteo Creek channel, approximately ¼- to ½-mile from the subject site, which also roughly aligns with the inferred fault projection discussed above and highlighted on Figure 2.

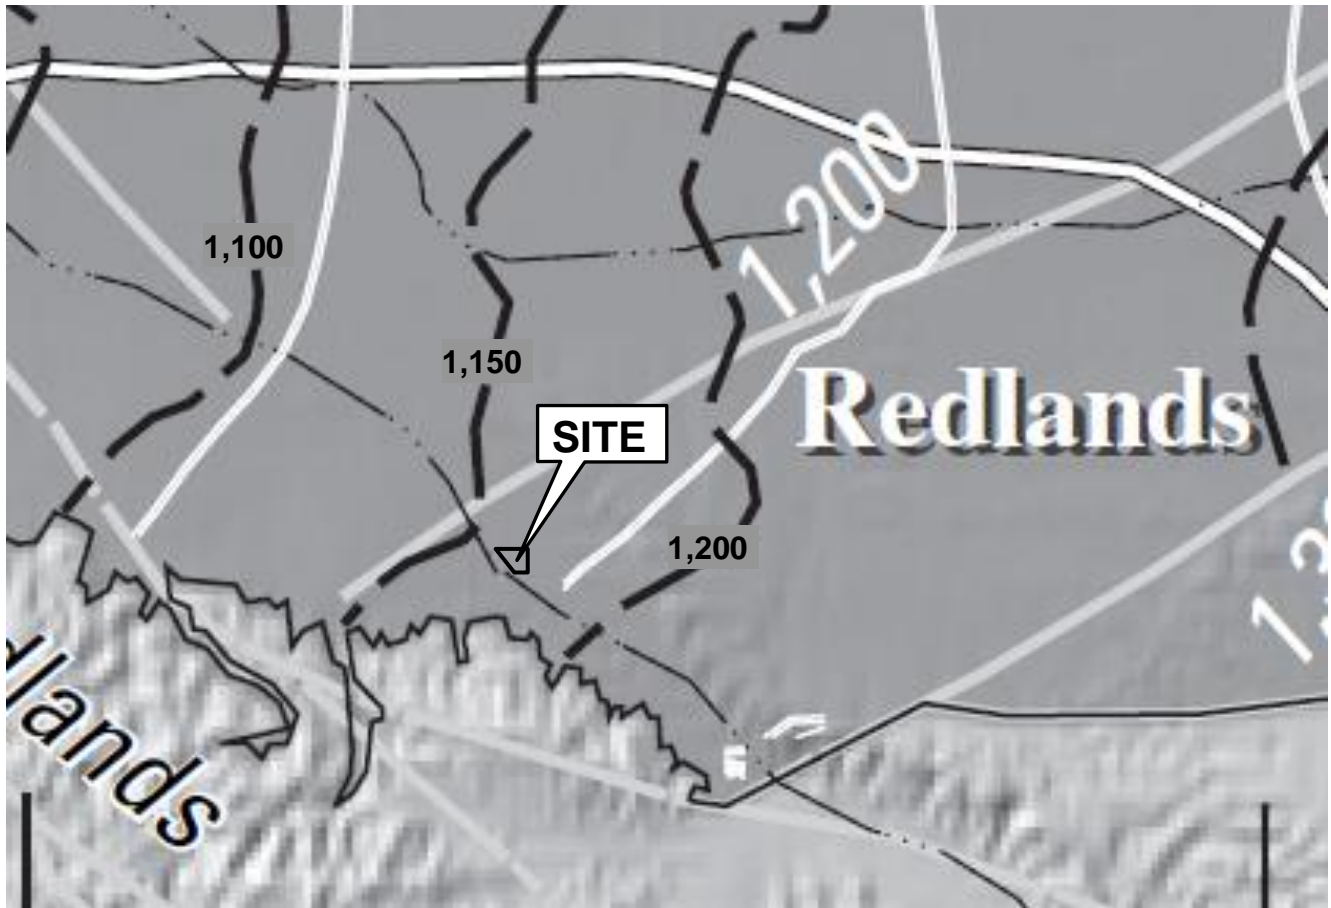
1945 GW CONTOURS – OFR 2005-1278

Figure 42. Measured ground-water levels and simulated hydraulic heads for the unconfined part of the valley-fill aquifer in the San Bernardino area, California, 1945. Measured contours adapted from unpublished map by F.B. Laverty (San Bernardino Valley Municipal Water District, written commun., 1998).

According to USGS Open File Report 2005-1278, the 1945 ground water elevation contour beneath the subject site was 1160', corresponding to a depth of approximately 90' below the current surface grade (see Figure 4). According to this reference, the 1945 ground water elevation contour gradient is approximately 57' per mile along San Timoteo Wash, in an area bracketing the subject site. Extrapolation of the Spring 2017 ground water elevation of 1050.6' (136' depth) from a well approximately 1 mile northwest of the site (Bryn Mawr #4, State Well #01S03W31B001S, El. 1186.6'), located along the alignment of the San Timoteo Wash, would yield a ground water elevation of approximately 1108' (or 142' depth) at the subject site.

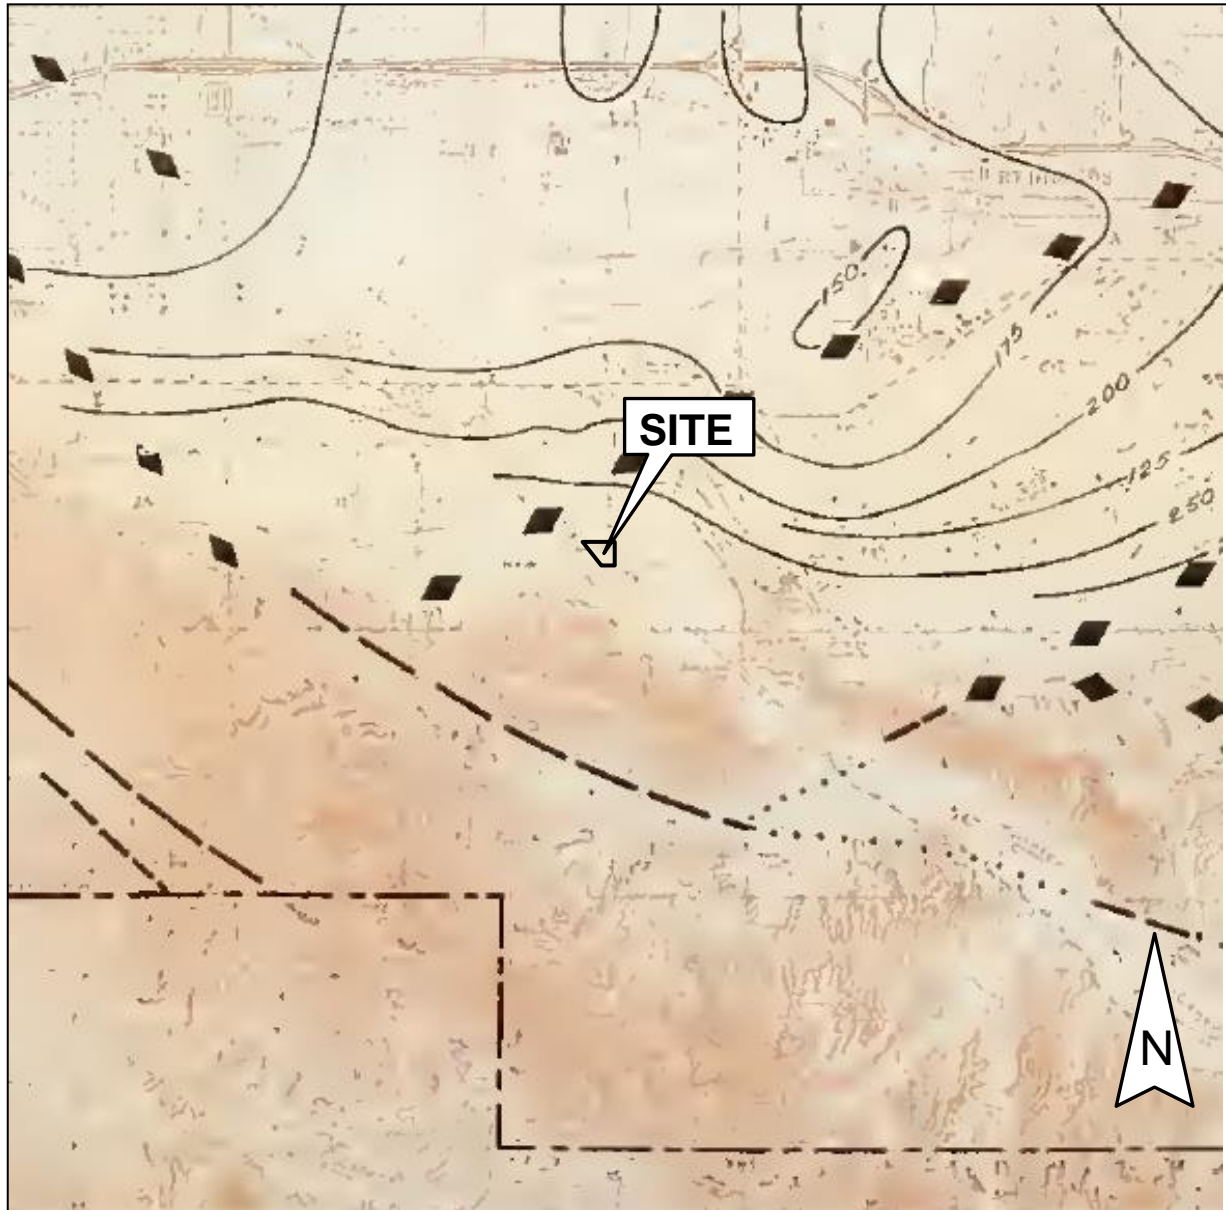
FIGURE 5

GROUND WATER ELEVATIONS (1960's) – SR 113

MAP SHOWING SURFACE WATERS AND MARSHES IN THE LATE 1800s, AND GENERALIZED DEPTH TO GROUND WATER (1960)*UPPER SANTA ANA VALLEY, SOUTHWESTERN SAN BERNARDINO COUNTY, CALIFORNIA
Compiled By Donald L. Fife, 1974

175
Line of equal depth to ground water in feet

Ground water elevation contours presented in CDMG Special Report 113 (1976) indicate depth to ground water below the subject site of approximately 250' (or greater) during the 1960's (see Figure 5).

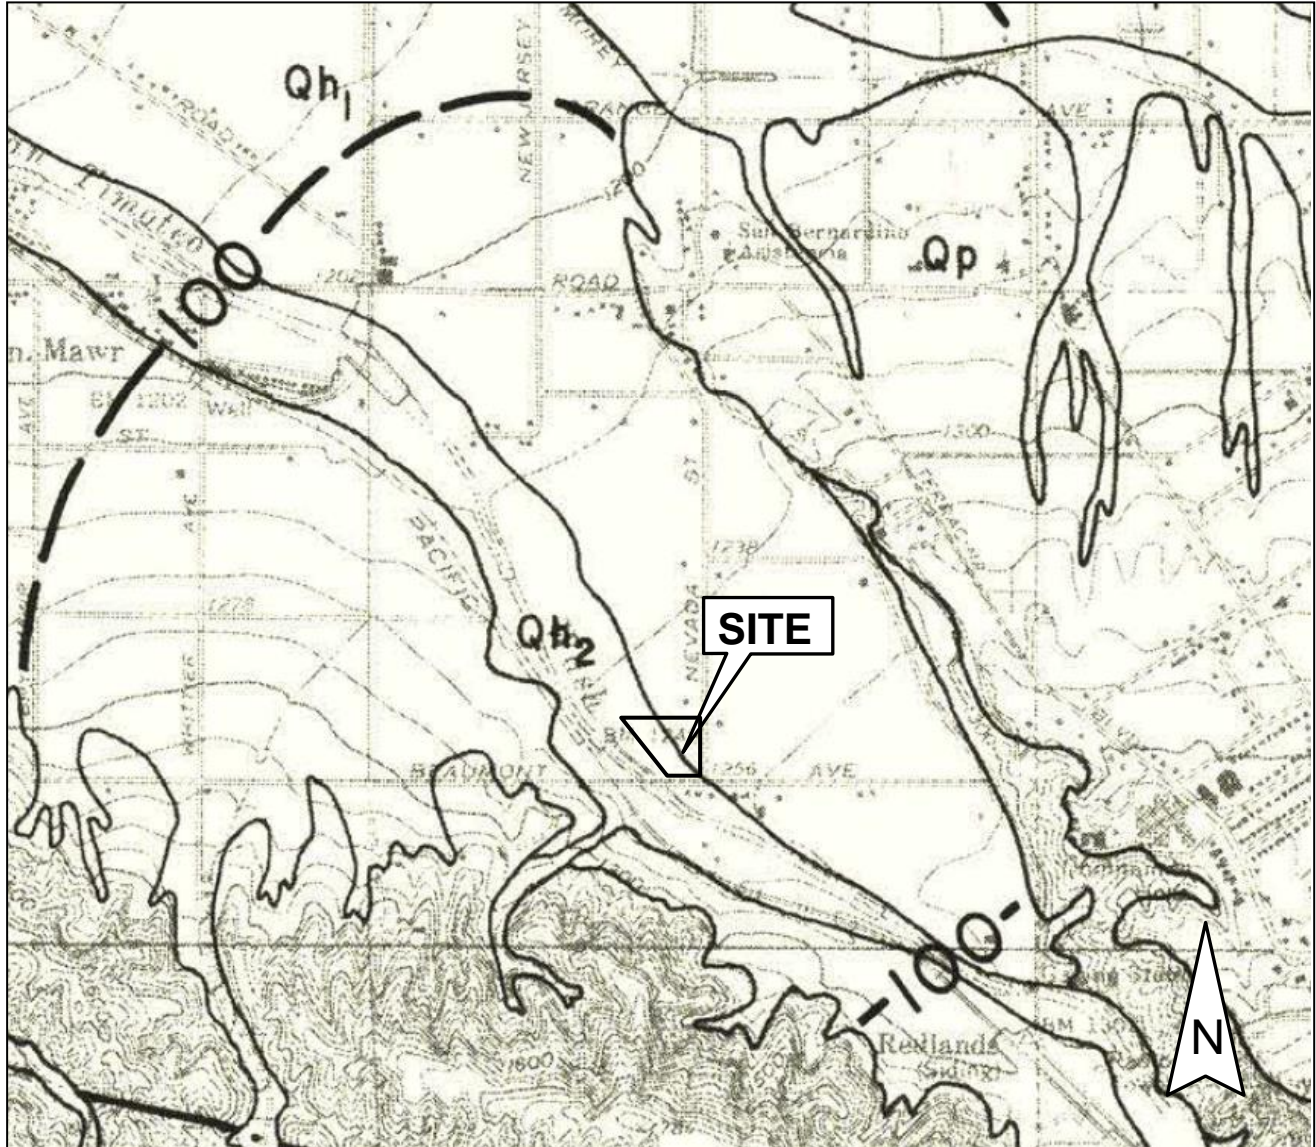
**CONTOUR MAP SHOWING MINIMUM DEPTH TO GROUND WATER,
SAN BERNARDINO VALLEY AND VICINITY, 1973-1983**

— 50 — — — — CONTOUR LINE SHOWING MINIMUM DEPTH TO GROUND WATER DURING 1973–1983 PERIOD—Dashed where location uncertain; depth in feet below land surface. Contour interval 20 ft at depths less than 50 ft, 25 ft between 50 and 100 ft, and 50 ft at depths greater than 100 ft

According to USGS Bulletin 1898, ground water contours indicate a minimum depth of approximately 100' below surface during 1973-1978 (see Figure 6).

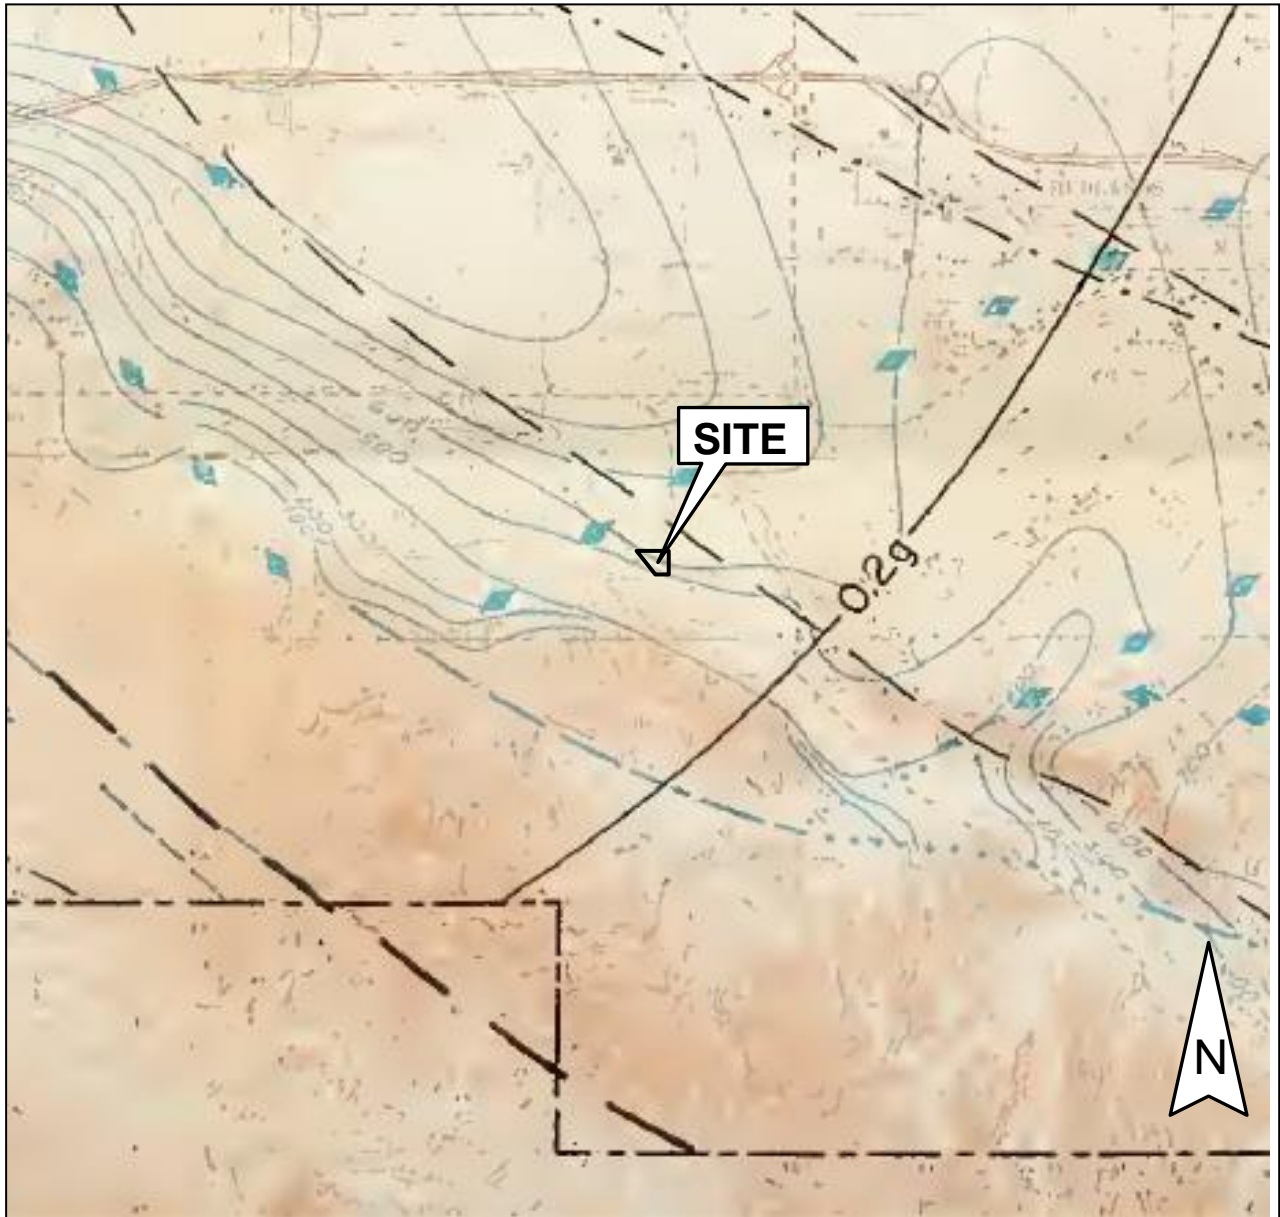
FIGURE 7

ALLUVIAL ISOPACH – SR 113

GENERALIZED GEOLOGIC MAP OF SOUTHWESTERN SAN BERNARDINO COUNTY, CALIFORNIA

Both CDMG SR 113 (Figure 7) and USGS OFR 2005-1278 (Figure 8) refer to a northeast-aligned groundwater barrier identified as the Bryn Mawr Barrier on Figure 8. This ground water barrier is located approximately ½-mile northwest of the subject site.

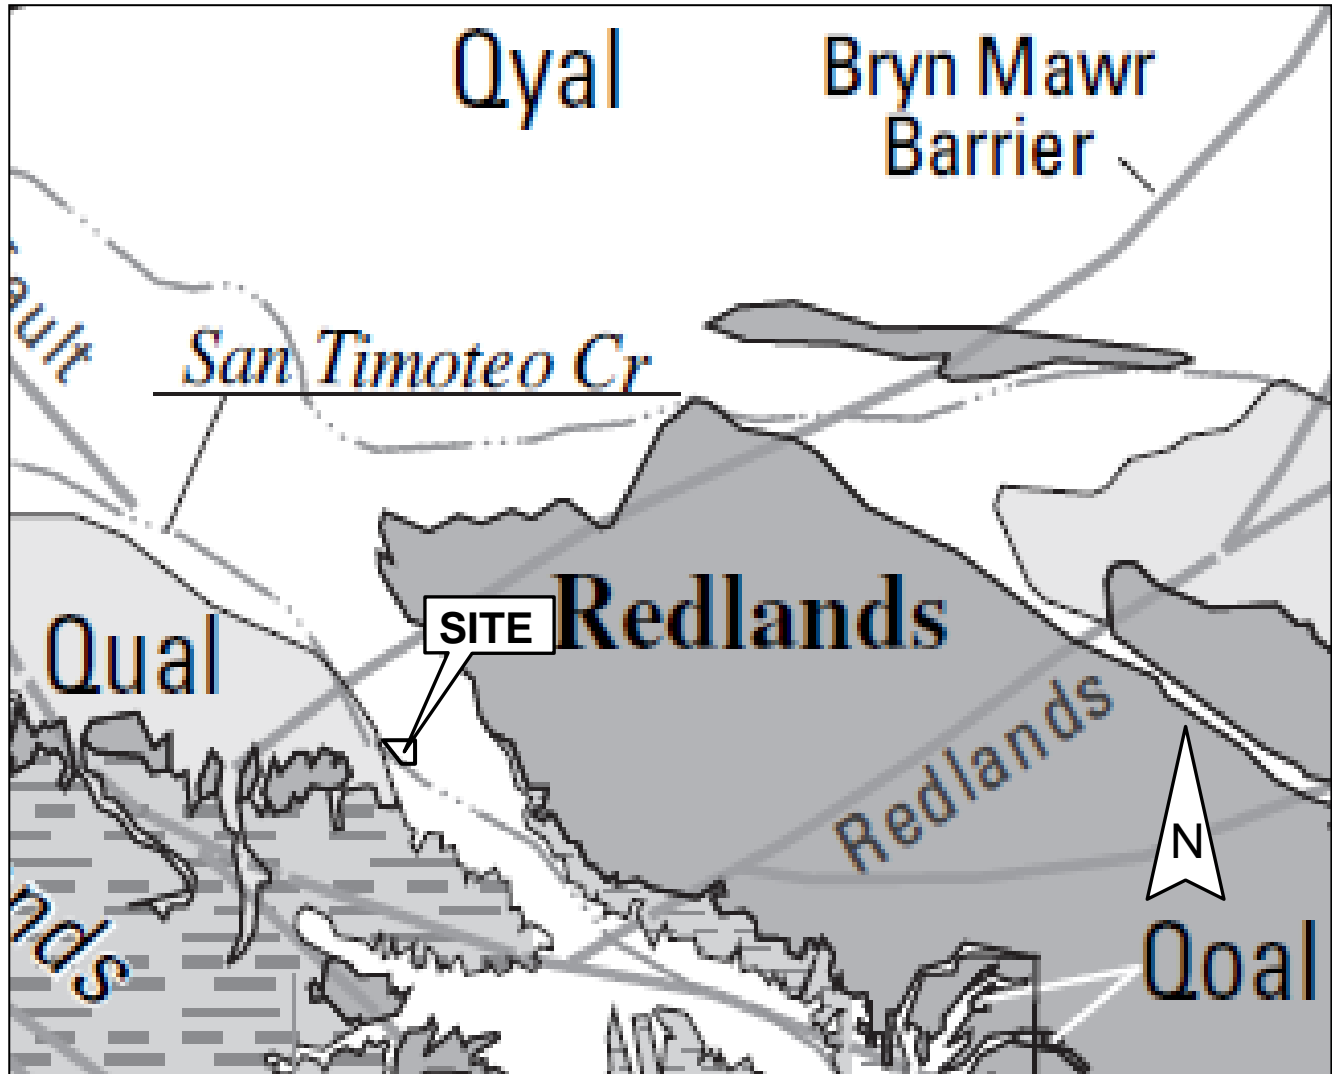
FIGURE 8

REGIONAL FAULTS – OFR 2003-0302

Fault or ground-water barrier— May be concealed or approximately located

Figure 5. Generalized surficial geology of the San Bernardino area, California, adapted from Morton (1974) and Dutcher and Garrett (1963).
