FINAL
Drainage Feasibility Study
Volume III (Geotechnical Component Vol. 2)

Community of Rimforest
County of San Bernardino, CA

November 8, 2010

APPENDIX B
PHOTOGRAPHS

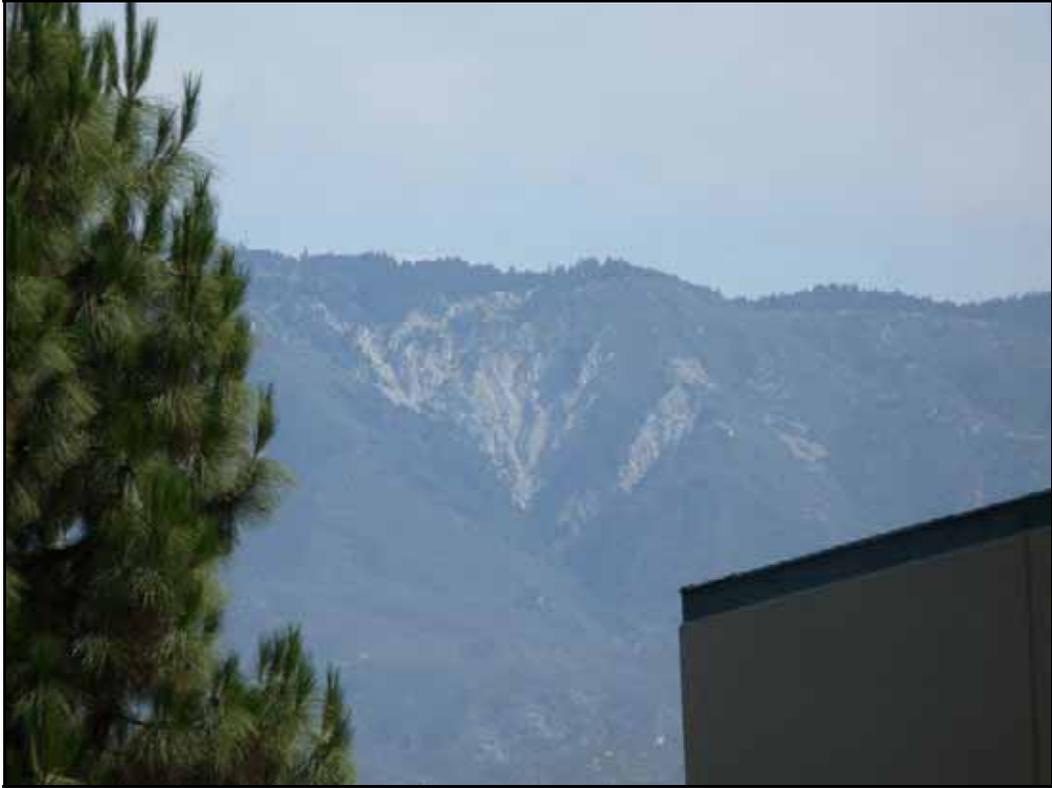
The Rimforest landslides, as seen with a telephoto lens from the Hilltop Geotechnical, Inc. office in San Bernardino.

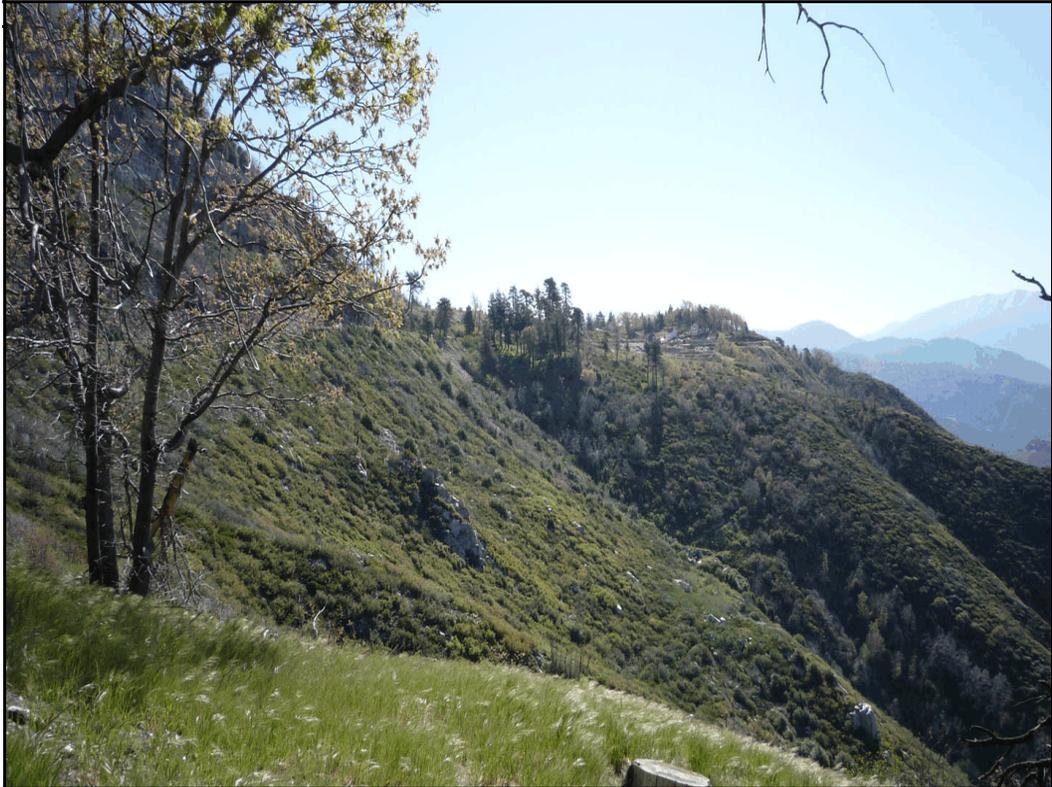
The west side of Rimforest, as seen from the edge of Highway 18.

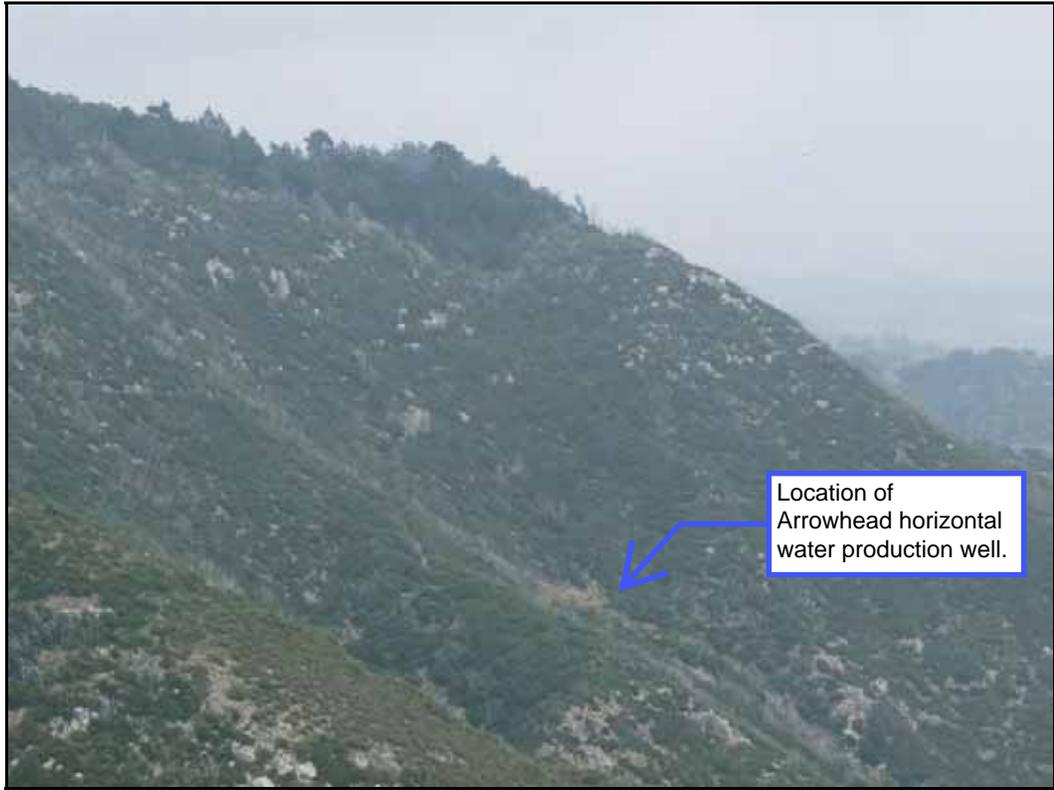
Location of Arrowhead horizontal water production well.

The slope south of Rimforest. The Rimforest fault extends from the notch in the top center through the bare spot near the center bottom: the Arrowhead Water horizontal well

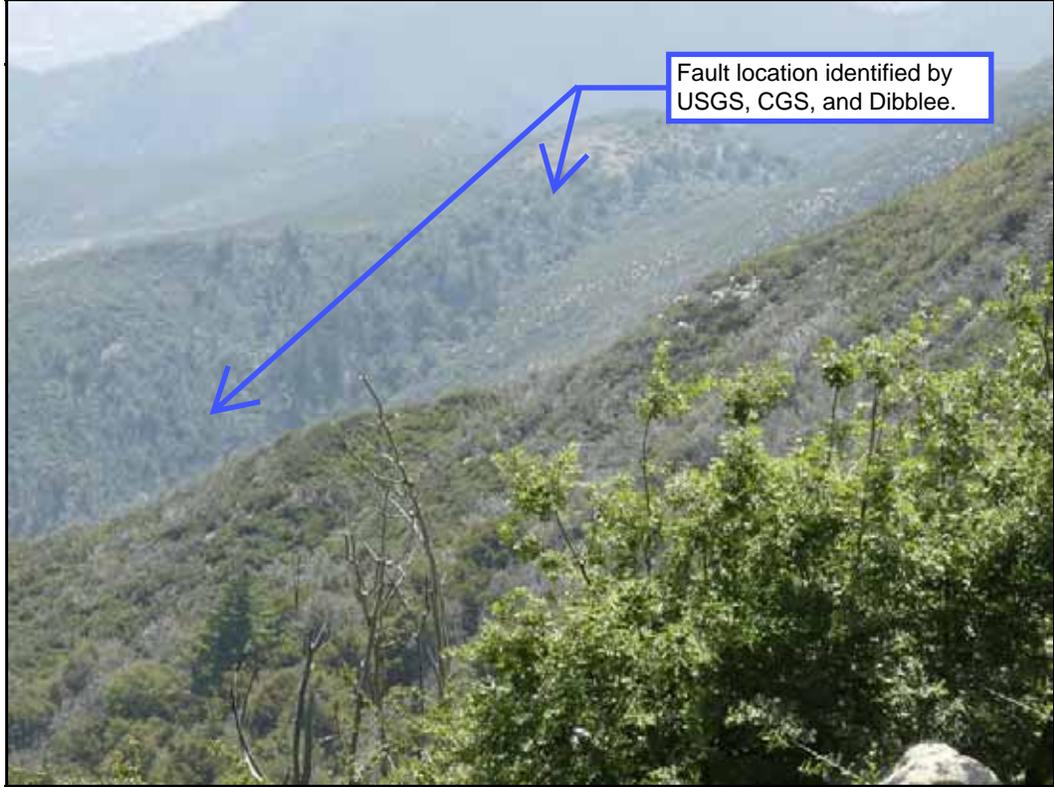
Fault location identified by USGS, CGS, and Dibblee.

The line of trees in the topographic notch represents the closest published fault to Rimforest. This view is from the Arrowhead Water well looking southwest.

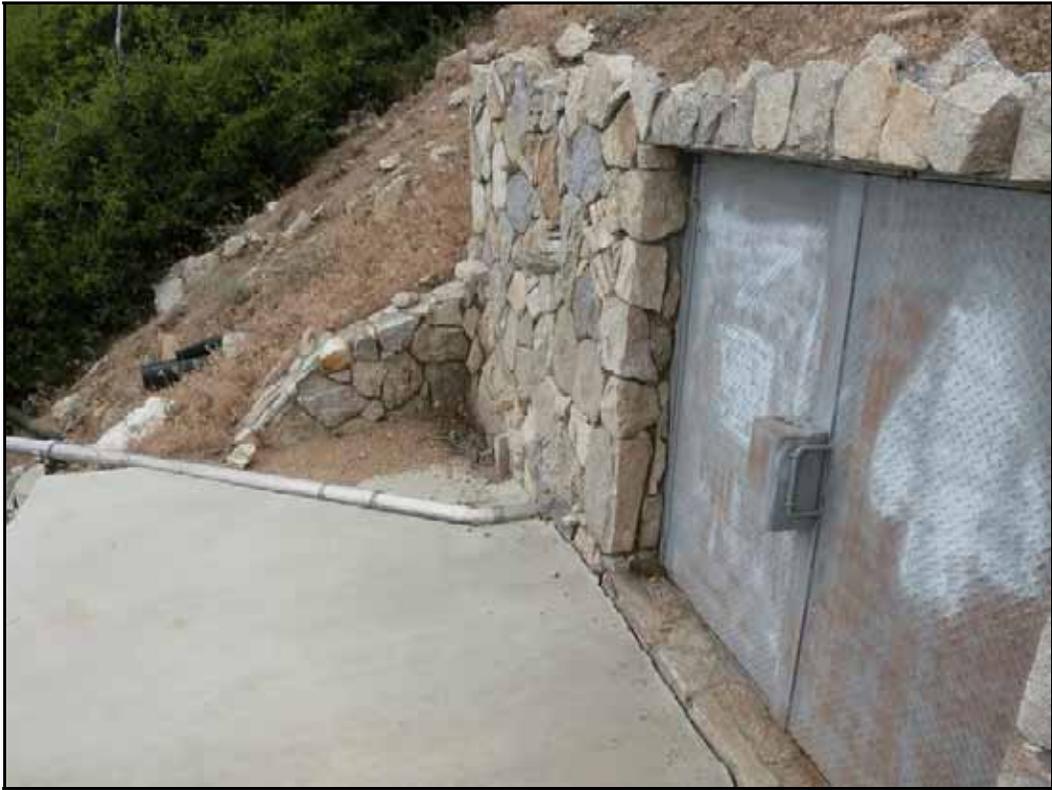
The newer Arrowhead Water well.

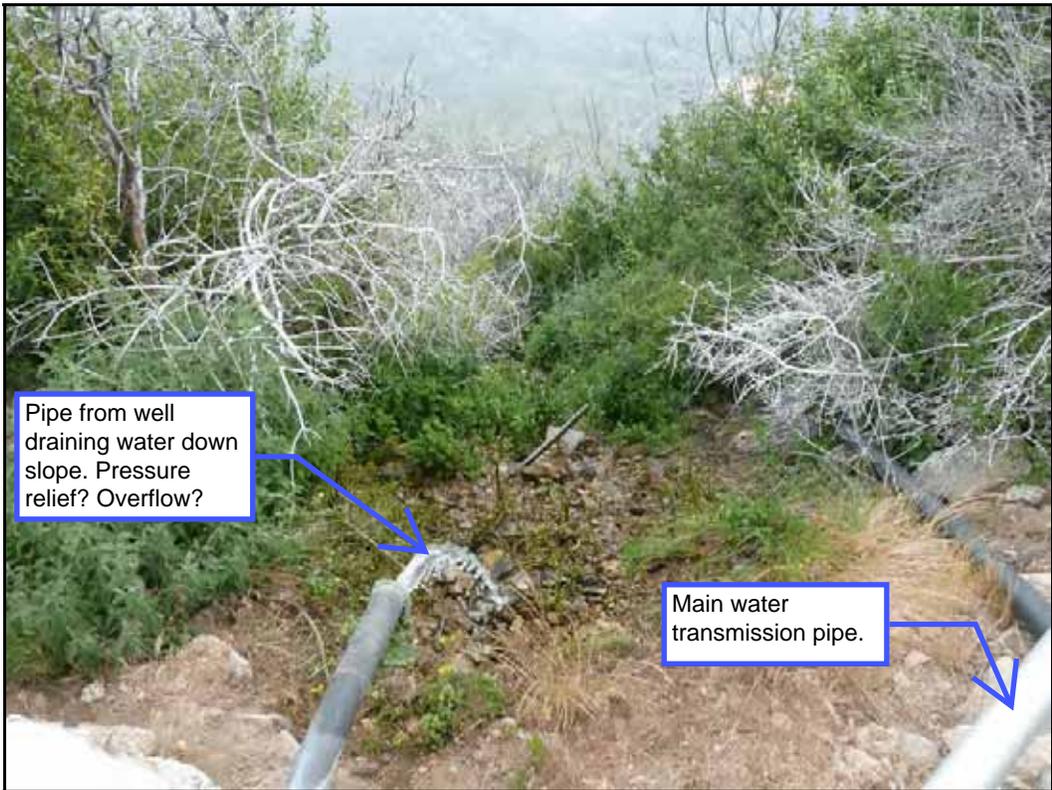
A single pipe from the operational water well was draining water downslope, south of the well building.

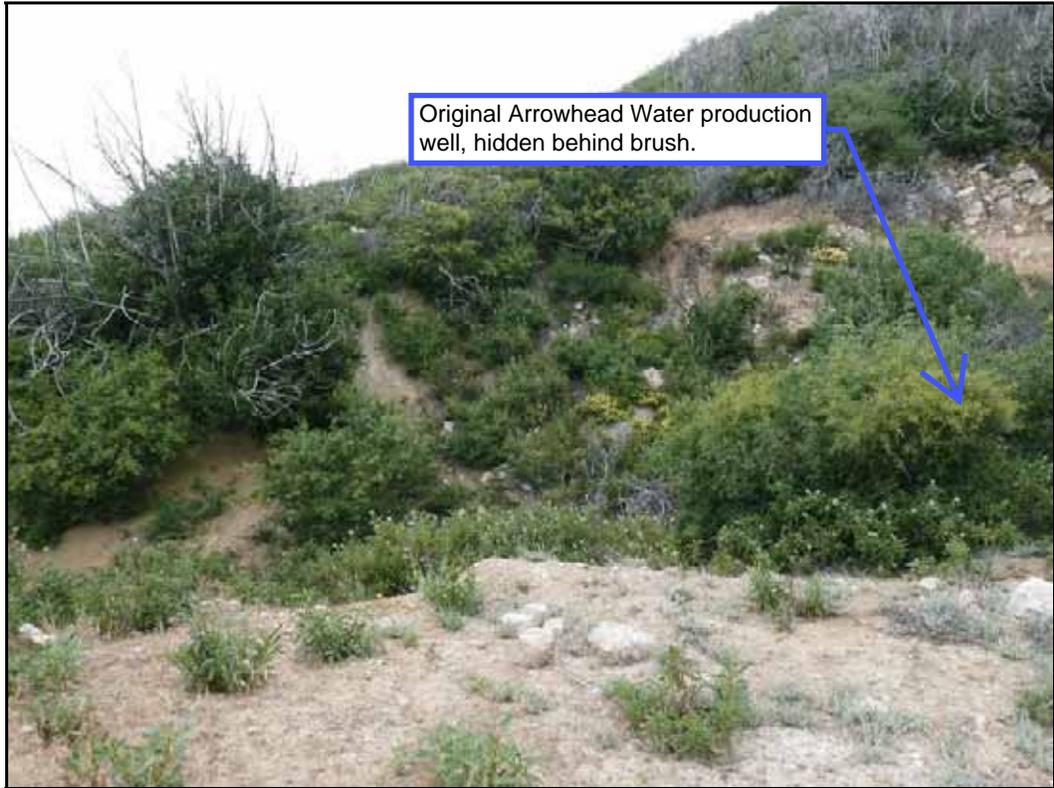
The original Arrowhead Water well is located within the brush. This well appears to no longer be in use. The Rimforest fault passes immediately south of the original well.

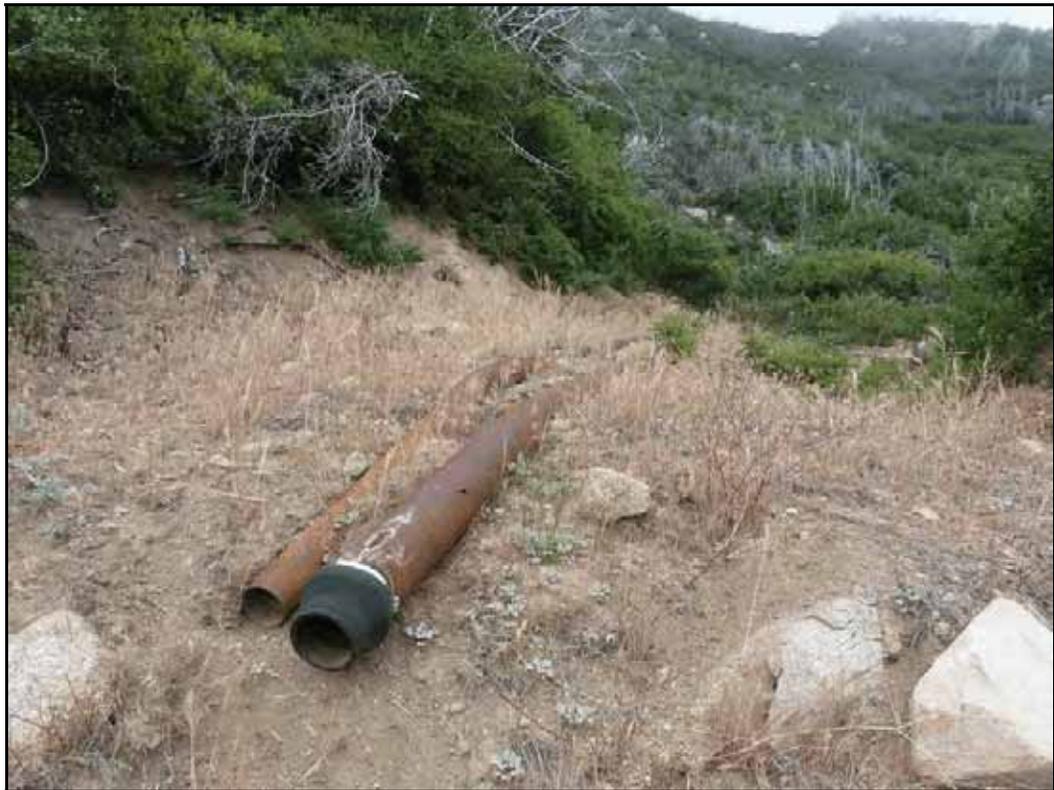
Abandoned water pipes, which extended southward from the original well.

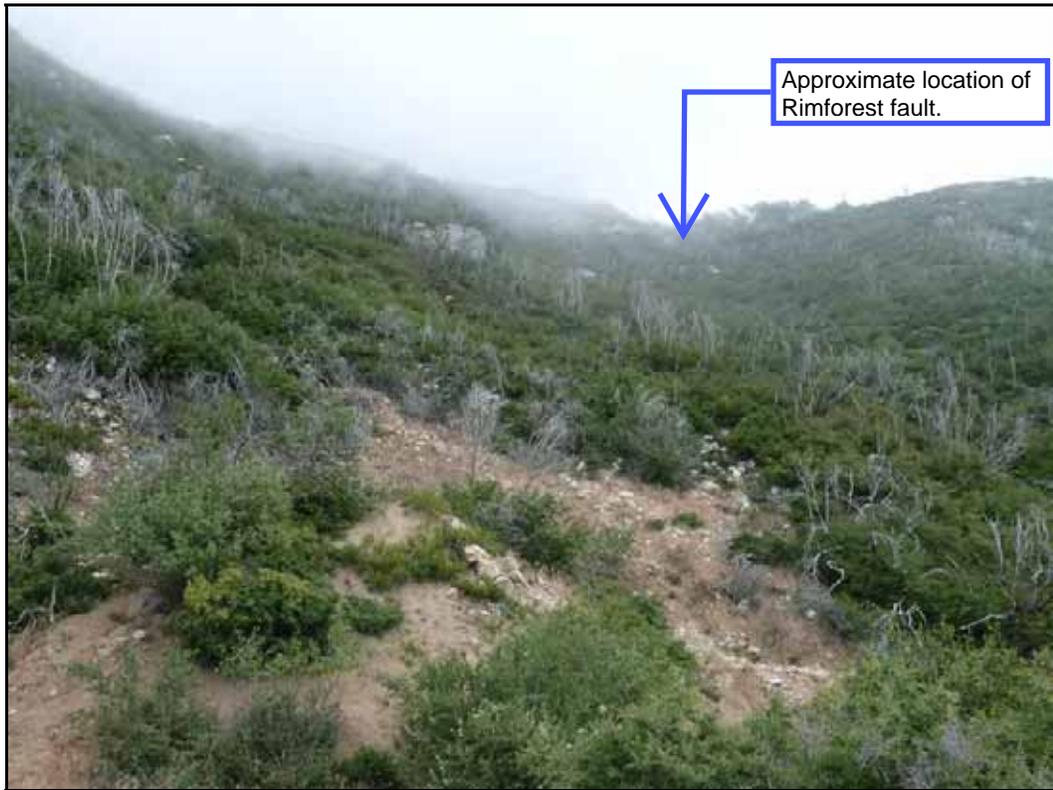
The Rimforest fault passes through the notch at the top of the photo toward the photo location.

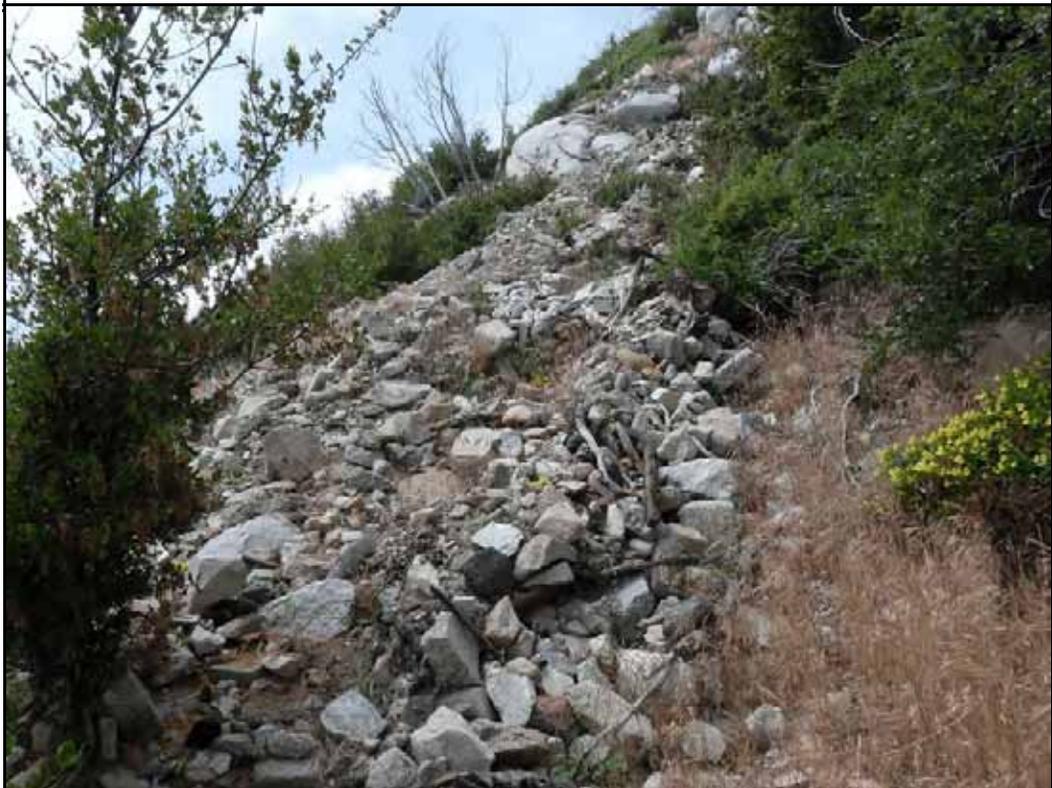
A pile of construction debris, including wood, brick, concrete, and asphalt, was blocking the Arrowhead access road on the west end of Rimforest. This material was dumped from the empty commercial building pads at least 150 feet up slope.

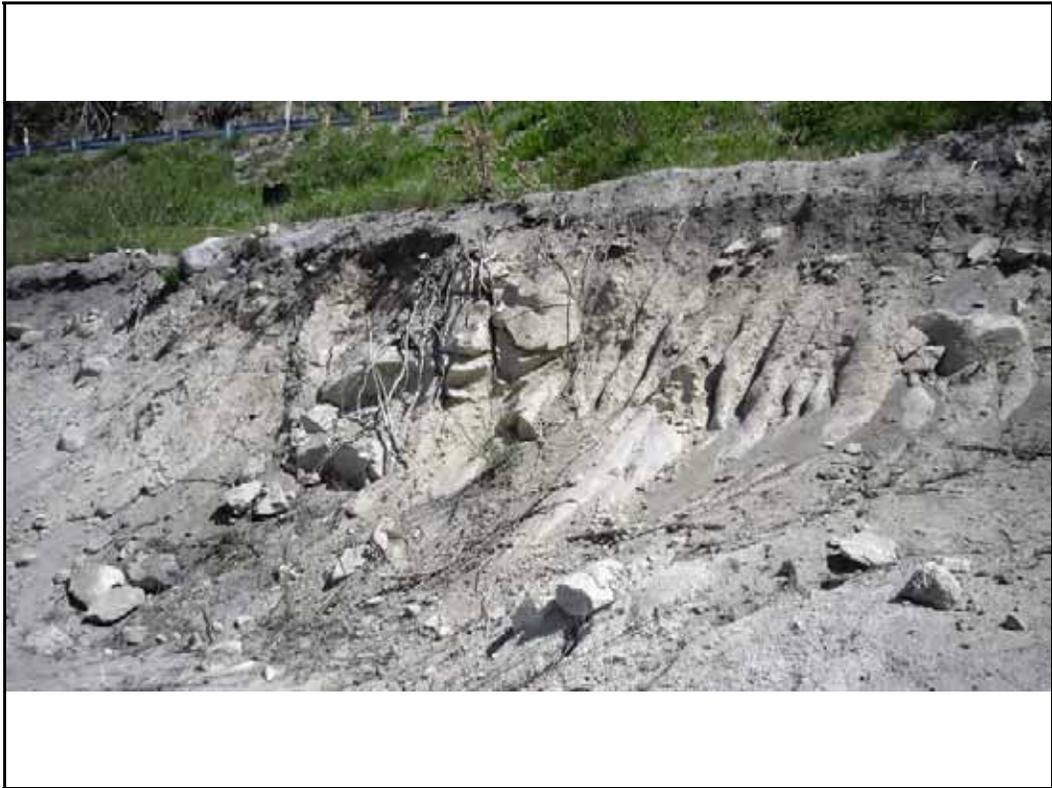
Deep colluvial deposit on the west side of Rimforest, just below Highway 18.

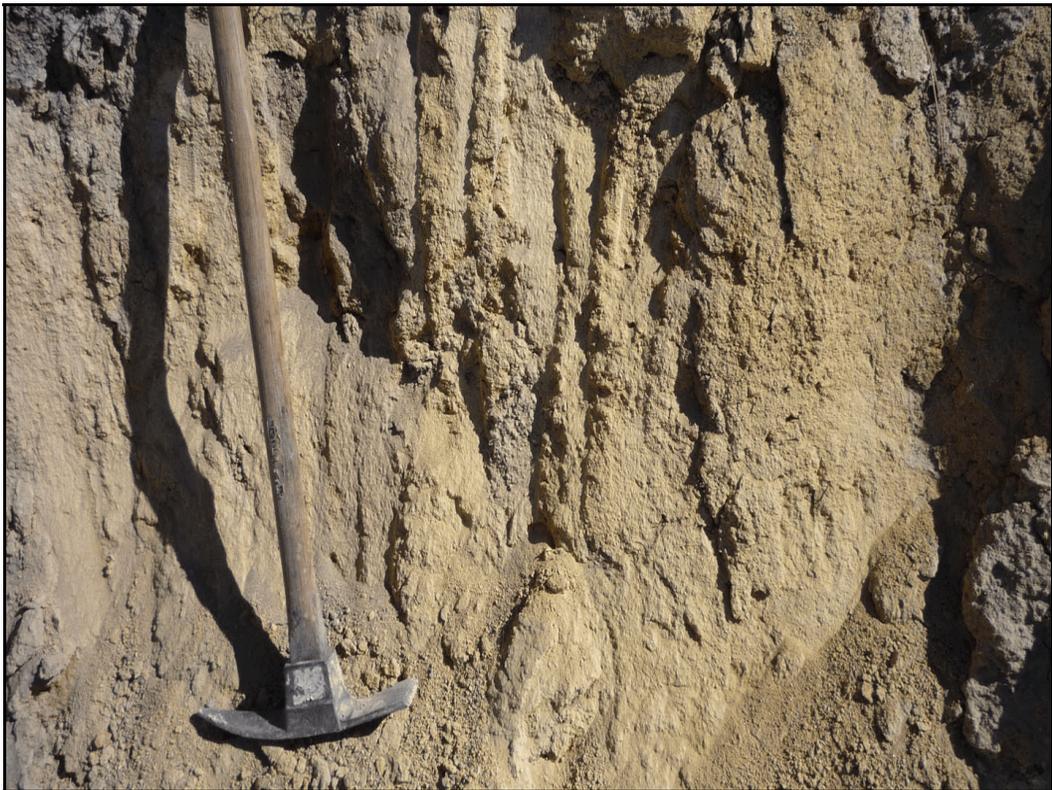
A closer look at the west Rimforest deep colluvial soil. This material is poorly consolidated and appears to erode readily.

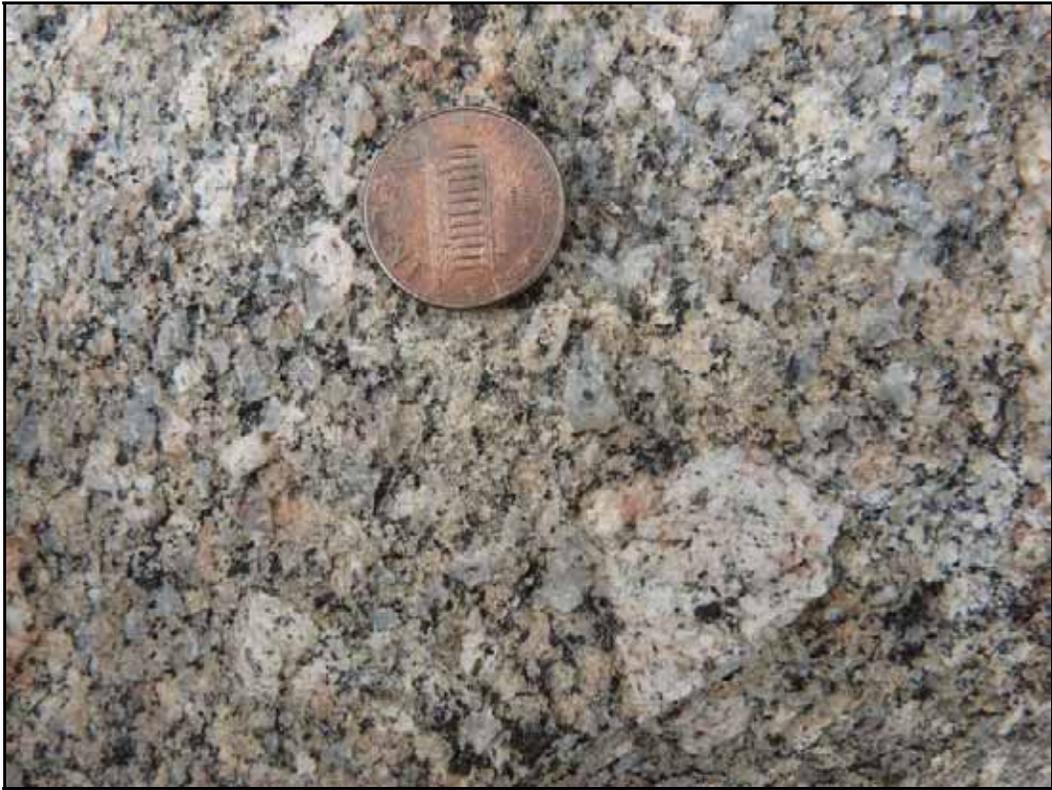
The mixed granitics of Silverwood lake (Mzsl) demonstrated great variability of composition and texture. Here is a typical sample from Rimforest showing the characteristic (for this location) white feldspar phenocrysts.

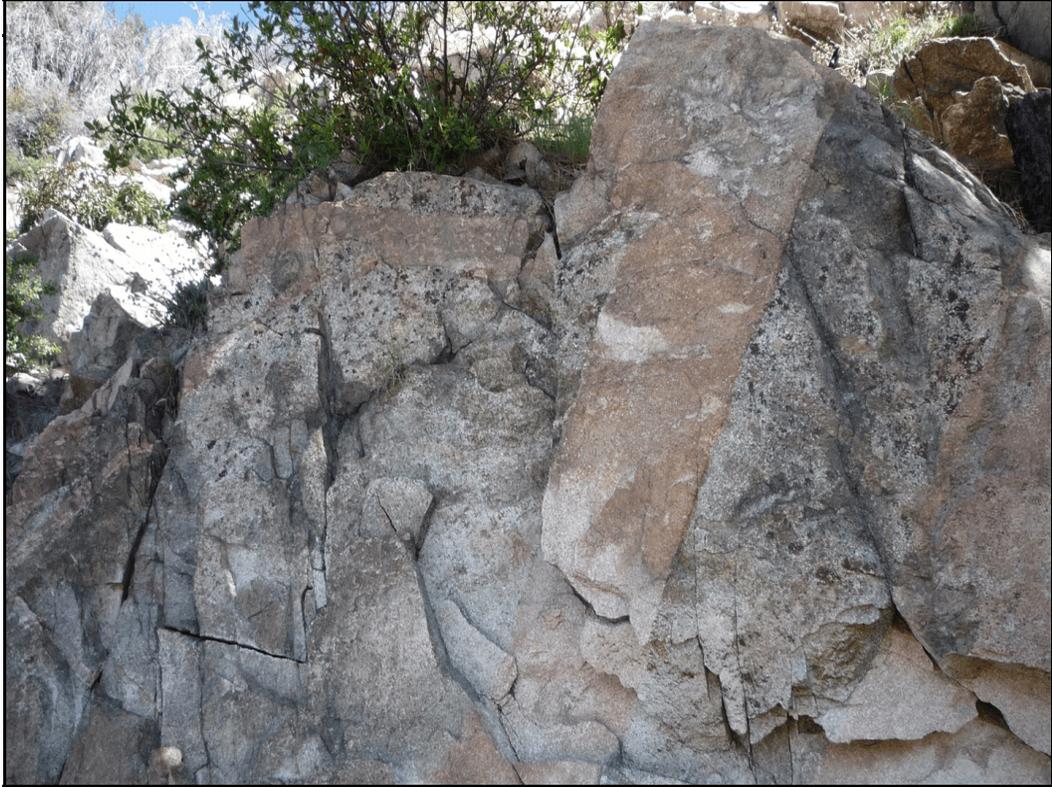
In other places, all the rock in an outcrop remained relatively hard and competent, despite age, textural, and compositional differences.

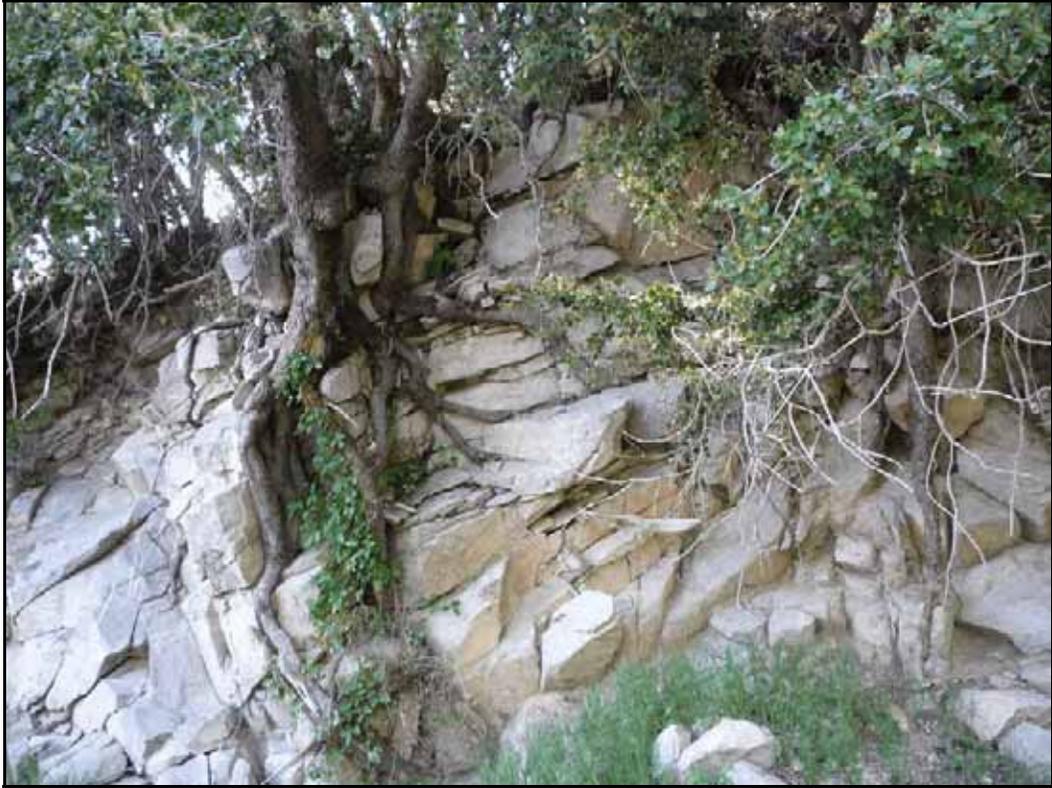
Some exposed bedrock east of Rimforest is very hard and resistant. This picture was taken adjacent to the Old Daley Canyon toll road.

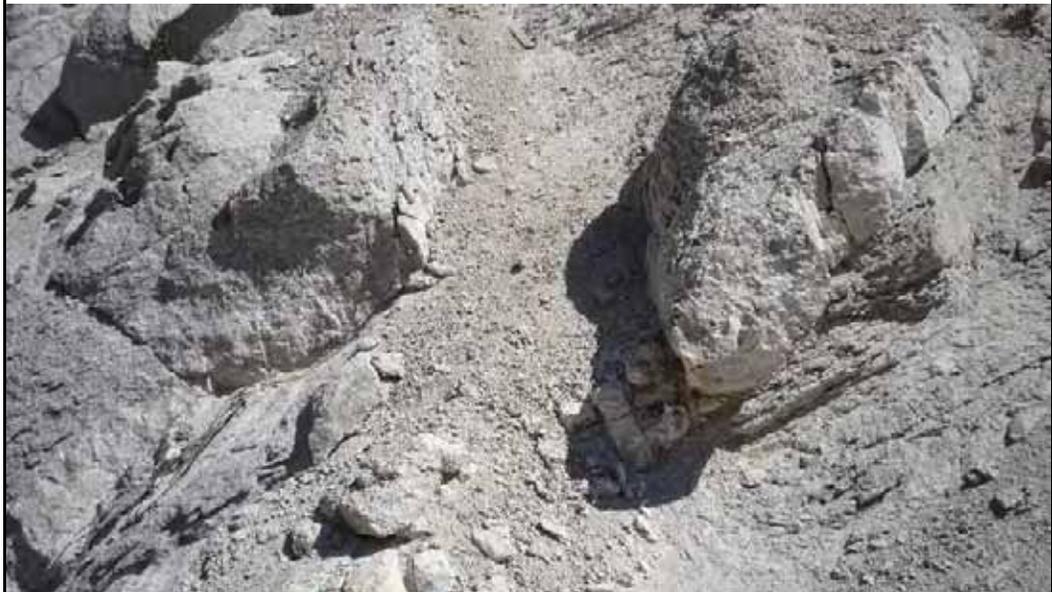
Another photo from the Old Daley Canyon toll road shows deeply weathered and crumbling rock.

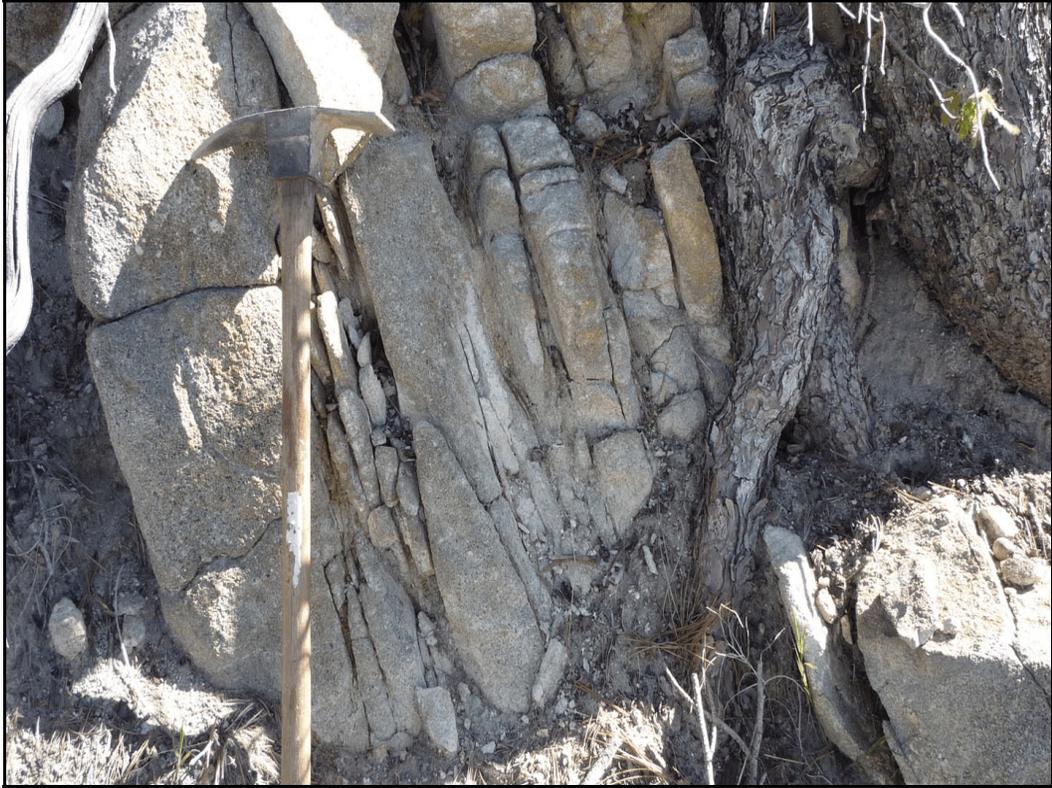
Jointed, hard rock within deeply weathered bedrock, east of Rimforest. The hard rock in this photo appeared to closer to granodiorite in composition.

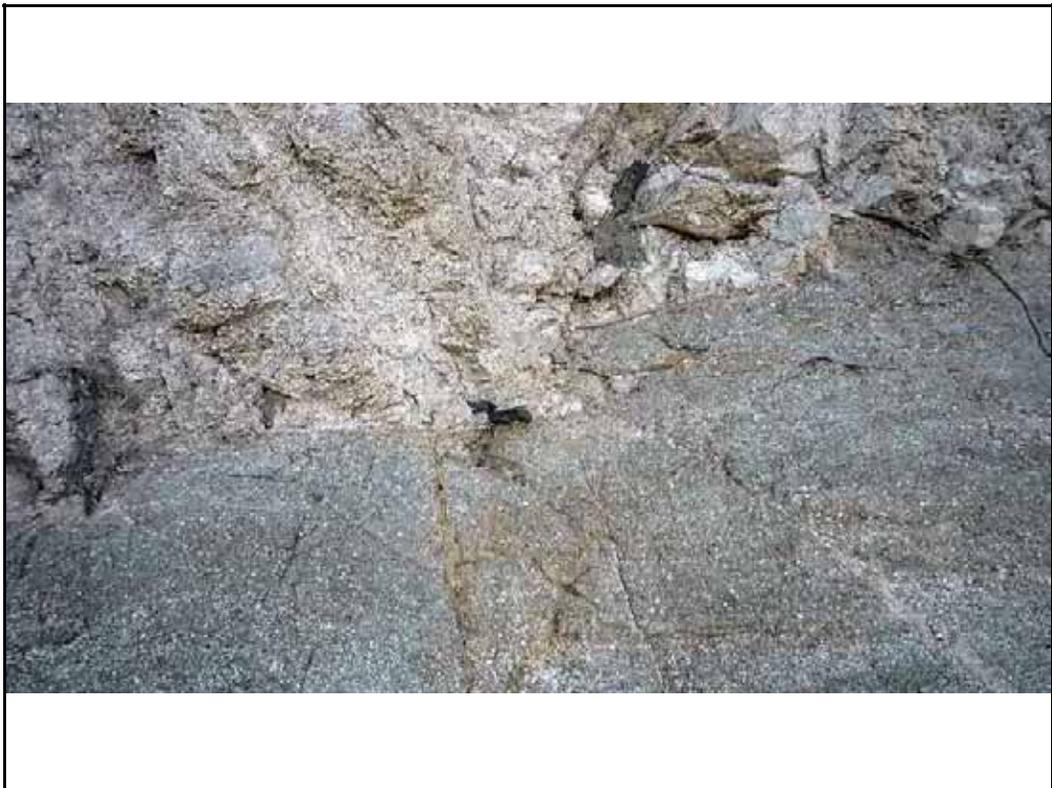
Shattered, sheared, and deeply weathered granodiorite and diorite east of Rimforest.

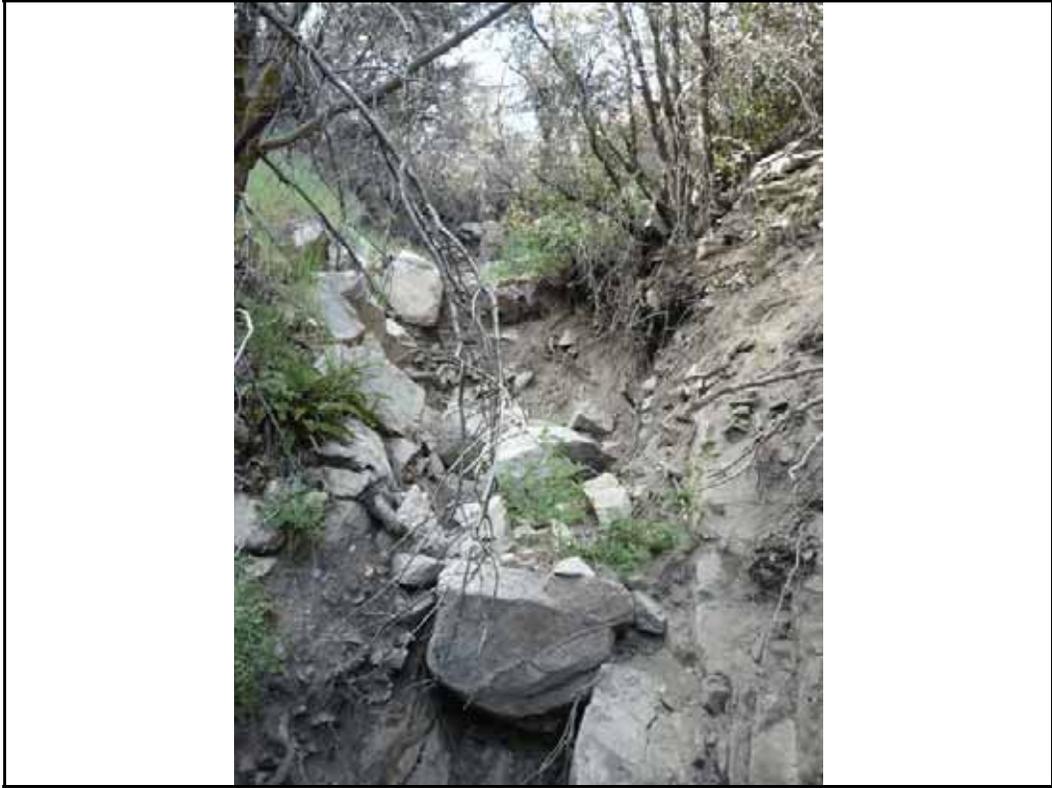
Deepening erosion within a proposed alignment for runoff diversion just east of Rimforest.

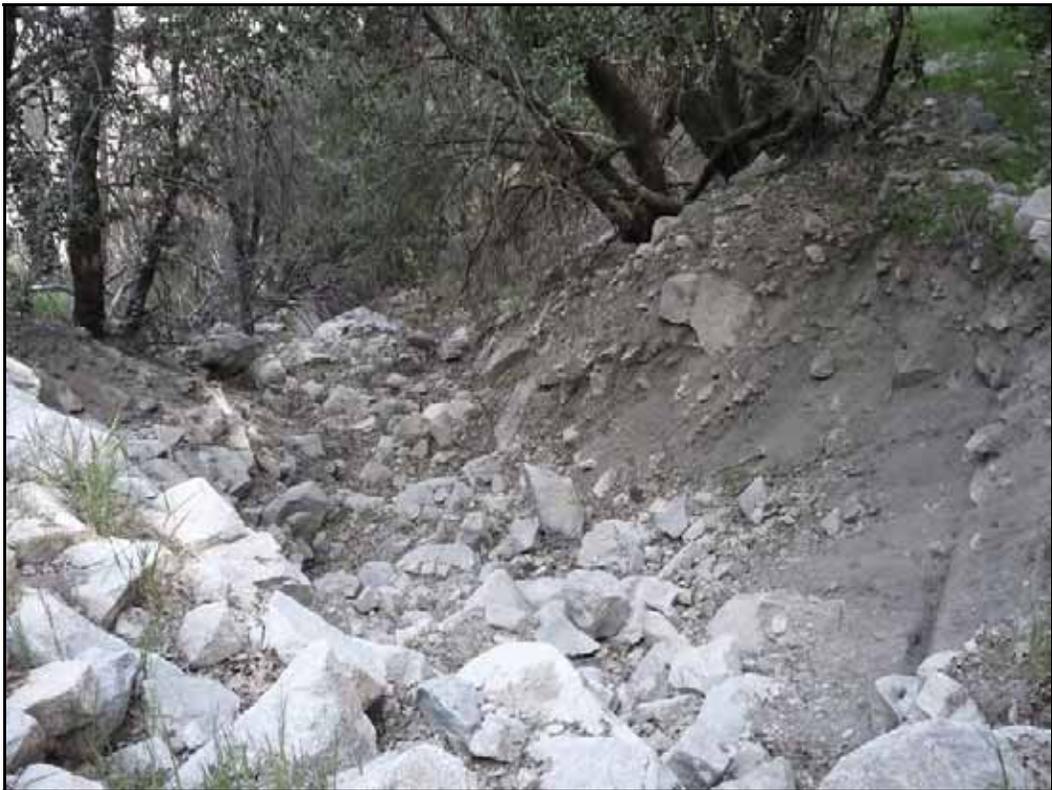
Deepening erosion into colluvial soils and highly weathered bedrock within a proposed alignment for runoff diversion just east of Rimforest. The Old Daley Canyon toll road had been almost completely removed by erosion in this location.

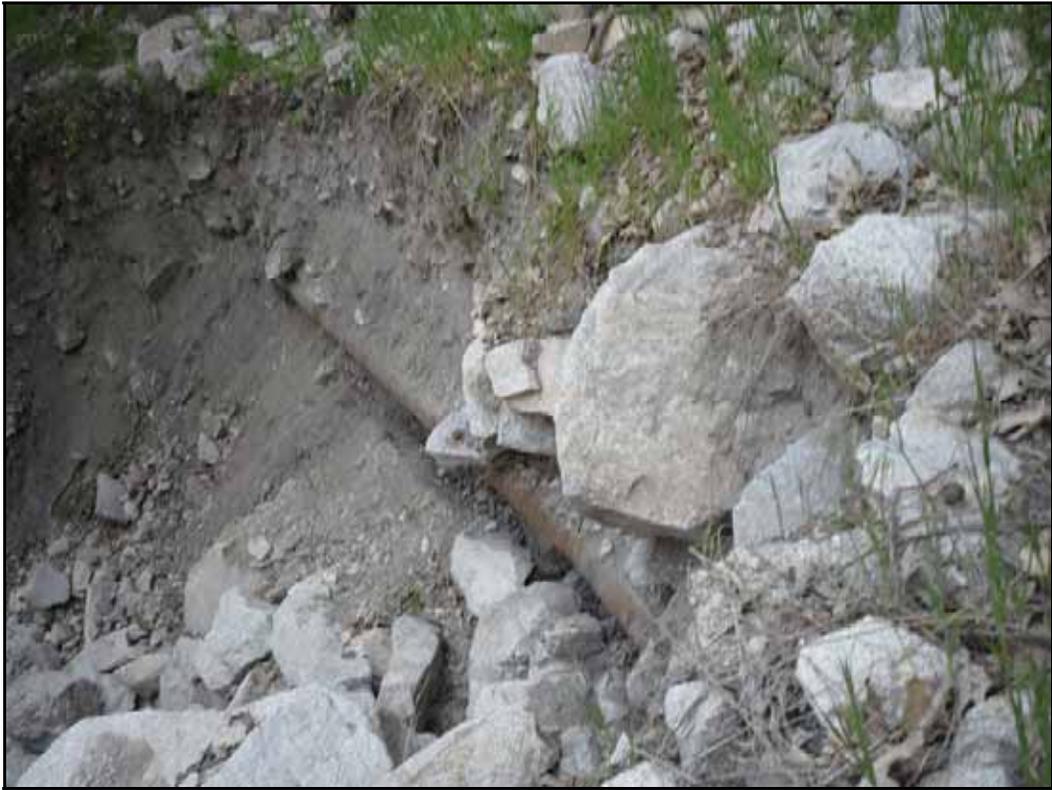
Exposed gas pipeline along the Old Daley Canyon toll road. In one location, the pipe had been undermined and was unsupported for several feet.

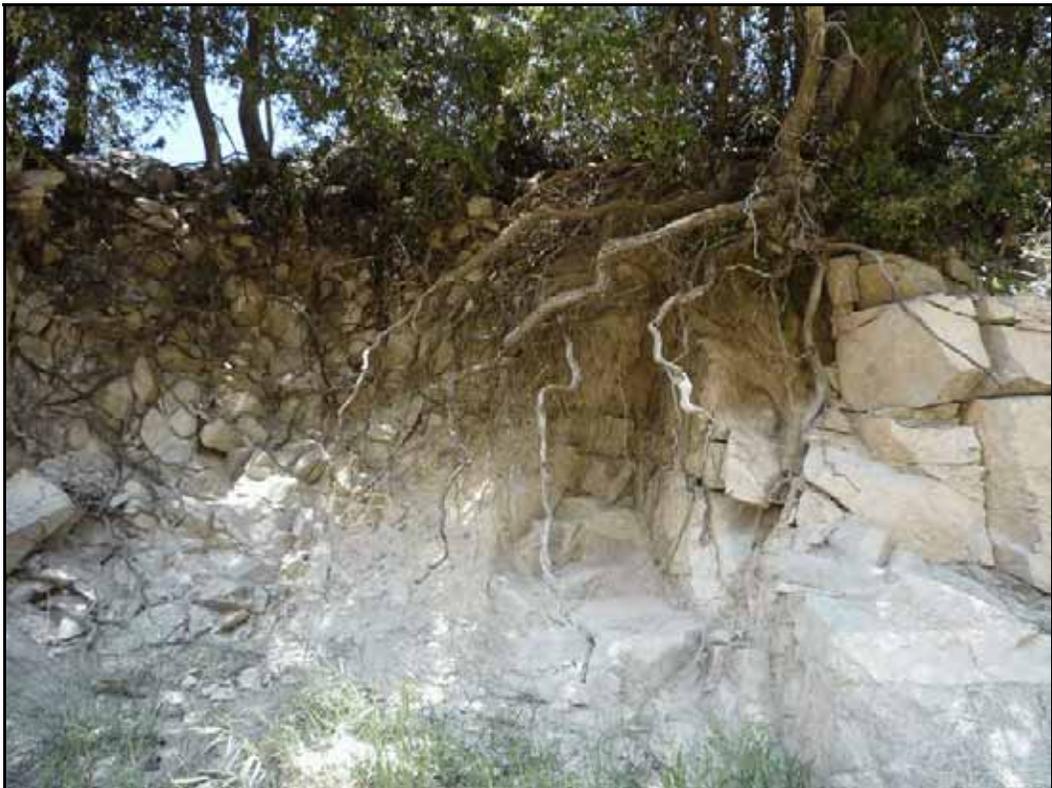
A zone of relatively soft, weathered granitic rock, eroding from beneath tree roots east of Rimforest.

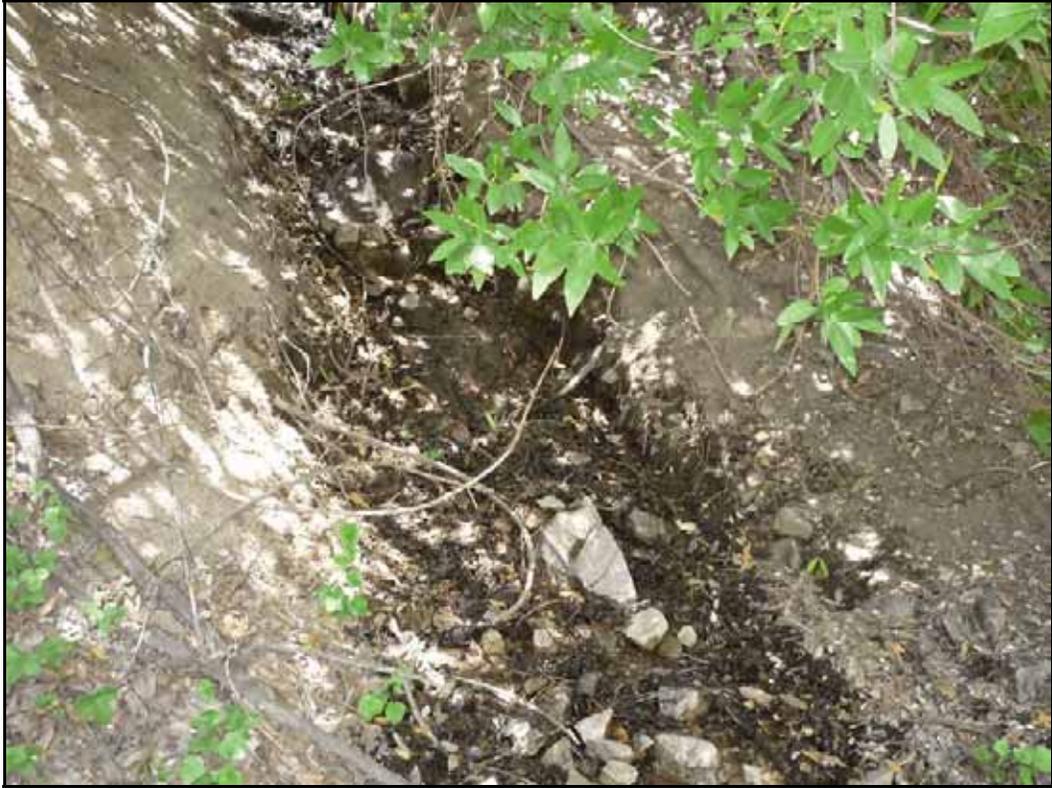
Shallow creek crossing the Old Daley Canyon toll road, fed by spring located up slope. The spring was still running in July, after four years of drought.

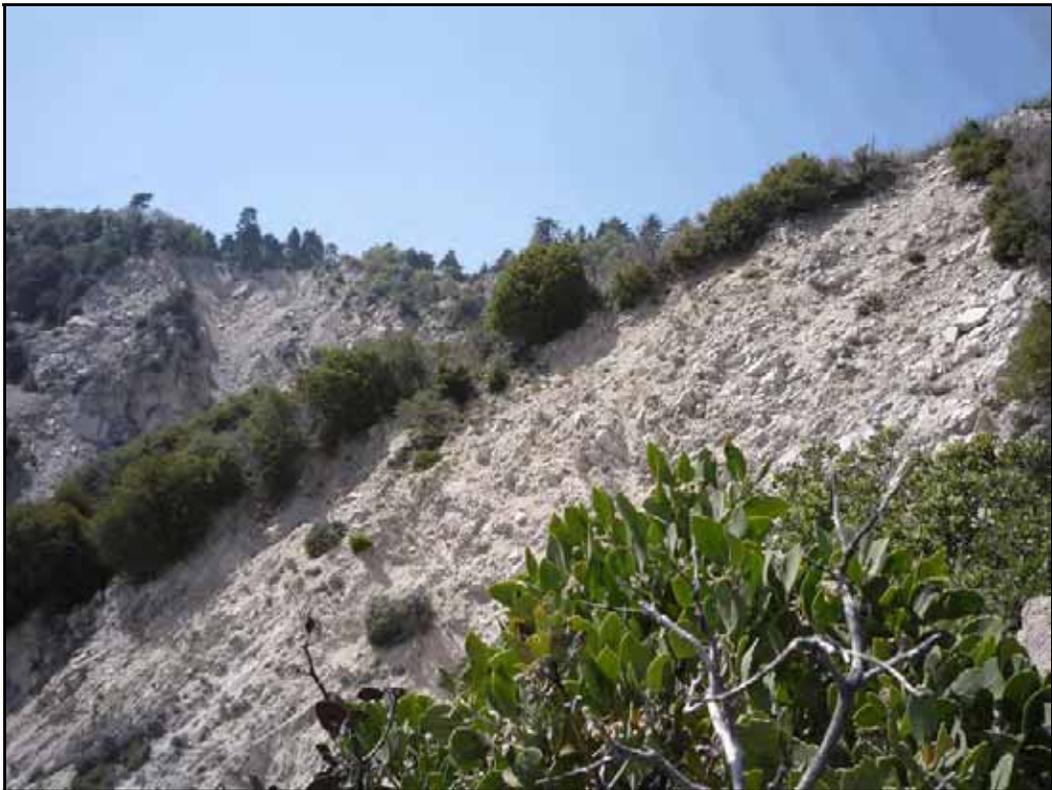
The northern edge of the southeastern landslide. View toward northwest. Rockfall area of the western landslide is visible in the background.

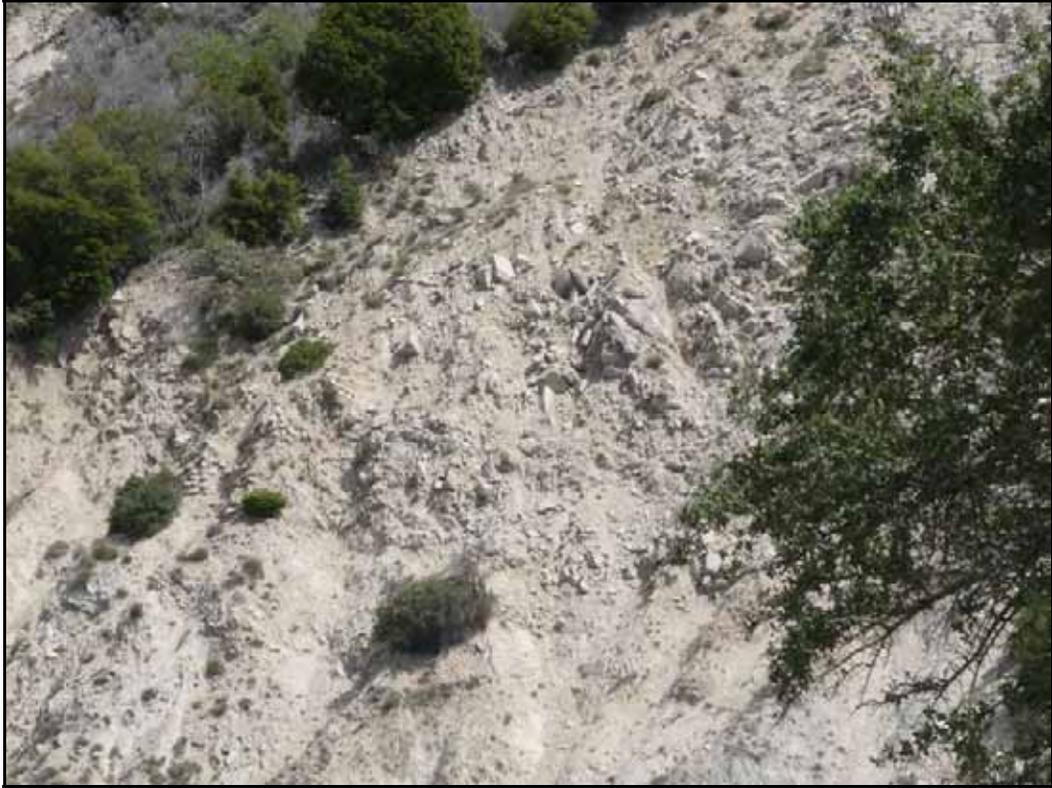
The northern edge of the southeastern landslide; the lower portion of the slope. The visible texture in lower third of the scar in this image appears to be more crushed and weathered than does the upper two-thirds.

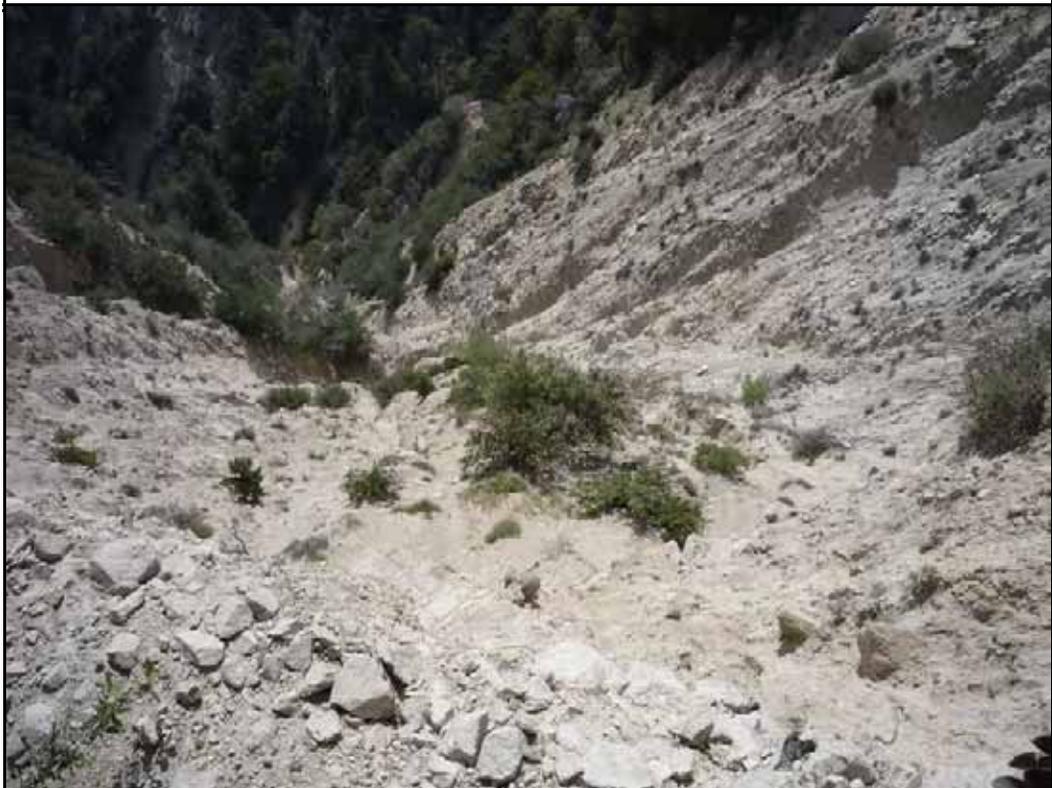
The southeastern landslide. View from the top of the scar looking down toward the bottom of the canyon.

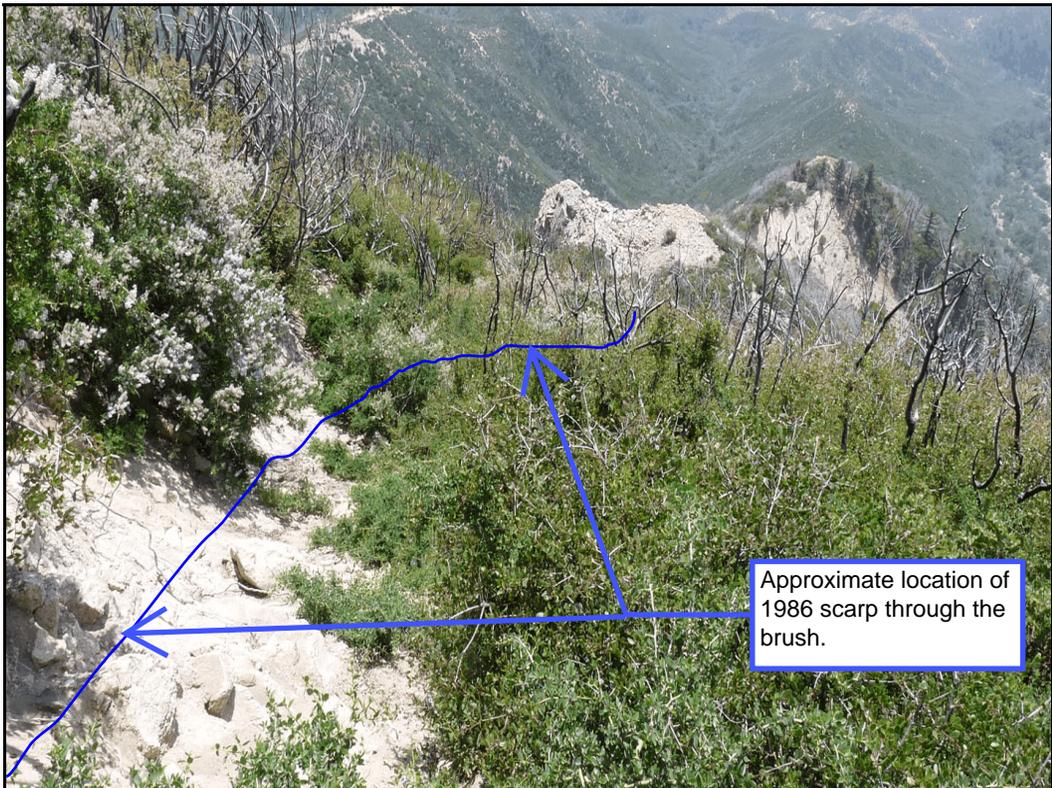
Approximate location of 1986 scarp through the brush.

The 1986 scarp. The visible portion of this scarp reaches from the rock outcrop, visible in the upper middle of this photo, northward, nearly to the edge of the northeastern landslide.
