FINAL
Drainage Feasibility Study
Volume III (Geotechnical Component Vol. 2)

Community of Rimforest
County of San Bernardino, CA

November 8, 2010

APPENDIX B
PHOTOGRAPHS

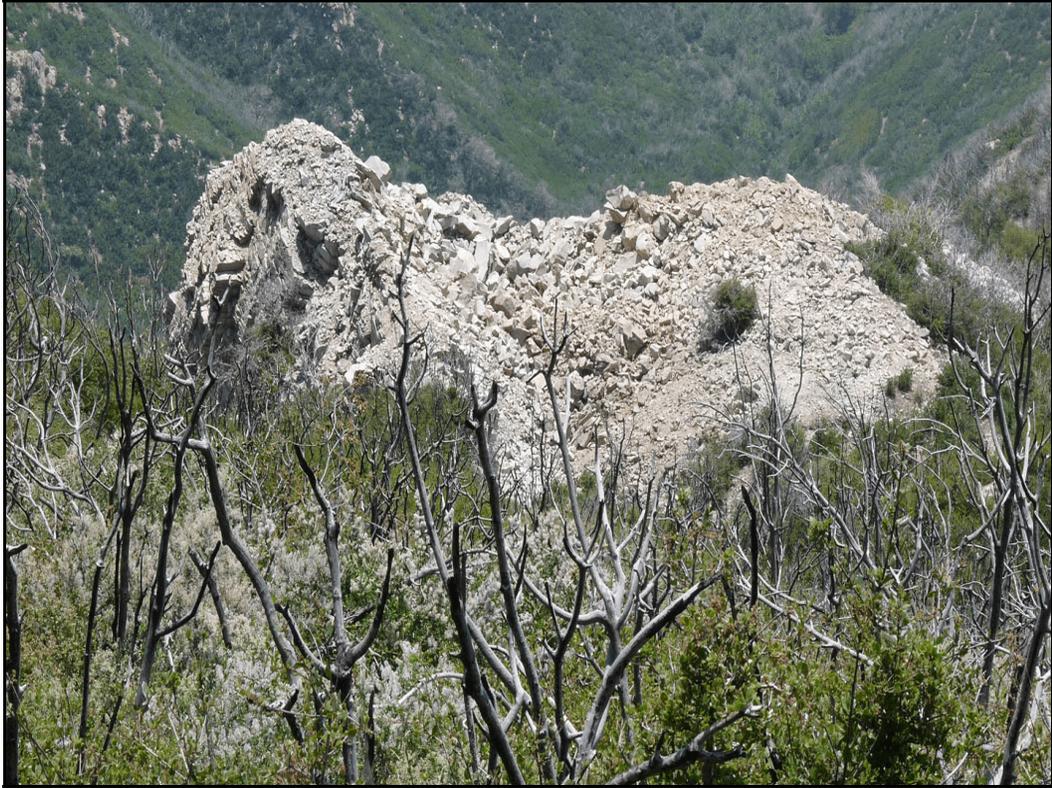
This outcrop of hard, resistant rock is located at the southern end of the 1986 scarp. Based on aerial photo data, the west part of this scarp probably was flattened by a dozer during fire break construction prior to 1938.

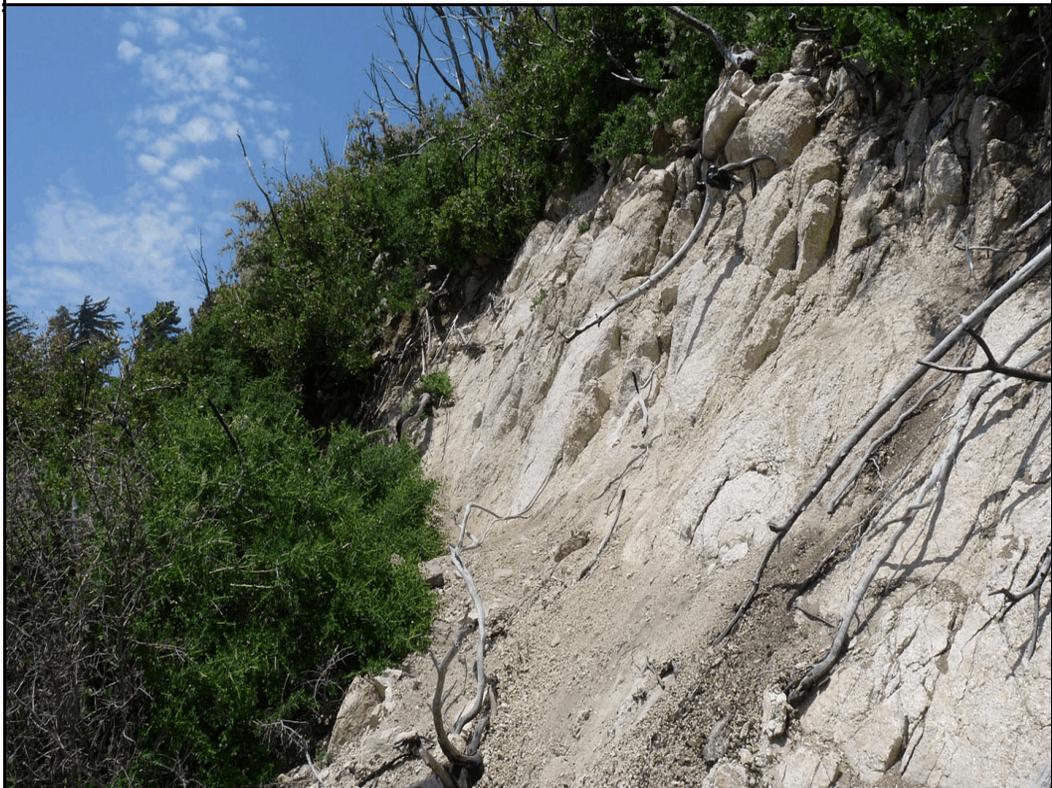
Accessible portions of the 1986 scarp ranged from ten feet in height, as seen in this photo, to less than one foot in height. The measured scarp incline ranged from 52 to 60 degrees.

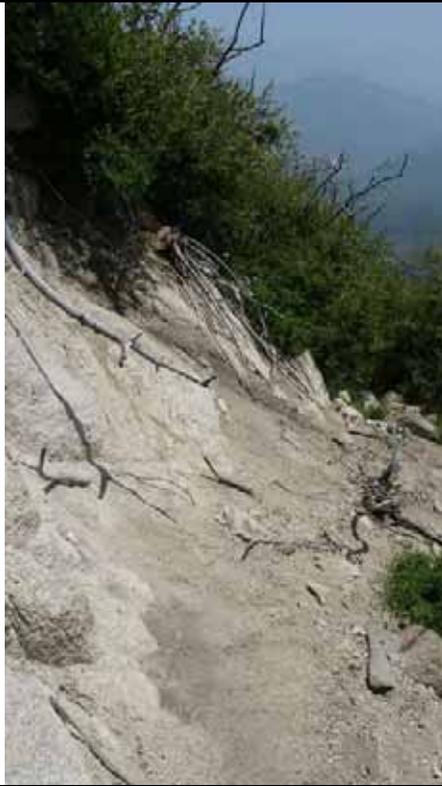
Access to much of the 1986 scarp was difficult due to deep, heavy brush. This exposure was over seven feet in height. (vertical image)

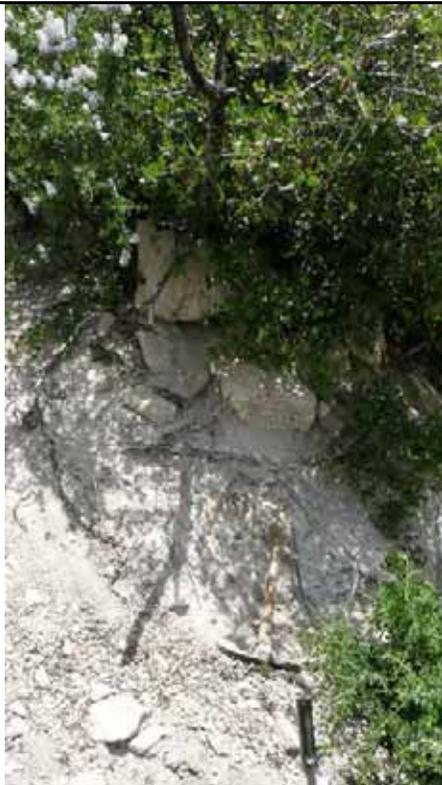
An accessible portion of the 1986 scarp. This part of scarp was estimated to be six to seven feet in height; the top is obscured by brush. The pick handle was 26 inches in length. (vertical image)

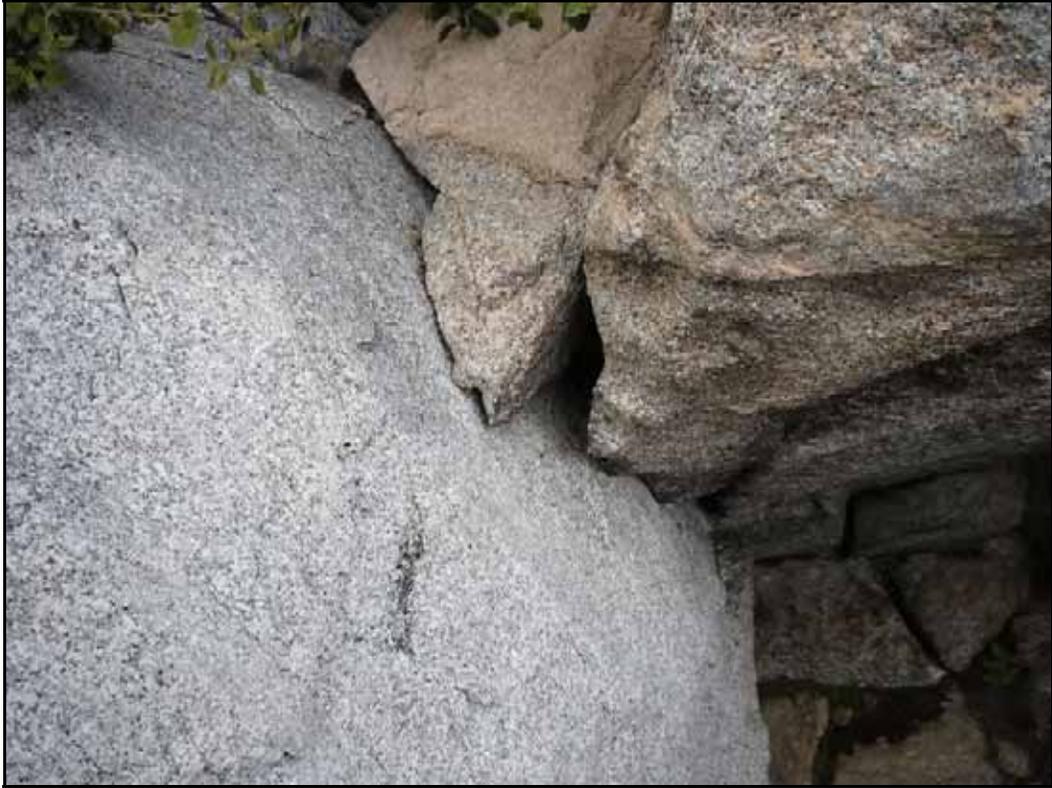
Rock outcrops below the 1986 scarp were generally disturbed; rocks and boulders had shifted from their original position, as in this photo. Common within landslide areas, outcrops outside of slide areas in Rimforest did not demonstrate this characteristic.

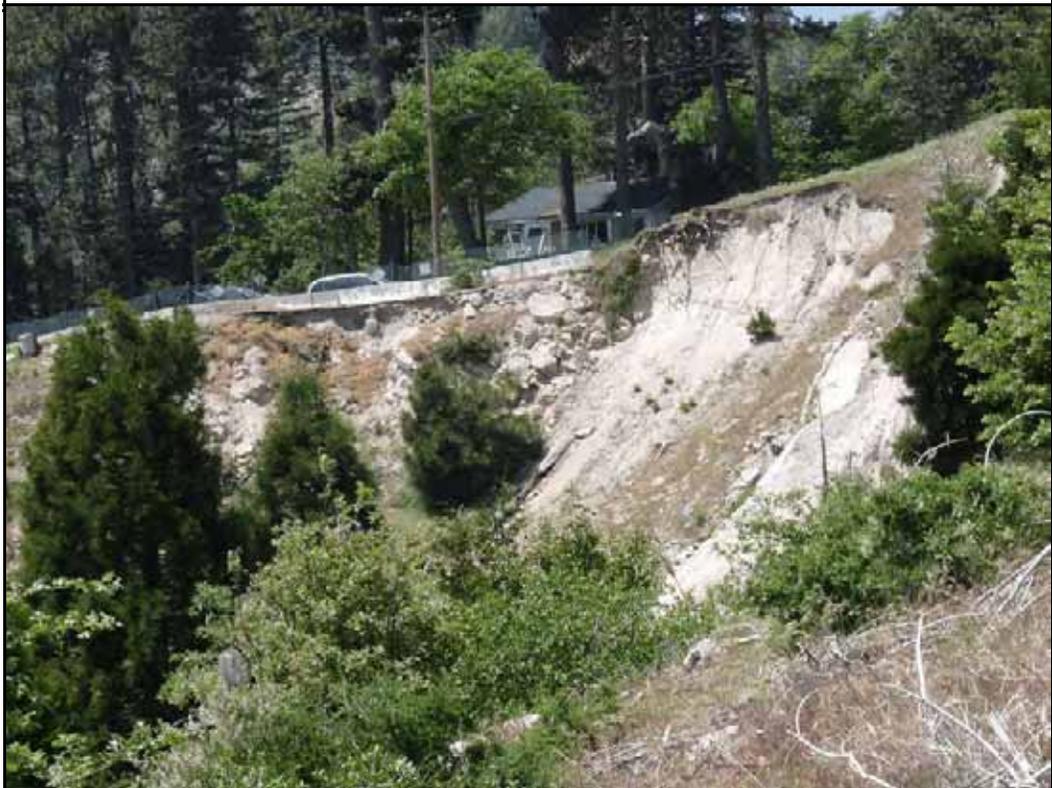
The current headscarp of the northeastern landslide. View from the southeast.

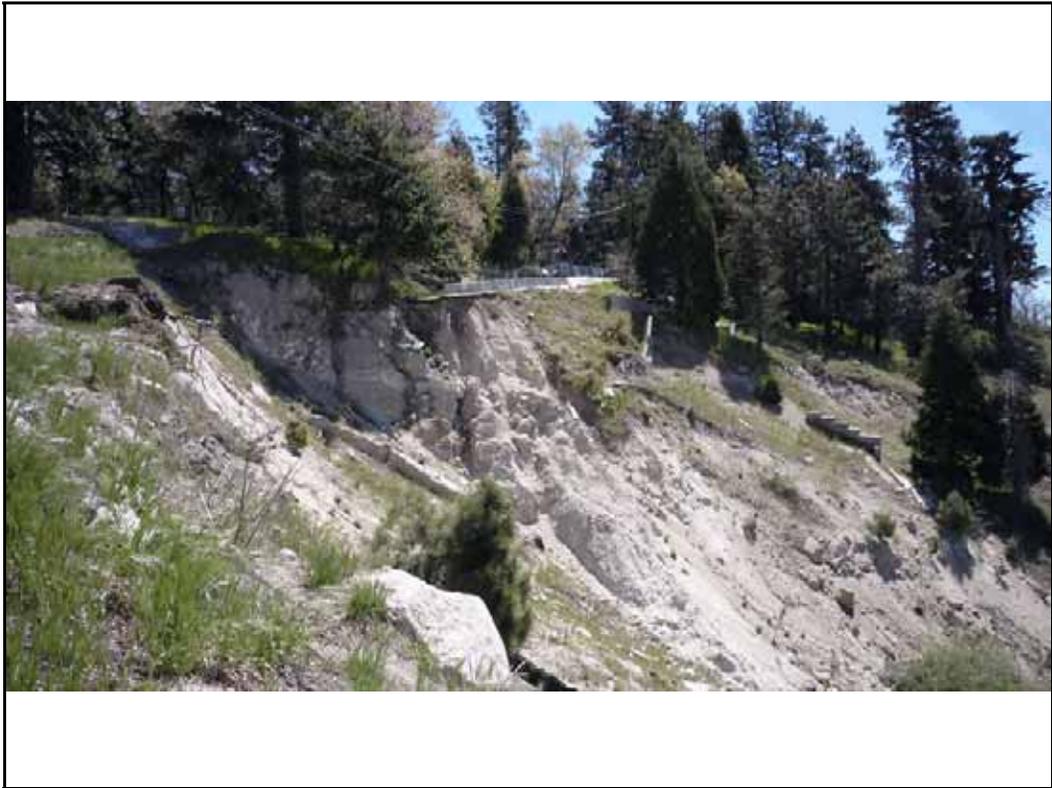
The current headscarp of the northeastern landslide. View from the west.

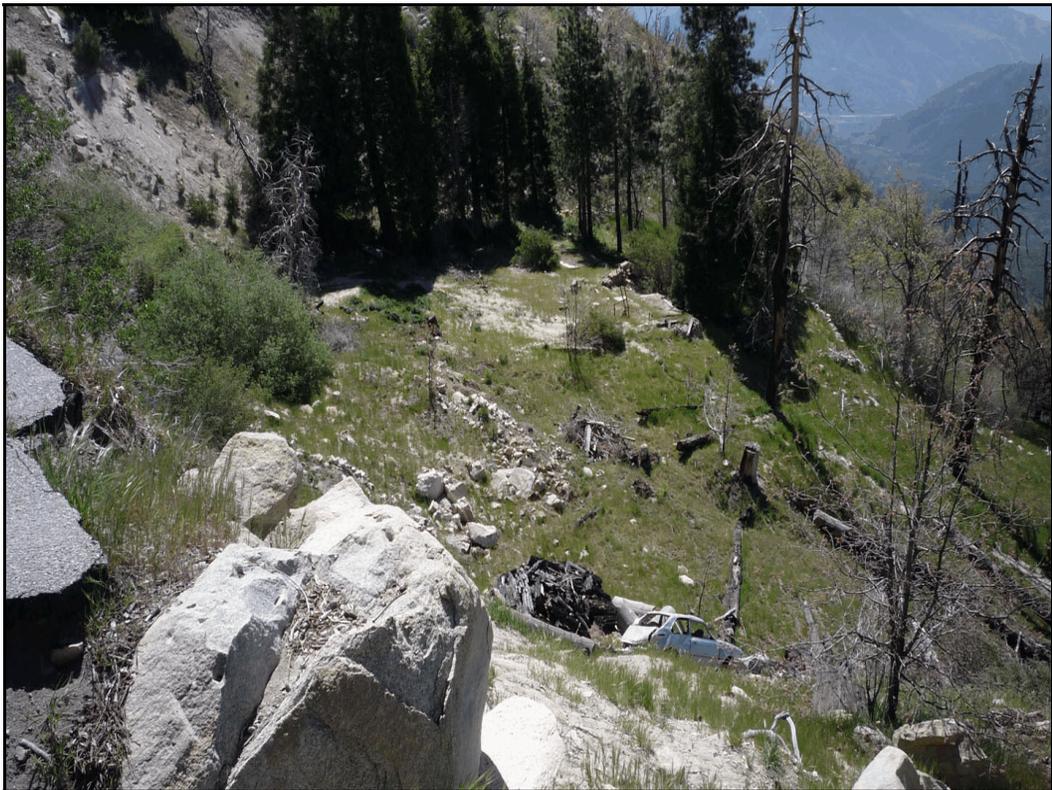
Northeastern landslide. The bench visible in this photo is the upper portion of the main slide block. View from the northwest.

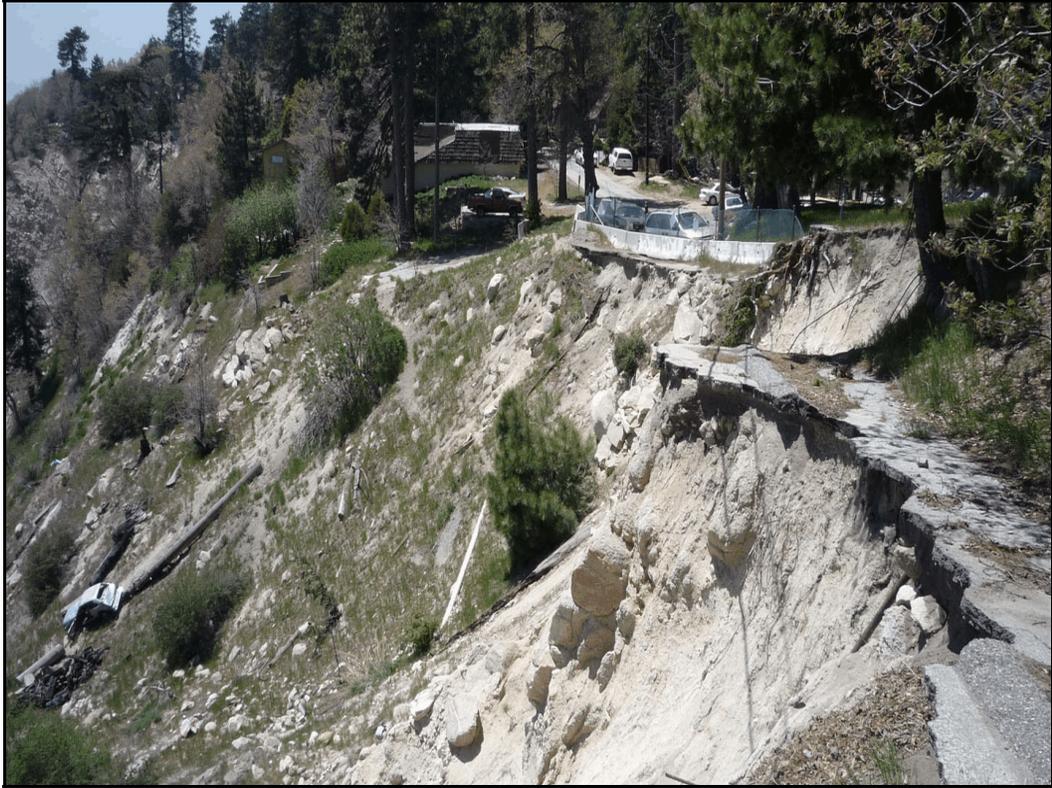
Northeastern landslide. Current headscarp as seen from the eastern remnant of Blackfoot Trail East.

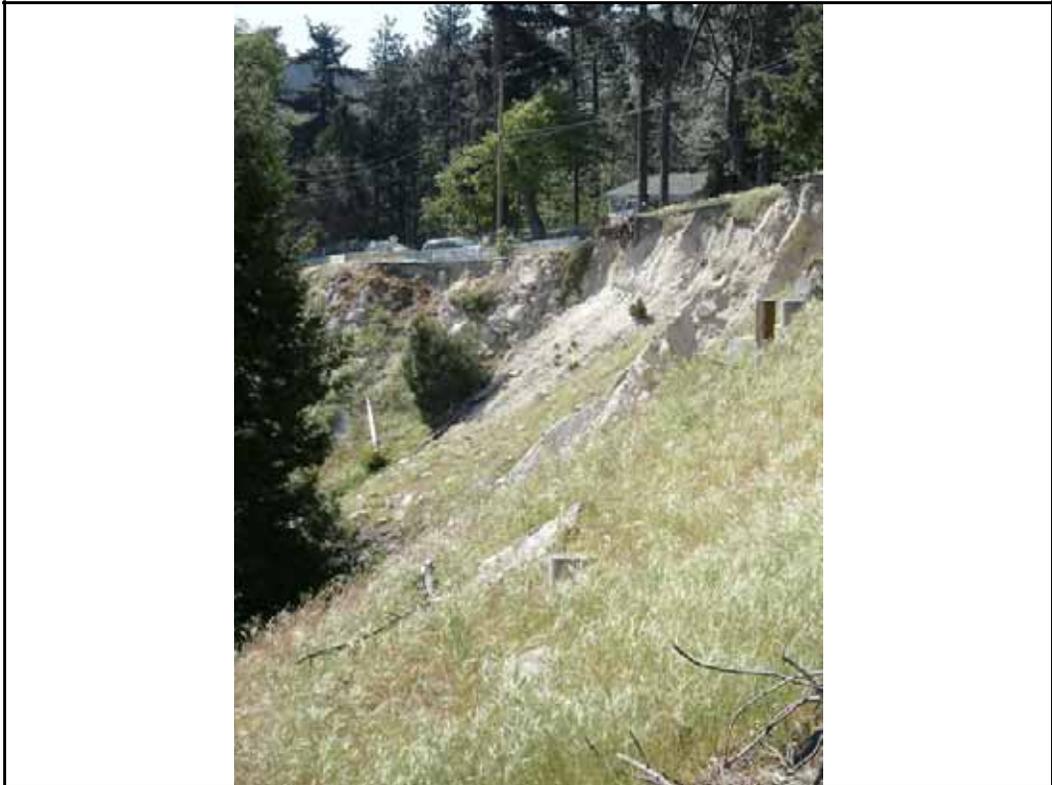
Northeastern landslide, current headscarp. (vertical image)

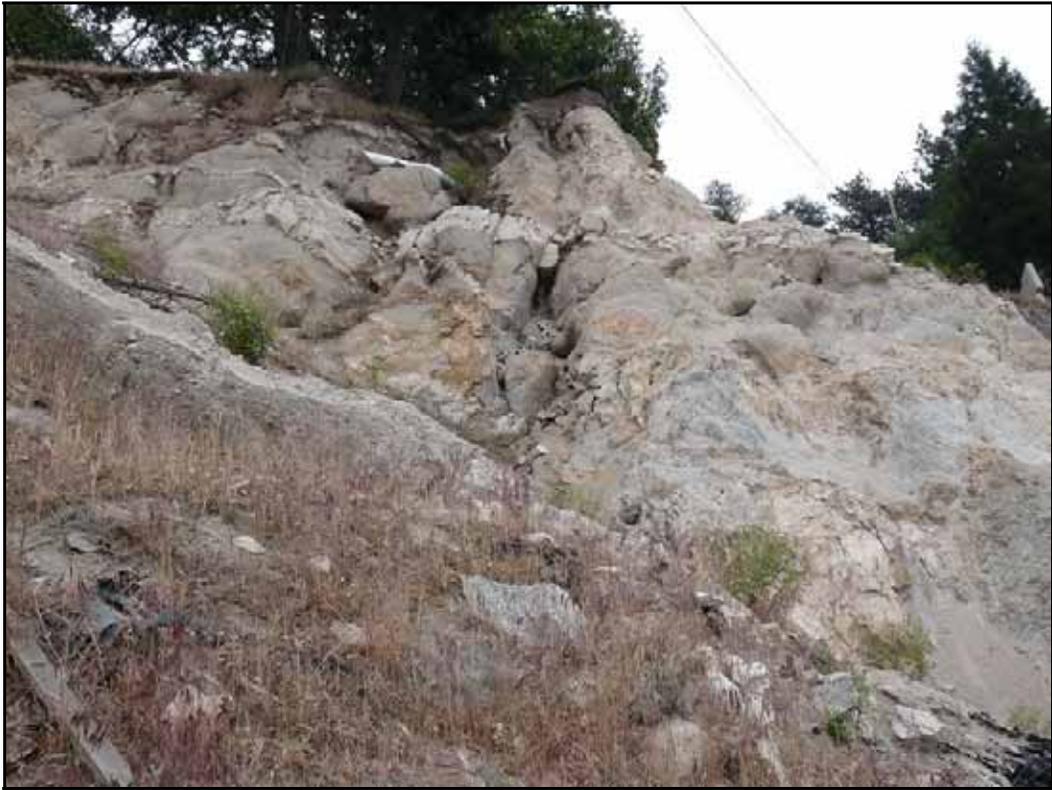
Northeastern landslide, current headscarp. A large block of bedrock within the scarp had moved downhill less than 10 feet. Continued downhill motion is expected in the future.

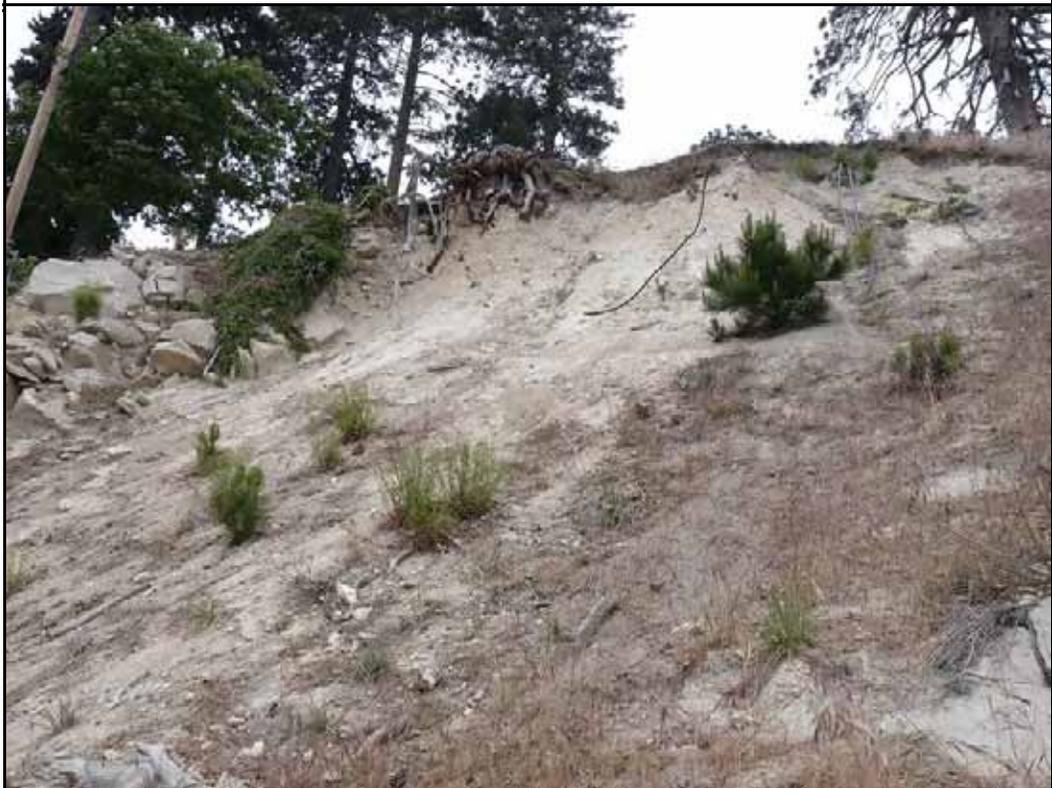
Northeastern landslide, current headscarp. The Rimforest fault passes through the headscarp. This zone of pulverized rock and gouge was located between more resistant bedrock to the northwest (on left side of photo) and to the southeast.

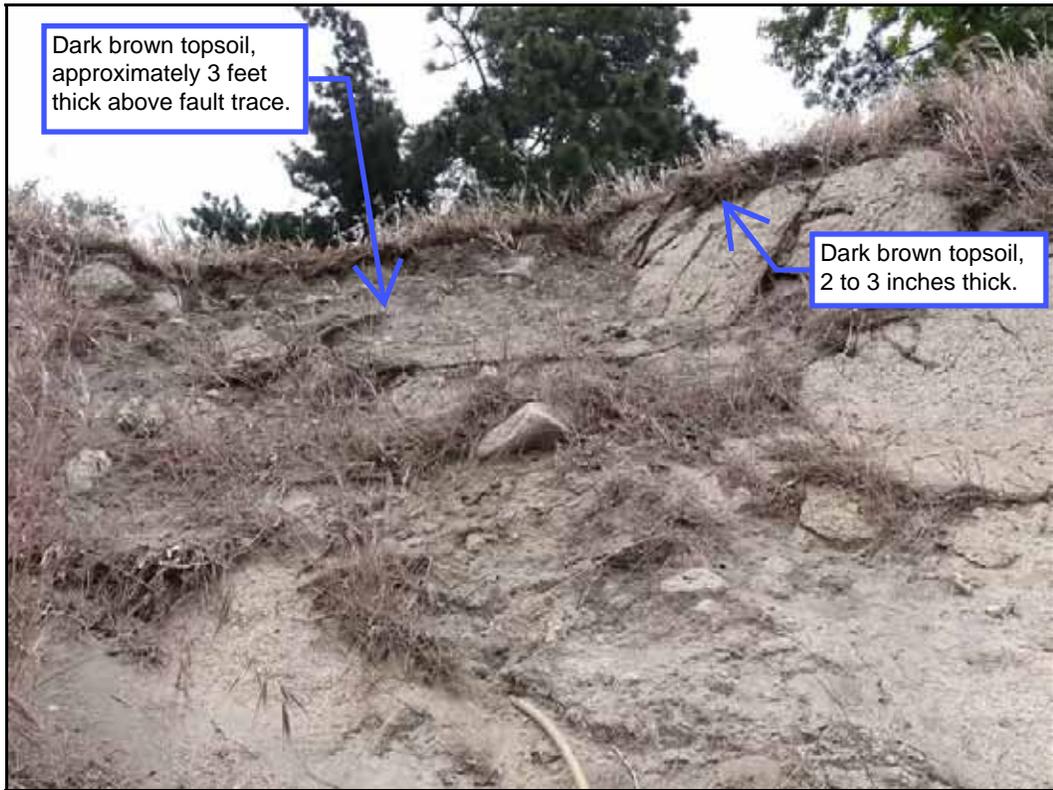
Northeastern landslide. The exposed eastern edge of the Rimforest fault as it contacts more resistant rock. The brown topsoil east of the fault is only a few inches thick. Above the fault it is more than 3 feet thick and forms a wedge that thins westward.

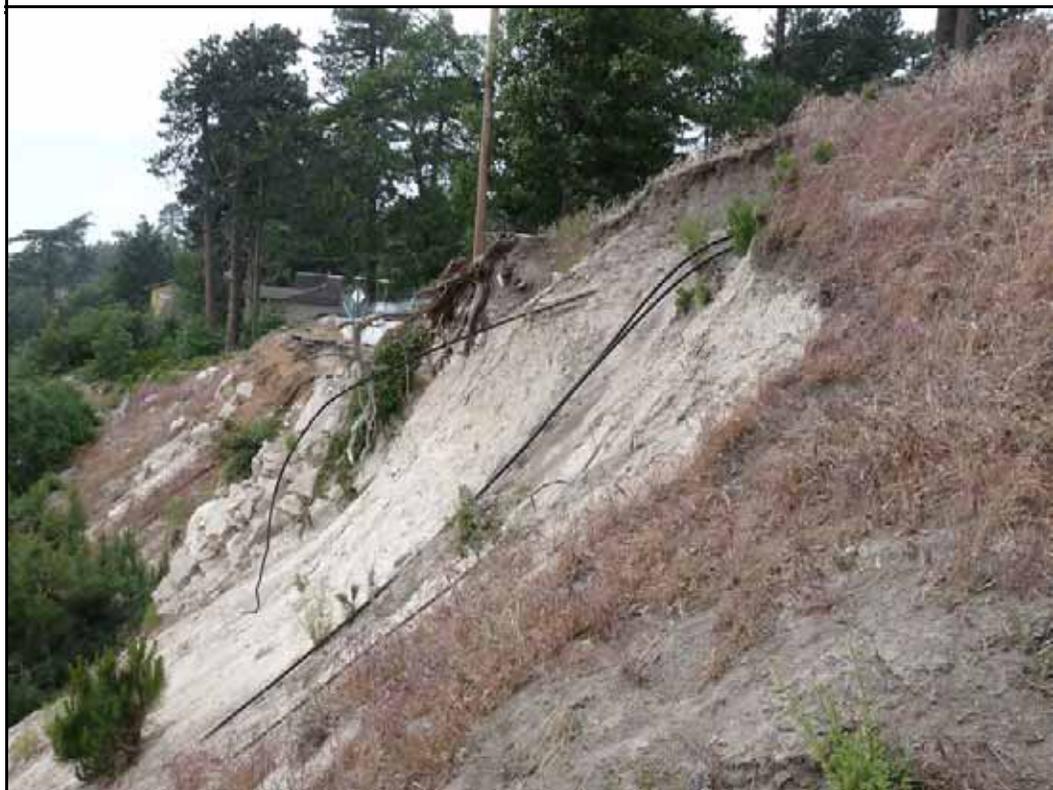
Northeastern landslide, view toward the west. Pulverized and weathered material within the Rimforest fault is seen in the middle of the photo. The brown topsoil wedge is visible above the fault zone.

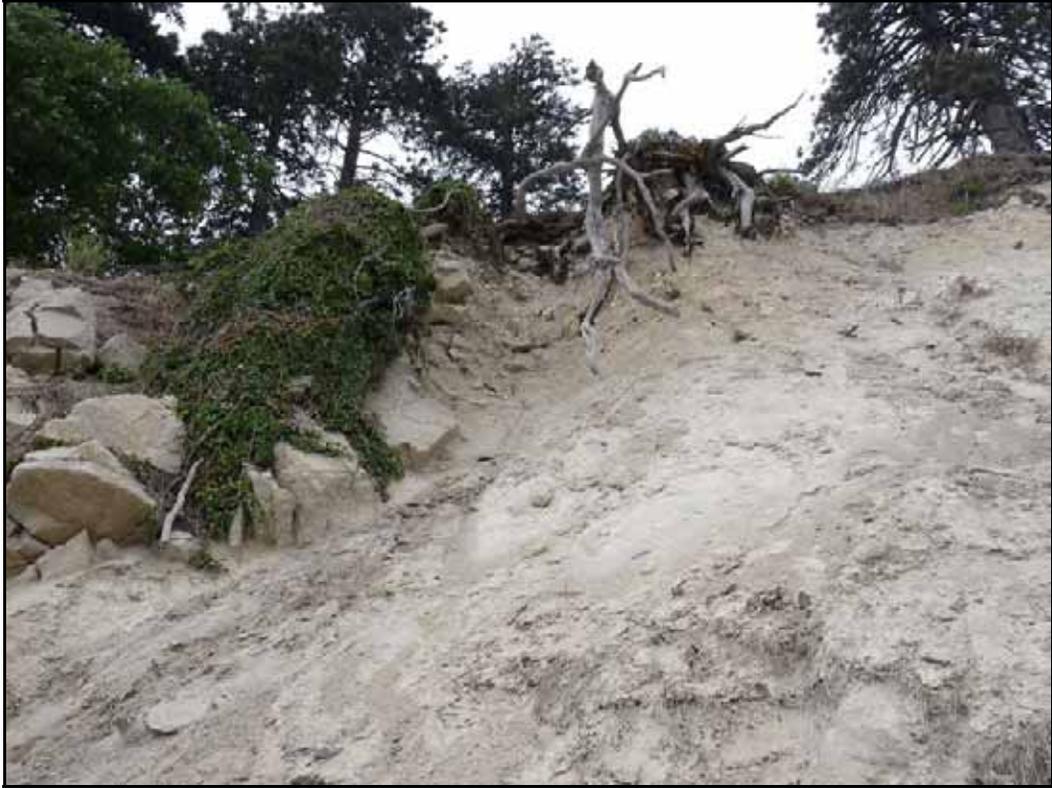
Northeast landslide. Contact between the west edge of the Rimforest landslide and more resistant rock.

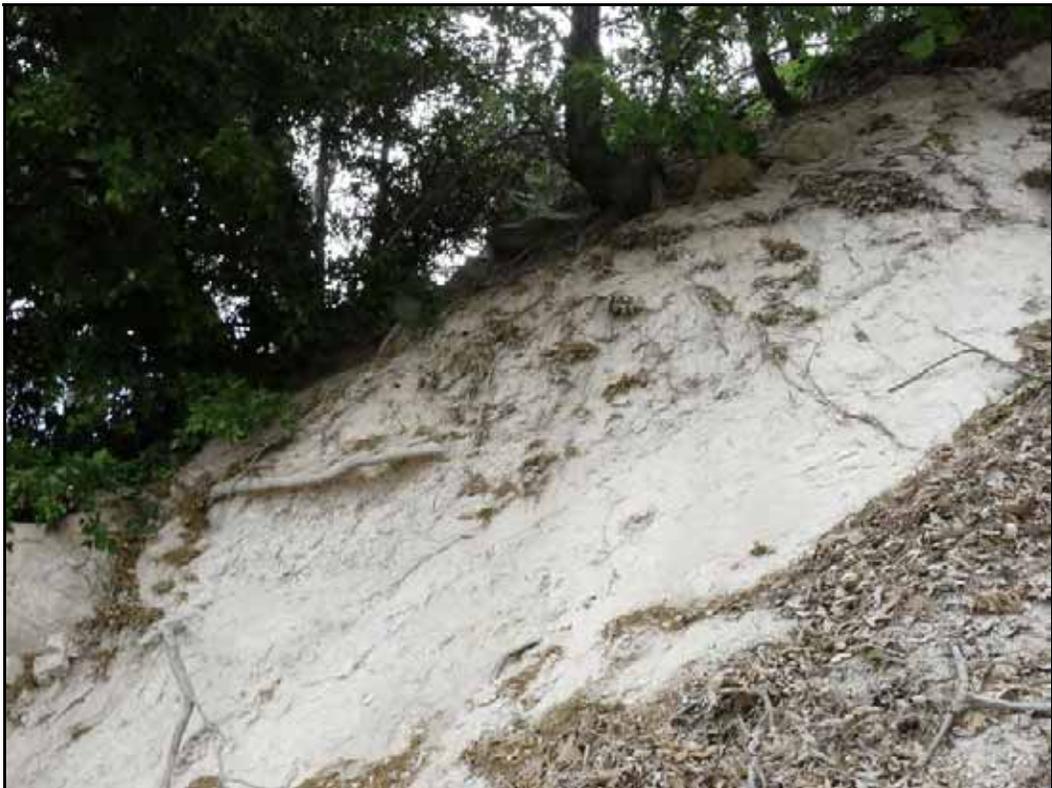
West of northeastern landslide. Erosion exposed crushed and powdered rock within the Rimforest fault zone. The prominent soil creep zone is visible as a diagonal line parallel to the soil surface and by significantly bent tree trunks.

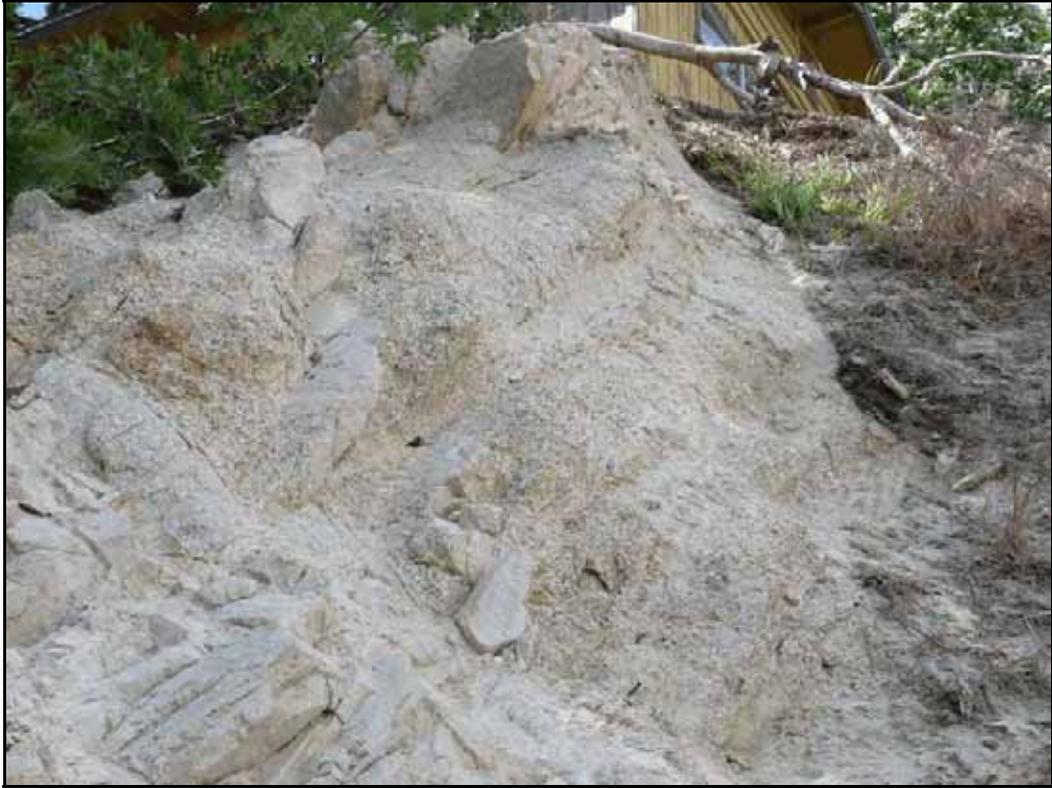
A closer view in the same location as the previous photo. The parallel planes are revealed as slip surfaces. Displacement was a few inches or less.

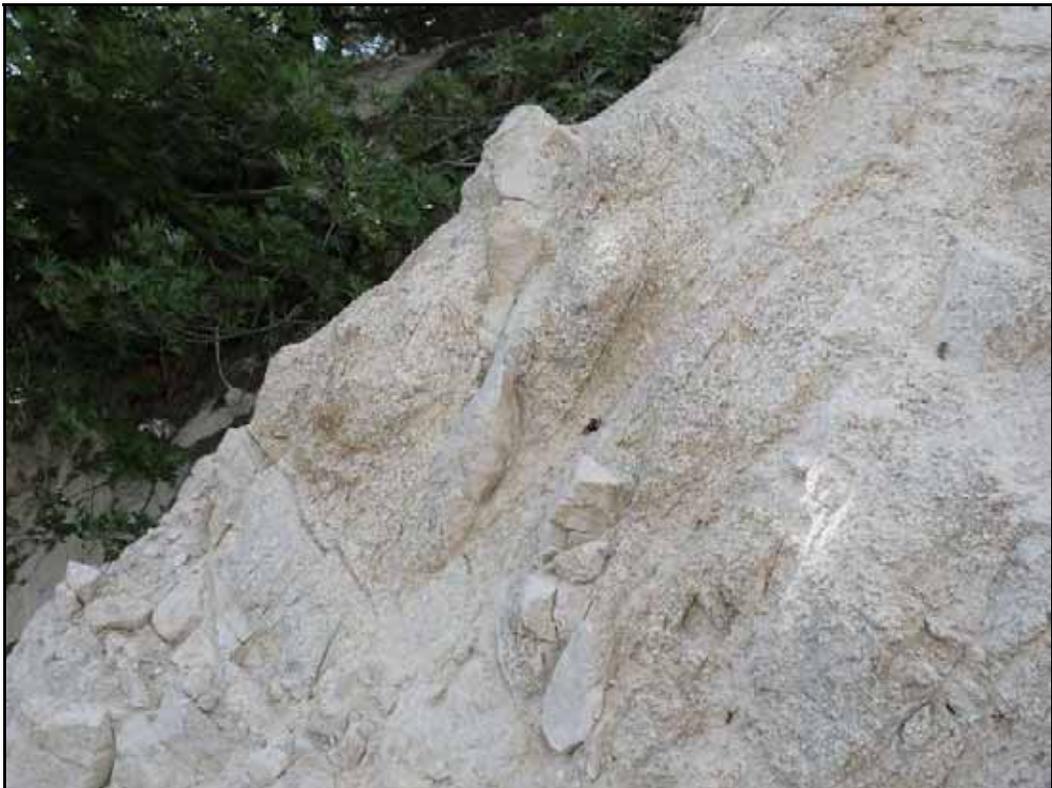
A closer view from the previous photo shows numerous slip planes in greater detail.

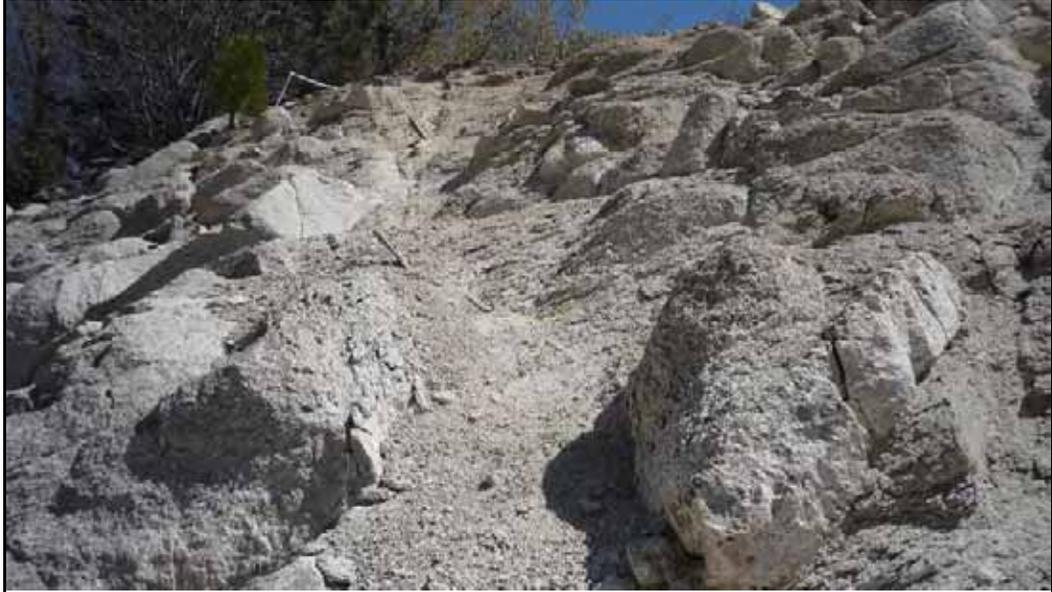
West of the northeastern landslide. Unlike crushed and powdered rock within the fault zone, the rock fabric here appears intact. However, this material is highly fractured, deeply weathered, and generally friable. (Note: photo full size. Aspect ratio 16:9)

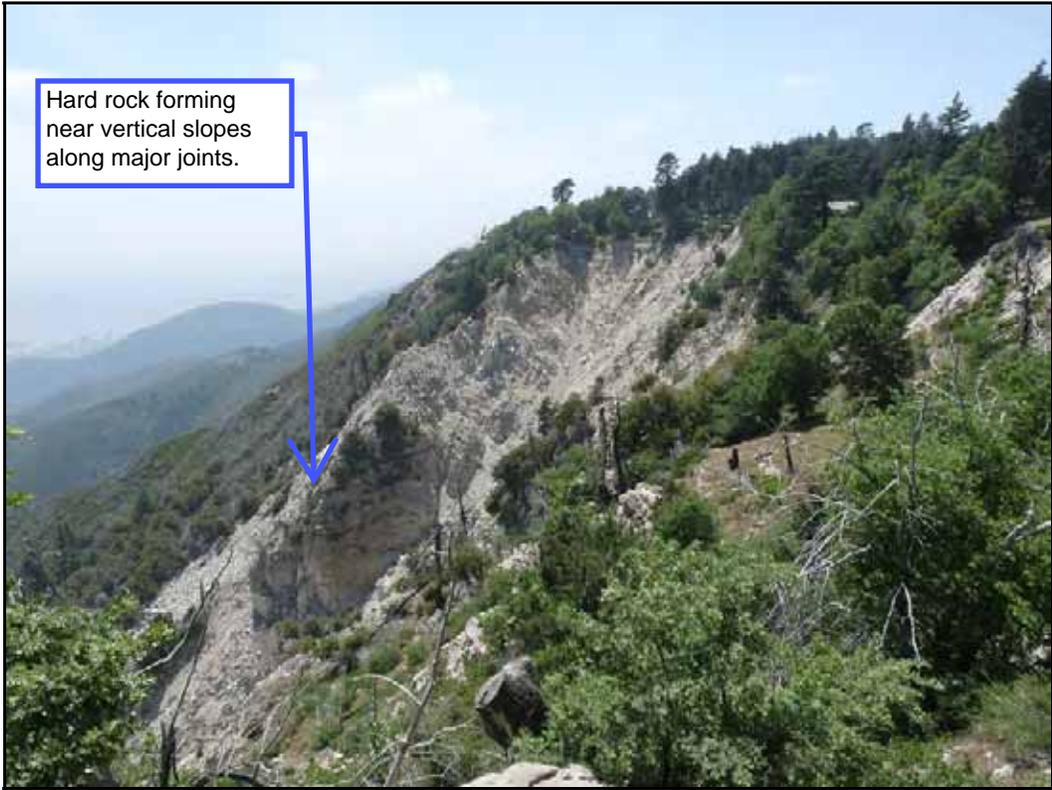
Western landslide, view from east side of northeastern landslide. Large block of hard, resistant rock below and left of the slide scar.

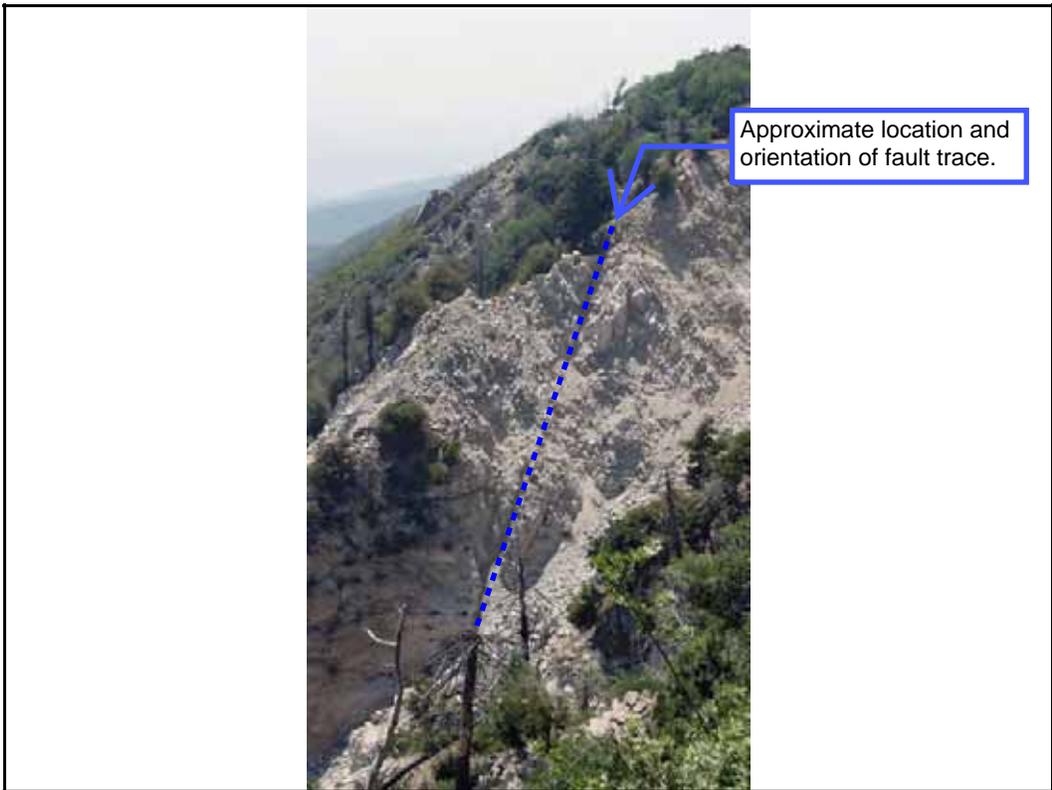
Western landslide. One trace of the Rimforest fault visible within slope face. (vertical photo)

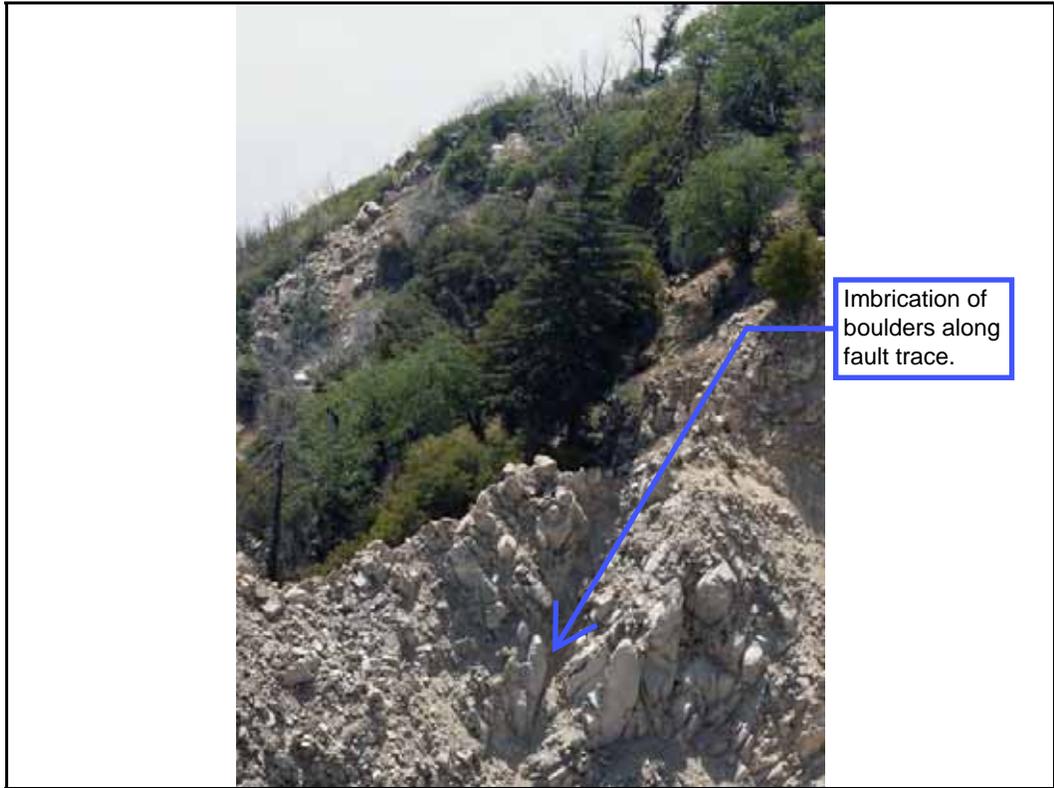
Imbrication of boulders along fault trace.

Western landslide. Closer view showing imbrication of some large rocks along the fault trace. (vertical photo)

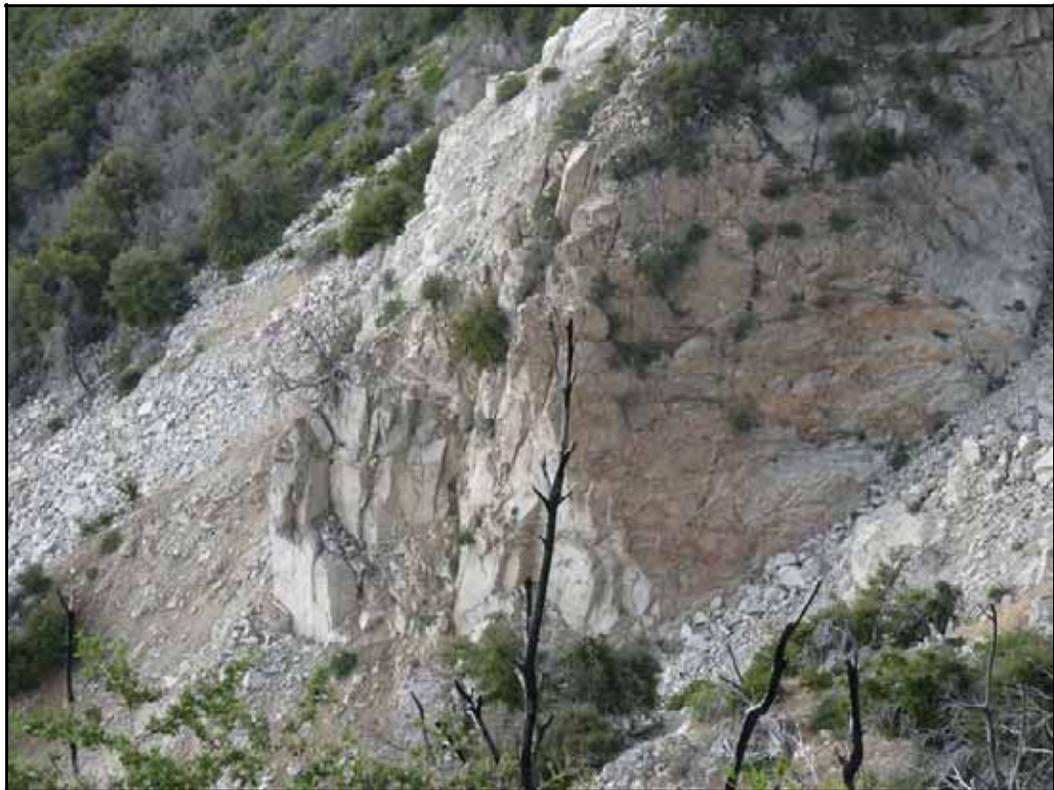
Western landslide. Intersection of two major, nearly vertical joint trends within large block of very hard, resistant rock that lies below the western landslide.

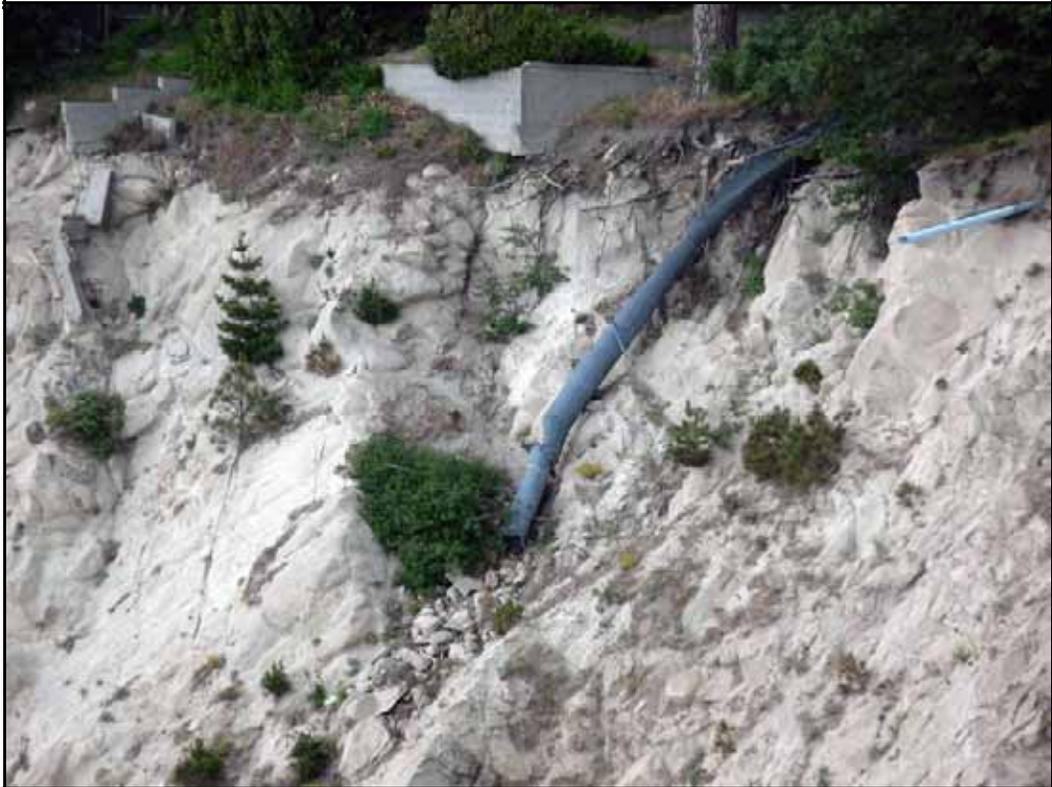
Western landslide. Two storm drain pipes extend out from the edge and direct runoff flow down into the landslide scar.

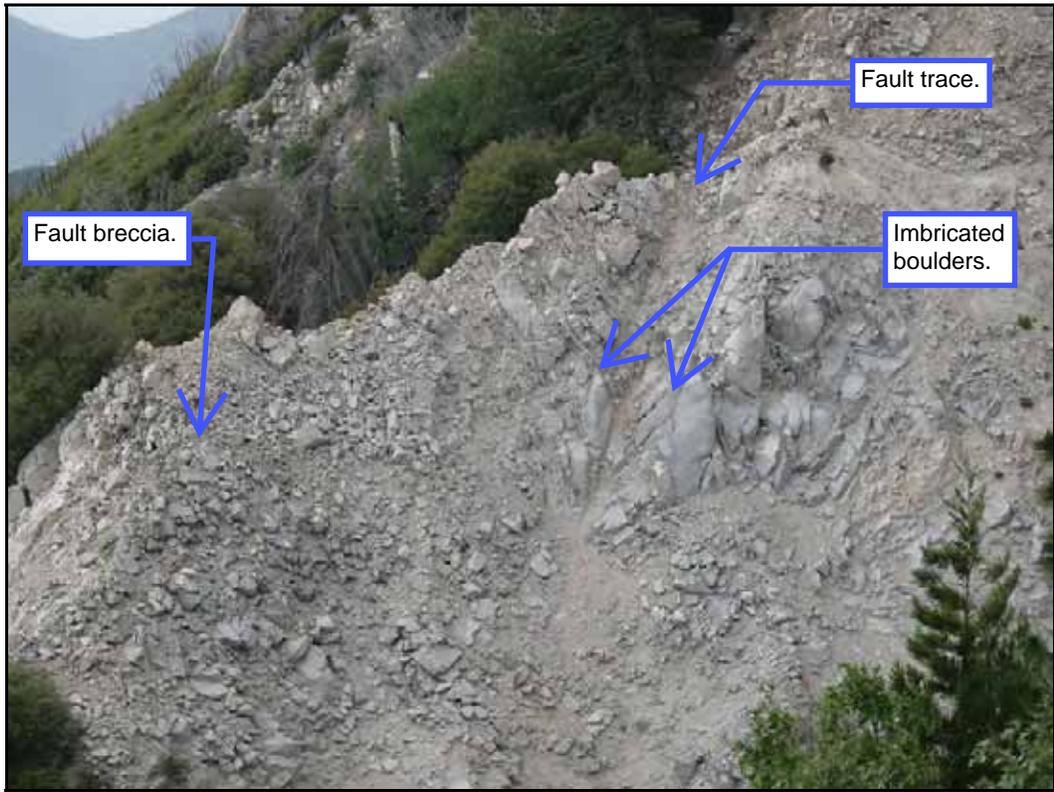
Western landslide. A closer view of one Rimforest fault trace, imbricated rocks, and fault breccia.

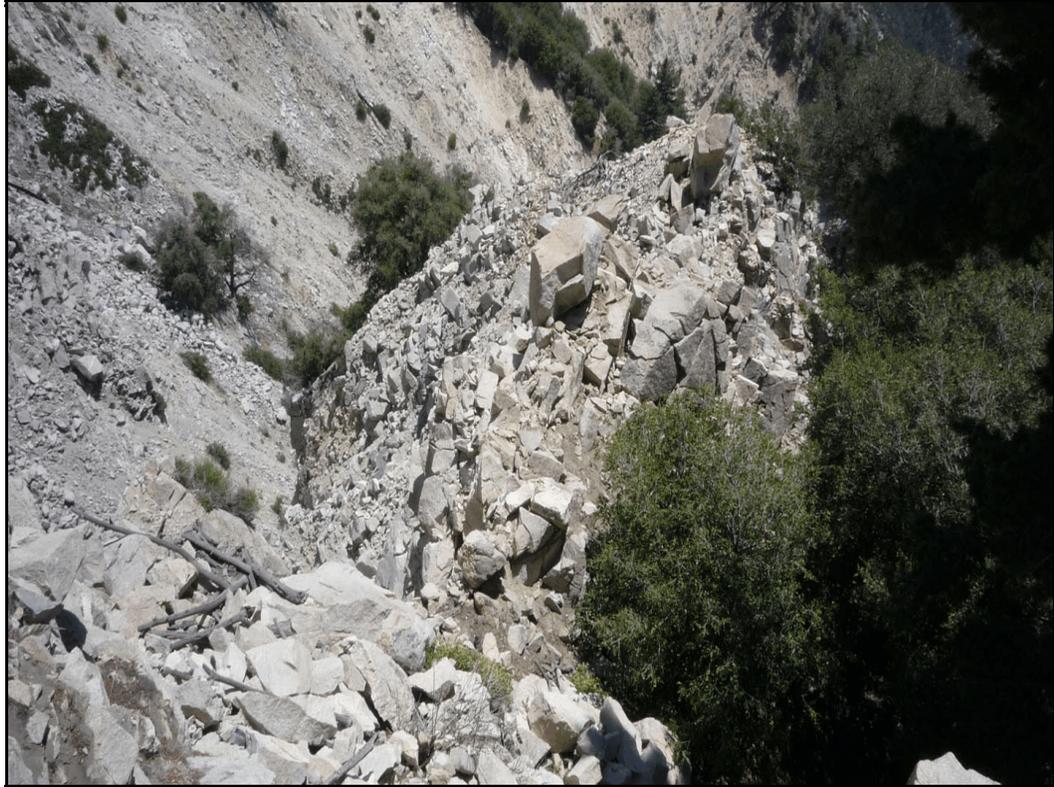
Western landslide. Viewed from a point south of the Rimforest fault and above the block of hard rock that is below the landslide.

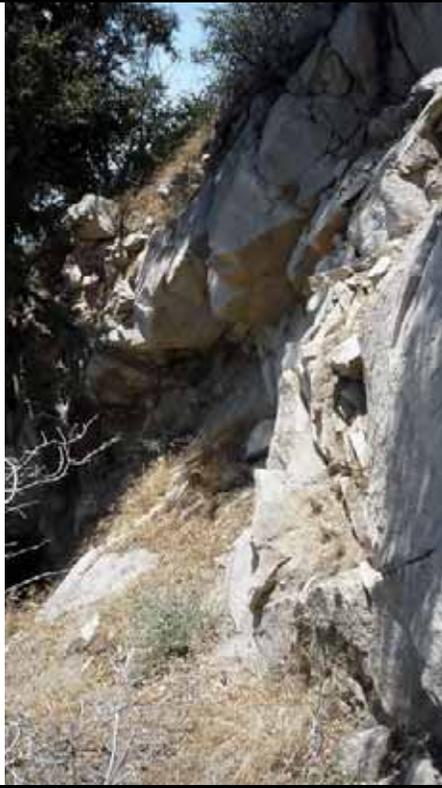
South of the western landslide. This overhang, from previous, small slide block movement, was outside active landslide areas and was unaffected by development or fire break construction. Slope failures in Rimforest would occur without human activity.

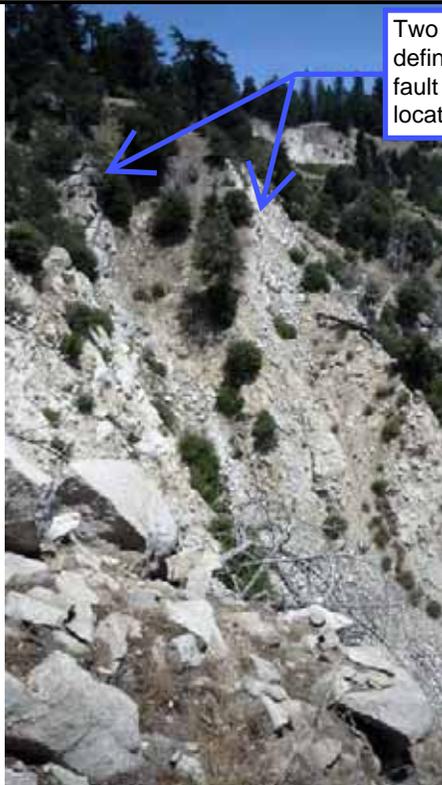
Two parallel traces define the Rimforest fault zone in this location.

The eastern edge of the western landslide. The Rimforest fault zone is visible in this slope as a pair of parallel traces. (both photos on this plate have vertical orientation)

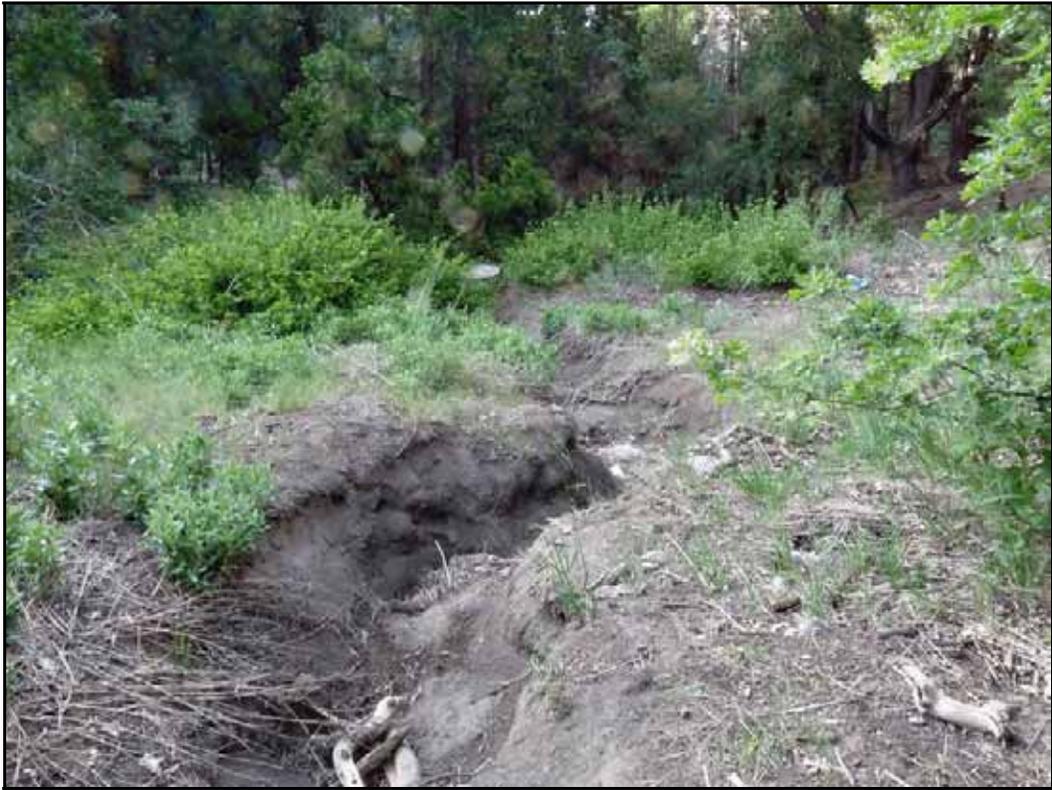
Little Bear Creek, located northeast of Rimforest. The soft alluvium is easily eroded.
