FINAL
Drainage Feasibility Study
Volume III (Geotechnical Component Vol. 2)

Community of Rimforest
County of San Bernardino, CA

November 8, 2010

APPENDIX B
PHOTOGRAPHS

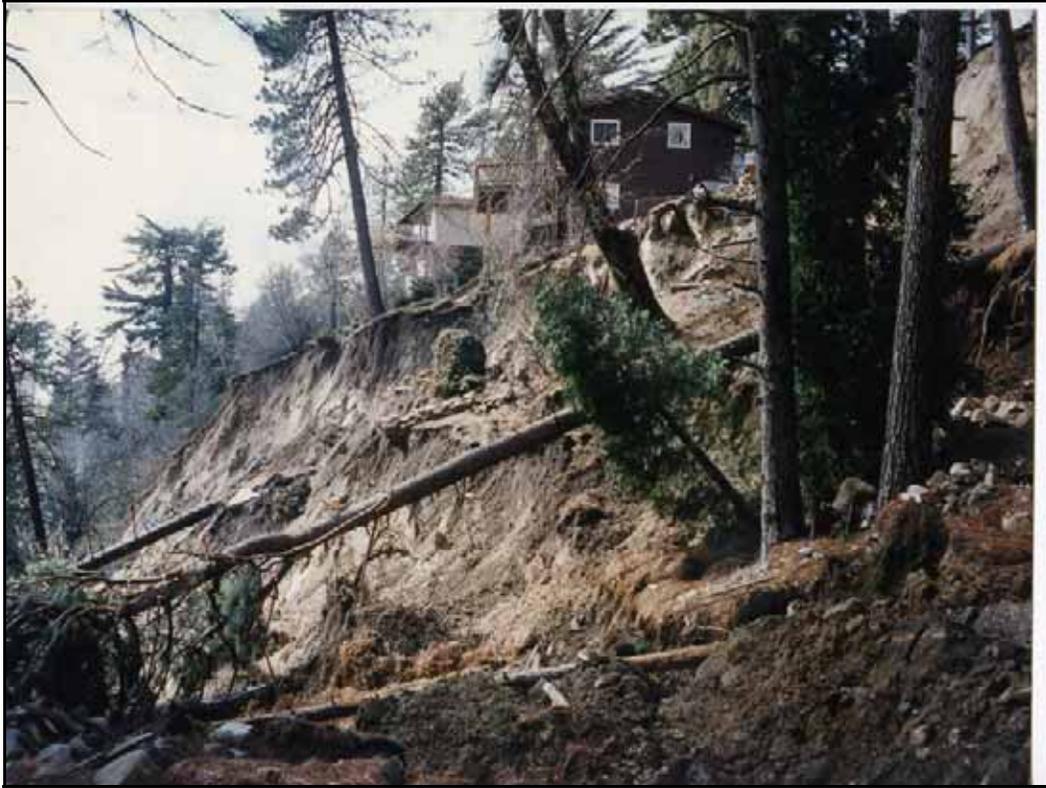
Large fissures above western landslide, 1933. Virtually all small fissures and most medium-sized fissures from this event were no longer visible in 2009. Only the larger fissures are still apparent.
Photo supplied by Wes Reeder.

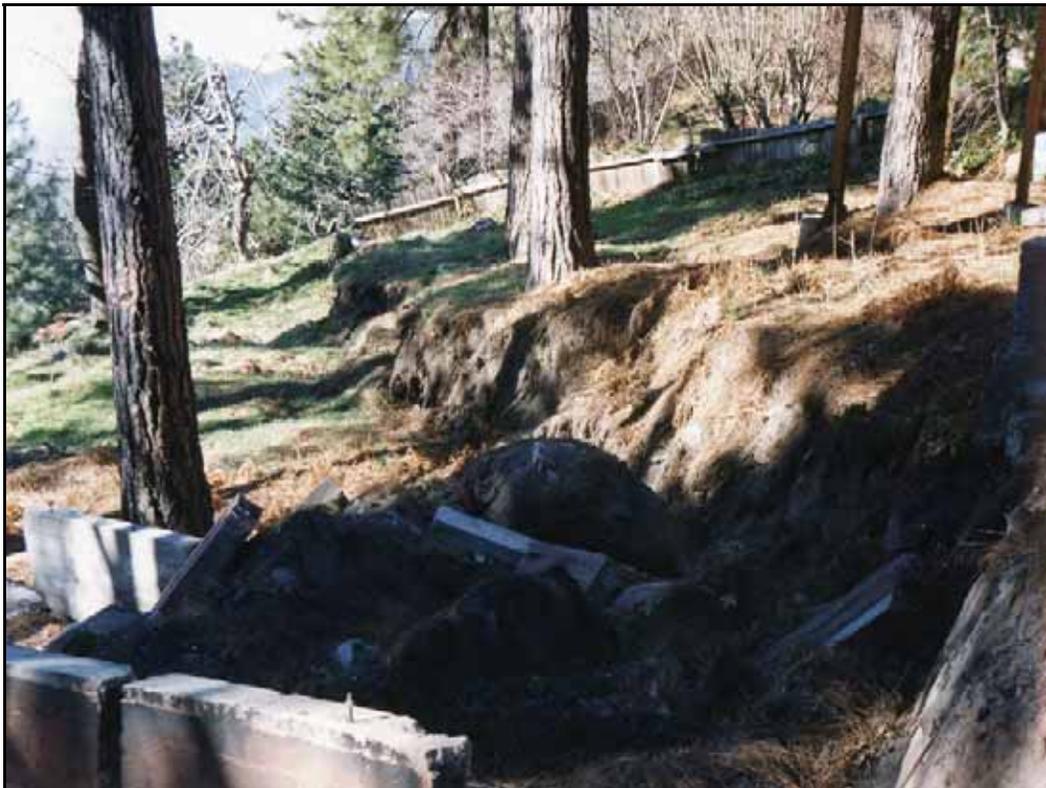
Large fissures, like this one, by 2009 have eroded to form 'steps' in the topography above the western landslide. A few fissures remain open. Photo supplied by Wes Reeder.

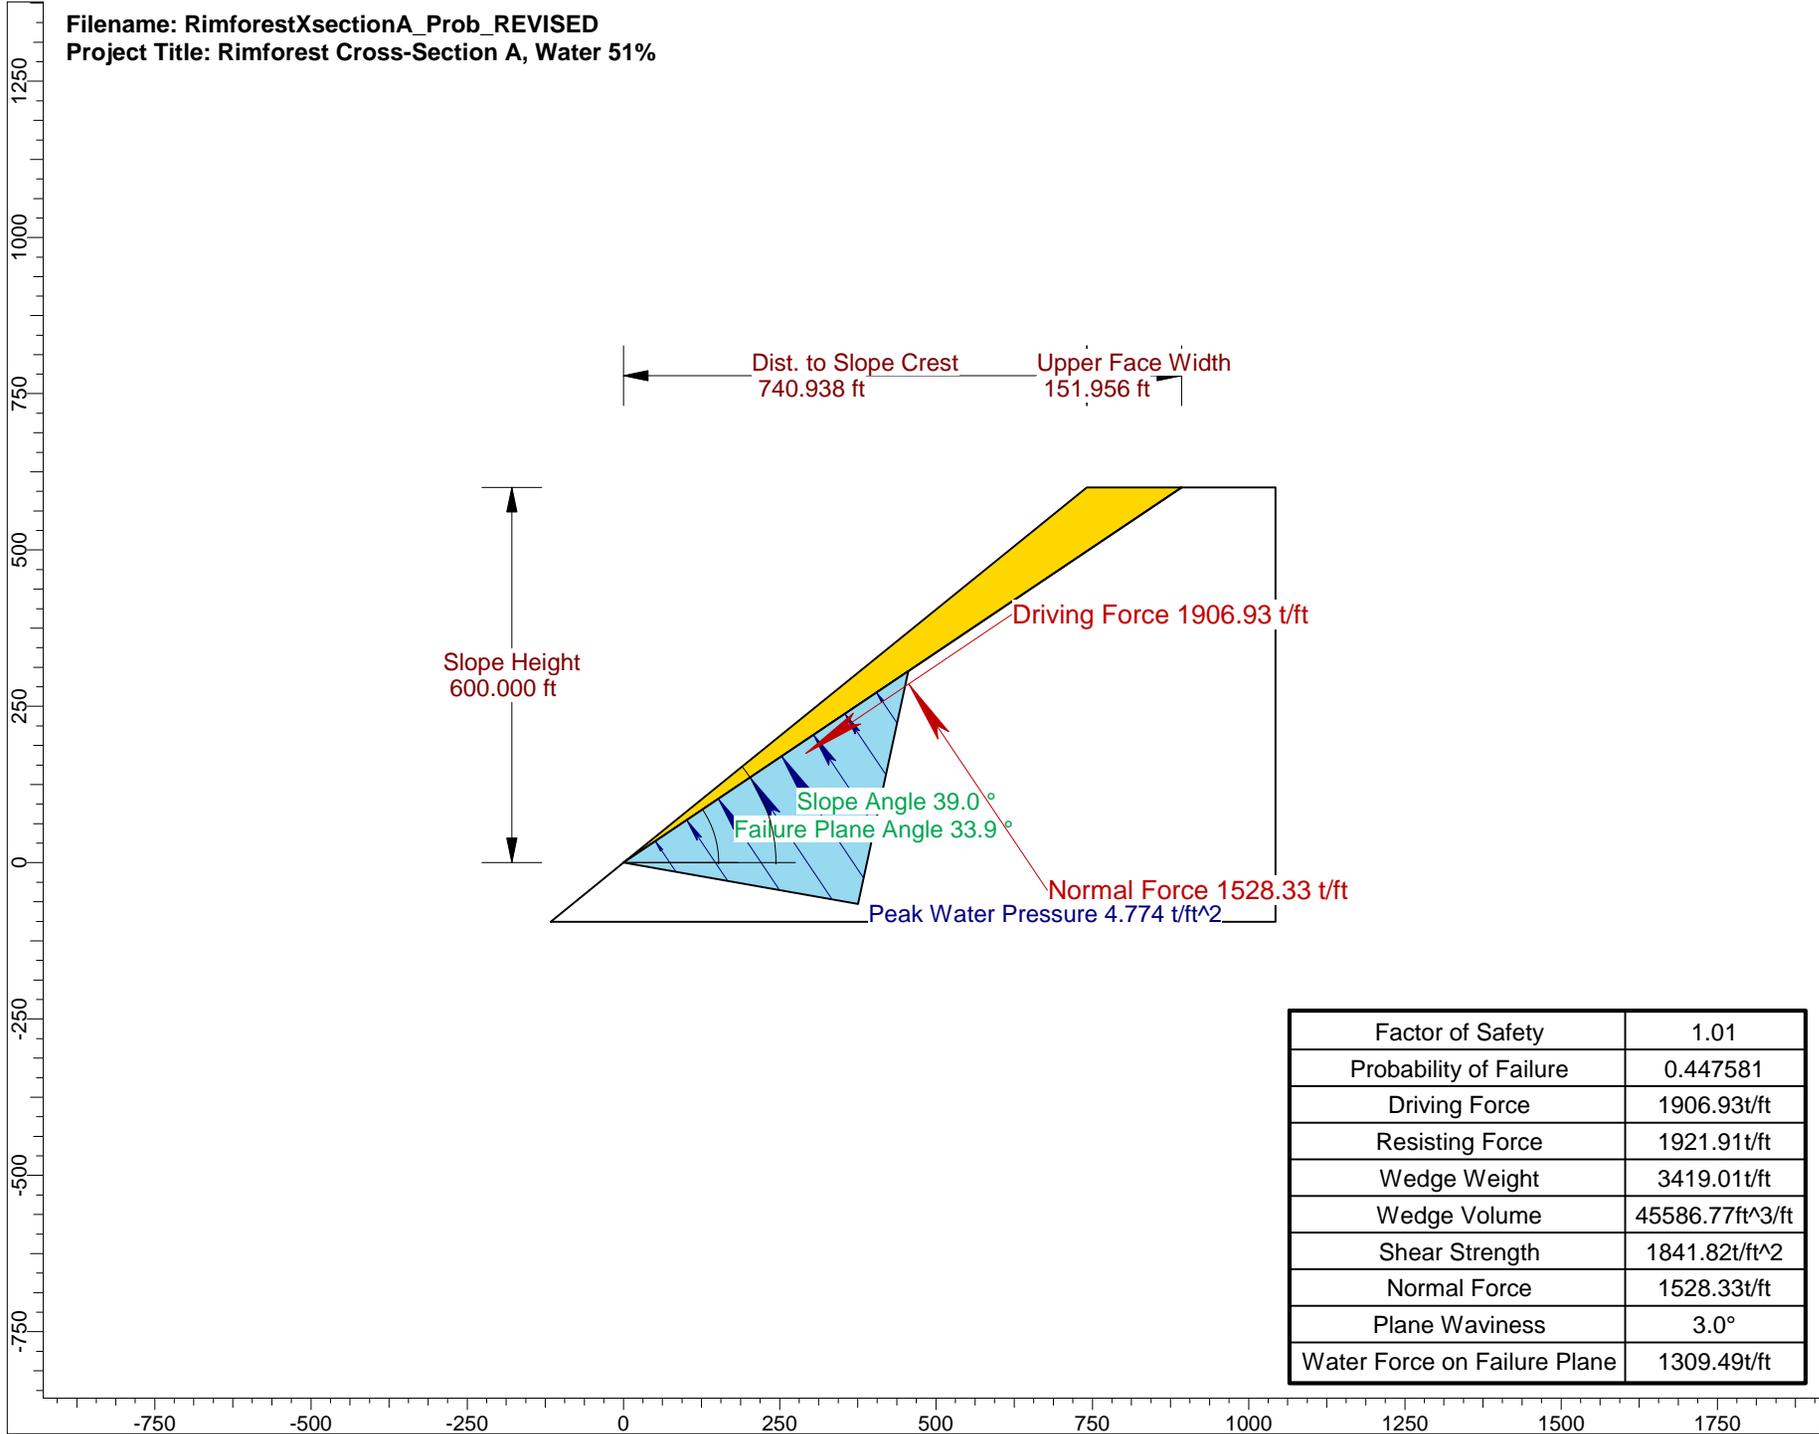
Factor of Safety	0.73
Probability of Failure	0.941532
Driving Force	3183.95t/ft
Resisting Force	2324.31t/ft
Wedge Weight	3419.01t/ft
Wedge Volume	45586.77ft ³ /ft
Shear Strength	2220.56t/ft ²
Normal Force	1979.70t/ft
Seismic Force	1538.55t
Plane Waviness	3.0°

Filename: RimforestXsectionA_Prob_REVISIED
 Project Title: Rimforest Cross-Section A, Water 51%

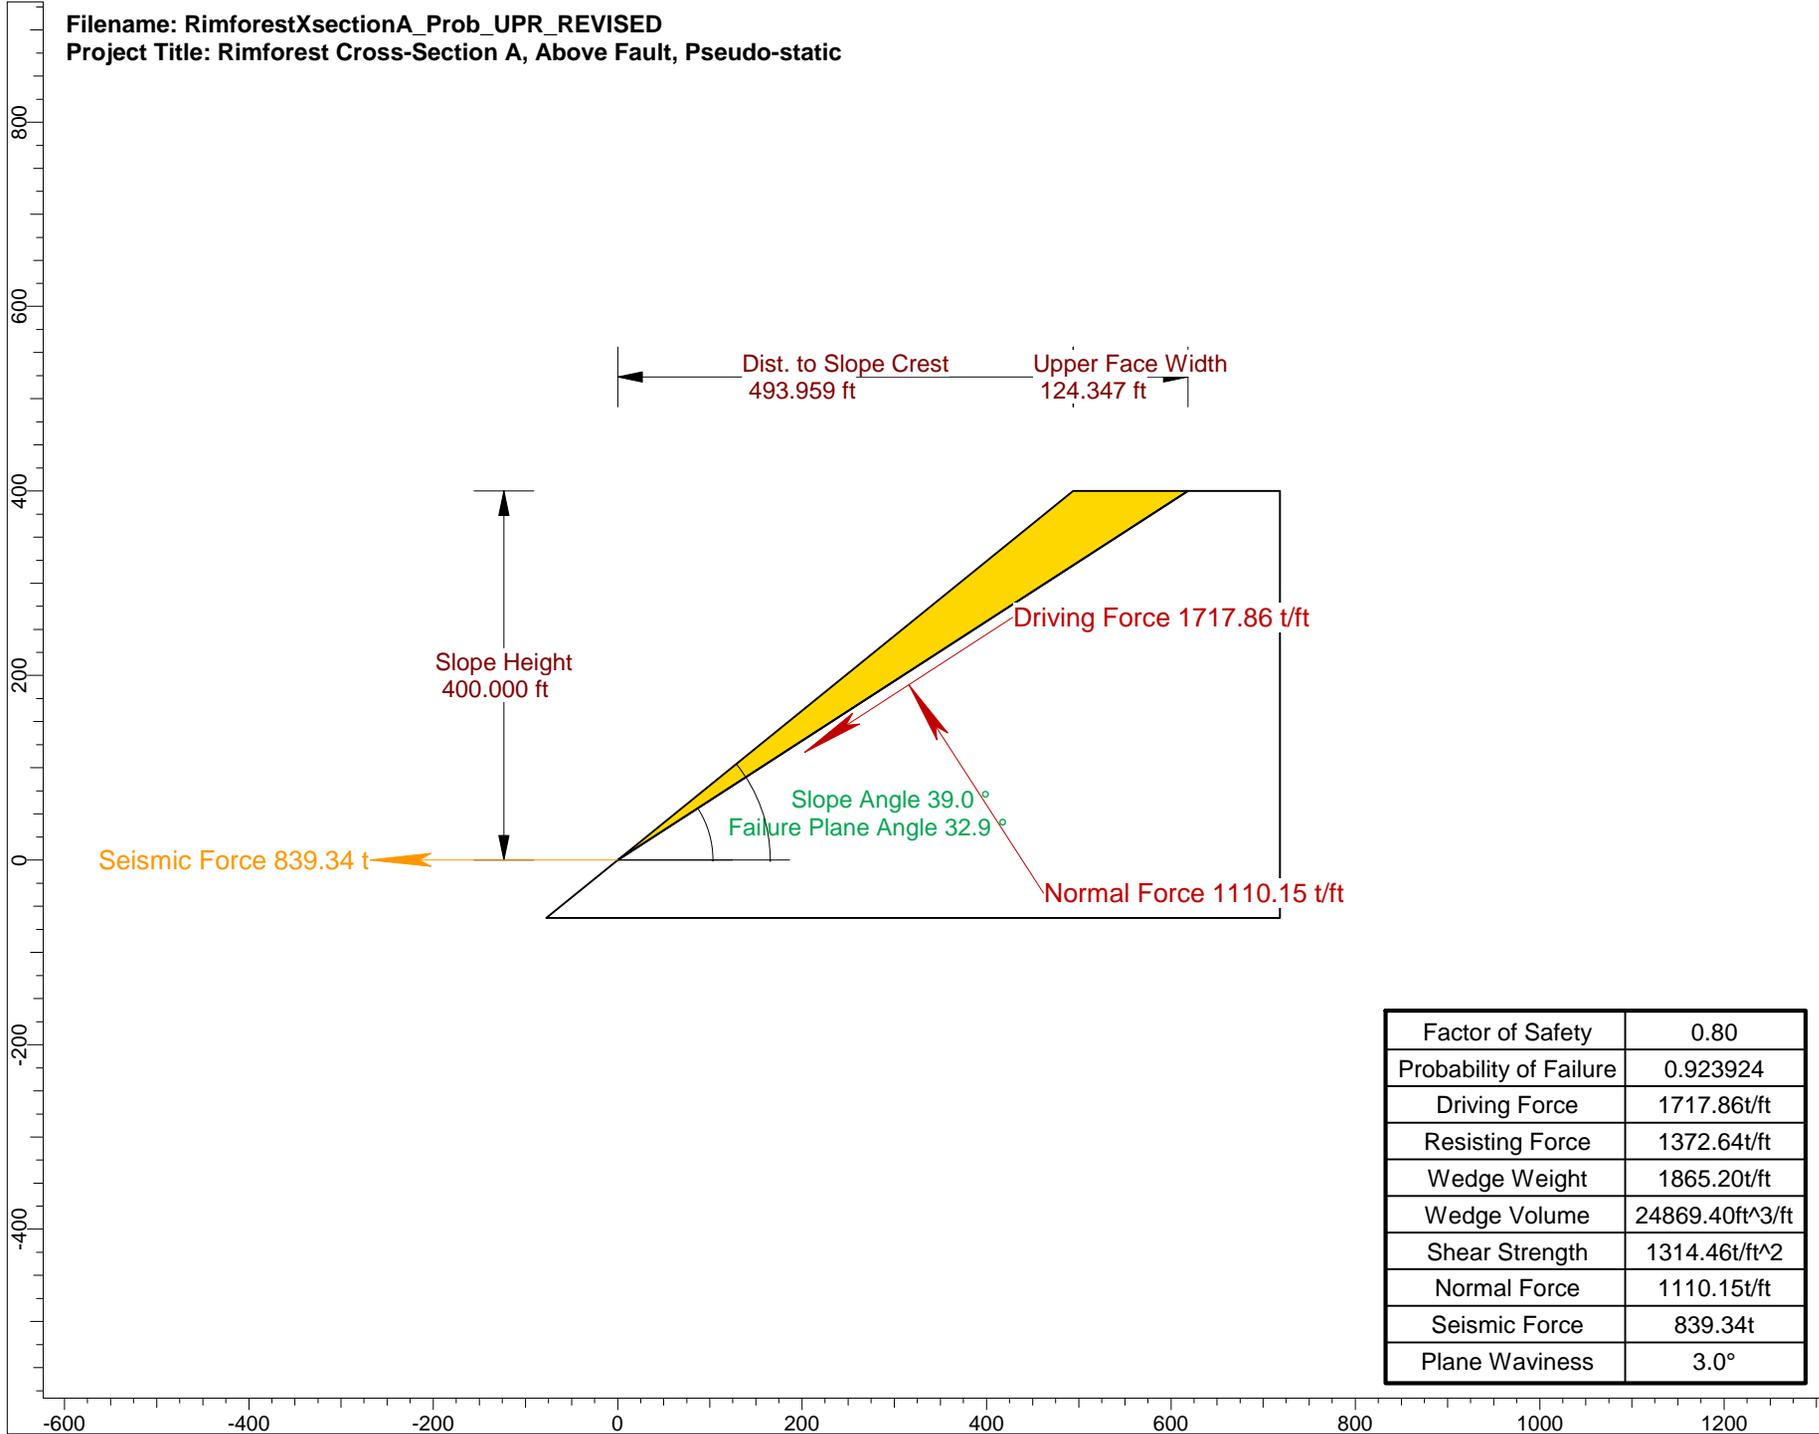
Factor of Safety	1.76
Probability of Failure	0
Driving Force	1013.13t/ft
Resisting Force	1779.09t/ft
Wedge Weight	1865.20t/ft
Wedge Volume	24869.40ft ³ /ft
Shear Strength	1697.02t/ft ²
Normal Force	1566.06t/ft
Plane Waviness	3.0°

Filename: RimforestXsectionA_Prob_UPR_REVISIED
 Project Title: Rimforest Cross-Section A, Above Fault, Pseudo-static

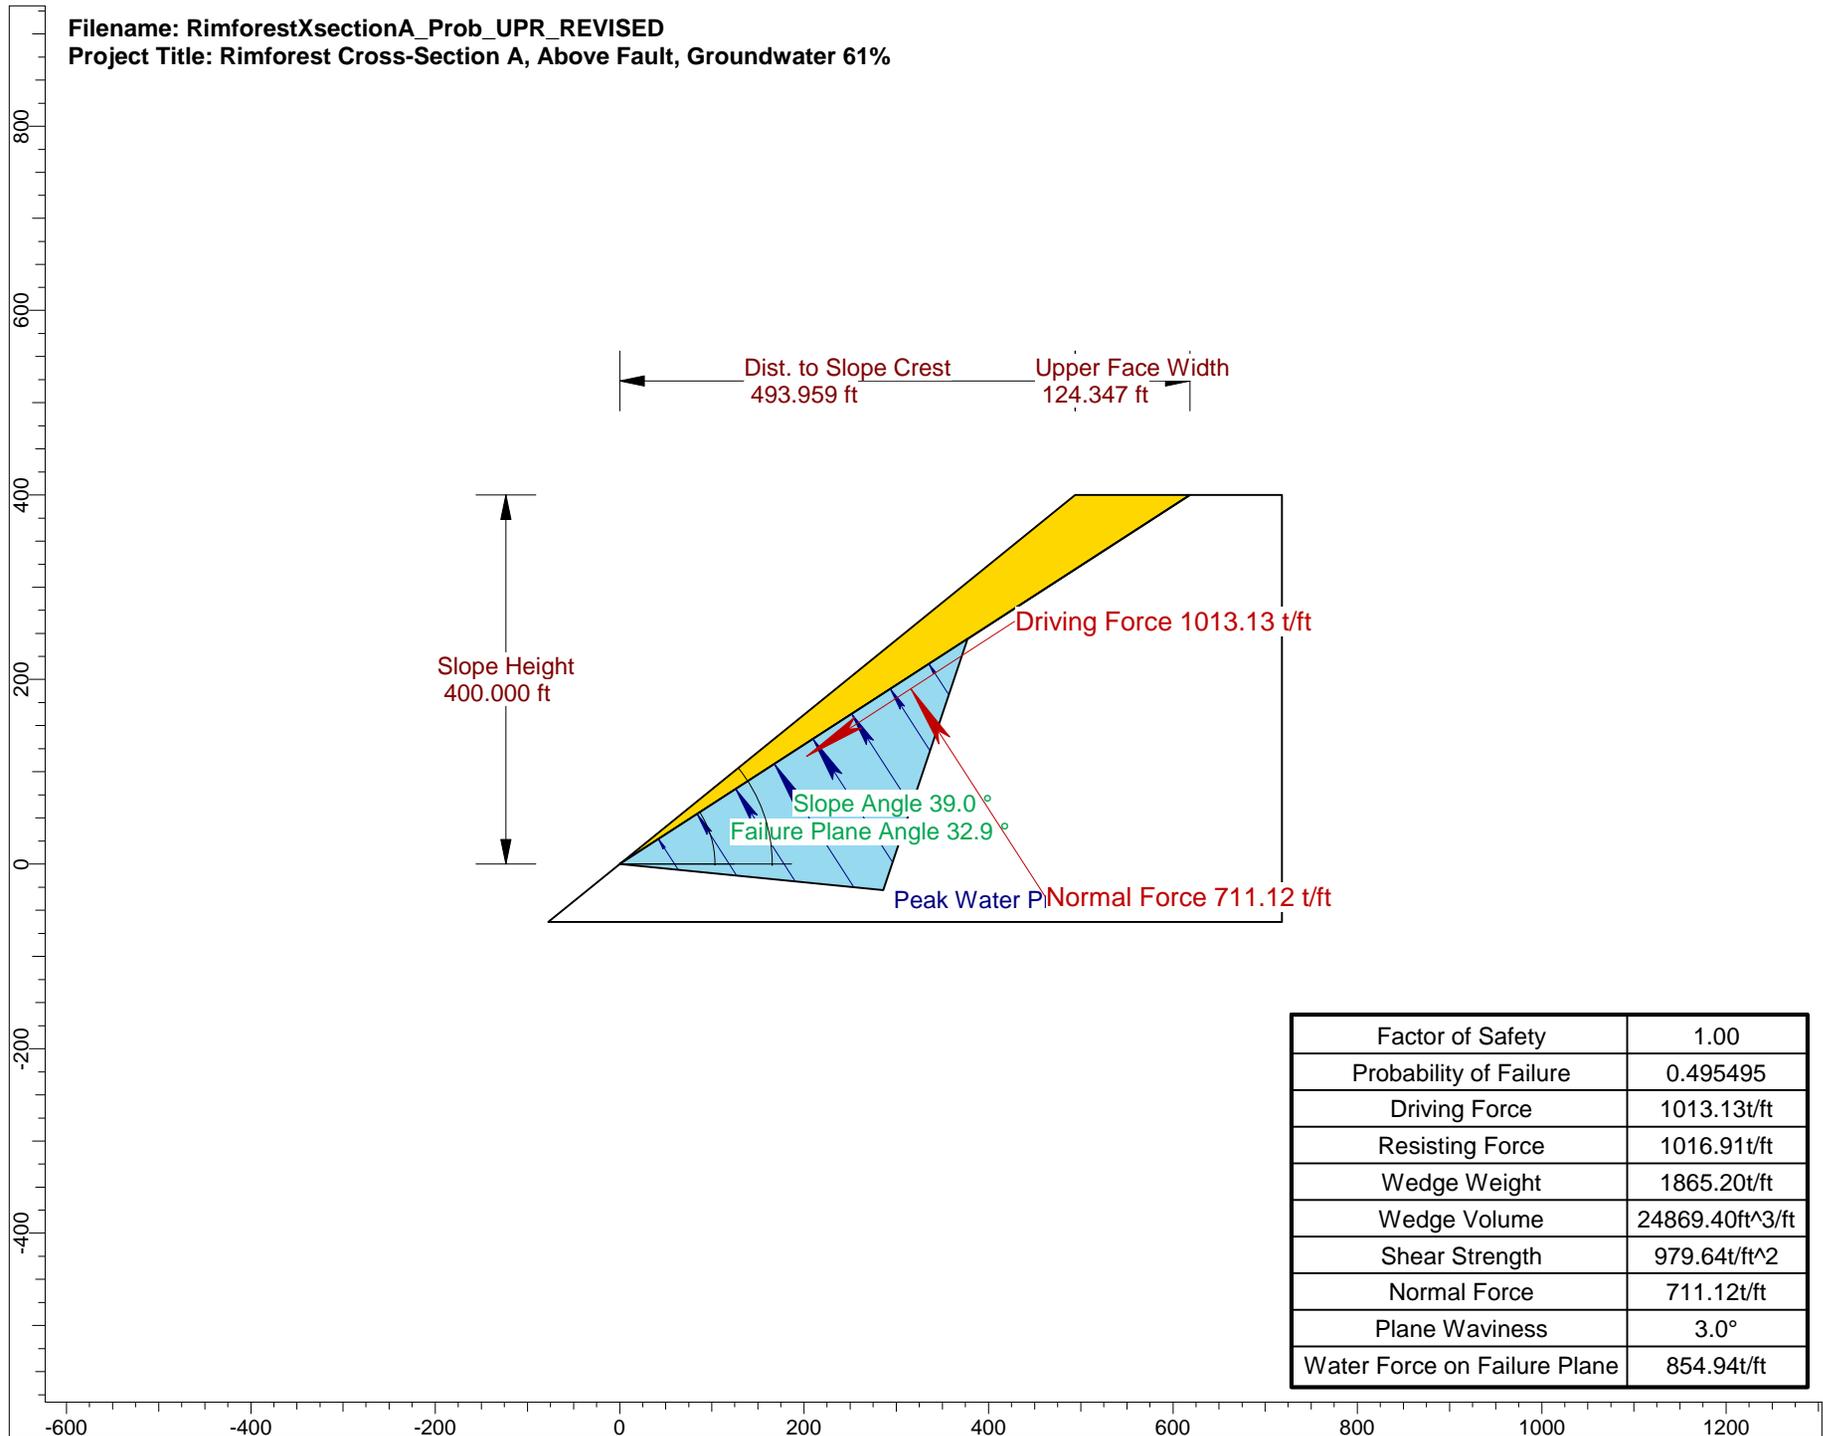
Filename: RimforestXsectionA_Prob_UPR_REVISIED
 Project Title: Rimforest Cross-Section A, Above Fault, Groundwater 61%

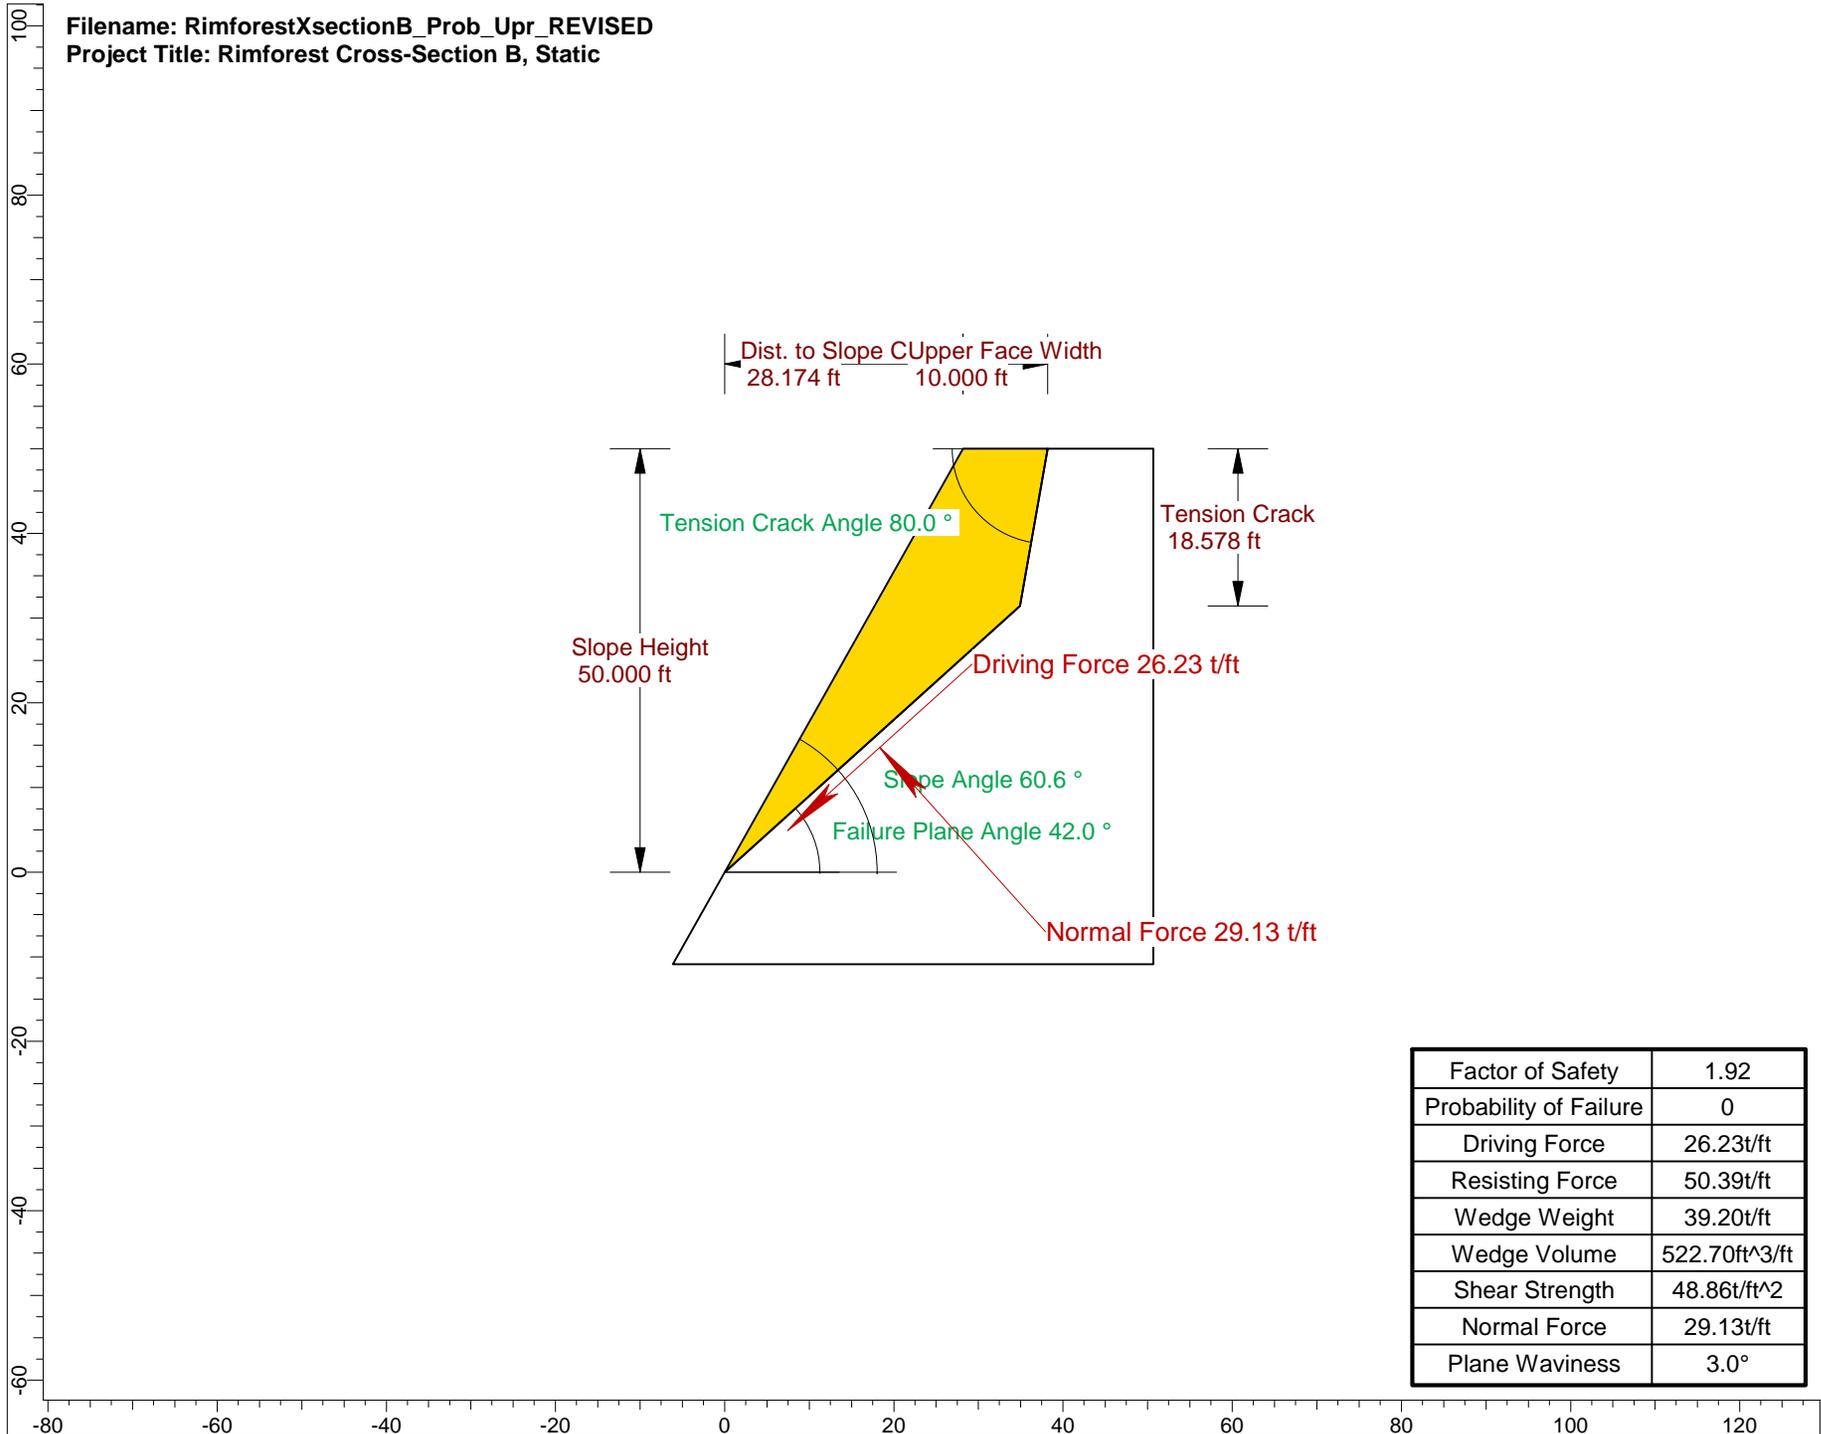
Filename: RimforestXsectionB_Prob_Upr_REVISED
 Project Title: Rimforest Cross-Section B, Static

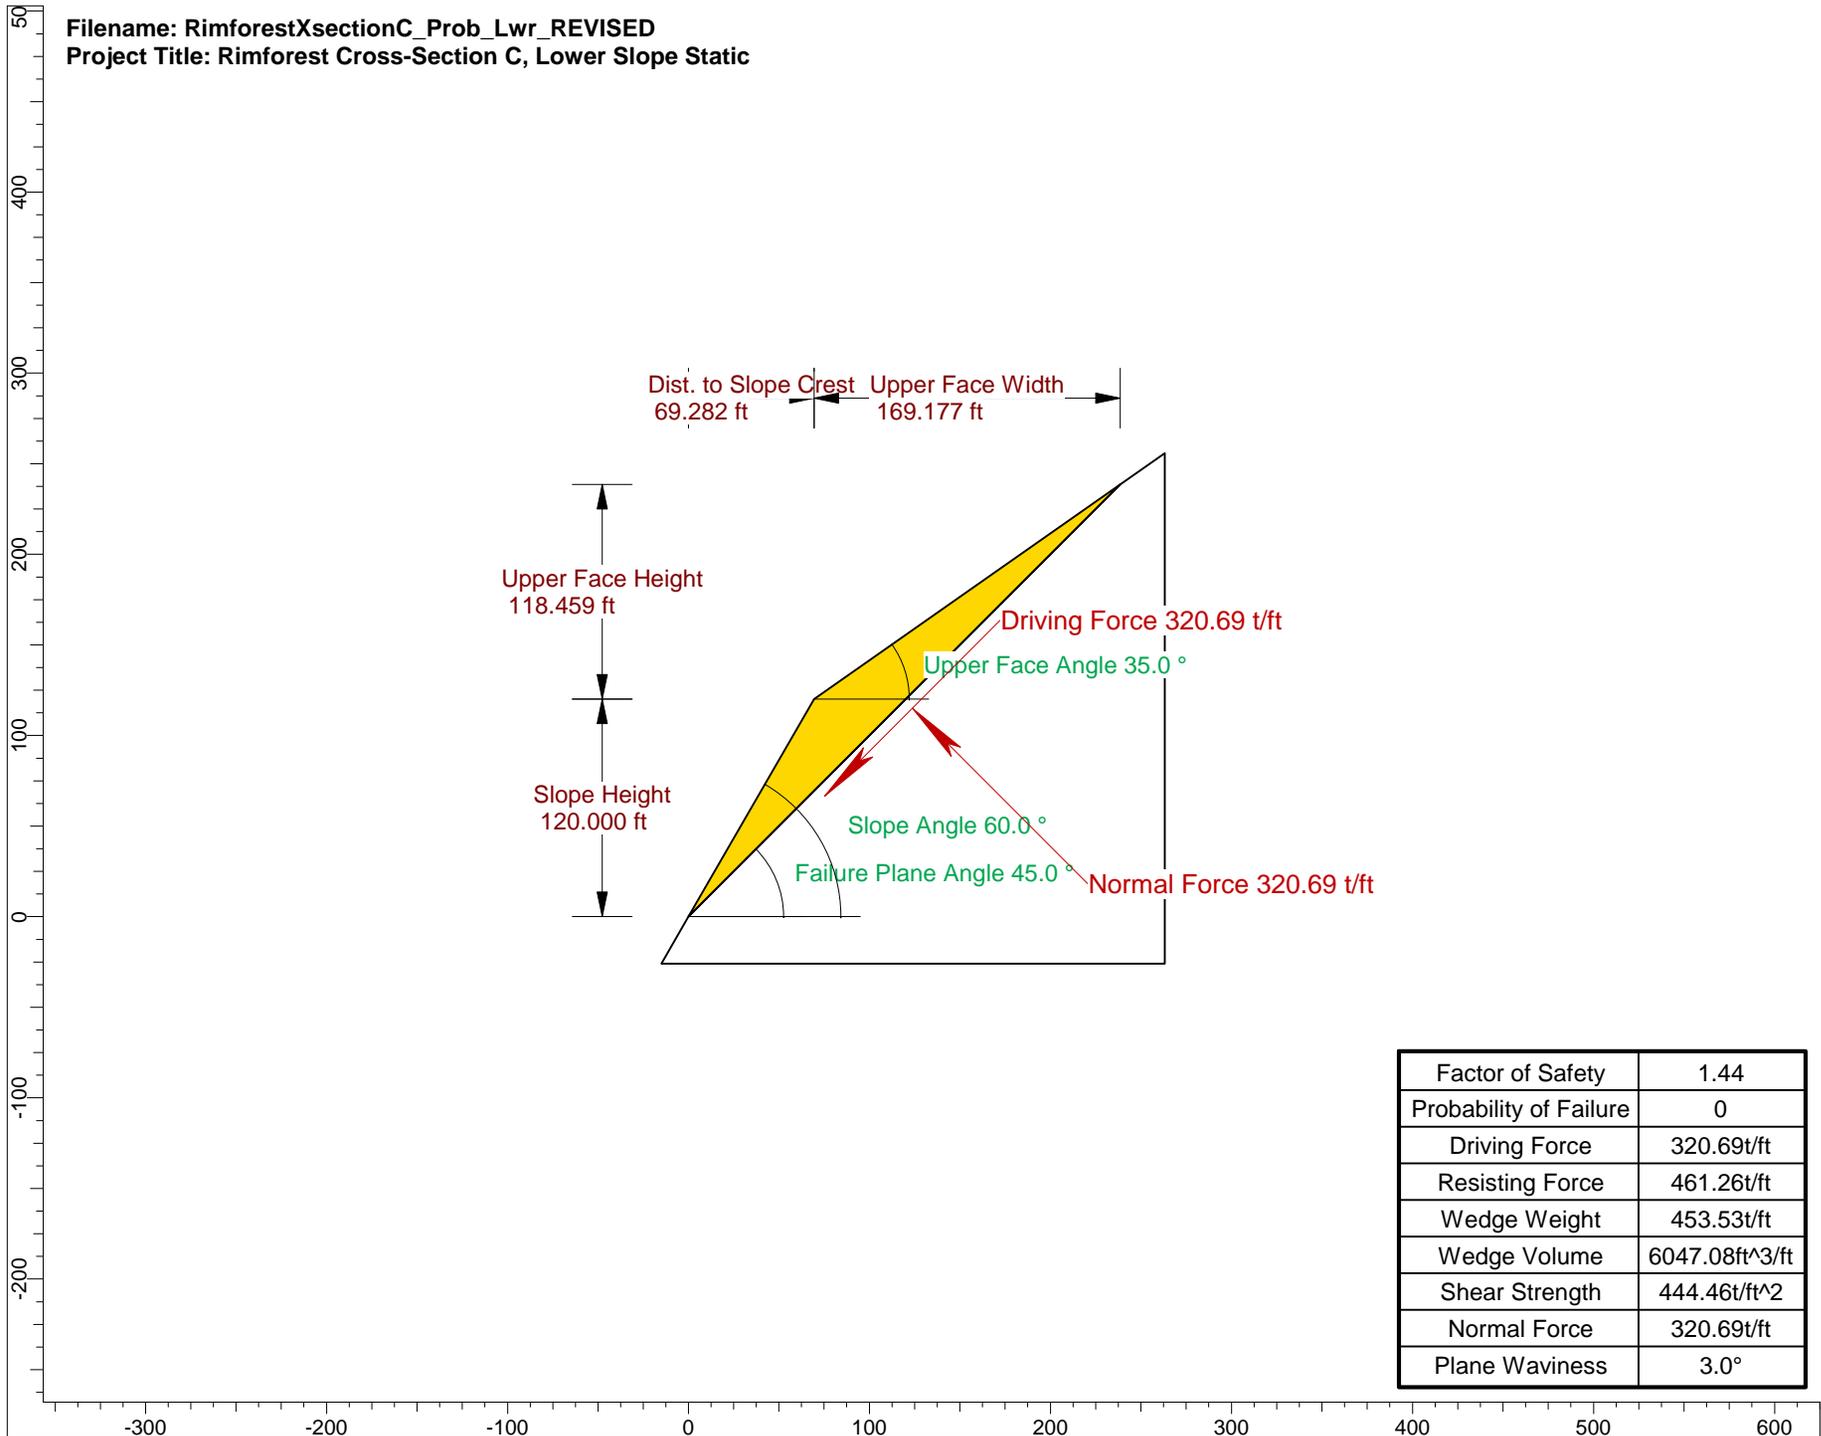
Filename: RimforestXsectionC_Prob_Lwr_REVISED
 Project Title: Rimforest Cross-Section C, Lower Slope Static

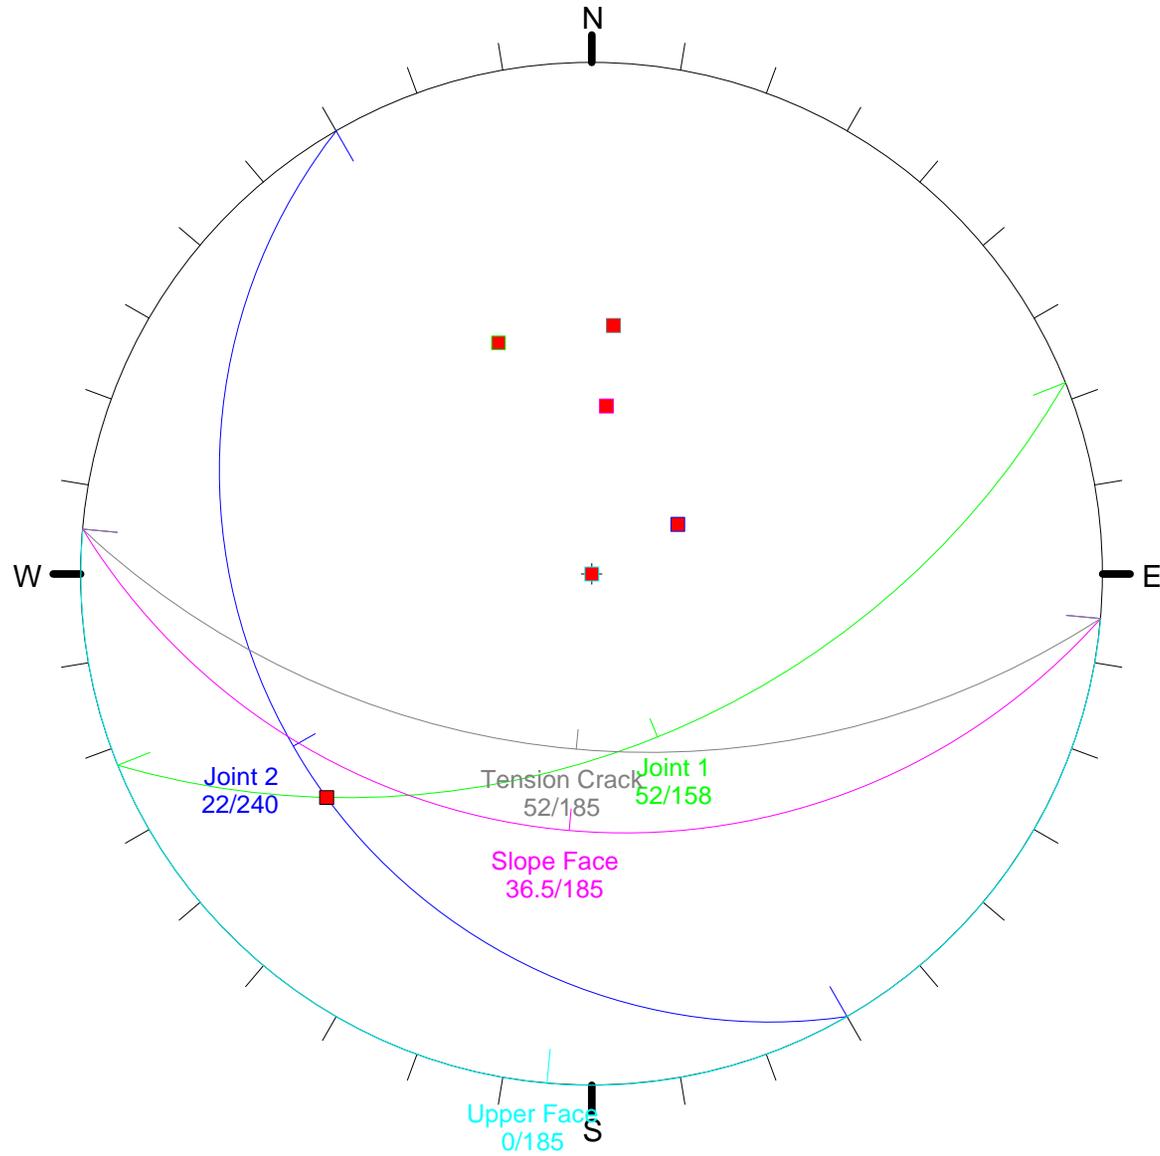
- Job Title: Rimforest Cross-Section C, Wedge 1
- Analysis: Joint Set Wedge Failure Analysis
- Author: Richard George
- Company: Hilltop Geotechnical, Inc.
- Date Created: 9/12/2009, 5:22:56 PM

- Analysis type: Deterministic
- Safety Factor: 0.9871
- Wedge height (on slope) [ft]: 1050.00
- Bench width (on upper face) [ft]: 0.00
- Wedge volume [ft³]: 54066562.752
- Wedge weight [tons]: 2973660.935
- Wedge area (joint1) [ft²]: 377492.85
- Wedge area (joint2) [ft²]: 440096.28
- Wedge area (slope) [ft²]: 1060068.88
- Wedge area (upper face) [ft²]: 0.00
- Wedge area (tension crack) [ft²]: 343834.53

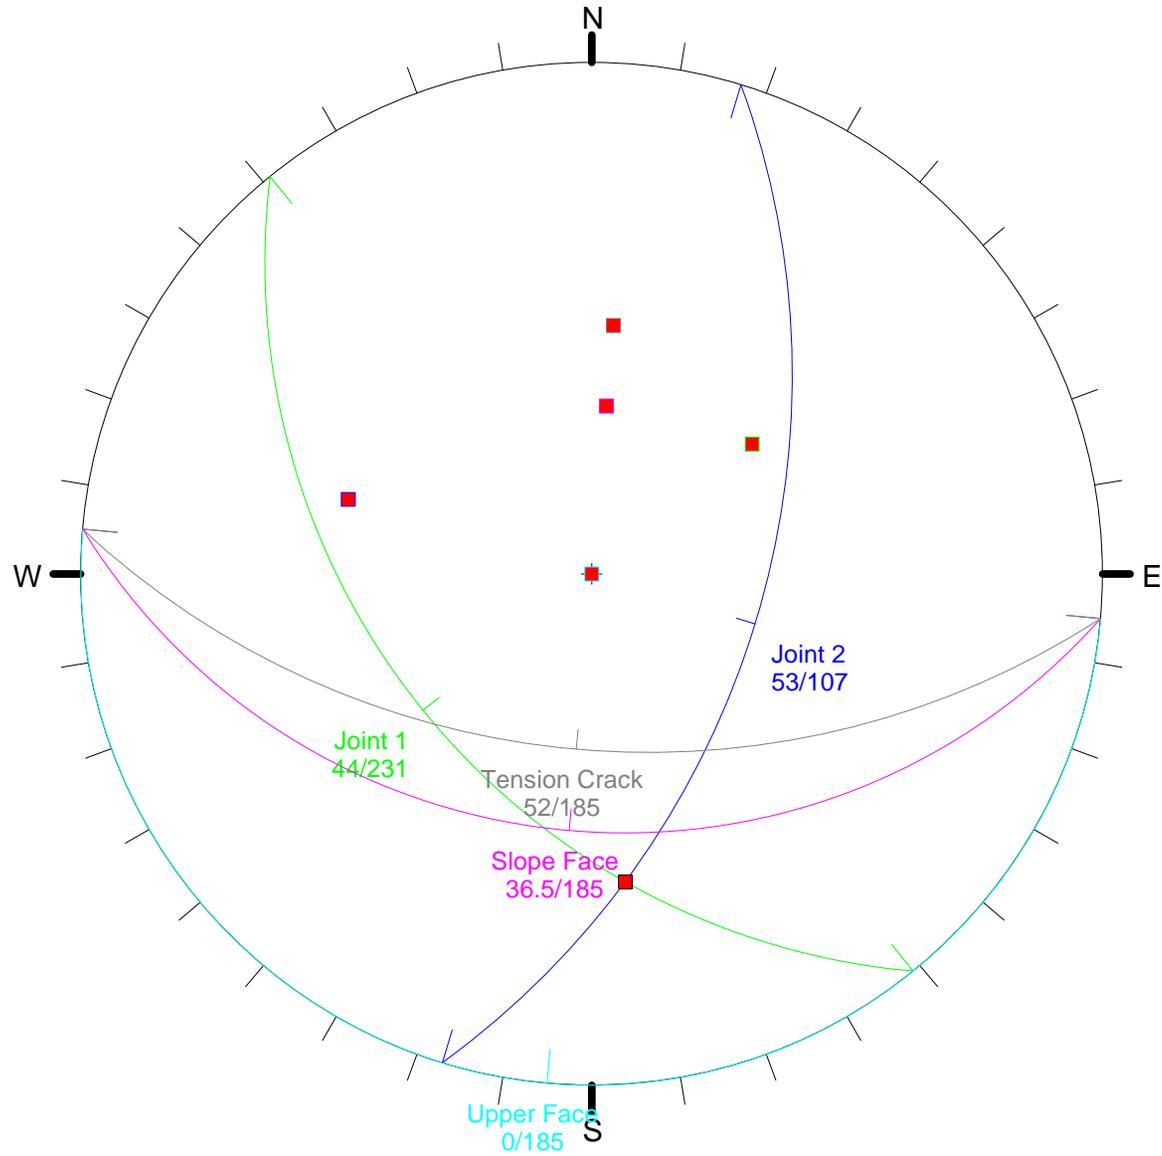
- Job Title: Rimforest Cross-Section C, Wedge 2
- Analysis: Joint Set Wedge Failure Analysis
- Author: Richard George
- Company: Hilltop Geotechnical, Inc.
- Date Created: 9/12/2009, 5:22:56 PM

- Analysis type: Deterministic
- Safety Factor: 0.9947
- Wedge height (on slope) [ft]: 1050.00
- Bench width (on upper face) [ft]: 0.00
- Wedge volume [ft³]: 32544430.219
- Wedge weight [tons]: 1789943.652
- Wedge area (joint1) [ft²]: 301279.15
- Wedge area (joint2) [ft²]: 192717.62
- Wedge area (slope) [ft²]: 572394.15
- Wedge area (upper face) [ft²]: 0.00
- Wedge area (tension crack) [ft²]: 206965.23

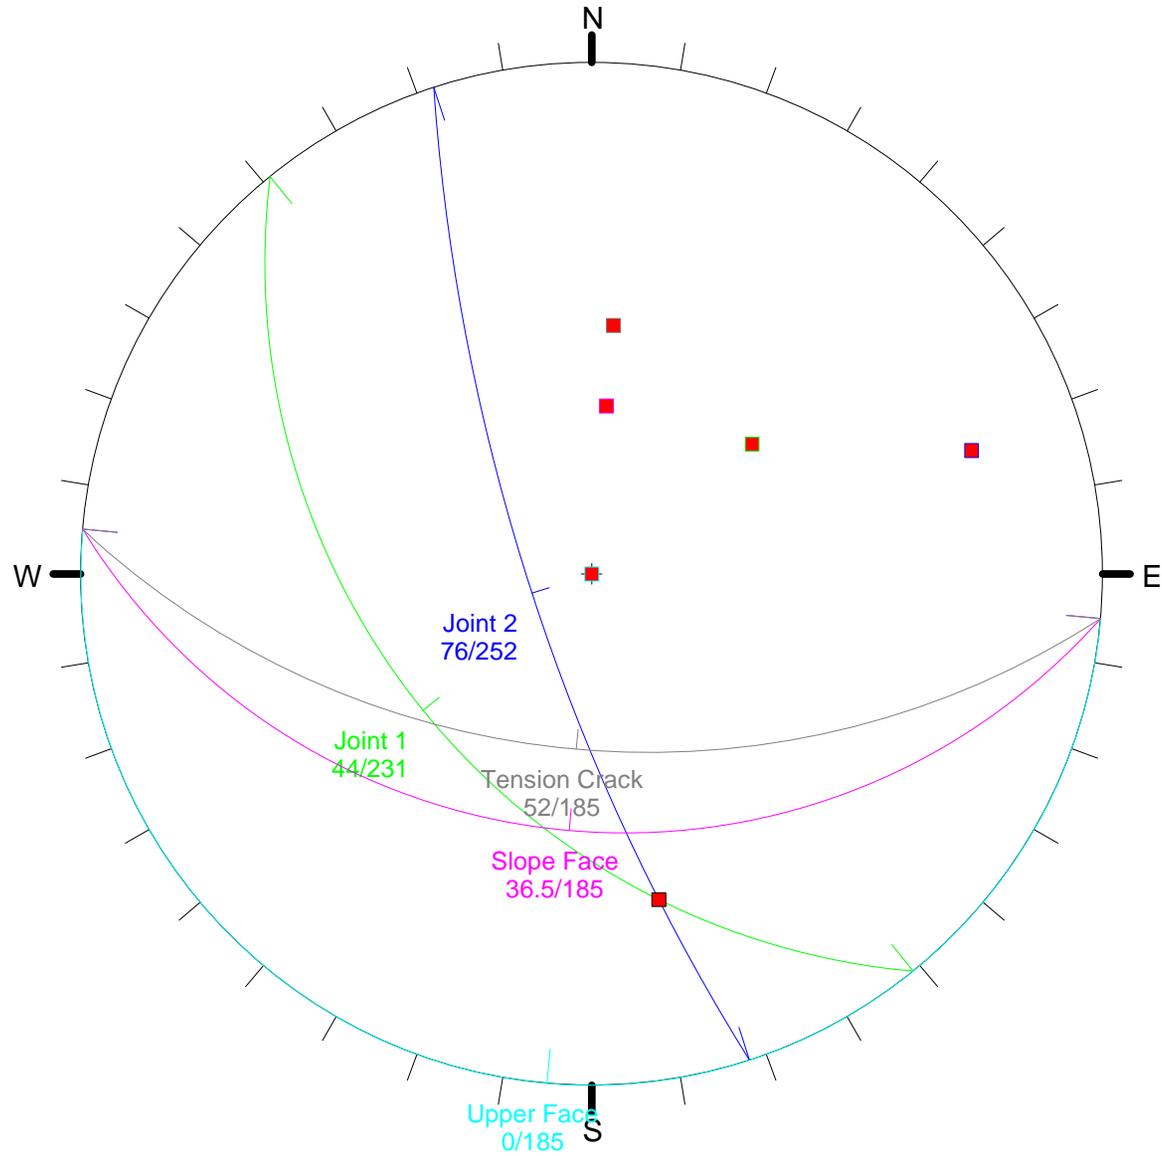
- Job Title: Rimforest Cross-Section C, Wedge 3
- Analysis: Joint Set Wedge Failure Analysis
- Author: Richard George
- Company: Hilltop Geotechnical, Inc.
- Date Created: 9/12/2009, 5:22:56 PM

- Analysis type: Deterministic
- Safety Factor: 0.9869
- Wedge height (on slope) [ft]: 1050.00
- Bench width (on upper face) [ft]: 0.00
- Wedge volume [ft³]: 28201793.640
- Wedge weight [tons]: 1551098.642
- Wedge area (joint1) [ft²]: 368753.35
- Wedge area (joint2) [ft²]: 206305.66
- Wedge area (slope) [ft²]: 405254.98
- Wedge area (upper face) [ft²]: 0.00
- Wedge area (tension crack) [ft²]: 179348.38

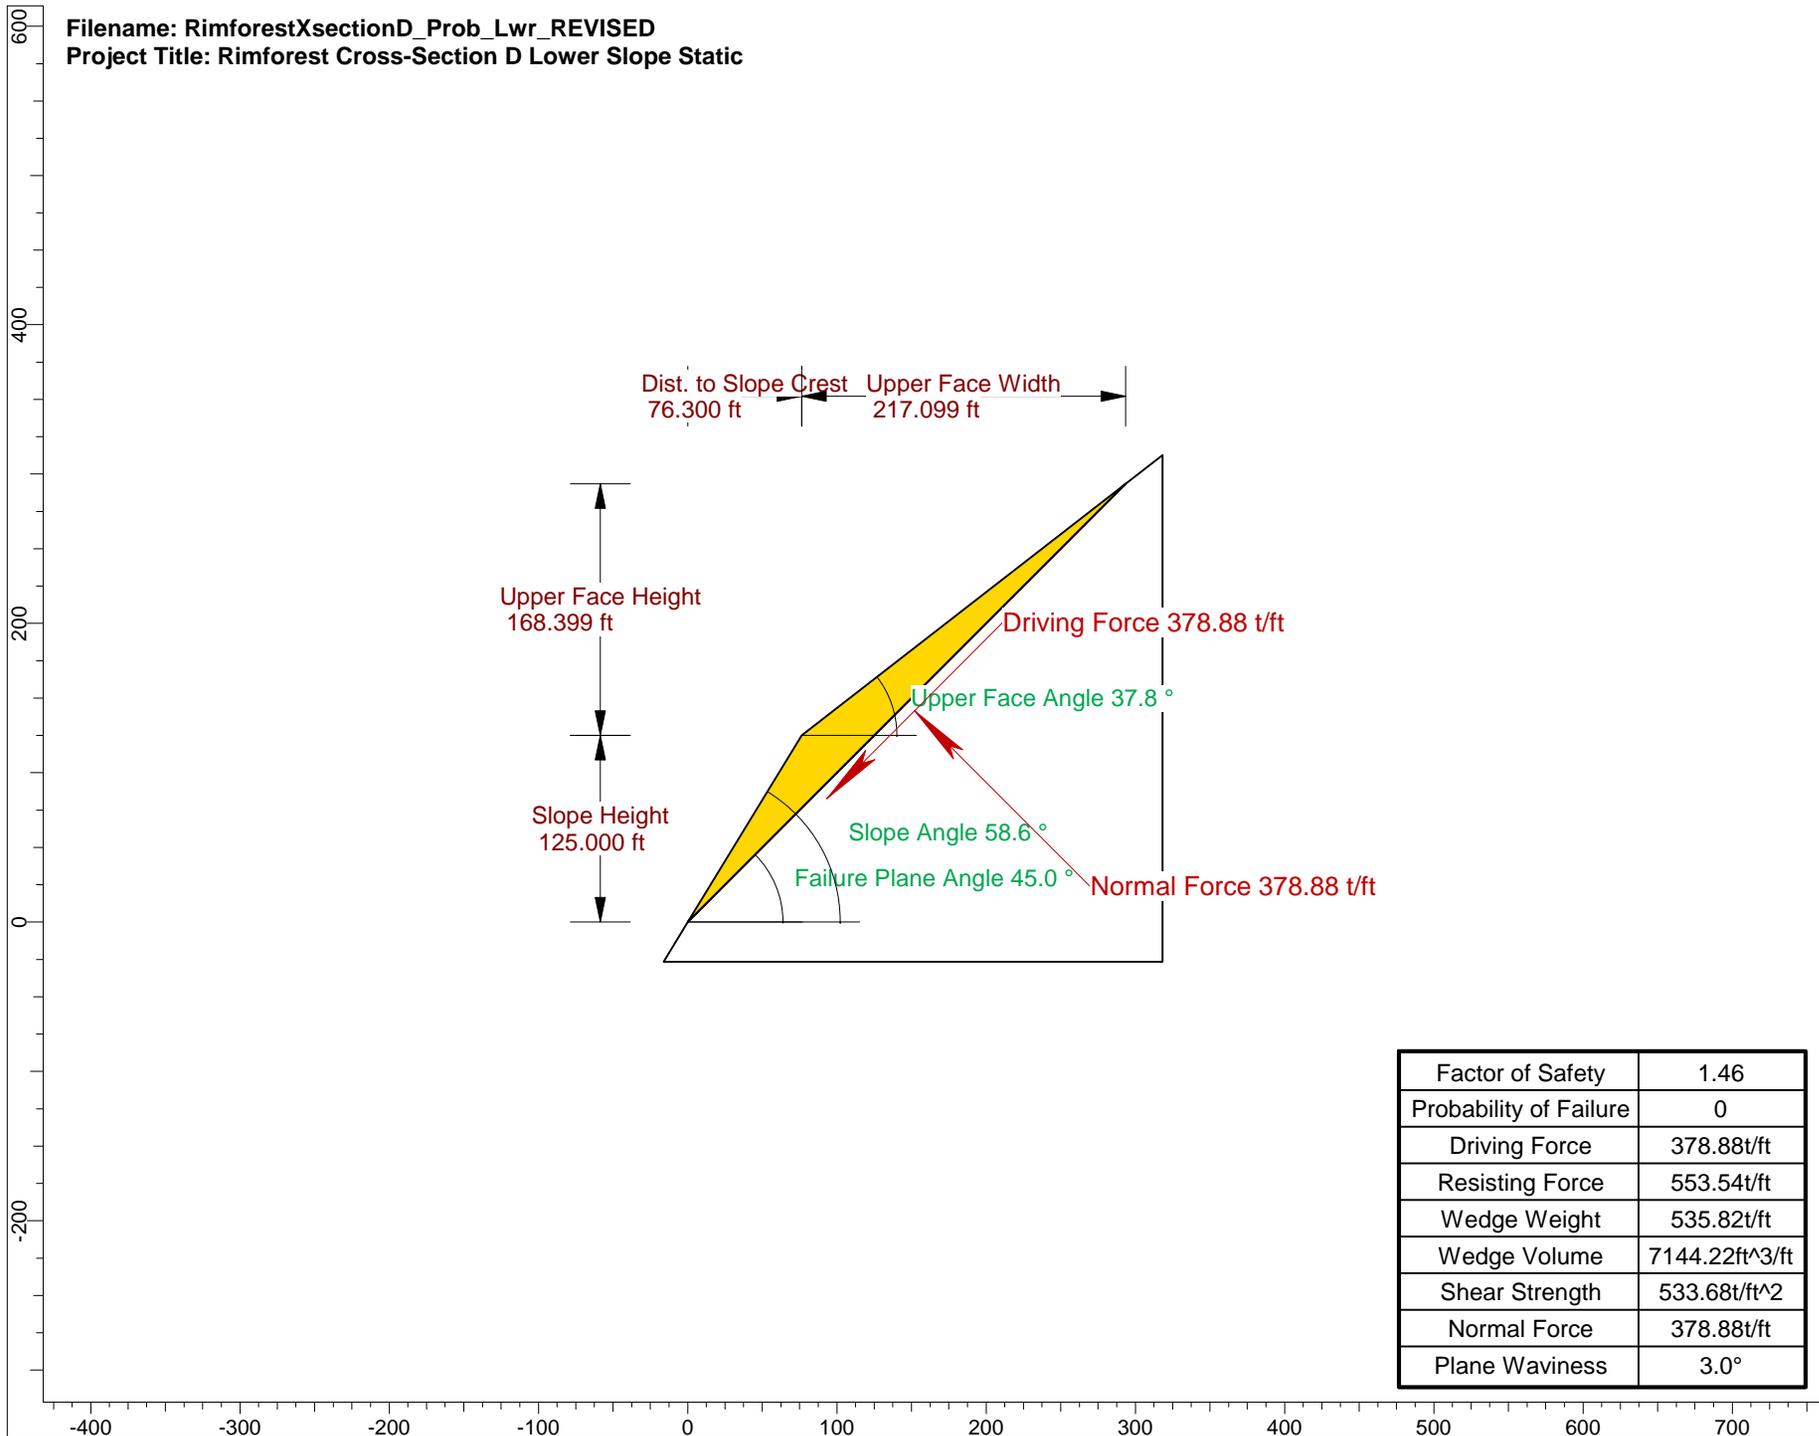
Filename: RimforestXsectionD_Prob_Lwr_REVISED
 Project Title: Rimforest Cross-Section D Lower Slope Static
