FINAL
Drainage Feasibility Study
Volume III (Geotechnical Component Vol. 2)

Community of Rimforest
County of San Bernardino, CA

November 8, 2010

APPENDIX B
PHOTOGRAPHS

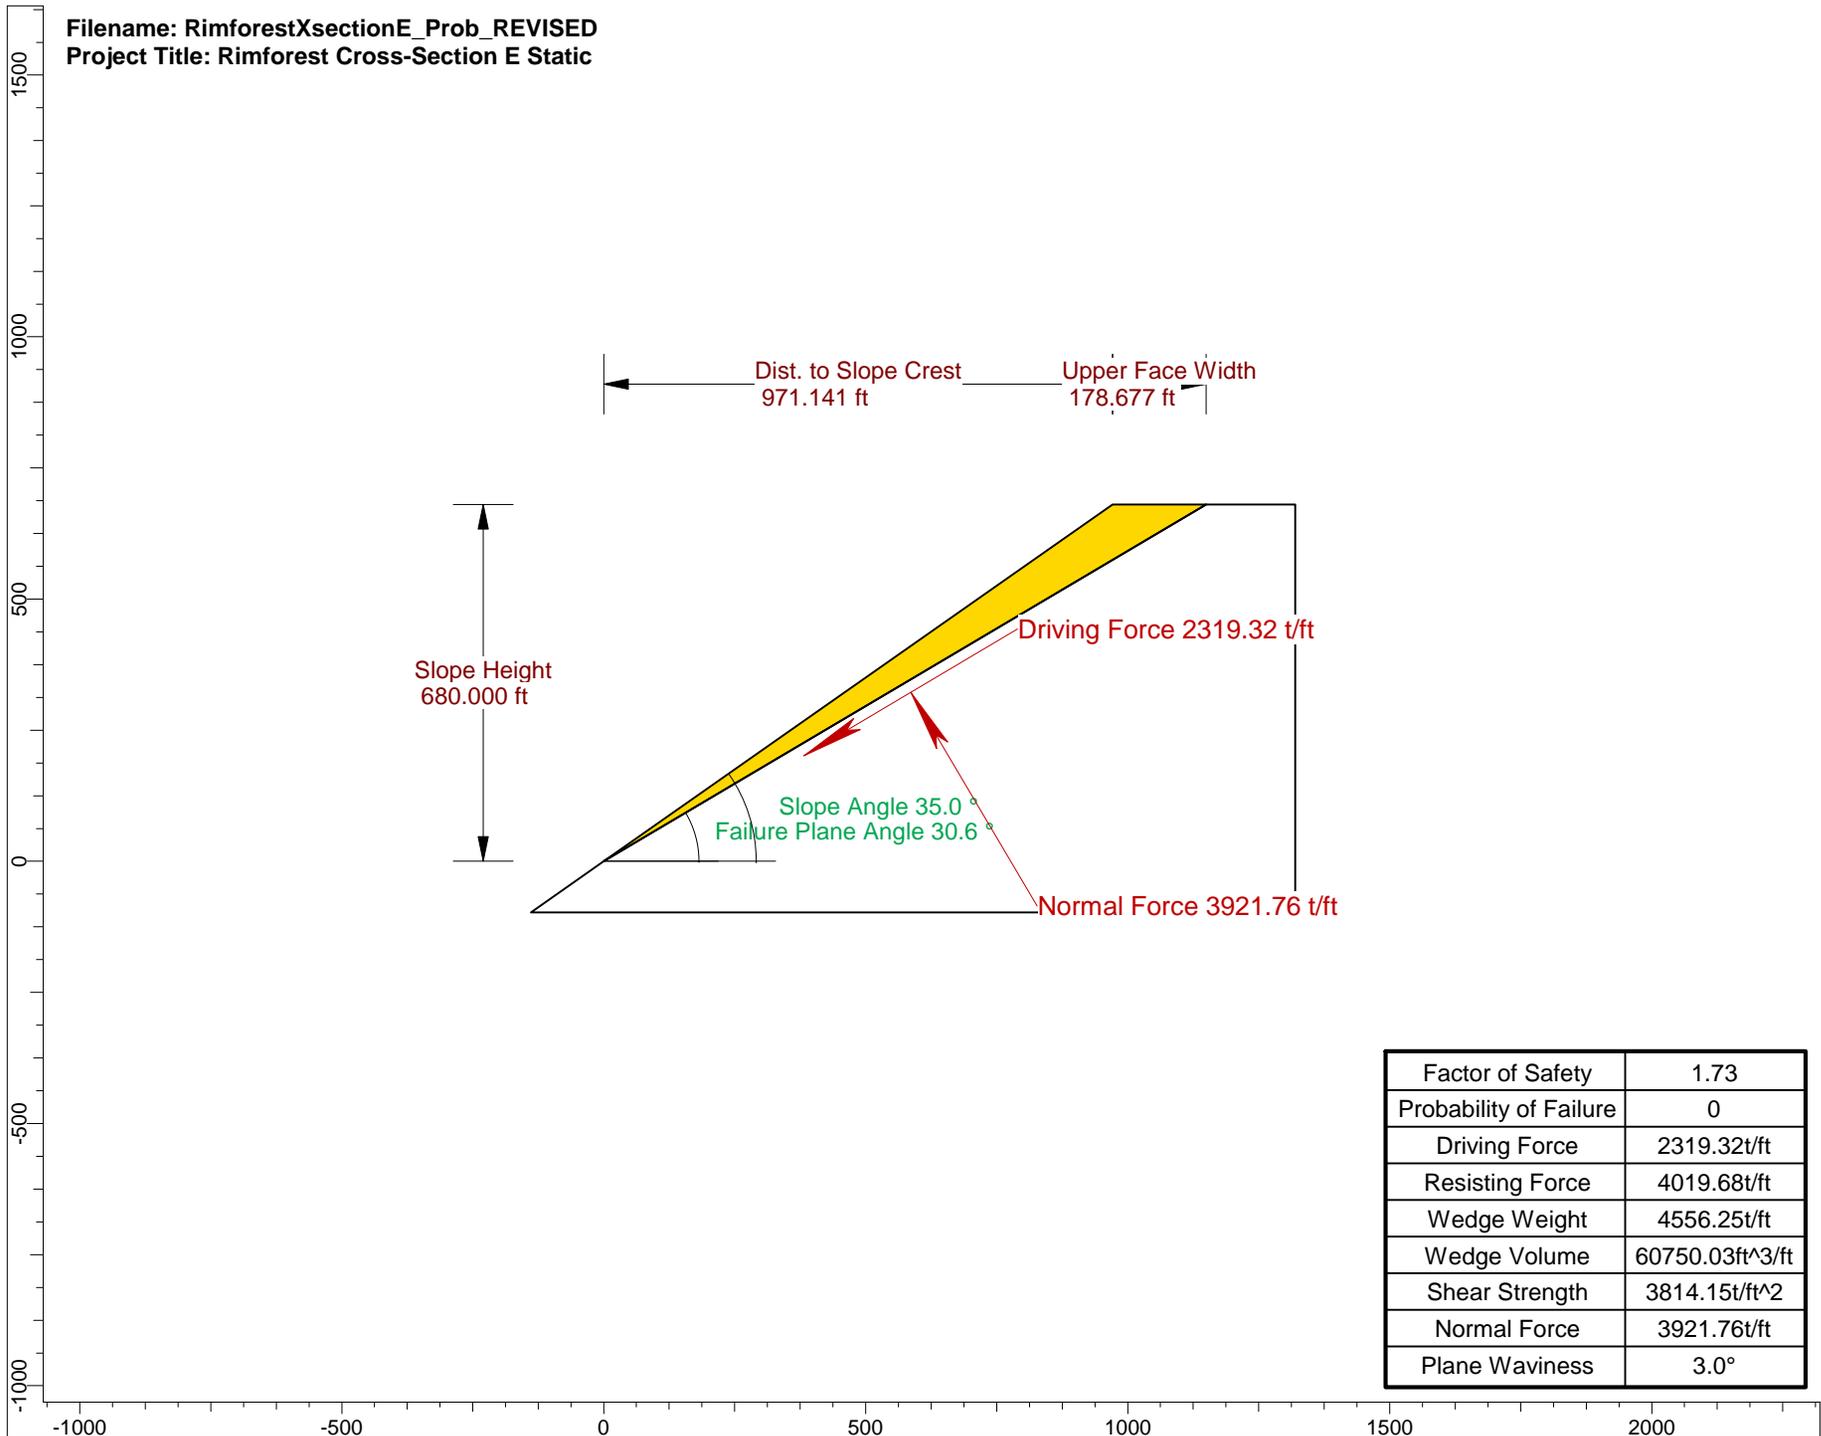
Filename: RimforestXsectionE_Prob_REVISED
 Project Title: Rimforest Cross-Section E Static

Factor of Safety	1.73
Probability of Failure	0
Driving Force	2319.32t/ft
Resisting Force	4019.68t/ft
Wedge Weight	4556.25t/ft
Wedge Volume	60750.03ft ³ /ft
Shear Strength	3814.15t/ft ²
Normal Force	3921.76t/ft
Plane Waviness	3.0°

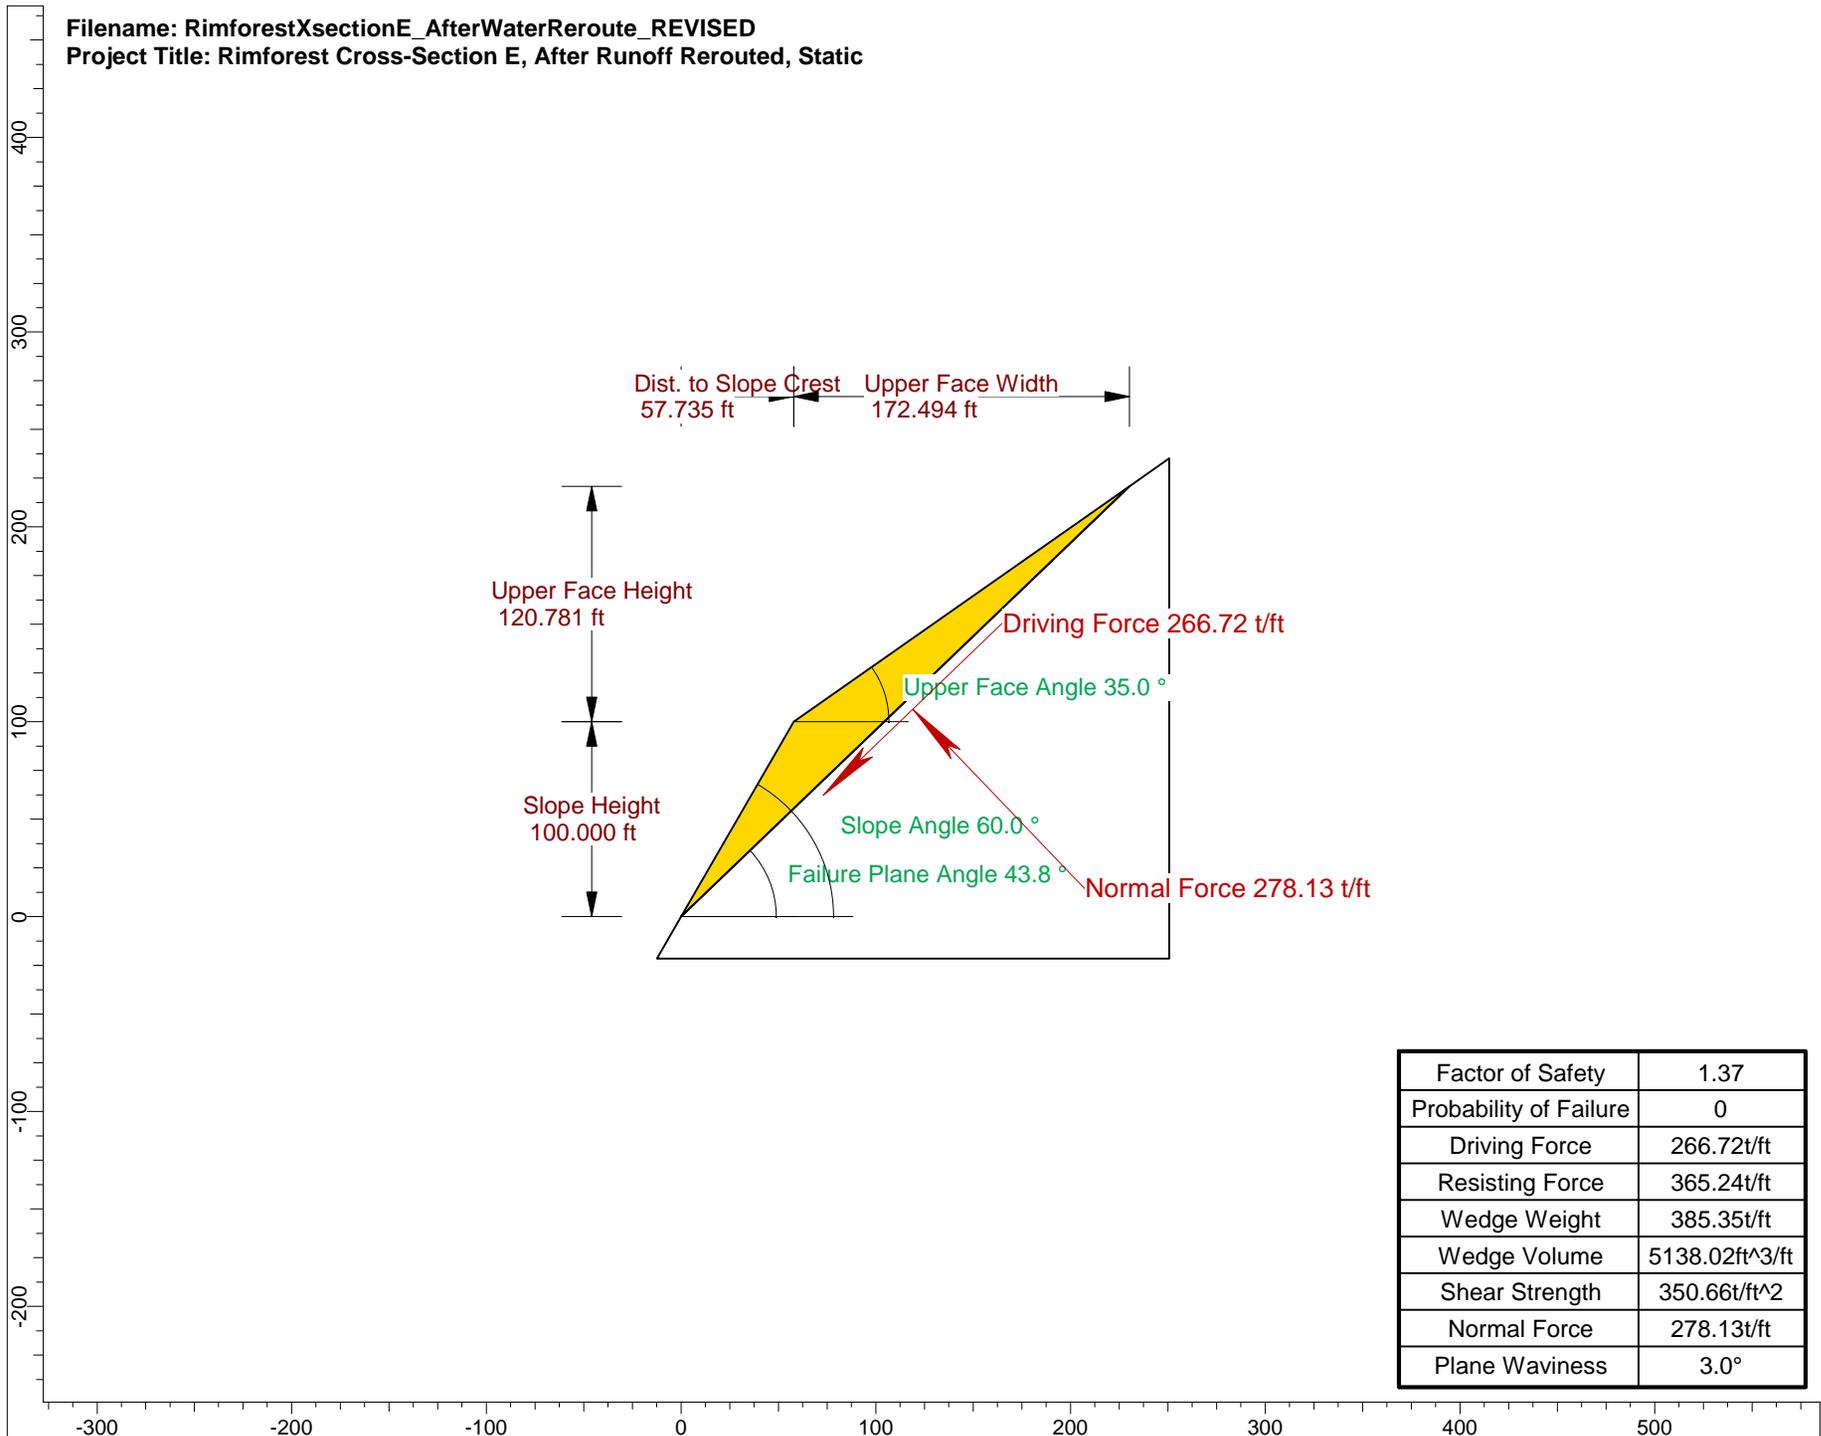
Filename: RimforestXsectionE_AfterWaterReroute_REVISED
 Project Title: Rimforest Cross-Section E, After Runoff Rerouted, Static

Factor of Safety	1.37
Probability of Failure	0
Driving Force	266.72t/ft
Resisting Force	365.24t/ft
Wedge Weight	385.35t/ft
Wedge Volume	5138.02ft ³ /ft
Shear Strength	350.66t/ft ²
Normal Force	278.13t/ft
Plane Waviness	3.0°

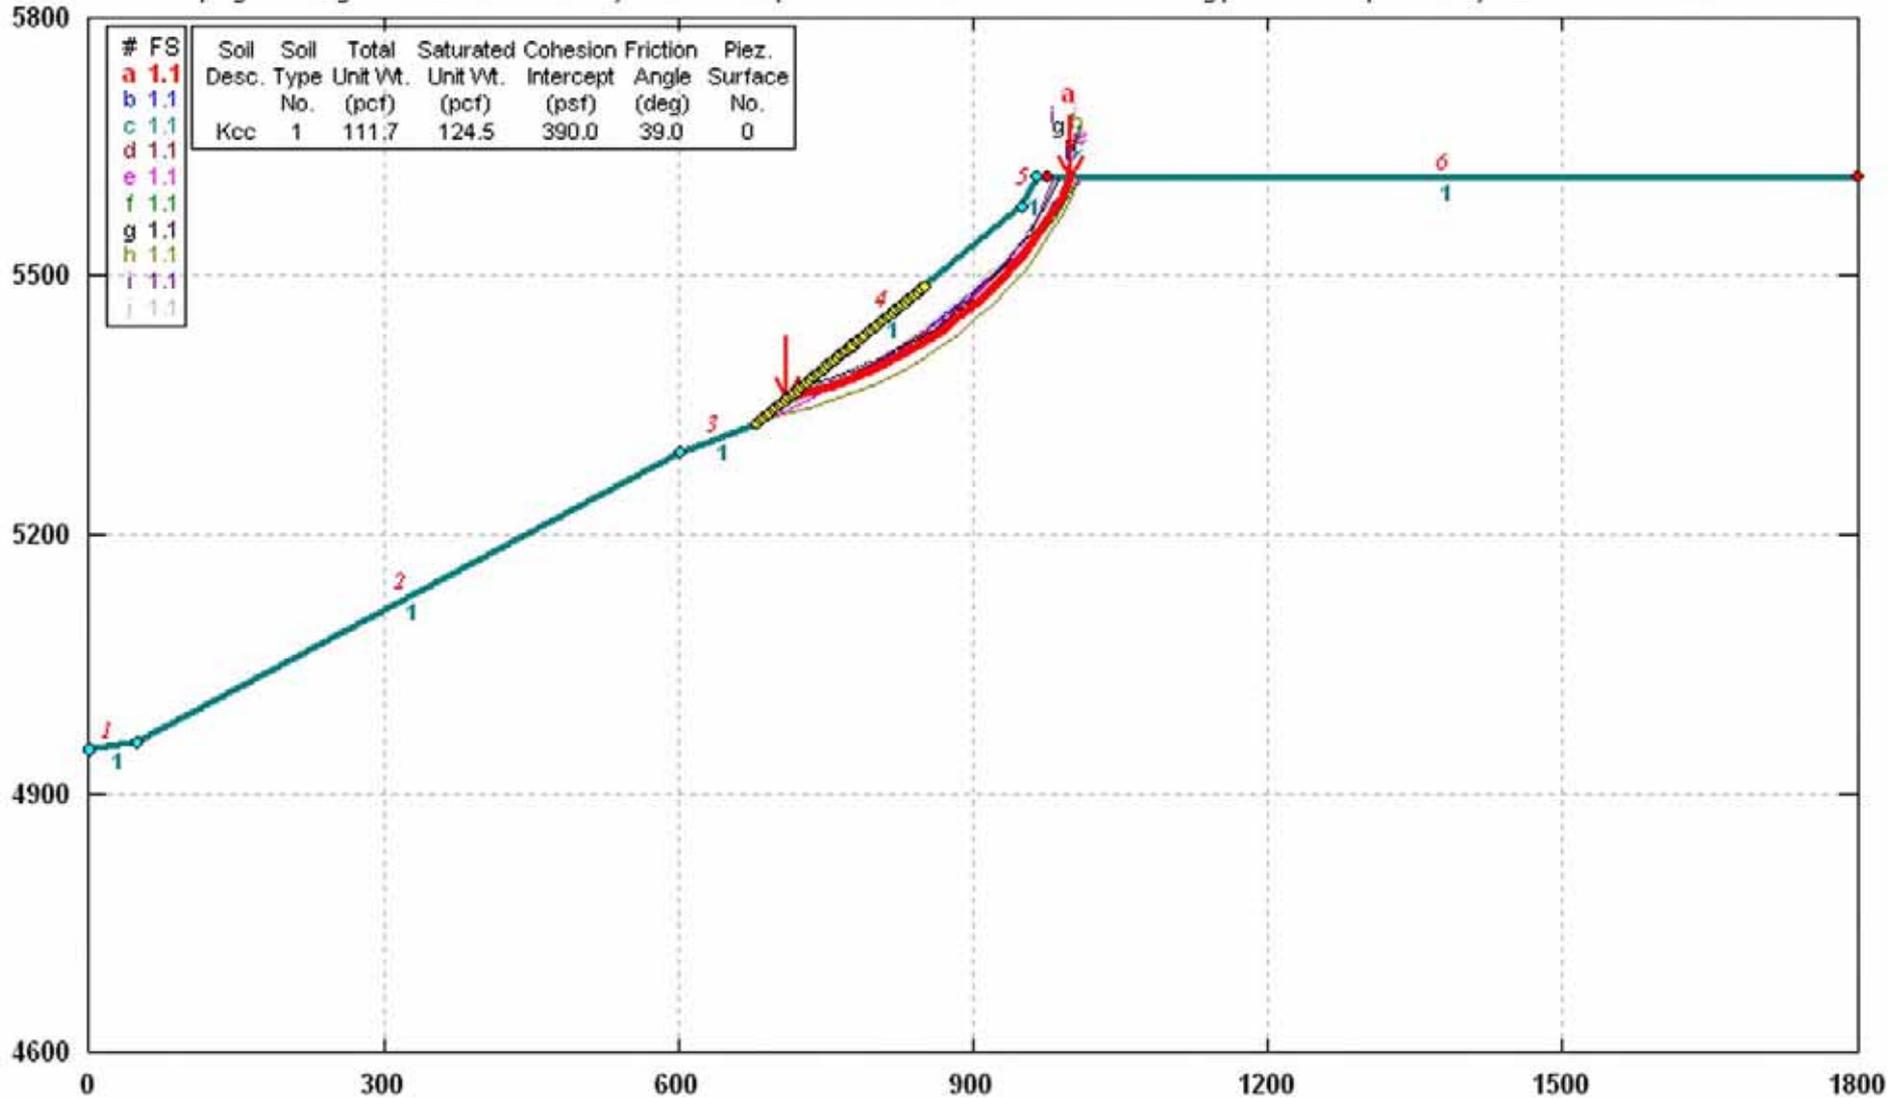
168-H09.1, Rim Forest Landslide Study Section B-B', Seismic Avg. Peak FS 1.1

GSTABL7 v.2 FSmin=1.1

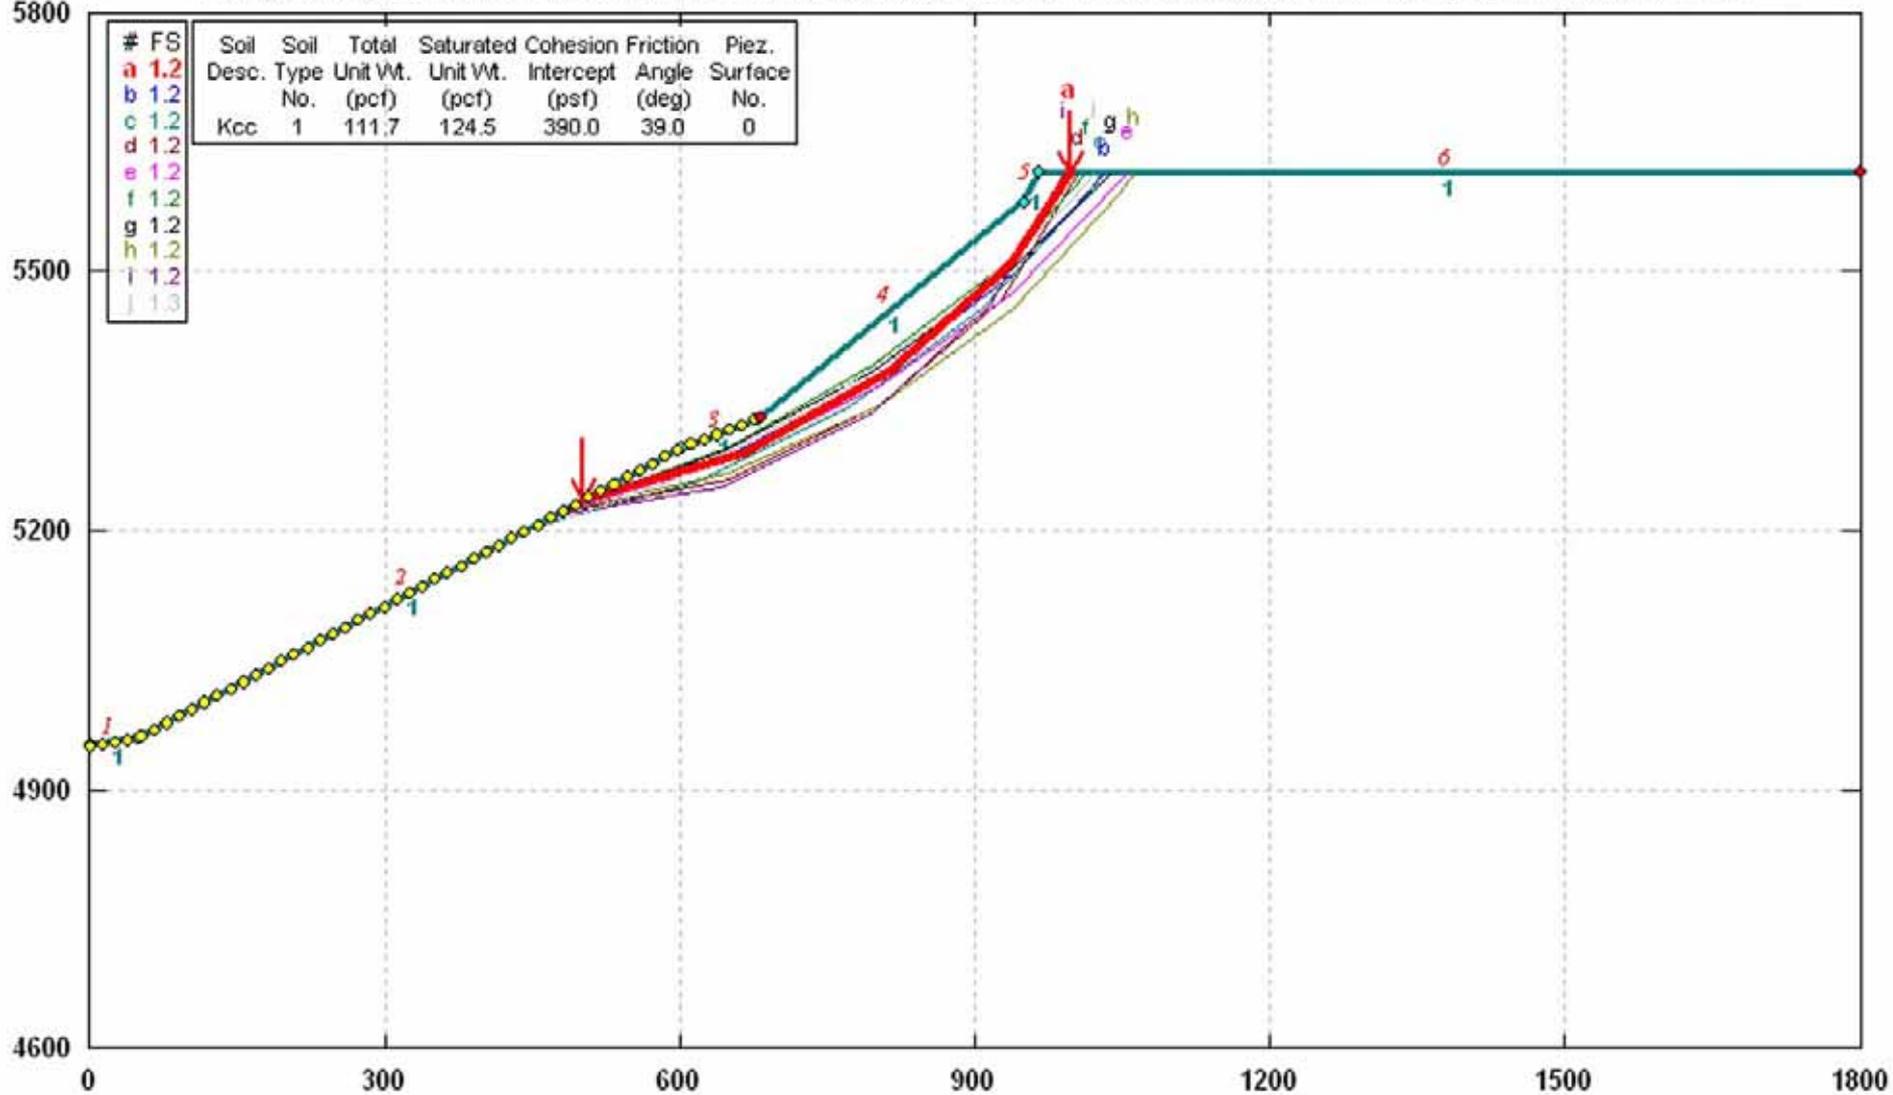
168-H09.1, Rim Forest Landslide Study Section B-B', Seismic Avg. Peak Str.

GSTABL7 v.2 FSmin=1.2

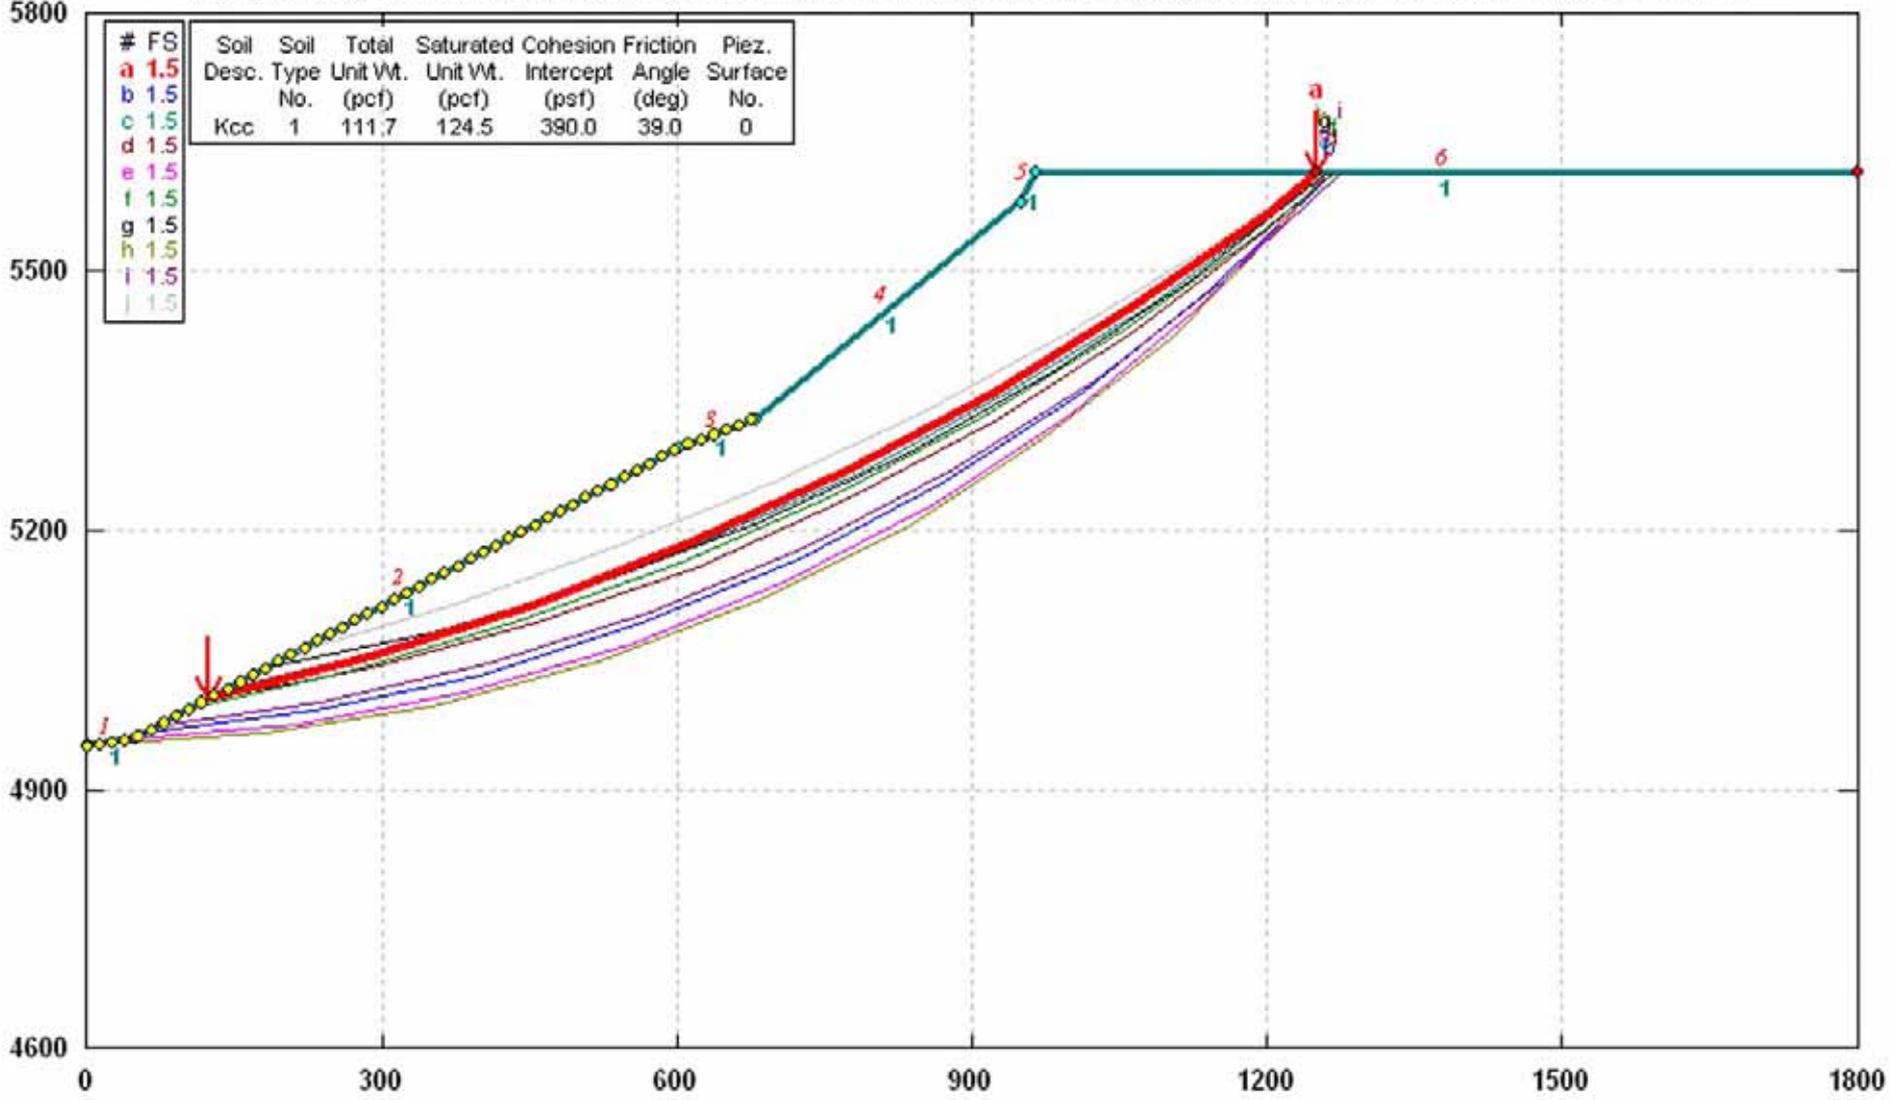
168-H09.1, Rim Forest Landslide Study Section B-B', Static Avg. Peak FS 1.5

GSTABL7 v.2 FSmin=1.5

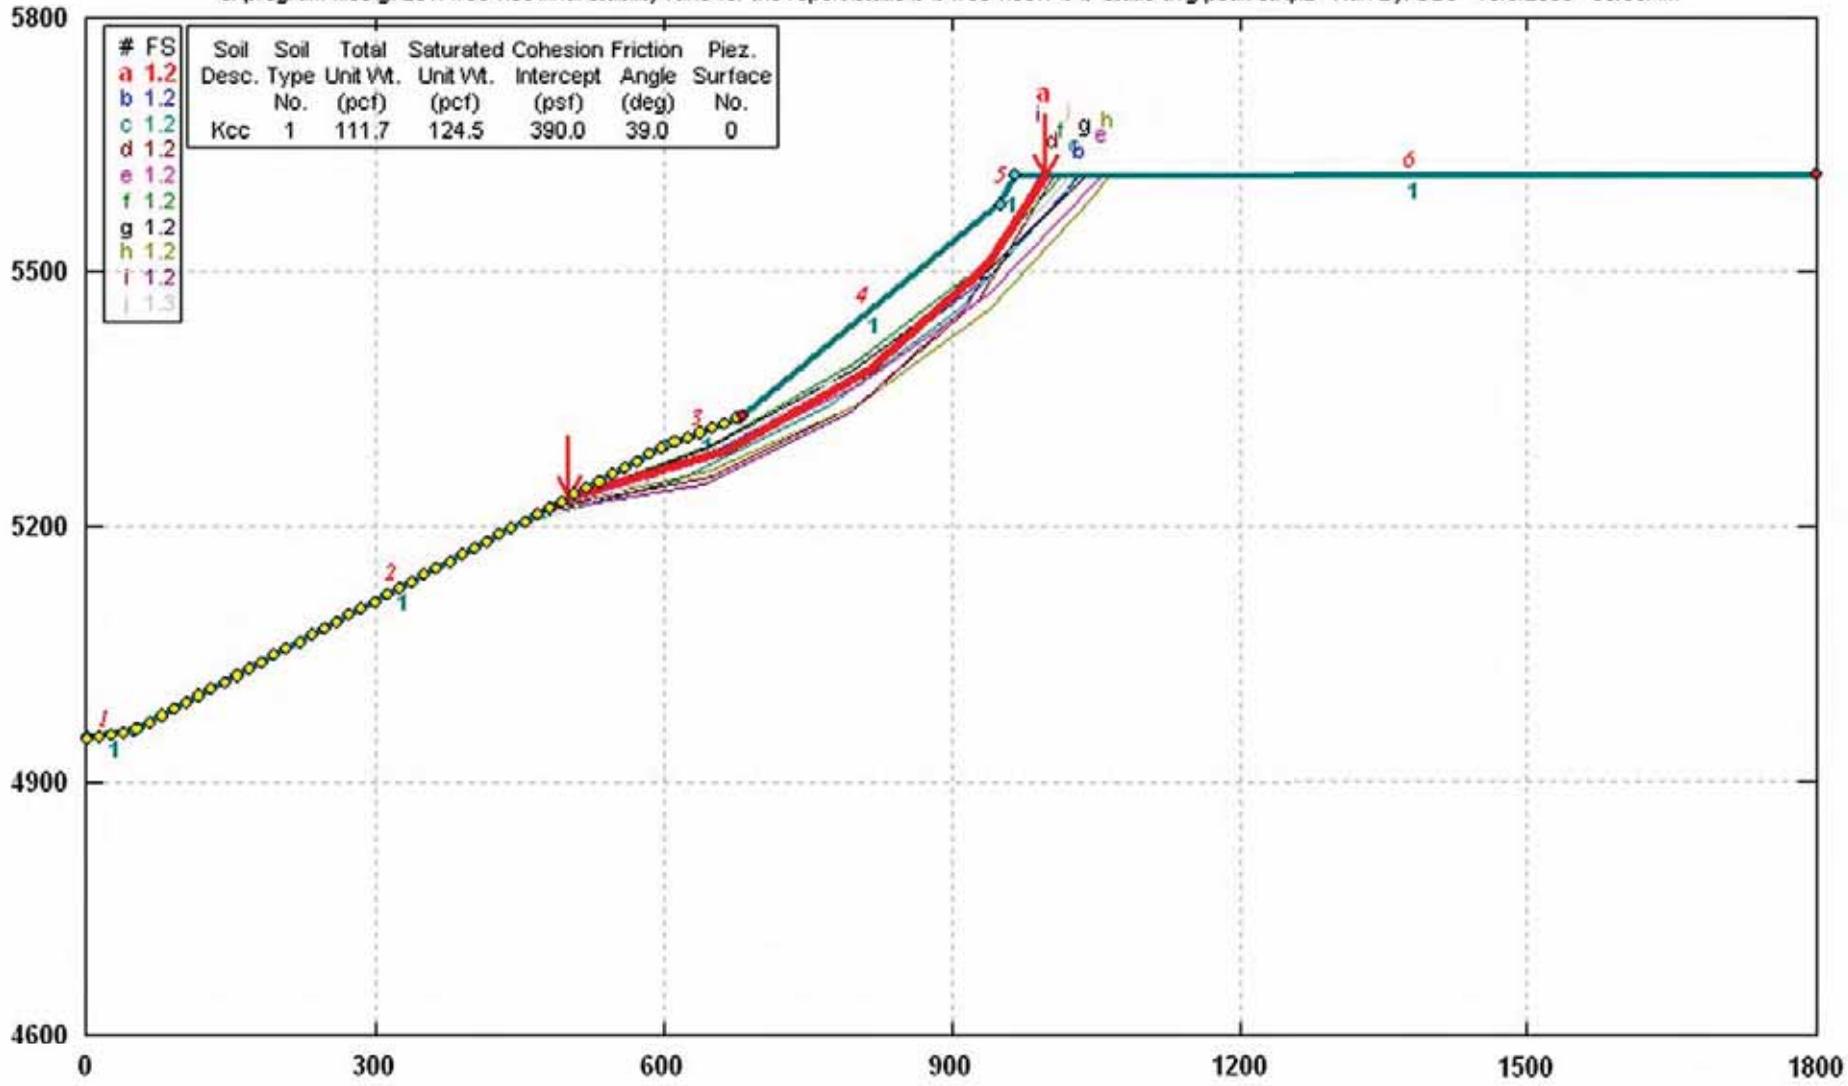
168-H09.1, Rim Forest Landslide Study Section B-B', Static Avg. Peak Str.

GSTABL7 v.2 FSmin=1.2

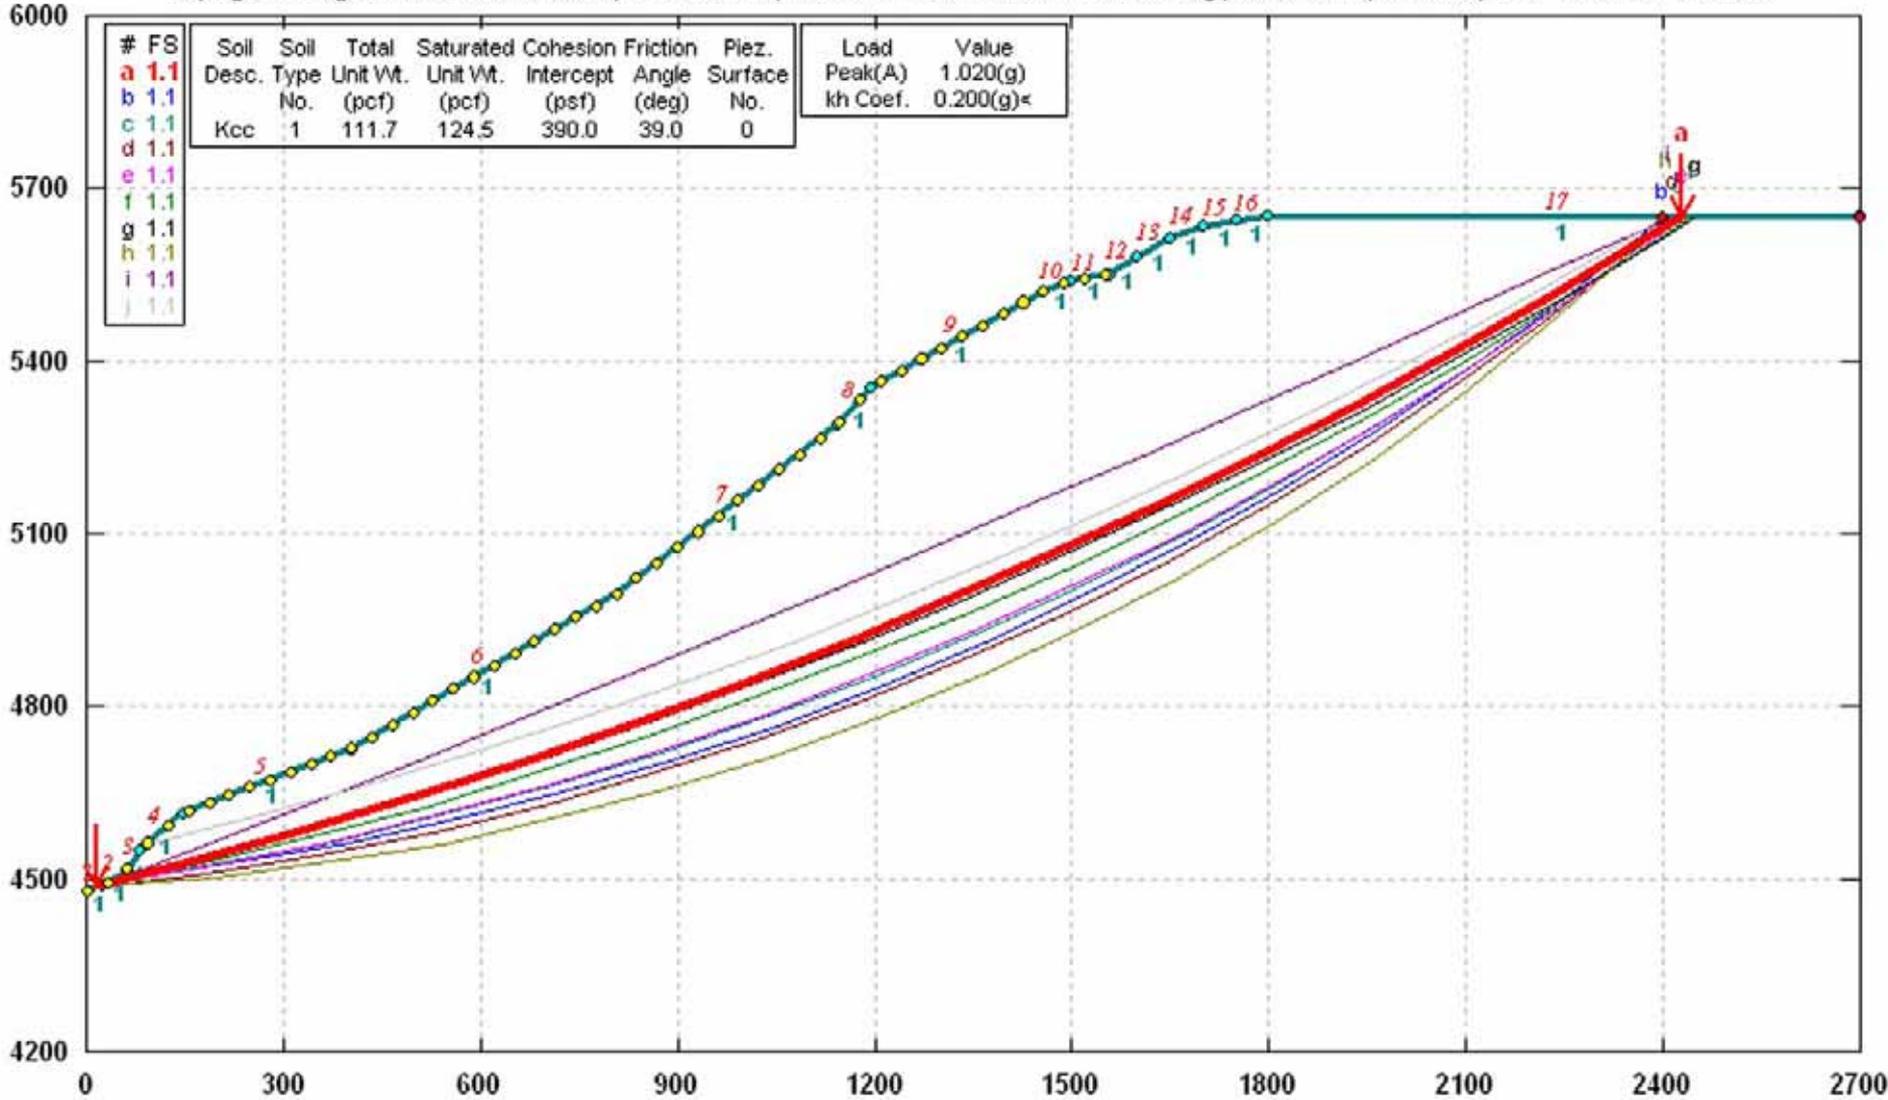
168-H09.1, Rim Forest Landslide Study Section C-C', Seismic Avg. Peak FS 1.1

GSTABL7 v.2 FSmin=1.1

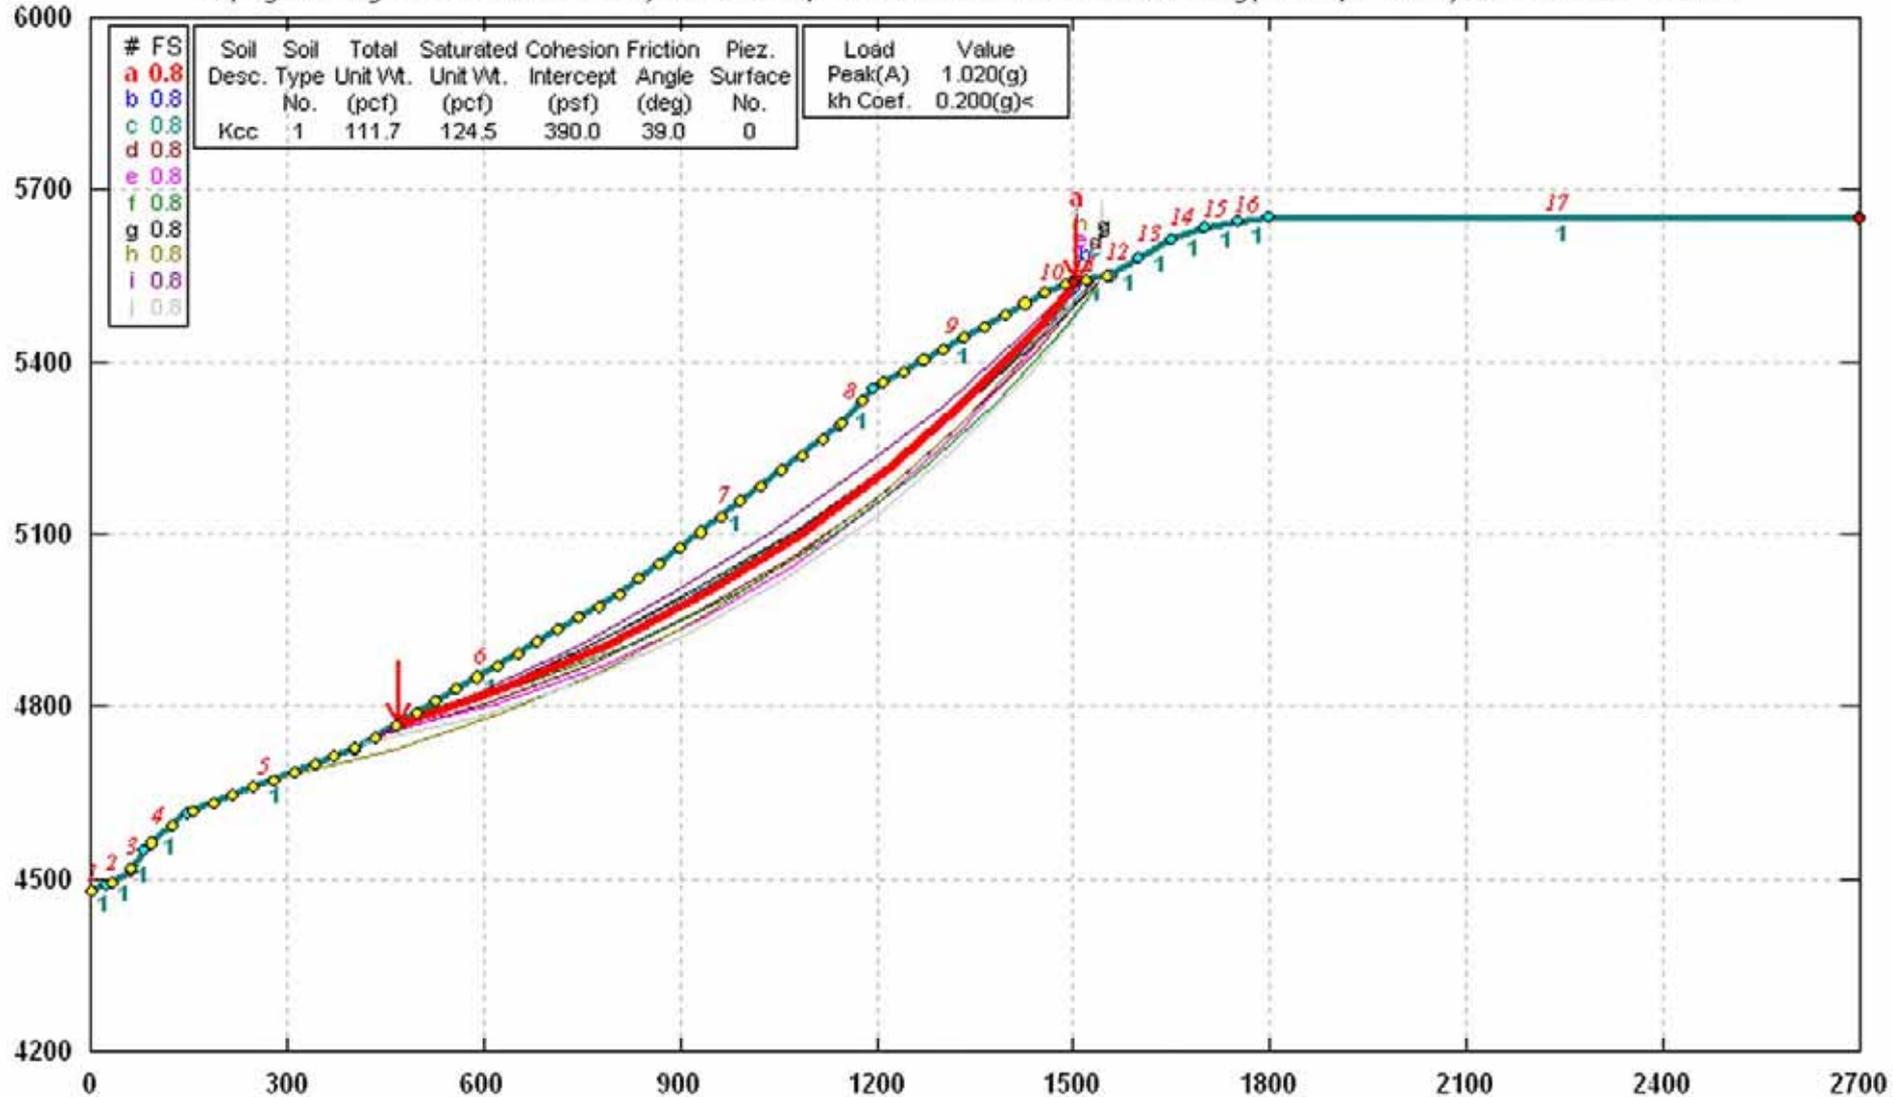
168-H09.1, Rim Forest Landslide Study Section C-C', Seismic Avg. Peak Str.

GSTABL7 v.2 FSmin=0.8

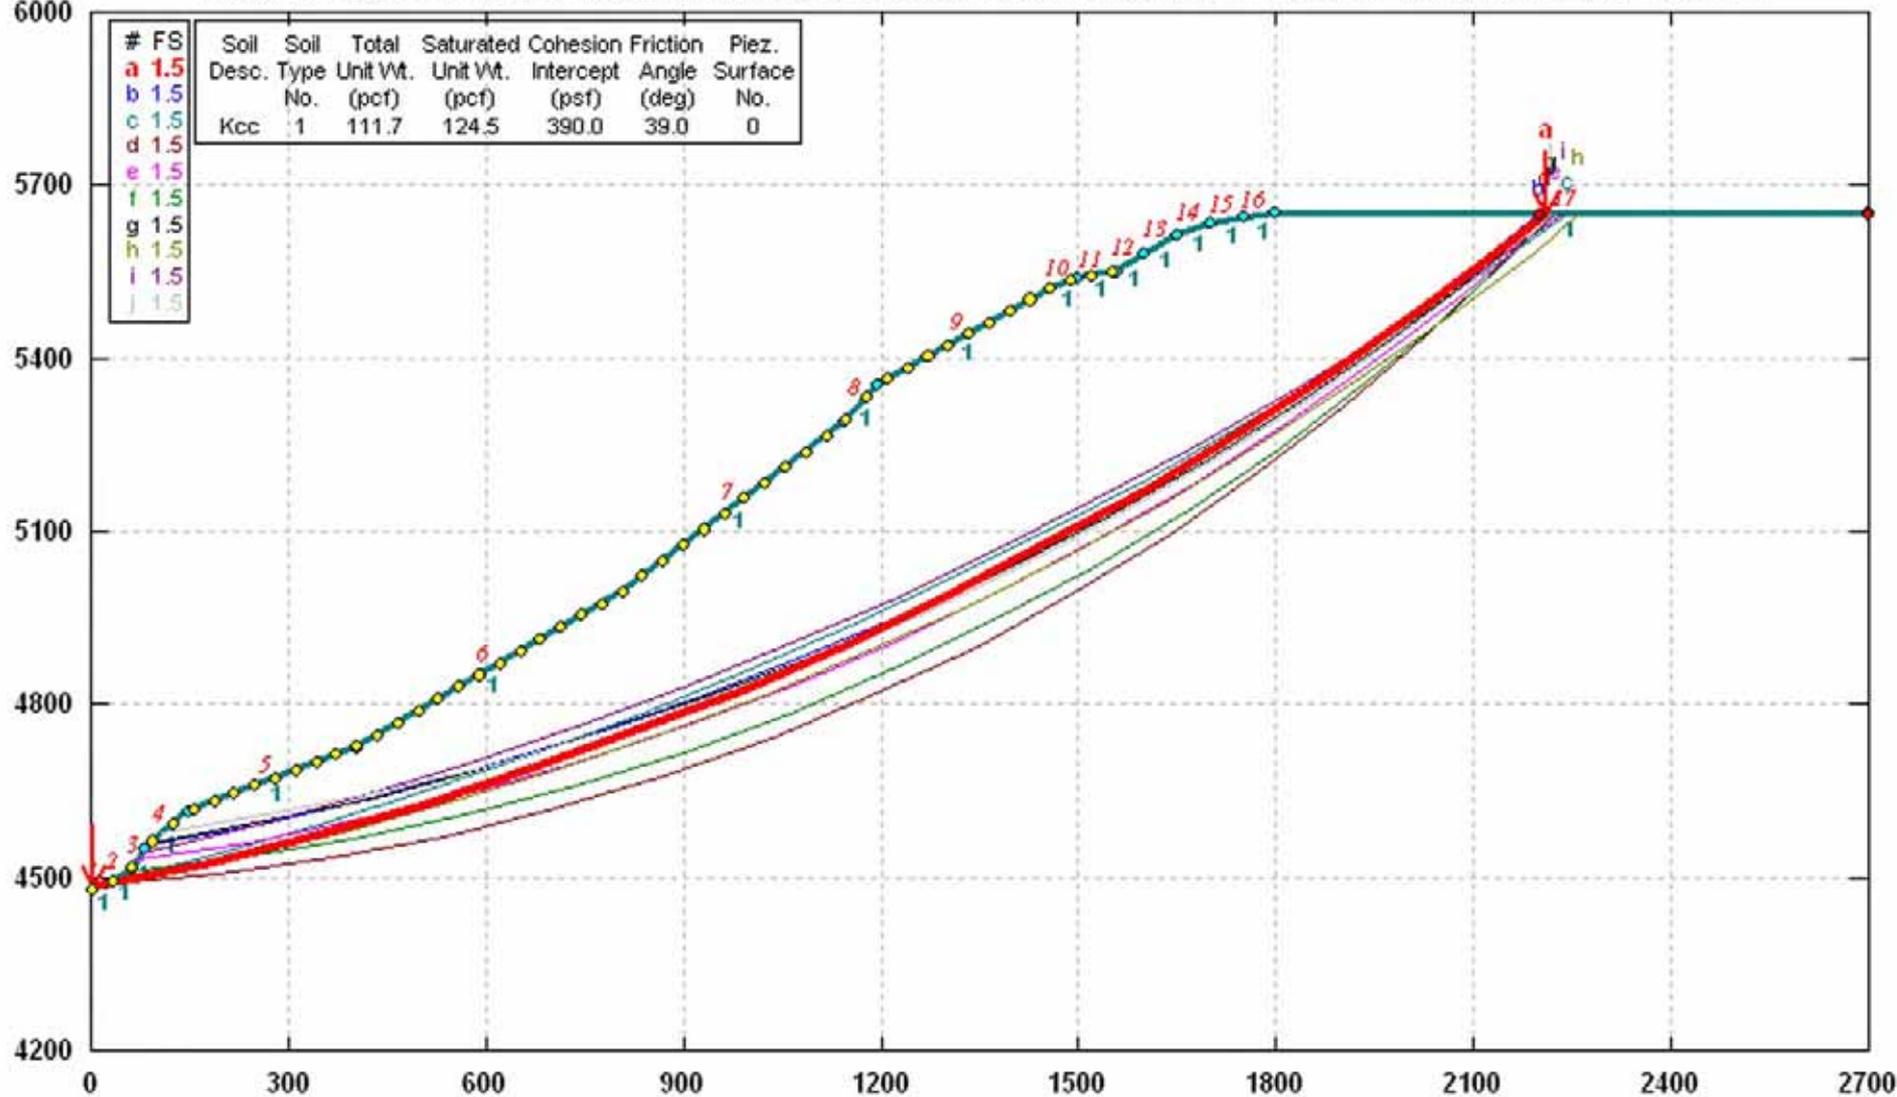
168-H09.1, Rim Forest Landslide Study Section C-C', Static Avg. Peak FS 1.5

GSTABL7 v.2 FSmin=1.5

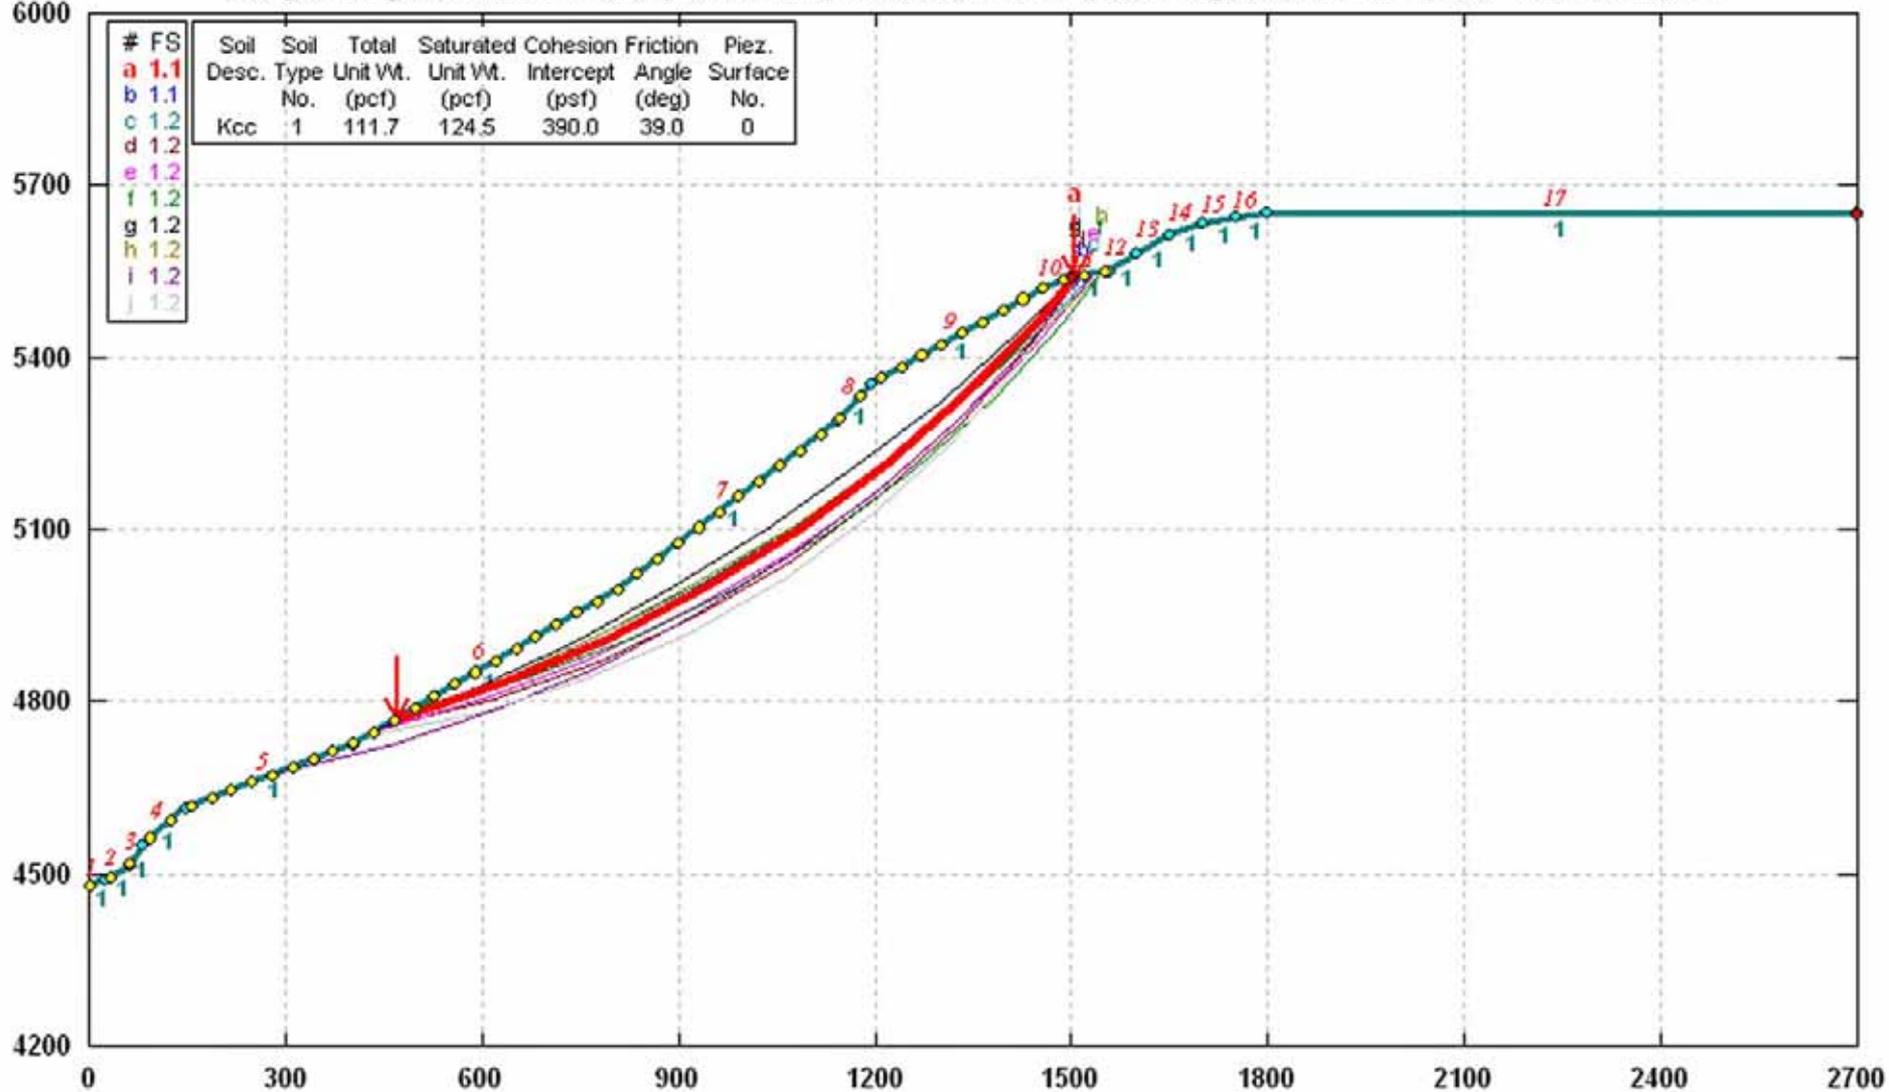
168-H09.1, Rim Forest Landslide Study Section C-C', Static Avg. Peak Str.

GSTABL7 v.2 FSmin=1.1
