April 8, 2014  
J.N. 13-305

**Subject: Revised Fault Rupture Hazard Investigation, Proposed Ling Yen Mountain Temple Site, Located at 13938 DeCliff Drive Generally Northeast of the Intersection of DeCliff Drive and Wardman Bullock Road, Etiwanda Area, San Bernardino County, California.**

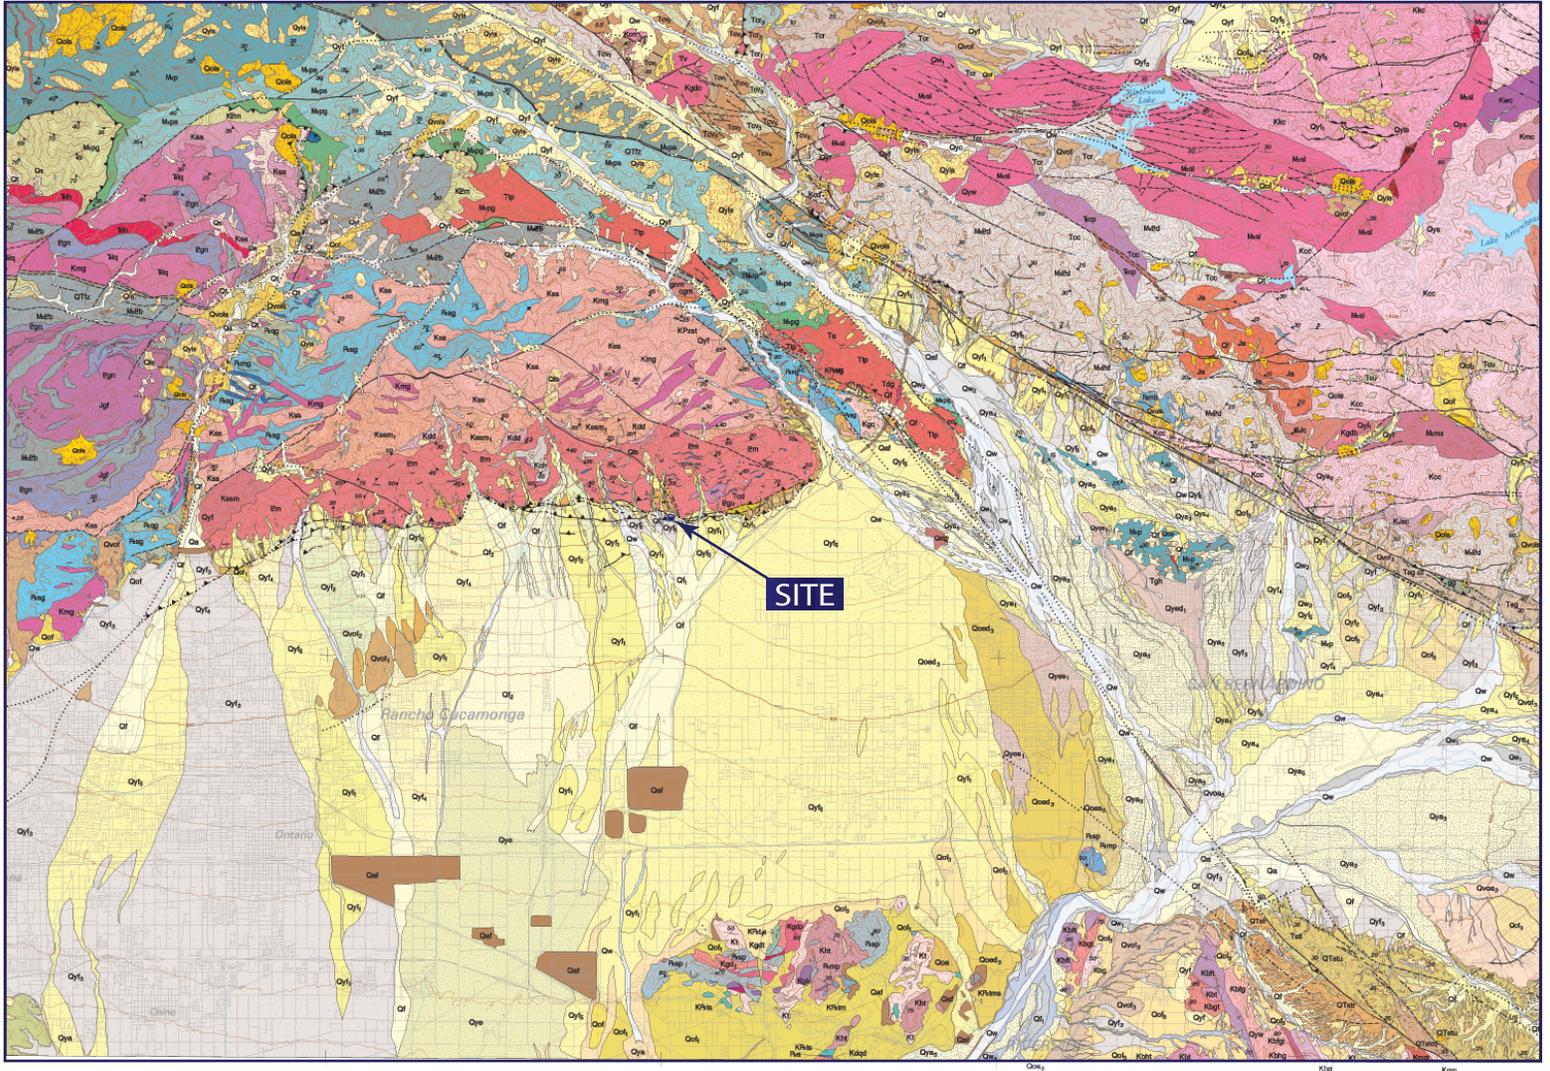
DATE: April 2014	J.N.: 13-305	<b>Plate 1</b>
DWG BY: AP	SCALE: See Bar Scale

The Building Restriction Proposed by Kaup was presented on the EGL (2006) report, discussed below. The Kaup Building restriction zone is plotted on Plate 1 of this report and, due to the more extensive trenching discussed in this report, is fully enveloped by the Building restriction zone proposed by Petra.

Morton and Matti (1987) mapped faults though the LYMT site. The locations of thos faults are presented on Plate 1.

It is our opinion, based on the results of our trenching investigation, that active/potentially active faulting occurs at the site at the locations presented on Plate 1. Accordingly, building restriction/setback zones should be established. The building restriction/setback zones are shown on Plate 1 and described below.

Note: Southern Building Setback - There is a water line owned and operated by the Cucamonga Valley Water District (CVWD) immediately north of the right of way for Decliff Drive. Our investigation was restricted by the presence of this waterline and we were not able to trench across all the area considered for development that is within the Alquist-Priolo Fault zone. Accordingly, we trenched as close as practicable to the waterline and established a setback from the furthest southerly point in the trench that we could establish unfaulted sediments. This point is identified as Station 9+00 in Trench ST-4. This corresponds to a distance of 70 feet north of the northern boundary of Decliff Drive as shown on Plate 1 along the length of Decliff Drive.
