GEOTECHNICAL ENGINEERING
& GEOLOGY UPDATE REPORT

VERIZON CELLULAR FACILITY
MOUNT BALDY RESORT
LAX-277

801 SAN ANTONIO CREEK ROAD
MT. BALDY, CALIFORNIA 91759

PROJECT NO: VS-4195-06

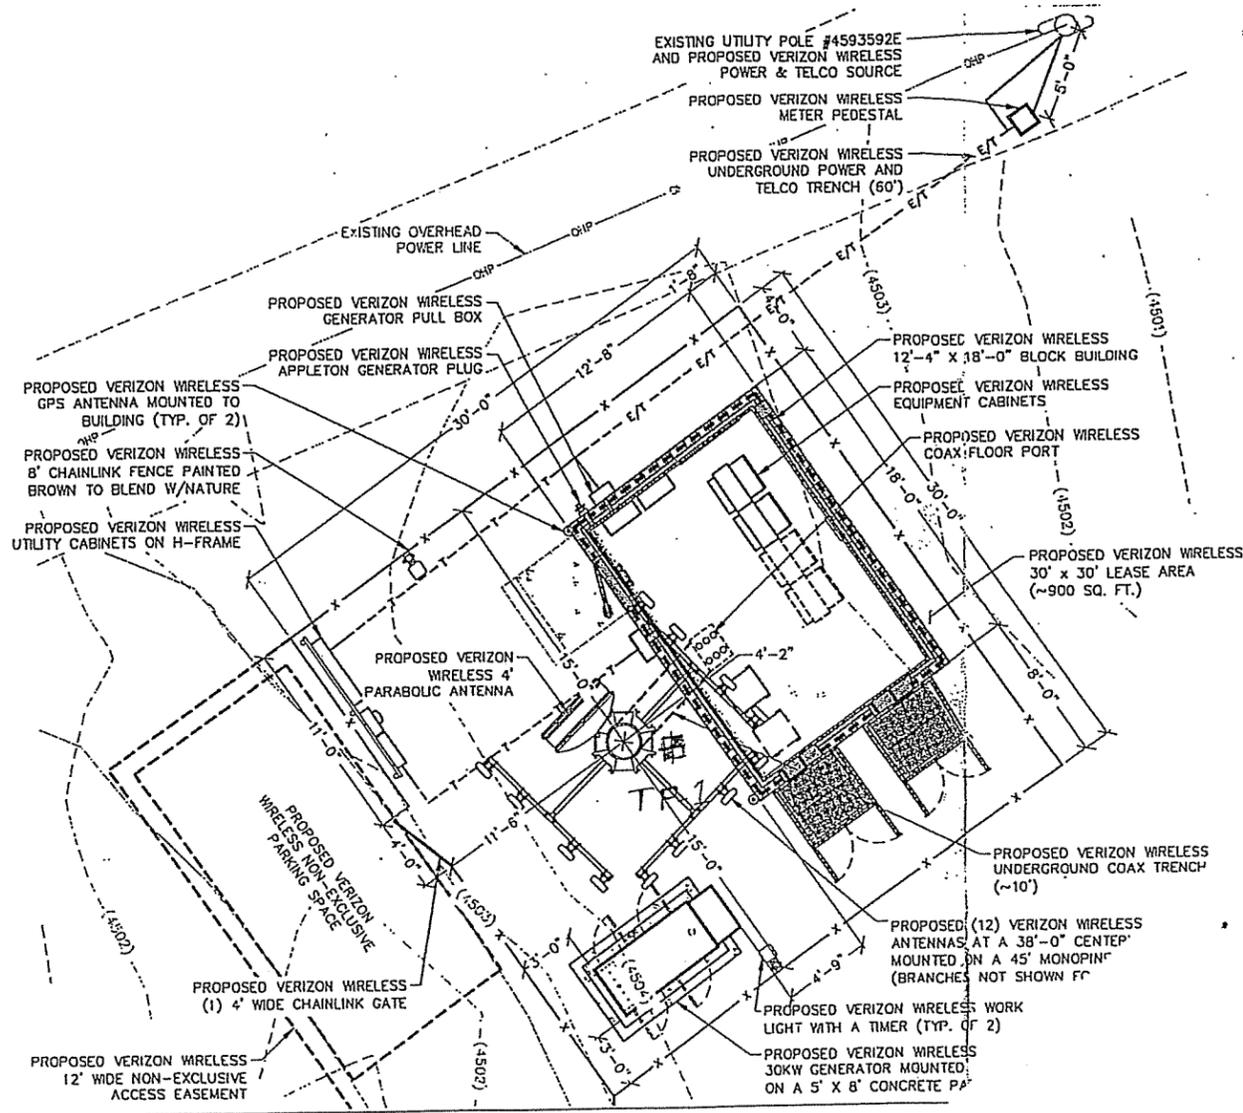
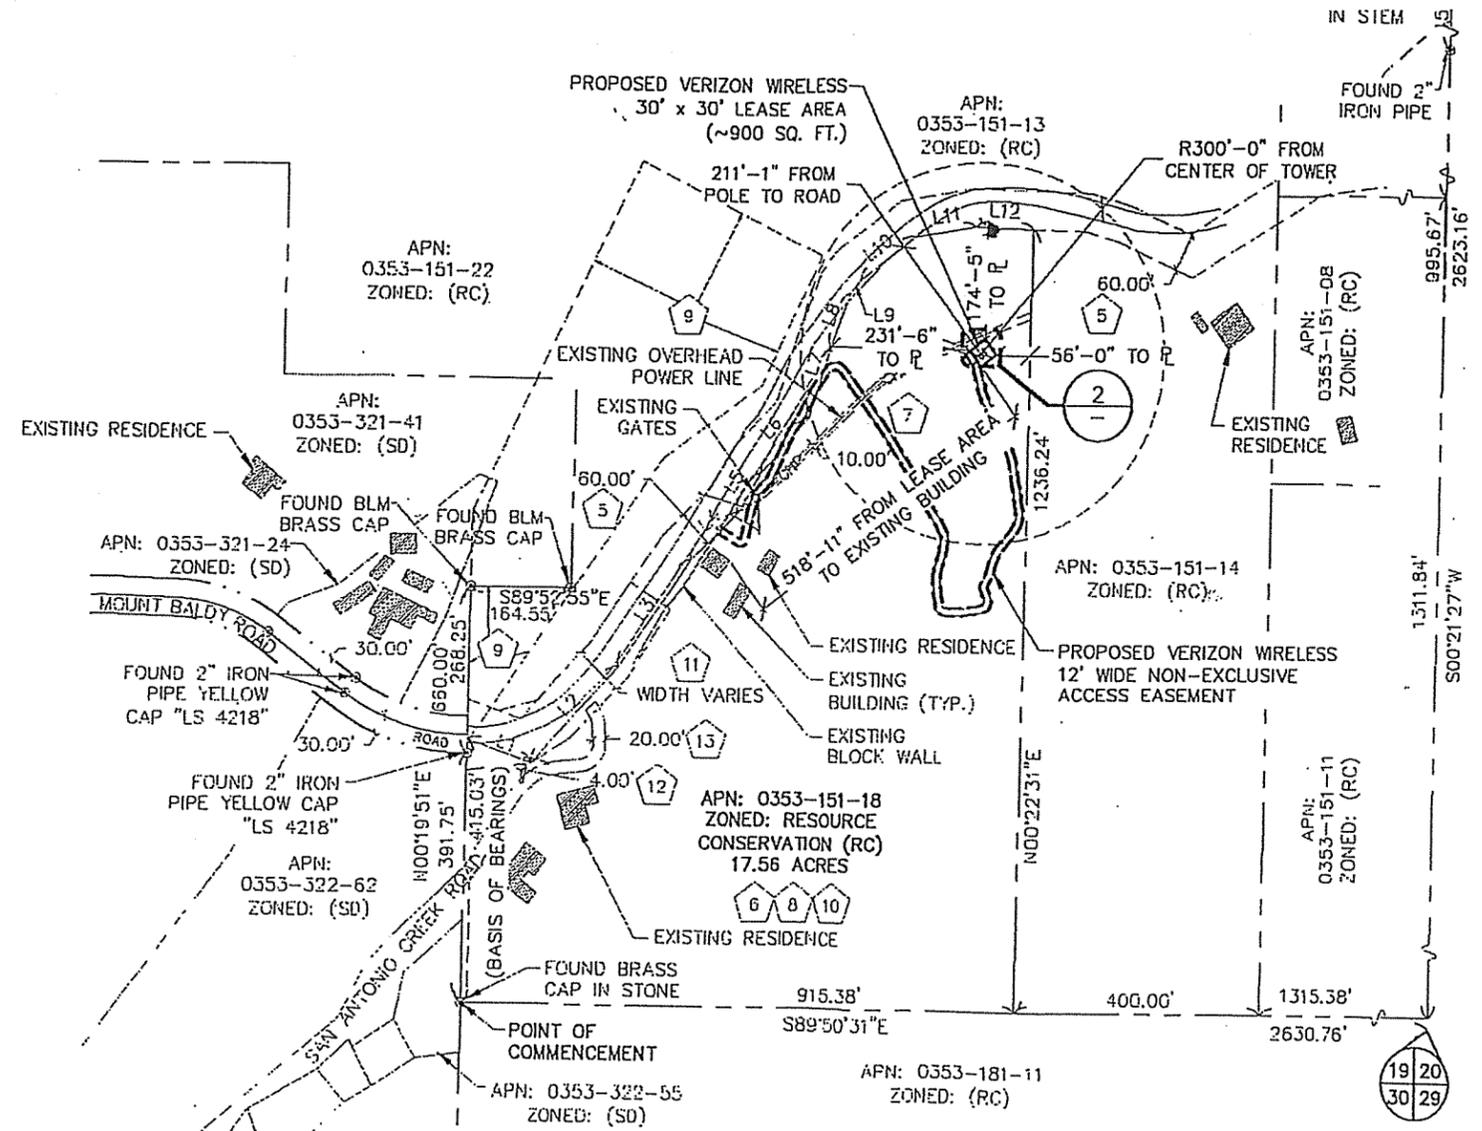
PLOT PLAN & BORING LOCATION MAP

ENLARGED PLAN
SCALE: 1" = 10'

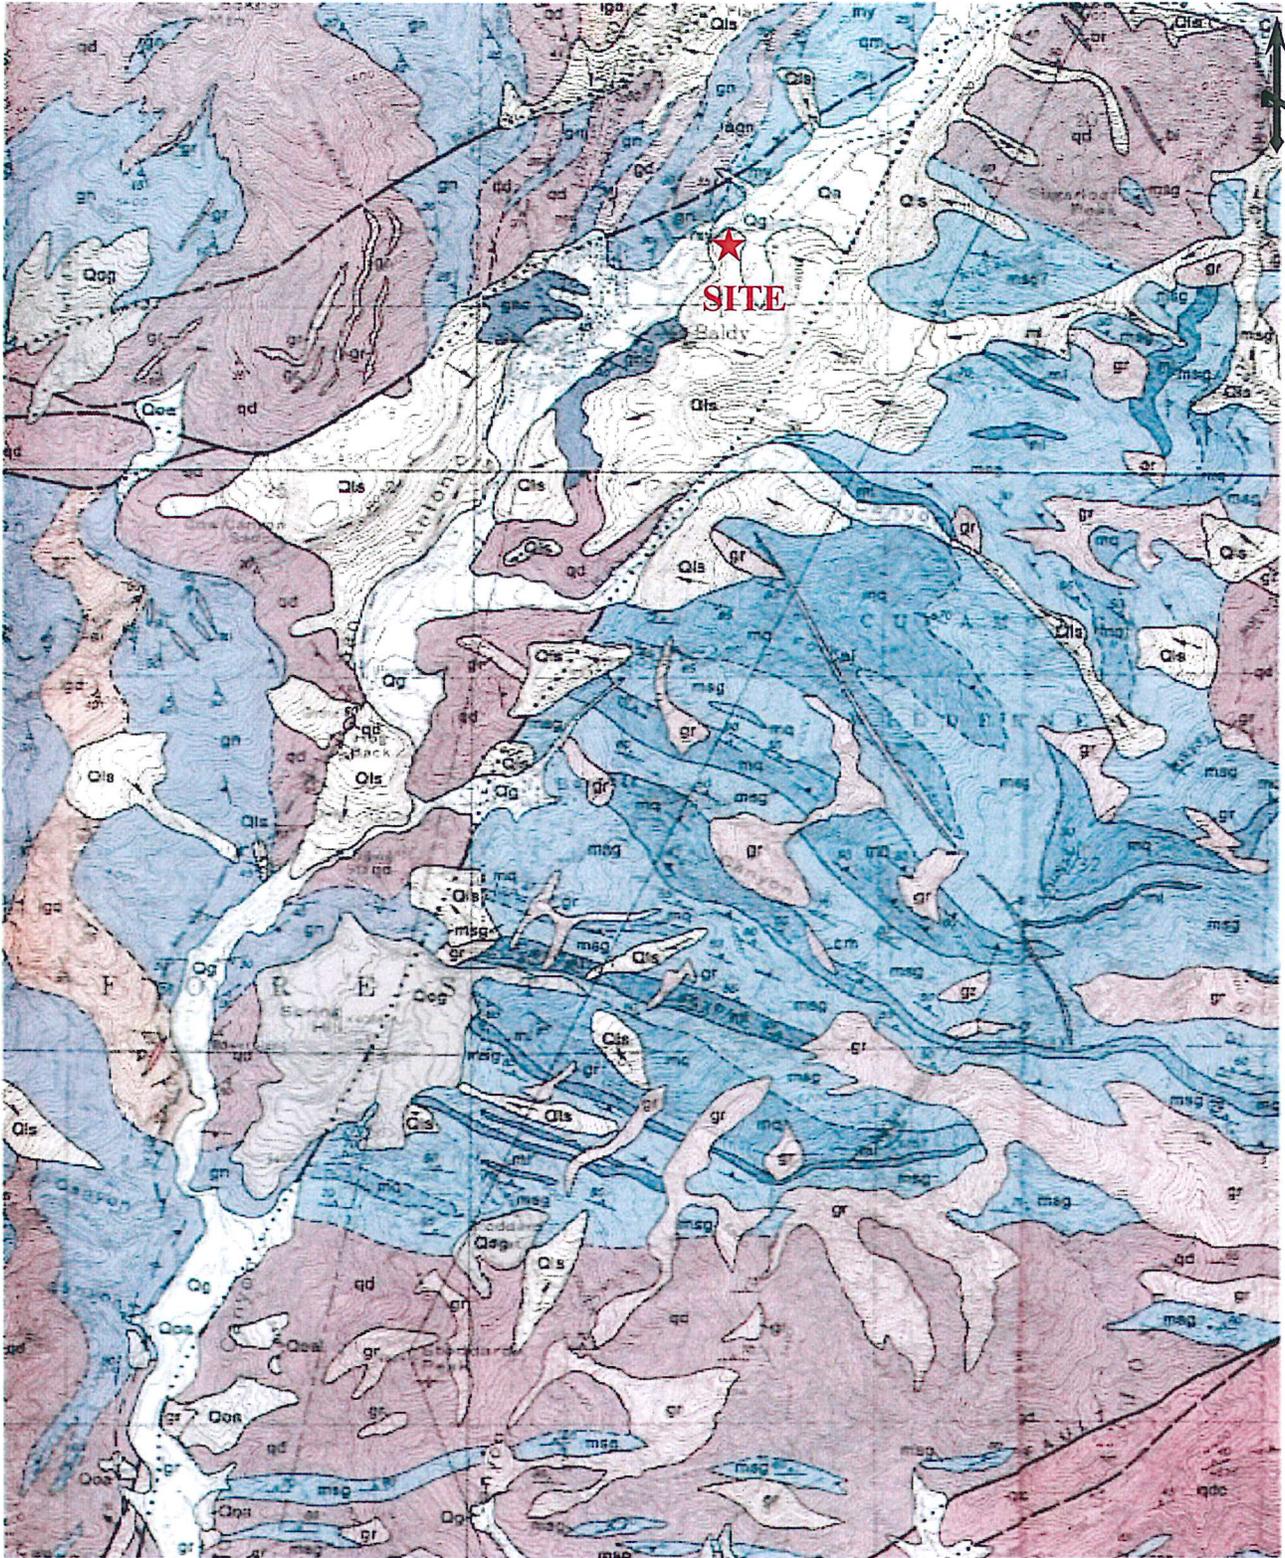
GEOLOGY MAP

Geologic Map of the San Antonio Canyon in the vicinity of Mt. Baldy Village. From Dibblee, 2002.

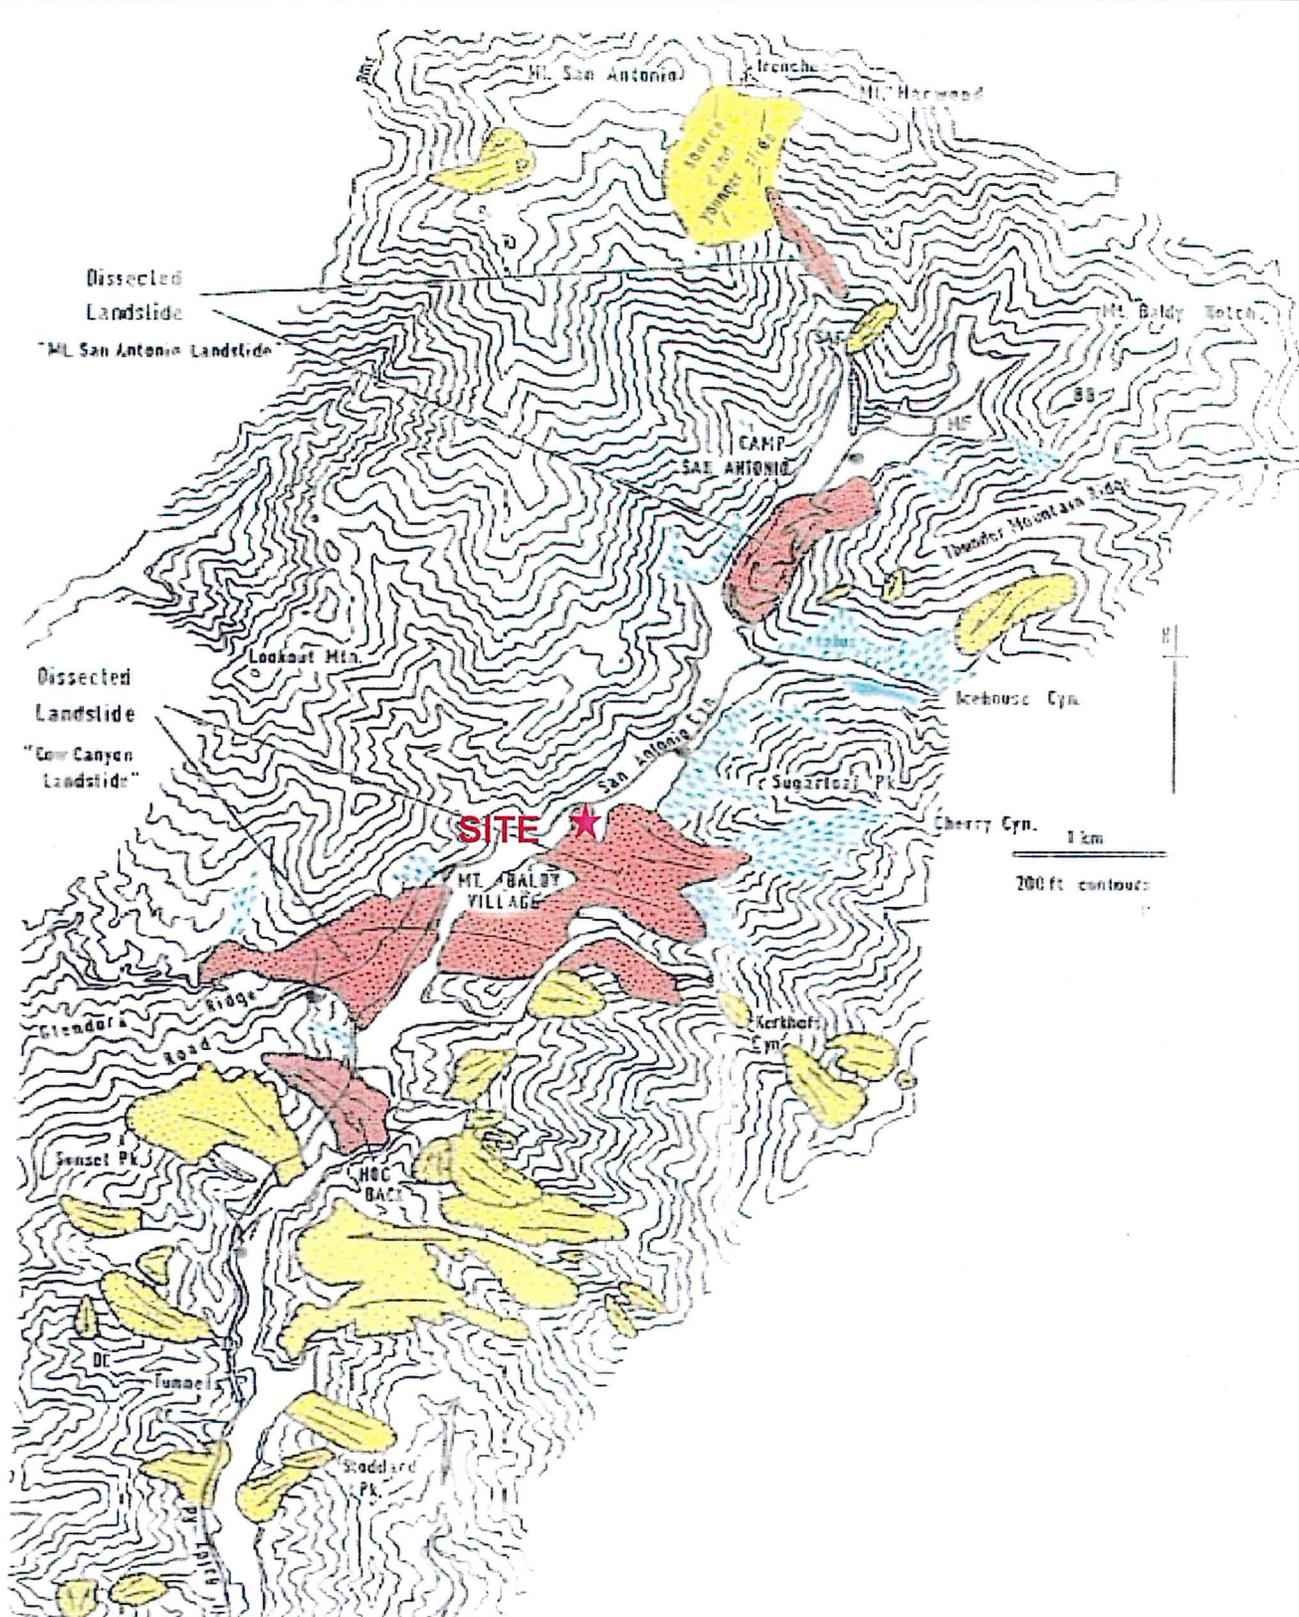
Landslide and Debris Map

Landslides and Debris Flows in the San Antonio Canyon (from Hazlett, 2001)

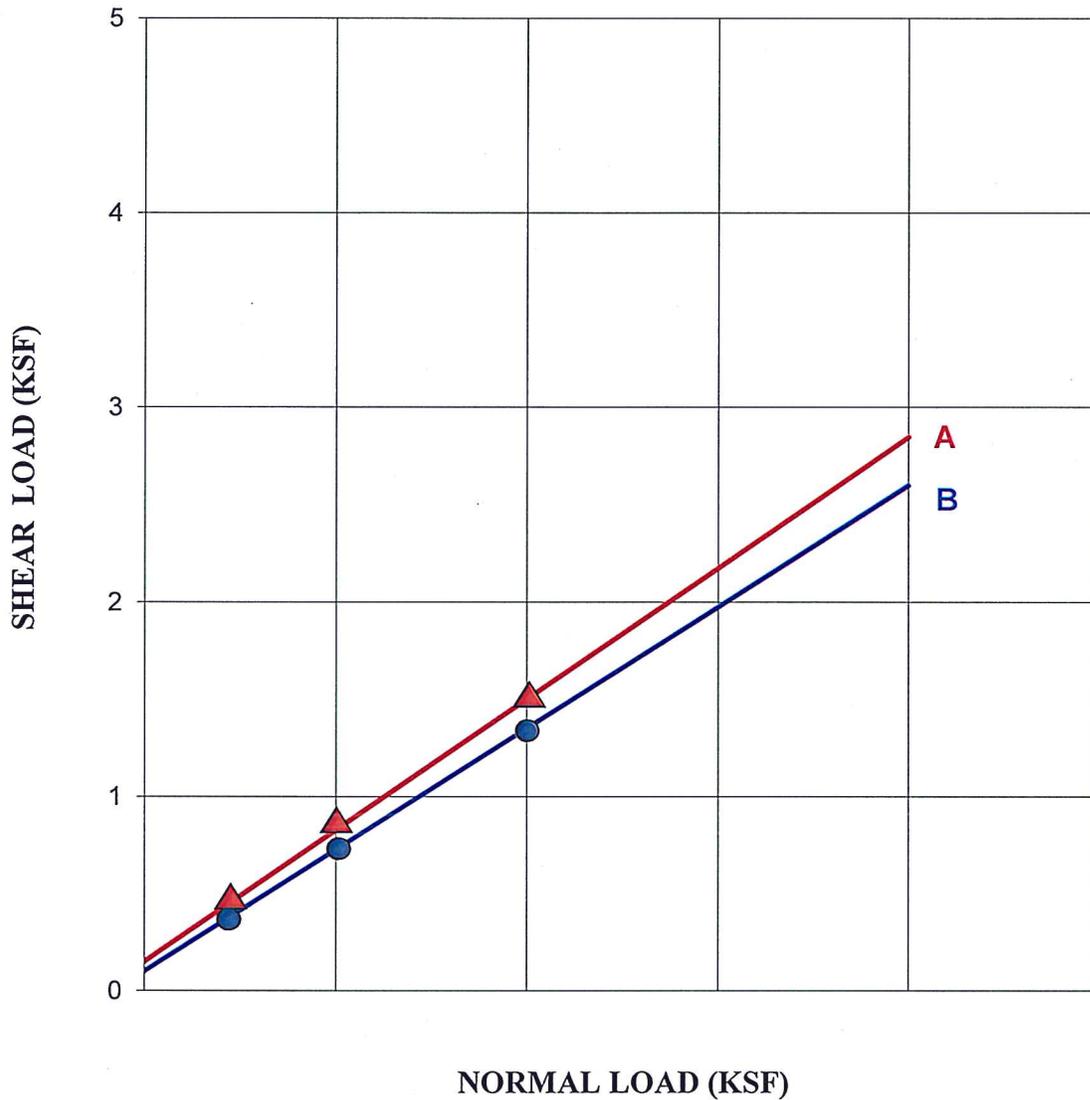
DIRECT SHEAR

SYMBOL	LOCATION	DEPTH (FT)	TEST CONDITION	COHESION (PSF)	FRICTION (DEG)
A	Test Pit TP-1	2'	Saturated - Drained Peak	150	34
B	Test Pit TP-1	2'	Saturated - Drained Ultimate	100	32

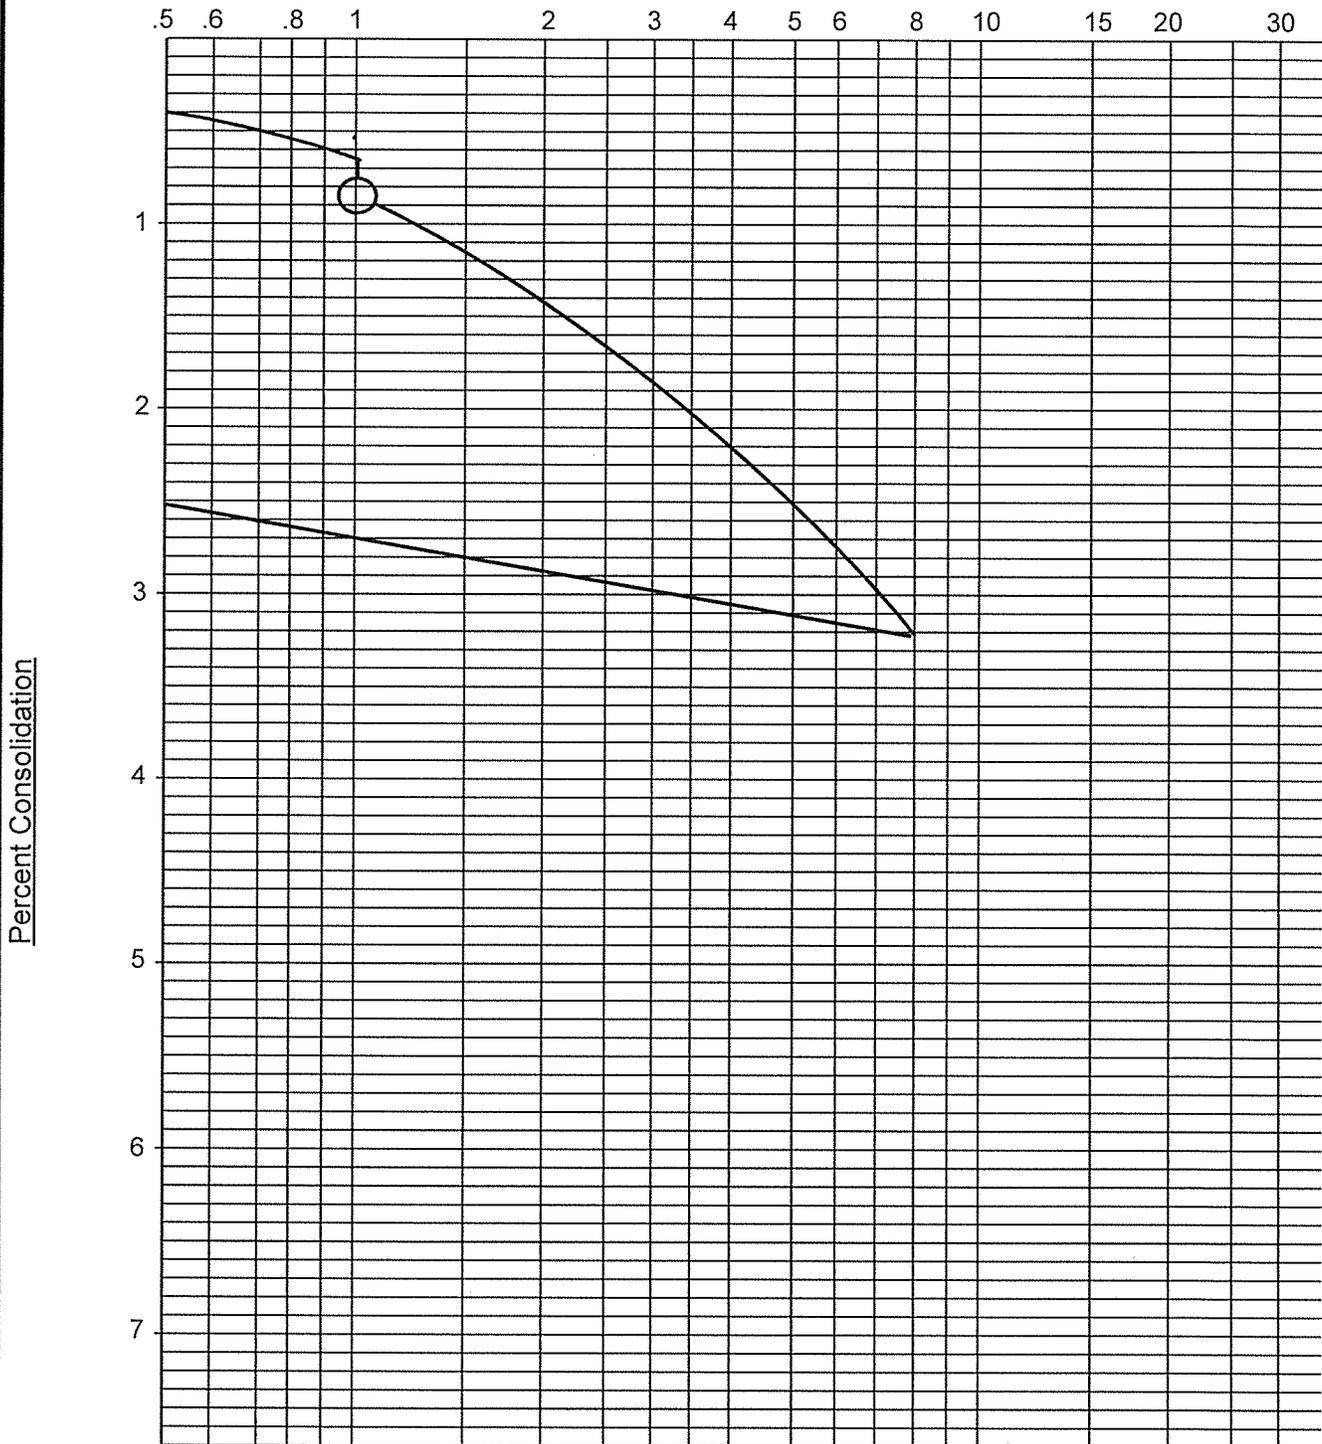
CONSOLIDATION

Load In Kips per Square Foot

○ After water added to the sample

Test Pit TP-1 @ 2'

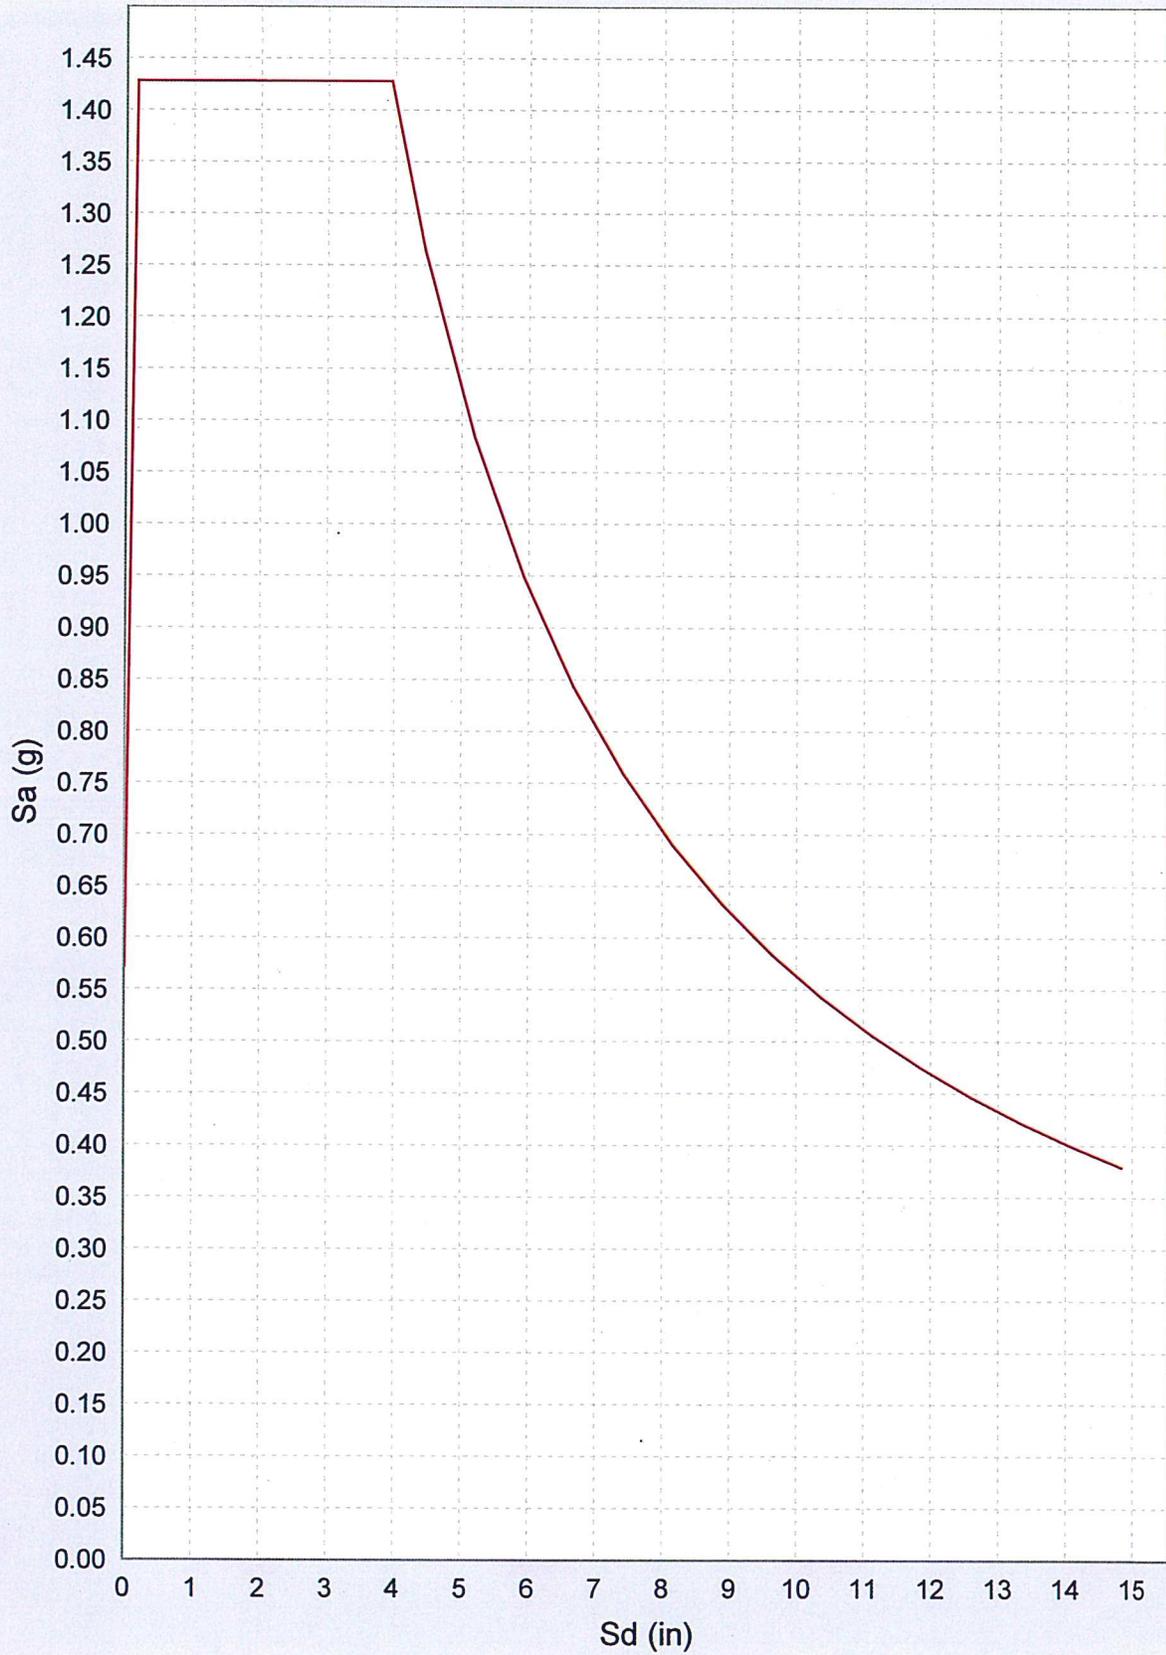
Design Spectrum Sa Vs Sd

NEHRP Seismic Design Provisions
Verizon Wireless – Mt. Baldy LAX-277
VS-4195-06

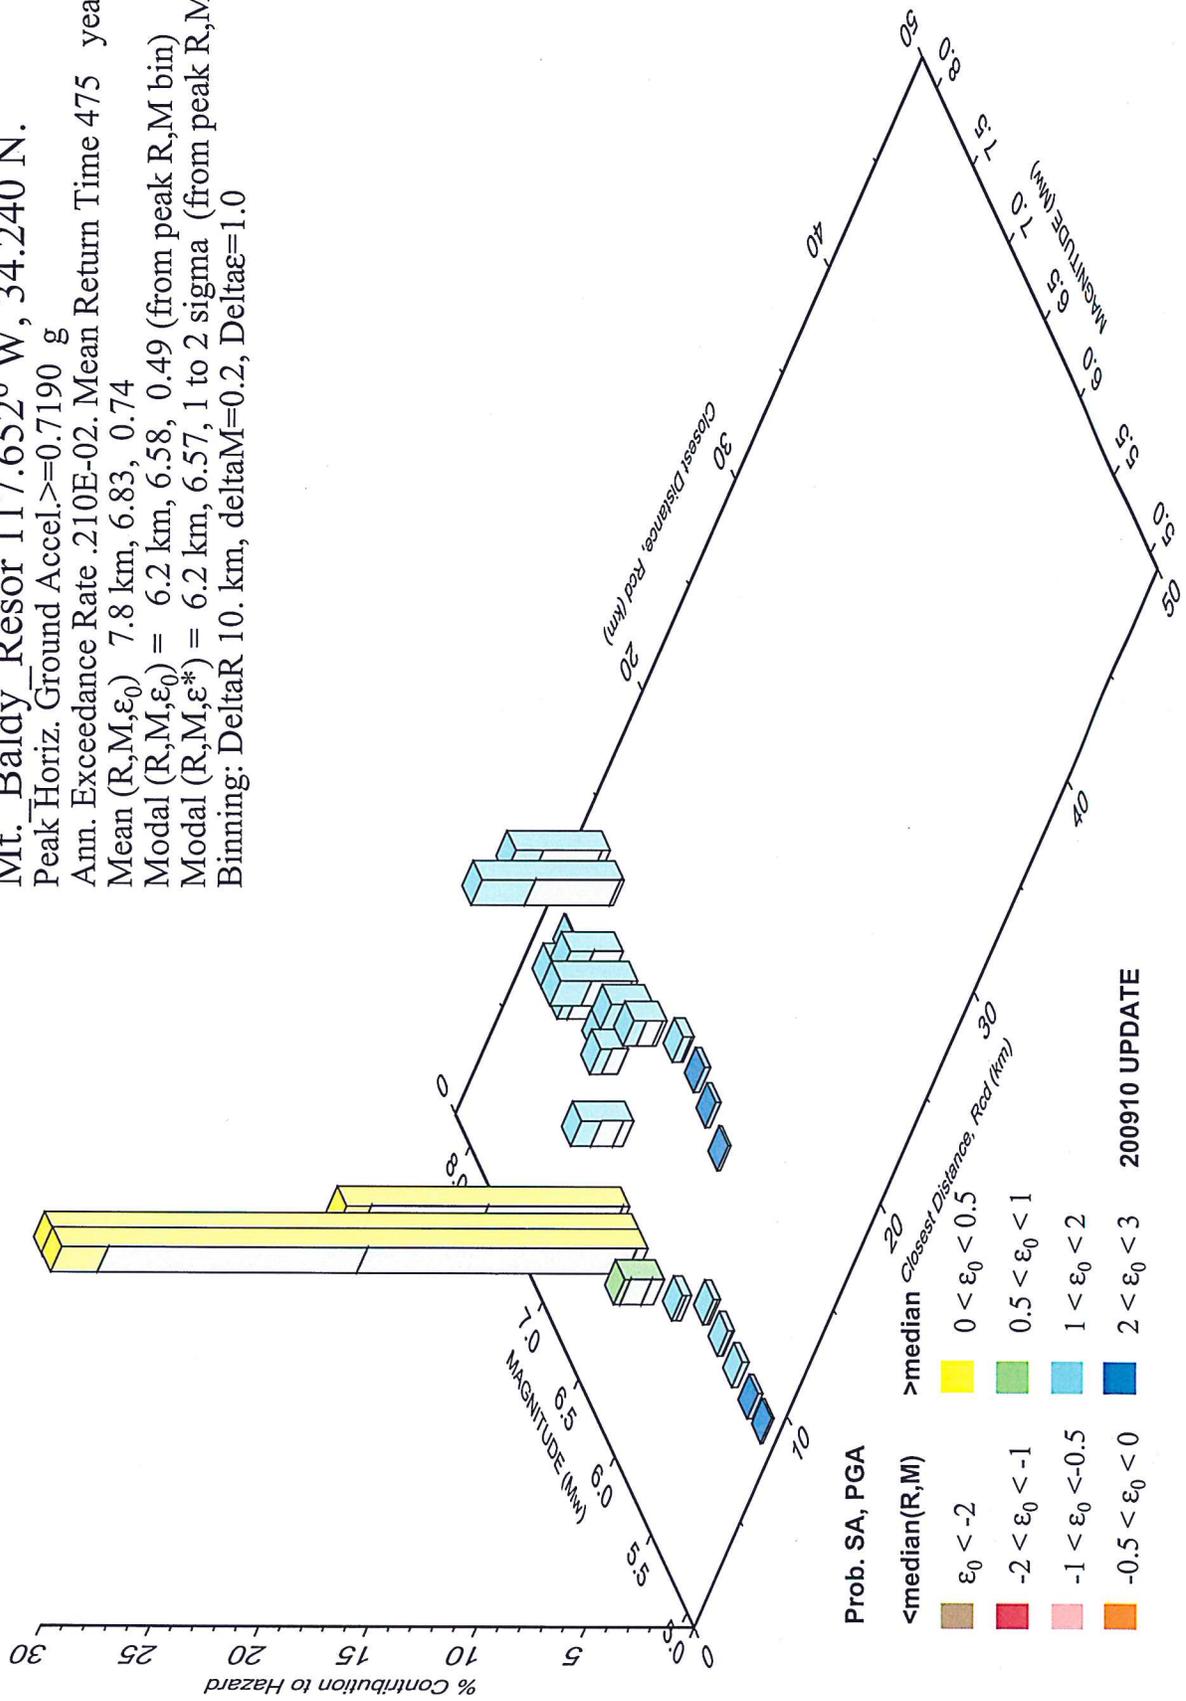
PSH Deaggregation on NEHRP BC rock
 Mt. Baldy Resor 117.652° W, 34.240 N.
 Peak Horiz. Ground Accel. ≥ 0.7190 g
 Ann. Exceedance Rate .210E-02. Mean Return Time 475 years
 Mean (R, M, ϵ_0) 7.8 km, 6.83, 0.74
 Modal $(R, M, \epsilon_0) = 6.2$ km, 6.58, 0.49 (from peak R, M bin)
 Modal $(R, M, \epsilon^*) = 6.2$ km, 6.57, 1 to 2 sigma (from peak R, M, ϵ bin)
 Binning: DeltaR 10. km, deltaM=0.2, Delta ϵ =1.0

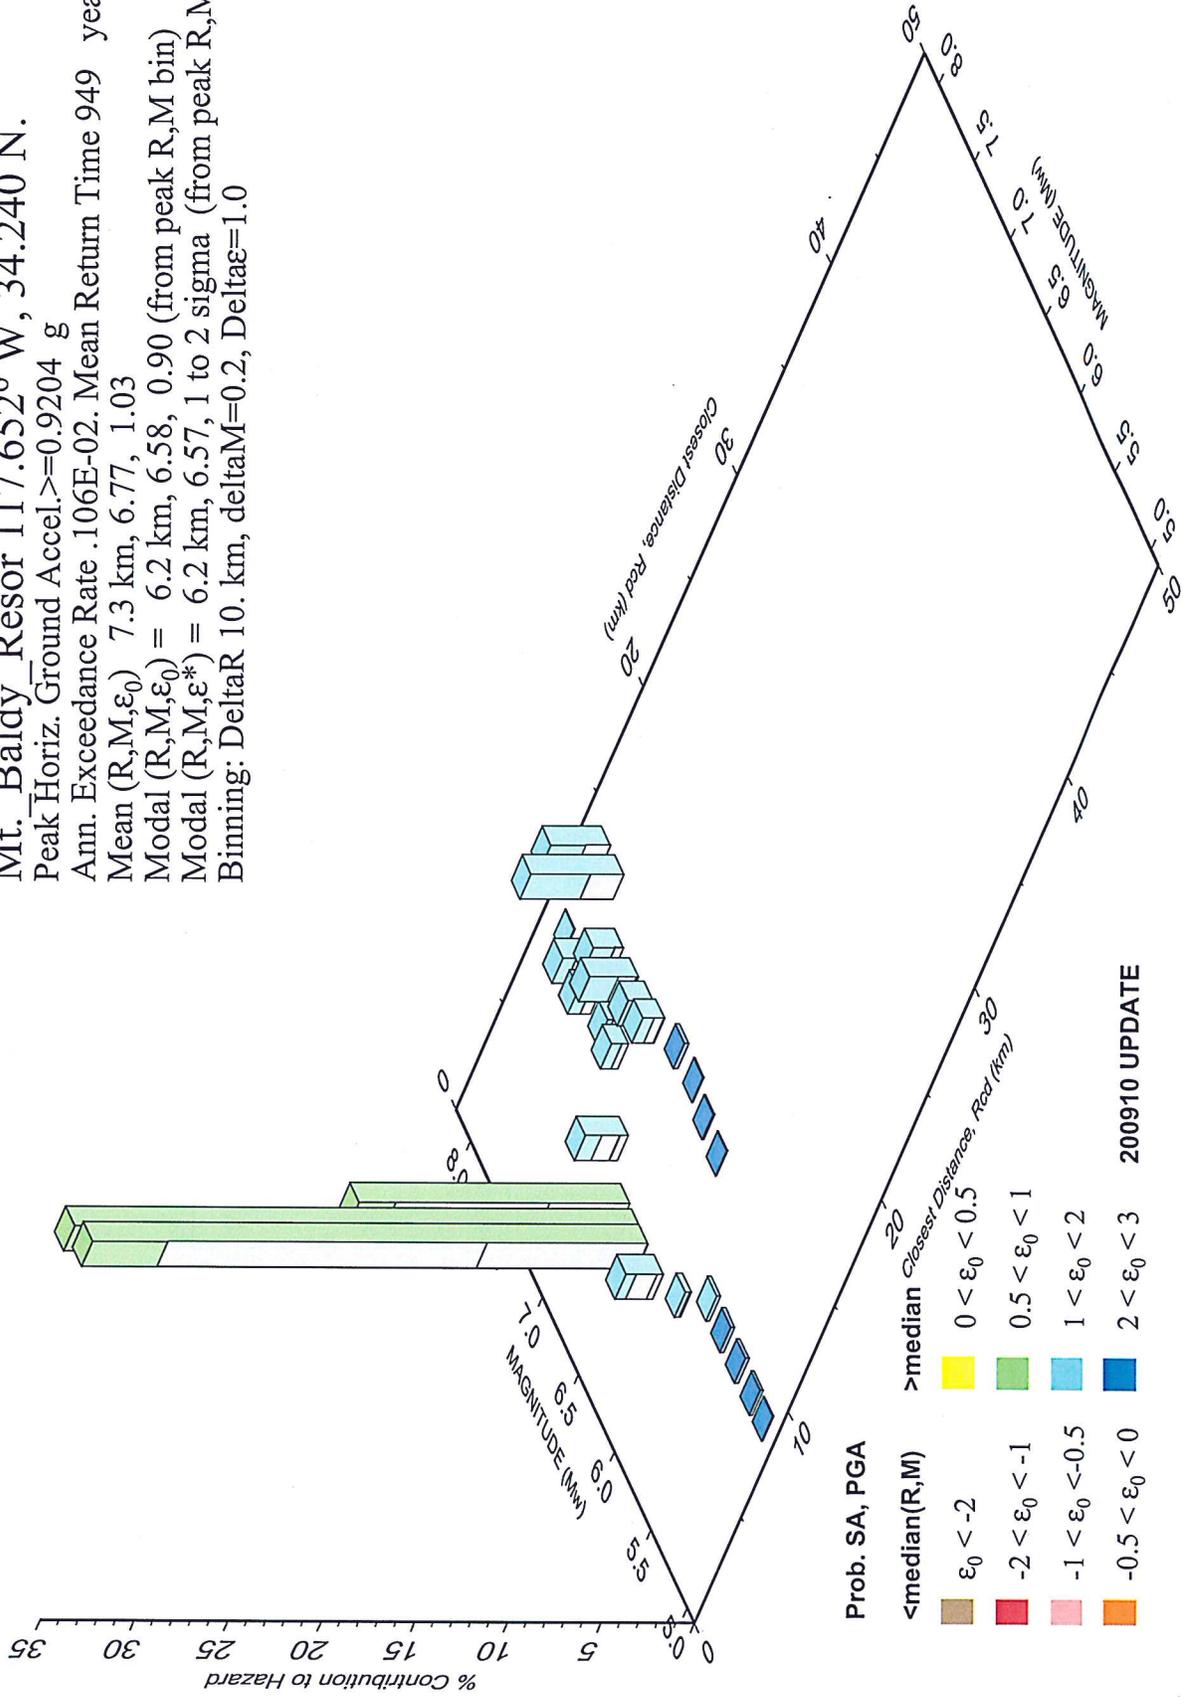
PSH Deaggregation on NEHRP BC rock
 Mt. Baldy Resor 117.652° W, 34.240 N.
 Peak Horiz. Ground Accel. ≥ 0.9204 g
 Ann. Exceedance Rate .106E-02. Mean Return Time 949 years
 Mean (R, M, ϵ_0) 7.3 km, 6.77, 1.03
 Modal $(R, M, \epsilon_0) = 6.2$ km, 6.58, 0.90 (from peak R, M bin)
 Modal $(R, M, \epsilon^*) = 6.2$ km, 6.57, 1 to 2 sigma (from peak R, M, ϵ bin)
 Binning: DeltaR 10. km, deltaM=0.2, Delta ϵ =1.0

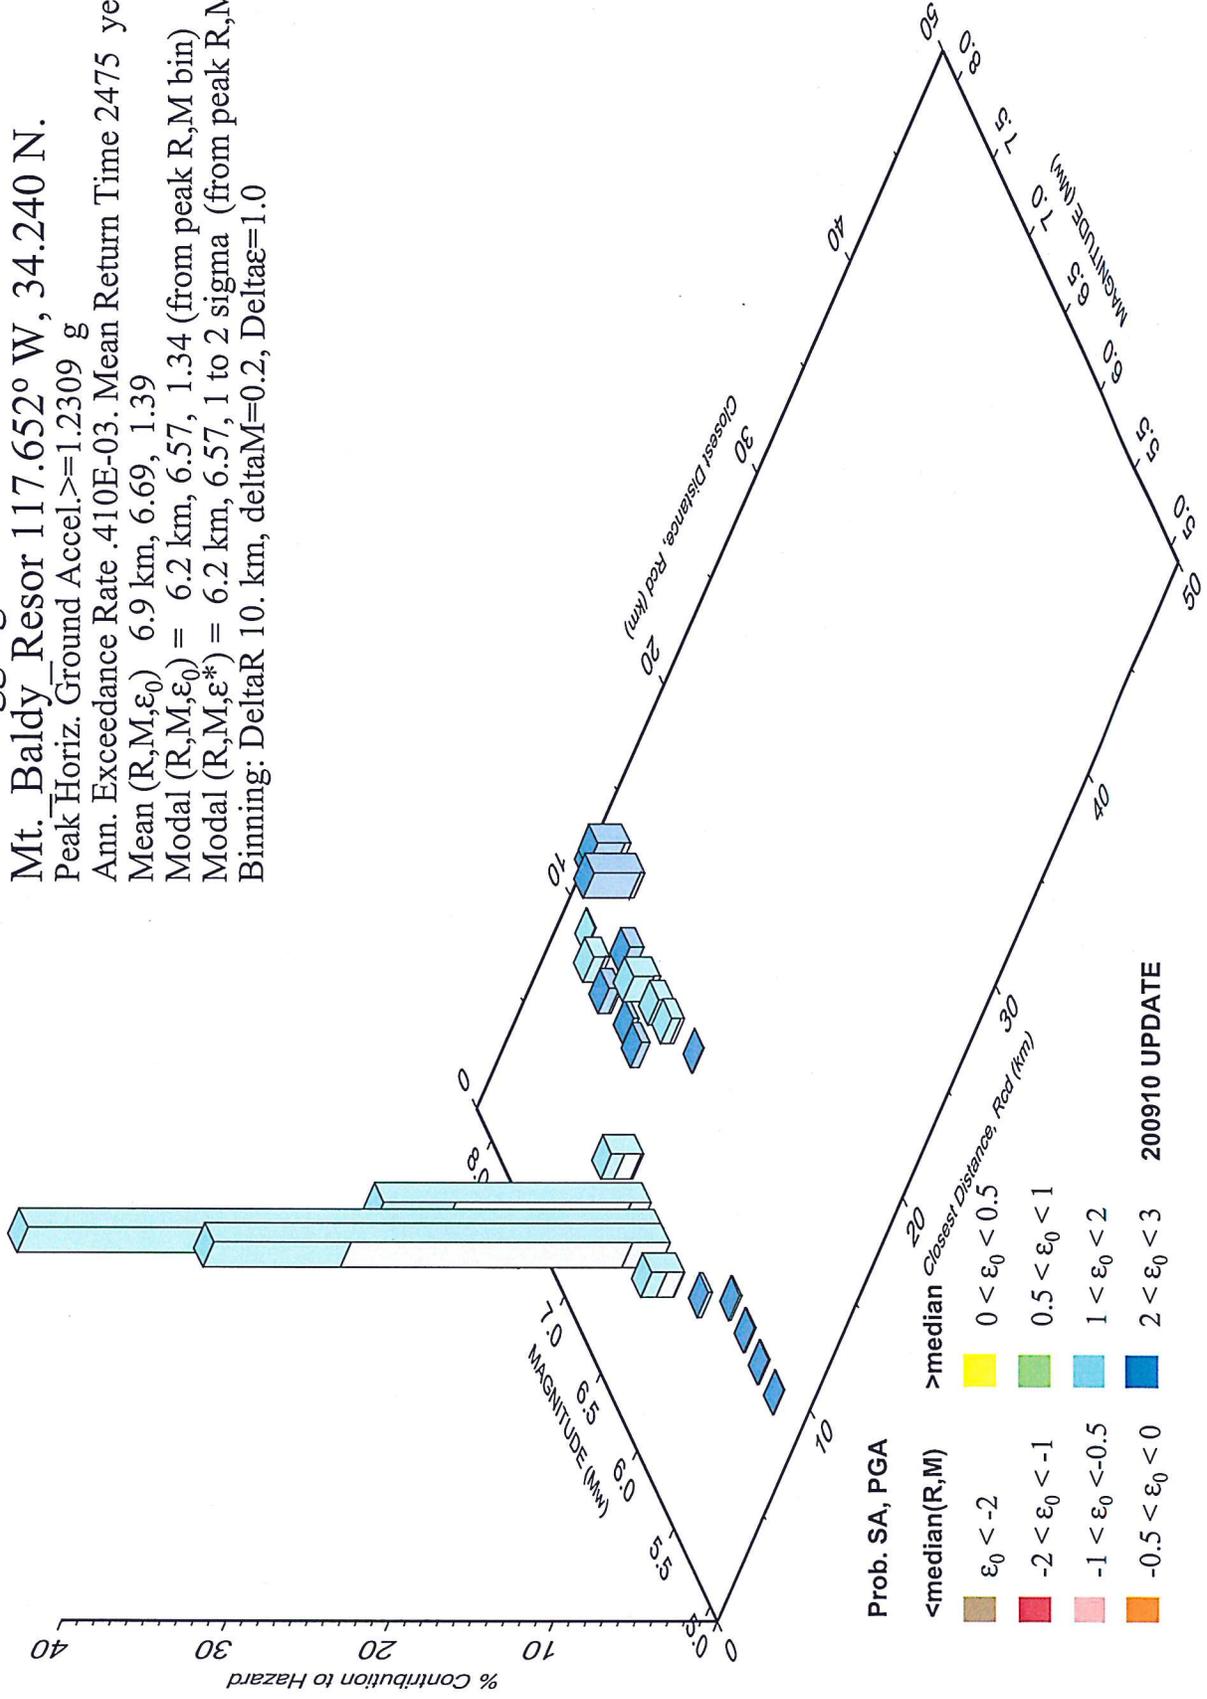
PSH Deaggregation on NEHRP BC rock
 Mt. Baldy Resor 117.652° W, 34.240 N.
 Peak Horiz. Ground Accel. ≥ 1.2309 g
 Ann. Exceedance Rate .410E-03. Mean Return Time 2475 years
 Mean (R,M, ϵ_0) 6.9 km, 6.69, 1.39
 Modal (R,M, ϵ_0) = 6.2 km, 6.57, 1.34 (from peak R,M bin)
 Modal (R,M, ϵ^*) = 6.2 km, 6.57, 1 to 2 sigma (from peak R,M, ϵ bin)
 Binning: DeltaR 10. km, deltaM=0.2, Delta ϵ =1.0
