**REPORT OF
GEOTECHNICAL EVALUATION FOR
ENVIRONMENTAL IMPACT REPORT**

**HACIENDA AT FAIRVIEW VALLEY
SAN BERNARDINO COUNTY,
CALIFORNIA**

**MARCH 25, 2009
PROJECT NO. A8528-06-01**

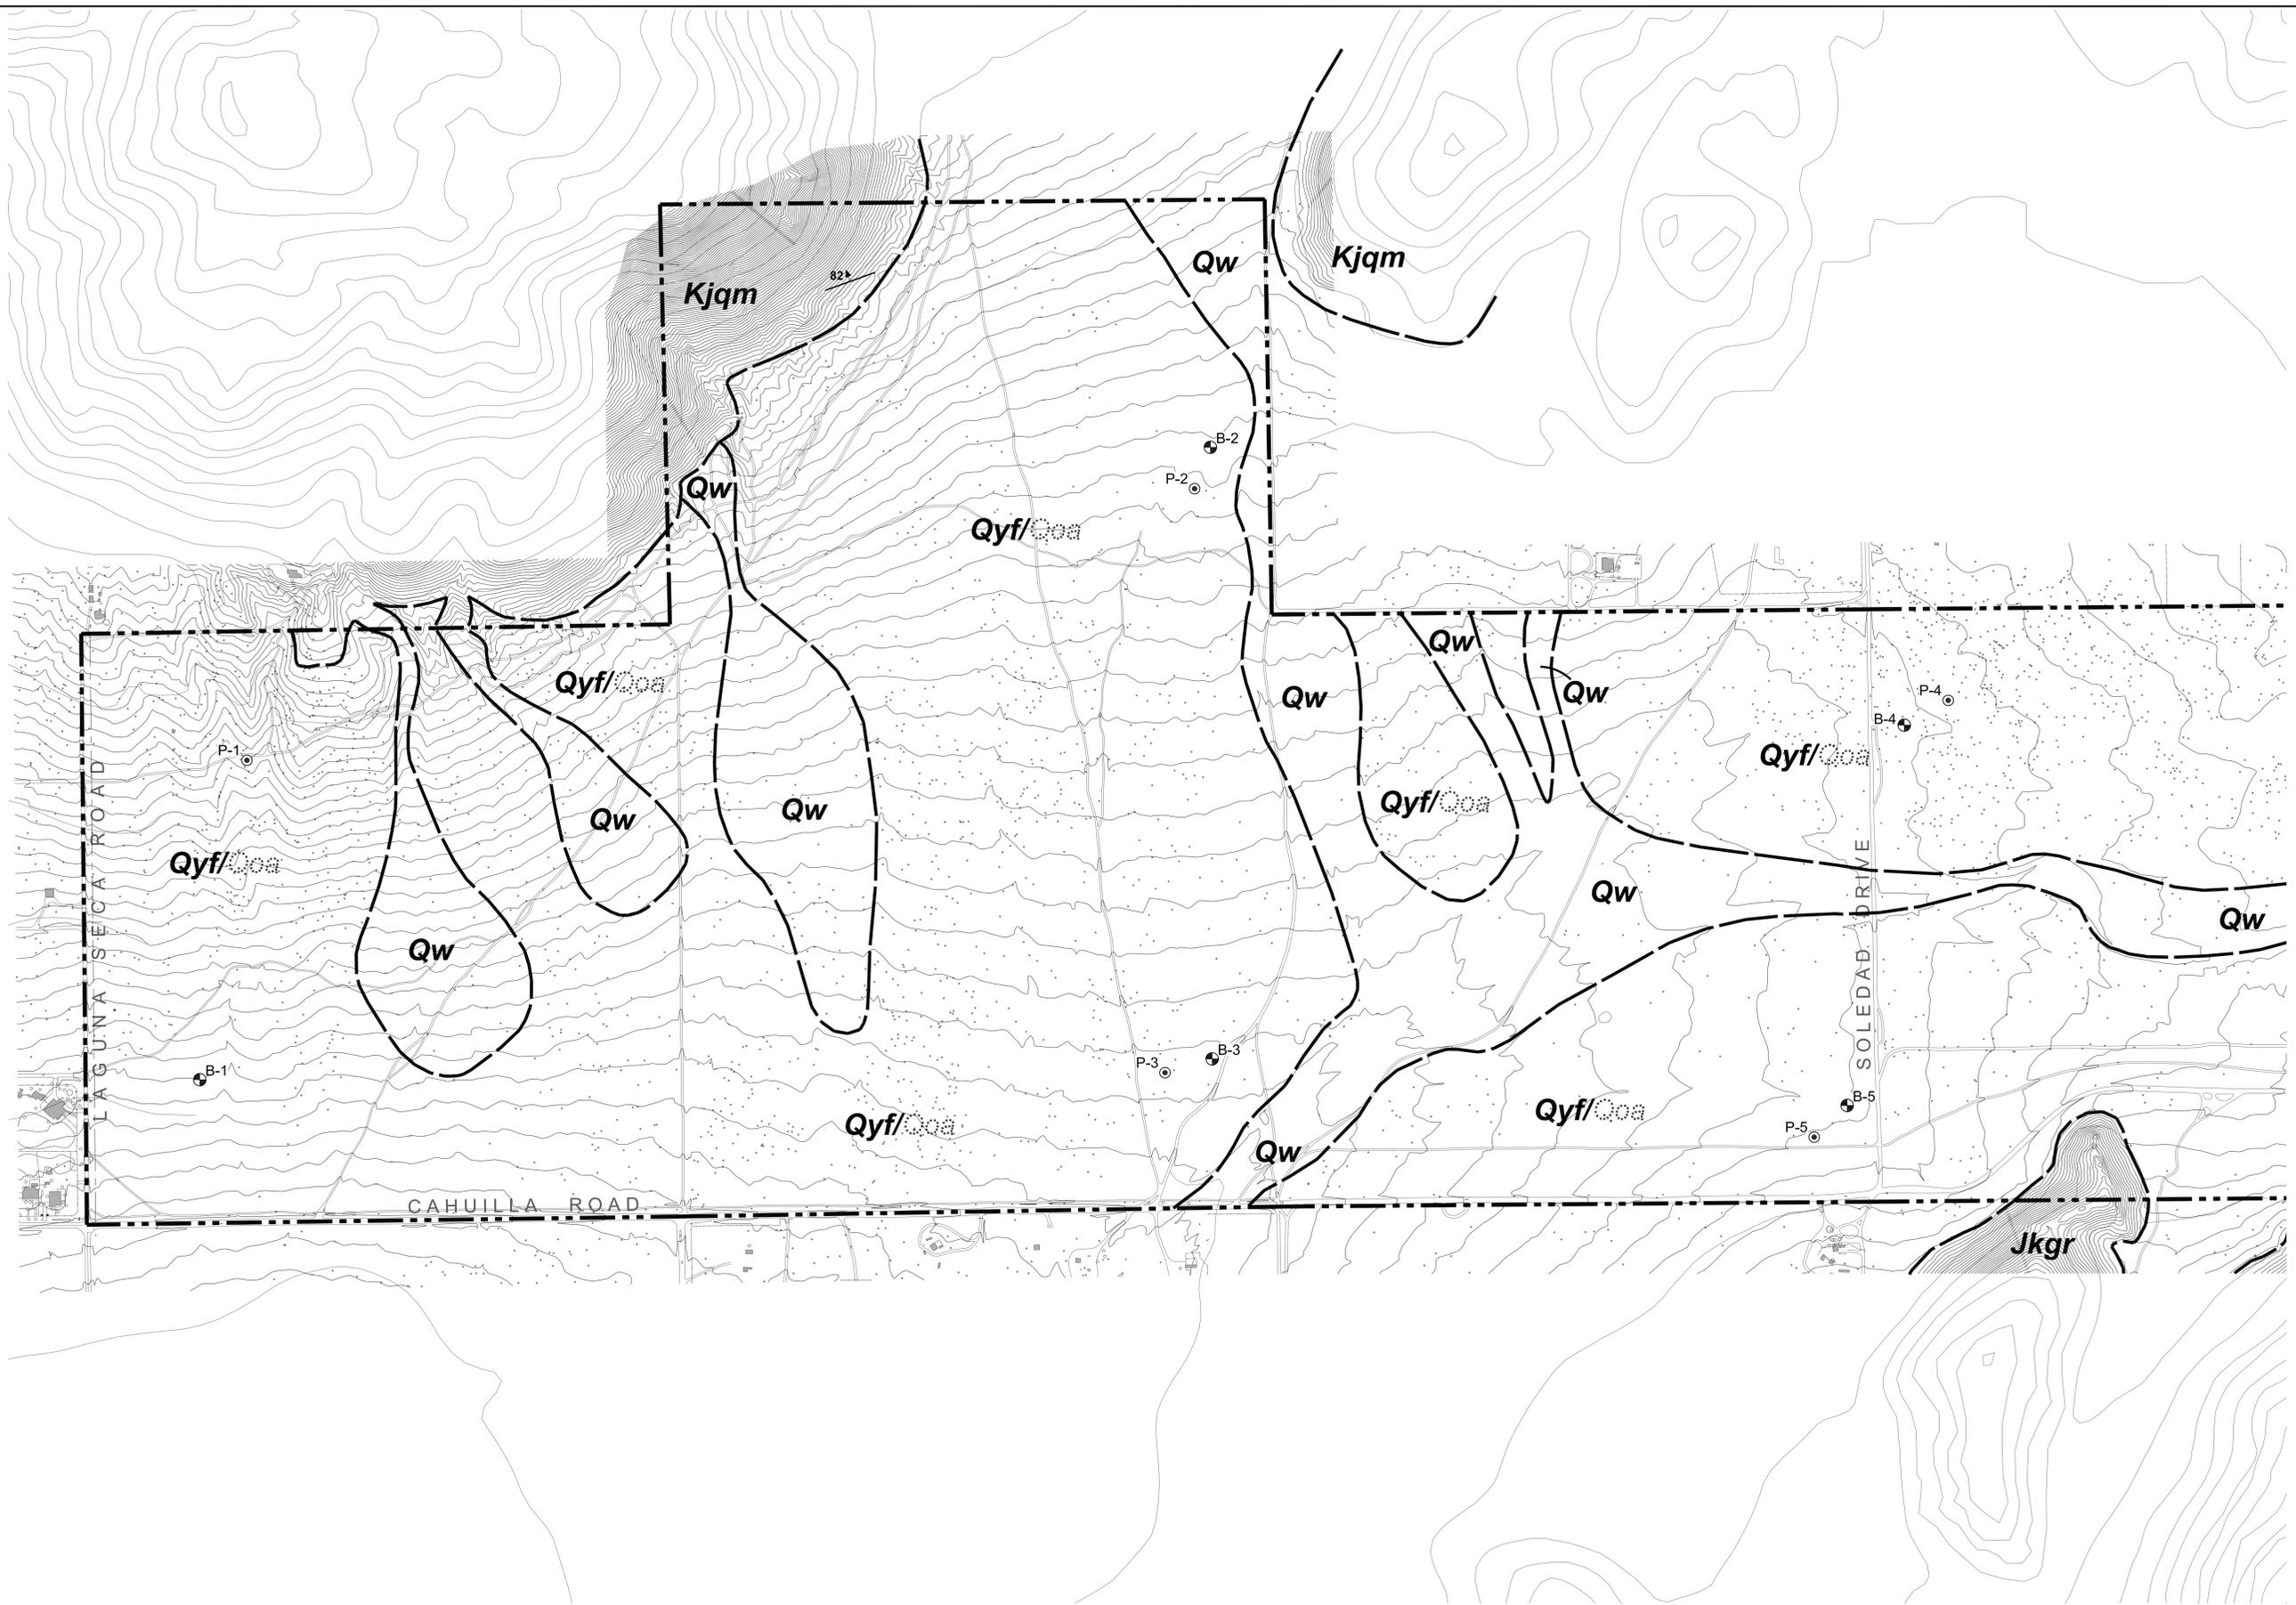
- GEOCON LEGEND**
- Qw** WASH DEPOSITS
 - Qyf** YOUNG ALLUVIAL FAN DEPOSITS
 - Qoa** OLD ALLUVIAL DEPOSITS (Dotted Where Buried)
 - Kjqm** CRETACEOUS OR JURASSIC QUARTZ MONZONITE
 - Jkgr** JURASSIC OR CRETACEOUS GRANITE
 - B-17** APPROX. LOCATION OF EXPLORATORY BORING
 - P-8** APPROX. LOCATION OF PERCOLATION TEST
 - 70°** STRIKE AND DIP OF FOLIATION
 - APPROX. LOCATION OF GEOLOGIC CONTACT
 - APPROX. LOCATION OF FAULT (Dashed Where Approximate; Dotted Where Buried; Queried Where Uncertain)
 - DELINEATED STRAIGHT LINE SEGMENTS THAT CONNECT CIRCLED TURNING POINTS SO AS TO DEFINE THE EARTHQUAKE SPECIAL STUDY ZONE
 - APPROX. LOCATION OF EARTHQUAKE SPECIAL STUDY ZONE

Geocon performed percolation testing at eight locations in the northern property (see Geologic Map, Figures 2 and 3) to evaluate the suitability of the underlying soil for on-site wastewater disposal systems. We performed the percolation tests according to the County of San Bernardino Department of Environmental Health as outlined in their manual, *Waste Disposal for Individual Homes, Commercial and Industrial*. The results of our percolation testing are summarized in Table 14. We performed percolation tests on boring excavations extending to approximately 3 feet below the existing ground surface in the alluvial soils. The percolation test locations were randomly spread across the northern site in near proximity to exploratory borings to evaluate whether suitable site conditions exist to support a septic system. The test results indicate that the percolation rates varied from approximately 2.7 minutes per inch (min/inch) to 6.7 min/inch in the locations tested and indicate that septic and leach field systems are appropriate. Individual wastewater disposal systems should be designed according to the site-specific percolation rates and the specifications of the governing agencies.

The field investigation included the excavation of 17 small diameter borings. The approximate location of the excavations are shown on the Geologic Map, Figures 2 through 4 (map pocket). The exploratory borings were excavated to a maximum depth of 51 feet using a truck-mounted drill rig equipped with 8-inch diameter hollow stem augers. As drilling proceeded, the soil and geologic conditions encountered were logged and sampled.

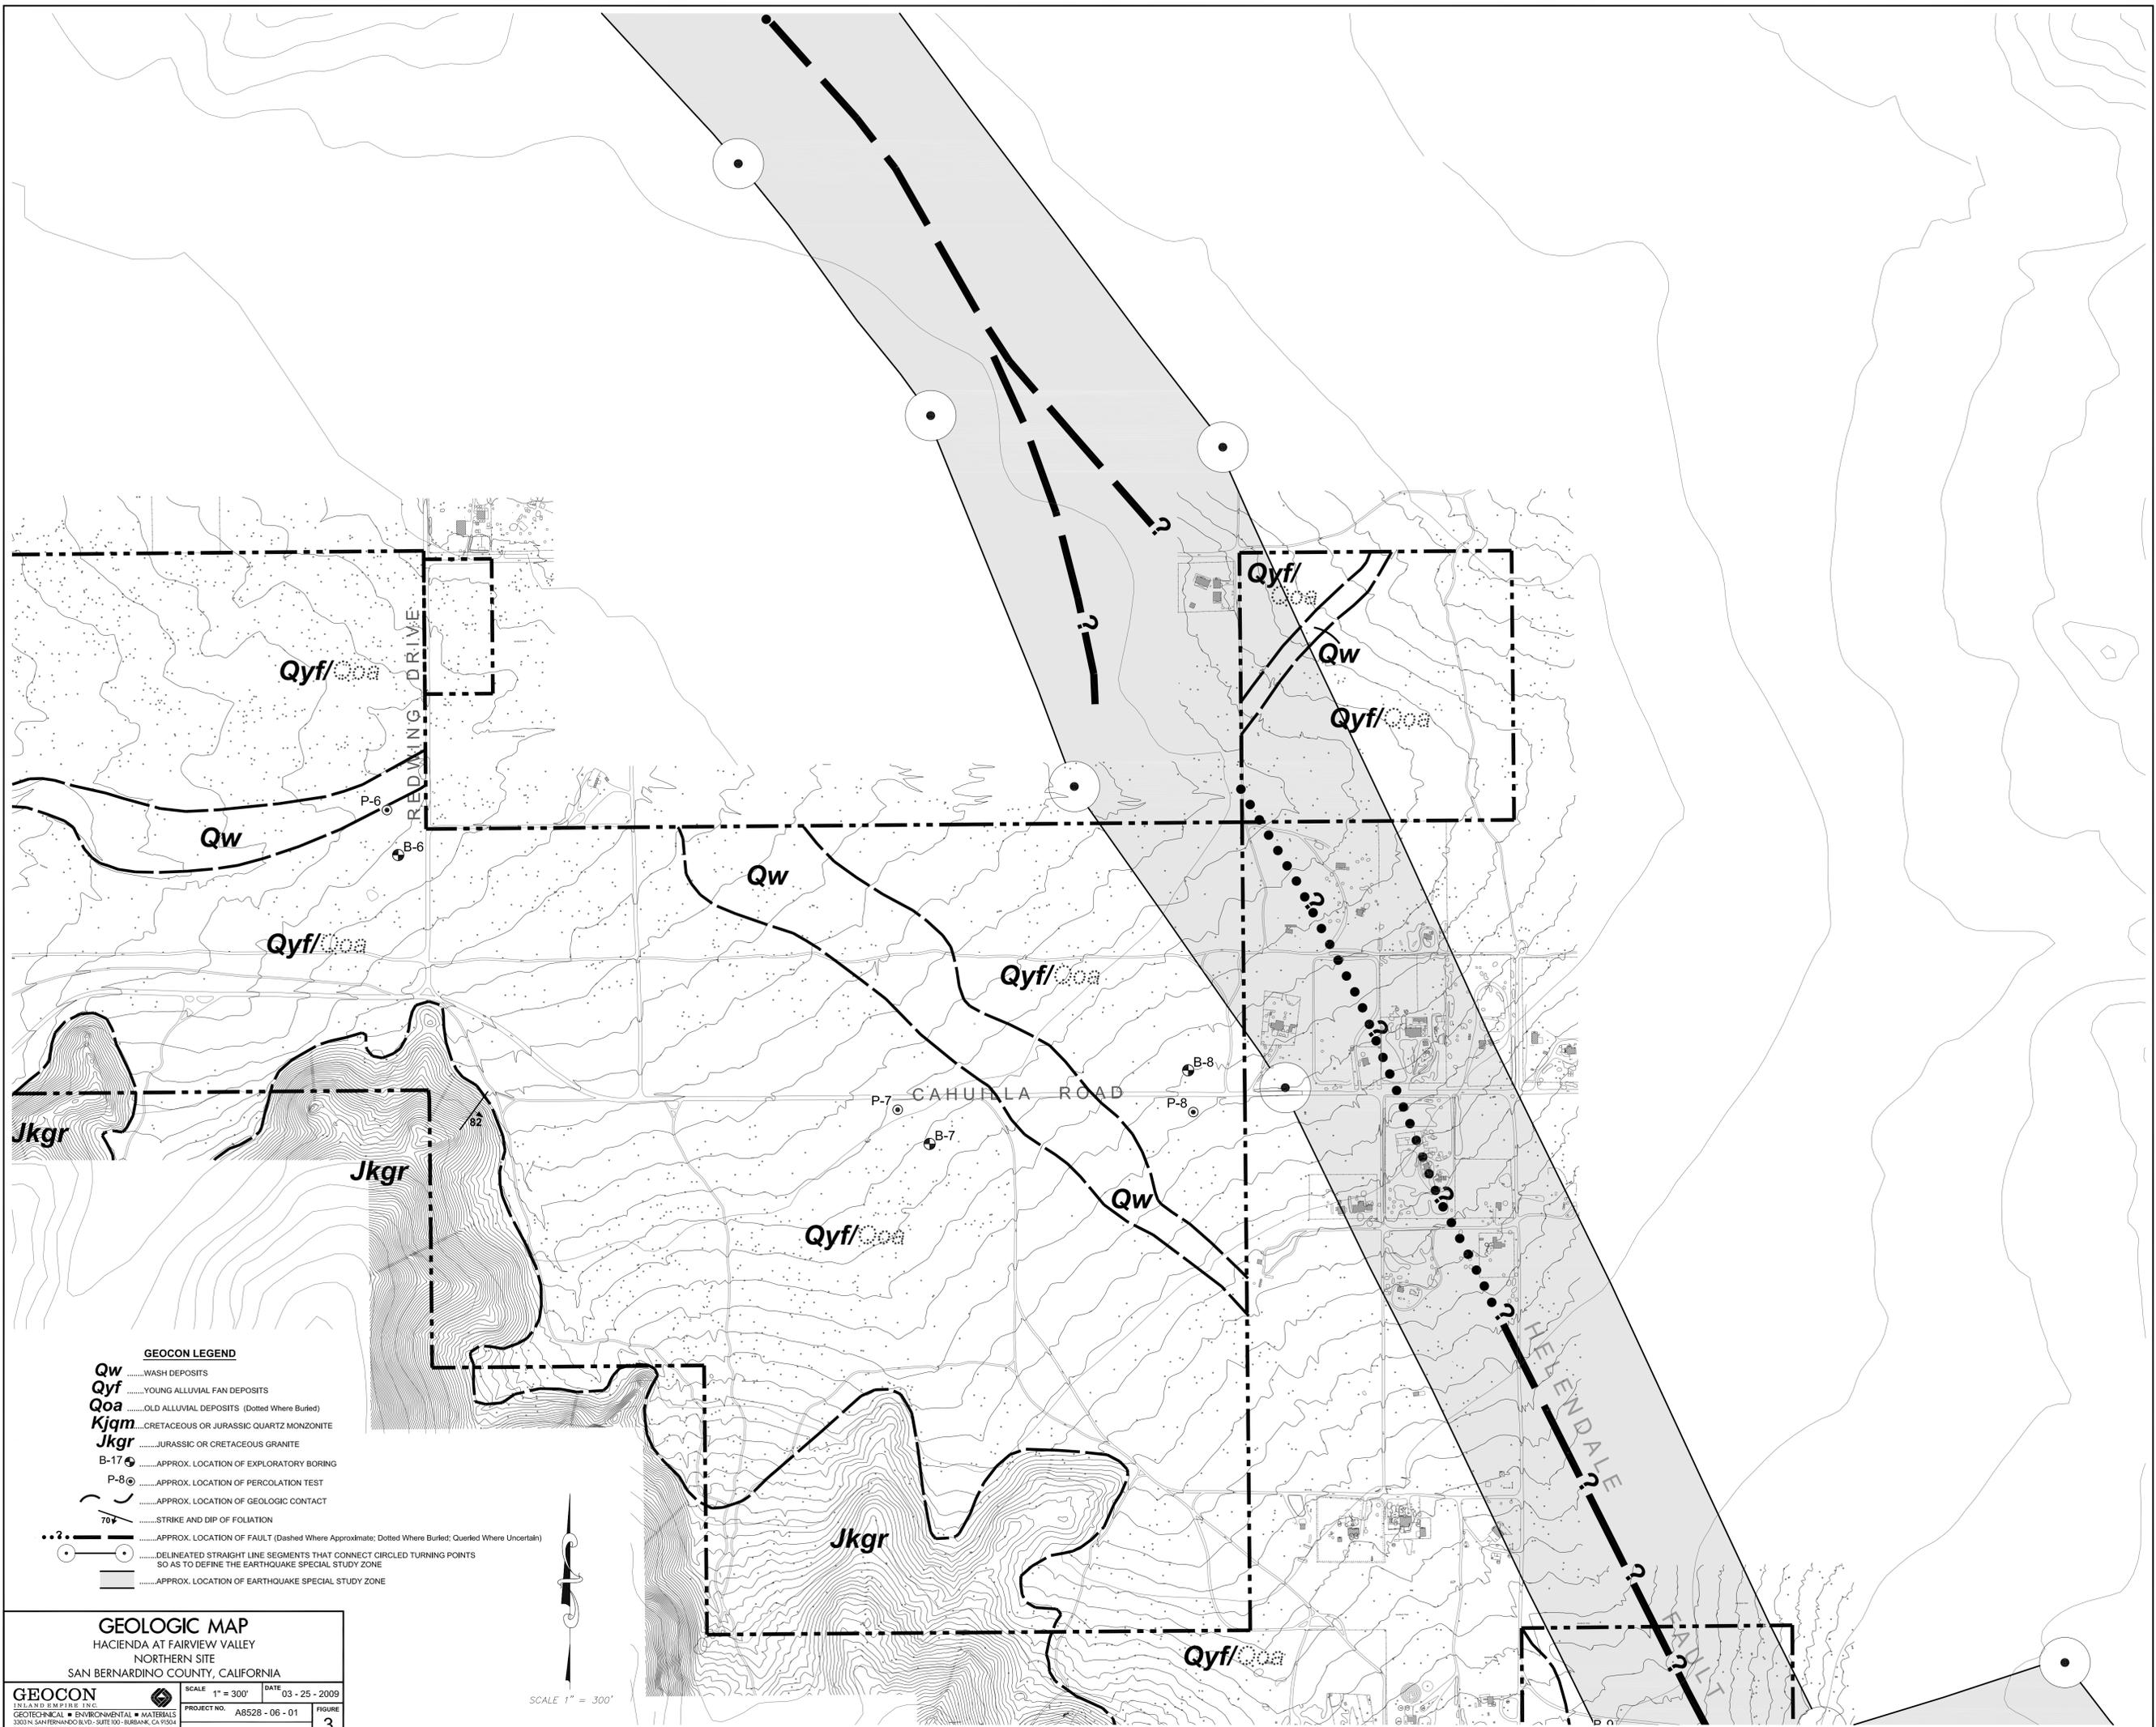
GEOCON <small>INCORPORATED</small> <small>3003 N. SAN FERNANDO BLVD., SUITE 100 - BURBANK, CA 91504</small> <small>PHONE: 818 841-8388 - FAX: 818 841-9704</small>	SCALE 1" = 300' PROJECT NO. ABS28-06-01 SHEET 1 OF 1	DATE 03-25-2009 FIGURE 3
--	--	-----------------------------

- Qw** WASH DEPOSITS
- Qyf** YOUNG ALLUVIAL FAN DEPOSITS
- Qoa** OLD ALLUVIAL DEPOSITS (Dotted Where Buried)
- Kjgm** CRETACEOUS OR JURASSIC QUARTZ MONZONITE
- Jkgr** JURASSIC OR CRETACEOUS GRANITE
- B-17** APPROX. LOCATION OF EXPLORATORY BORING
- P-8** APPROX. LOCATION OF PERCOLATION TEST
- APPROX. LOCATION OF GEOLOGIC CONTACT
- STRIKE AND DIP OF FOLIATION
- APPROX. LOCATION OF FAULT (Dashed Where Approximate; Dotted Where Buried; Queried Where Uncertain)
- DELINEATED STRAIGHT LINE SEGMENTS THAT CONNECT CIRCLED TURNING POINTS SO AS TO DEFINE THE EARTHQUAKE SPECIAL STUDY ZONE
- APPROX. LOCATION OF EARTHQUAKE SPECIAL STUDY ZONE

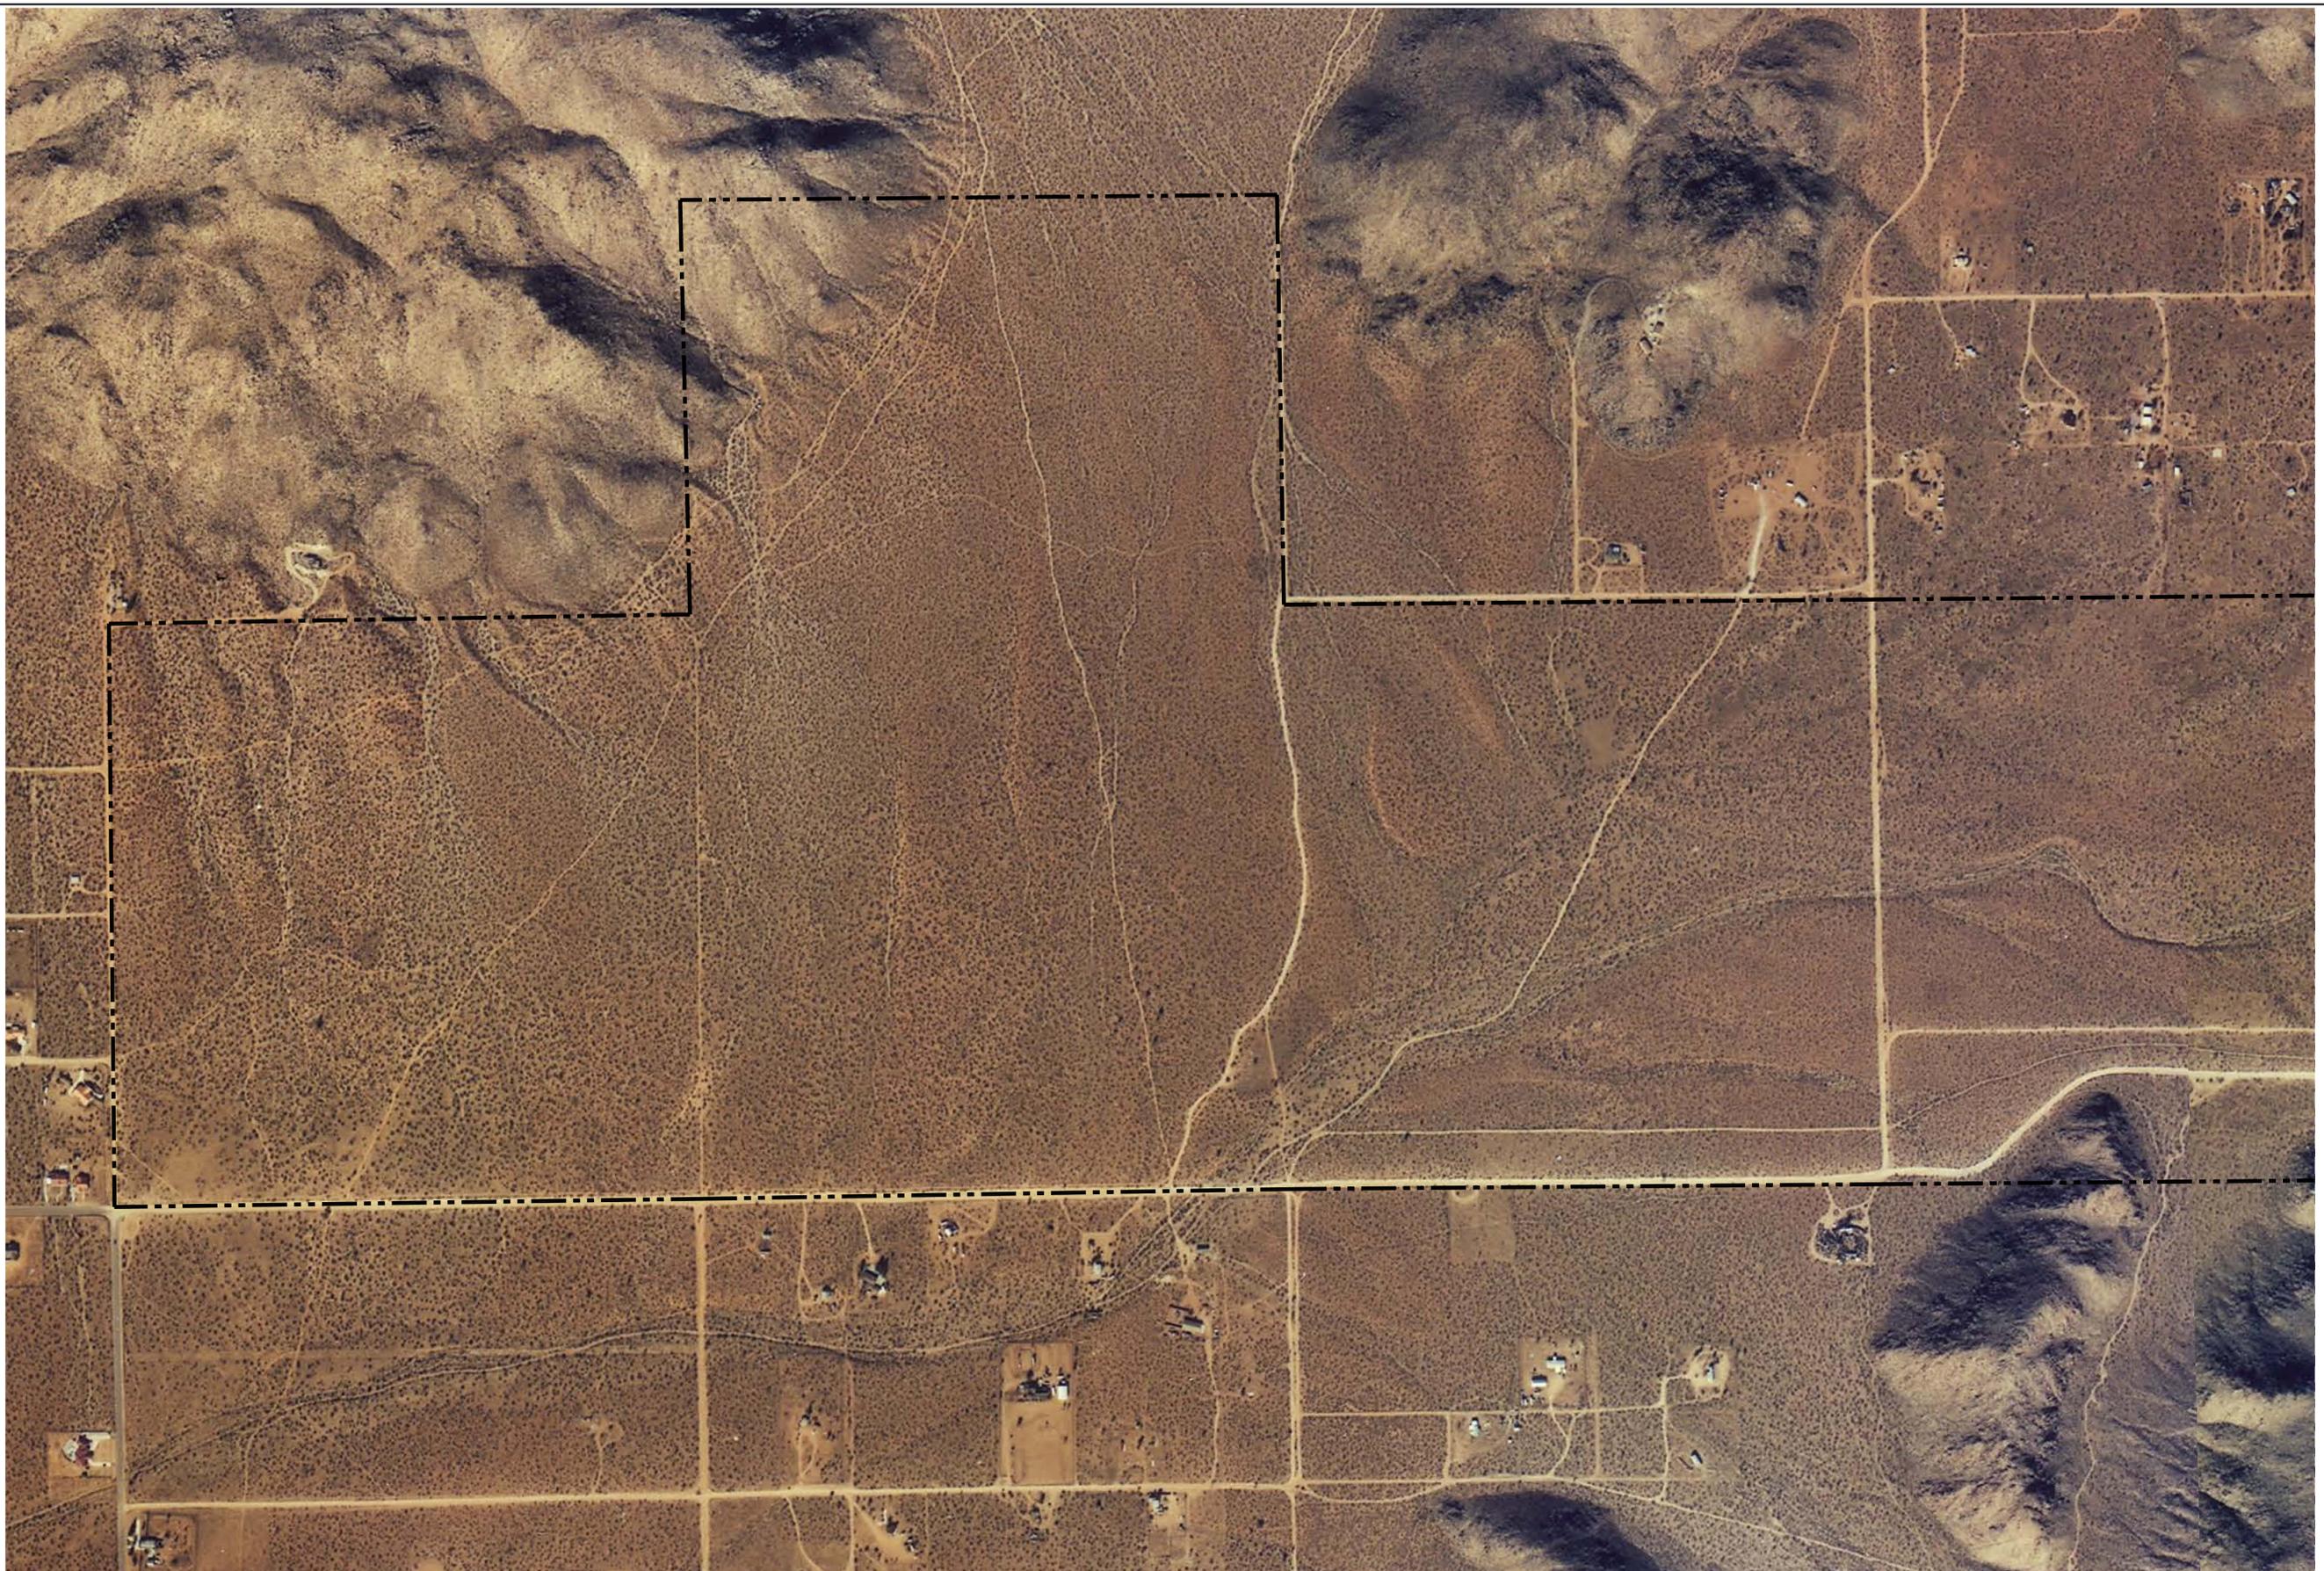
SCALE 1" = 300' DATE 03 - 25 - 2009
 PROJECT NO. A8528 - 06 - 01 FIGURE 5
 SHEET 1 OF 1

GEOLOGIC FAULT AND LINEAMENT MAP
 HACIENDA AT FAIRVIEW VALLEY
 NORTHERN SITE
 SAN BERNARDINO COUNTY, CALIFORNIA

The Granite Mountains contain numerous sublinear, non fault related lineaments that trend in multiple directions and are associated with the development of regional foliation and jointing due to uplift and release of rock stresses in pre-Holocene time. We observed photo lineaments within the rock units in the western and northwestern portions of the site. These lineaments are likely a result of Mesozoic faulting or the formation of foliation and are not associated with the Helendale Fault and do not extend from the rock units into the adjacent alluvial soils. Previous evaluations by various researchers did not map any of these lineaments shown on Figure 7 west of the site as part of the Helendale Fault Zone.

Fault lineaments associated with the Helendale Fault are fairly prominent within the Earthquake Fault Zone to the east of the site within the granitic rock units and are more poorly detailed as they extend into the alluvial soils. Lineaments that were photo observed within, and adjacent to, the eastern portion of the site have been included on a 1 inch equals 300 scale blowup of the stereo photographs included as Figures 5 through 7. The majority of the lineaments are depicted on Figure 7 northeast of the Southern Site. The lineaments are generally *en echelon* or transverse faults, possibly representing extensional components associated with a pull-apart structure between subparallel strands of the Helendale Fault mapped by Morton et al. (1980), in addition to the main shear displacement. The majority of the lineaments were photo observed within the Earthquake Special Study Zone. One lineament was observed within the property in the northern portion of the Southern Site and within the central portion of the Northern Site, but outside of the Earthquake Special Study Zone. The buried portion of the Helendale Fault mapped by Dibblee (1960) extends within the property through the northern and northeastern portions of the Southern Site. The mapped fault strands and lineaments existing on the property will require future analyses during future fault investigations.

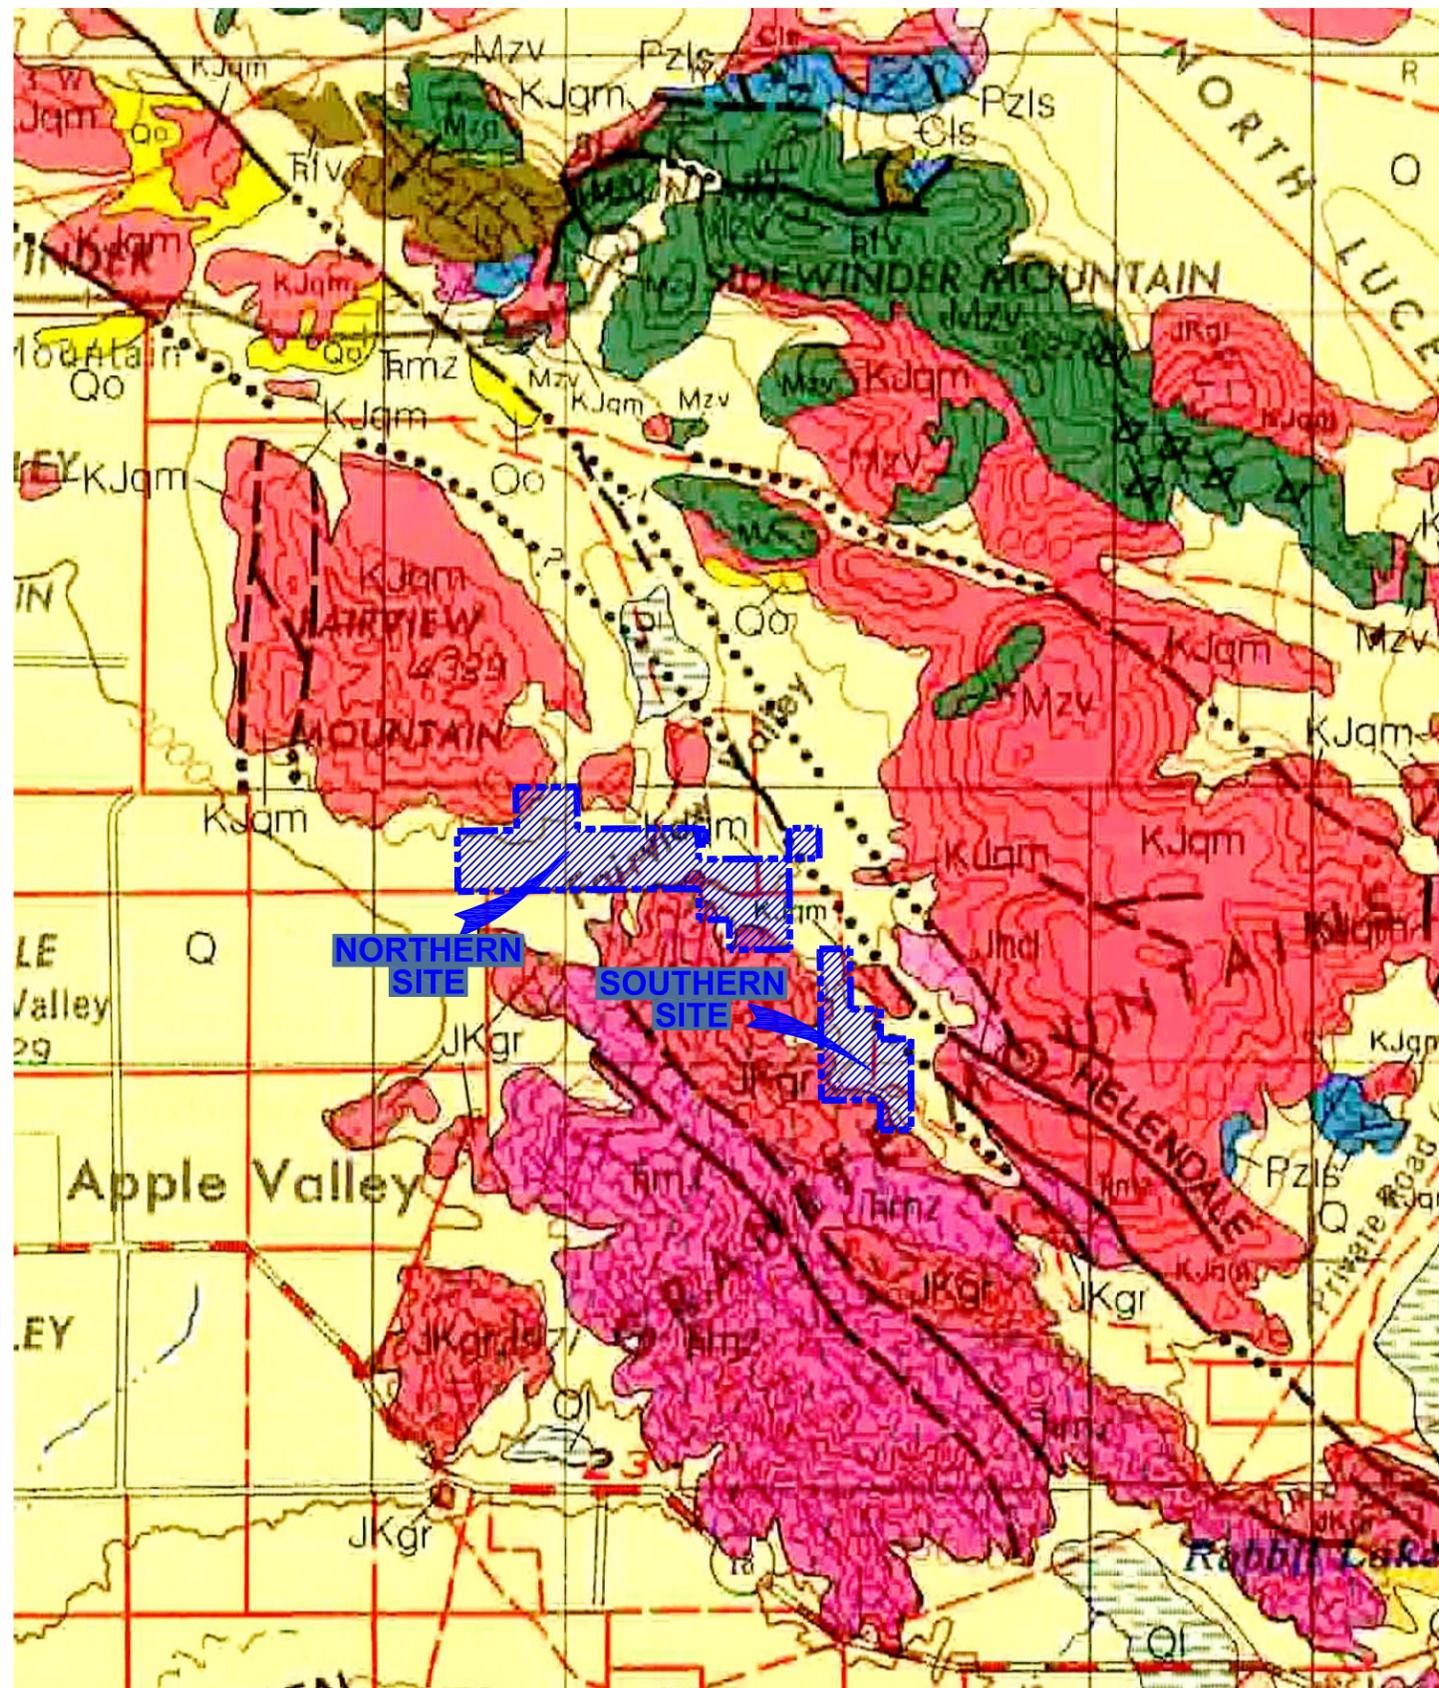
Source: GEOLOGIC MAP OF SAN BERNARDINO QUADRANGLE, CALIFORNIA
COMPILED BY E.J. BORTUGNO AND T.E. SPITTLER (Revised, 1998)

We mapped and encountered three surficial soil types and two geologic formations at the site during our investigation. The surficial units consist of wash deposits, young alluvial fan deposits and old alluvial deposits. The two geologic formations are composed of igneous granite and quartz monzonite rocks of Jurassic and Cretaceous age. The formational and surficial units are discussed below in order of increasing age. The approximate lateral extent of these units is presented on the Geologic Map, Figures 2 through 4 (map pocket). The geologic nomenclature and age of the units have been obtained from Bortugno and Spittler, 1998 as shown on the Regional Geologic Map (Figure 8).
