BIOLOGICAL RESOURCES REPORT

SLOVER AVENUE STREET WIDENING – TAMARIND AVENUE TO CEDAR AVENUE, BLOOMINGTON

San Bernardino County Department of Public Works

November 17, 2009

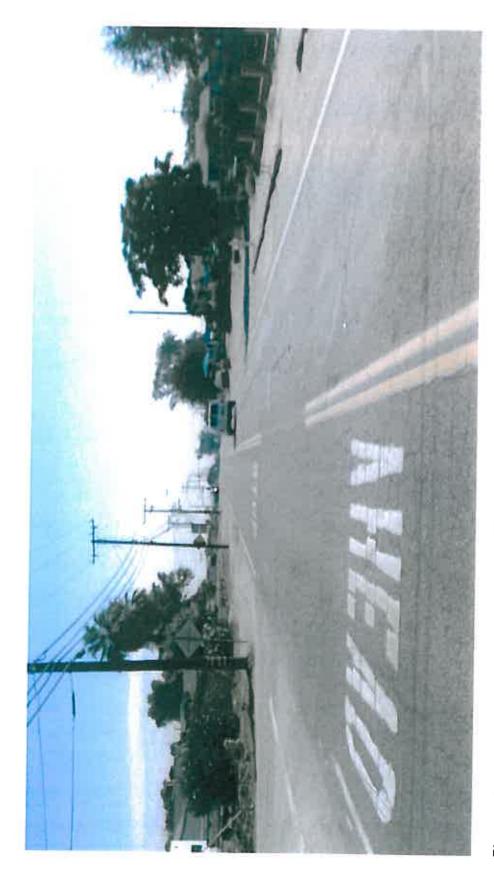
- Between Cedar Avenue and Orchard Street, only compact, bare ground with no vegetation exists on both the north and south sides (Photograph 1);
- Between Valencia Street and Linden Avenue, the north side has one (1) Canary Island date palm tree (*Phoenix canariensis*), a tree of heaven tree (*Ailanthus altissima*), and two (2) Mexican fan palm trees (*Washingtonia robusta*), while on the south side there is

Photograph 1. Slover Avenue between Cedar Avenue (top) and Orchard Street (bottom) facing in an eastern direction.

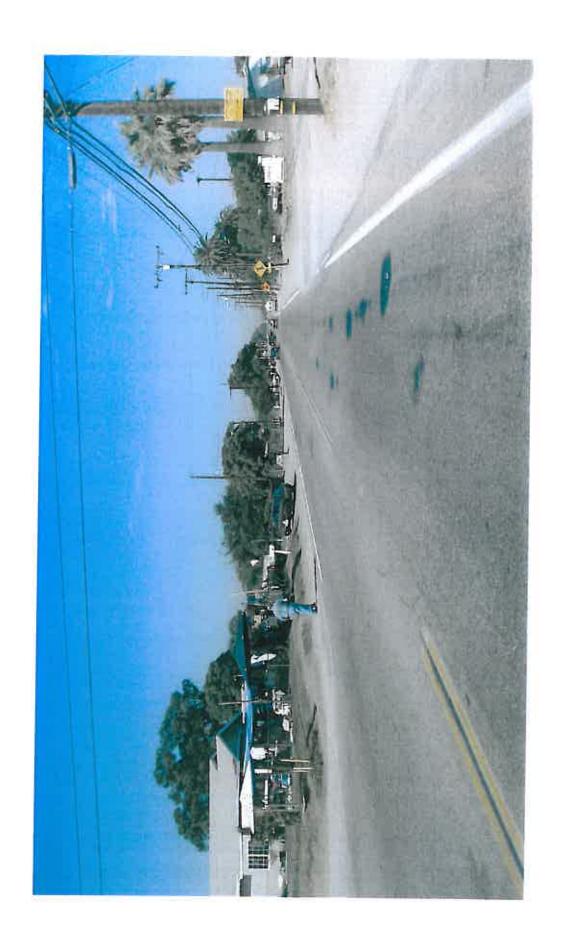
primarily asphalt with small areas of compact bare ground and no vegetation (Photograph 2);

Photograph 2. Slover Avenue between Valencia Street (bottom) and Linden Street (top) facing in a western direction.

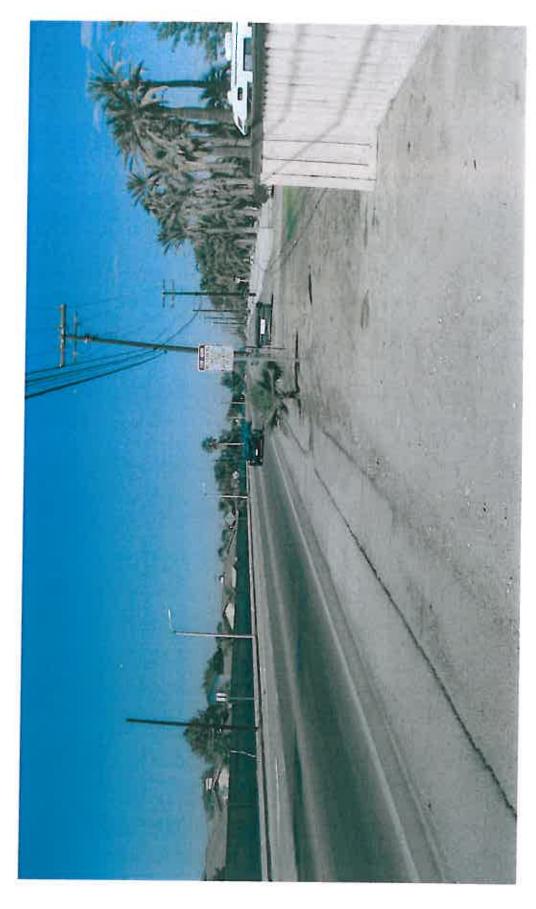
- Between Linden Avenue and Maple Avenue, the north side is professionally landscaped with a variety of different palm tree species, whereas the southern portion has an already existing sidewalk intermixed with open areas of compact soil and no existing vegetation (Photograph 3);

Photograph 3. The photograph was taken at the Slover Avenue and Linden Avenue Intersection on the north side of Slover Avenue facing west. For reference, Maple Avenue is at the top of the photograph.

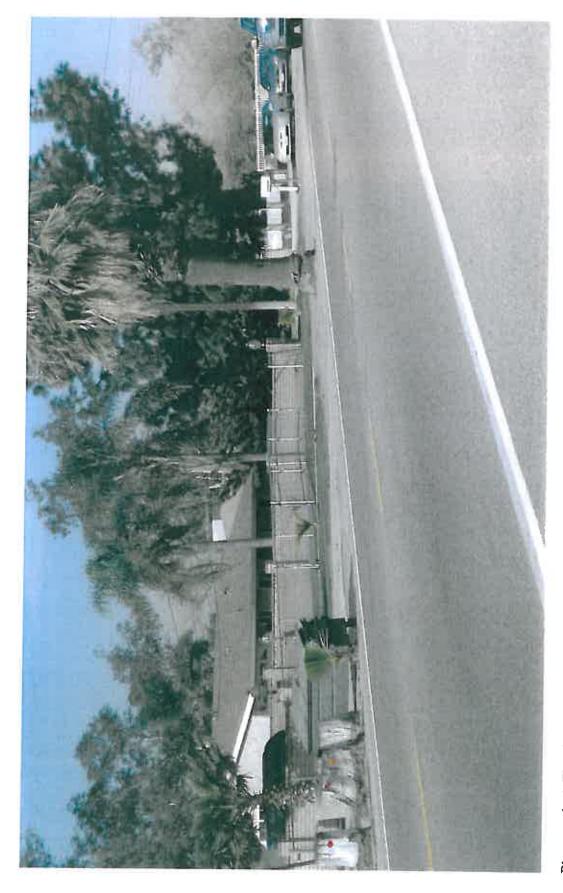
- Between Maple Avenue and Locust Avenue, the south side contains one (1) mature (~30 feet) and approximately ten (10) immature (< 5 feet) Mexican fan palm trees that are adjacent to residential housing (Photograph 4), while the north side consists of manicured landscaping with red fountain grass (Pennisetum setaceum rubrum) and Brazilian pepper trees (Schinus terebinthifolius) (Photograph 5);

Photograph 4. The photograph was taken facing west of the Slover Avenue and Maple Avenue Intersection. For reference, the upper portion of the photograph is the south side of Slover Avenue just west of Maple Avenue.

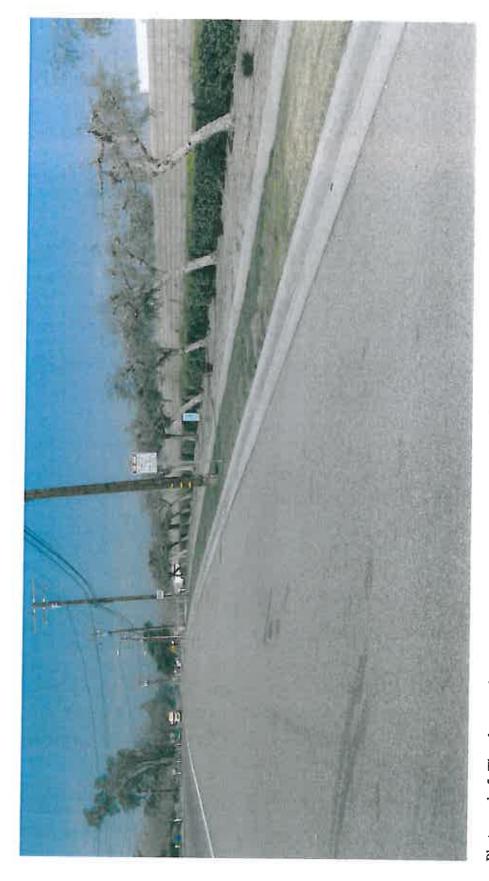
Photograph 5. The photograph was taken at the Slover Avenue and Maple Avenue Intersection on the north side of Slover Avenue facing west. For reference, Locust Avenue is at the top of the photograph.

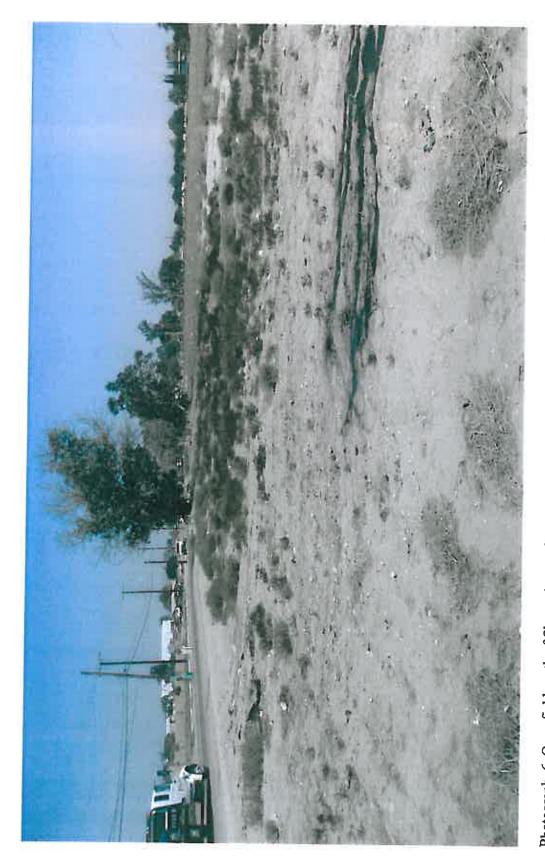
- Between Locust Avenue and Laurel Avenue, an open field occurs (Photograph 6) immediately south of the widening project. Within the proposed right-of-way, approximately fifteen (15) eucalyptus trees (*Eucalyptus* spp), along with a Mexican fan palm tree, tree of heaven, and Russian thistle (*Salsola kali*) are present along the south side (Photograph 7), while to the north, compact, bare ground abuts rural, residential housing (Photograph 8);

Photograph 6. Open field south of Slover Avenue between Laurel Avenue (west) and Locust Avenue (east).

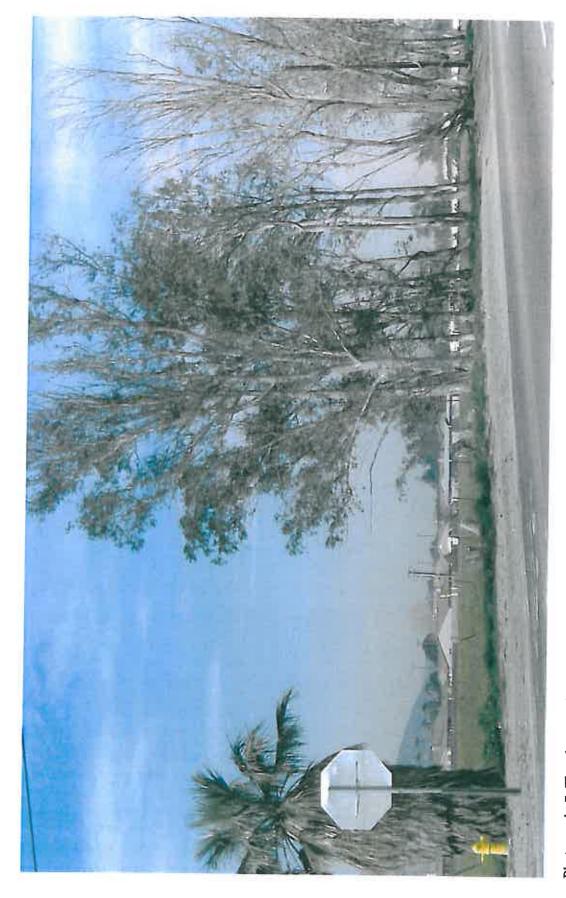
Photograph 7. The photograph was taken at the Slover Avenue and Locust Avenue Intersection on the south side of Slover Avenue facing west. For reference, Locust Avenue is at the bottom of the photograph.

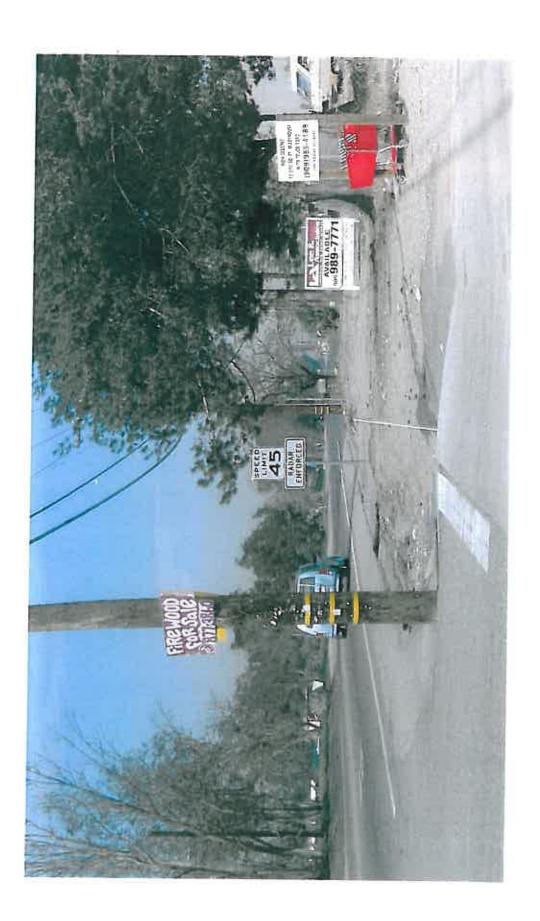
Photograph 8. The photograph was taken at the Slover Avenue and Locust Avenue Intersection on the north side of Slover Avenue facing west. For reference, Locust Avenue is at the bottom of the photograph.

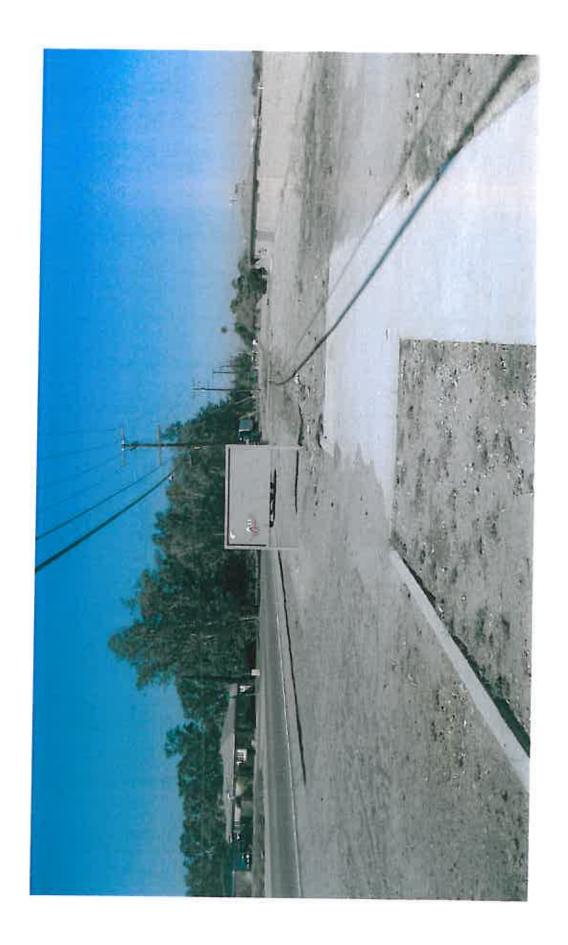
- Between Laurel Avenue and Alder Avenue, a row of approximately twenty (20) eucalyptus trees exists to the south (Photograph 9), where a narrow stretch of open, compact bare ground and no vegetation exists on the northern portion (Photograph 10); and

Photograph 10. The photograph was taken at the Slover Avenue and Laurel Avenue Intersection on the north side of Slover Avenue facing west.

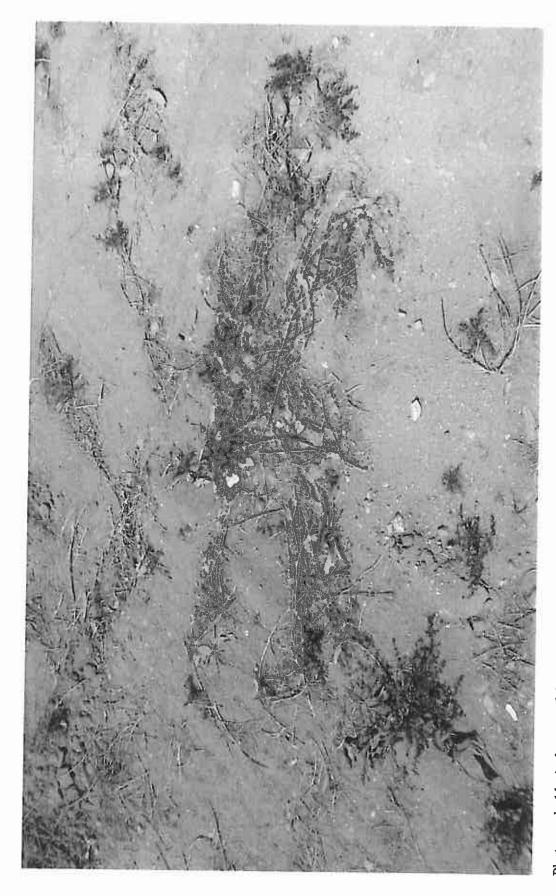
"The specific project site is highly disturbed and native soils have been mixed with non-native soils and compacted. Therefore, based on the current habitat conditions, I believe the proposed street-widening project will not result in take of the DSF."

Photograph 11. A close up of the soil composition contained within the open field that is immediately south of Slover Avenue between Laurel Avenue and Locust Avenue.
