APPENDIX D
Subject Property Photographs

Sunray Solar Site

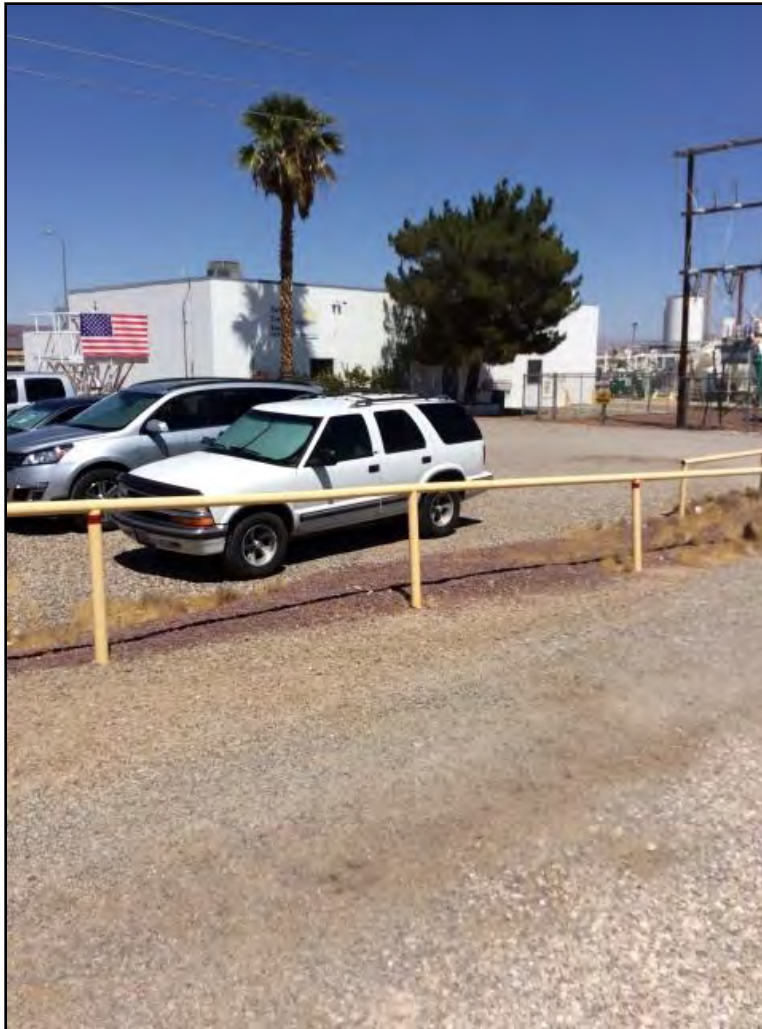
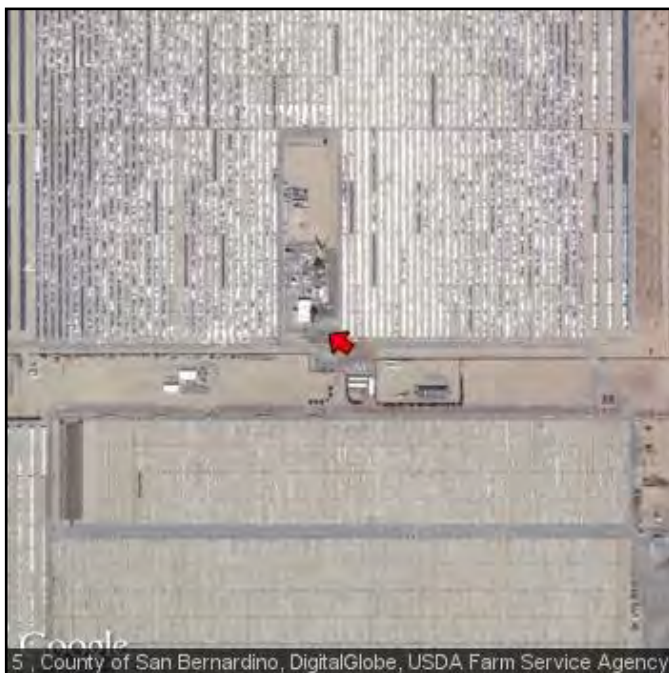
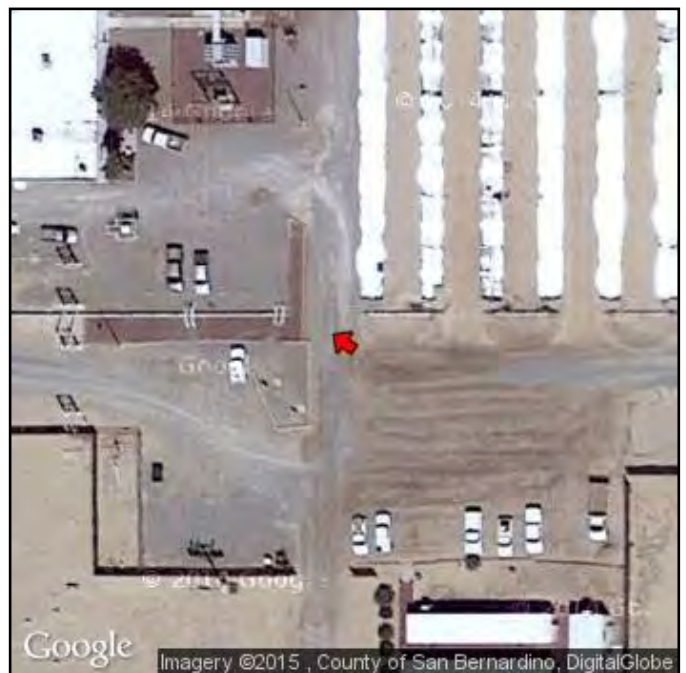
Photo ID: 1

Attributes	
Comments	Main office at SEGs 1 powerblock
Photo ID	1

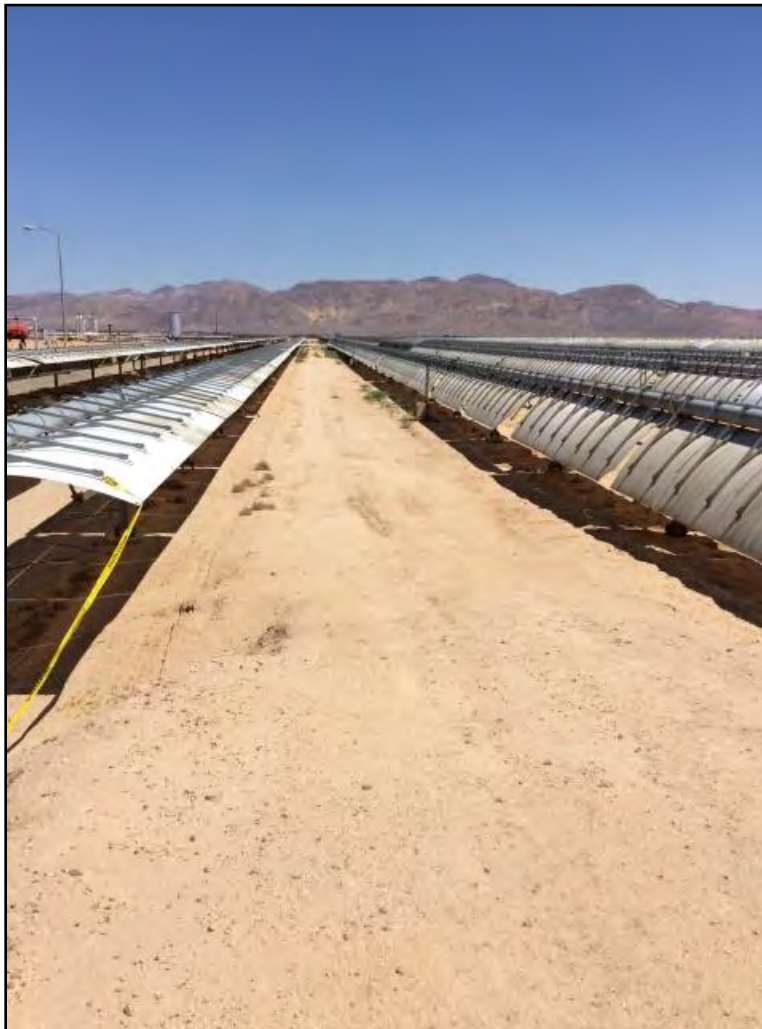
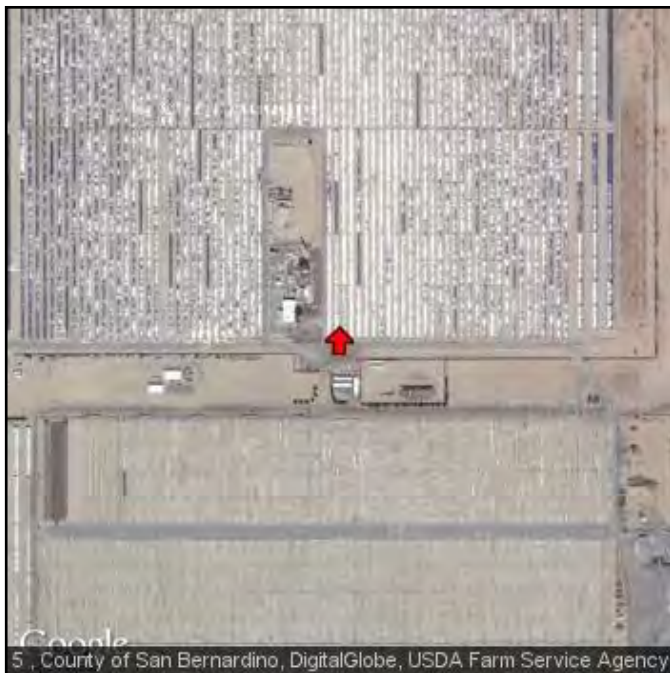
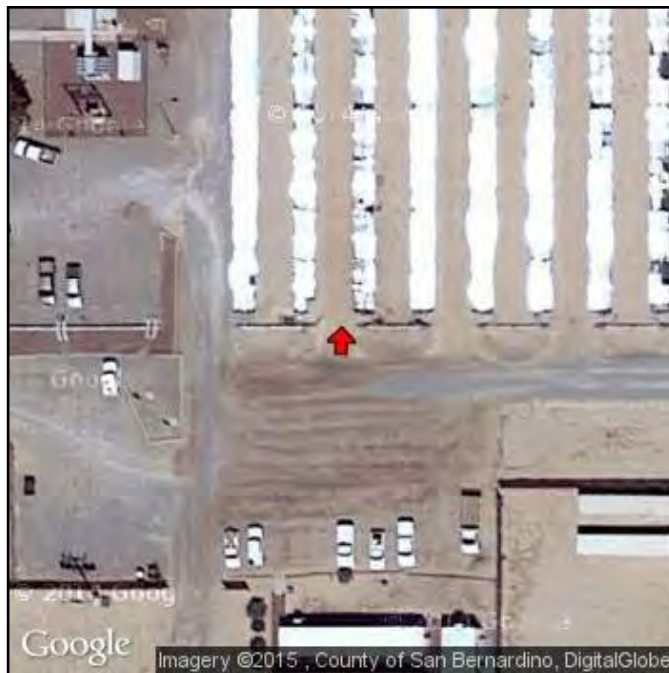
Attributes	
Comments	Location of boring S-4
Photo ID	2

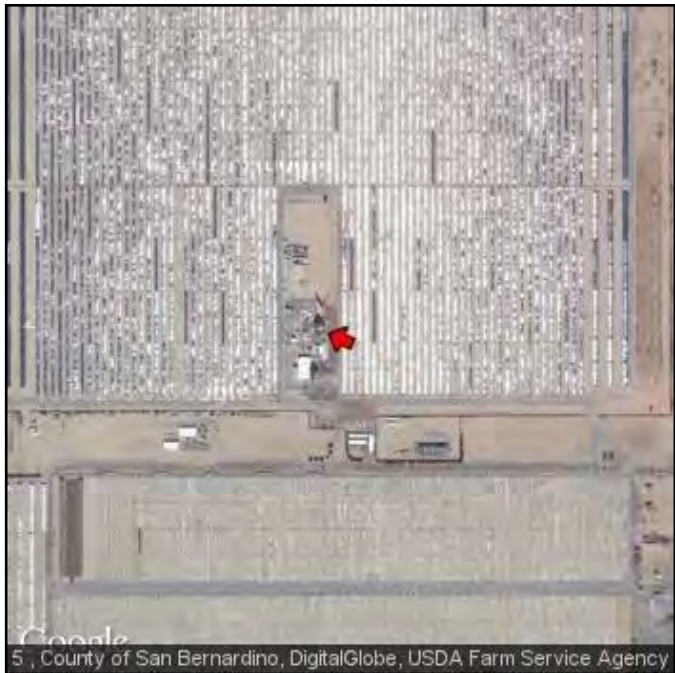
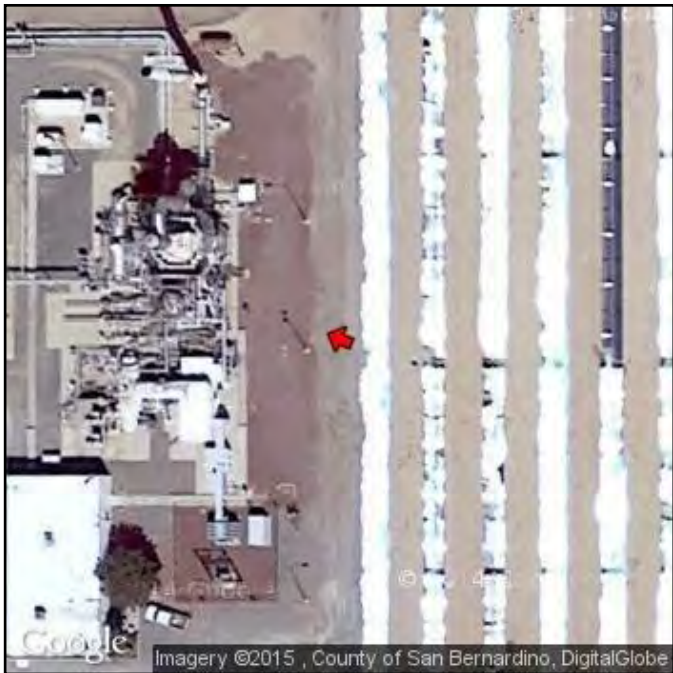
Attributes	
Comments	SEGS 1powerblock
Photo ID	3

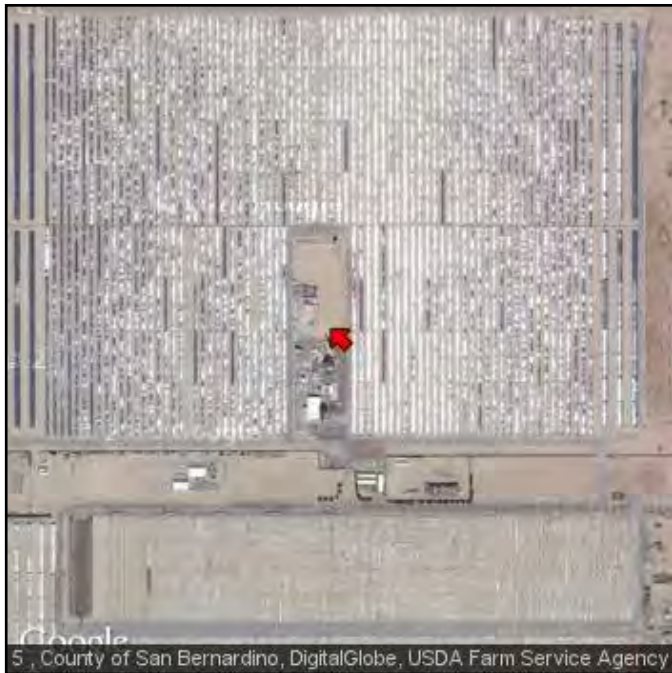
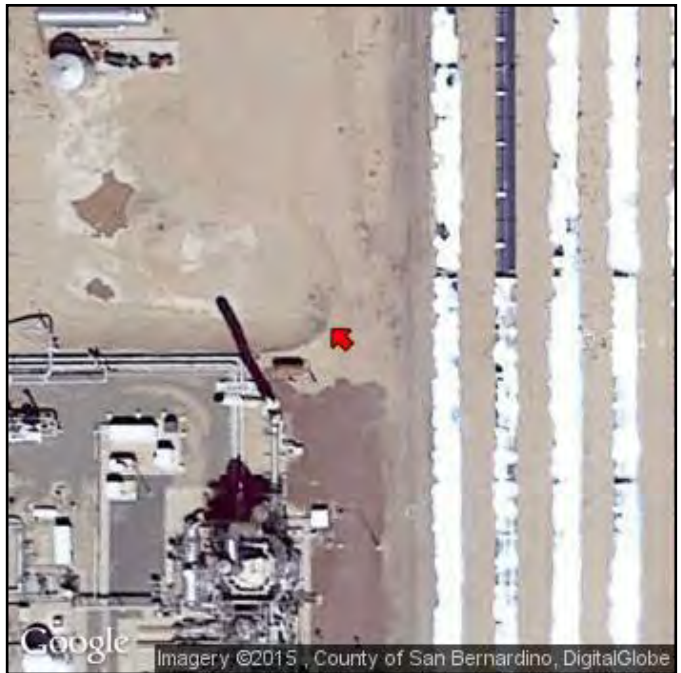
Attributes	
Comments	Caloria tanks in SEGs 1. Also, location of fire pit.
Photo ID	4

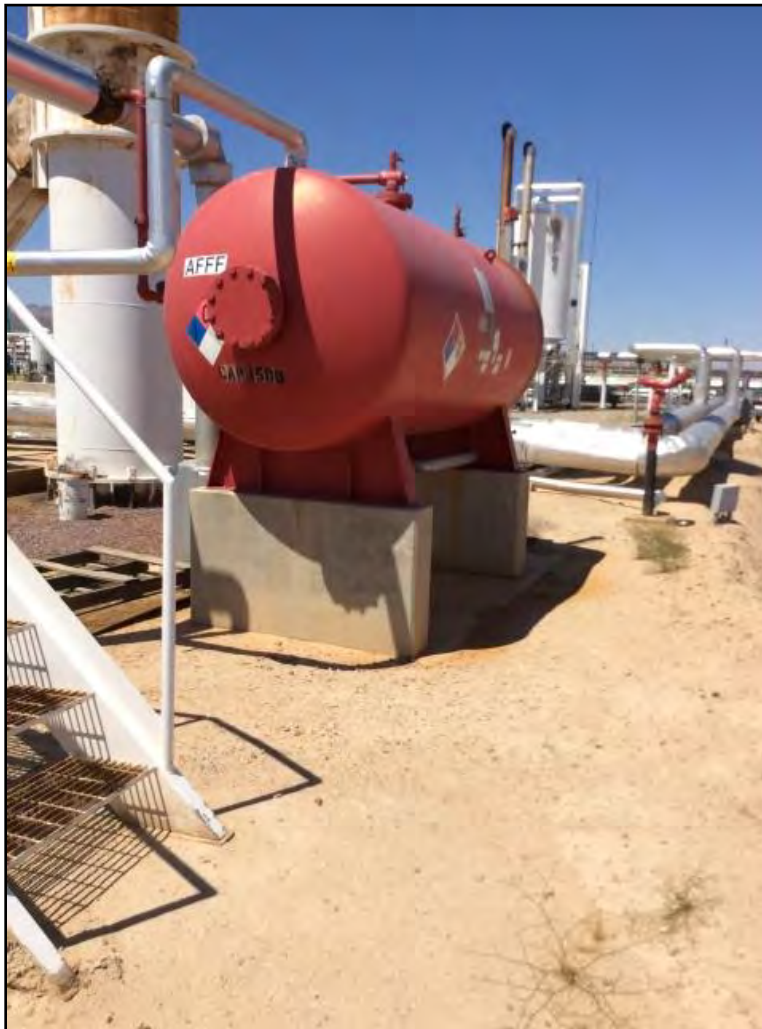
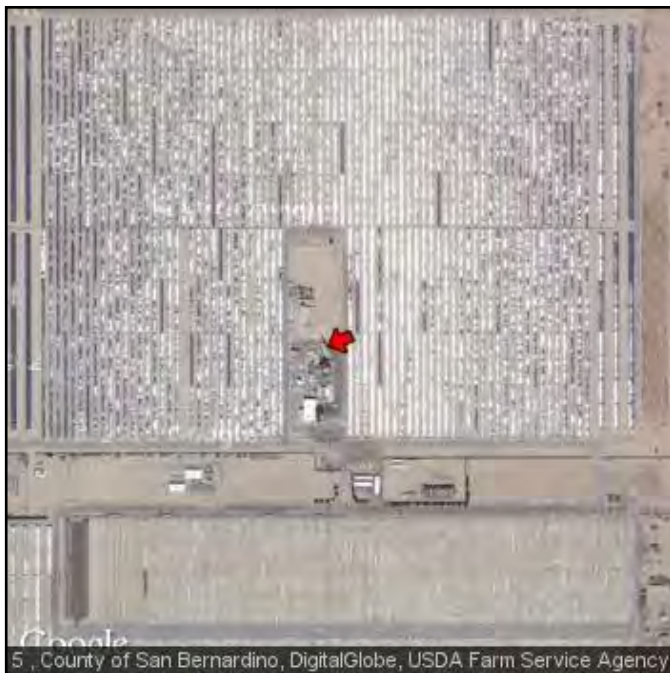
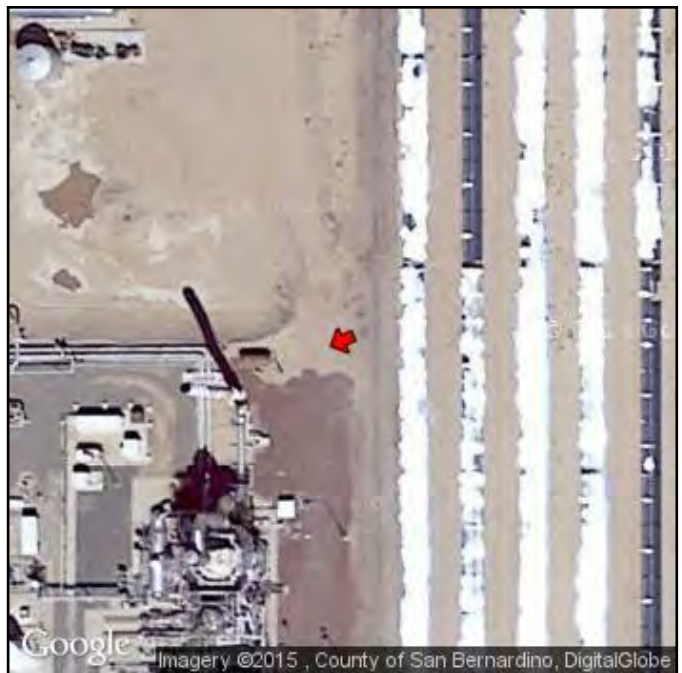
Attributes	
Comments	Firefighting foam AST
Photo ID	5

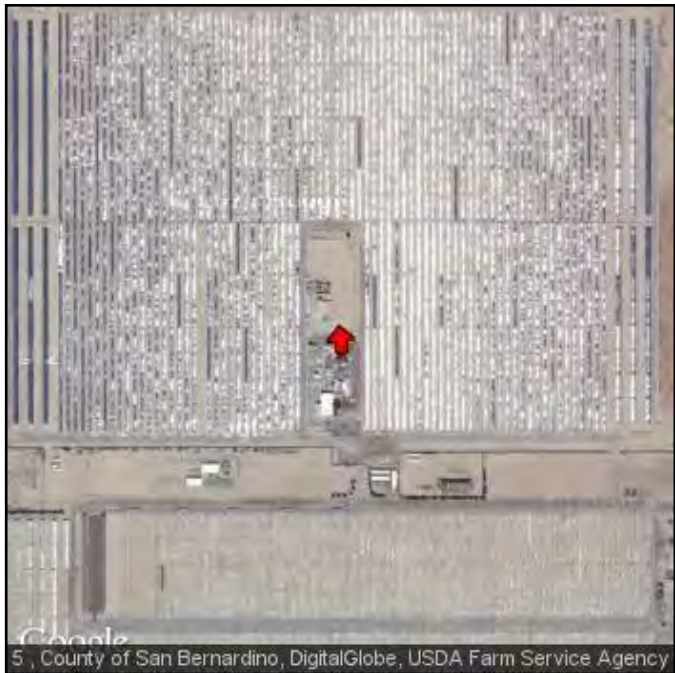
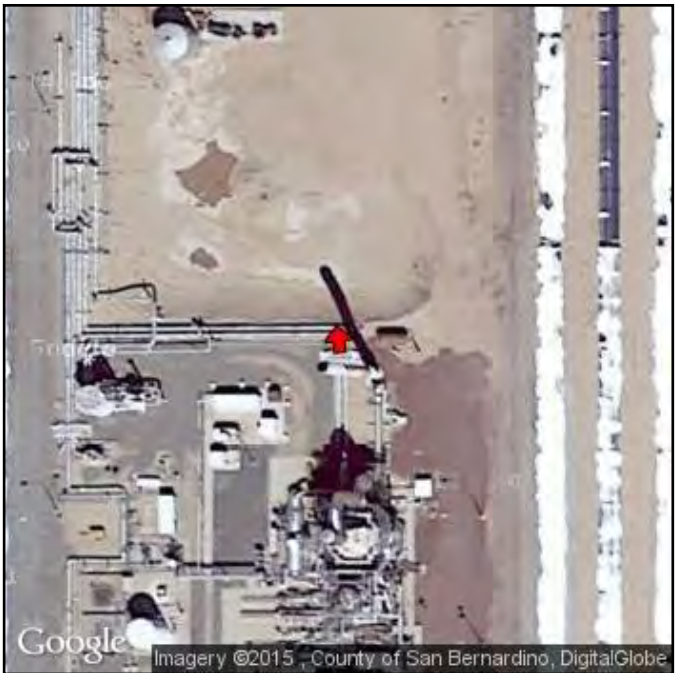
Attributes	
Comments	Caloria ASTs in fire pit area at SEGs
Photo ID	6

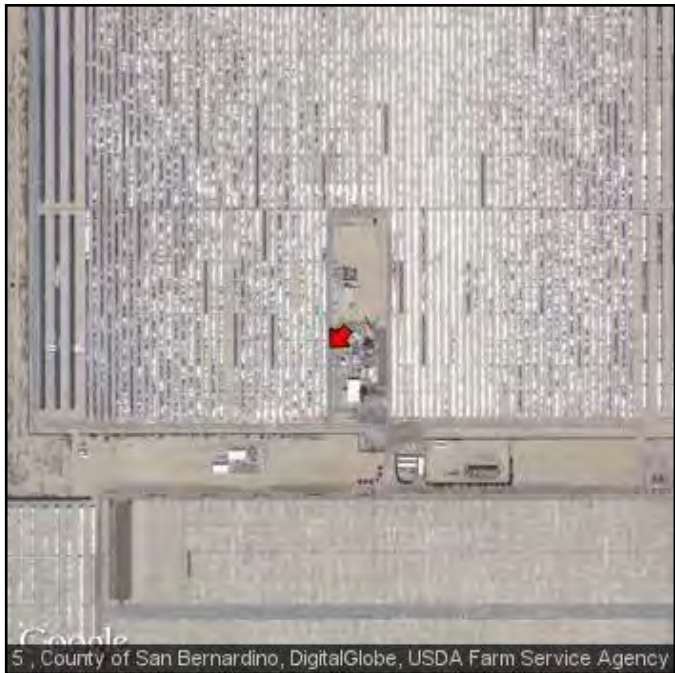
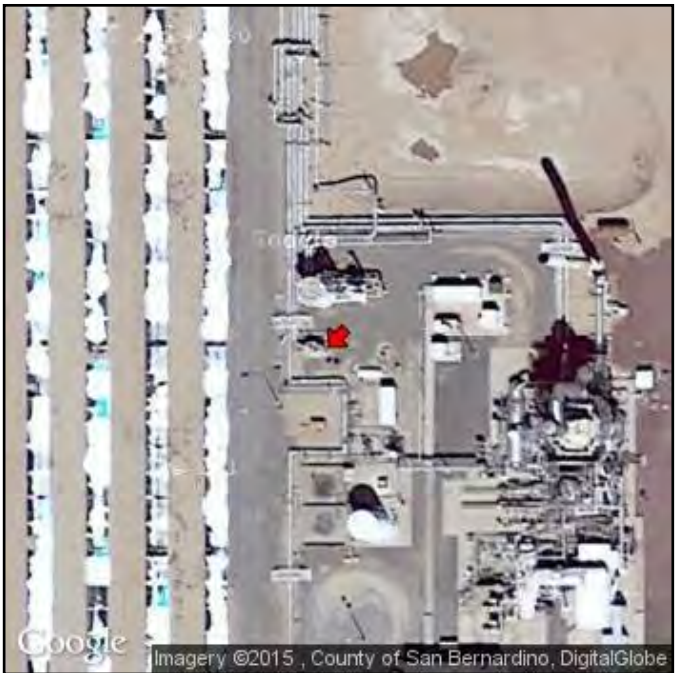
Photo ID: 7

Attributes	
Comments	Boring location S-1 HTF line at SEGs 1 powerblock
Photo ID	7

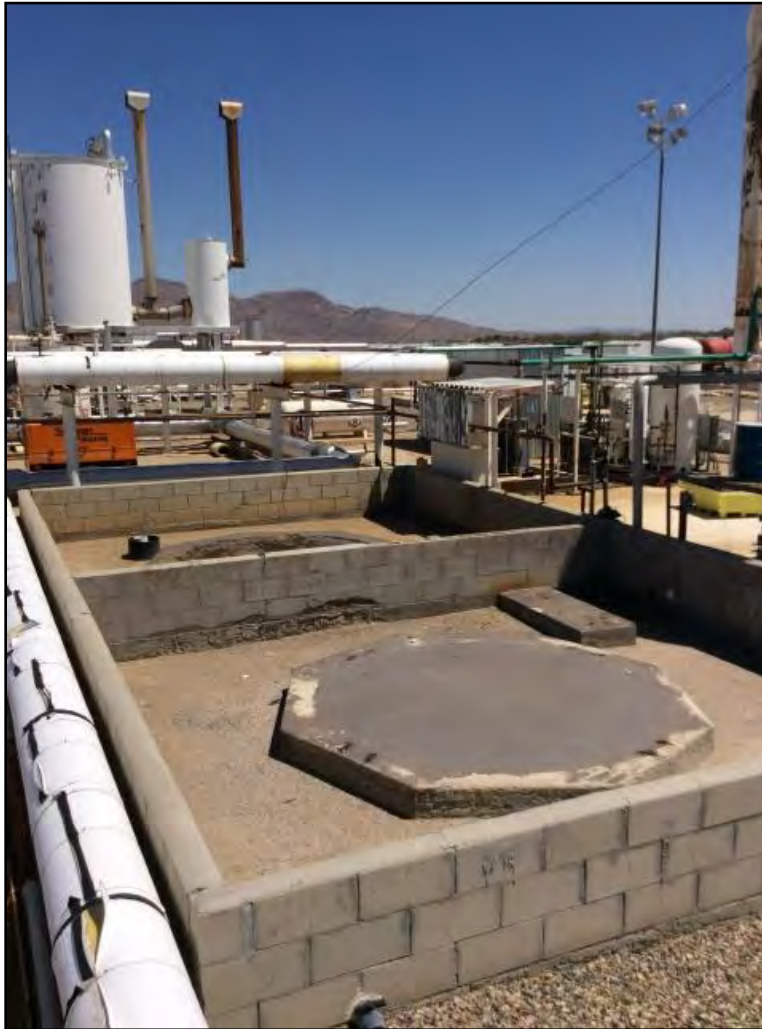
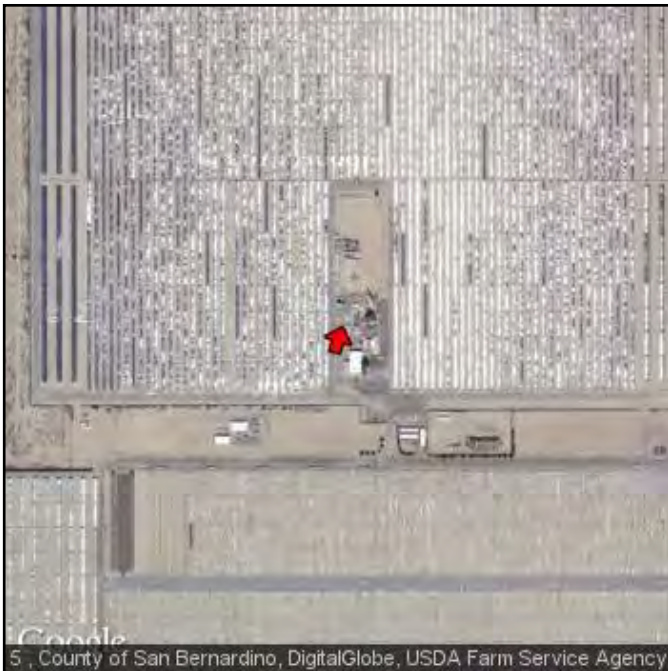
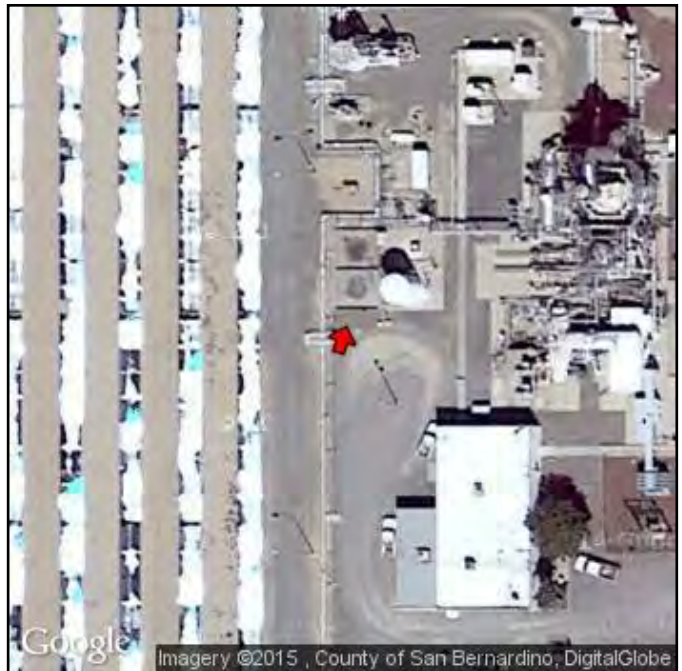
Attributes	
Comments	ASTs containing caustics for water treatment were removed in 2010 at SEGs 1 powerblock area.
Photo ID	8

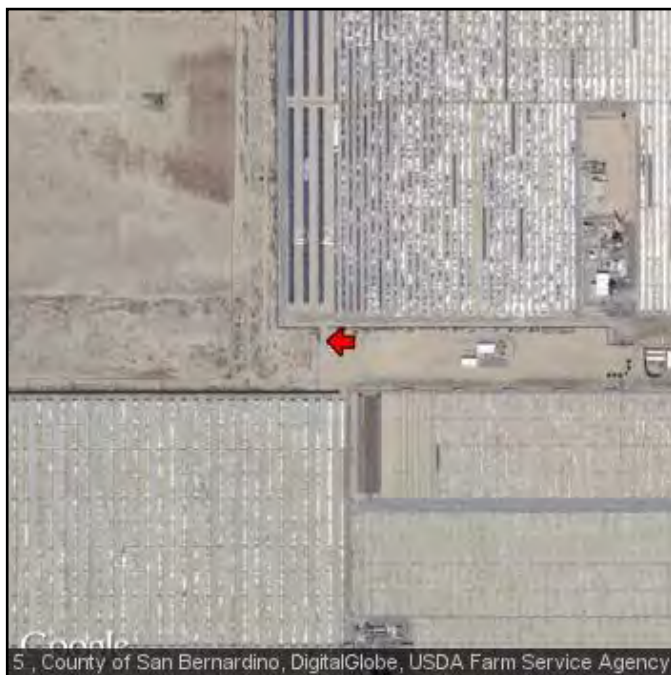
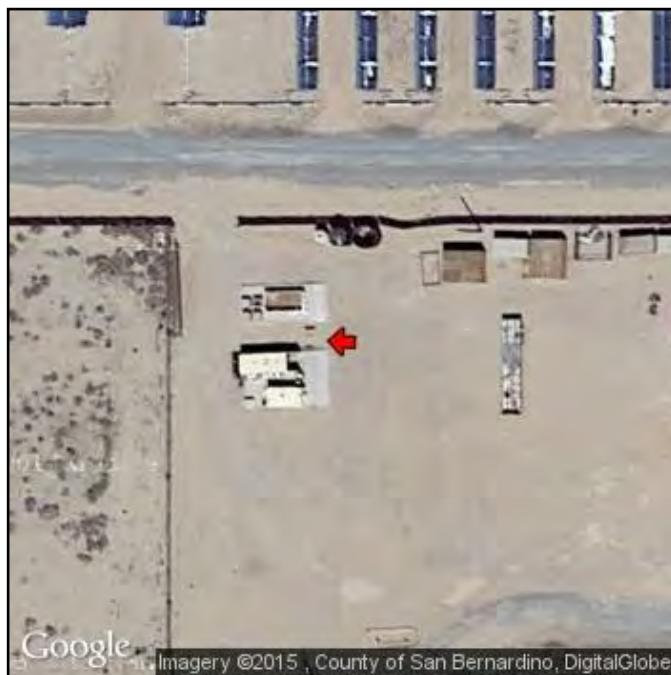
Attributes	
Comments	Hazardous waste storage containers.
Photo ID	9

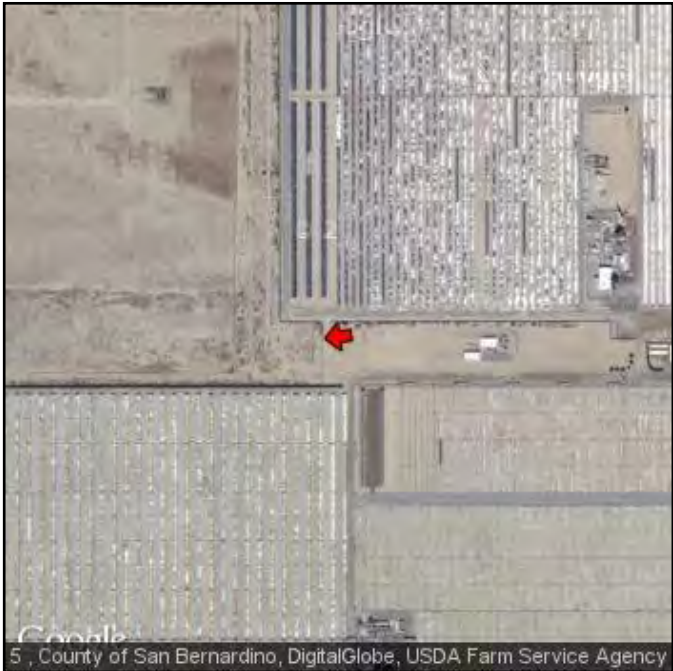
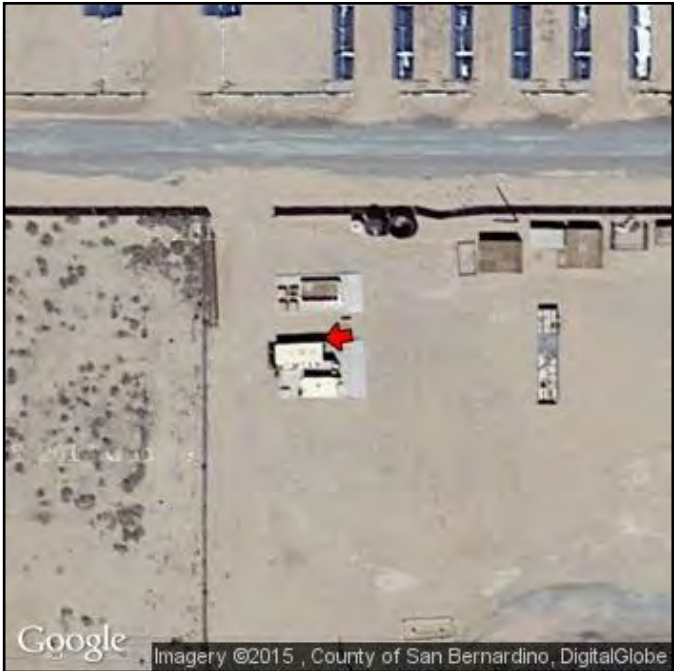
Attributes	
Comments	Drip pans, oil residues drums, in hazardous waste storage container
Photo ID	10

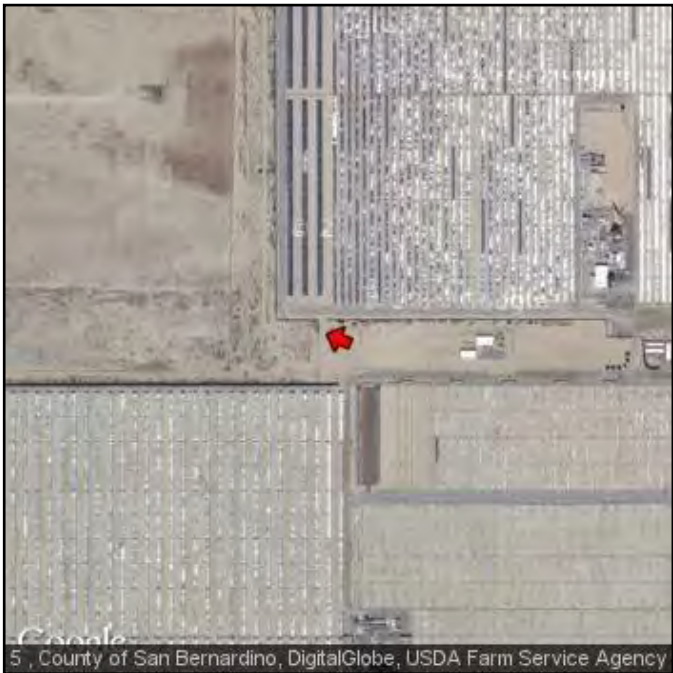
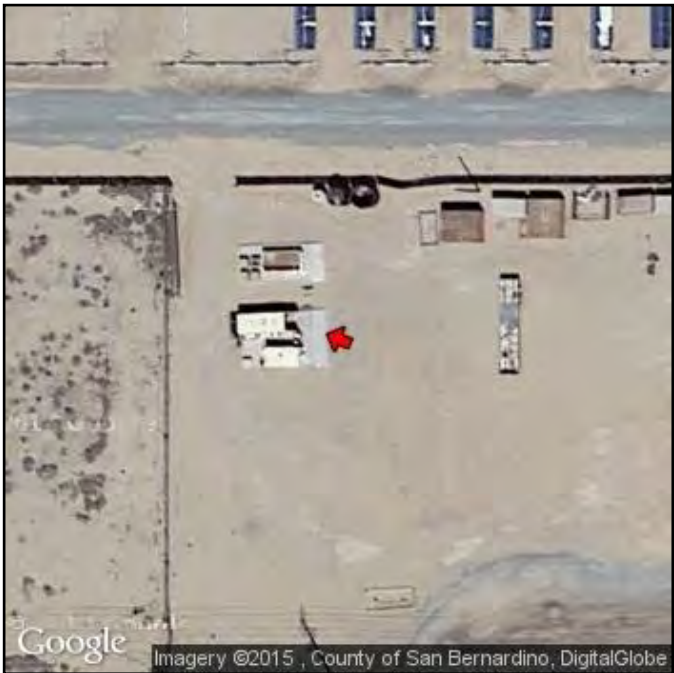
Attributes	
Comments	Drums in hazarous waste storage area
Photo ID	11

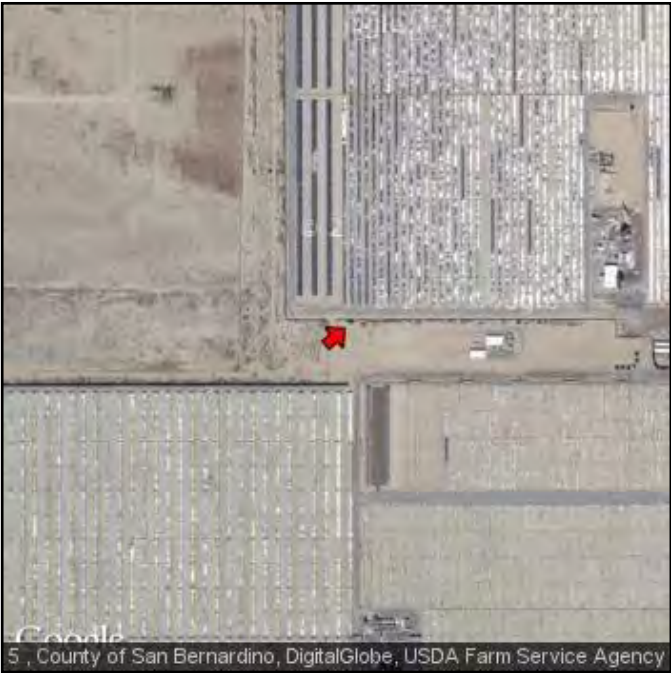
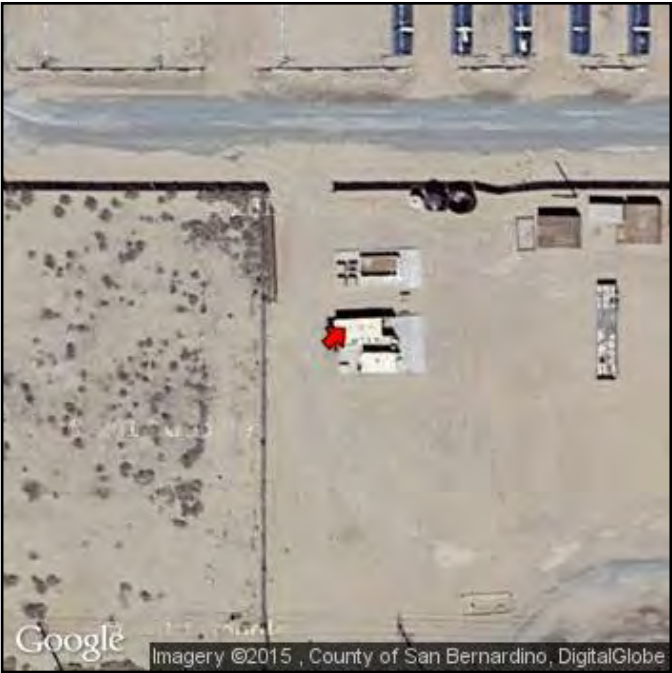
Attributes	
Comments	Hazardous waste area. Note battery storage in yellow container. No leaks or spills observed on drip/spill pads. Cracks have been recently sealed.
Photo ID	12

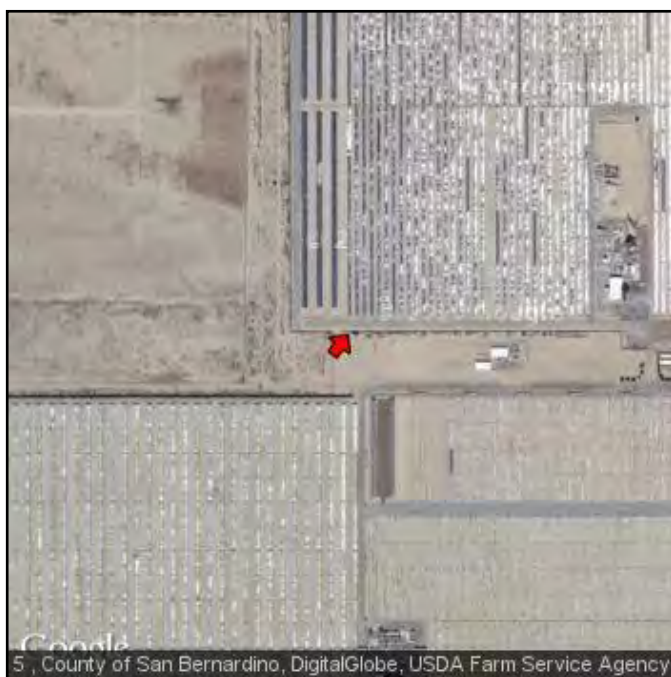
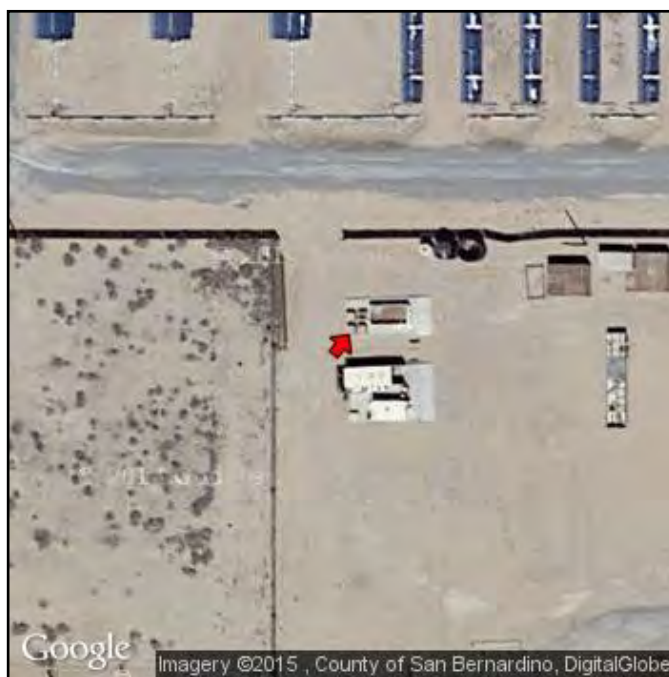
Photo ID: 13

Attributes	
Comments	Storage of mirror glass. The mirror glass has a coating that contains lead. The glass is considered hazadous waste because of TCLP testing above the 5 mg/L limit.
Photo ID	13

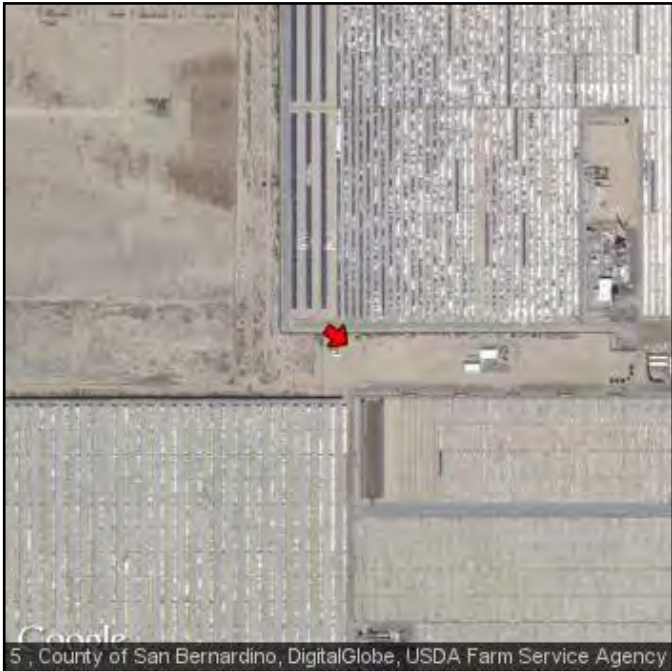
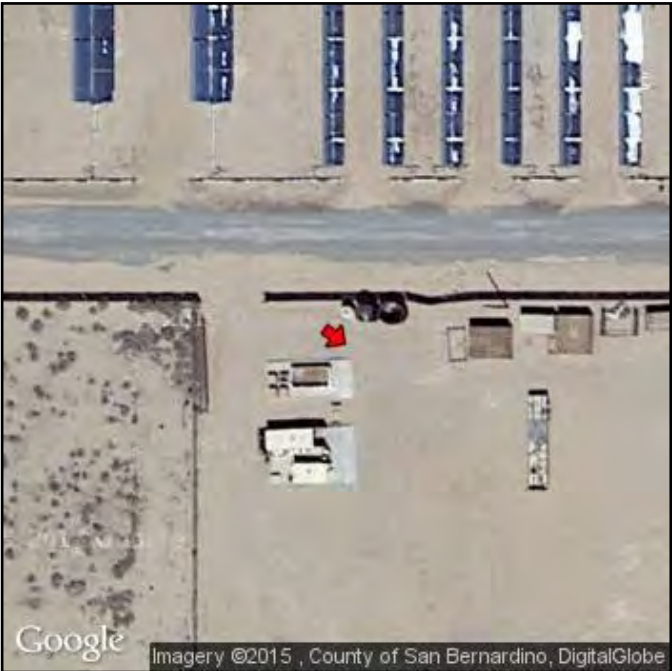
Attributes	
Comments	The olive green and faded olive green mirror glass contains the lead that tests above the limits. The white coating does not contain lead.
Photo ID	14

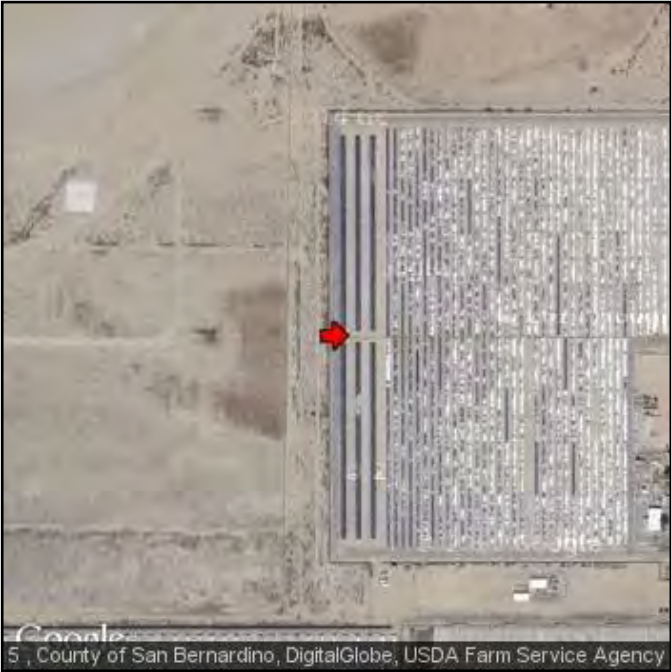
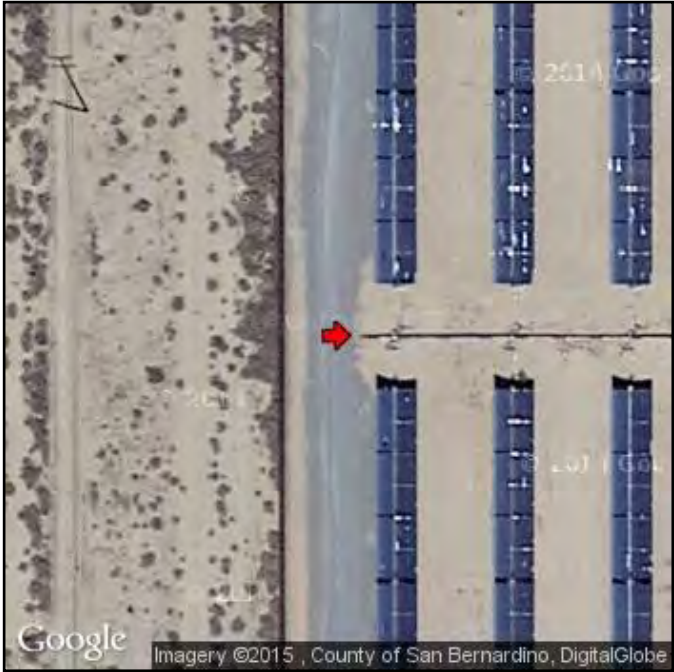
Attributes	
Comments	Header lines at SEGs 1 array field that contains or contained caloria. The SEGs 1 field is no longer in operation. They are currently purging the oil out of the lines with a evacuation pump and storing the oil for recycling in the ASTs located in the fire pit area.
Photo ID	15

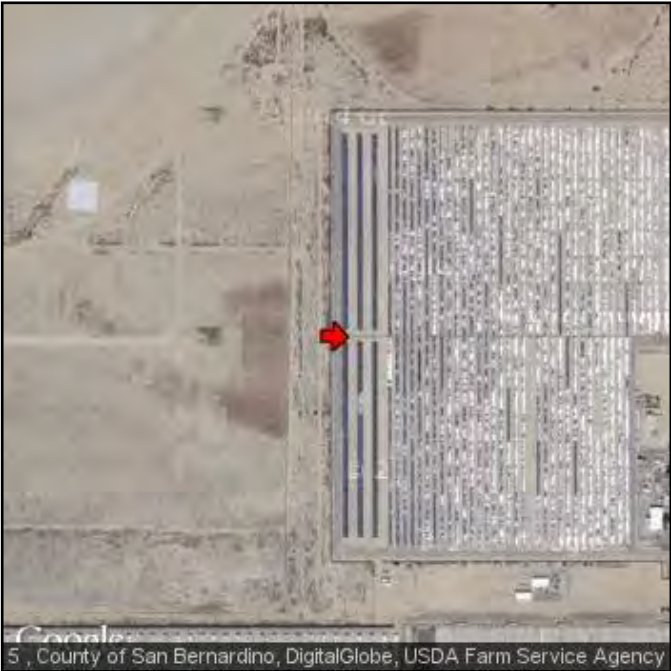
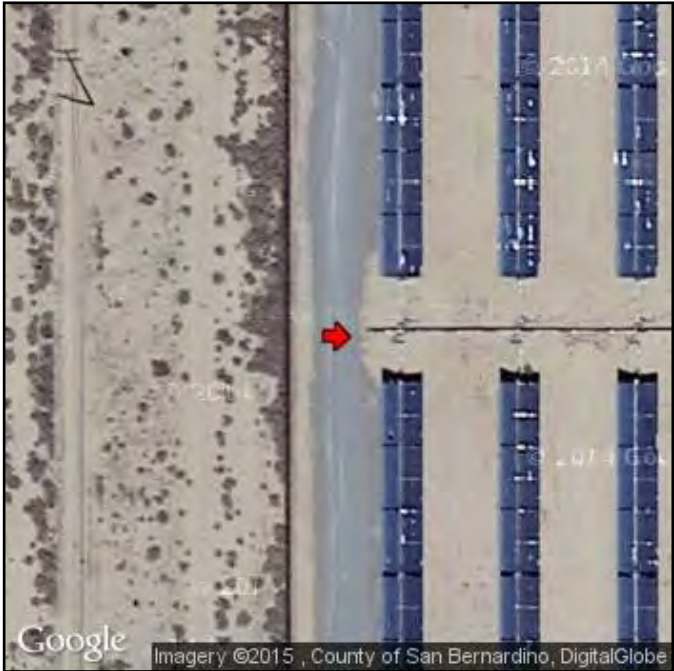
Attributes	
Comments	Note different mirror panels in SEGs 1 array field. White panels do not have lead-based coatings.
Photo ID	16

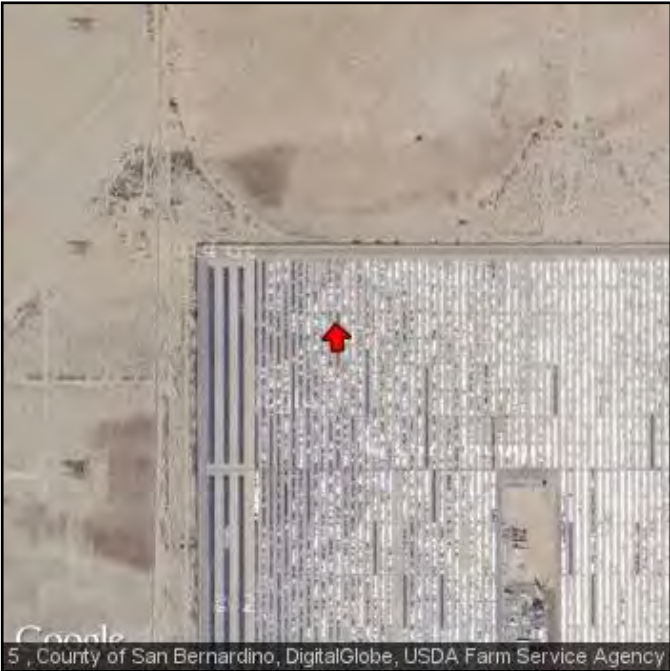
Photo ID: 17

Attributes	
Comments	Active remediation near boring location P-1
Photo ID	17

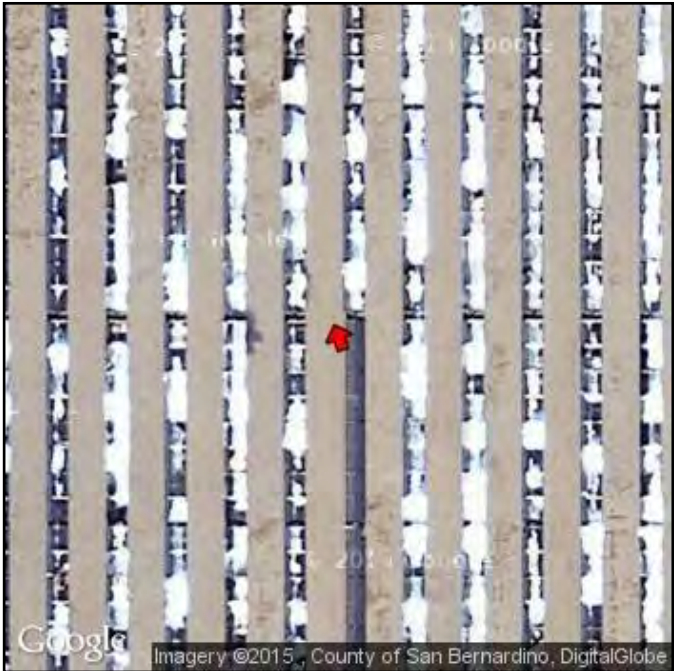
Attributes	
Comments	Active remediation near row 16A at double flex hose near boring P-1
Photo ID	18

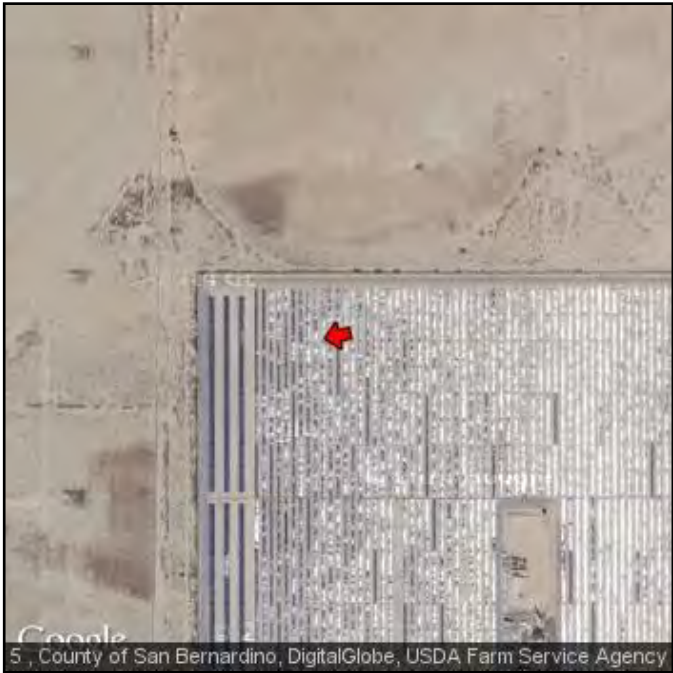
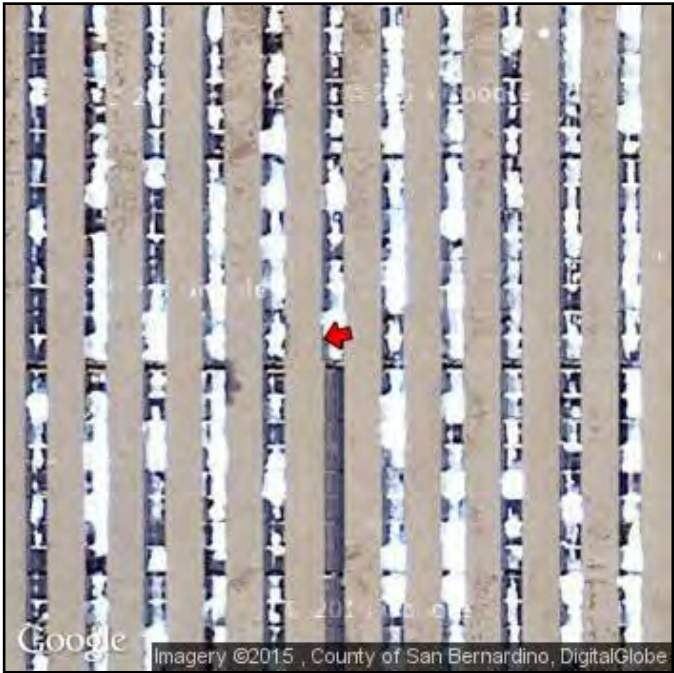
Attributes	
Comments	Double flex hose is were leaks commonly occur
Photo ID	19

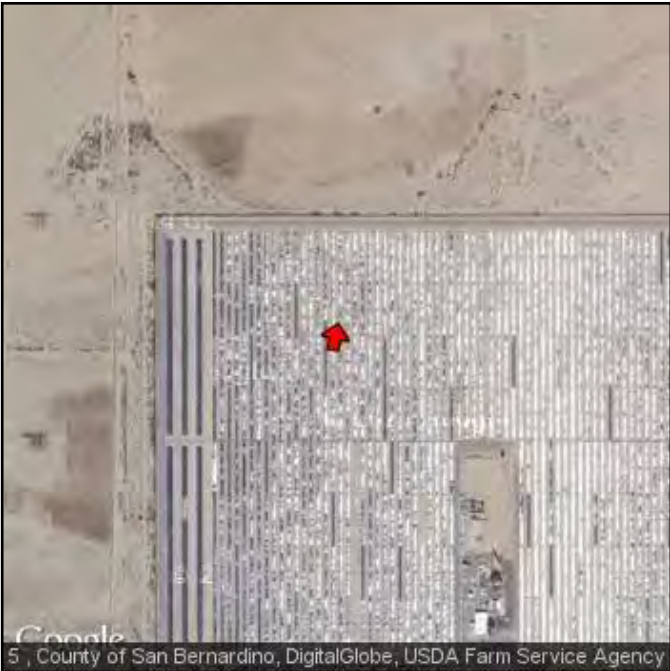
Attributes	
Comments	Spill cleanup at 22C in progress
Photo ID	20

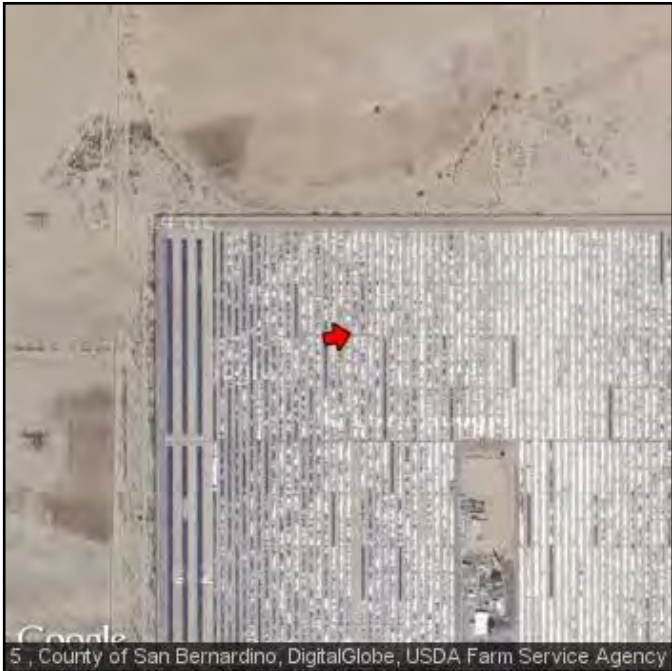
Attributes	
Comments	Spill cleanup at 23B/C completed.
Photo ID	21

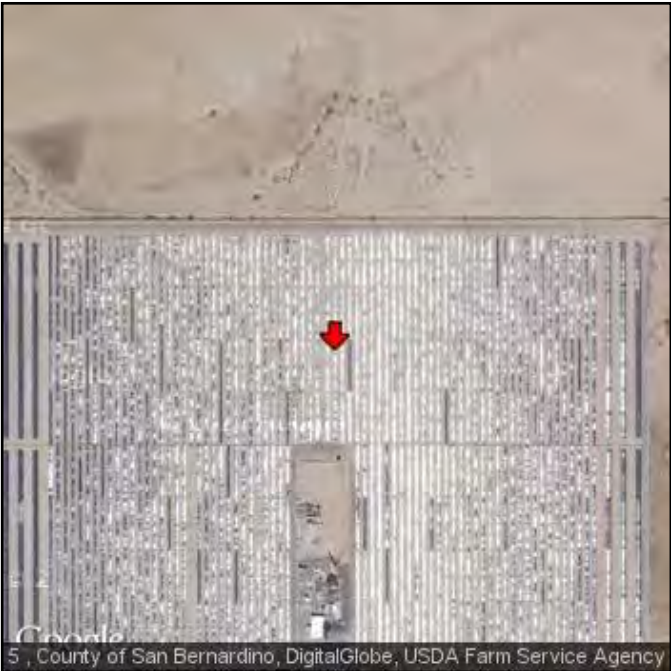
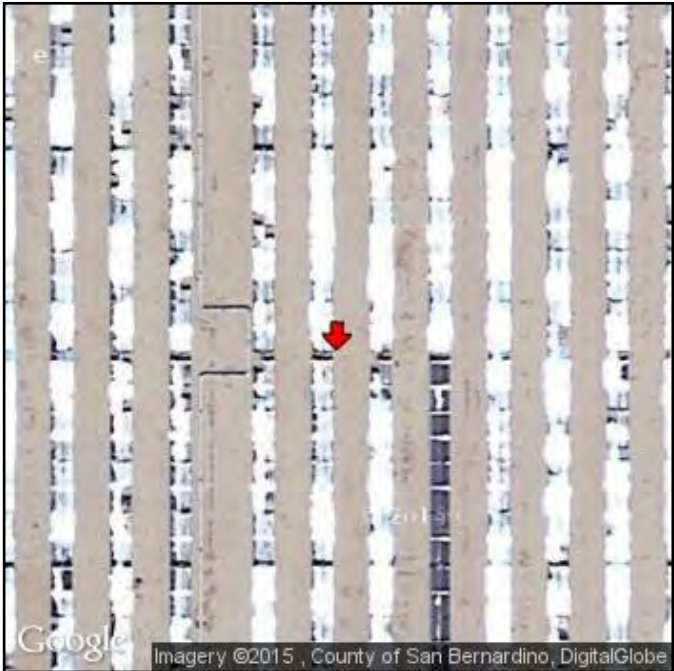
Attributes	
Comments	Boring P-18 location and view of north side of Powerblock 1 in SEGS 1 array field
Photo ID	22

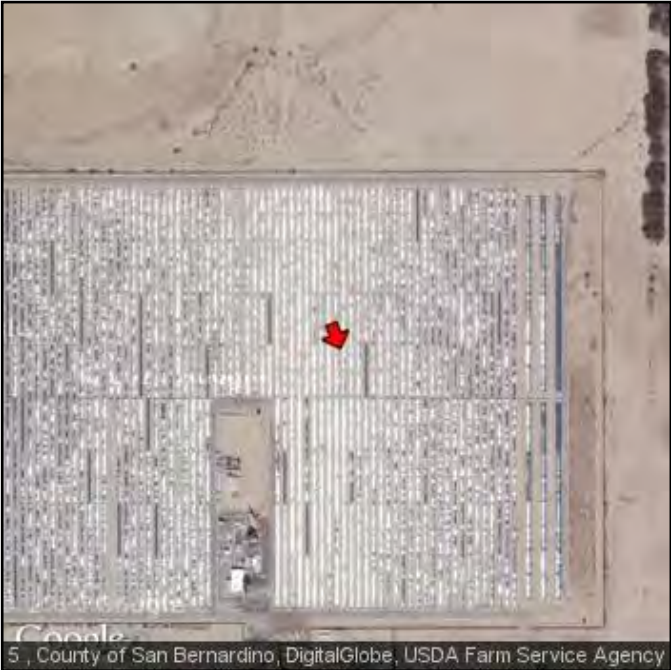
Attributes	
Comments	Excavation remediation at leak from double flex hose - rows 55 and 56C/D
Photo ID	23

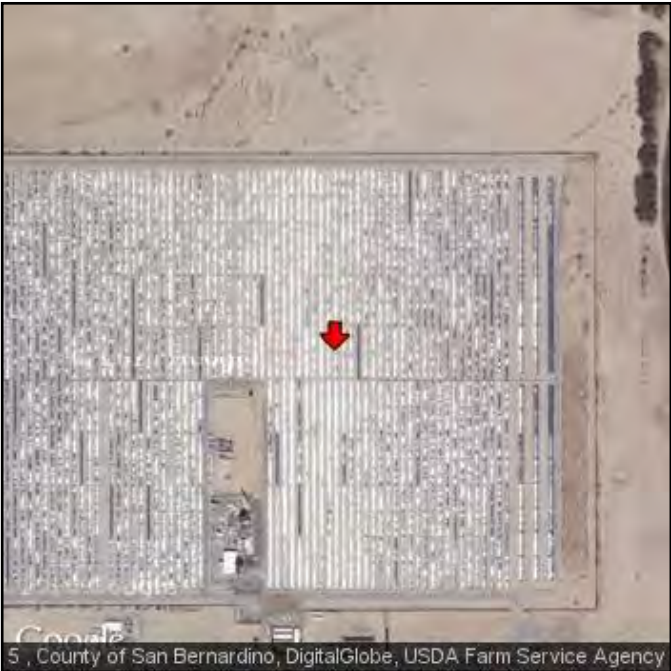
Attributes	
Comments	Concrete piling for array structure. Note contaminated soil around concrete.
Photo ID	24

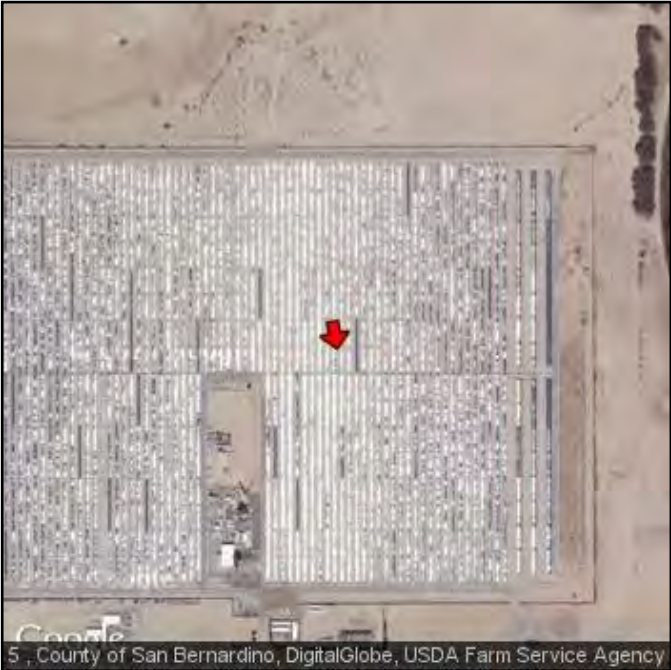
Attributes	
Comments	Caloria contaminated soils on concrete piling.
Photo ID	25
