APPENDIX D
Subject Property Photographs

Sunray Solar Site

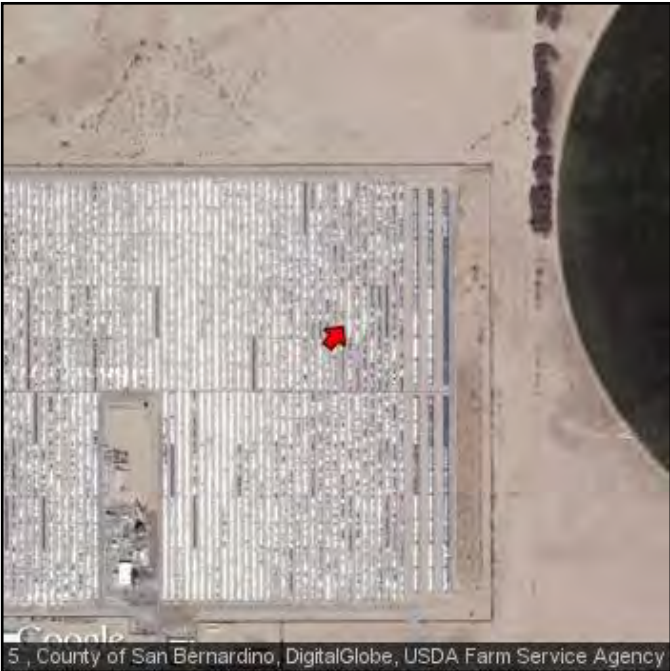
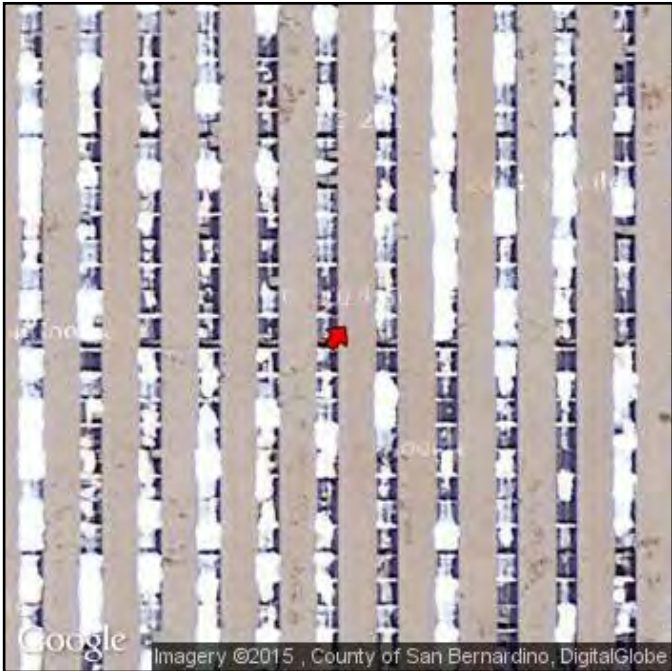
Attributes	
Comments	Note deminimus spills in row 70/71 array C.
Photo ID	26

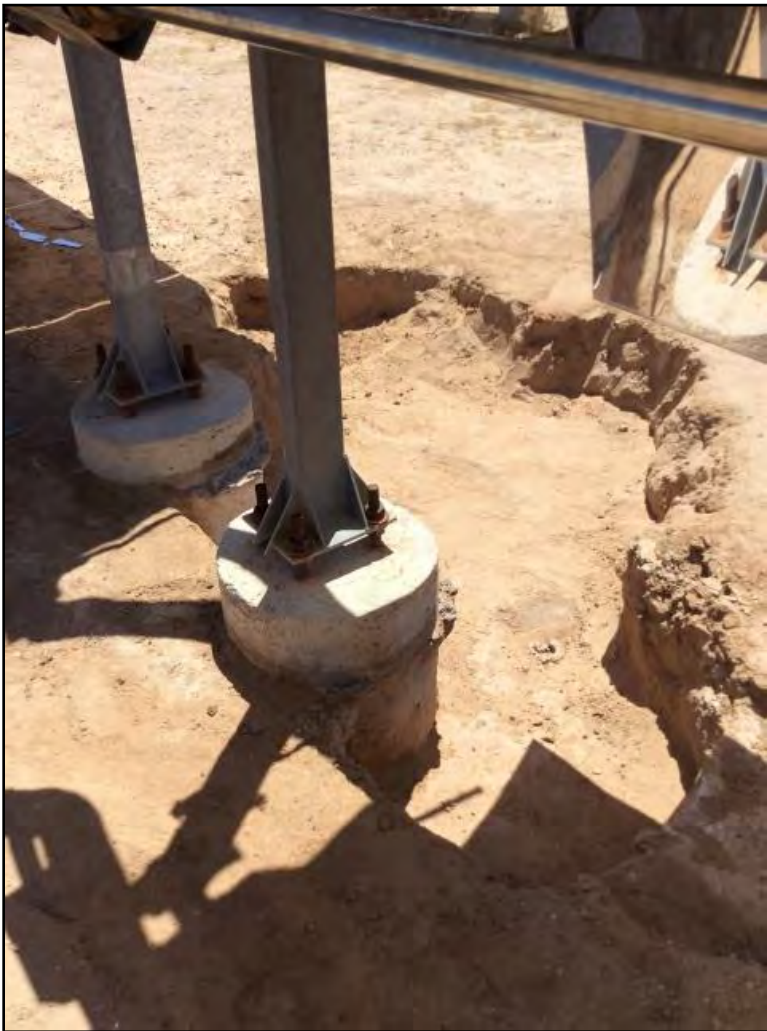
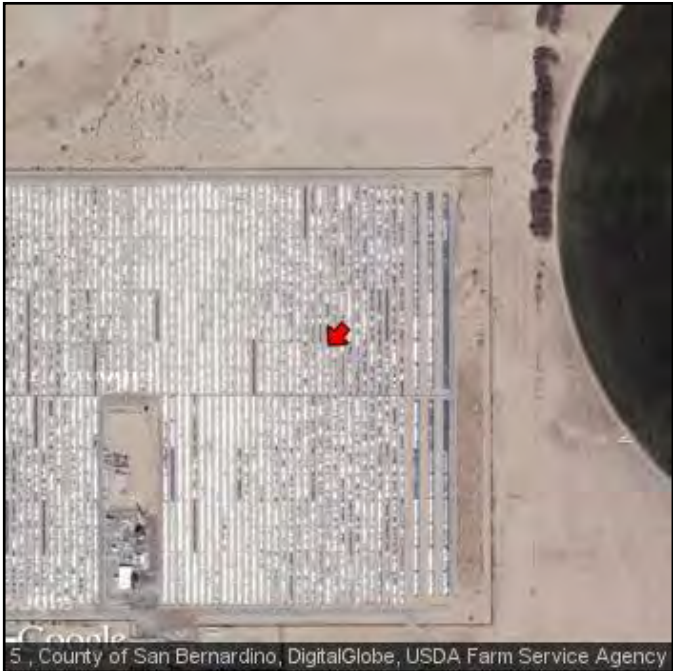
Attributes	
Comments	Note at row 70/71 c remediated 1cy excavation
Photo ID	27

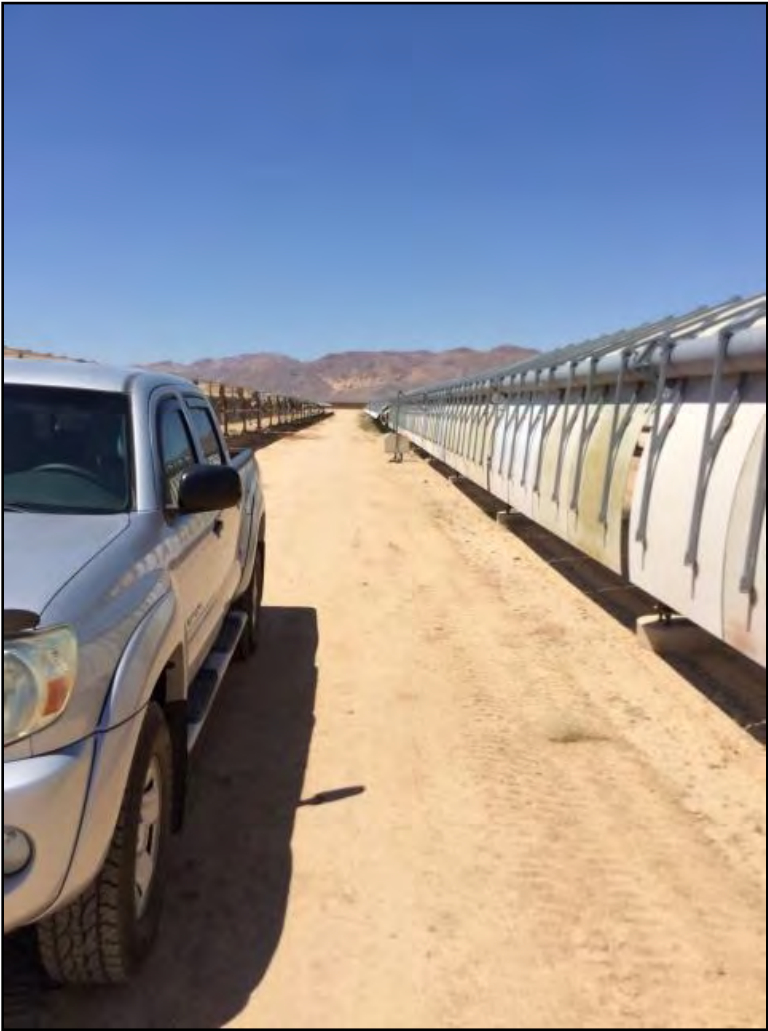
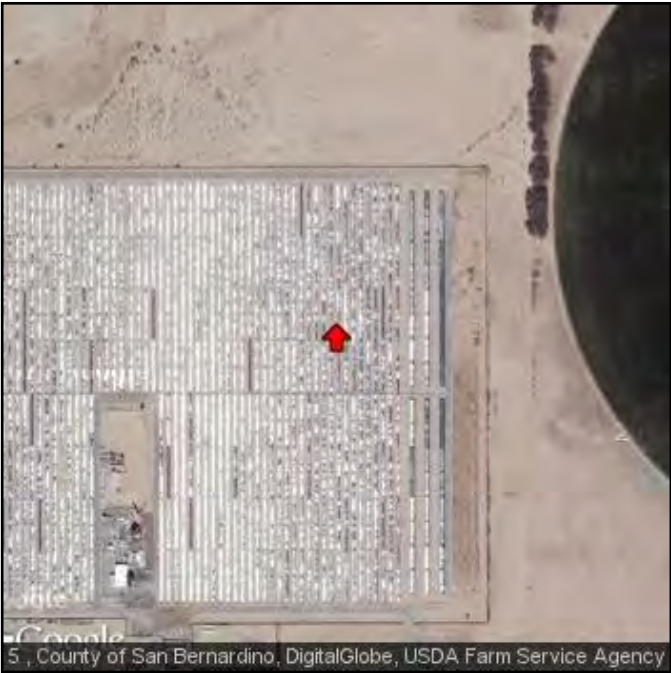
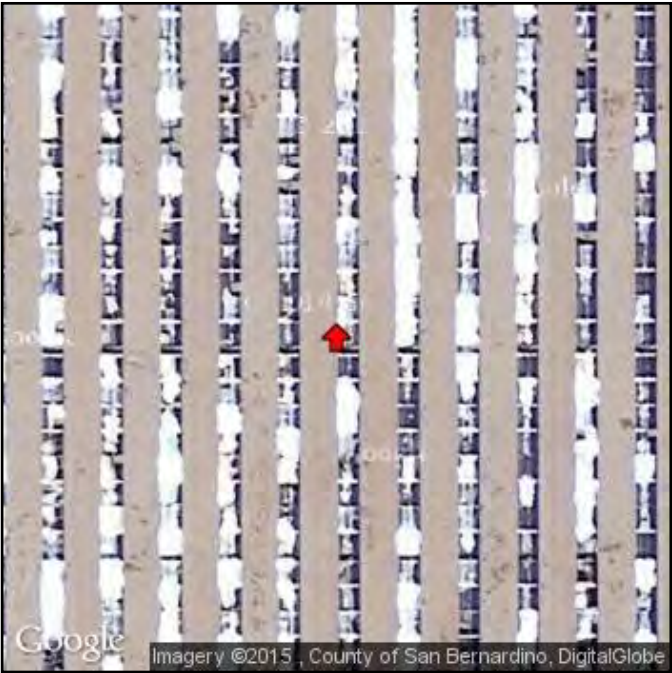
Attributes	
Comments	Row 71/70 C
Photo ID	28

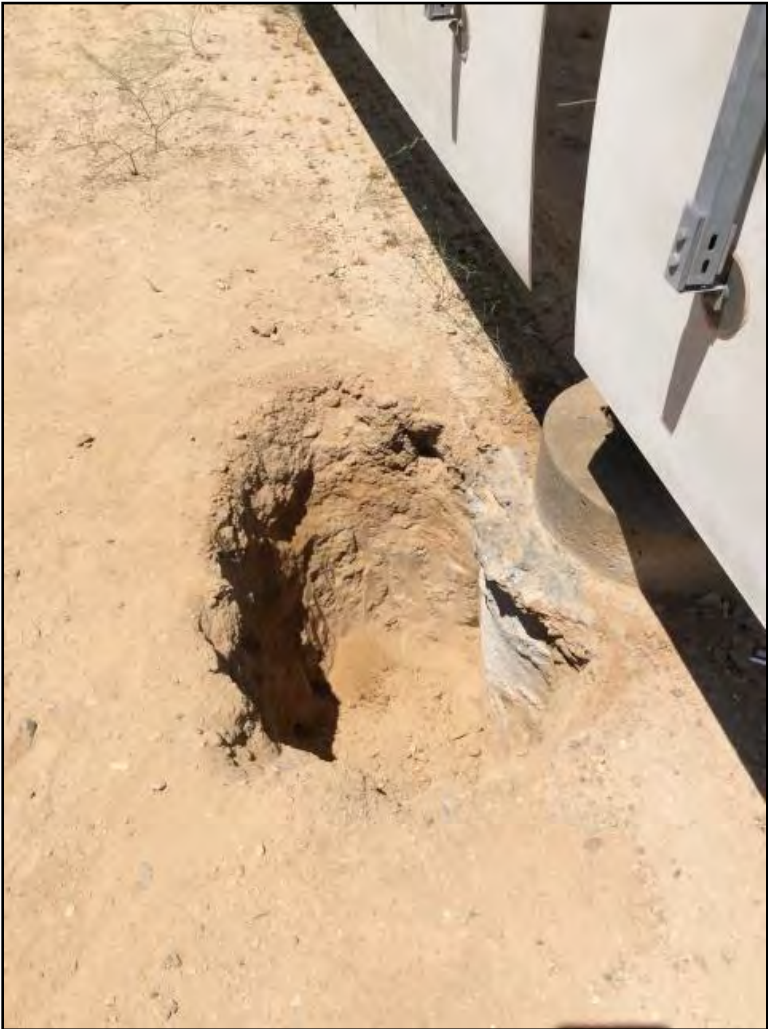
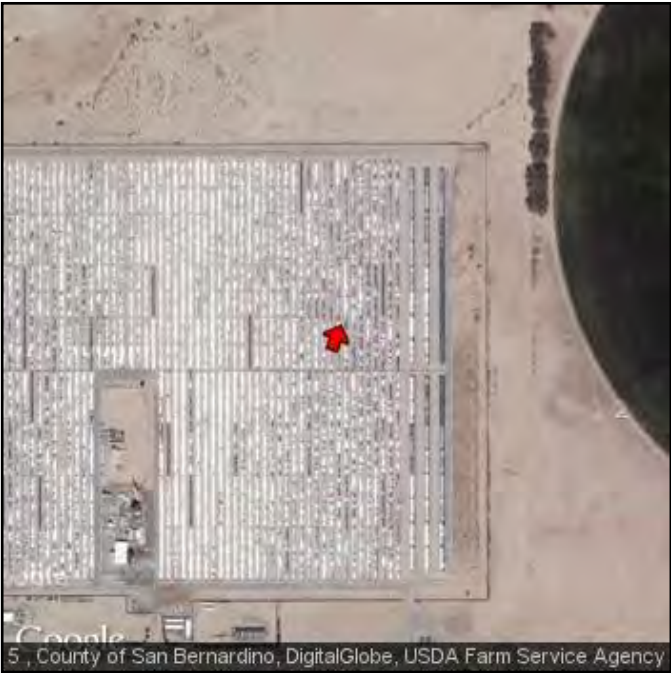
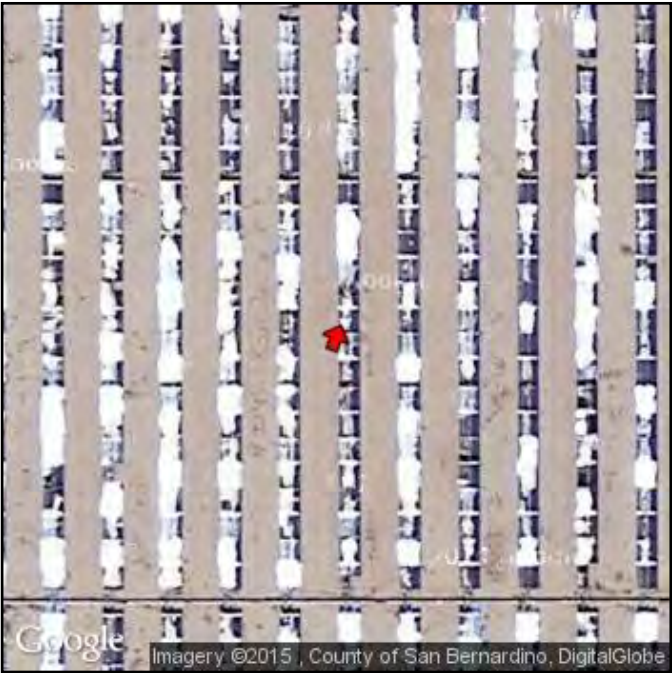
Attributes	
Comments	71/72D in progress. Note darker layer of sand is where caloria is present
Photo ID	29

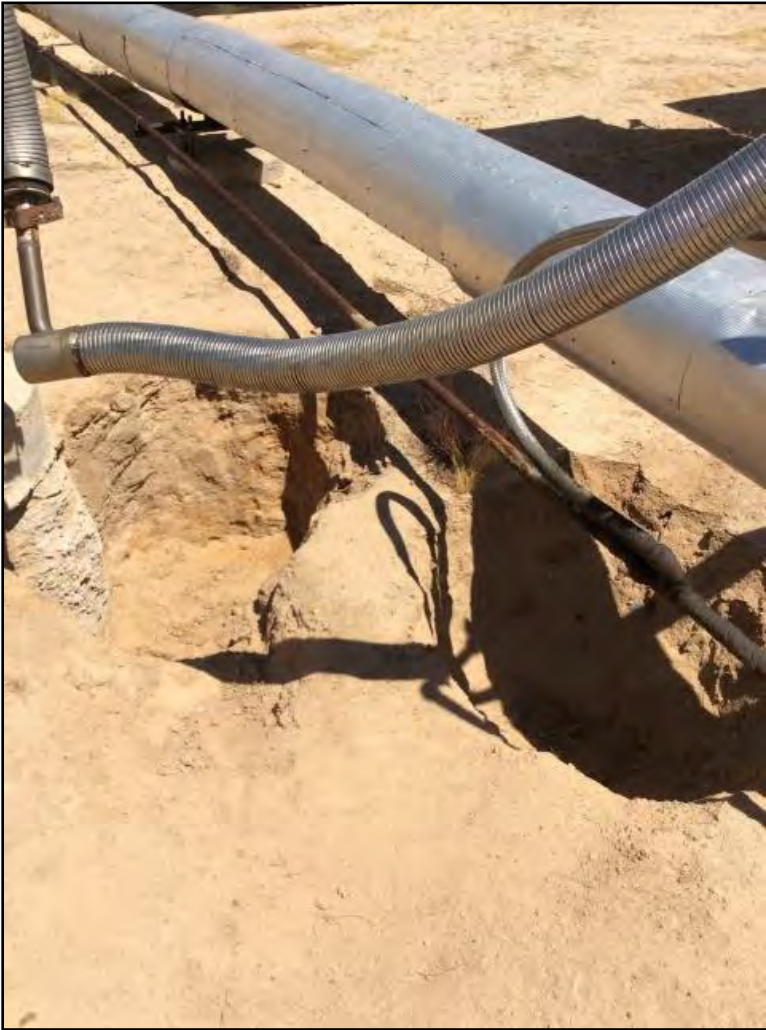
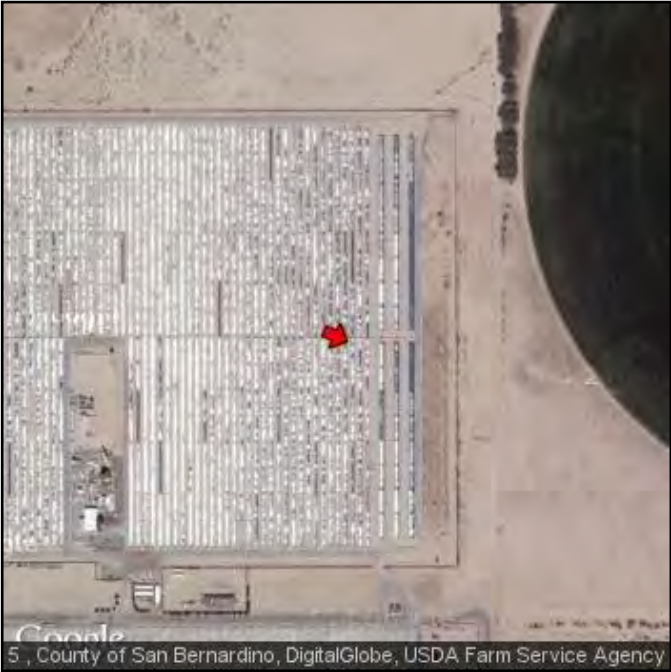
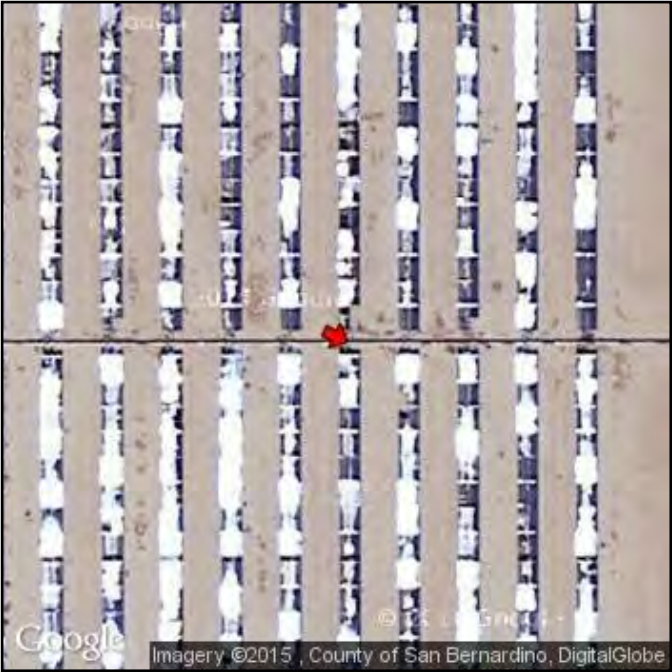
Attributes	
Comments	Deminimus spill at row 75 D south from single flex. A hand excavation completed.
Photo ID	30

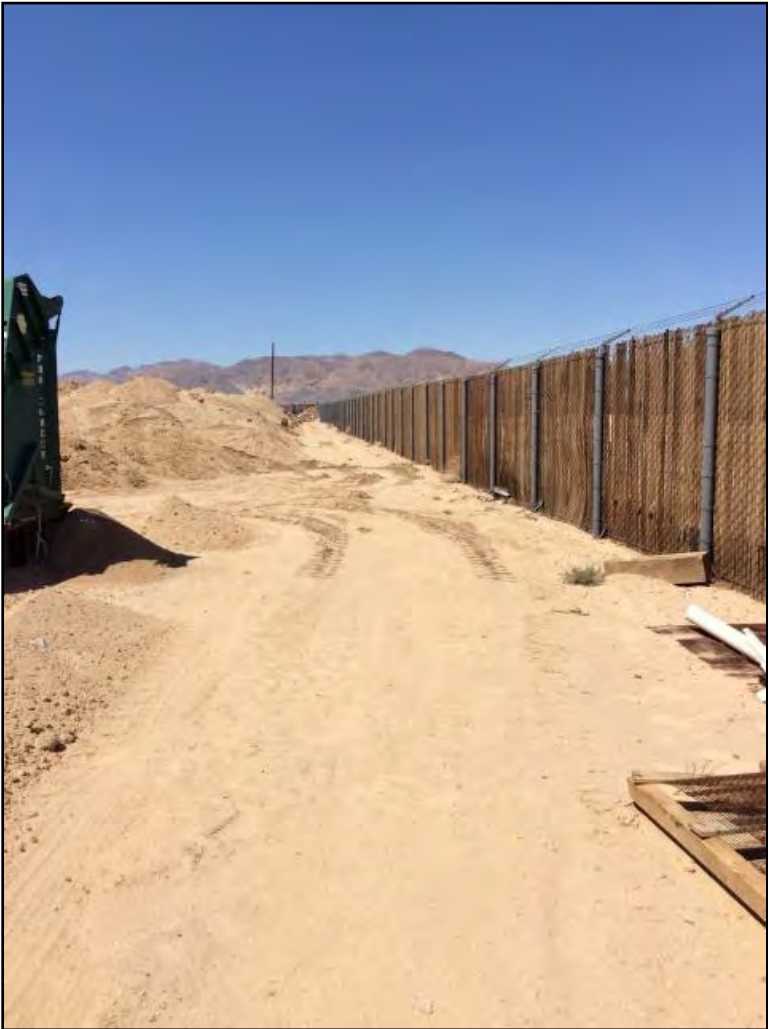
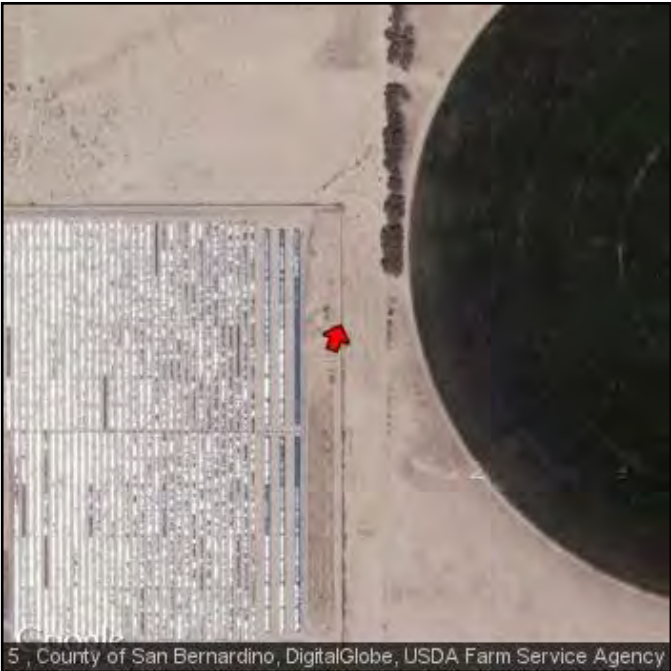
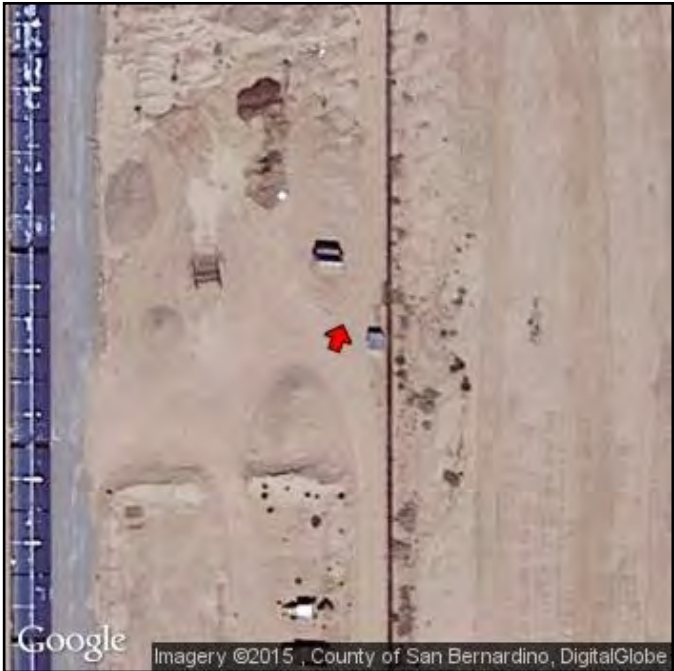
Attributes	
Comments	Boring P-5 at east side of stockpile for LTU 1
Photo ID	31

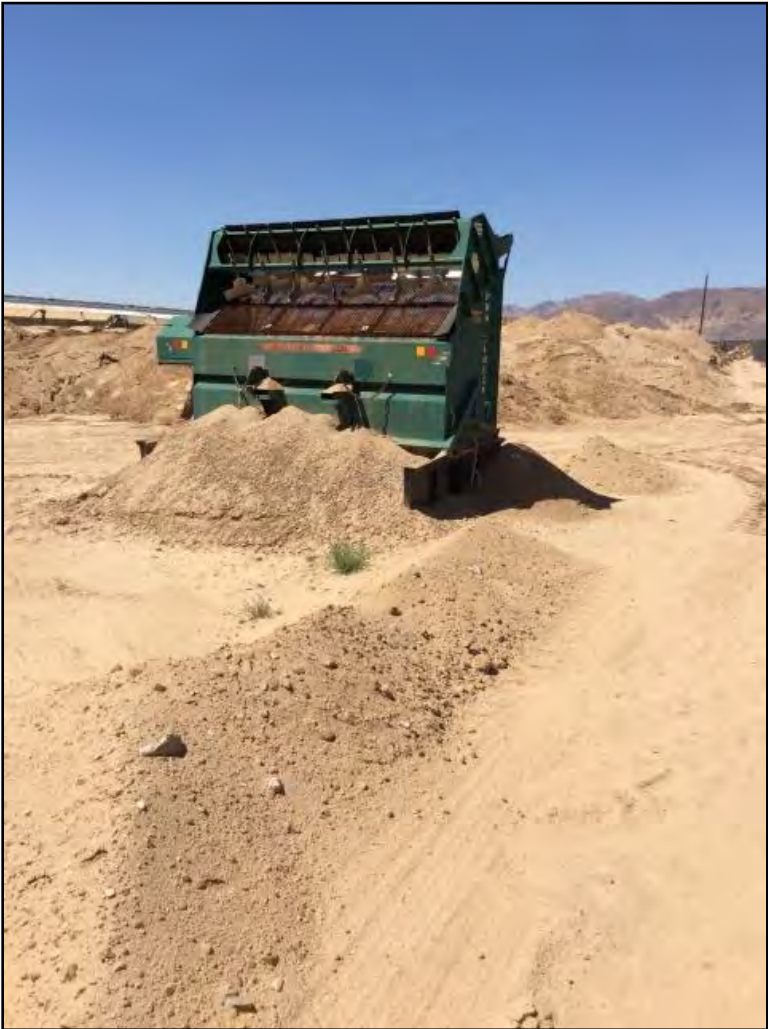
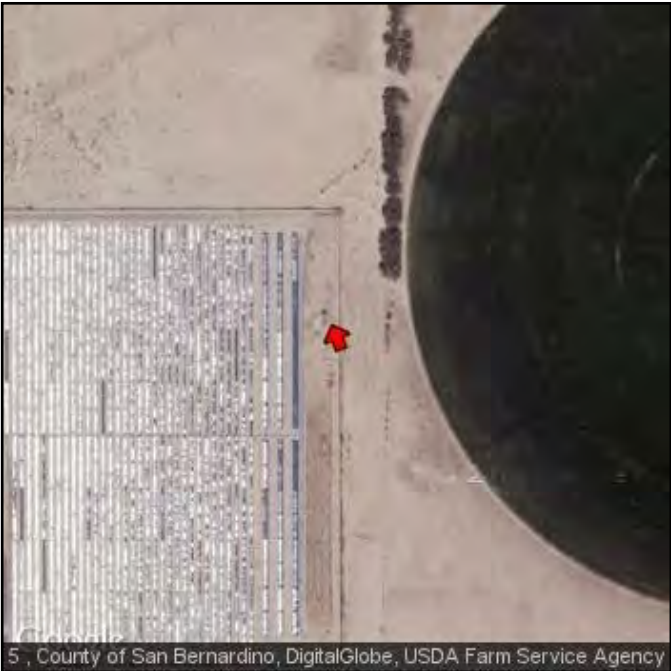
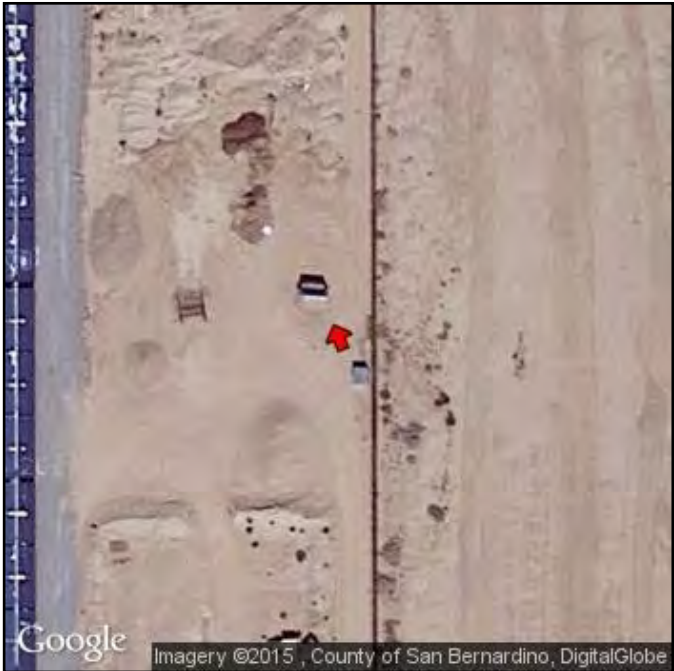
Attributes	
Comments	Screen machine to screen glass out
Photo ID	32

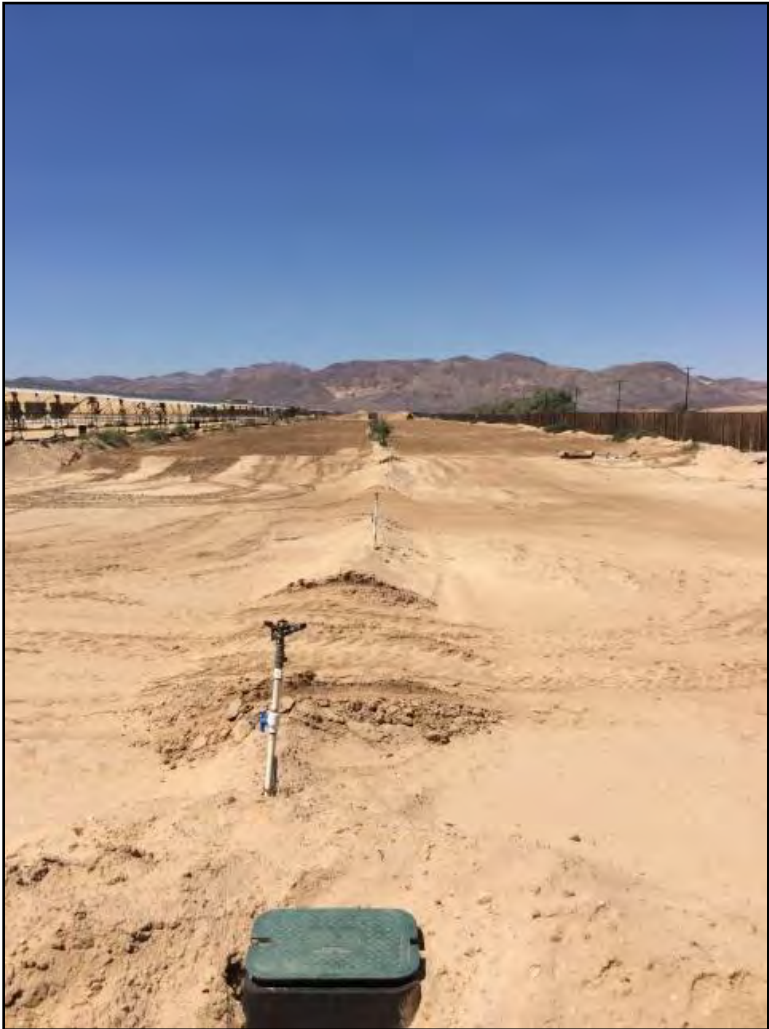
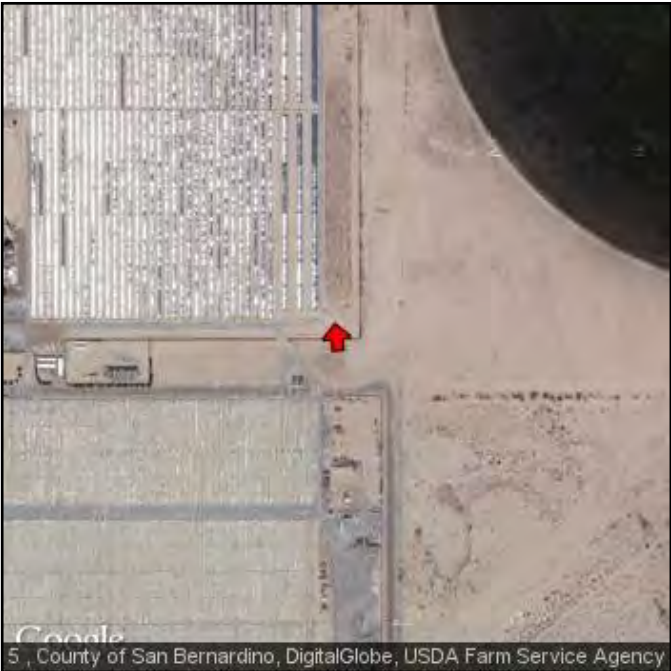
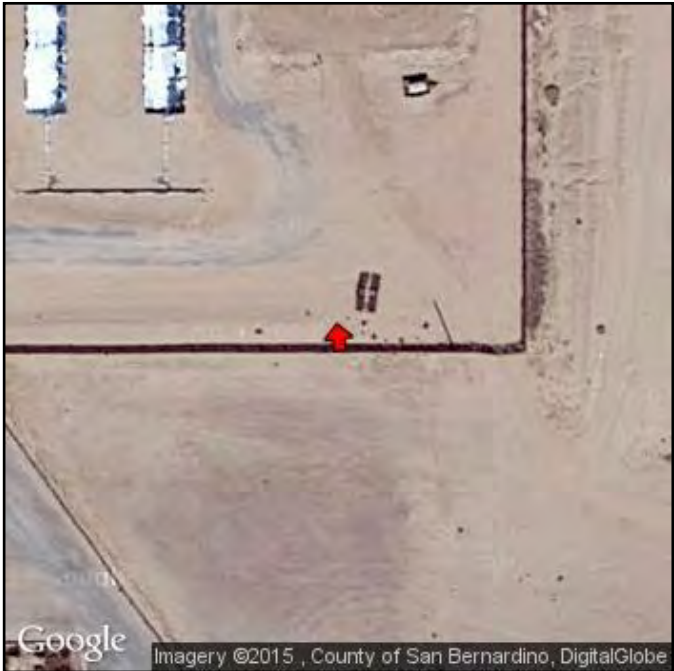
Attributes	
Comments	South end of LTU 1.
Photo ID	33

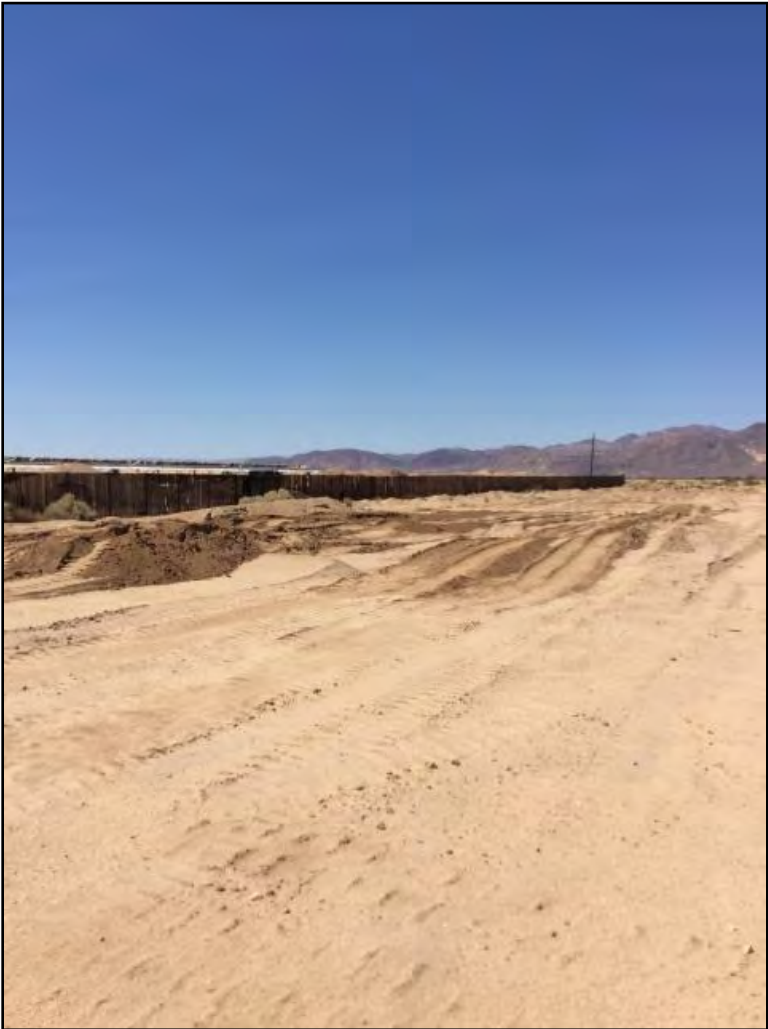
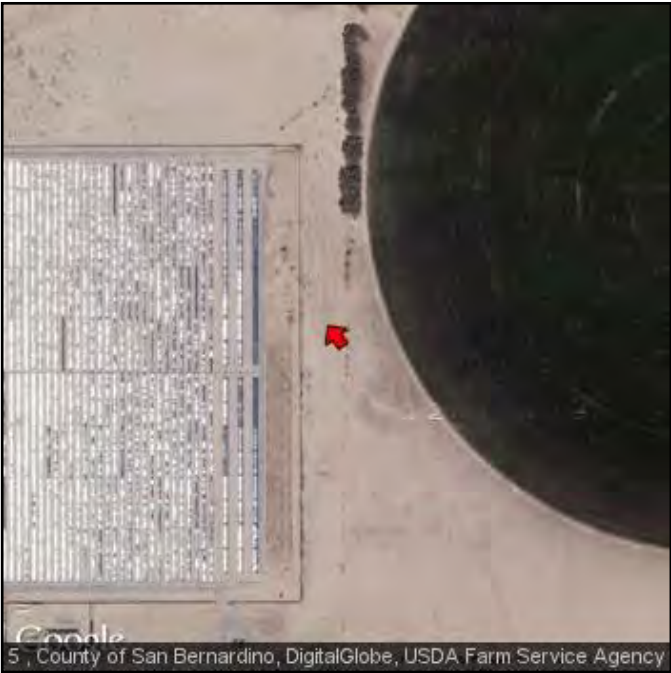
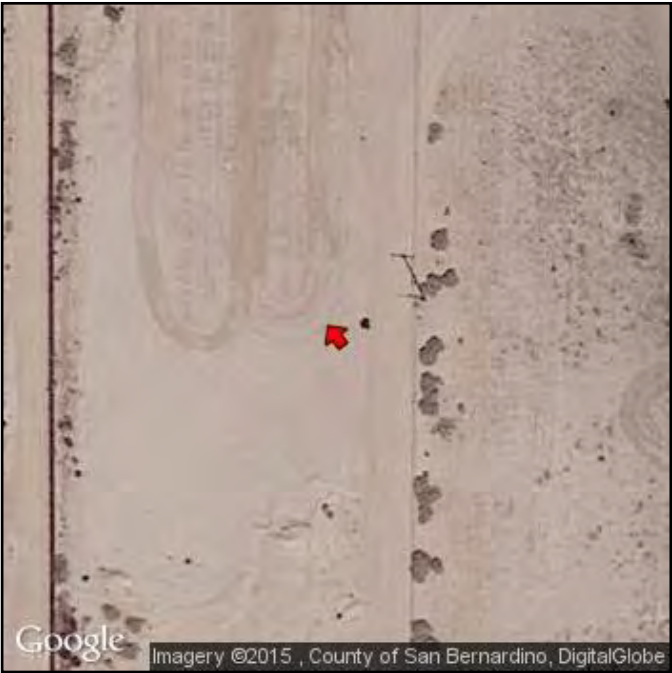
Attributes	
Comments	Remediated soil pile from SEGS 1 array field.
Photo ID	34

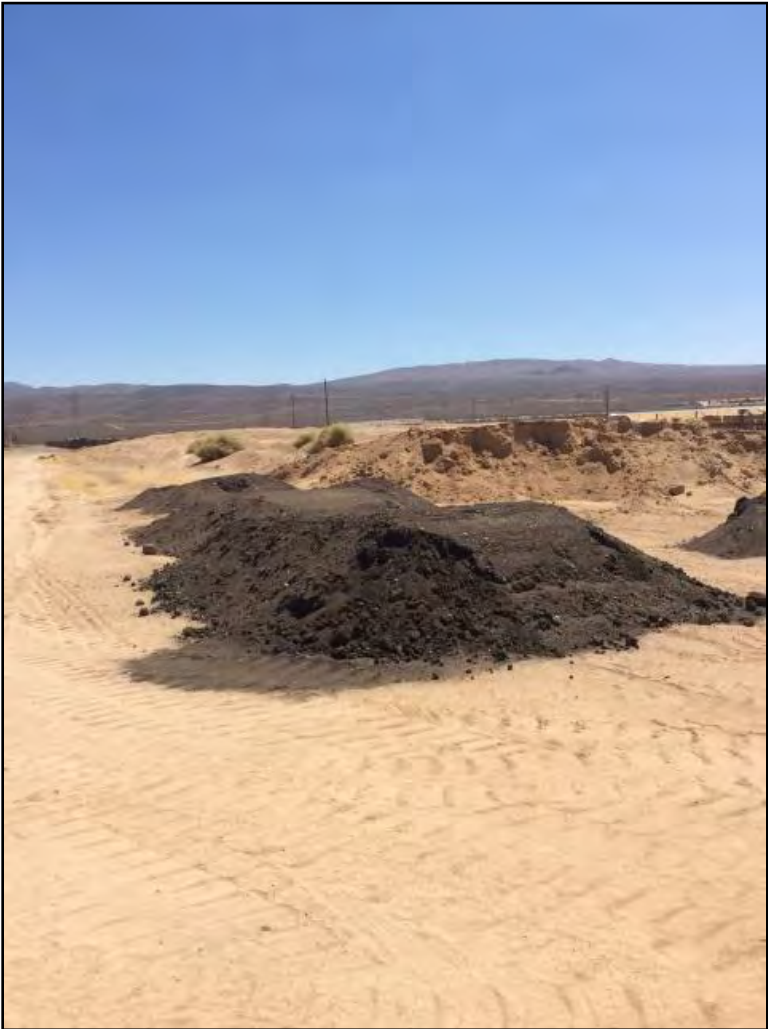
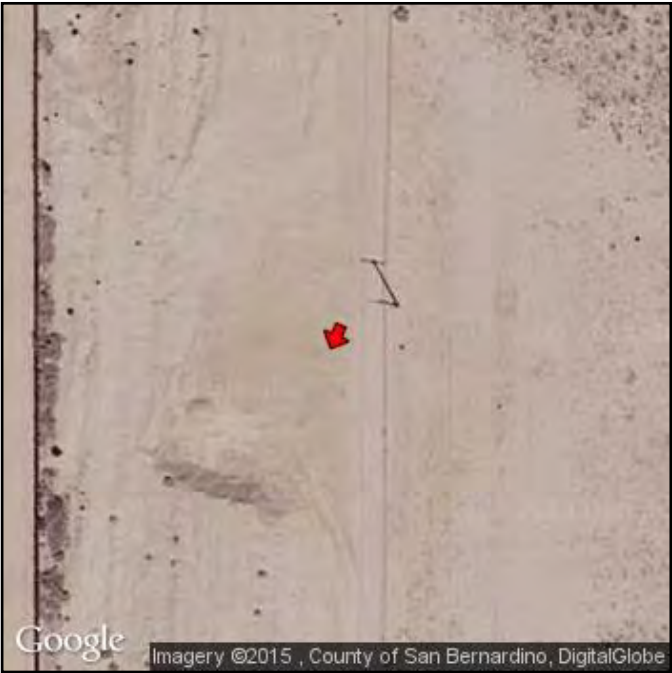
Attributes	
Comments	Thermally treated soil that once contained oil from the equipment yard area
Photo ID	35

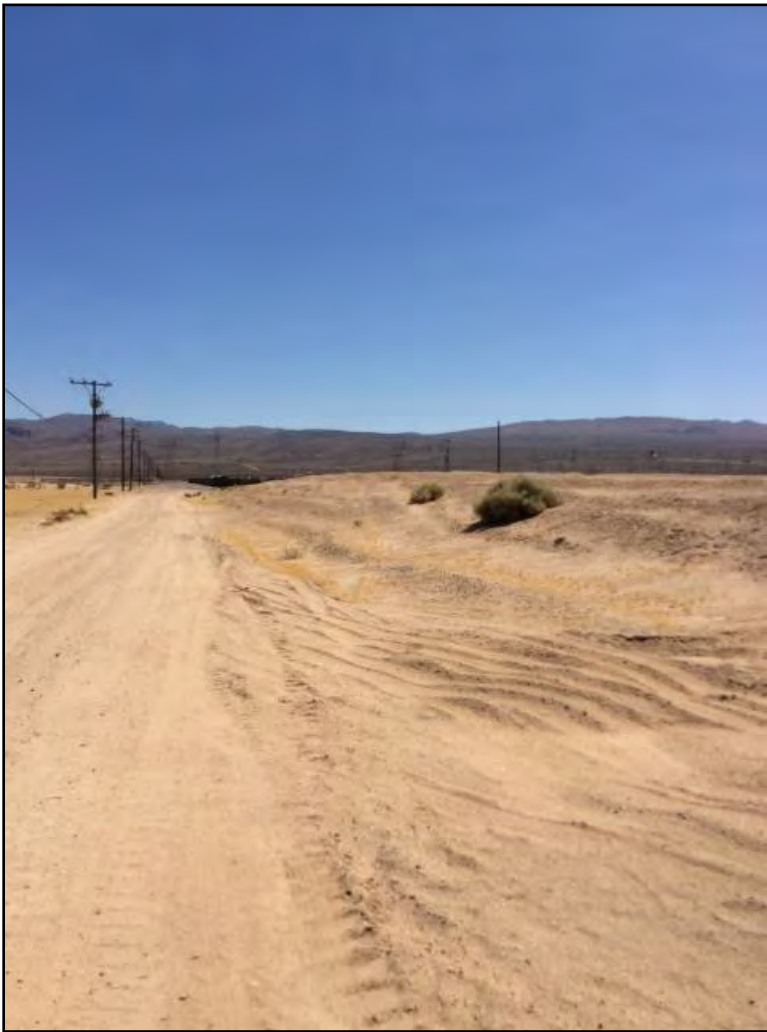
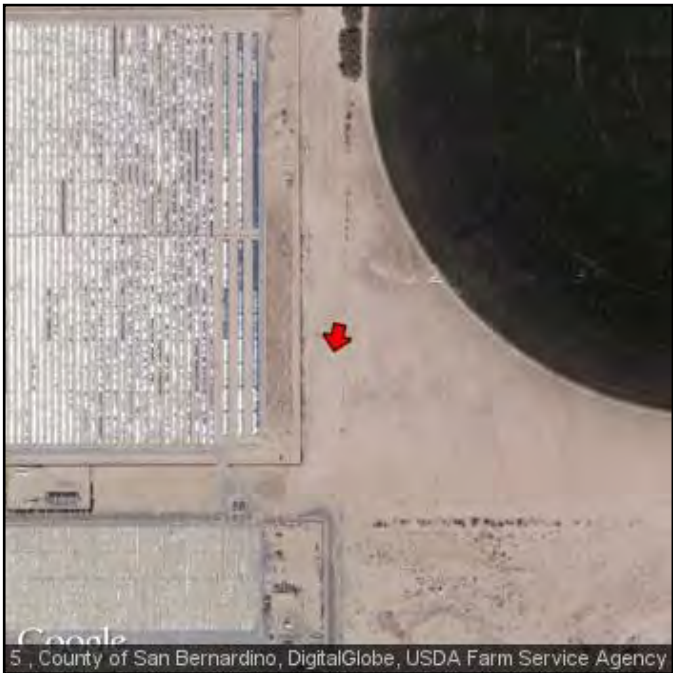
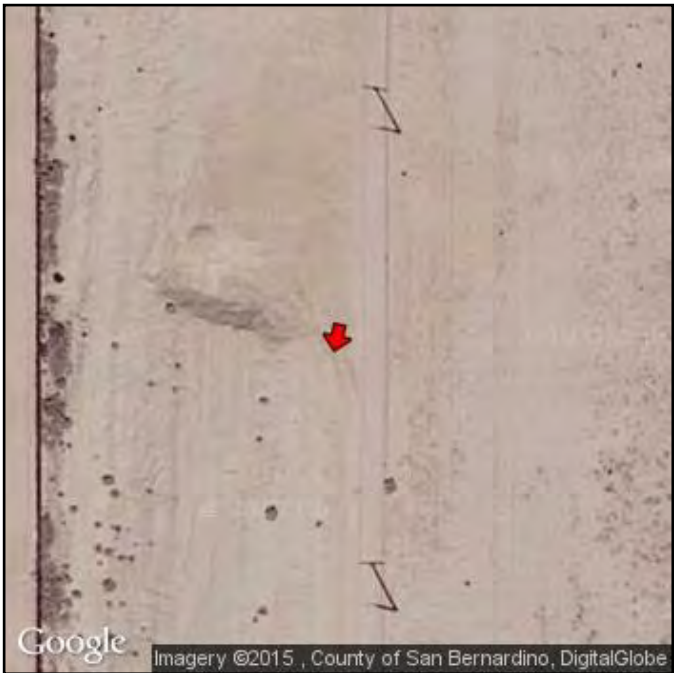
Attributes	
Comments	Treated soil from LTU 1
Photo ID	36

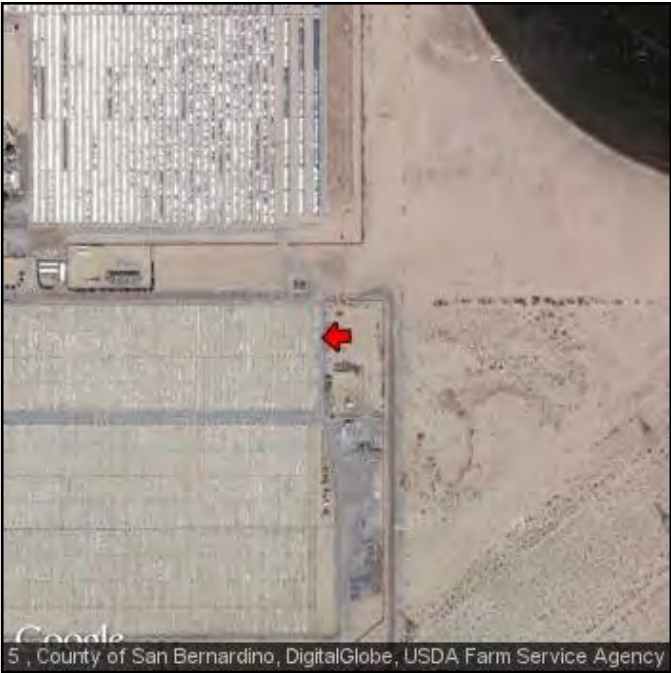
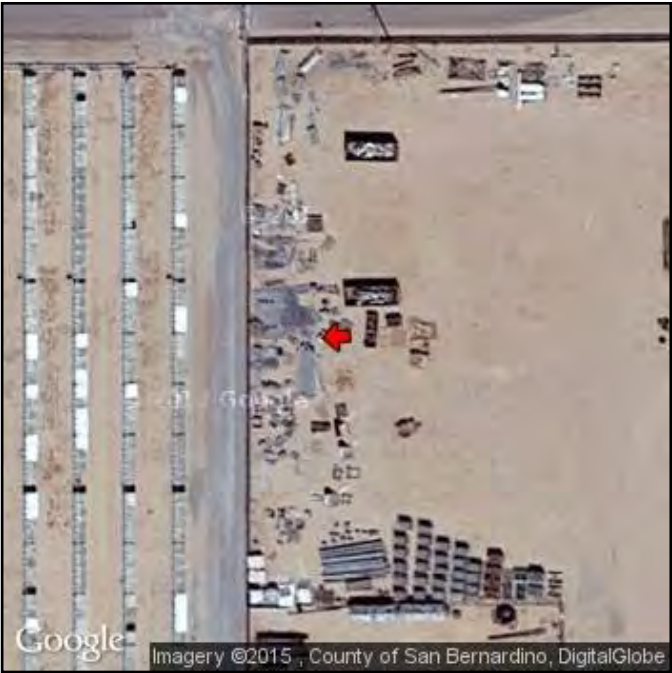
Attributes	
Comments	Guardian mirror glass does not have lead coating on the back of the mirror like the others.
Photo ID	37

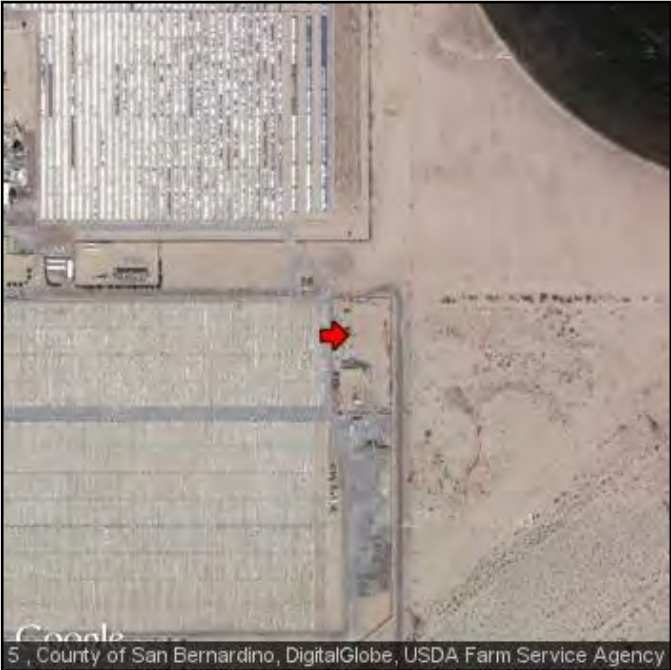
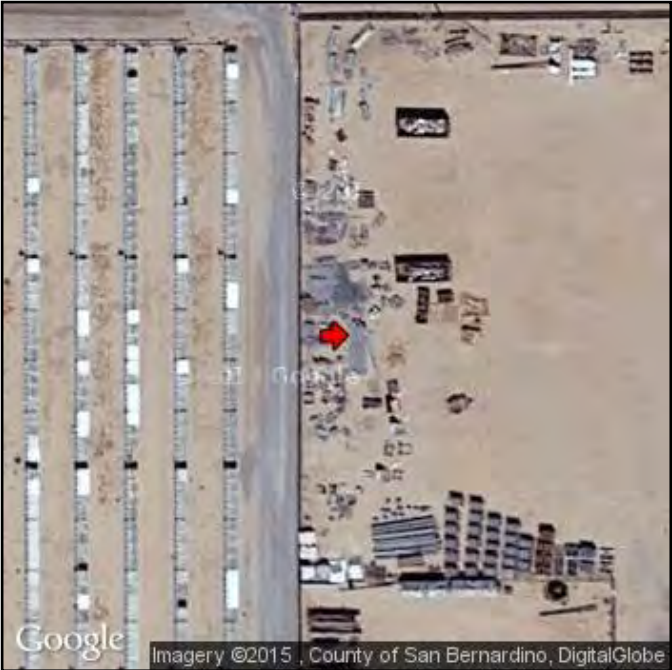
Attributes	
Comments	Guardian mirror glass.
Photo ID	38

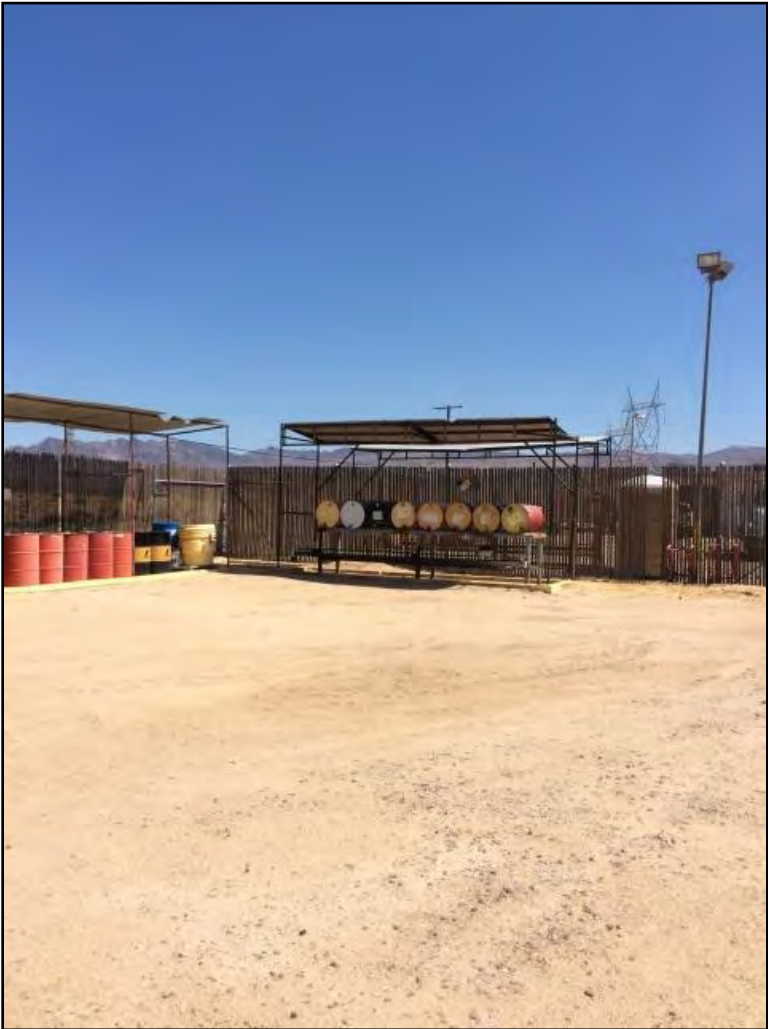
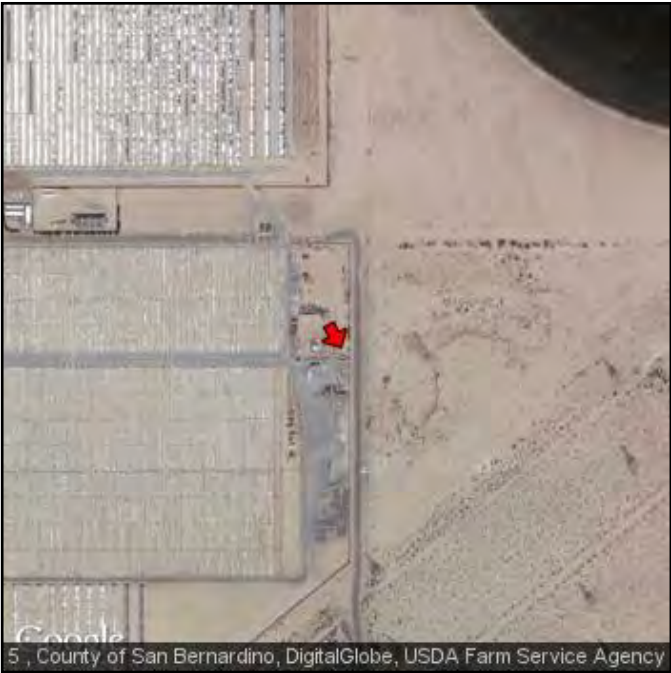
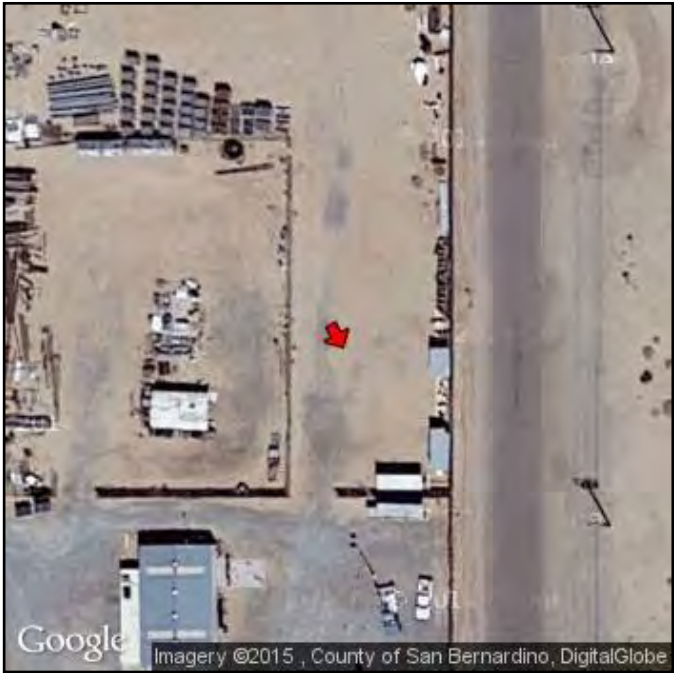
Attributes	
Comments	Oil lube and motor oil drums
Photo ID	39

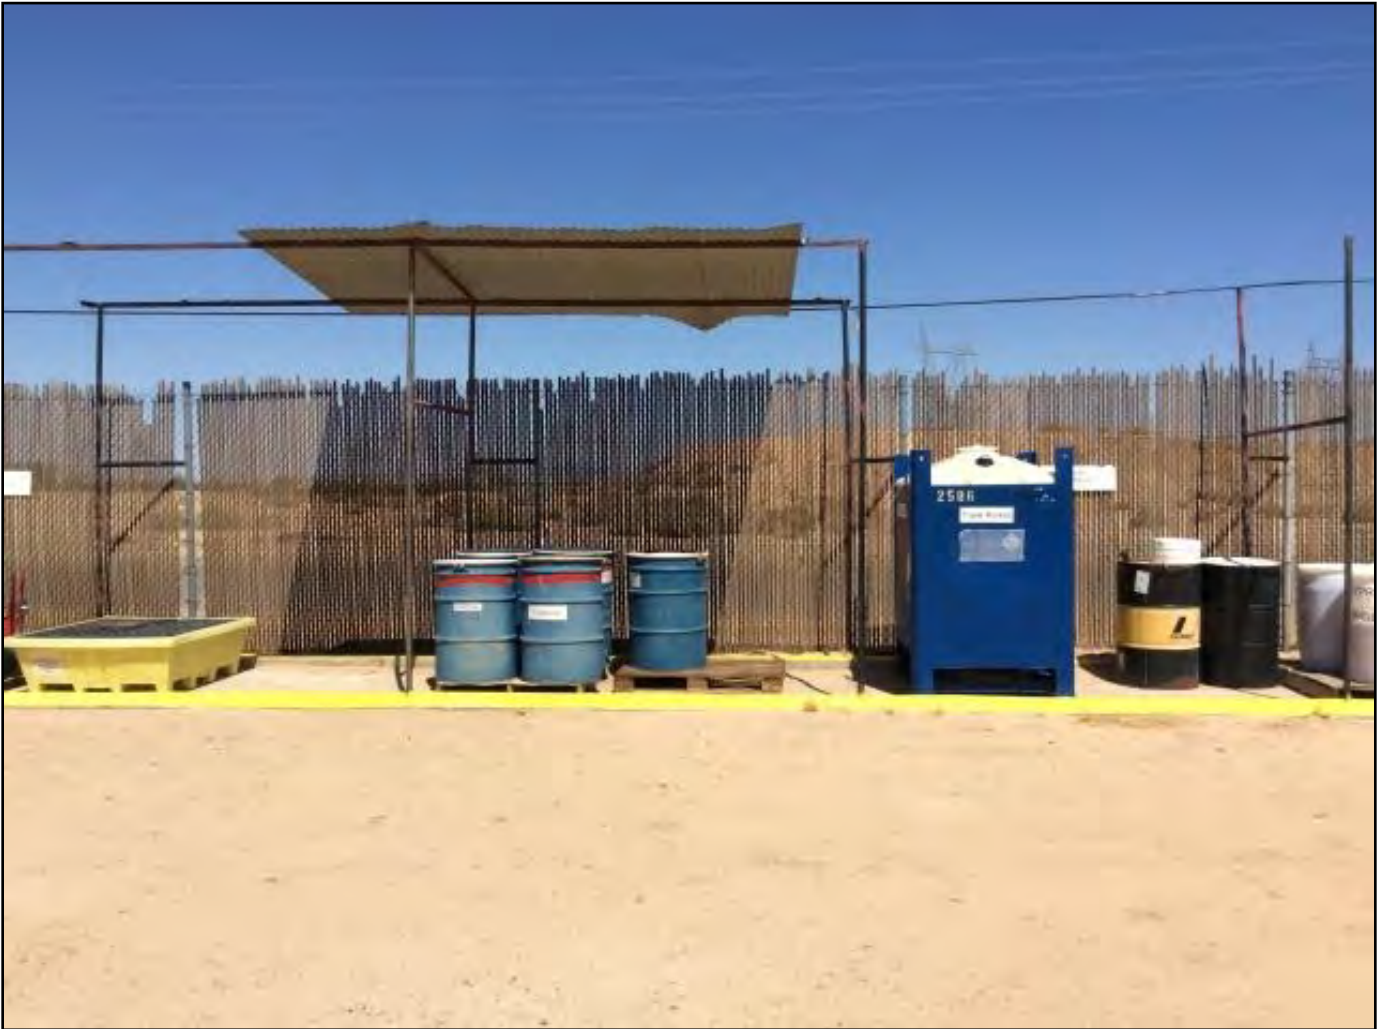
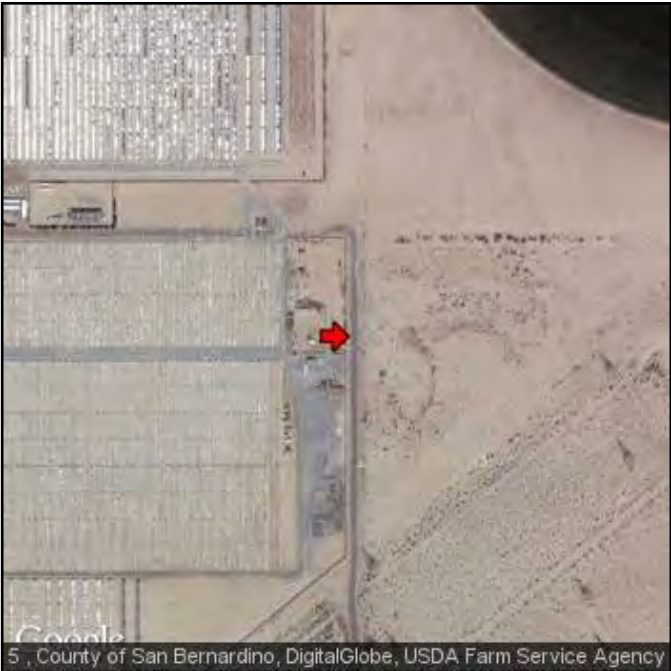
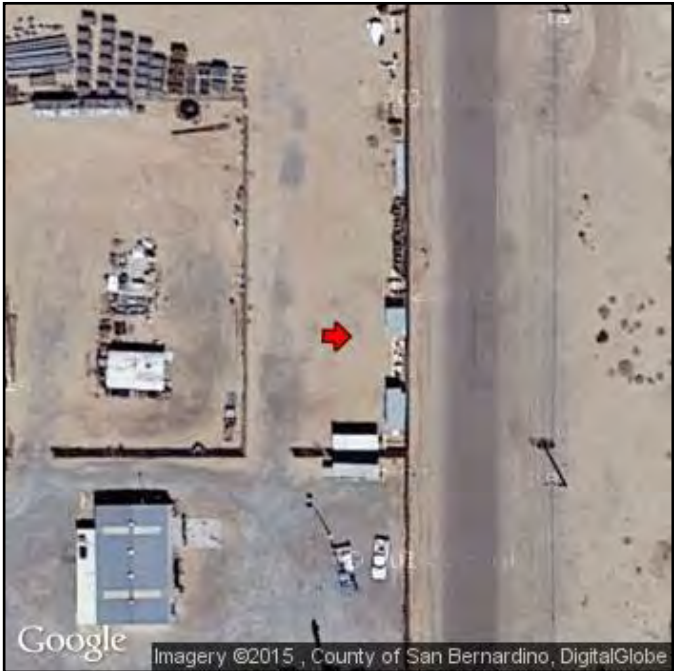
Attributes	
Comments	Charcoal for air treatment in drums and phosphorous for water treatment in blue cube tote.
Photo ID	40
