APPENDIX D
Subject Property Photographs

Sunray Solar Site

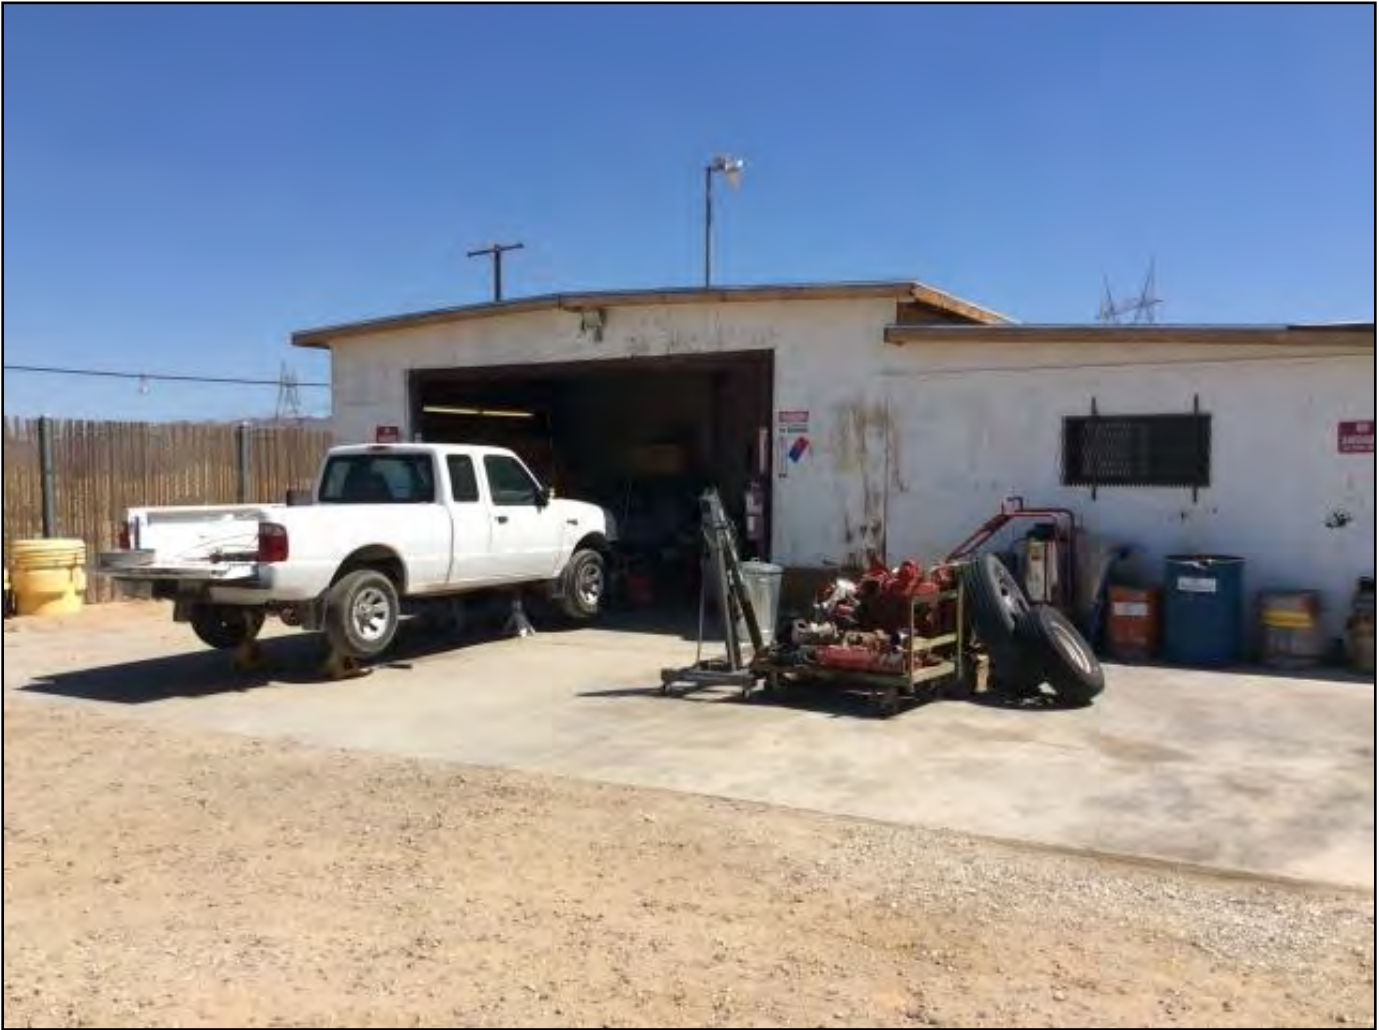
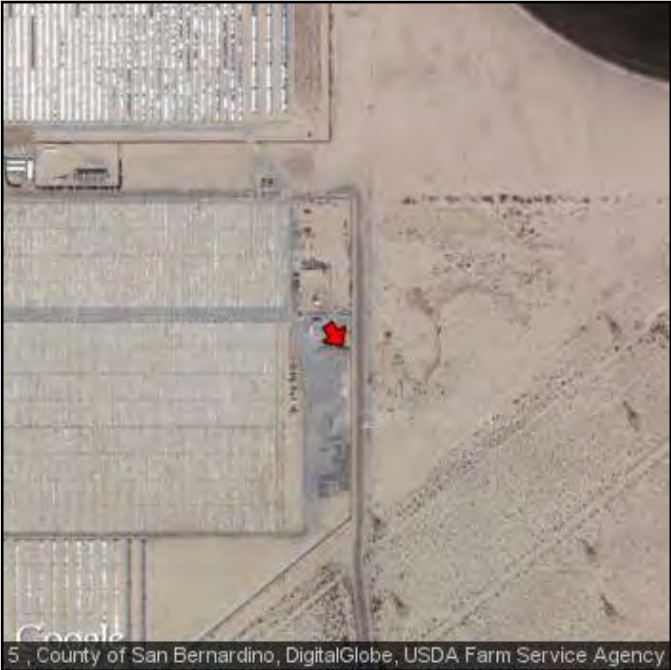
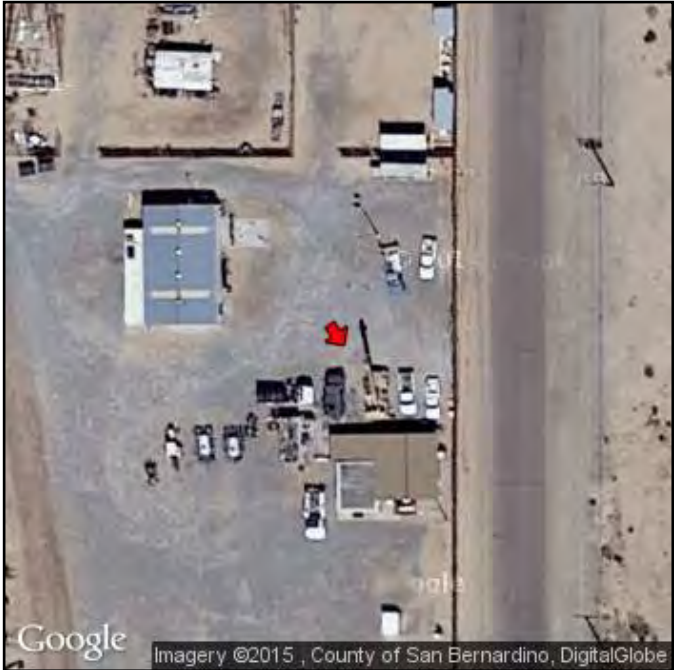
Attributes	
Comments	Maintenance garage for vehicles
Photo ID	41

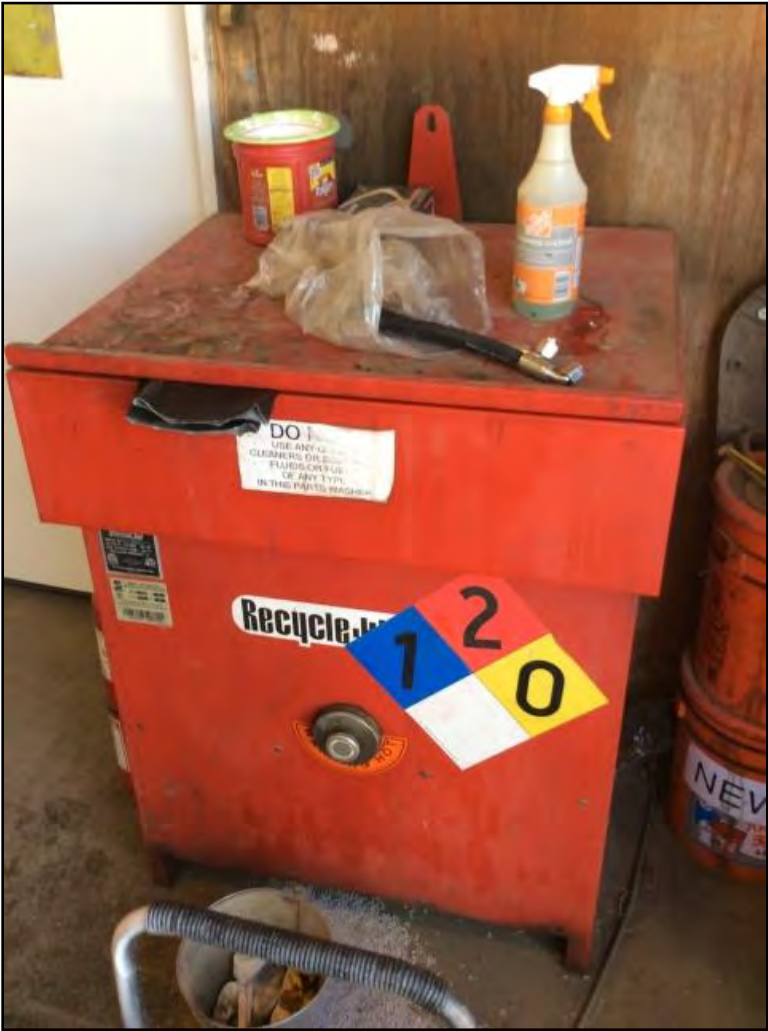
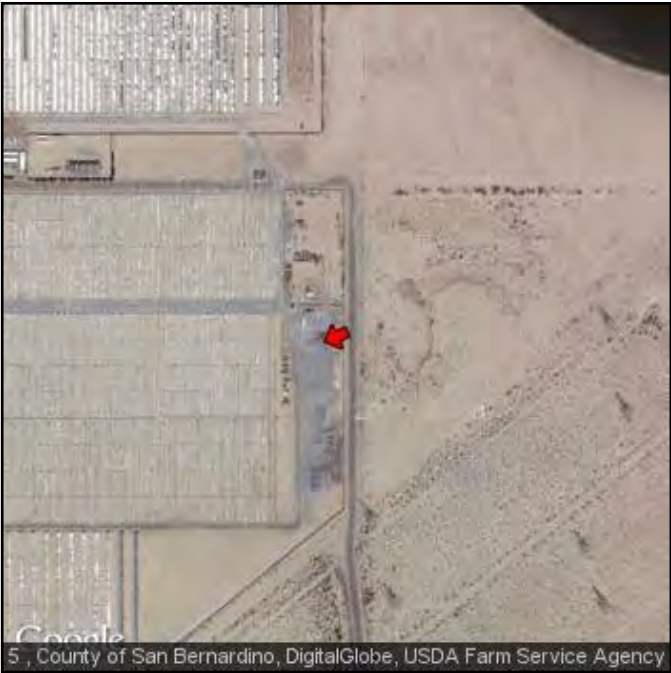
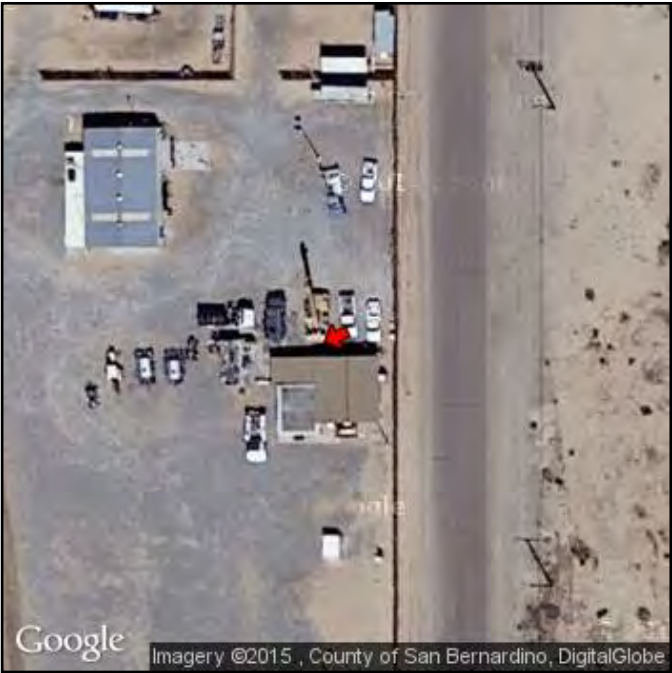
Attributes	
Comments	Parts cleaner recycled in maintainence garage
Photo ID	42

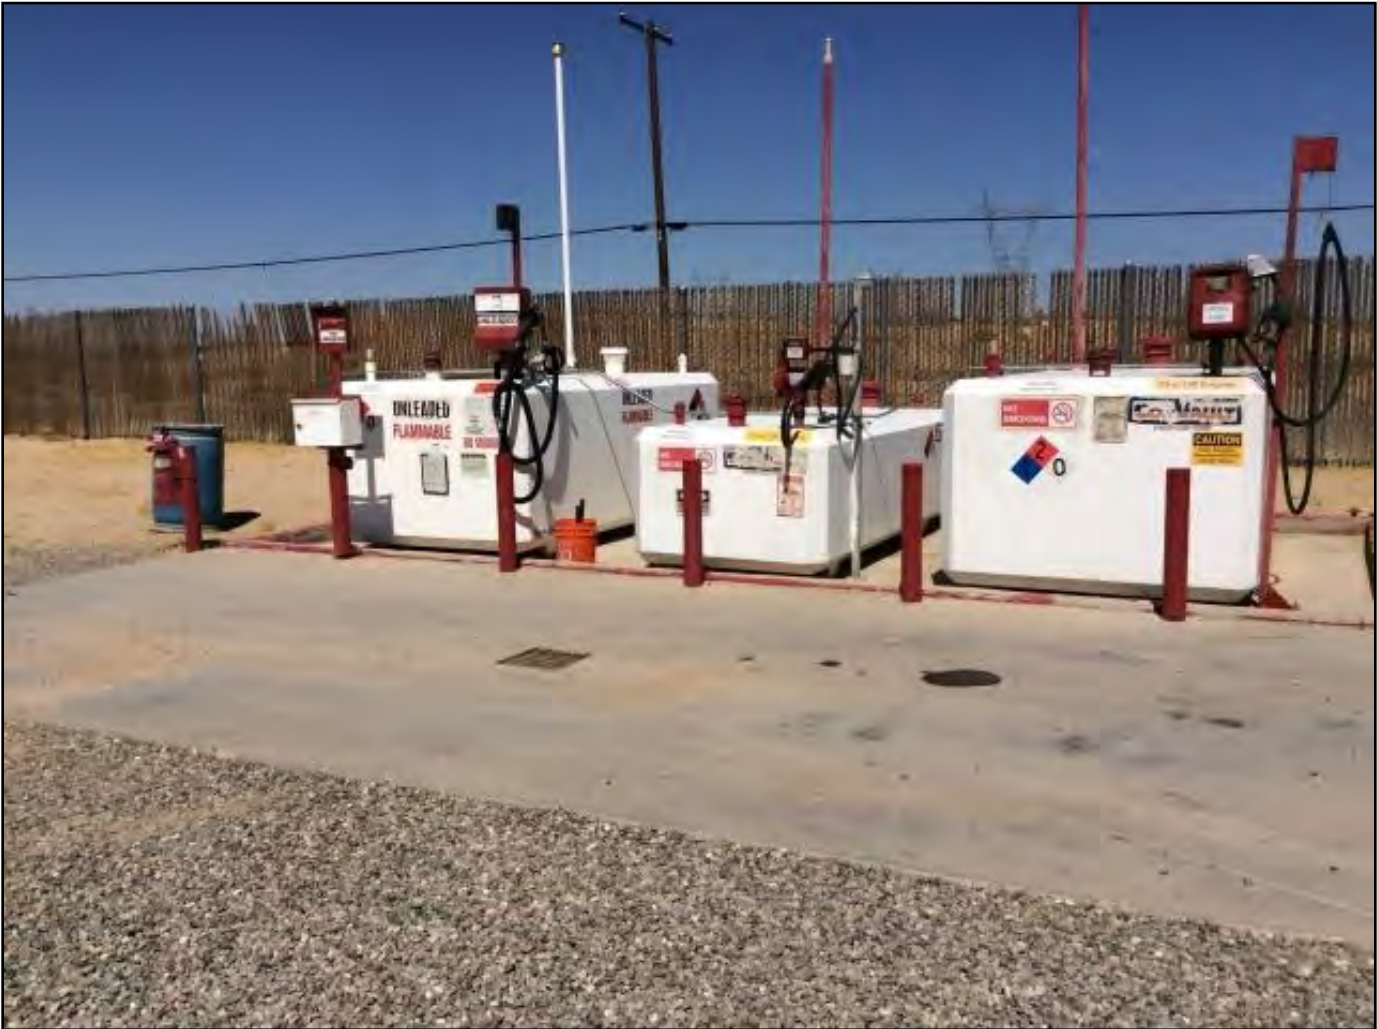
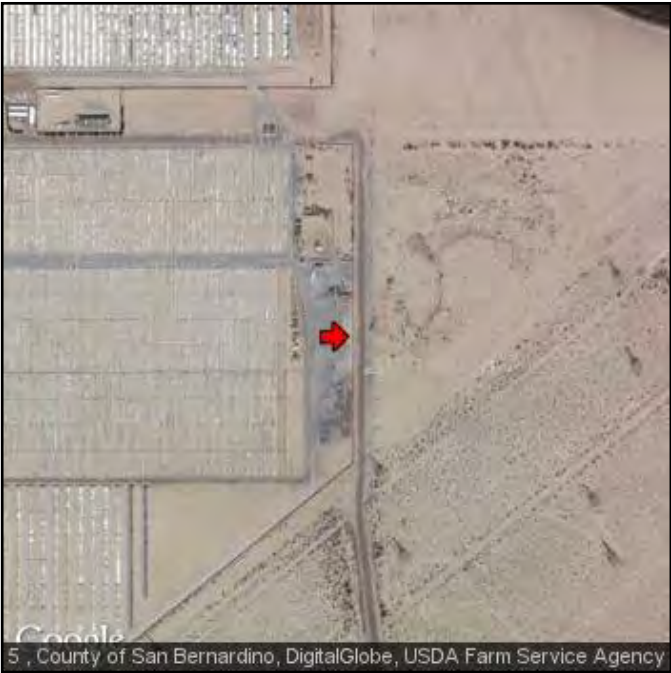
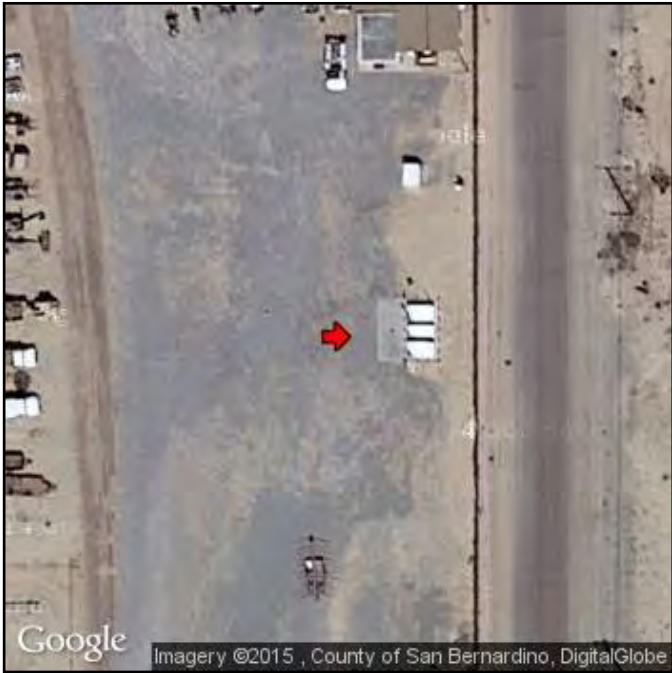
Attributes	
Comments	Diesel and gasoline ASTs for on-site vehicles. Boring M-5 is located off the pad.
Photo ID	43

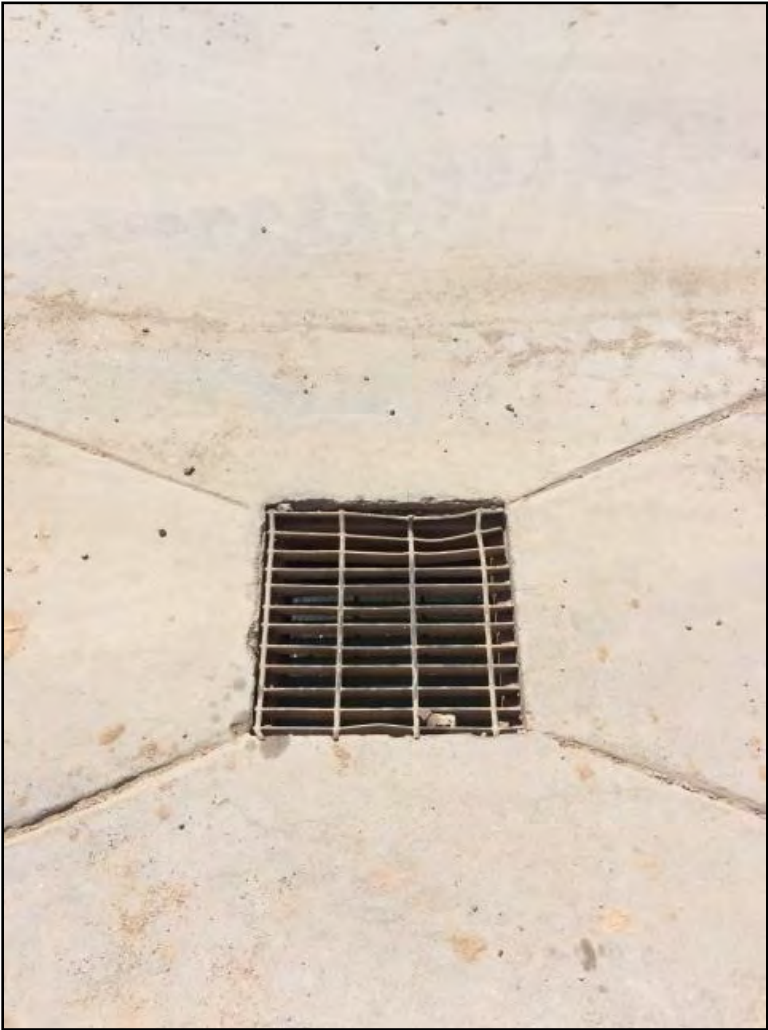
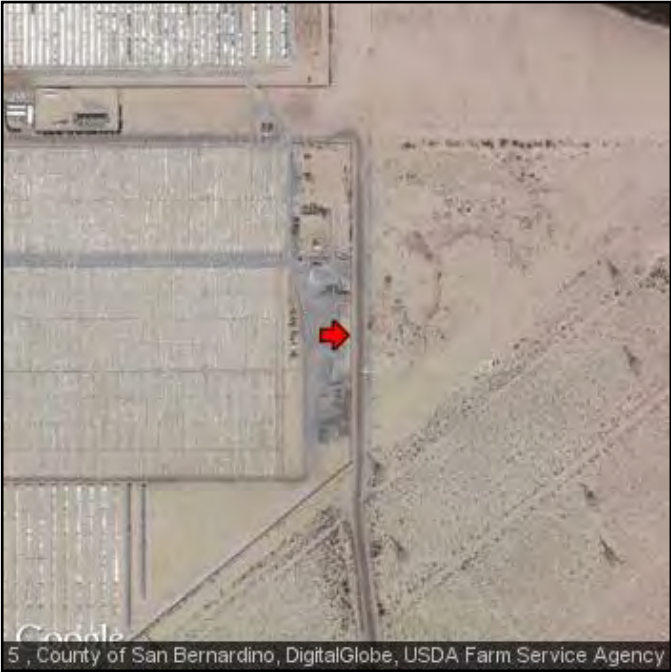
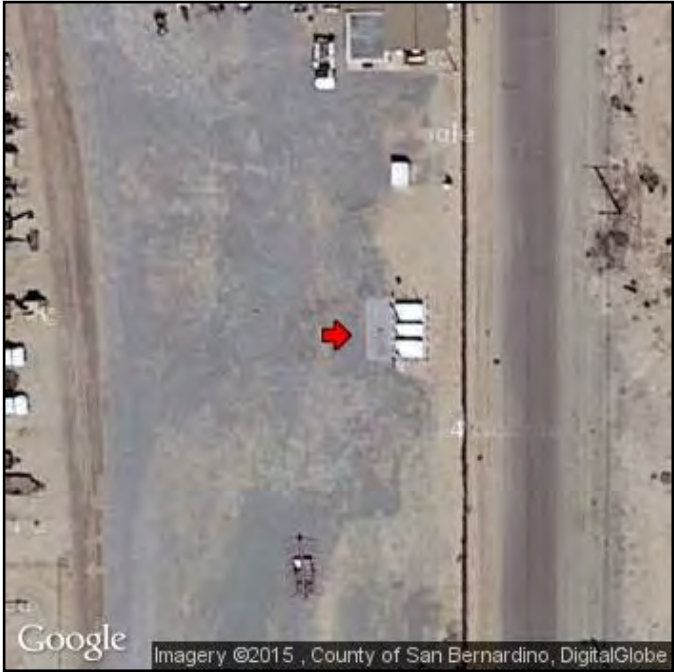
Attributes	
Comments	One cubic yard sump drains on fuel tanks pad
Photo ID	44

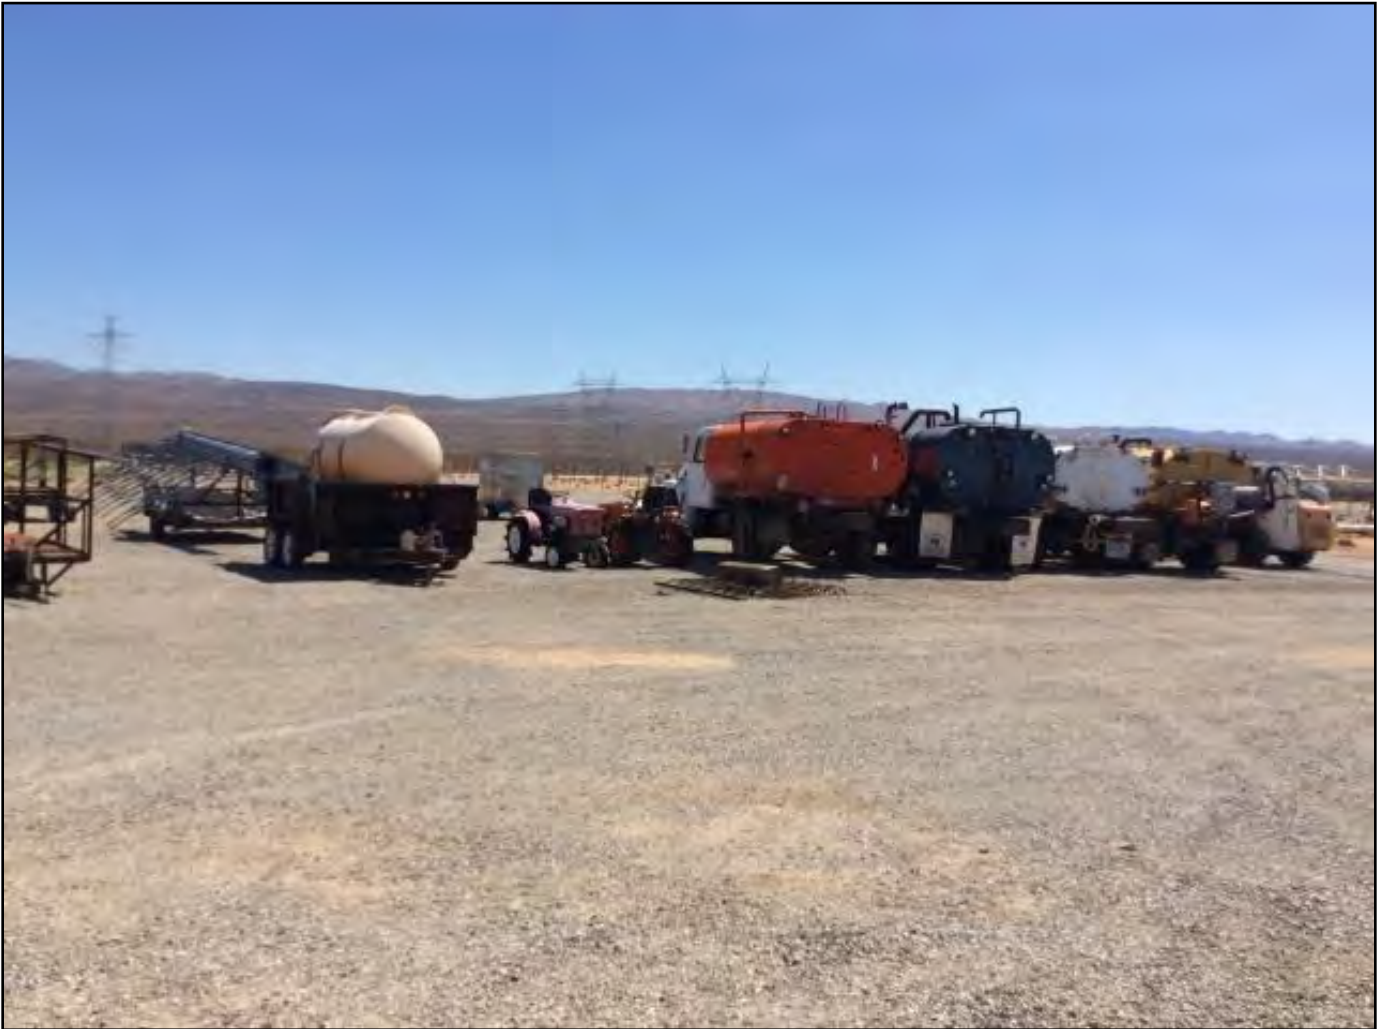
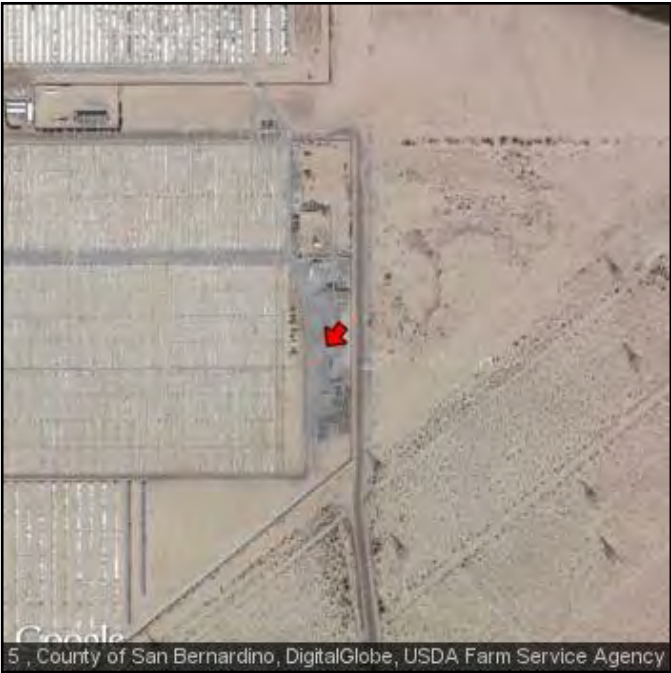
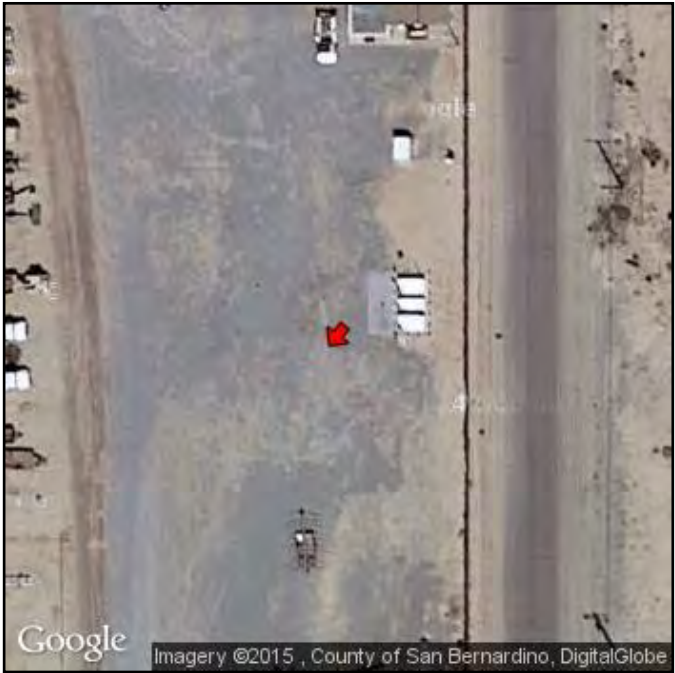
Attributes	
Comments	Water and inoculation tanks for LTUs
Photo ID	45

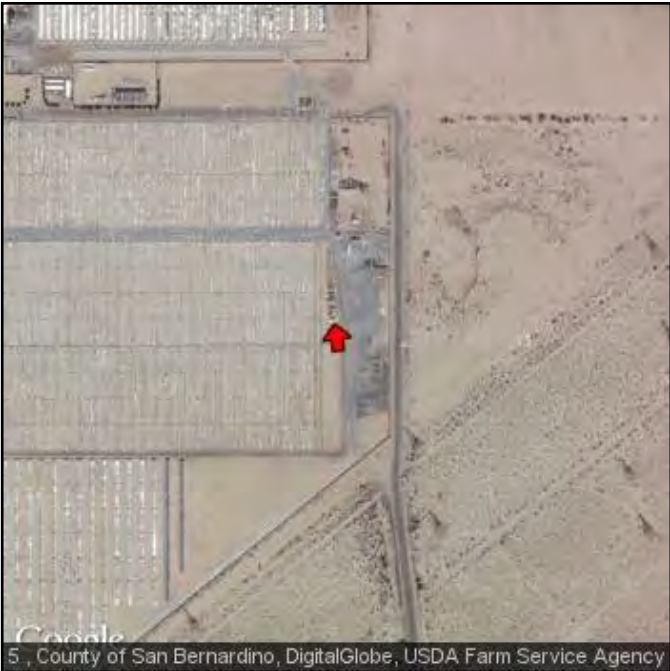
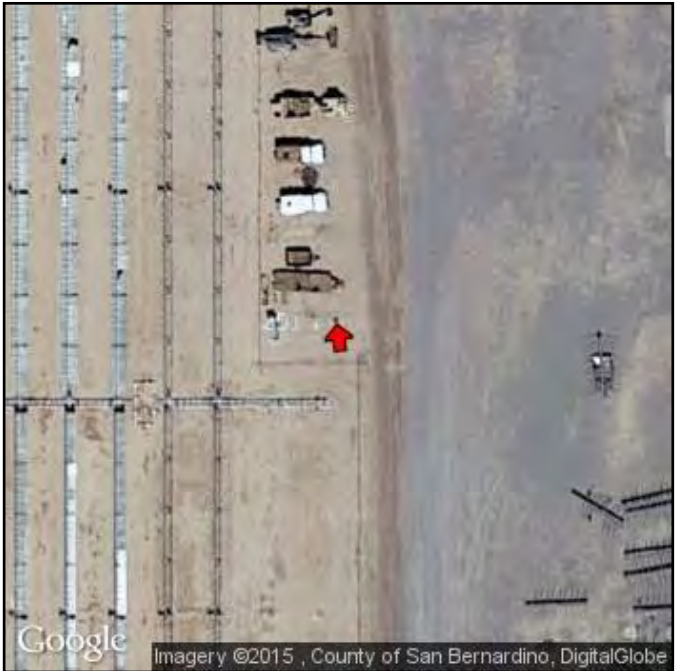
Attributes	
Comments	Remediated area where numerous deminimus leaks from vehicles in the maintenance and storage yard.
Photo ID	46

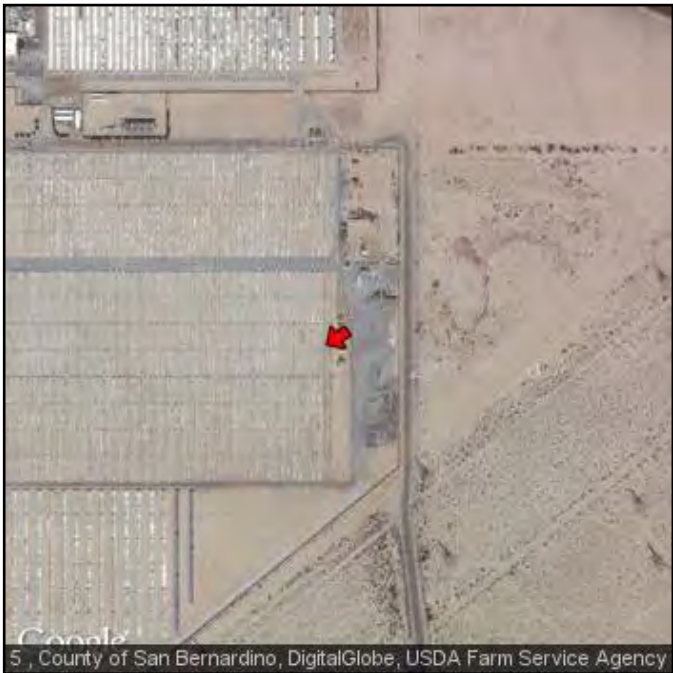
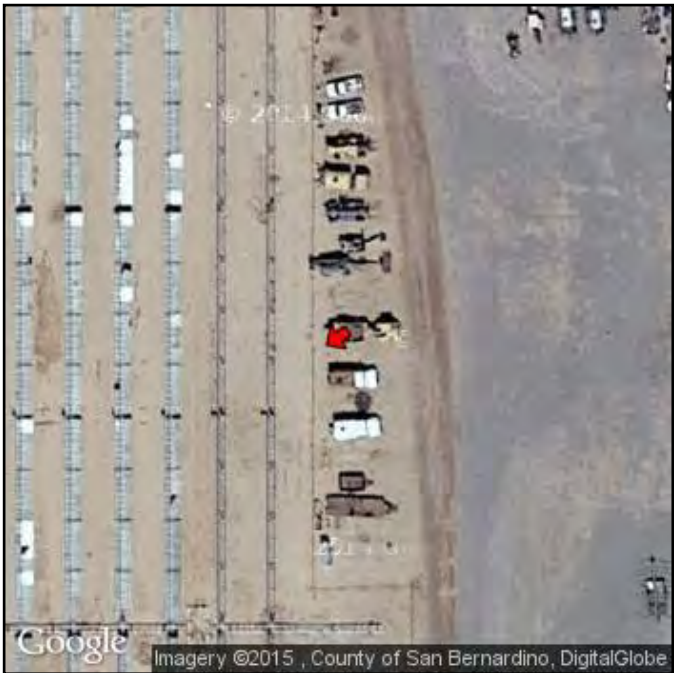
Attributes	
Comments	Soil boring M-6 located in the remediated oil area.
Photo ID	47

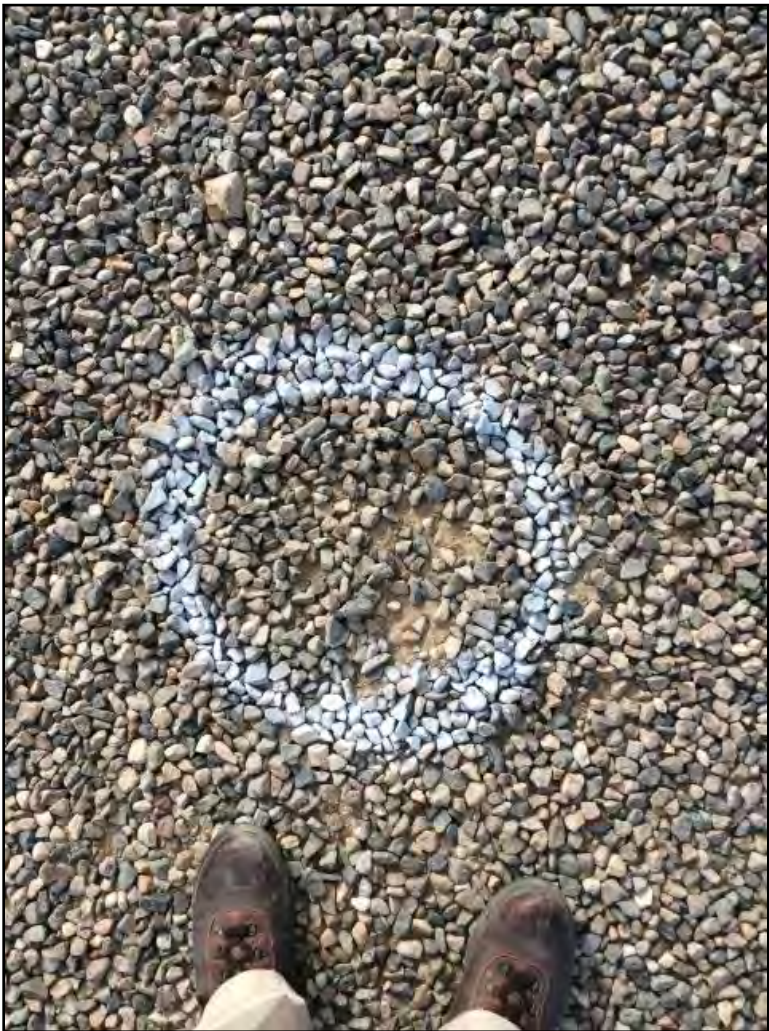
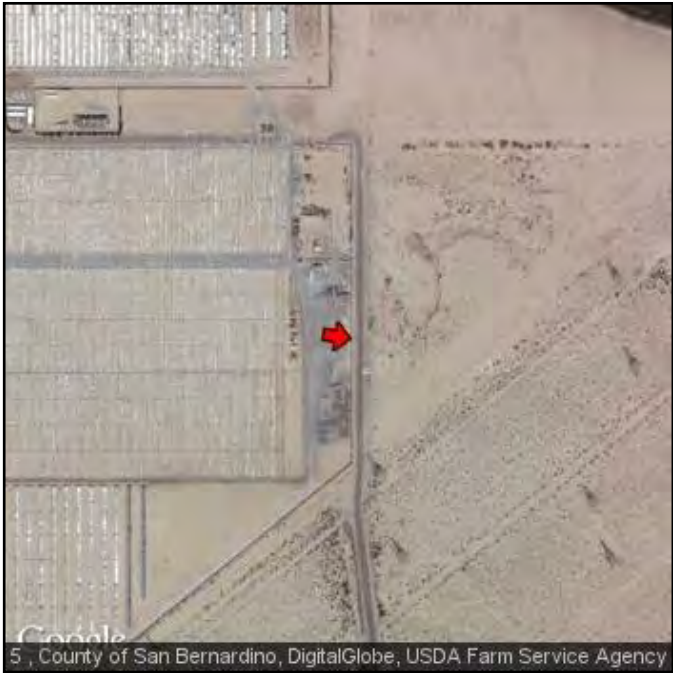
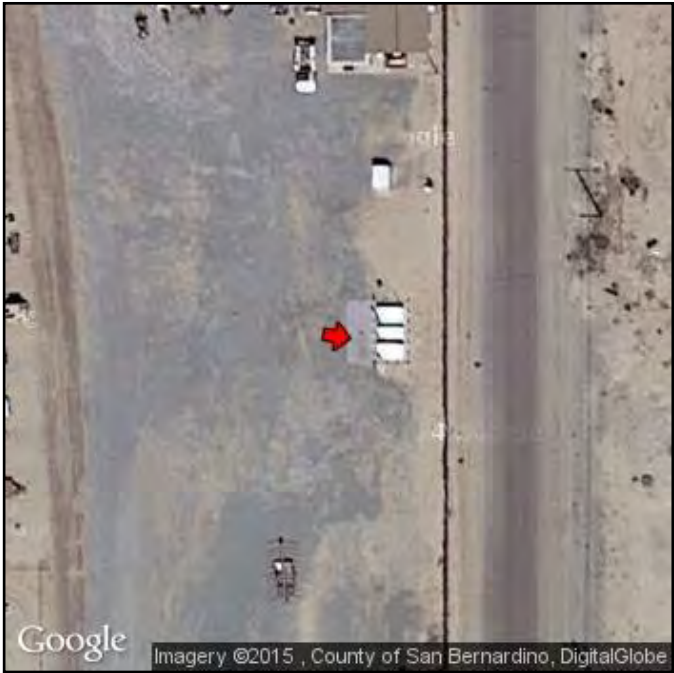
Attributes	
Comments	42m5 by gas tanks
Photo ID	48
